## SEWER INSPECTION REPORT

Rick Coffman  
(858)-257-2888  
Prepared - 8/13/2016

**123 Sample Street  
San Diego, CA 92128**

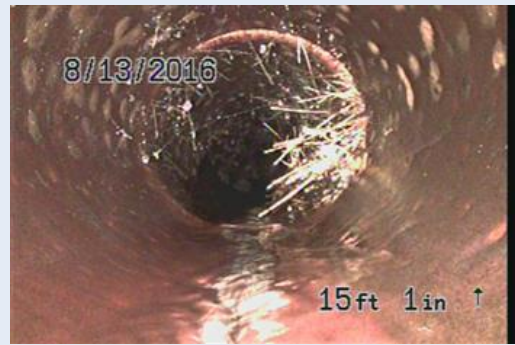
ABS under the house is open and in serviceable condition. ABS outside of the house to the cleanout access in the front yard is open and in serviceable condition. Clay from the front yard cleanout to the city main is damaged (area was located and marked with tape in the street) and has roots in one connection.

Roots in the Clay

\* Recommend cabling annually as maintenance to remove roots and help prevent backups.

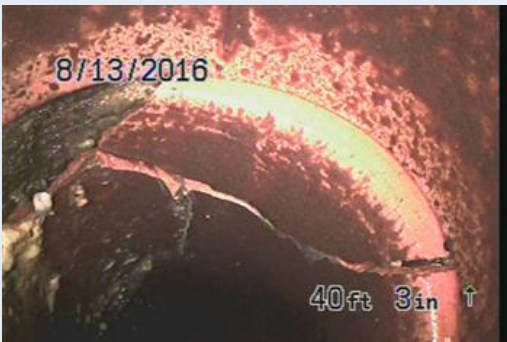
Damaged Clay connection

\* Recommend repair of the damaged Clay as needed by a reputable plumbing contractor. Inquire with the local municipality to see if they cover any sewer repairs under the street.

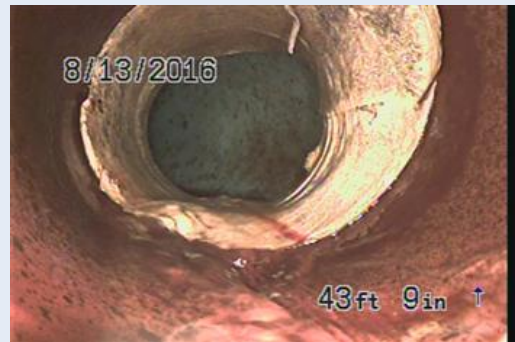
End of the city liner repair

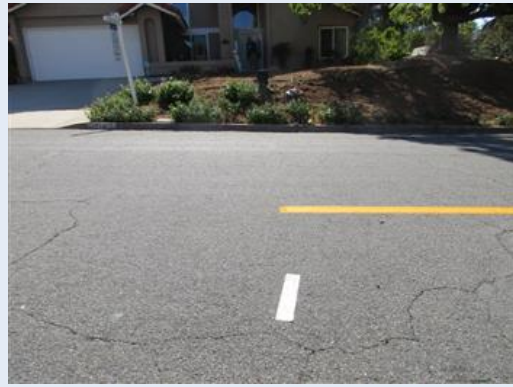
Tape marking the damaged Clay in the street
