Inspection Report

Property Address:
4321 Smth Dr
La Mesa CA 91941

The Property Inspection Pros

Date: 6/13/2024	Time: 09:00 AM	Report ID:
Property: 4321 Smth Dr La Mesa CA 91941	Customer: Jimmy Johns	Real Estate Professional:

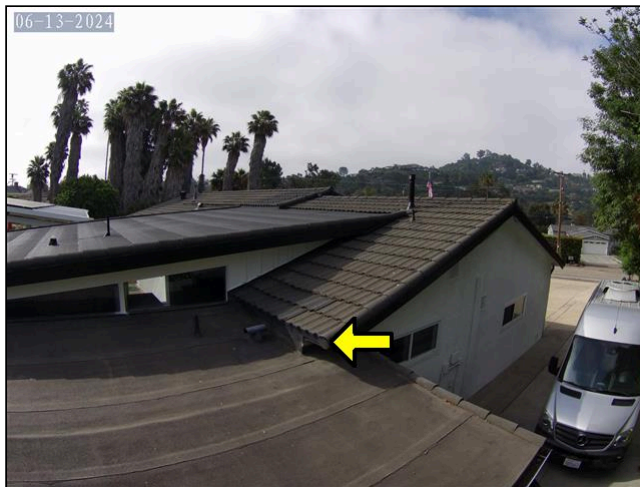
1.3 Item 1(Picture)

(1) Some rain gutters and downspouts are present/ installed. A complete rain gutter system helps control water flow and keeps moisture away from the foundation/ structure. We recommend having additional gutters and downspouts installed where needed by a qualified licensed contractor as an upgrade.

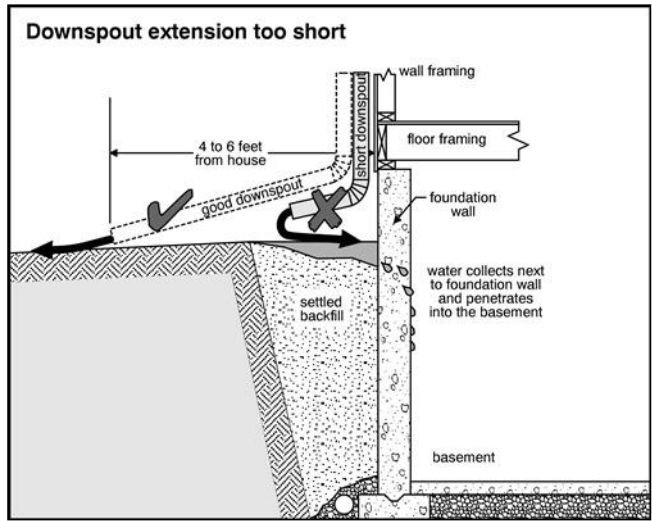
1.3 Item 2(Picture)

(2) Some of the downspouts need extension and/or a buried drain line to carry water away from the home at several areas. We recommend necessary corrections where needed by a qualified contractor.

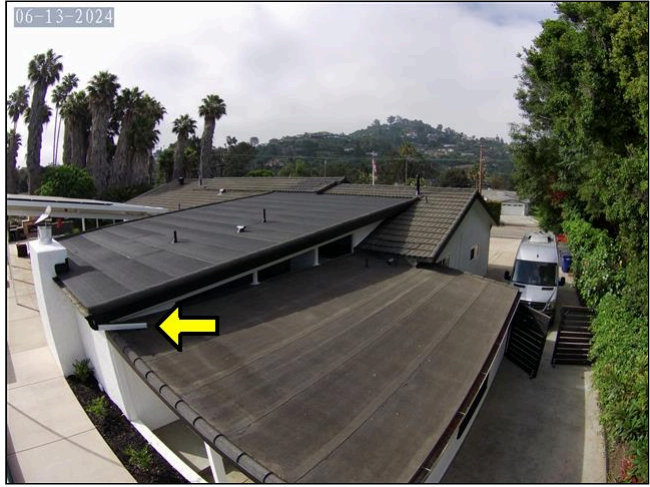
1.3 Item 4(Picture)

(3) There is an upper level roof downspout that is discharging water onto the lower roof. This causes excessive water to flow in a concentrated portion of the roof causing wear, and staining. During heavy rain water can also be forced under the roofing material causing leaks. We recommend rerouting the downspout to direct water away from the lower roof to an approved location such as a lower gutter, or a downspout all the way to the ground by a qualified contractor.

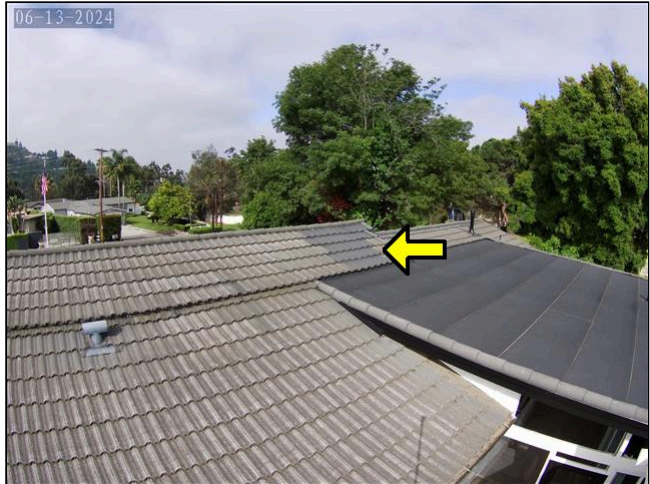
1.5 Item 7(Picture)

(2) The roof has had repairs made to it at several areas. We are unable to determine if these repairs are made correctly and successful. We recommend asking the seller about these repairs, and if concerned we recommend further evaluation by a qualified licensed

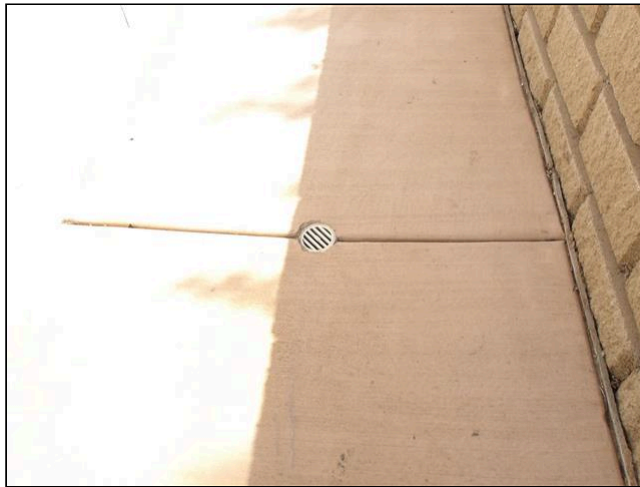
2.2 Item 1(Picture)

(1) Ground drain lines were visible in the yard at several areas. These drains are not tested for functional flow or adequacy. It is important to maintain these drains and prevent debris from entering. We recommend having all ground drain lines inspected and cleaned after moving into the property and on a periodic basis by a qualified person.

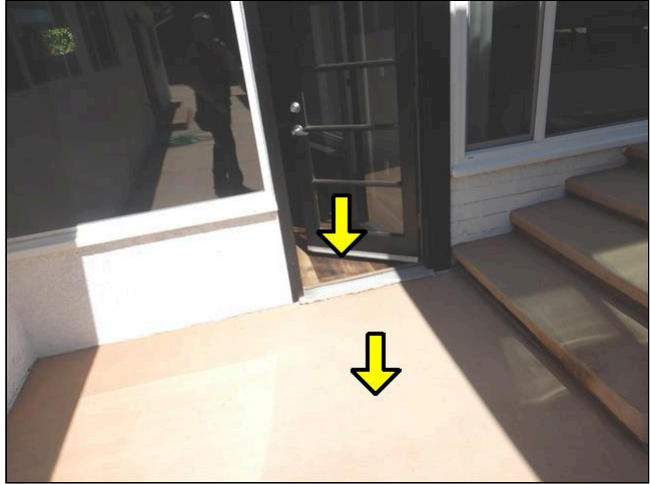
2.2 Item 3(Picture)

(3) This home has a slab which has been built at the same level or slightly above the soil outside. The ideal building will have interior floors that will be several inches higher than the exterior grade, and the building will have gutters and downspouts and a system of drainage designed to prevent any moisture from threatening the foundation or the living space. This property does not meet this ideal requirement. Repairs may be need to prevent damage/moisture intrusion. We recommend further evaluation and necessary repairs by a licensed landscaping contractor.

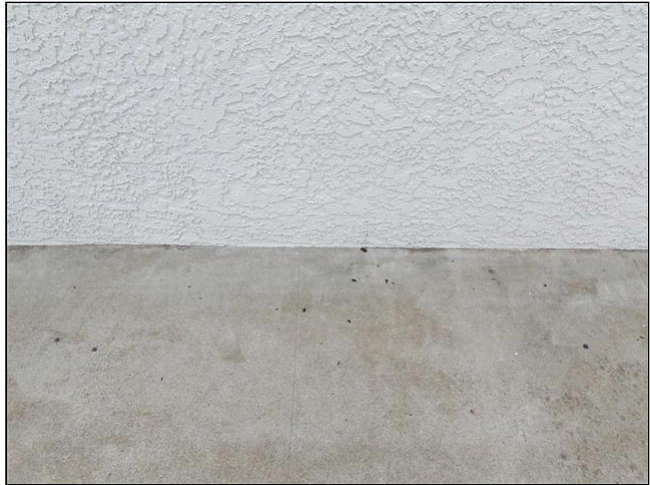
2.3 Item 1(Picture)

(2) Stucco on older homes built prior to the 1970's were installed without a weep screed. Since the stucco traverses the junction of the the concrete foundation and the wood frame walls, a horizontal crack is common. This is due to the inevitable movement of the walls in relation to the concrete foundation. This crack is unlikely to cause damage if it remains small. Patching this crack is a temporary measure. Installing a weep screed will be needed to avoid cracking. The Weep screed flashing will allow for movement between the wood frame wall and the foundation stem wall. (The weep screed is a metal band at the bottom of the stucco.) We recommend installing a weep screed by a licensed stucco repair contractor.

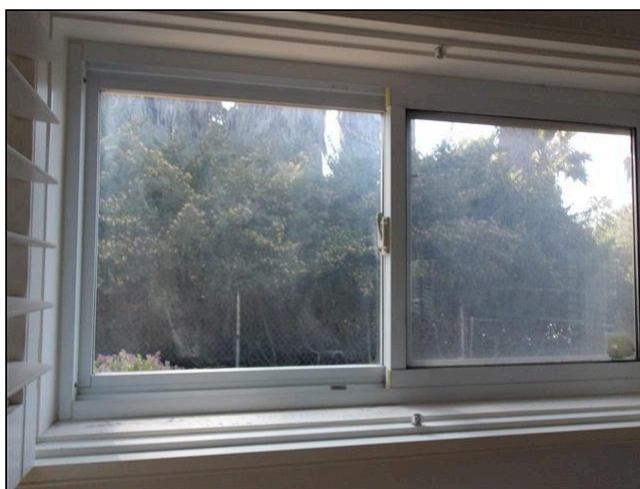
2.6 Item 2(Picture)

(2) Condensation was observed between the panes of glass at several windows throughout the house. This occurs when the seal has failed between the panes of glass, and ambient air has entered the assembly. Replacement of the glass is required. Since some failed windows may not be easily found due to changing ambient conditions (heat, humidity, etc). We recommend having all of the windows reviewed by a licensed window contractor to determine how many windows require repair/replacement. We recommend repairing or replacing all windows that have failed window seals by a licensed window contractor.

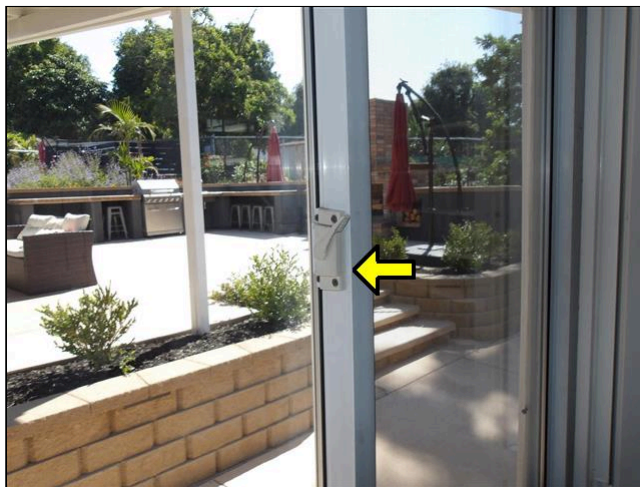
2.6 Item 4(Picture)

(3) Window latches are inoperable at several windows throughout the house. We recommend necessary repair or replacement by a qualified licensed window contractor.

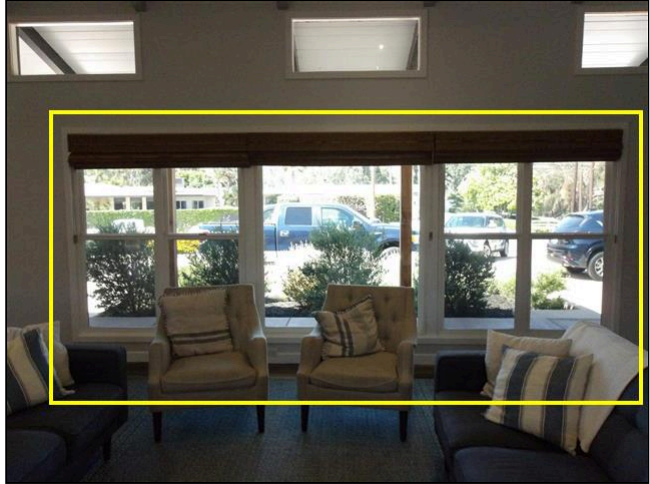
2.7 Item 1(Picture)

(1) Window(s) in the family room do(es) not appear to have safety tempered glass as required. I could not find any markings on the glass which would confirm this safety feature. Having standard plate glass could cause serious injury if the glass breaks. While this may have been standard installation at the time of the original construction. We recommend upgrading the glass/ windows to tempered glass/ windows by a qualified licensed window contractor as a safety upgrade.

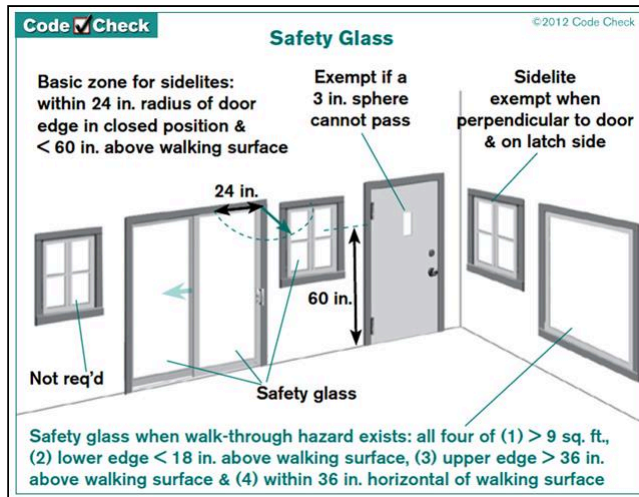
2.7 Item 2(Picture)

Since plate glass was acceptable at the time of construction, home inspectors can only recommend upgrades for safety, but sellers do not have to bring an old house up to today's building code. Also some safety glass cannot be identified without specialty testing equipment which home inspectors do not use. We recommend upgrading doors and windows as needed for safety by a qualified licensed window contractor.

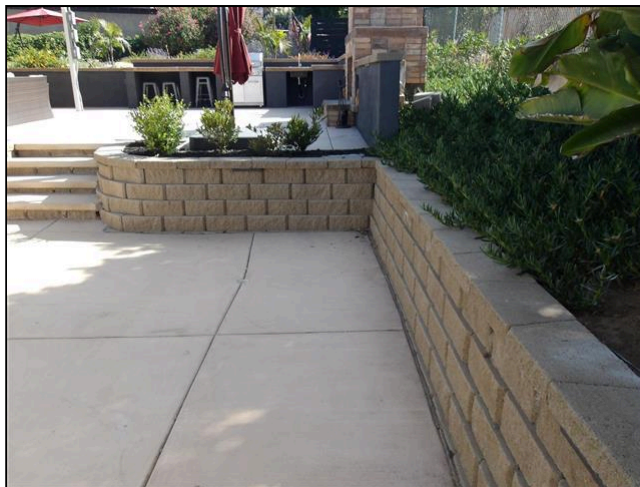
2.8 Item 2(Picture)

(2) There is a crack in the concrete patio. We recommend necessary repairs by a licensed concrete contractor.

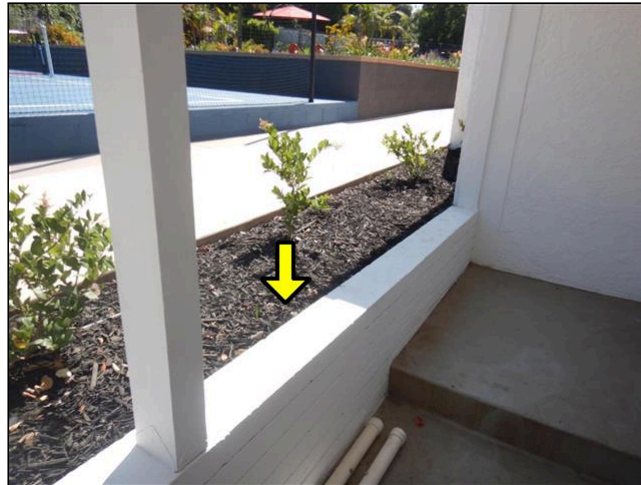
2.10 Item 1(Picture)

(1) A fence, barrier or guard rail is needed at several areas around the yard. A fall hazard is present at several areas. We recommend installing an approved fence, barrier, or guard rail where needed for safety by a qualified licensed contractor.

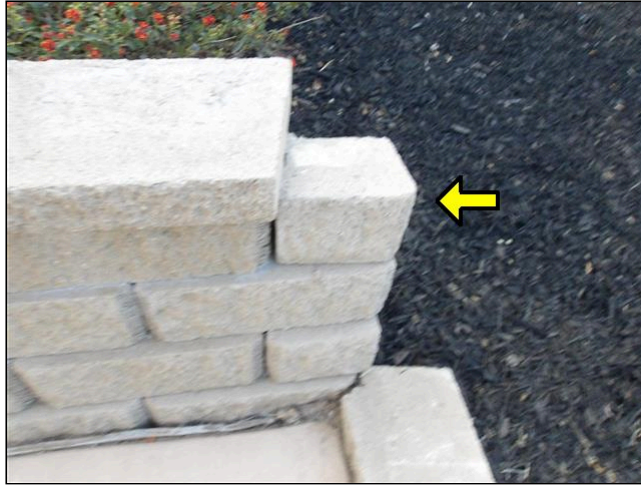
2.10 Item 3(Picture)

(2) The front yard masonry/ block wall is damaged/loose in several areas. We recommend necessary repairs by a qualified licensed contractor to help prevent further deterioration of the wall which could lead to instability.

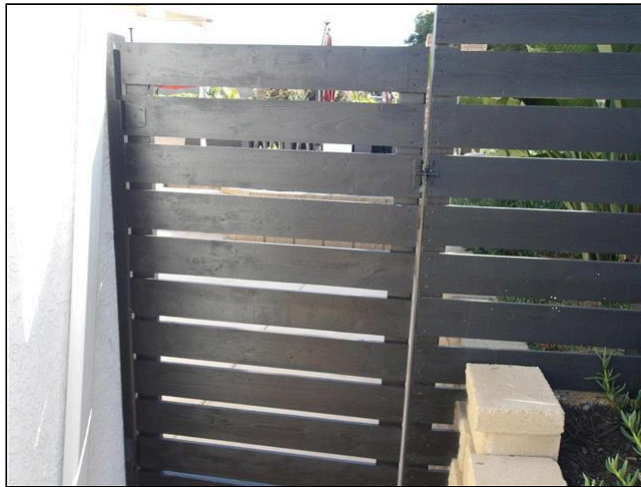
2.10 Item 4(Picture)

(3) The gates that give pool access are not compliant with common safety standards and should be corrected for safety. To help prevent child drowning, pool/spa area fencing and gates should be sixty inches tall and be non-climbable. Gates are required to self-close and include latches at forty-eight inches, and should open away from a pool or spa (so that a toddler could not push open an unlatched gate). We recommend further evaluation and necessary corrections and repairs by a licensed fence contractor or pool contractor.

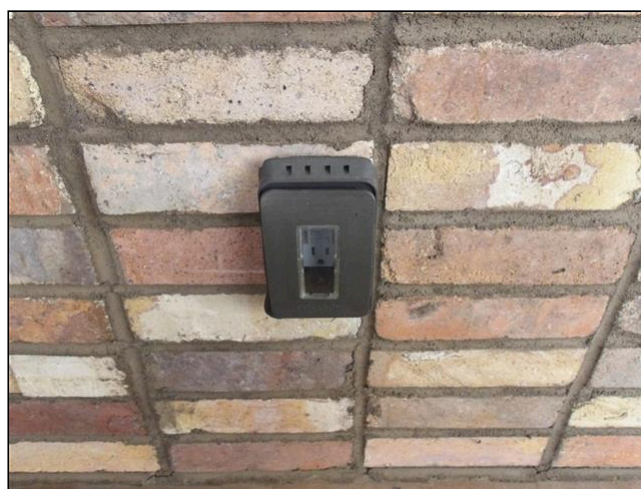
3.10 Item 2(Picture)

(3) Several GFCI receptacles located at the exterior walls of the house are not operating properly, or have failed as they did not trip when tested. The outlets may be defective or mis-wired. We recommend replacement where needed by a qualified licensed electrician.

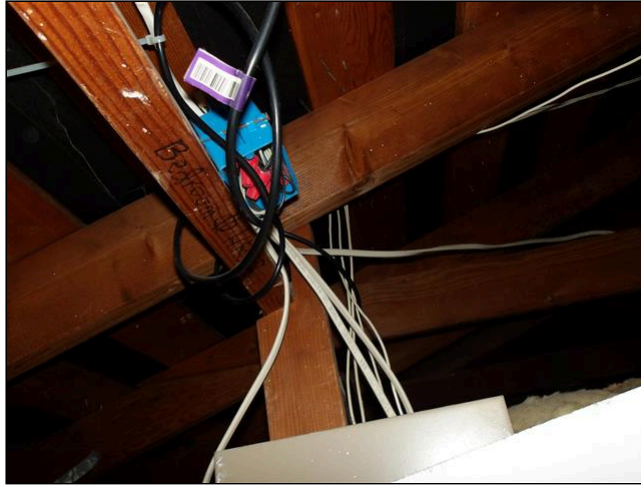
3.12 Item 1(Picture)

(1) Several open junction boxes observed in the attic. All electrical splices must be enclosed in a junction box. We recommend necessary repairs by a qualified person for safety.

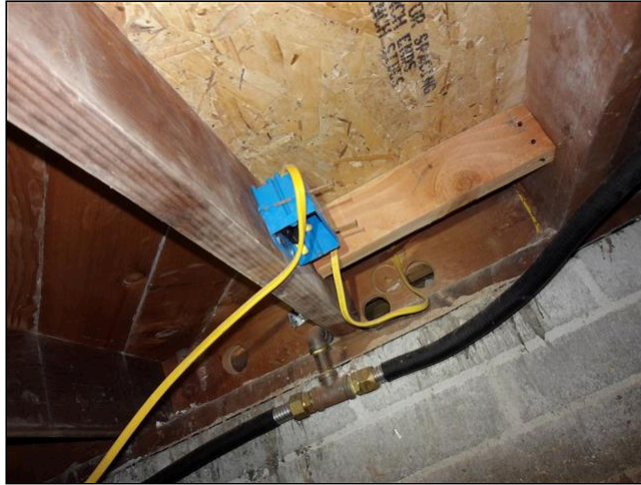
3.12 Item 4(Picture)

(2) Several open junction boxes observed in the crawlspace. All electrical splices must be enclosed in a junction box. We recommend necessary repairs by a qualified person for safety.

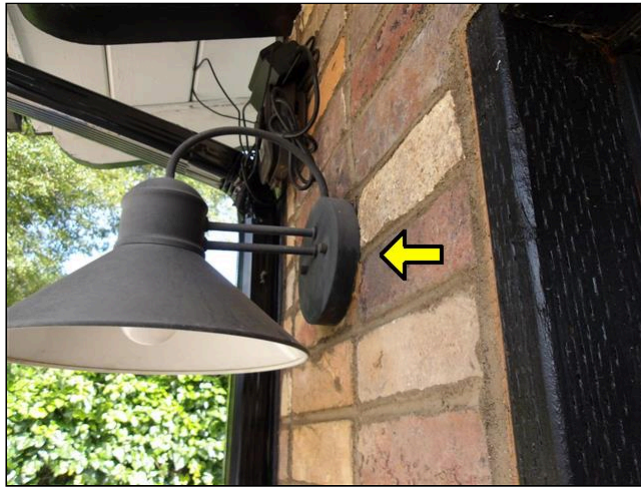
3.13 Item 1(Picture)

- (1) A representative number of exterior lights were tested and were found to be functional at the time of the inspection.
- (2) The exterior light fixtures were not sealed where the fixture meets the wall. This condition could allow moisture intrusion in this area. We recommend sealing exterior light fixtures where they meet the wall by a qualified person.

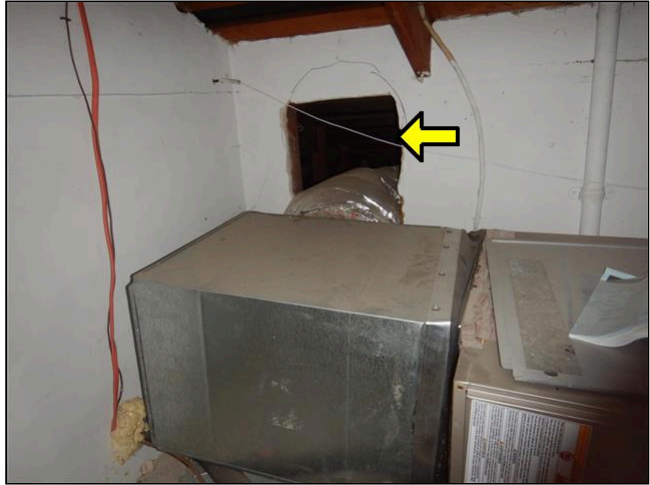
4.3 Item 1(Picture)

- (1) The walls have typical cosmetic wear. You may wish to view this for yourself and have necessary repairs made as needed by a qualified person.
- (2) There are several holes observed in the fire wall in the garage. Wherever the garage shares a wall with adjacent living space, the fire-rated sheetrock must be installed and intact for fire resistive performance. We recommend having the holes patched with fire-rated drywall or necessary corrections by a qualified licensed contractor.

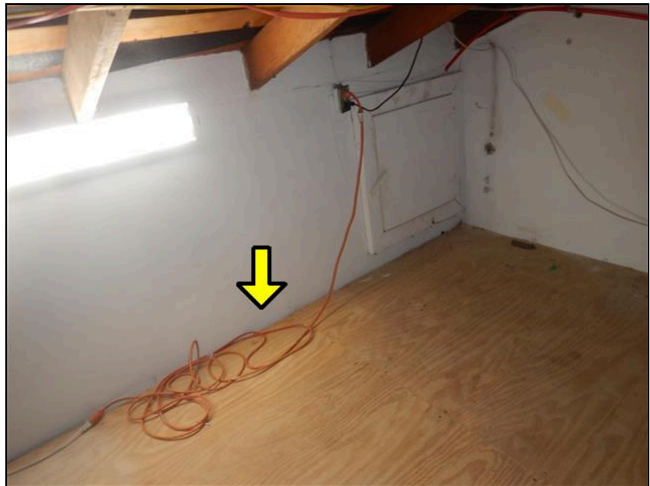
4.8 Item 3(Picture)

(3) There are extension cords that are being used as permanent wiring in the garage. Extension cords are considered for temporary use only and a safety hazard when used long term. We recommend removing the extension cords and replacing with proper wiring by a qualified licensed electrician.

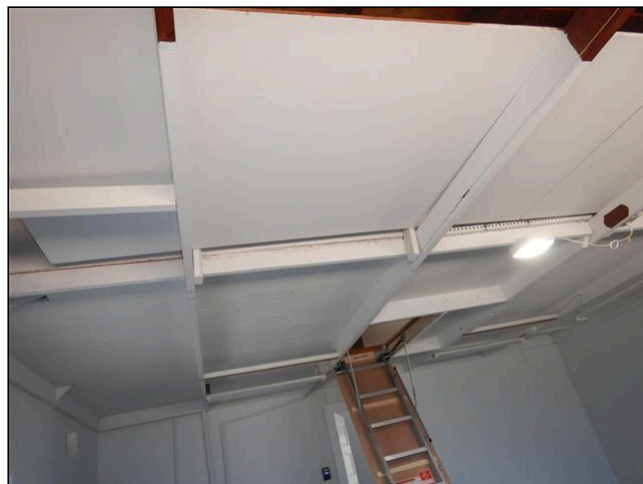
4.11 Item 1(Picture)

shelving does not appear to be constructed in a manner to carry a heavy load. This could be a safety hazard. We recommend removing this overhead shelving.

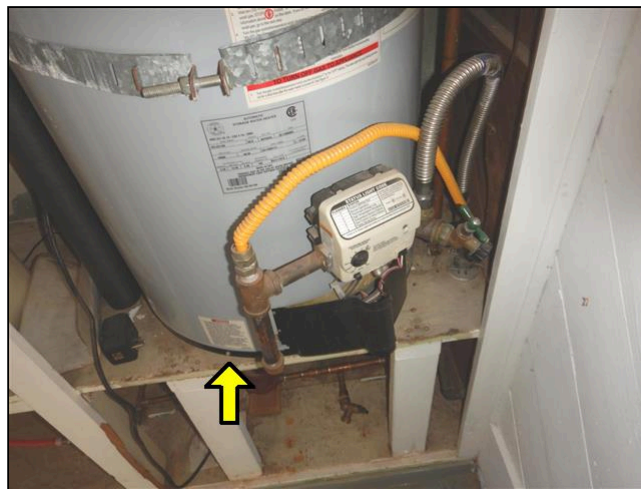
5.0 Item 3(Picture)

(3) A leak pan is not installed under the water heater. We recommend installing a leak pan under the water heater by a qualified licensed plumber.

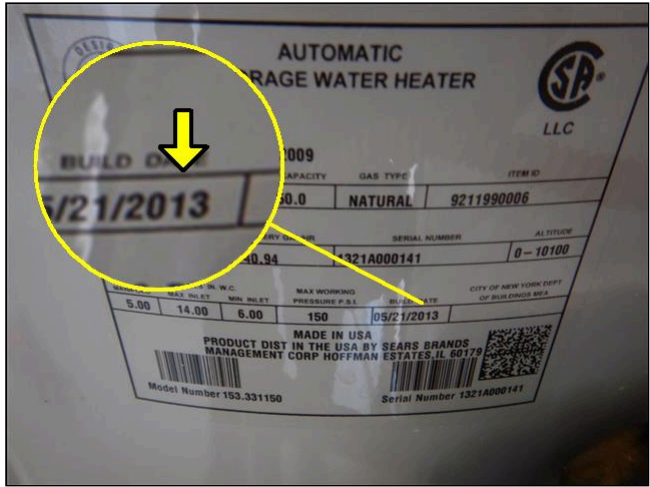
5.0 Item 4(Picture)

(4) The water heater is an older unit/ 10 plus years, and repairs or even failure can be expected. Based on manufacture's statistics the average life of a water heater is 7-10 years. We recommend replacing the water heater by a qualified licensed plumber.

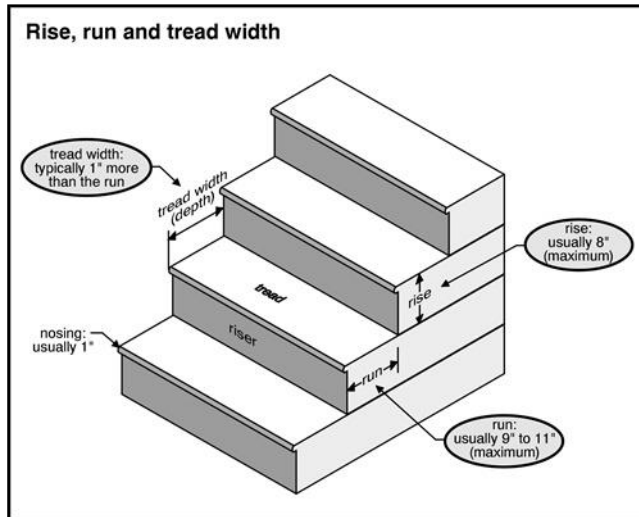
6.4 Item 1(Picture)

The garage stair length/height is non-standard and/or inconsistent. This is a possible safety concern. We recommend having the stairs corrected by a qualified licensed contractor.

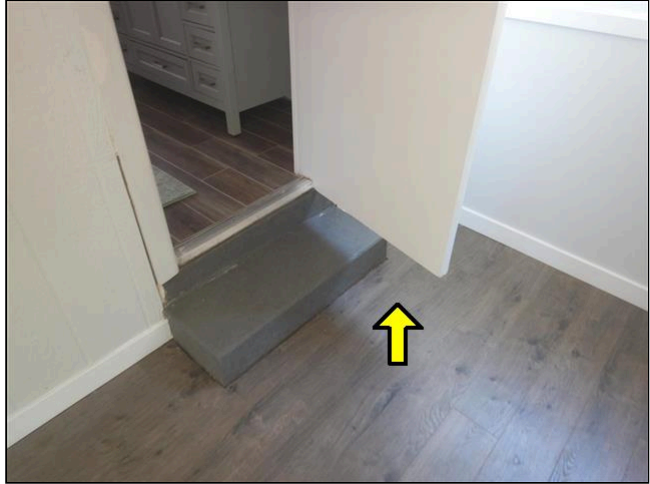
6.6 Item 1(Picture)

(1) A door swings over a lower floor level. Current building standards would require that a 36 inch landing no more than 1 inch lower than the threshold be installed so that the door does not swing over a lower floor level. This may have been acceptable at the time of construction and therefore the requirement is unknown. Recommend installing a proper landing by a qualified licensed contractor as an upgrade for safety.

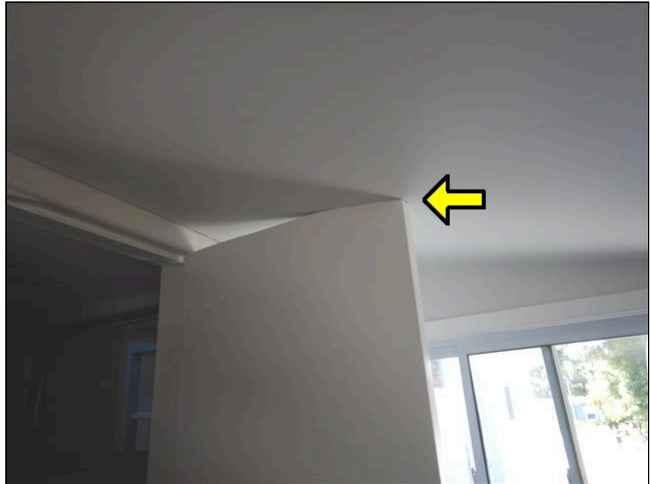
6.6 Item 2(Picture)

(2) A door rubs on the ceiling. We recommend necessary corrections by a qualified person.

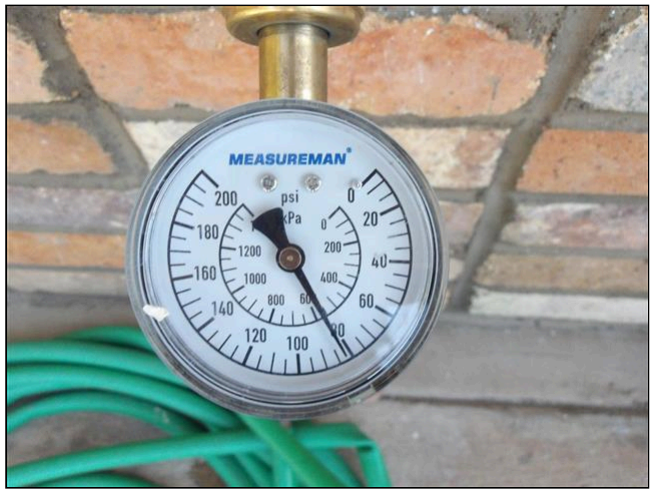
7.2 Item 1(Picture)

The water pressure was checked with a water pressure gauge and was measured to be higher than 80 PSI at the time of the inspection. This is to high and corrections are needed. We recommend further evaluation by a qualified licensed plumber for necessary repairs or corrections.

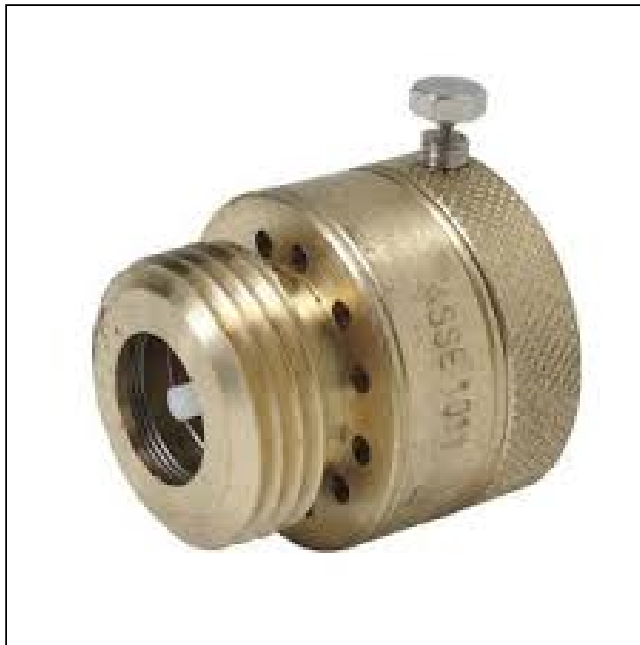
7.3 Item 2(Picture)

(2) The exterior hose spigots do not have anti-siphon or anti-backflow devices installed on them. These anti-siphon or anti-backflow devices help prevent contaminated water from flowing back into the the house water supply system. We recommend installing anti-siphon or anti-backflow devices at the every exterior hose spigots by a qualified person.

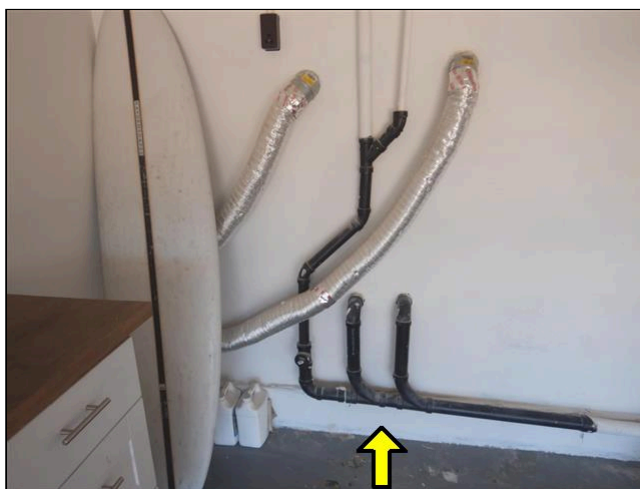
9.0 Item 1(Picture)

The laundry waste pipe(s) do not appear to have a P-Trap as required by today's standards. We recommend further evaluation by a licensed plumber. If one is not present, we recommend having one installed by a qualified licensed plumber.

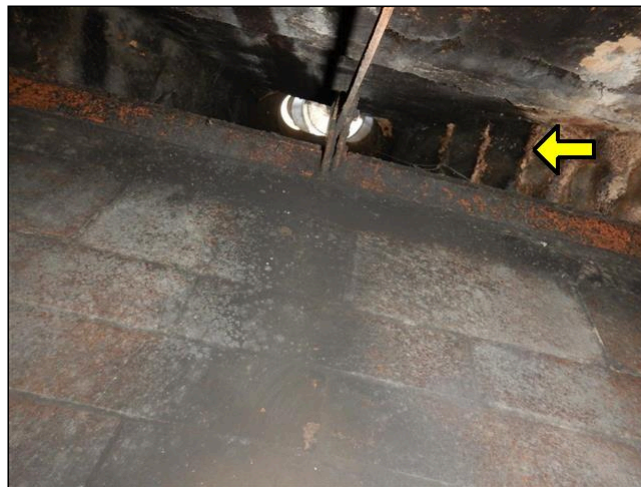
10.0 Item 1(Picture)

- (1) We recommend having the fireplace and chimney cleaned and inspected by a licensed chimney sweep for safety prior to using.
- (2) There is no liner in the flue of the brick chimney. Most chimney sweeps insist on a liner installation before considering the chimney safe to be used. We recommend having the chimney inspected and a liner be installed by a licensed chimney contractor prior to use.

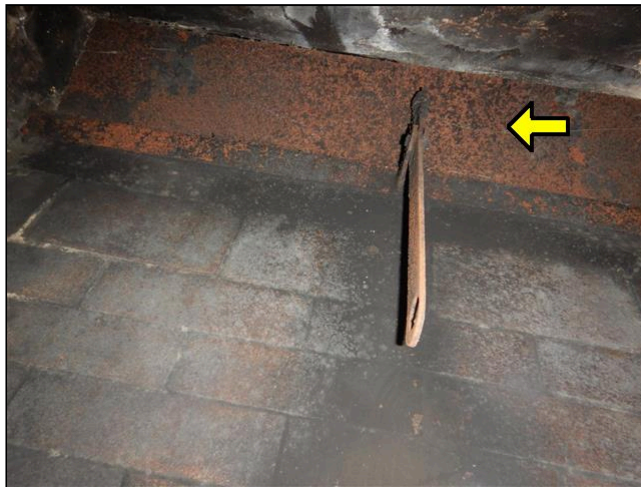
10.1 Item 2(Picture)

- (3) Some of the metal components inside the fireplace are rusted. We recommend further evaluation by a licensed chimney contractor and repairs made as needed.

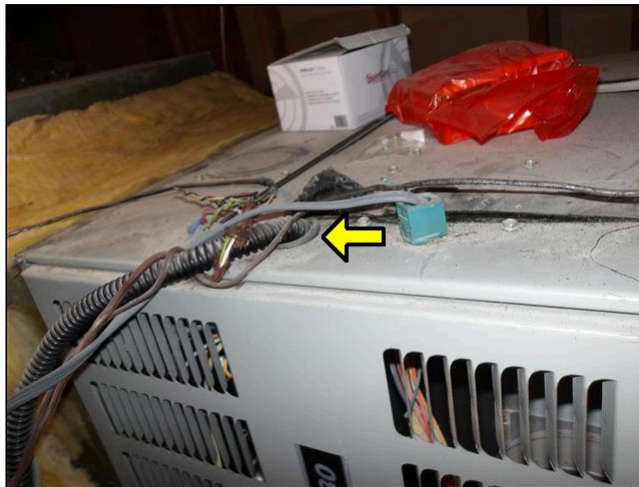
12.0 Item 7(Picture)

(5) The flexible gas supply pipe passes through the furnace housing. Vibration from the furnace can wear through flexible gas pipe which could cause a gas leak. SDG&E is "Red Tagging" this condition as they considered it to be unsafe. Due to this condition we recommend a rigid cast pipe be installed from the gas regulator through furnace housing, to the exterior of furnace housing by a qualified licensed HVAC contractor.
