Inspection Report

Property Address:
1221 Main Ave.
Oceanside CA 92056

The Property Inspection Pros

Date: 9/24/2024	Time: 01:00 PM	Report ID:
Property: 1221 Main Ave. Oceanside CA 92056	Customer: John Smitty	Real Estate Professional:

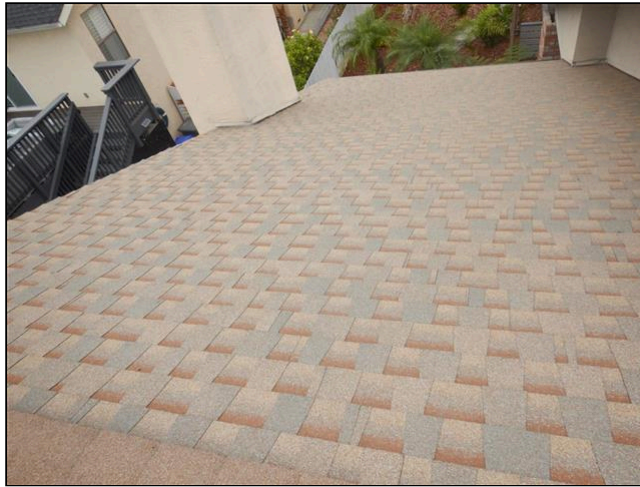
1.0 Item 3(Picture)

(2) The roof material shows normal wear for its age and type; appears to be in serviceable condition.

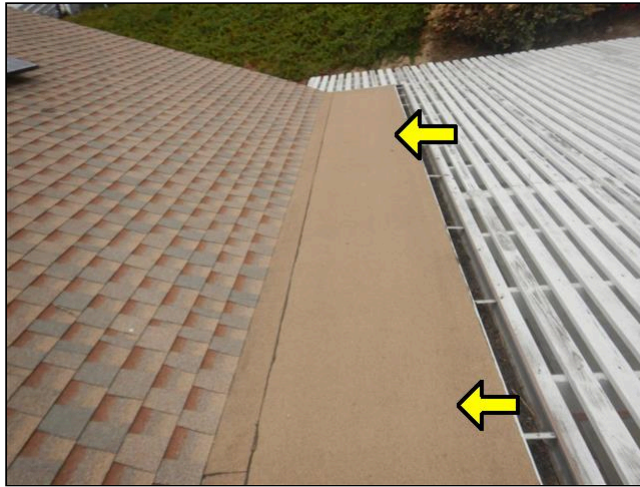
1.1 Item 1(Picture)

The flat roof material shows normal wear for its age and type; appears to be in serviceable condition.

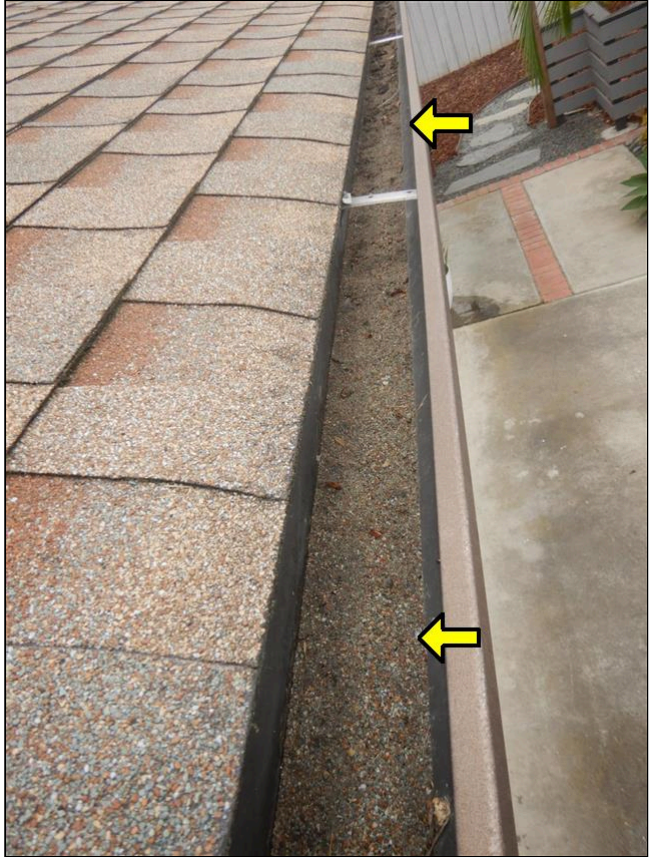
1.3 Item 1(Picture)

- (1) Gutters appear intact but due to the lack of recent or current rain I am unable to determine if the gutters leak at seams or drain properly.
- (2) Gutters require cleaning. We recommend having the gutters cleaned by a qualified contractor.

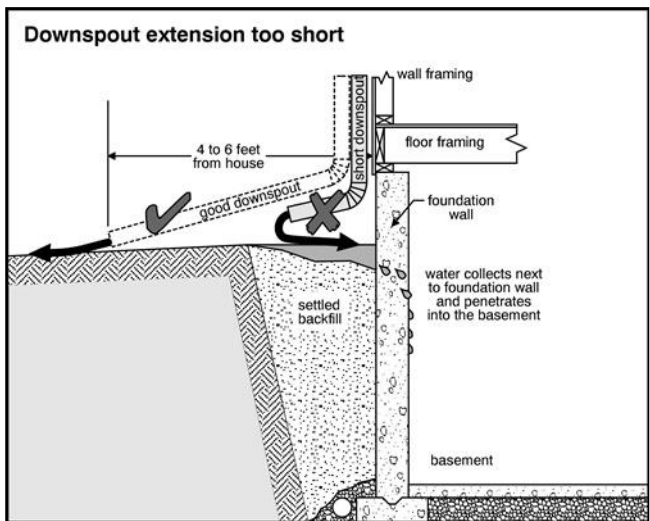
1.3 Item 2(Picture)

- (3) Some of the downspouts need extension and/or a buried drain line to carry water away from the home at several areas. We recommend necessary corrections where needed by a qualified contractor.

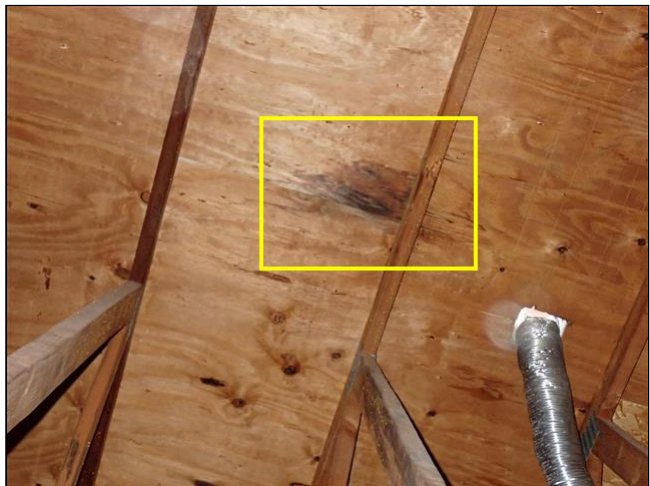
1.4 Item 1(Picture)

Stain(s) observed in the roof sheathing. Water stains on the ceilings, or on the framing within attics will not necessarily confirm an active leak without some corroborative evidence, and such evidence can be deliberately concealed. Without recent rain, determining if the active leaks are present is not possible within the scope of a home inspection. Consequently, only a licensed roof contractor can credibly guarantee that a roof will not leak. We cannot, and do not give any such guarantees. We will examine the roof, evaluate it, but we will not predict its remaining life expectancy, nor guarantee that it will not leak. However, given the current age and condition of the roof, active leaks are likely present. The sellers or the occupants of a residence will generally have the most intimate knowledge of the roof and of its history. Therefore, we recommend that you carefully read the transfer disclosure statement and that you either include comprehensive roof coverage in your home warranty policy, or that you obtain a roof certification from an established local roofing company. We recommend further evaluation of the roof by a licensed roof contractor prior to the close of your contingency period.

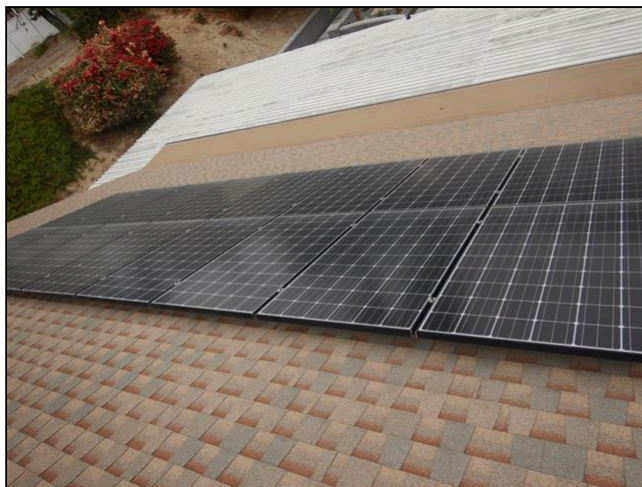
1.5 Item 1(Picture)

The electric solar system and its related components are beyond the scope of the home inspection and was not inspected. We recommend verifying that the electric solar system is operational prior to the end of your contingency period.

We also recommend having all the solar panels cleaned by a qualified person.

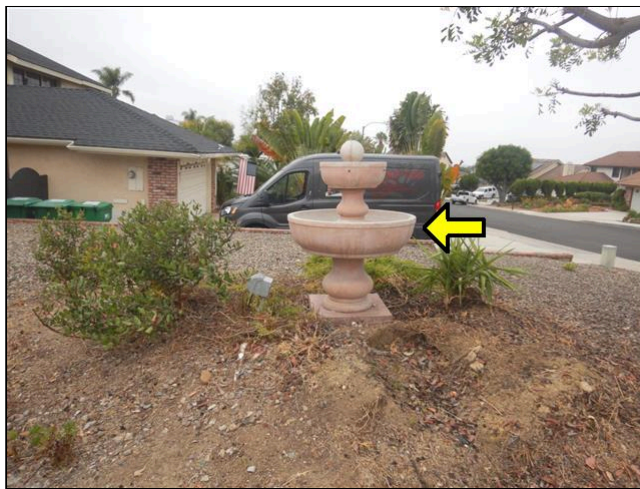
2.0 Item 1(Picture)

(1) Unsecured items in a yard may be hazardous. Inspecting unsecured items for proper installation is beyond the scope of our general home inspection. We recommend that any unsecured items be checked by you or by a qualified person to ensure proper installation.

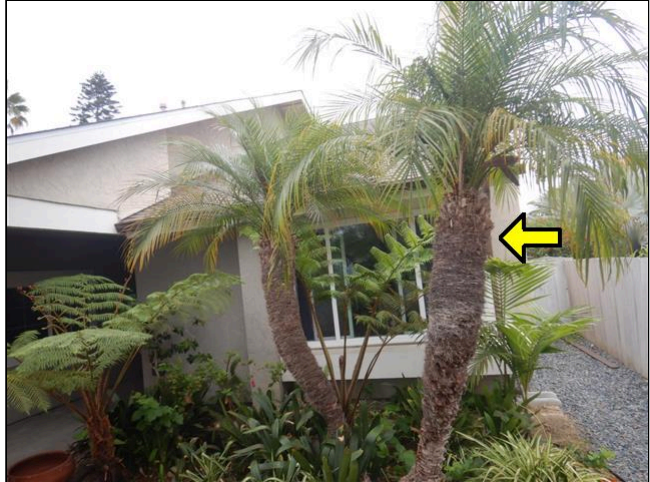
2.1 Item 1(Picture)

Tree(s) and/or large plants are located too close to the house. Tree limbs/vegetation that are too close to the house can cause damage in several ways. Limbs or vines in contact with roof or hanging near roof should be trimmed to prevent damage to roof and/or to prevent rodent infestation. Also, as the plants grow, damage can occur to the siding, concrete flat work and to the foundation. We recommend having the foliage removed or trimmed by a qualified professional to prevent damage to the house as soon as possible.

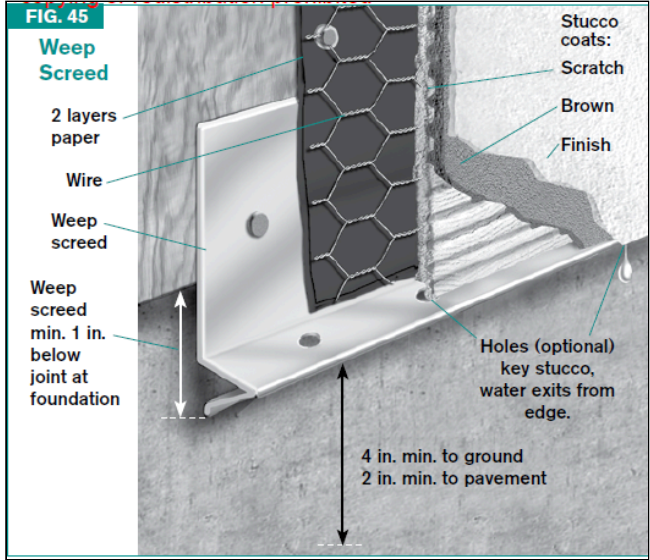
2.2 Item 1(Picture)

(1) The stucco/weep screed is in contact with ground/ concrete patio at several areas. The weep screed is the metal band at the base of the stucco which has holes to allow the stucco to "breathe" and water to "weep" from the stucco. Having the soil above the weep screed can lead to stucco damage due to limited air flow. We recommend a ground clearance of four inches where possible allow for proper drainage and for ventilation of the stucco walls. Dirt in contact with the stucco can promote deterioration, including rot, pest infestation, and water intrusion during rain. We recommend further evaluation and necessary corrections by a qualified licensed contractor.

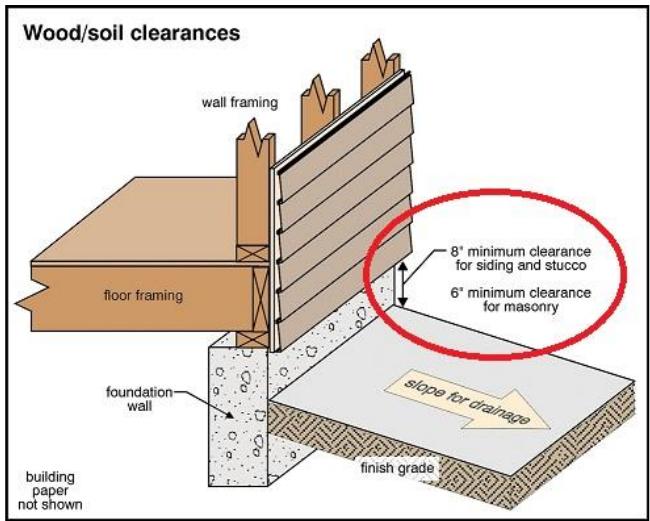
2.2 Item 4(Picture)

(2) Siding at the ADU is in contact with the ground at several areas. Dirt in contact with the siding can promote deterioration, including rot, pest infestation, and water intrusion during rain. We recommend a ground clearance of four to six inches where possible by a qualified contractor.

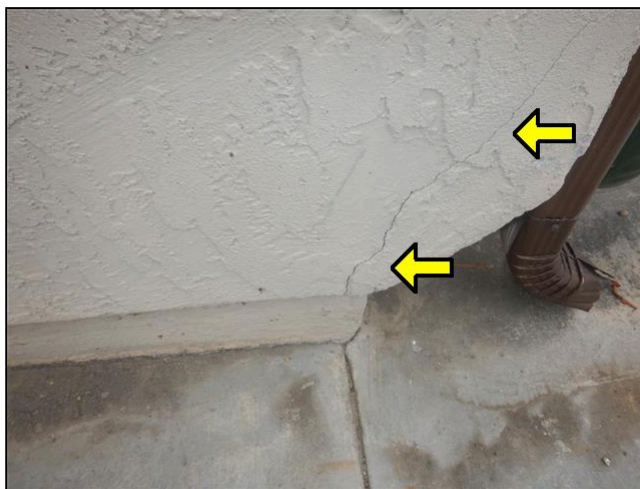
2.3 Item 2(Picture)

(2) Hairline cracking was observed at the stucco at several areas. The cracks are less than 1/8 inch in width, and generally considered common in this material. These cracks should be caulked and painted where possible. If cracks increase in width, it may indicate that structural movement is occurring. Determining this is beyond the scope of a home inspection.

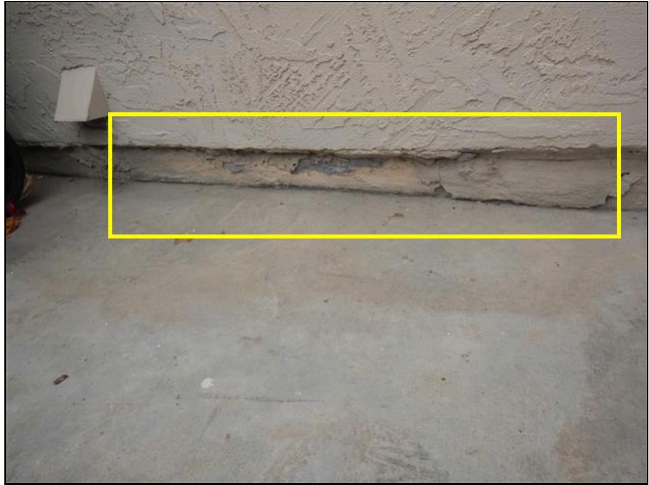
2.3 Item 7(Picture)

(4) The stucco skim-coat is deteriorating in areas around the foundation stemwall. This is typical cosmetic damage. If concerned we recommend necessary repairs by a licensed qualified contractor.

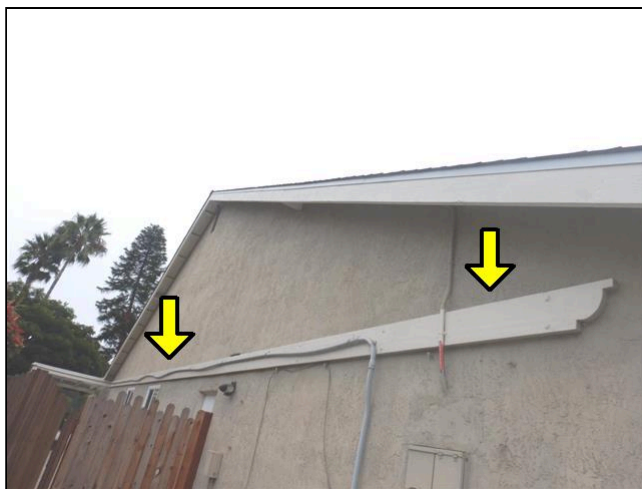
2.8 Item 4(Picture)

(3) The left side ledger board does not appear to be properly flashed or sealed to the siding or stucco wall(s). This condition is conducive to moisture intrusion and damage in this area. We recommend further evaluation by a qualified licensed contractor and necessary repairs made as needed.

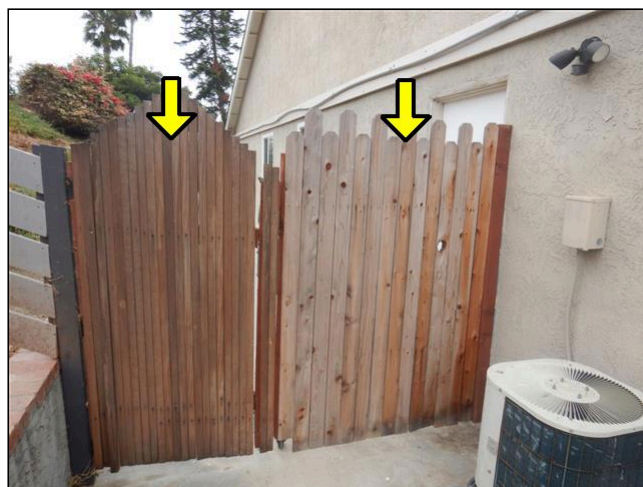
2.10 Item 3(Picture)

(2) The wood fencing/ gates are not painted or stained at several areas. Maintaining paint and/ or stain is essential to preventing the wood from deteriorating and damage. We recommend prep and painting or staining as needed by a licensed paint contractor.

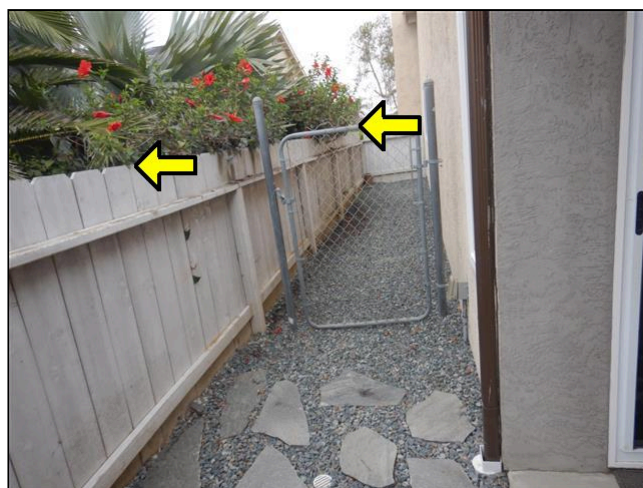
2.10 Item 4(Picture)

(3) Vegetation is growing on the fence in several areas. Vegetation can hold moisture to the fence and cause excessive weight and damage. We recommend trimming back and removing the vegetation by a qualified licensed landscaper.

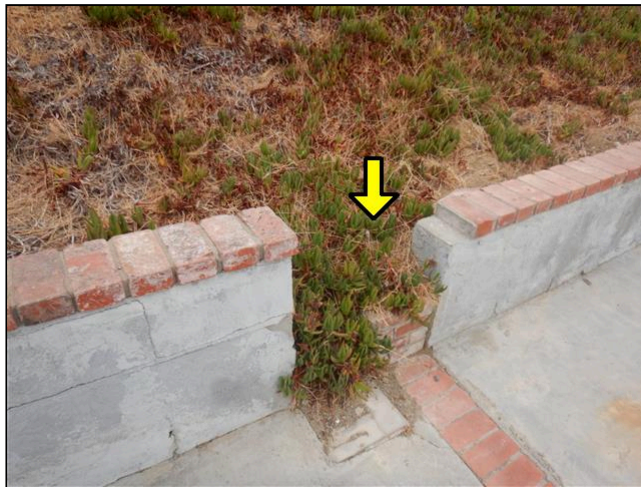
2.13 Item 1(Picture)

(1) There is missing masonry blocks and bricks missing at the front retaining wall. We recommend necessary repairs where needed by a qualified licensed contractor.

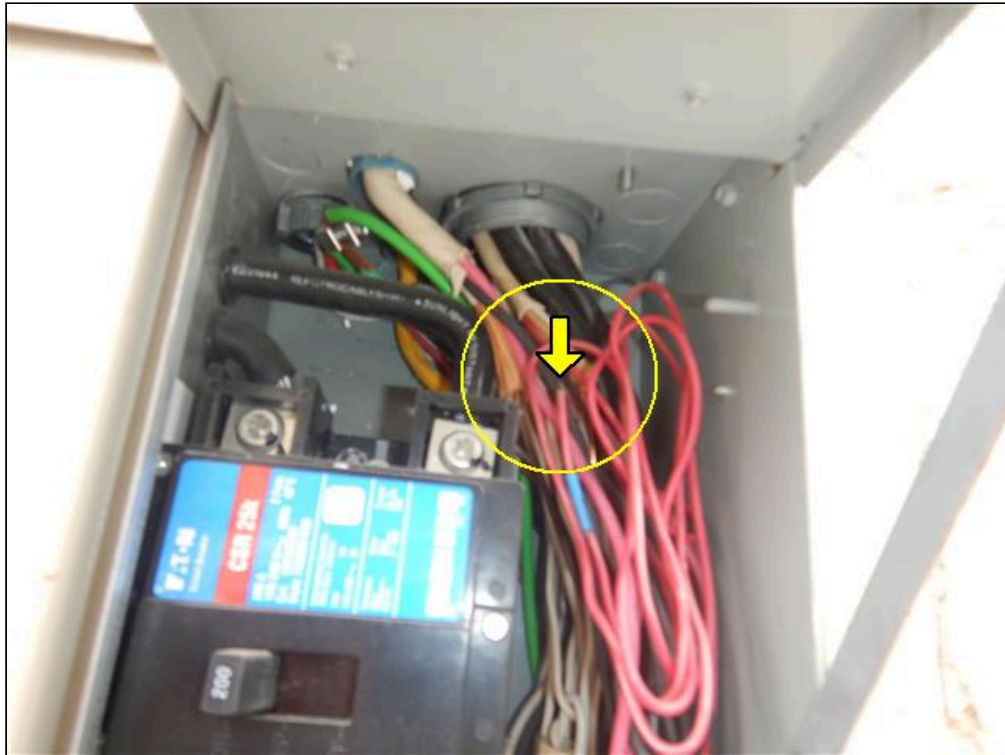
3.0 Item 2(Picture)

(2) There are improperly terminated wires observed in the main electrical panel. These wires must be properly terminated for safety. We recommend necessary corrections by a qualified licensed electrician.

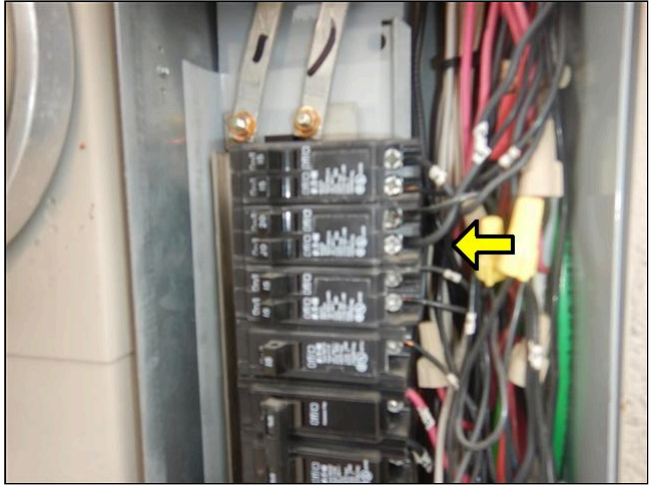
3.2 Item 2(Picture)

(2) The wire size and breaker rating are not compatible at several circuit breakers. This is non standard and corrections are needed. We recommend necessary corrections by a qualified licensed electrician.

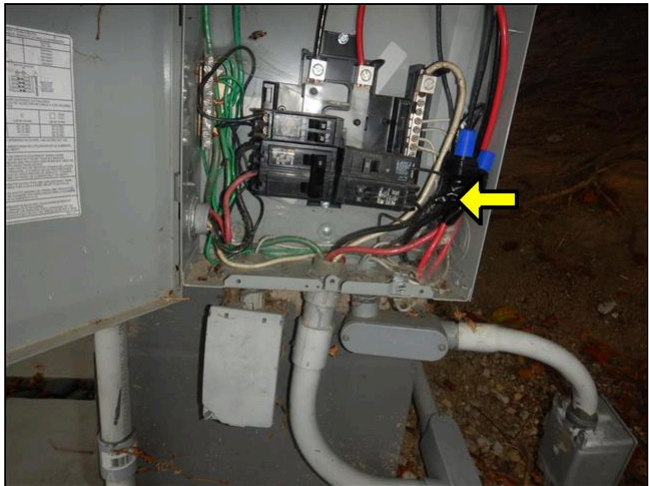
3.2 Item 3(Picture)

(3) The wire size and breaker rating are not compatible at several 20 AMP circuit breakers. This is non standard and corrections are needed. We recommend necessary corrections by a qualified licensed electrician.

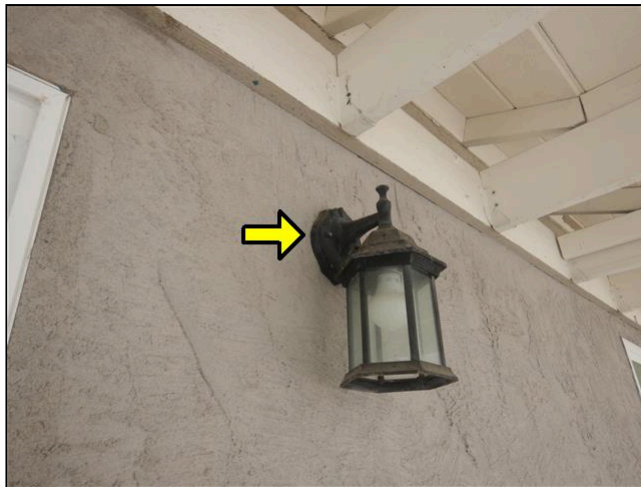
3.11 Item 2(Picture)

(2) The exterior light fixtures were not sealed where the fixture meets the wall. This condition could allow moisture intrusion in this area. We recommend sealing exterior light fixtures where they meet the wall by a qualified person.

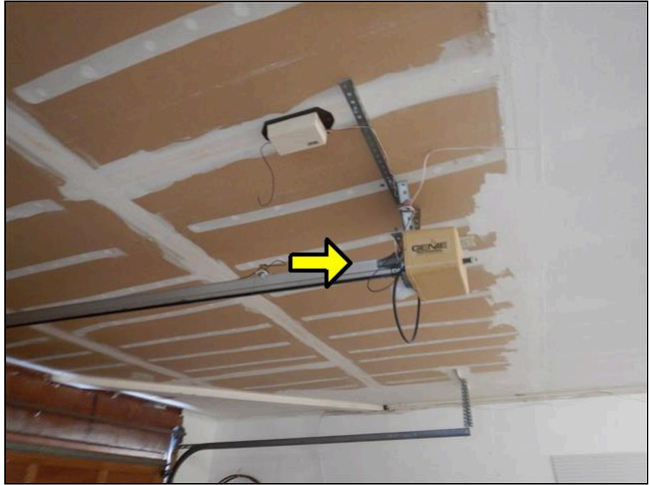
4.1 Item 1(Picture)

- (1) As of July 1st 2019 all garage door openers are required to have a battery back up that is designed to operate when activated due to an electrical outage. Replacement of the garage doors connected to an automatic opener requires updating to a battery backup type. Verification of compliance is beyond the scope of this inspection. Client is advised to verify compliance and update if needed.
- (2) The garage door opener light cover is missing. We recommend replacing.

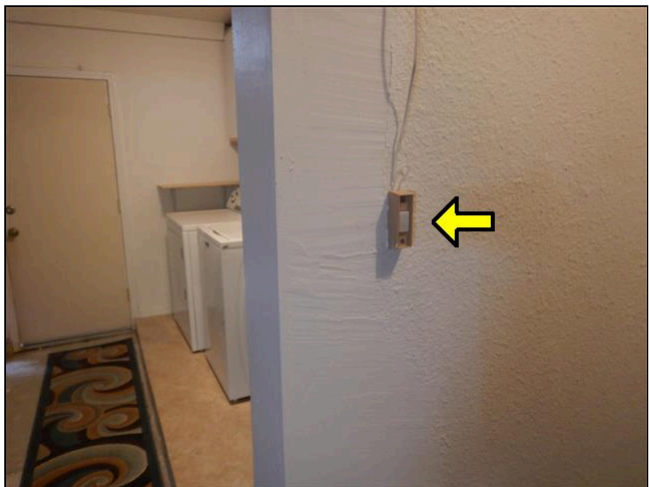
4.1 Item 2(Picture)

- (3) The garage door push-button switch was lower than the recommended 5-foot minimum height above the standing surface. This condition is potentially dangerous to children. We recommend that the switch be raised to the 5-foot minimum or higher by a qualified licensed garage door contractor for safety reasons.

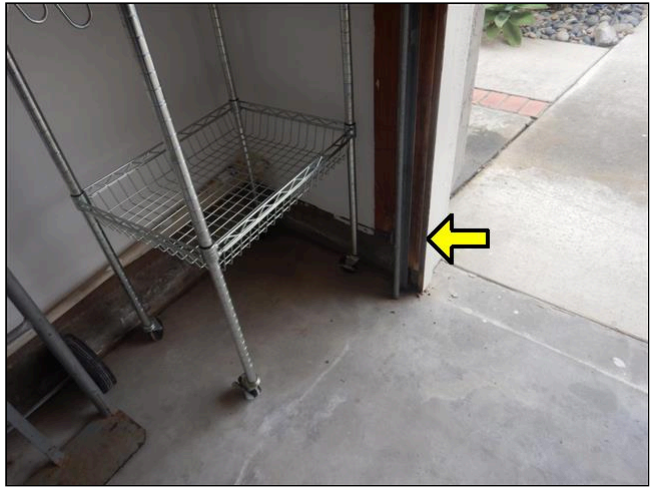
4.1 Item 3(Picture)

safety by triggering the vehicle door's auto-reverse feature without need for the door to come in contact with the object, person or animal that's preventing it from closing. We recommend having a qualified contractor install these devices for improved safety.

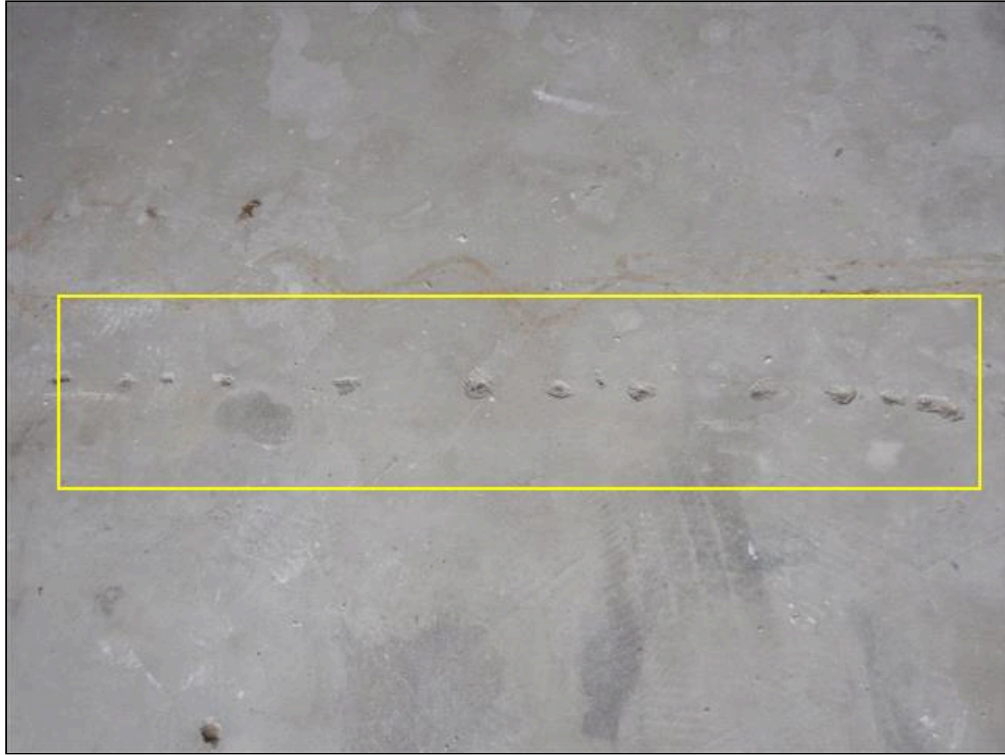
4.4 Item 1(Picture)

The garage slab has several holes/ pitted in several areas. We recommend necessary repairs by a qualified licensed foundation contractor.

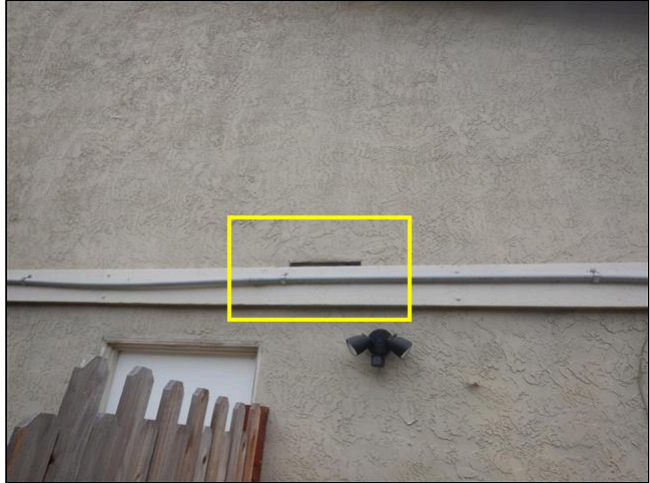
4.7 Item 1(Picture)

- (1) The screen material in the garage vents is damaged at some vents. This can allow rodent intrusion. We recommend replacing the screens as necessary by a qualified contractor.
- (2) A garage vent has been blocked or covered up. These vents are required to allow chemical or gas vapors to dissipate, and allow fresh combustion air for any gas burning appliances in the garage. We recommend restoring/ un blocking the vent openings as required by a qualified contractor.

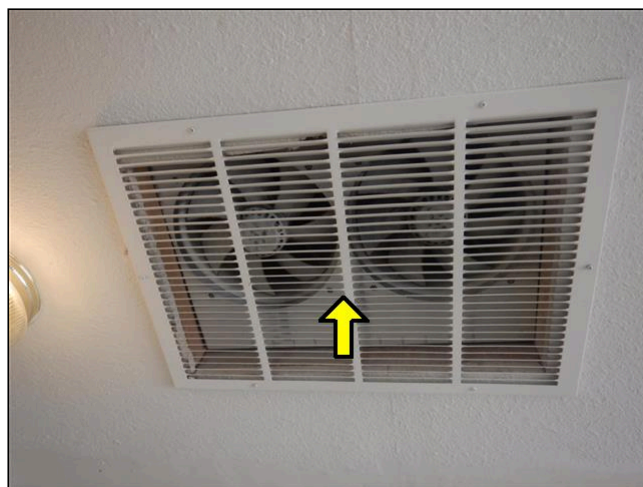
4.12 Item 1(Picture)

There is an un know fan in the garage ceiling. A switch to operate this fan was not found and it's operation could not be verified. We recommend asking the seller to verify proper operation prior to the end of your contingency period.

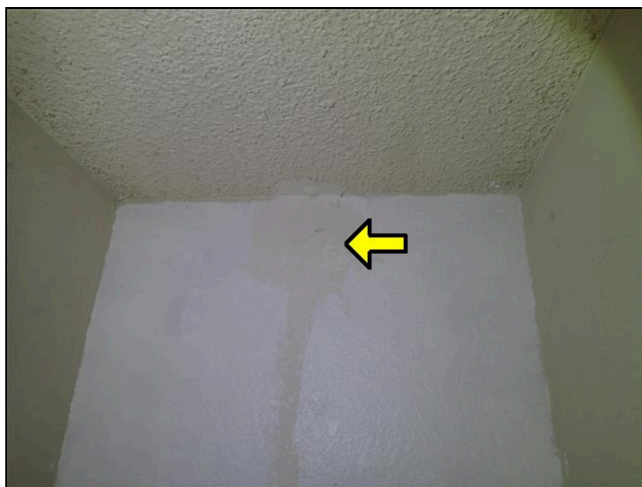
6.2 Item 3(Picture)

(3) Patching was noted at the walls in several areas. We recommend asking the seller if they have knowledge of the repair or cause.

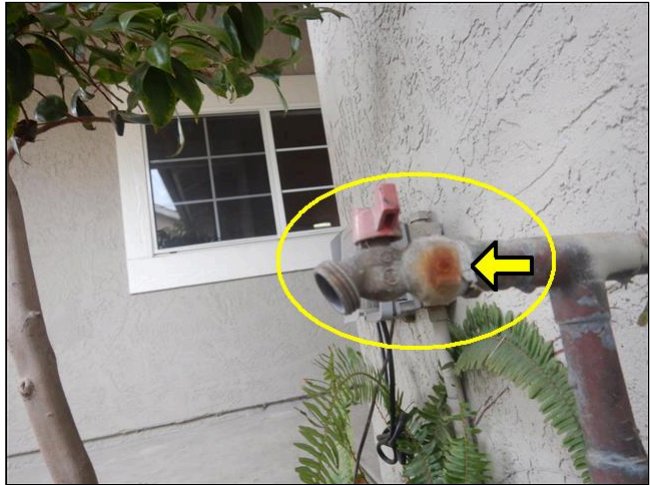
7.1 Item 1(Picture)

(2) A corroded pipe is observed at the front exterior wall of the house. We recommend further evaluation by a qualified licensed plumber and necessary repairs made.

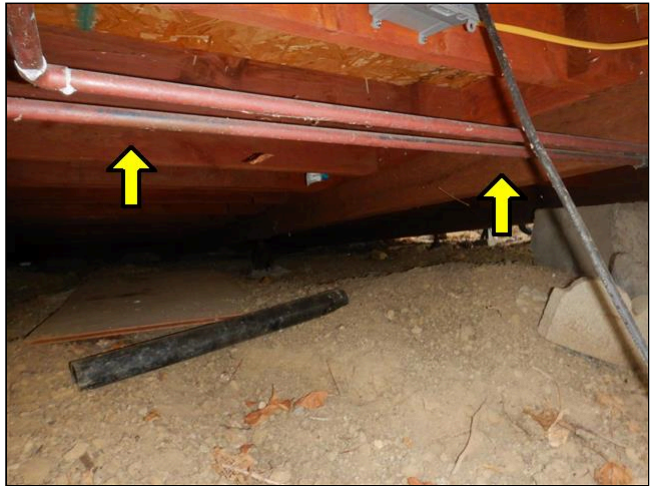
7.1 Item 2(Picture)

(3) There were un-insulated water supply pipes noted in the ADU crawl space area. All exposed water supply pipes, hot or cold should be insulated to help minimize heat loose. We recommend necessary corrections by a qualified licensed plumber.

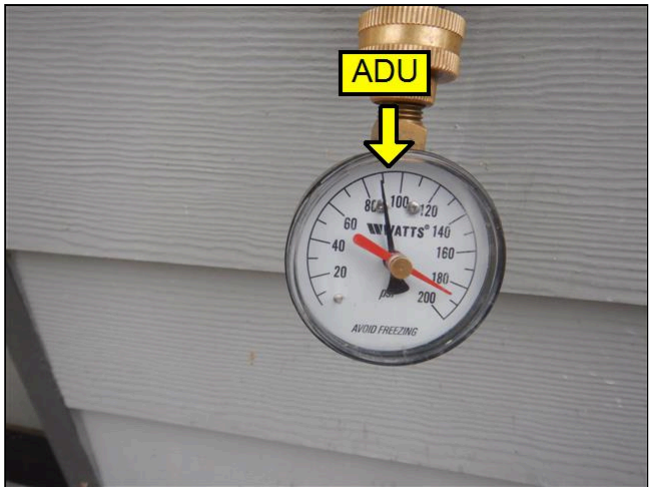
7.2 Item 2(Picture)

(2) The ADU water pressure was checked with a water pressure gauge and was measured to be higher than 80 PSI at the time of the inspection. This is to high and corrections are needed. We recommend further evaluation by a qualified licensed plumber for necessary repairs or corrections.

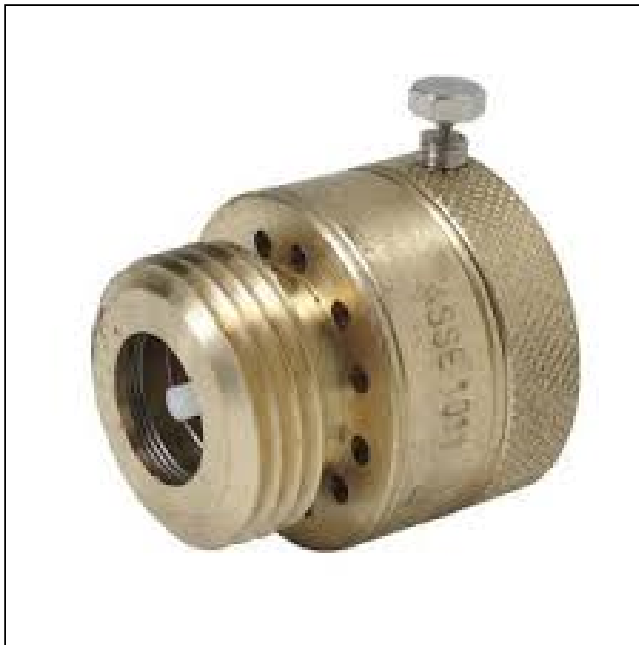
7.3 Item 2(Picture)

(2) The exterior hose spigots do not have anti-siphon or anti-backflow devices installed on them. These anti-siphon or anti-backflow devices help prevent contaminated water from flowing back into the the house water supply system. We recommend installing anti-siphon or anti-backflow devices at the every exterior hose spigots by a qualified person.

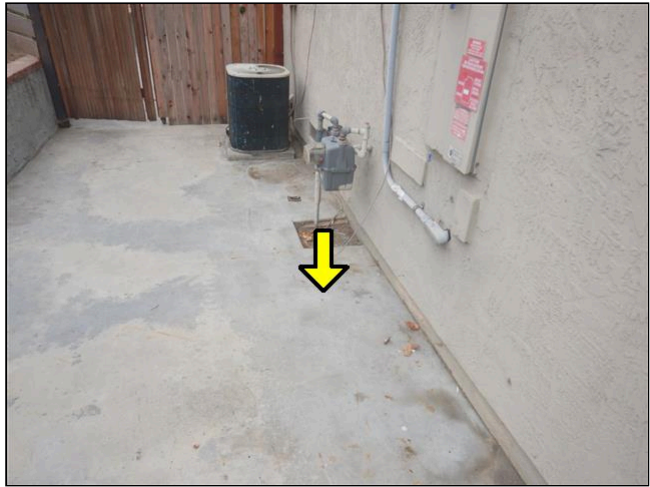
7.4 Item 1(Picture)

(1) The gas meter located at the rear of the house is subject to vehicle damage. We recommend adding a vehicle barrier (bollard) where needed by a qualified licensed contractor for added safety.

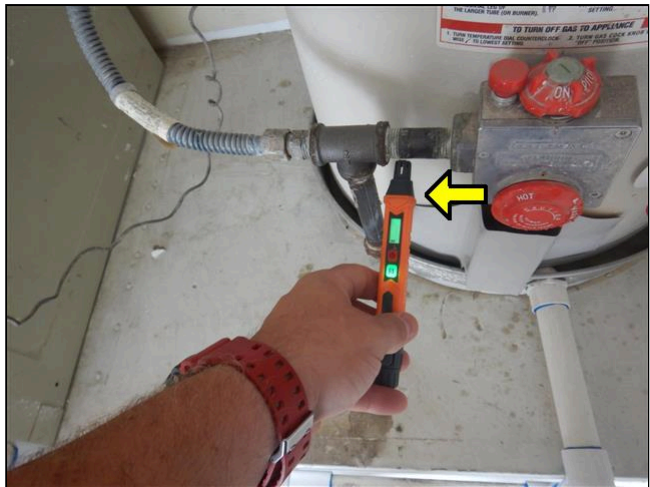
7.4 Item 2(Picture)

(2) A gas leak test was conducted at accessible gas fittings and appliances using a gas leak detector. There were no gas leaks detected at the time of the inspection.

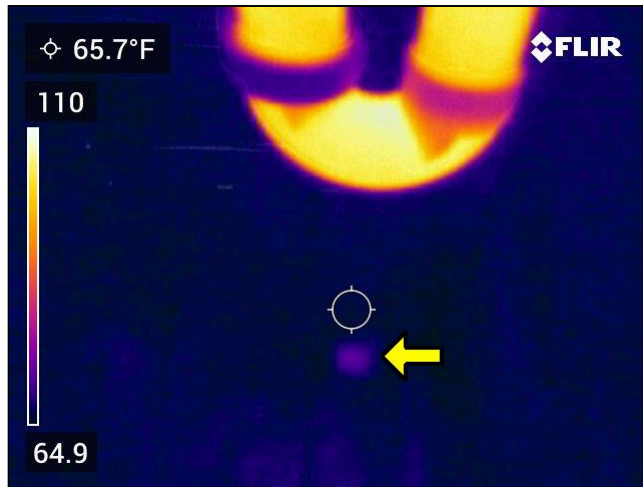
8.0.A Item 1(Picture)

(1) An active leak is present at the drain pipe under the sink. We recommend necessary repairs by a qualified licensed plumber.

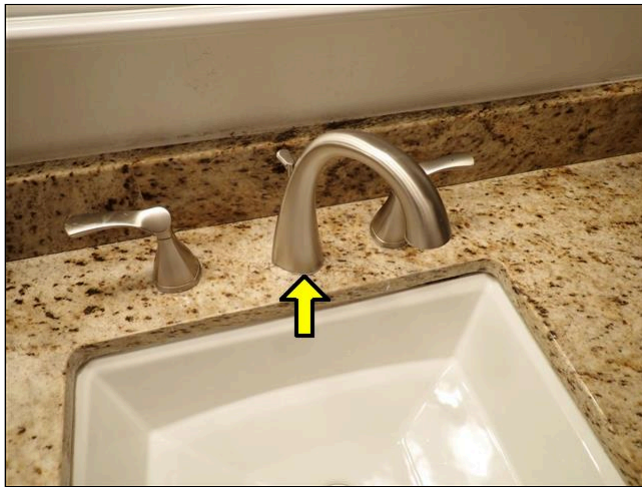
8.0.A Item 4(Picture)

(2) The sink faucet is loose. We recommend necessary repairs by a qualified licensed plumber.

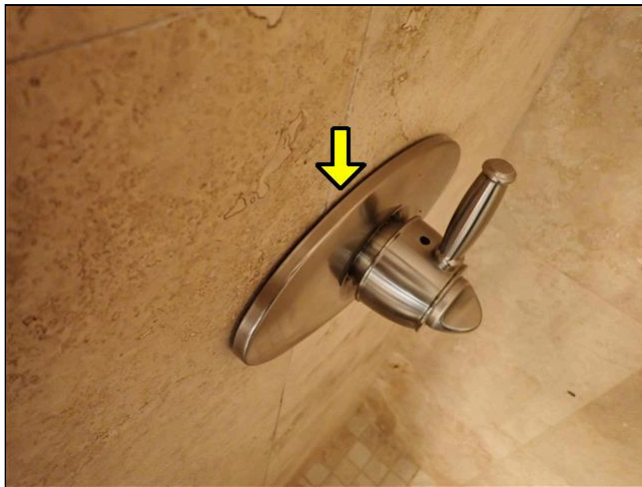
8.1.A Item 2(Picture)

(2) We recommend caulking around the shower faucet handle cover by a licensed contractor.

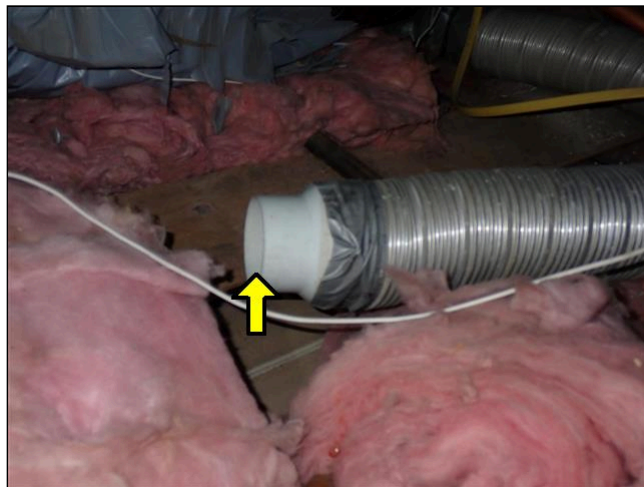
8.4.A Item 1(Picture)

The bathroom exhaust vent does not terminate to the exterior and vents into the attic space. This will allow excessive moisture to be introduced into the attic space which can lead to moisture related issues. We recommend properly ducting the bathroom vent(s) to the exterior of the attic space by a qualified licensed contractor.

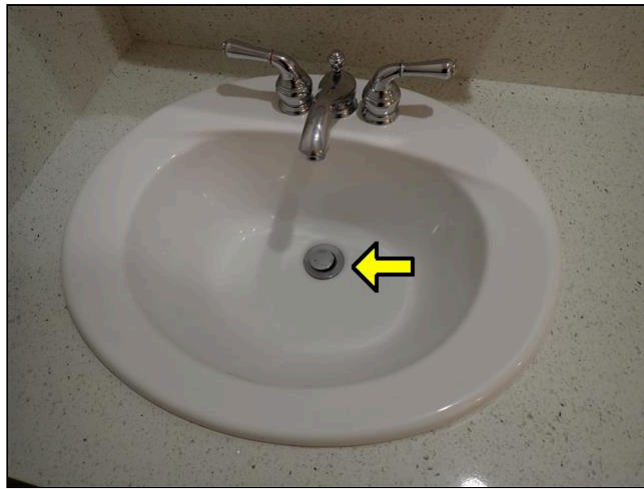
8.0.B Item 1(Picture)

The left side sink in the bathroom was slow draining at the time of the inspection This may indicate a blockage in the drain line. We recommend further evaluation by a qualified licensed plumber and repairs as needed.

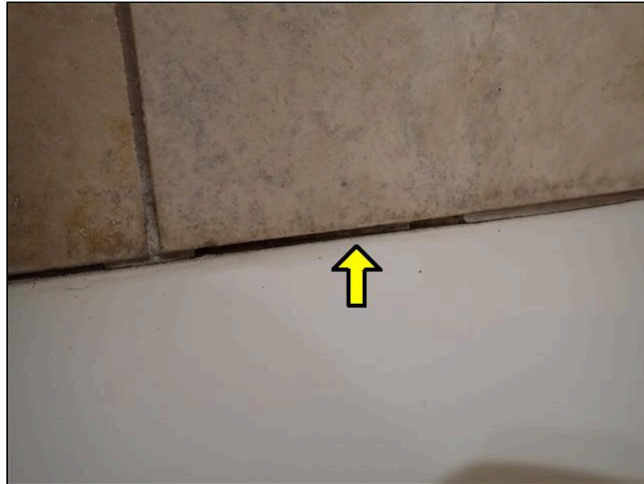
8.1.B Item 1(Picture)

The tile surround has cracked or missing grout between the tiles and needs repair or replace. There may be water damage to the wall behind the tiles which is not visible. Determining if water damage exists in the wall behind tiles is beyond the scope of our general home inspection. We recommend having the tiles repaired by a licensed tile contractor. Additional repairs may be required when tiles are removed. This area should be evaluated further by a qualified licensed tile contractor prior to the end of your contingency period.

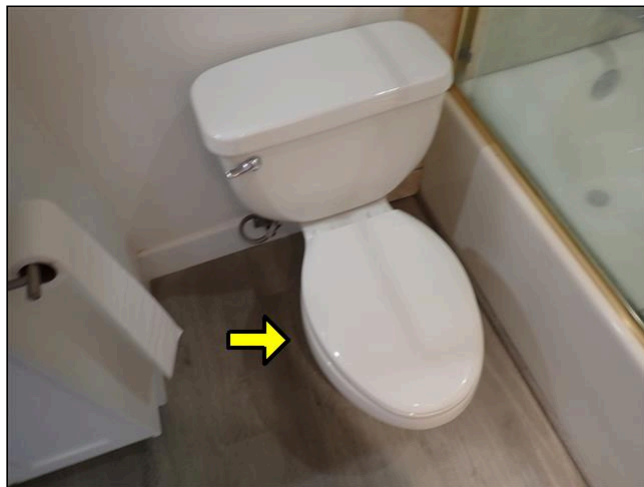
8.2.B Item 1(Picture)

The toilet is loose on the floor. This condition could damage the wax ring under the toilet. We recommend necessary repairs by a licensed plumber.

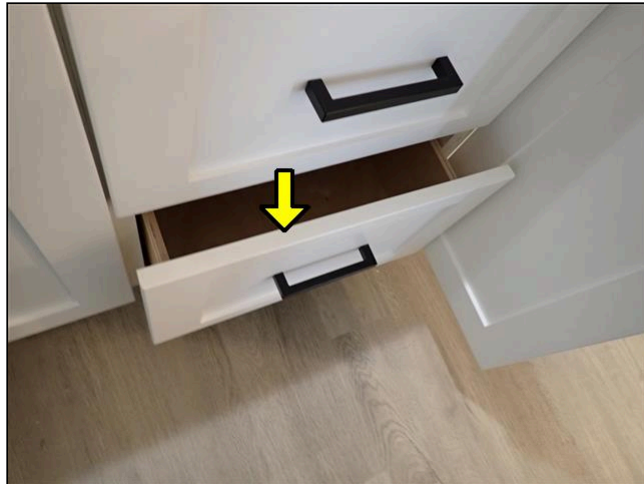
8.3.B Item 1(Picture)

(1) The bottom soft closing drawer was defective when tested. We recommend making necessary repairs where needed by a licensed cabinet contractor.

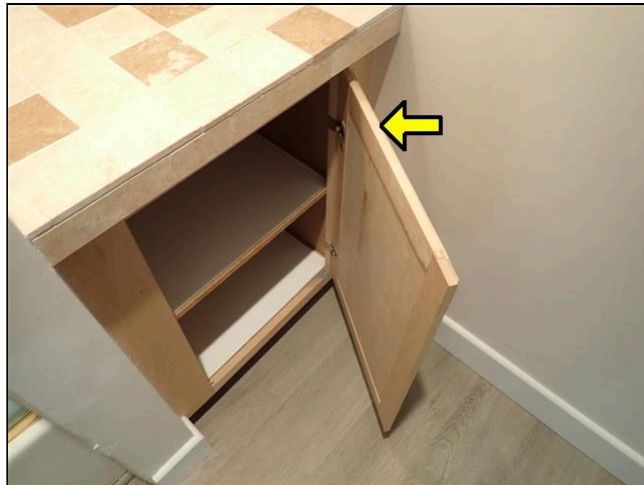
8.3.B Item 2(Picture)

(2) One of the cabinet doors makes excessive noise when opening. We recommend making necessary repairs where needed by a licensed cabinet contractor.

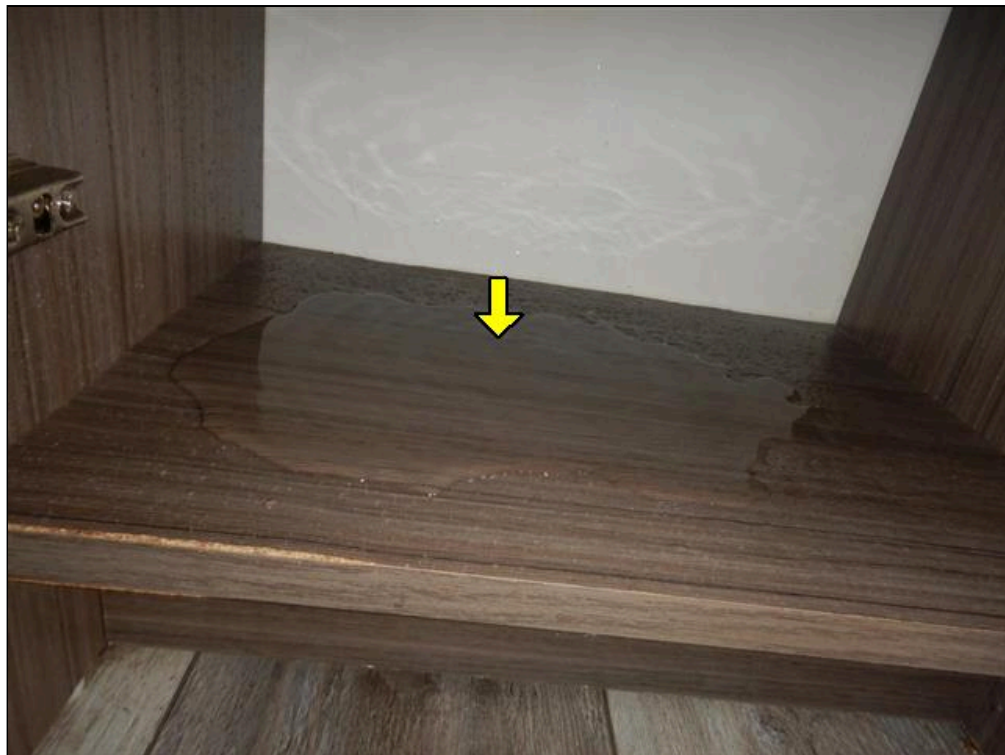
8.0.C Item 1(Picture)

An active leak is present at the drain pipe under the kitchen sink. We recommend necessary repairs by a qualified licensed plumber.

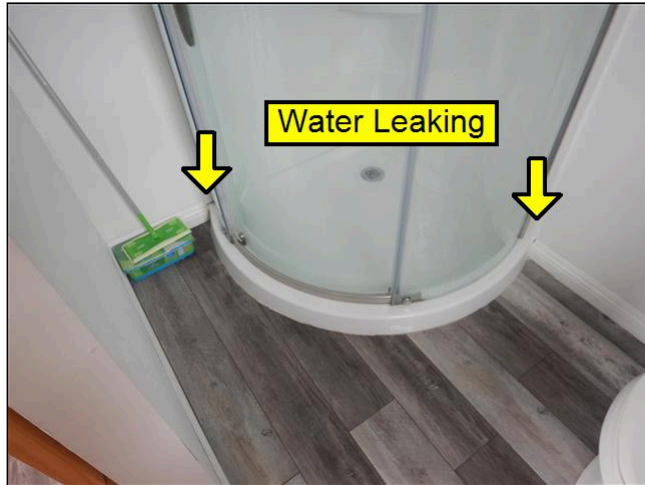
8.1.C Item 1(Picture)

Water was observed to leak from the shower enclosure at several areas and beneath the shower while the water was on in the shower. We recommend further evaluation and necessary repairs by a qualified licensed contractor.
