# Inspection Report

**Property Address:**  
2234 Main St  
Chula Vista CA 91911

**The Property Inspection Pros**

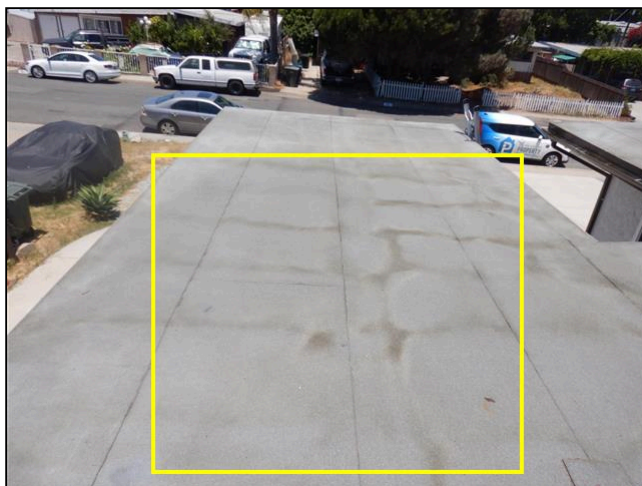
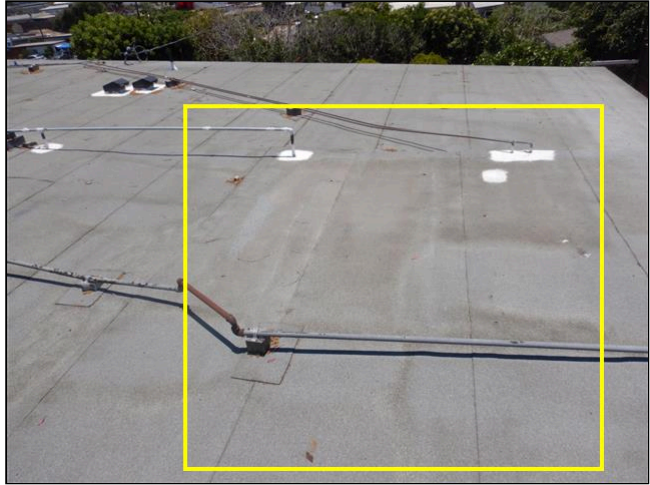
The flat roof shows areas of ponding (standing water) noted by dirt on the flat roof covering in several areas. This can lead to premature failure of the flat roof in these areas. We recommend further evaluation by a licensed roof contractor prior to the end of your contingency period and necessary repairs made.

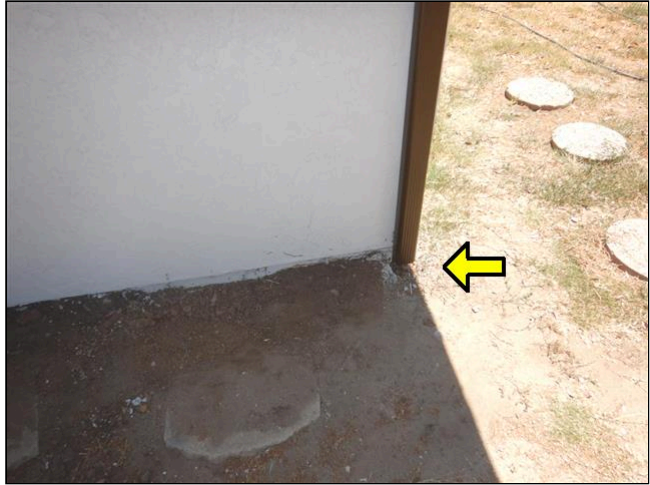
1.3 Item 1(Picture)

Some of the downspouts need extension and/or a buried drain line to carry water away from the home at several areas. We recommend necessary corrections where needed by a qualified contractor.

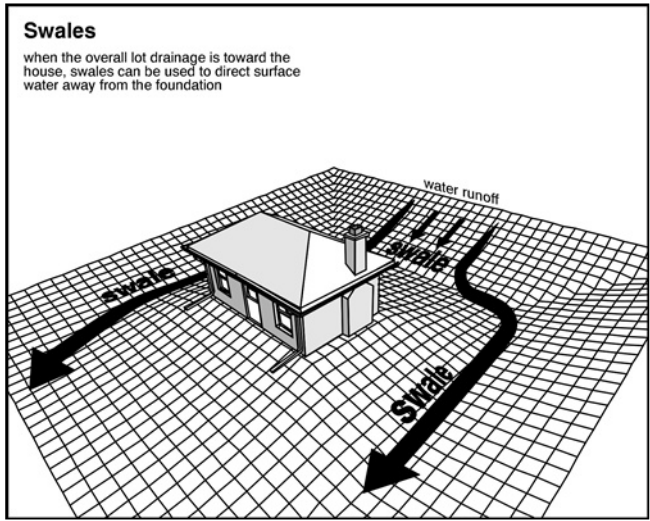
2.2 Item 1(Picture)

The lot grade is flat. Flat lot grades are common in older homes. However, the grade does not comply with current standards. We suggest controlling water near the foundation by re grading where needed, installing roof gutters and a drainage system. We recommend further review and necessary corrections by a licensed landscape contractor.

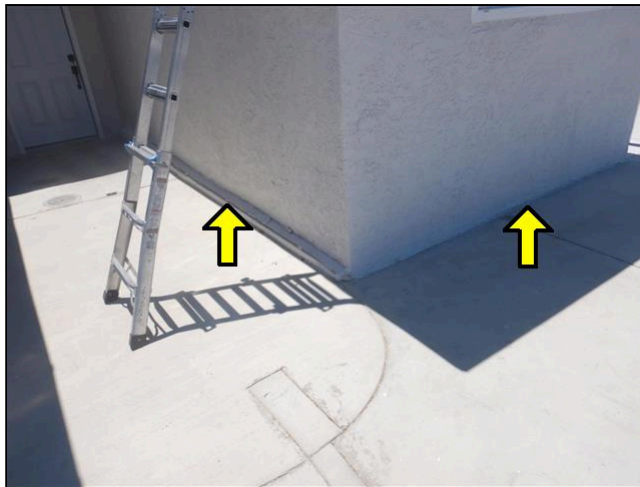
2.3 Item 1(Picture)

(2) Hairline cracking was observed at the stucco at several areas. The cracks are less than 1/8 inch in width, and generally considered common in this material. These cracks should be caulked and painted where possible. If cracks increase in width, it may indicate that structural movement is occurring. Determining this is beyond the scope of a home inspection.

(3) Stucco on older homes built prior to the 1970's were installed without a weep screed. Since the stucco traverses the junction of the the concrete foundation and the wood frame walls, a horizontal crack is common. This is due to the inevitable movement of the walls in relation to the concrete foundation. This crack is unlikely to cause damage if it remains small. Patching this crack is a temporary measure. Installing a weep screed will be needed to avoid cracking. The Weep screed flashing will allow for movement between the wood frame wall and the foundation stem wall. (The weep screed is a metal band at the bottom of the stucco.) We recommend installing a weep screed where needed by a licensed stucco repair contractor.

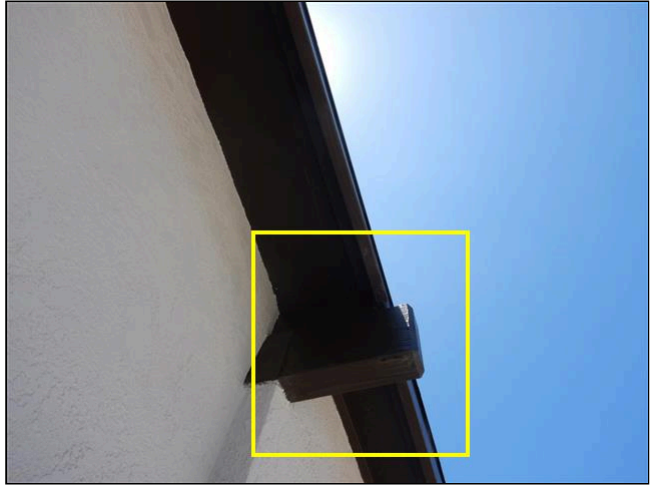
2.4 Item 1(Picture)

Some damaged wood was observed at the eaves and fascia boards at several areas. Determining if this damage was caused by termites is beyond the scope of a home inspection. Home inspectors do not have the authority to comment on termites or dry rot, which is the responsibility of a state licensed pest inspector. We recommend referring to the pest inspection report for a full evaluation and necessary repairs made by a qualified licensed contractor.

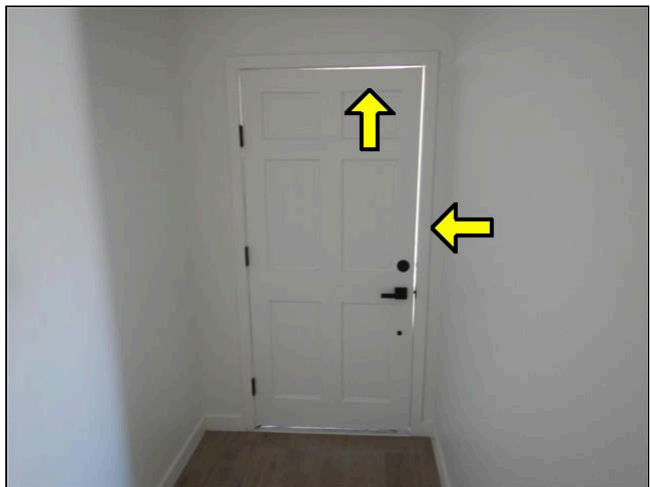
2.5 Item 1(Picture)

(1) The main house front entry door does not fit squarely in the door frame. This can be caused by several factors including poor installation or settlement of the house. We recommend necessary repairs by a qualified licensed door contractor.

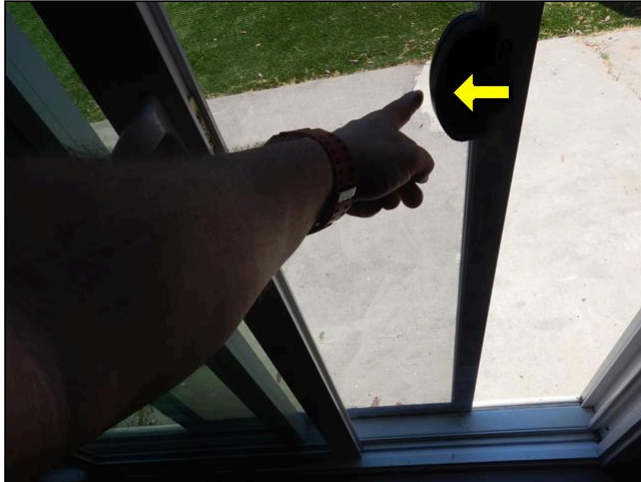
2.5 Item 2(Picture)

(2) The main house sliding screen door has a torn or damaged screen. We recommend repair or replacement by a qualified person.

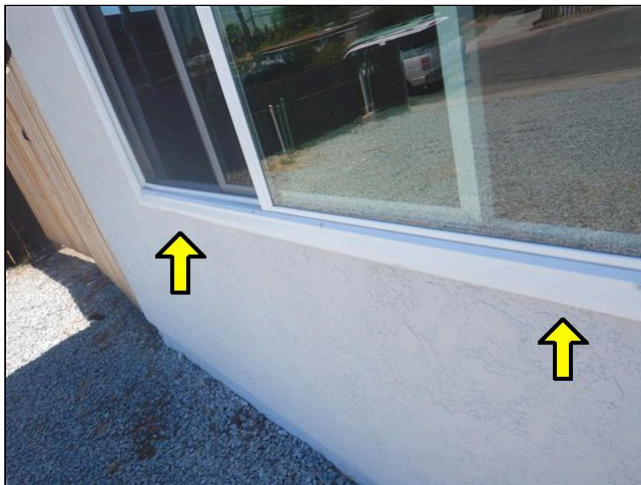
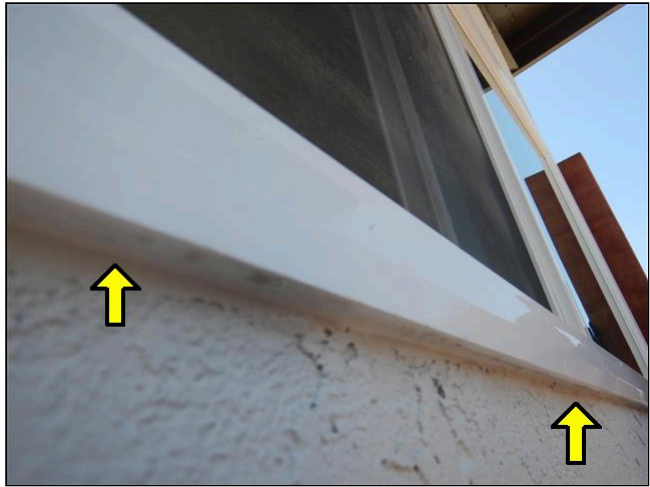
(1) The sealant around the retrofit replacement windows appears to have been poorly installed. Sealant should only be present at the top and sides of the windows not the bottom. Sealant was observed at the bottom of the retrofit windows. This condition could lead to water intrusion. We recommend further evaluation and necessary repairs by a qualified licensed window contractor.

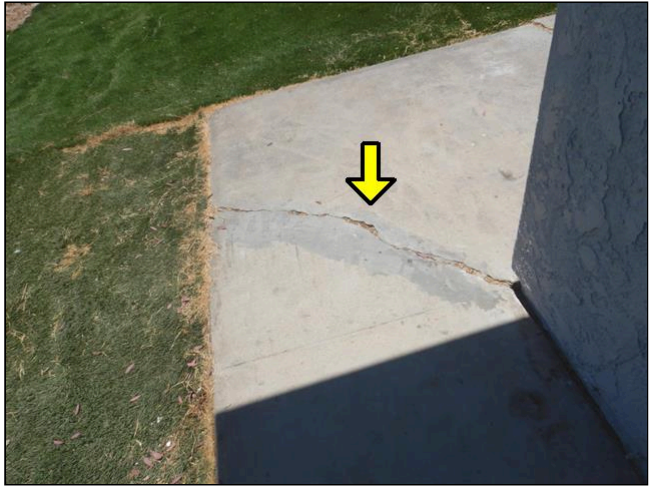
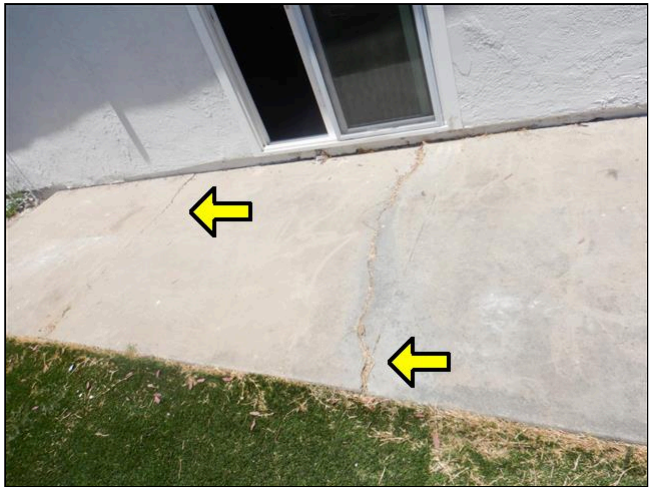
There are several cracks observed in the concrete patio. This may indicate that soil movement is occurring, there may be root encroachment, or the concrete was installed without re-enforcement. This patio may deteriorate further. We recommend obtaining a quote for necessary repairs or replacement by a licensed concrete contractor prior to the end of your contingency period.

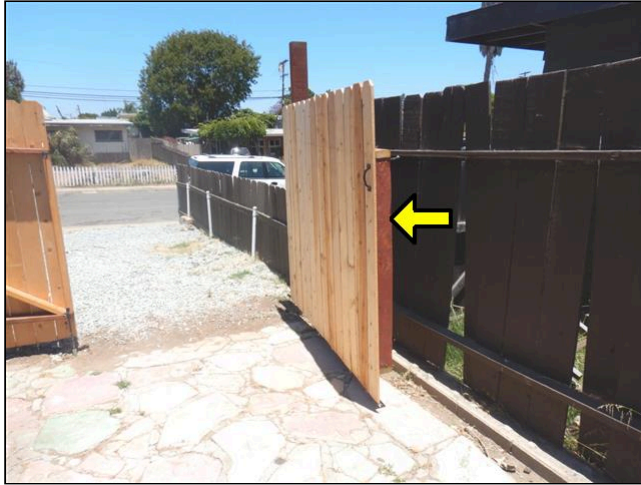
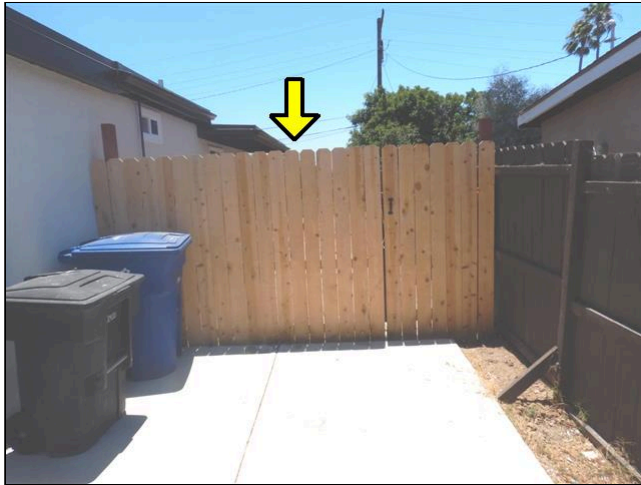
(1) The wood fencing is not painted or stained. Maintaining paint and/ or stain is essential to preventing the wood from deteriorating and damage. We recommend prep and painting or staining as needed by a licensed paint contractor.

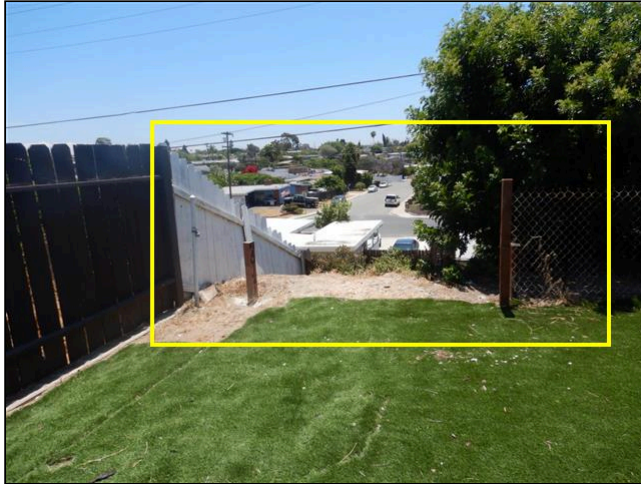
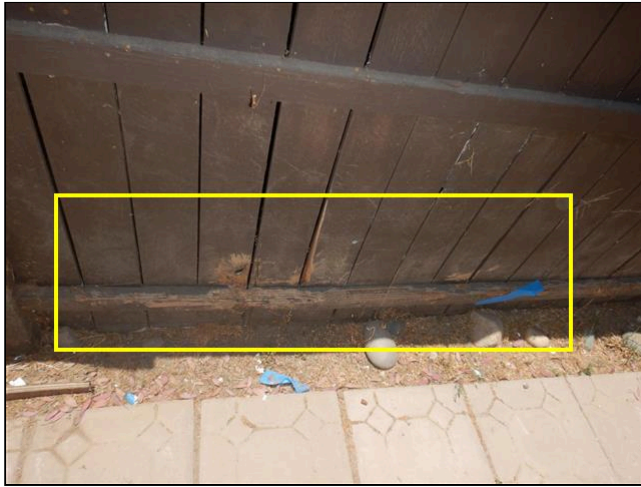
(2) A section of the rear fence is missing and damaged. We recommend necessary repairs or replacing as needed by a licensed fence contractor.

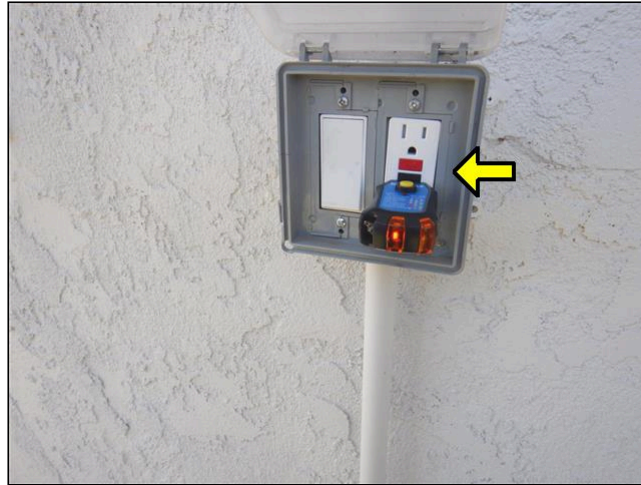
2.10 Item 1(Picture)

An exterior GFCI receptacle is not operating properly, or has failed as it did not trip when tested. The outlet may be defective or mis-wired. We recommend further evaluation by a qualified licensed electrician and necessary repairs or replacement made as needed.

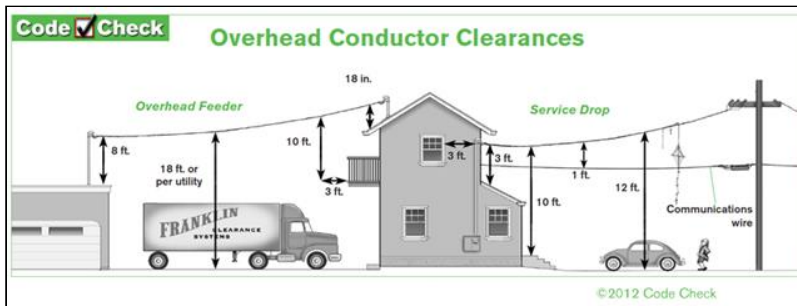
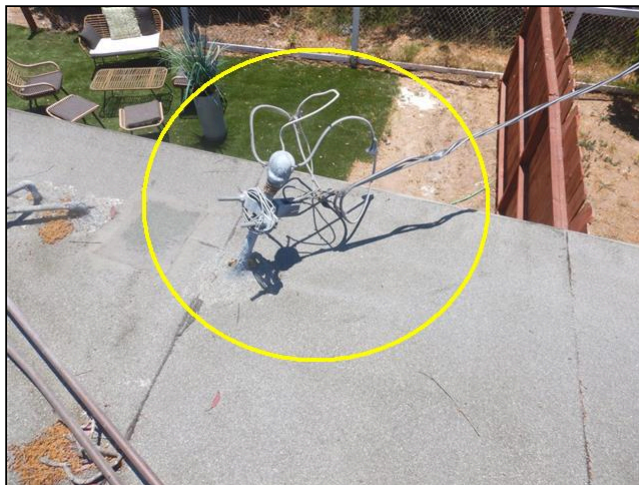
The overhead electrical service clearance above the roof is inadequate and a safety concern. Minimum standard clearances above a roof is 3 ft., a walkway is 10 ft. Driveways/residential property clearance require 12 ft. We recommend necessary corrections by a qualified licensed electrician.

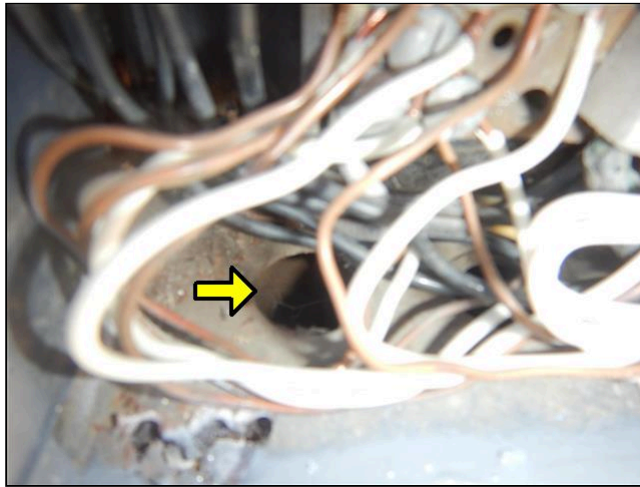
3.1 Item 2(Picture)

(4) A knockout is noted missing from inside the main electrical panel. When a knockout is removed and left empty a cover plug is required to be installed to prevent rodent intrusion for fire safety. We recommend installing knockout plug(s) where needed by a qualified licensed electrician for safety.

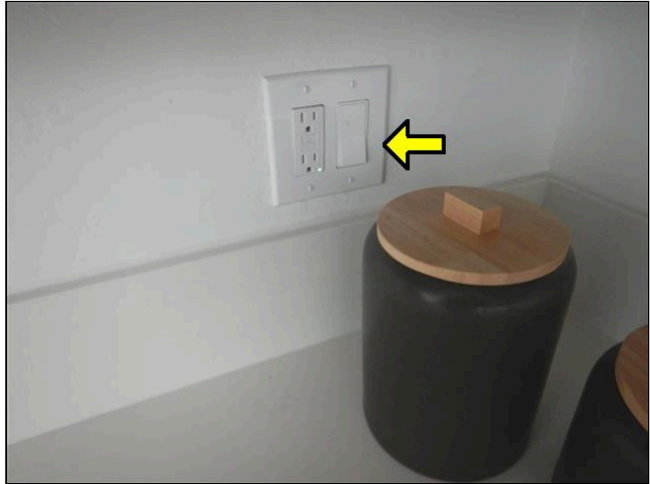
3.6 Item 1(Picture)

I was unable to determine the function of the switch in the main house kitchen. We recommend further evaluation by a qualified licensed electrician and repairs made as needed.

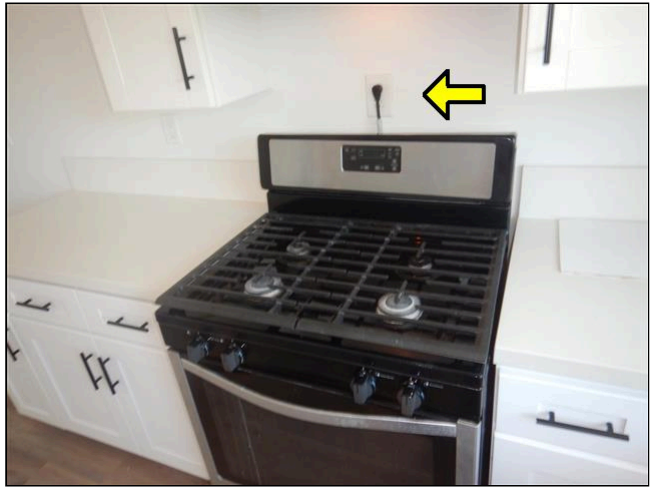
3.8 Item 1(Picture)

- (1) The refrigerators do not appear to be on dedicated circuits. We recommend further evaluation by a qualified licensed electrician. If not we recommend having a dedicated circuit installed by a qualified licensed electrician to reduce the chance of the refrigerator from shutting off if a breaker trips from another cause.
- (2) An outlet is located above the range in the ADU kitchen. This is non standard to today's requirements. We recommend relocating this outlet by a licensed electrician.

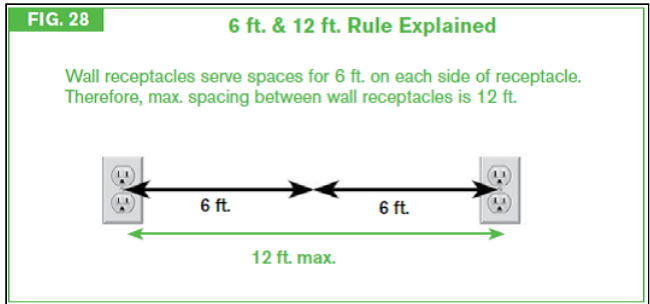
3.8 Item 2(Picture)

(3) Wall receptacles are required within 6 feet of any point along the floor line measured horizontally. A single wall receptacle serves spaces for 6 feet on each side of receptacle. Interior wall(s) in the family room were found with no or fewer wall receptacles than this standard. We recommend having additional receptacles installed by a qualified licensed electrician if additional receptacles are desired.

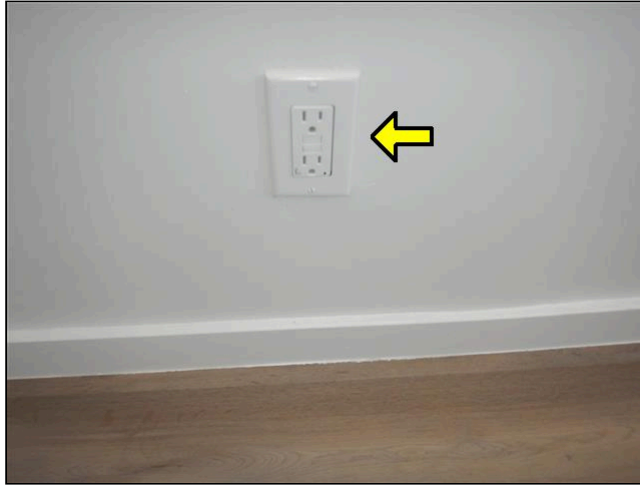
3.9 Item 1(Picture)

(2) Several interior and exterior GFCI receptacles are not operating properly, or have failed as they did not trip when tested. These outlets may be defective or mis-wired. We recommend replacement as needed by a qualified licensed electrician.

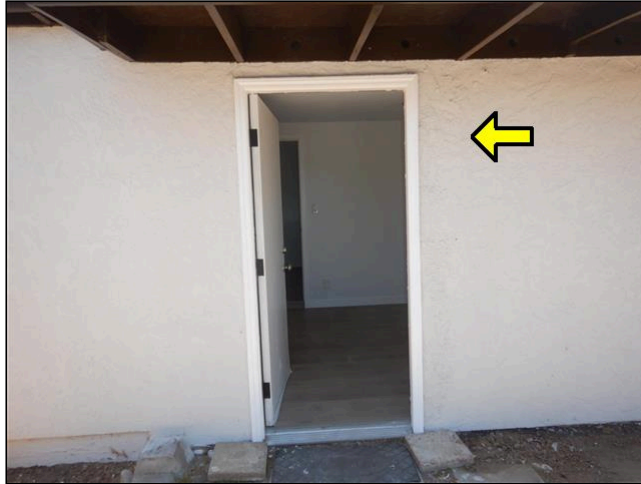
3.12 Item 2(Picture)

(2) There is no light installed by the left side exterior door. This is non standard and a safety hazard. We recommend having a light installed by a licensed electrician.

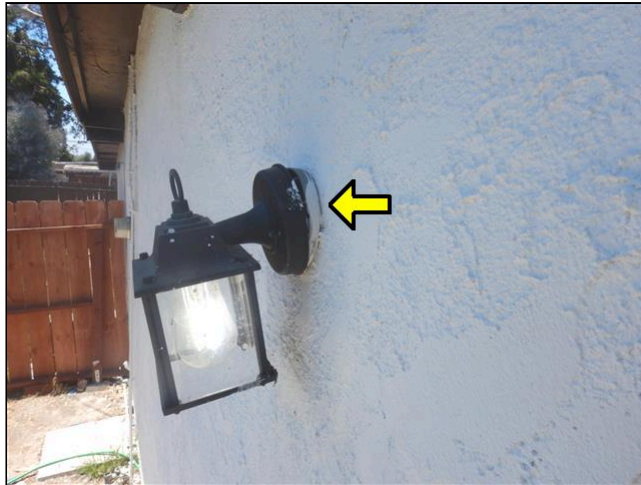
3.12 Item 3(Picture)

(3) The exterior light fixtures were not sealed where the fixture meets the wall. This condition could allow moisture intrusion in this area. We recommend sealing exterior light fixtures where they meet the wall by a qualified person.

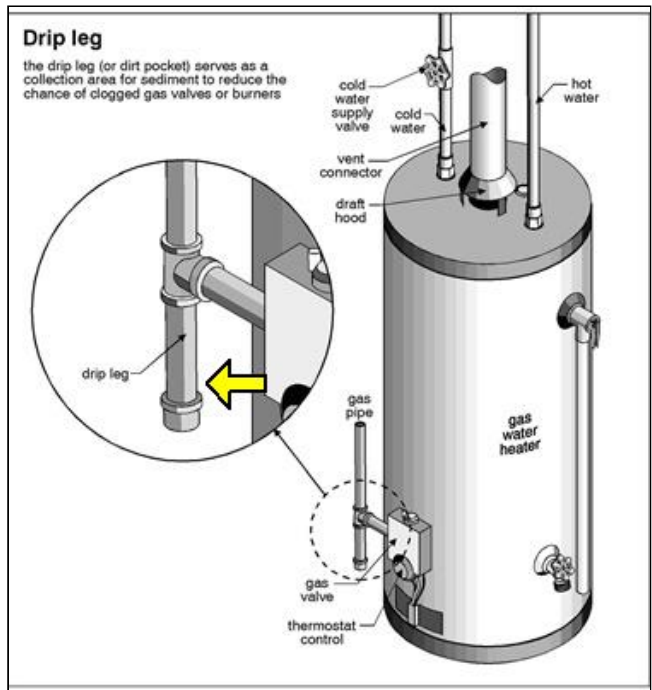
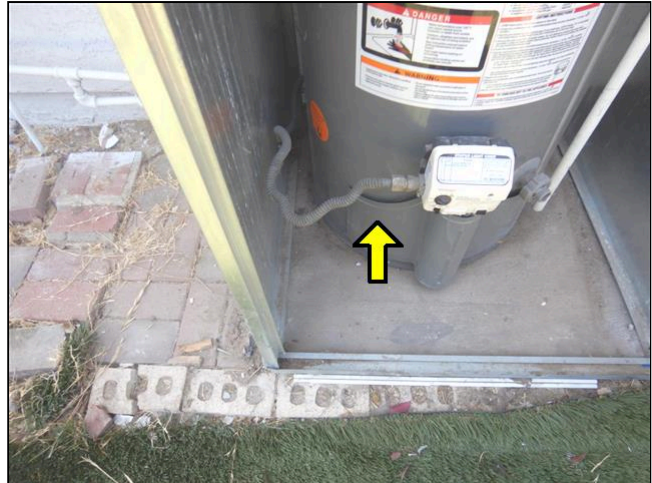
(2) The gas supply pipe at the water heater did not contained a drip leg/ sediment trap. This may have been standard at the time of installation but now is highly recommended. The purpose of a drip leg is to prevent sediment/ debris from entering and clogging the water heater gas valve which could cause the water heater to shut down. We recommend having a drip leg installed by a qualified licensed plumber.

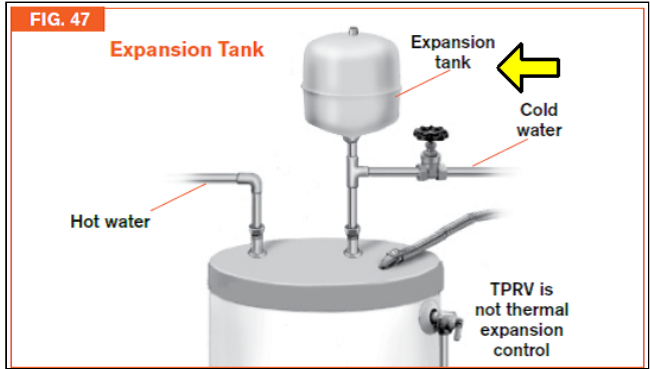
4.0 Item 4(Picture)

(3) The water heater does not have a "Thermal Expansion Tank" installed to prevent a possible leak at the T&P or "pop-off" valve. Recent changes in code require one when a new water heater is installed. This change is not retroactive on older previously installed Gas/LP water heaters. There were no leaks or drips at the T&P valve during inspection. If your water heater does begin to drip or leak, then a thermal expansion tank may be needed. We recommend installing a thermal tank by a qualified licensed plumber as an upgrade.

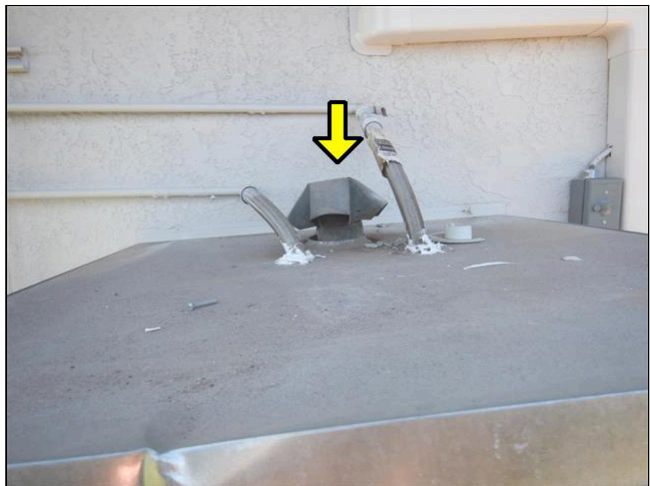
4.2 Item 1(Picture)

The water heater flue appeared to be too short. We recommend further evaluation by a qualified licensed plumbing contractor and necessary repairs made as needed.

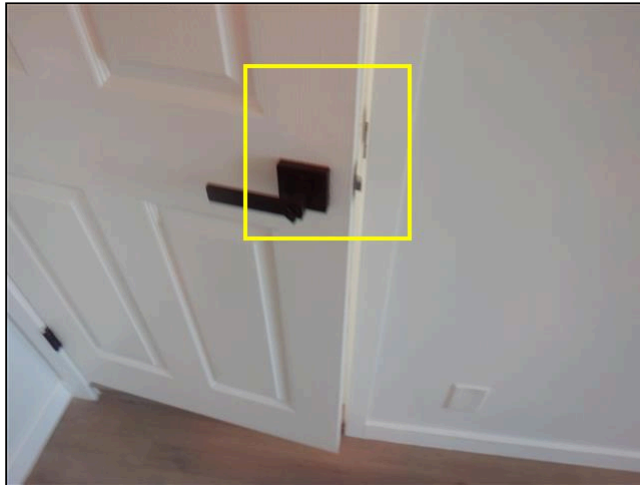
5.5 Item 1(Picture)

An interior door in the ADU door hardware is misaligned; the door does not latch. We recommend adjusting the strike plate or necessary corrections made by a qualified person.

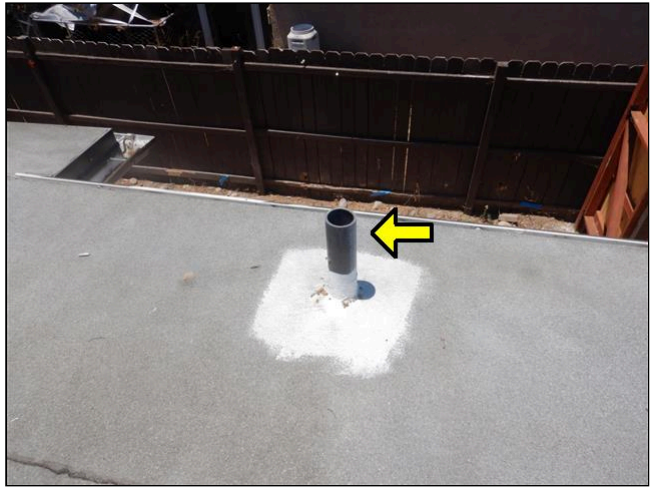
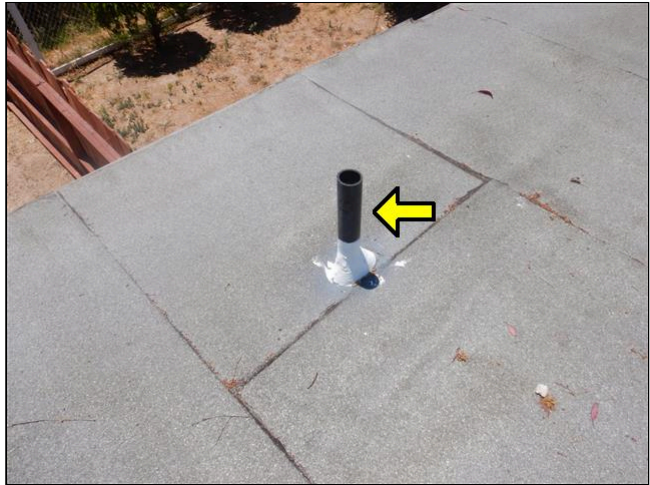
(1) The exposed ABS plumbing vents at the roof area were not painted. Paint is required at the exposed ABS vents. We recommend having the exposed ABS vents painted by a qualified licensed contractor.

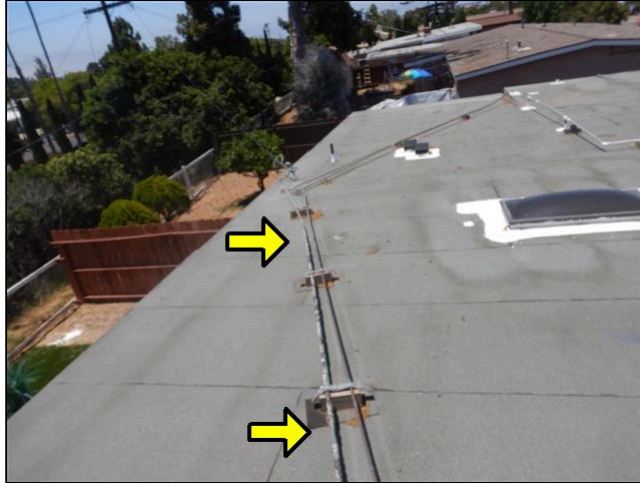
6.1 Item 1(Picture)

- (1) There is a lack of supply piping support observed at the supply piping in the crawlspace. We recommend necessary repairs by a licensed plumber.
- (2) Corroded pipes are observed at the roof area. We recommend further evaluation by a qualified licensed plumber and necessary repairs made.

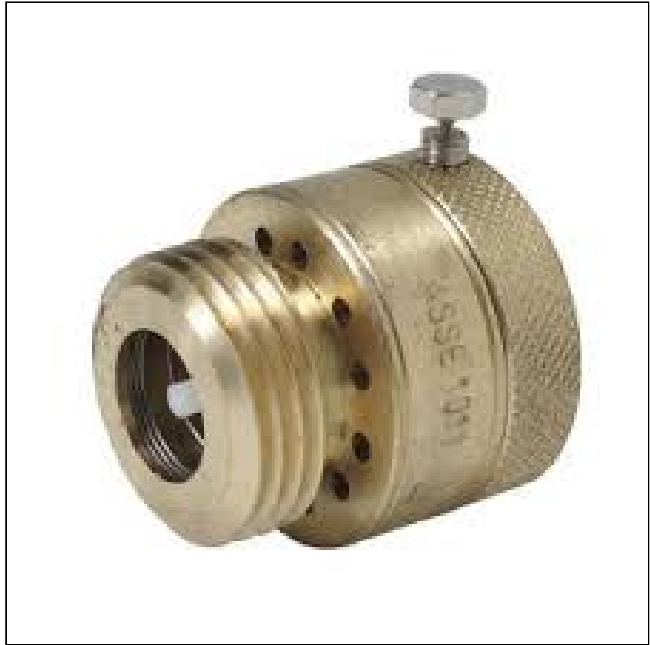
6.3 Item 1(Picture)

The exterior hose spigots do not have anti-siphon or anti-backflow devices installed on them. These anti-siphon or anti-backflow devices help prevent contaminated water from flowing back into the the house water supply system. We recommend installing anti-siphon or anti-backflow devices at the every exterior hose spigots by a qualified person.

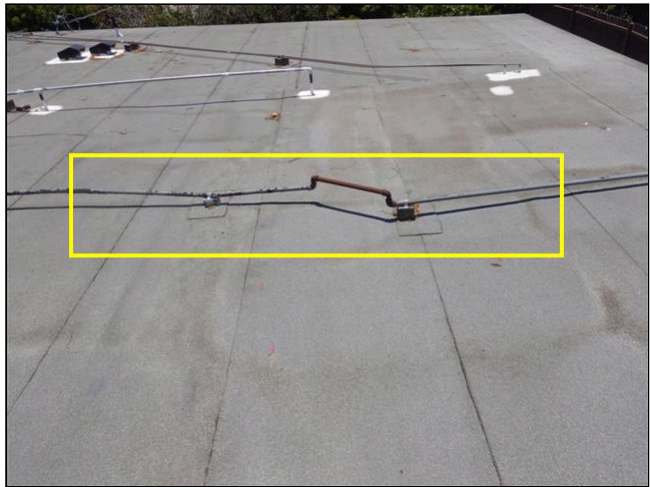
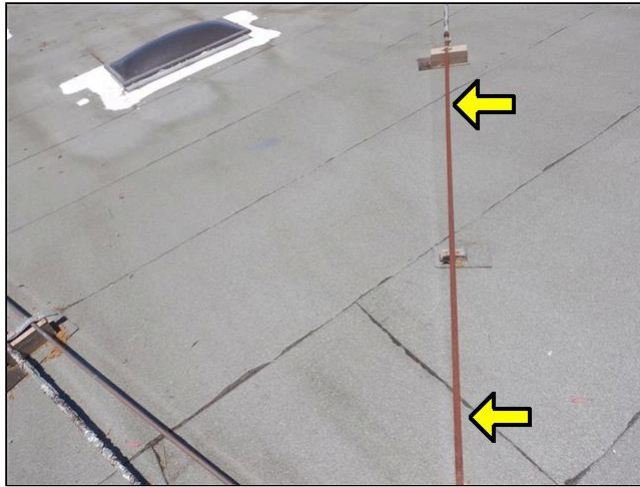
(1) Some of the gas piping observed at the roof are is rusted. We recommend further evaluation by a licensed plumber and necessary repairs or replacement as needed.

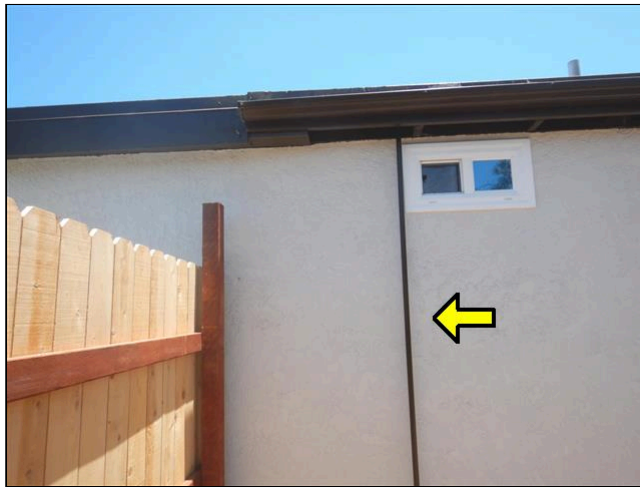
6.4 Item 3(Picture)

(2) The gas piping at the left exterior wall not properly secured as required. We recommend necessary repairs by a qualified licensed plumber.

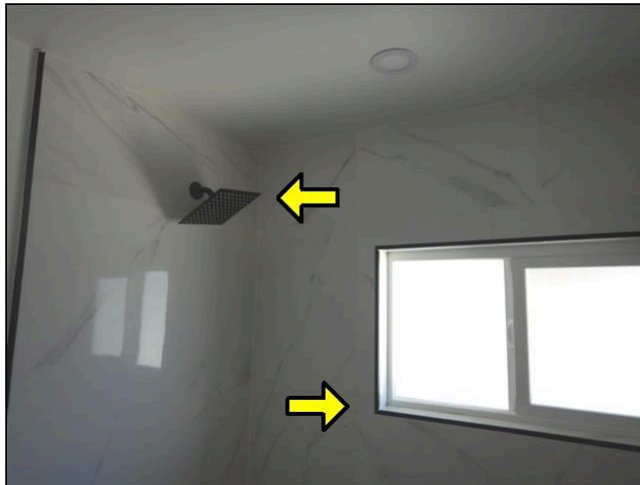
7.0 Item 1(Picture)

A window is installed below the shower head in the bathroom. Window sills are required to be installed at least five feet above the shower floor to prevent water intrusion into the wall below the window. There may be water damage to the wall below the window which is not visible. Determining if water damage exists in the wall behind the shower enclosure is beyond the scope of a home inspection due to its concealed location. We recommend removing the window or replacing the window with a smaller window, and enclosing the wall below the window by a qualified licensed contractor.

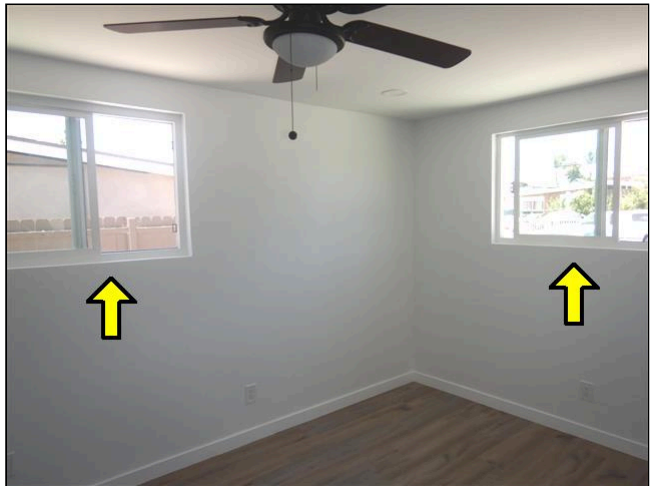
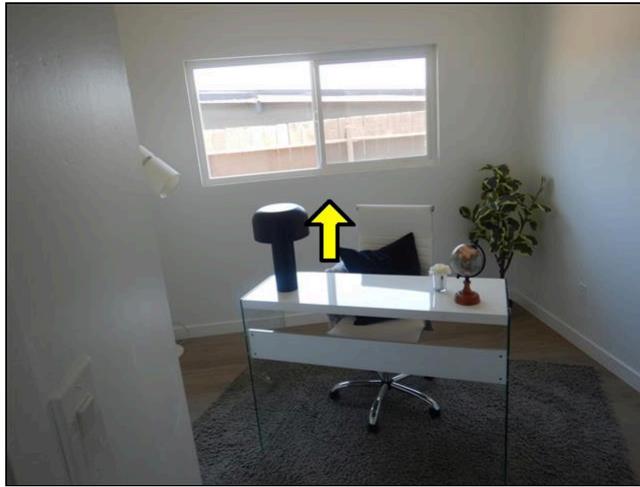
Several bedroom windows do not meet current egress requirements. There must be an openable window for light, ventilation, and fire escape. For light, the window size must be at least 8% of the floor area. For ventilation, the openable portion of the window must be at least 4% of the floor area. For fire escape, the window must be at least 5.7 square feet in area. The opening must have a minimum height of 24 inches, a minimum width of 20 inches, and a maximum sill height of 44 inches. The current installation does not meet one or more of these requirements. We recommend further evaluation by a qualified licensed contractor for corrective options.

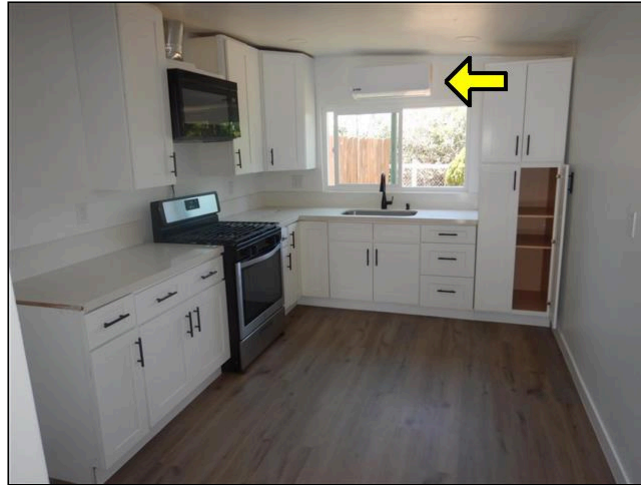
10.0 Item 2(Picture)

(2) The ADU mini split did not operate when tested at the time of the inspection. We recommend further evaluation of the furnace and related components by a qualified licensed HVAC contractor prior to the end of your contingency and repairs or replacement made as needed.

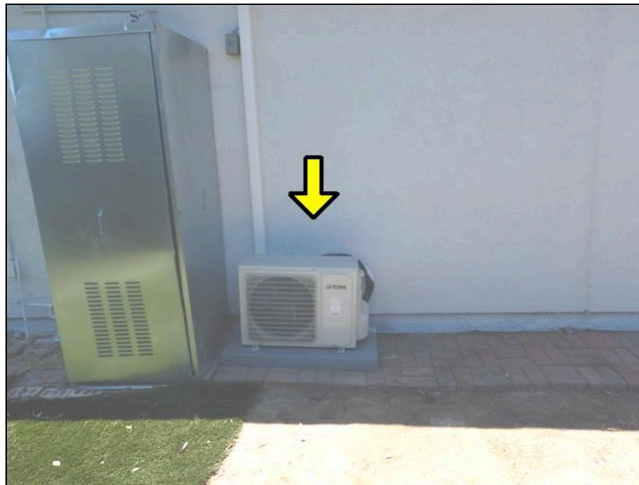
11.0 Item 1(Picture)

(1) The left side AC condenser is not level. This can put stress on the bearings and refrigerant lines. We recommend having the condenser leveled by a qualified licensed HVAC contractor.

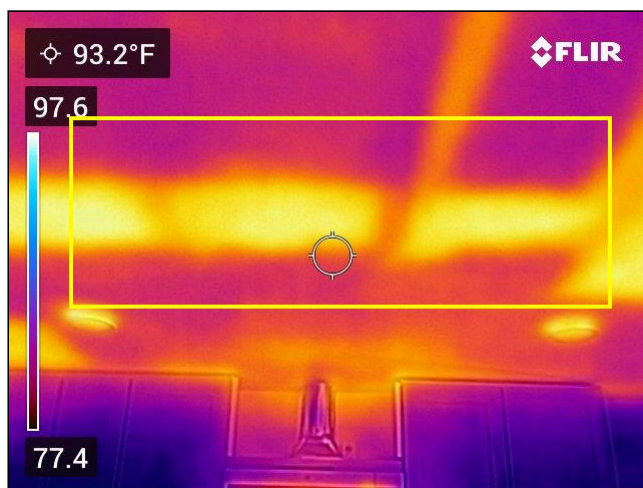
12.0 Item 1(Picture)

We recommend increasing the amount of insulation to improve the thermal efficiency of the house by a qualified licensed contractor.

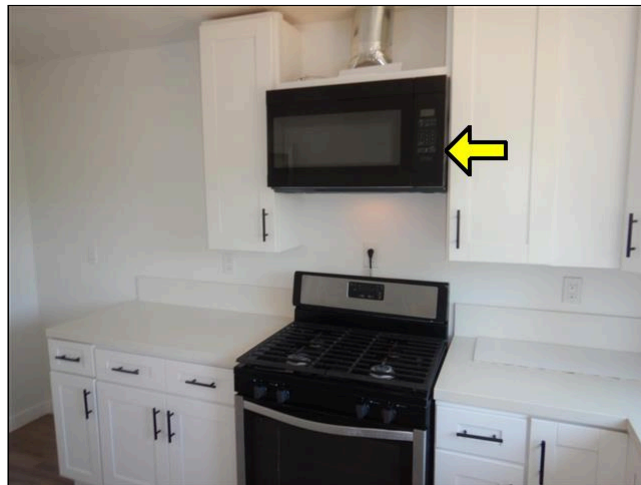
14.0 Item 1(Picture)

- (2) The built in microwave in the ADU did not work when tested. We recommend replacement.
