# Inspection Report

4132 Main Place  
San Diego CA 92037

## **The Property Inspection Pros**

<b>Date:</b> 7/11/2024	<b>Time:</b> 09:00 AM	<b>Report ID:</b>
<b>Property:</b> 4132 Main Place San Diego CA 92037	<b>Customer:</b> Rick Johns	<b>Real Estate Professional:</b>

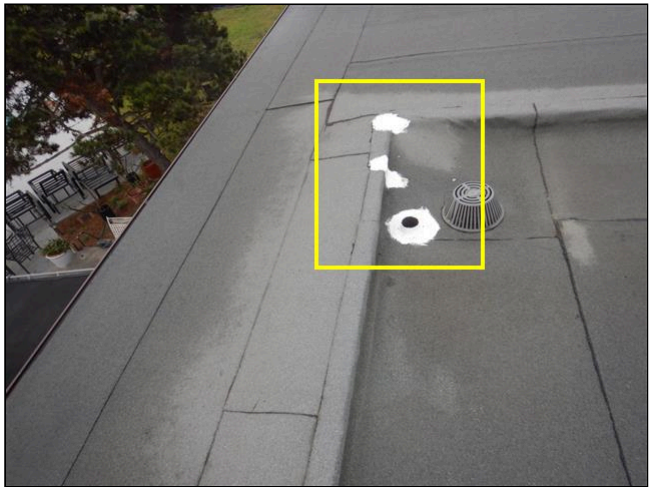
1.0 Item 5(Picture)

- (2) The flat roof material shows normal wear for its age and type; appears to be in serviceable condition.
- (3) The flat roof has had repairs made to it at several areas. We recommend asking the seller about these repairs, and if concerned we recommend further evaluation by a qualified licensed roof contractor.

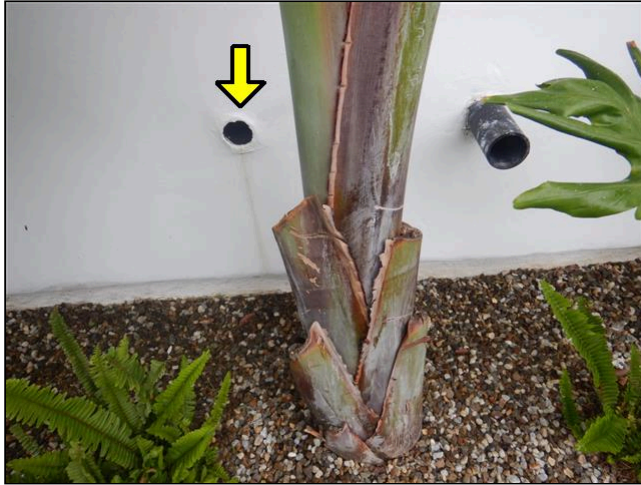
1.2 Item 1(Picture)

(1) A roof drain at the right exterior wall does not extend past the wall. This is non standard and could cause water intrusion/ damage in this area. We recommend having this drain extended by a qualified licensed contractor.

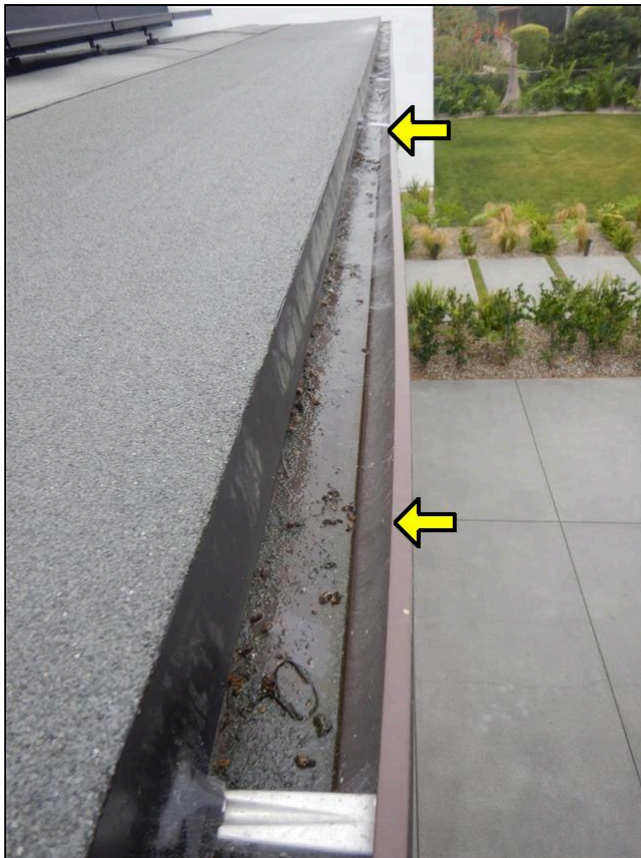
1.2 Item 2(Picture)

(2) Gutters appear intact but due to the lack of recent or current rain I am unable to determine if the gutters leak at seams or drain properly.

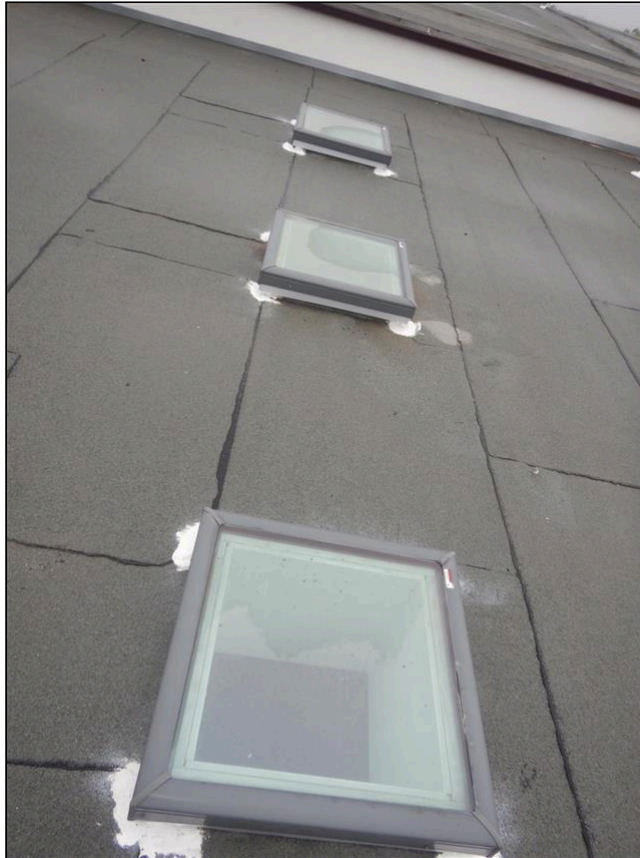
1.4 Item 1(Picture)

The skylights appear to be installed without being sloped/ pitched to help with water run-off/ proper drainage. We recommend further evaluation by a licensed roof contractor prior to the end of your contingency period and necessary repairs or adjustments made as needed.

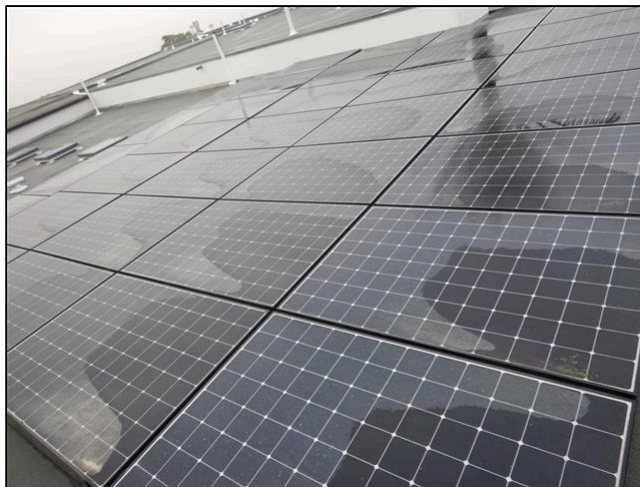
1.6 Item 1(Picture)

The electric solar system and its related components are beyond the scope of the home inspection and was not inspected. We recommend verifying that the electric solar system is operational prior to the end of your contingency period.

We also recommend having all the solar panels cleaned by a qualified person.

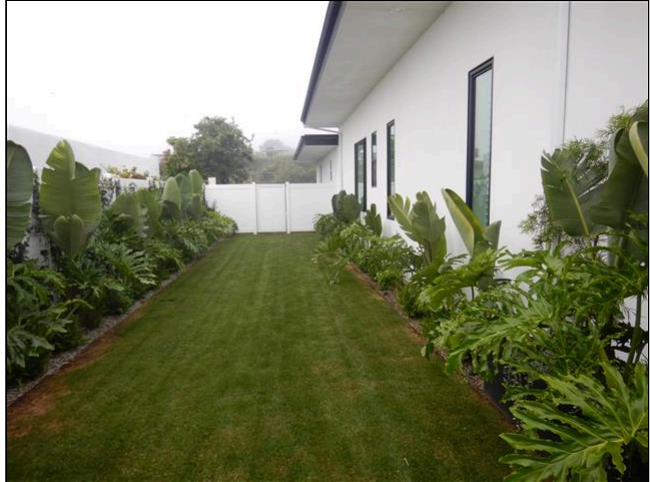
2.1 Item 1(Picture)

Tree(s) and/or large plants are located too close to the house. Tree limbs/vegetation that are too close to the house can cause damage in several ways. Limbs or vines in contact with roof or hanging near roof should be trimmed to prevent damage to roof and/or to prevent rodent infestation. Also, as the plants grow, damage can occur to the siding, concrete flat work and to the foundation. We recommend having the foliage removed or trimmed by a qualified professional to prevent damage to the house as soon as possible.

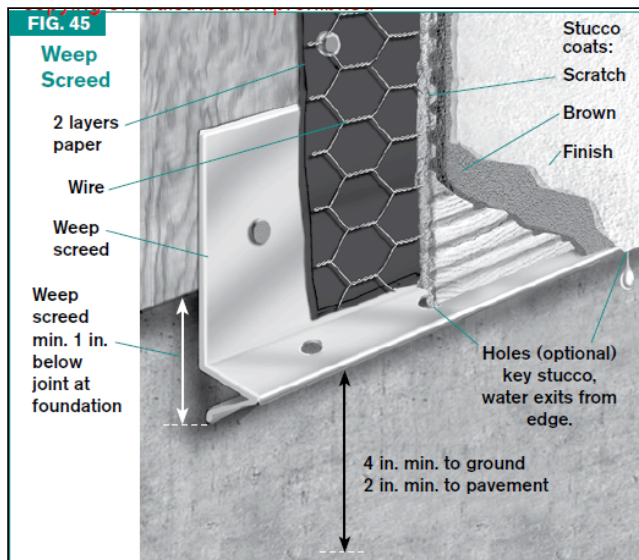
2.2 Item 2(Picture)

(3) The stucco/weep screed is in contact with ground at several areas. The weep screed is the metal band at the base of the stucco which has holes to allow the stucco to "breathe" and water to "weep" from the stucco. Having the soil above the weep screed can lead to stucco damage due to limited air flow. We recommend a ground clearance of four inches where possible allow for proper drainage and for ventilation of the stucco walls. Dirt in contact with the stucco can promote deterioration, including rot, pest infestation, and water intrusion during rain. We recommend further evaluation and necessary corrections by a qualified licensed contractor.

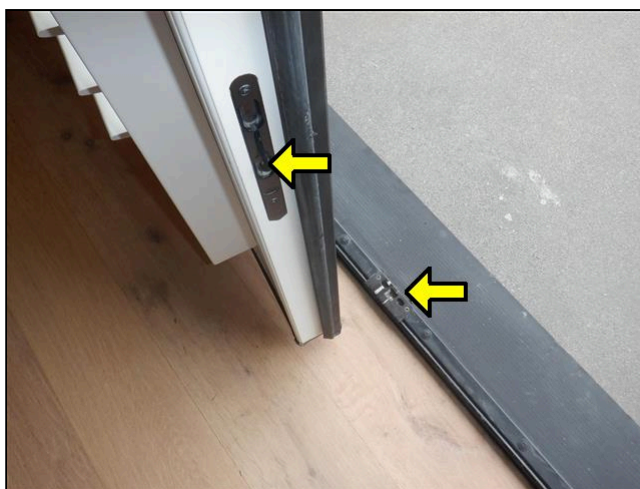
2.5 Item 2(Picture)

(2) The front right wing guest room double doors lowering locking latch does not latch the bottom metal threshold. We recommend making necessary repairs/replacement where needed by a licensed door contractor.

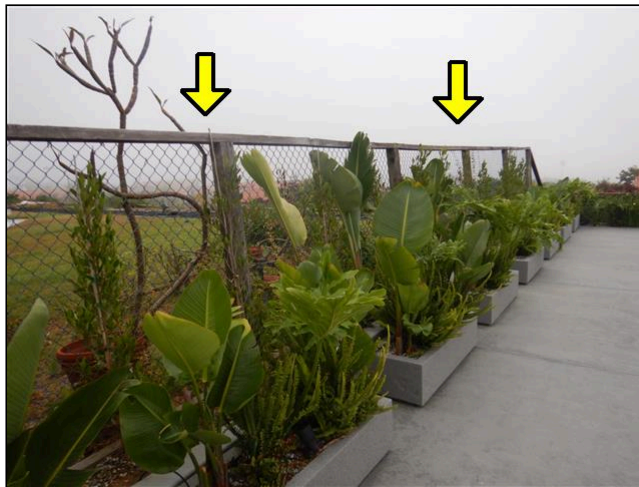
2.10 Item 1(Picture)

(1) The fence is loose and leaning at several areas. We recommend necessary repairs or replacing as needed by a licensed fence contractor.

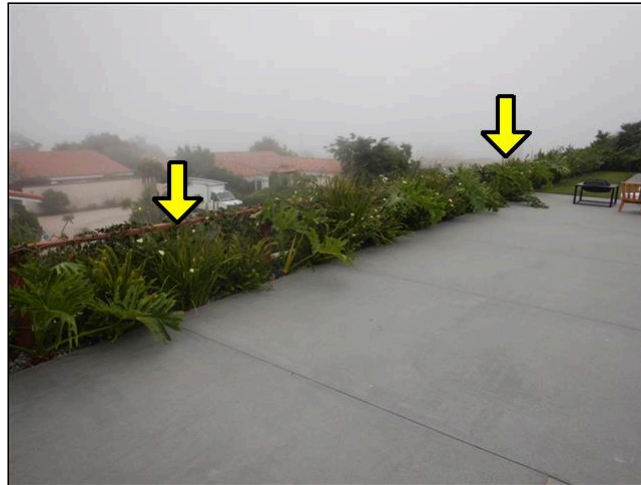
2.10 Item 2(Picture)

(2) Vegetation is growing on the fence in several areas. Vegetation can hold moisture to the fence and cause excessive weight and damage. We recommend trimming back and removing the vegetation by a qualified licensed landscaper.

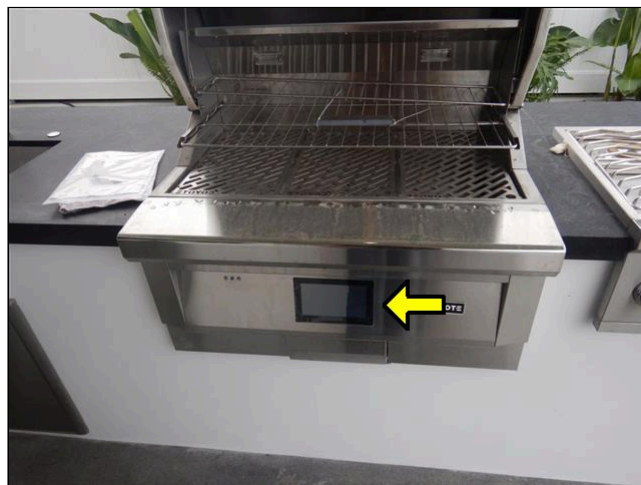
2.13 Item 1(Picture)

(1) The grill control panel did not operate at the time of the inspection. We recommend further evaluation by a qualified person and necessary repairs or replacement as needed.

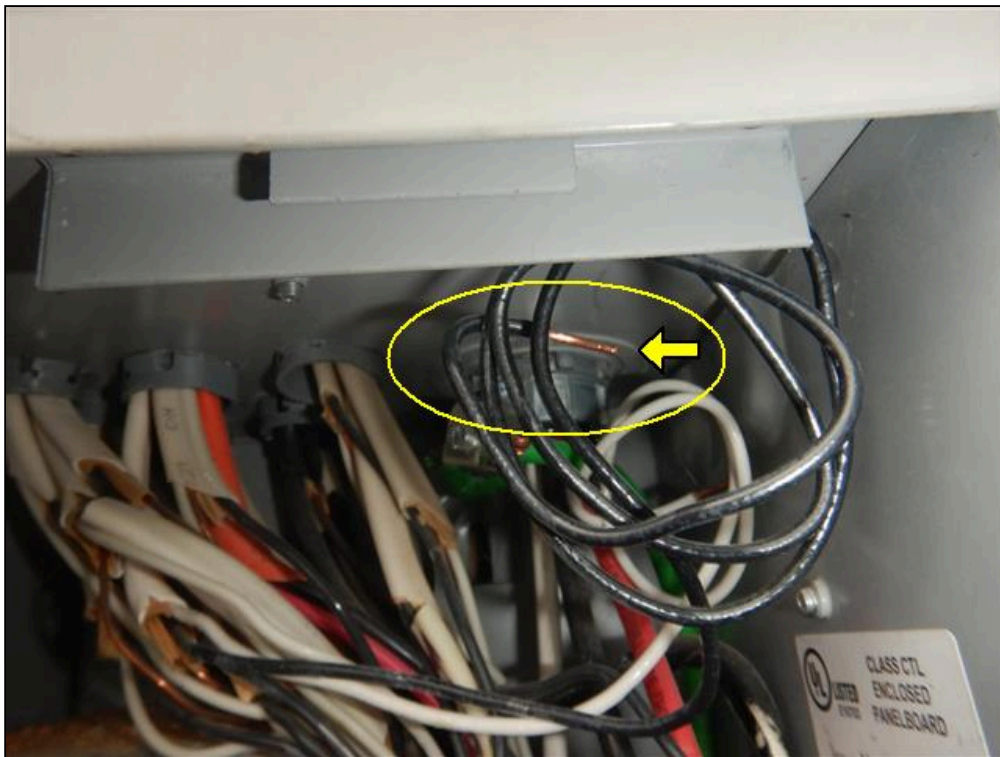
3.0 Item 3(Picture)

(3) There is an improperly terminated wire observed in the main electrical panel. These wires must be properly terminated for safety. We recommend necessary corrections by a qualified licensed electrician.

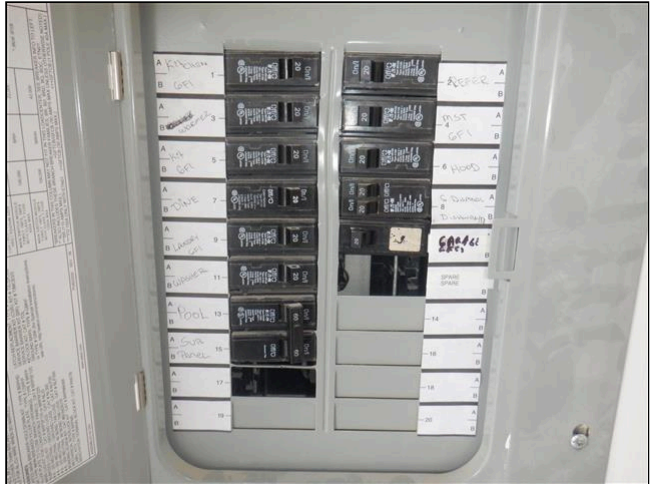
3.1 Item 1(Picture)

(1) **Photo of the sub electrical panel.**

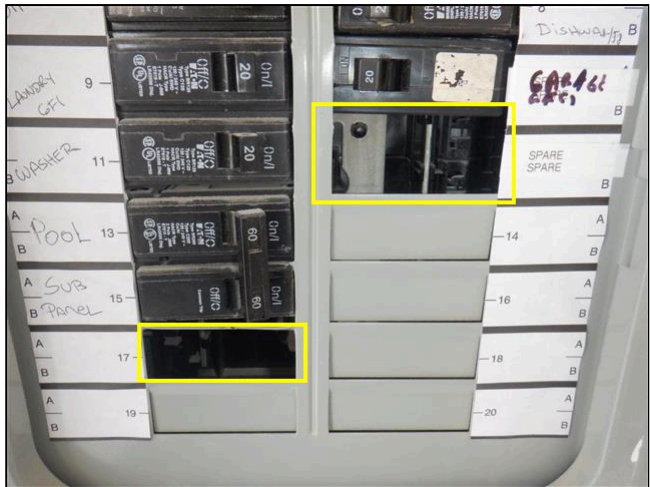
3.1 Item 2(Picture)

(2) Several twist outs are missing at the sub panel dead-front cover. Whenever a twist out is removed and no breaker is present then a cover insert is required to be installed to help prevent shocks and rodent intrusion. We recommend installing cover insert(s) where needed by a qualified person for safety.

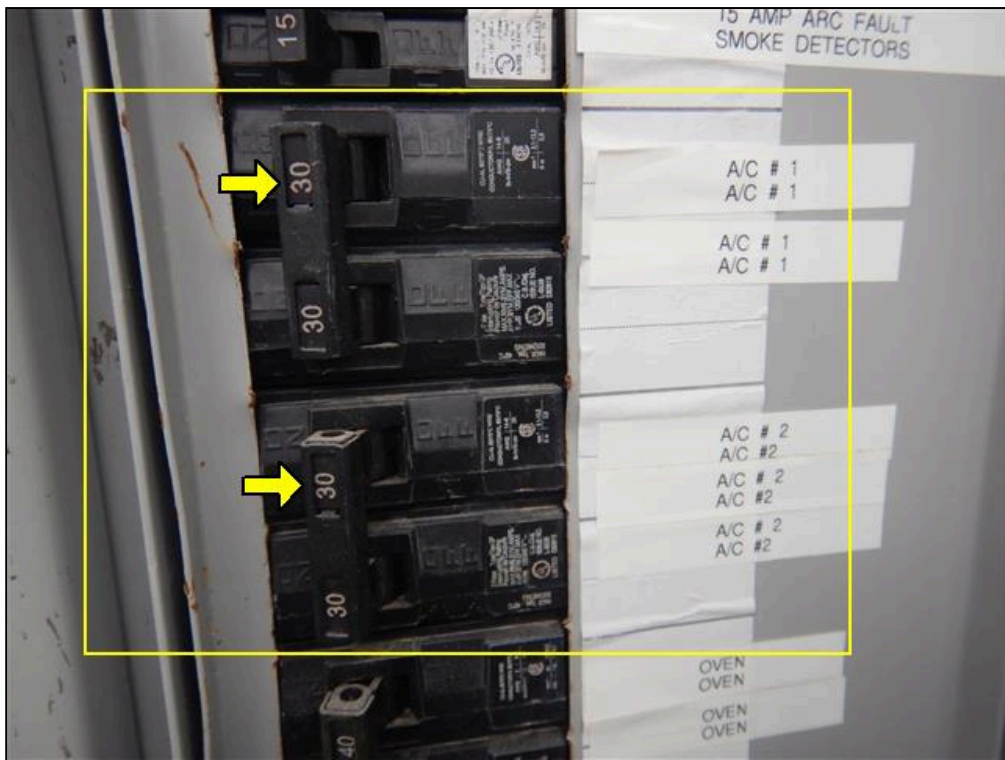
3.2 Item 5(Picture)

(3) The circuit breakers for the Main House air conditioner condensing units appear to be too small/ under fused which does not meet/ is less than the manufacturers installation requirements. We recommend further evaluation by a licensed HVAC contractor to determine if this is correct. If not we recommend necessary corrections as needed.

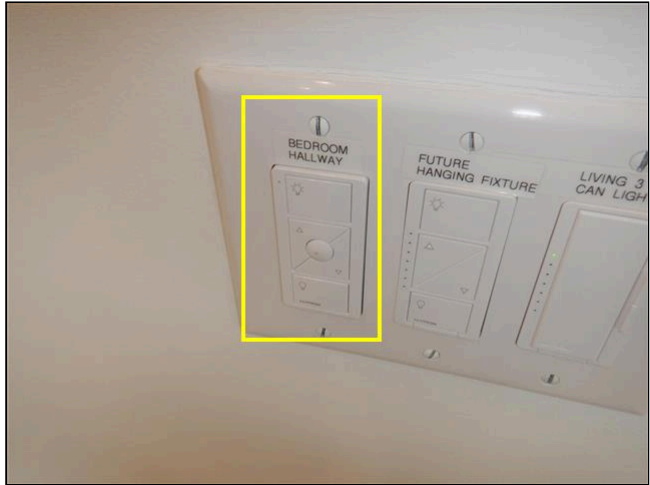
3.6 Item 1(Picture)

The right wing bedroom hallway (family room) switch did not turn the lights on at the time of the inspection. You need to go to the other side of the hallway to operate lights. We recommend further evaluation by a qualified licensed electrician and have repairs made where needed.

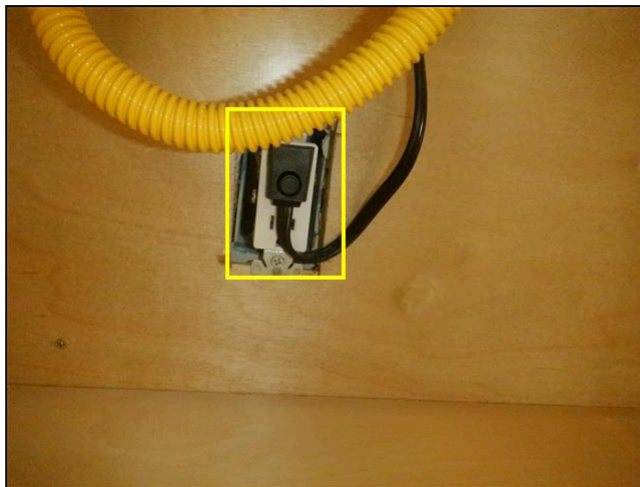
3.8 Item 1(Picture)

There is a receptacle cover missing in the kitchen. This is non standard and a potential shock hazard. We recommend installing a receptacle plate by a qualified person where needed for safety.

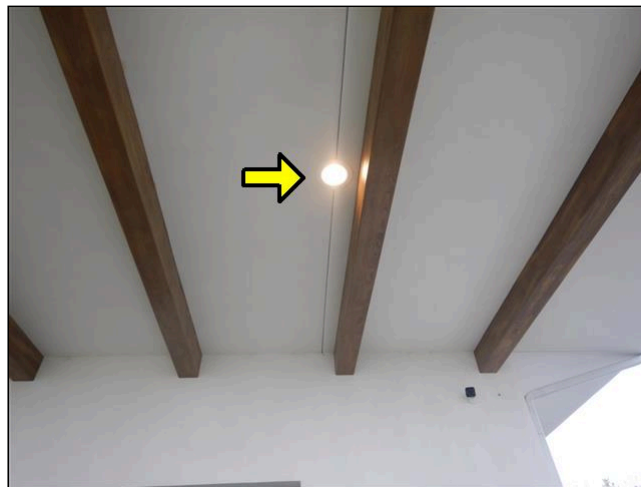
3.12 Item 1(Picture)

(1) A representative number of exterior lights were tested and were found to be functional at the time of the inspection.

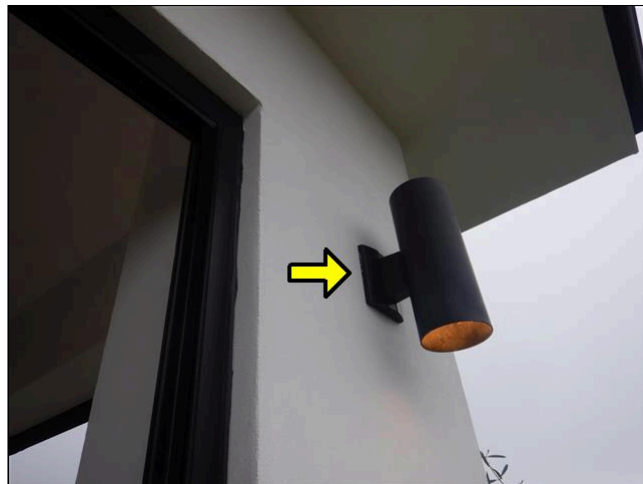
3.12 Item 3(Picture)

(2) The exterior light fixtures were not sealed where the fixture meets the wall. This condition could allow moisture intrusion in this area. We recommend sealing exterior light fixtures where they meet the wall by a qualified person.

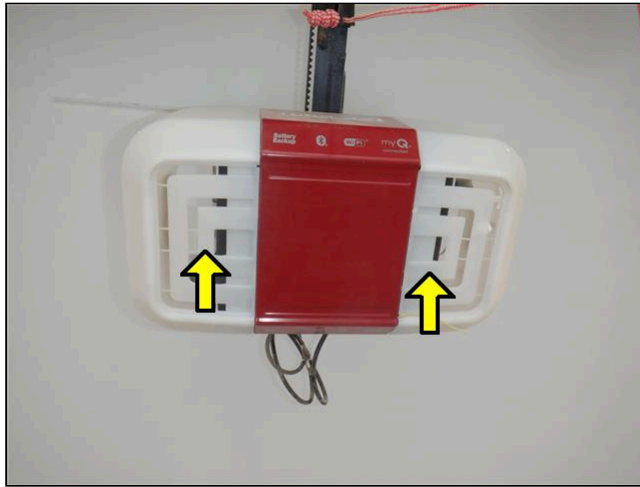
4.1 Item 1(Picture)

(1) The light bulbs are missing at the garage door opener. The lights built in the garage door opener are a safety device. We recommend installing light bulbs and testing again. If the bulbs fail to light we recommend necessary repairs or replacement by a qualified garage door contractor.

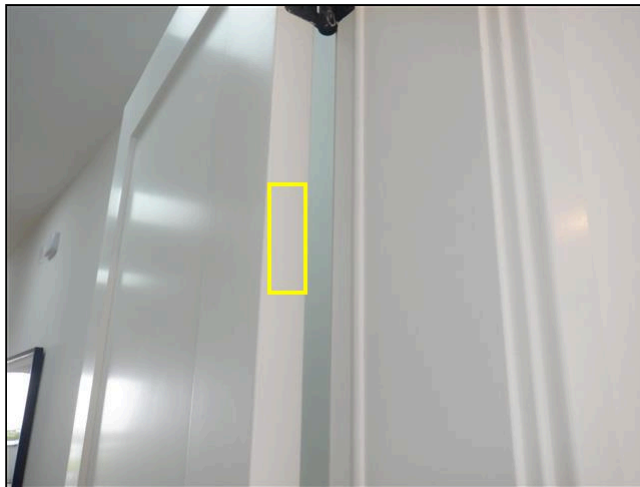
4.5 Item 1(Picture)

The door between the house and garage did not have a Fire Rating Certificate or Plate. Without a plate, I could not confirm whether the door meets fire code safety requirements. We recommend further evaluation by a licensed door contractor. The "fire door" is required to meet one of the following characteristics: 1-3/8 inch thick solid wood, 1-3/8 inch thick steel shell door with Honeycomb core, Fire-rated (with certificate plate). If the door is not rated as a fire door we recommend replacing by a qualified licensed door contractor for safety.

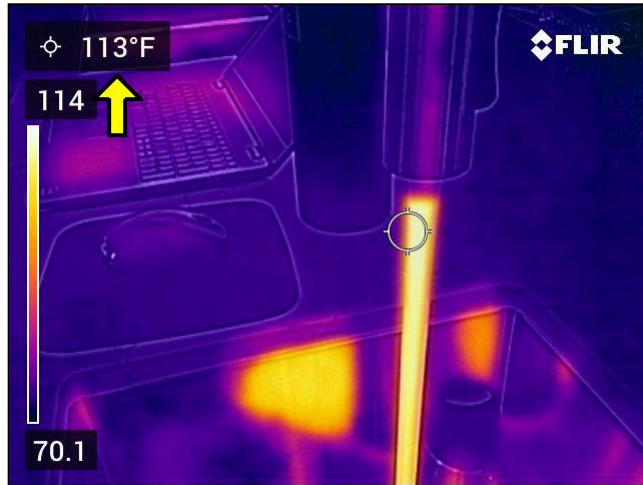
5.0.A Item 4(Picture)

The temperature of the water was tested using a thermal camera during the inspection and was found to be operating within normal range.

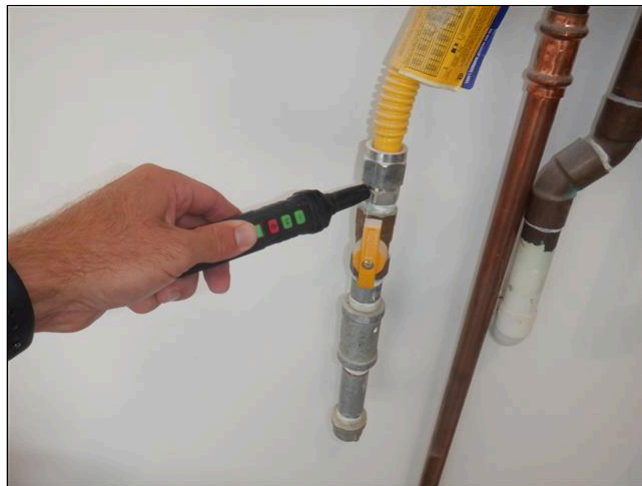
5.0.A Item 5(Picture)

(4) A gas leak test was conducted at accessible gas fittings at the water heater using a gas leak detector. There were no gas leaks detected at the time of the inspection.

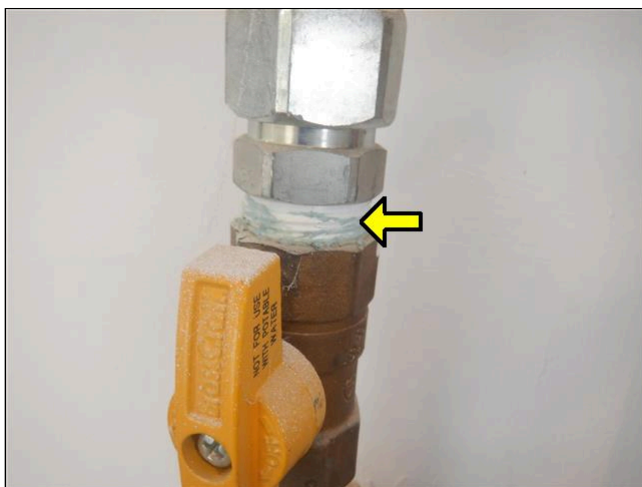
5.0.A Item 7(Picture)

(5) The water heater gas pipe fittings appear to have white teflon tape installed on them. This is non standard. White teflon tape is intended for use on water pipe fittings. We recommend necessary corrections by a qualified licensed plumber.

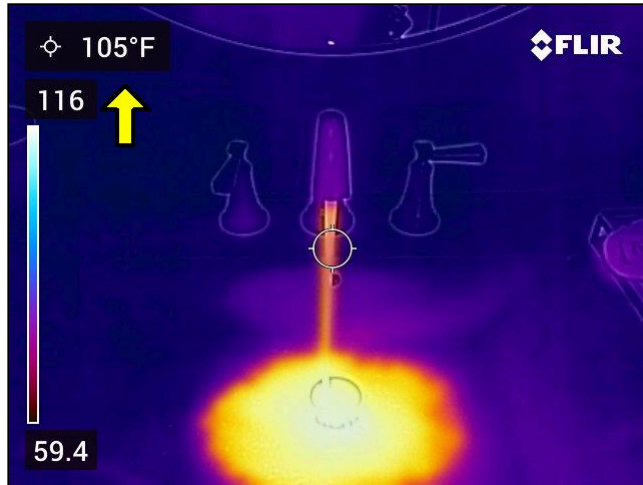
5.0.B Item 2(Picture)

The temperature of the water was tested using a thermal camera during the inspection and was found to be operating within normal range.

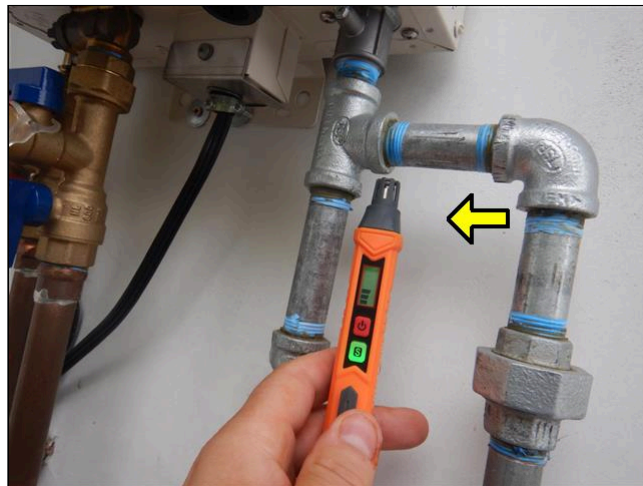
5.0.B Item 3(Picture)

(4) A gas leak test was conducted at accessible gas fittings at the water heater using a gas leak detector. There were no gas leaks detected at the time of the inspection.

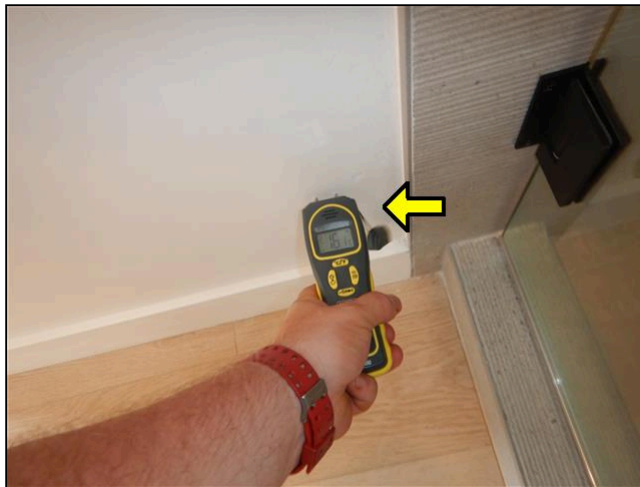
6.0 Item 1(Picture)

(1) A representative sampling for moisture was preformed at accessible interior walls using a moisture meter. (*areas prone to moisture, such as kitchens, bathrooms, below grade walls, exterior walls with doors/windows*).

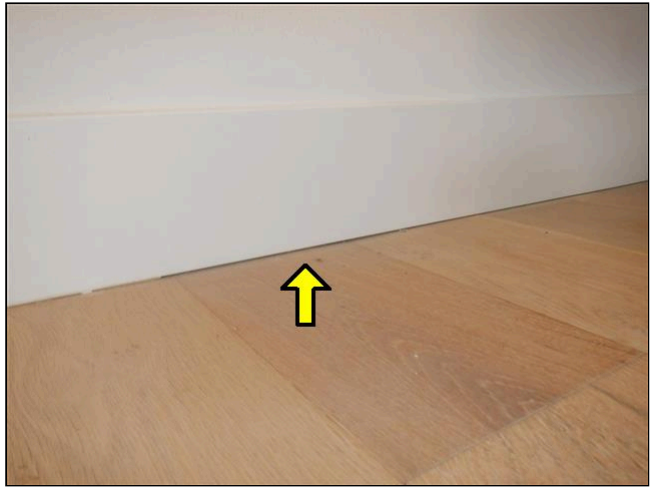
6.2 Item 1(Picture)

(1) Several gaps were observed where the baseboards meet the flooring in several areas throughout the house. We recommend making repairs where needed by a qualified licensed contractor.

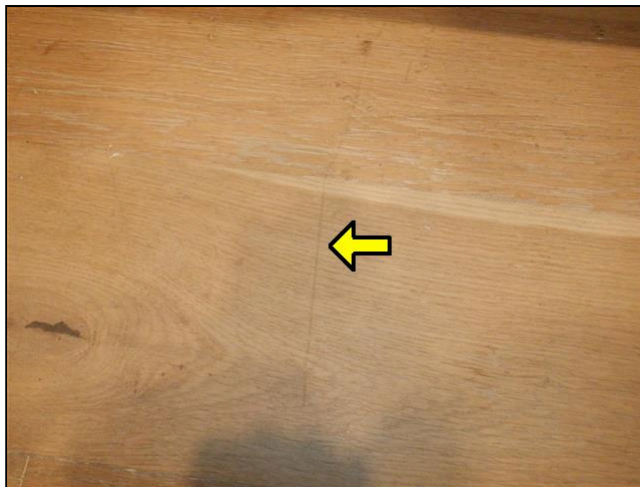
6.3 Item 6(Picture)

(4) Wood flooring in the home exhibited surface wear in several areas. We recommend repairs or replacing by a qualified licensed flooring contractor.

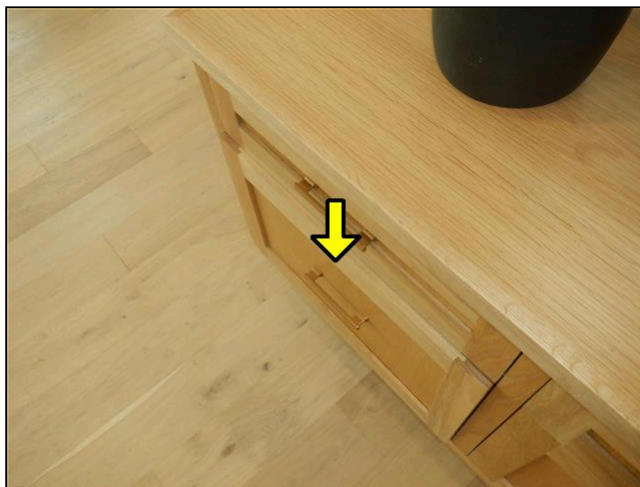
6.5 Item 1(Picture)

(1) One of the front entry cabinet drawers soft closer was found to be defective. We recommend repairs/replacement where needed by a licensed contractor.

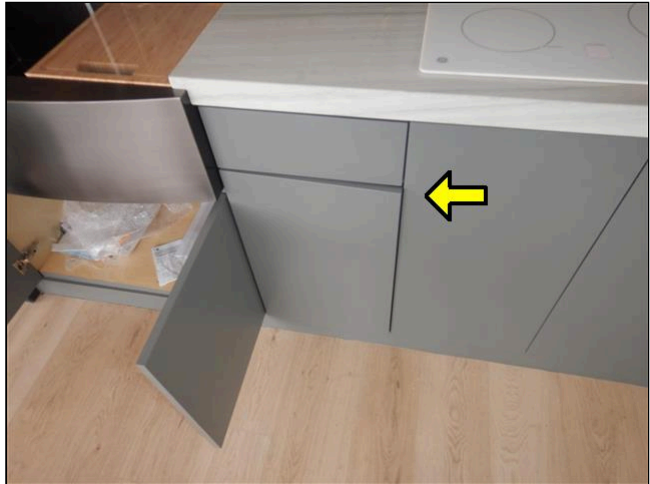
6.5 Item 2(Picture)

(4) Several pool house cabinet doors and drawers are difficult to open. We recommend necessary repairs made as needed by a qualified cabinet contractor.

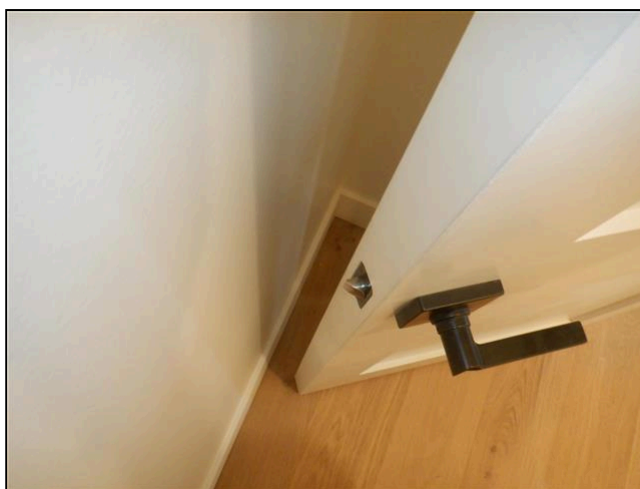
6.6 Item 4(Picture)

(3) Door stoppers are missing at several doors. Door stoppers are recommended where door handles contact walls. We recommend adding door stops and repair of any walls by a qualified person.

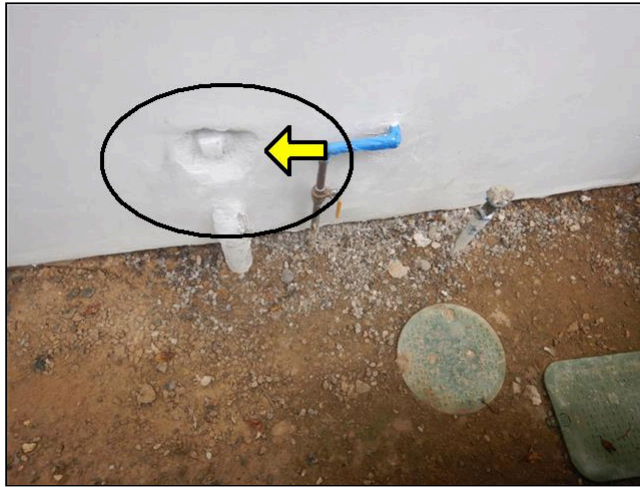
7.0 Item 1(Picture)

(1) The pool house clean out cap is covered up by stucco. Due to this conditions it will be difficult to take this clean out cap off if needed. We recommend necessary repairs by a qualified person in order to make these clean out caps accessible.

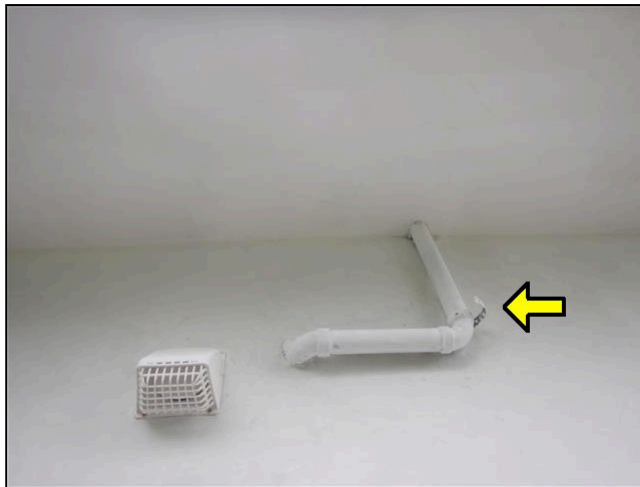
7.0 Item 2(Picture)

(2) A drain vent pipe at the rear exterior wall of the pool house is not secured. We recommend necessary corrections and repairs by a qualified licensed plumber.

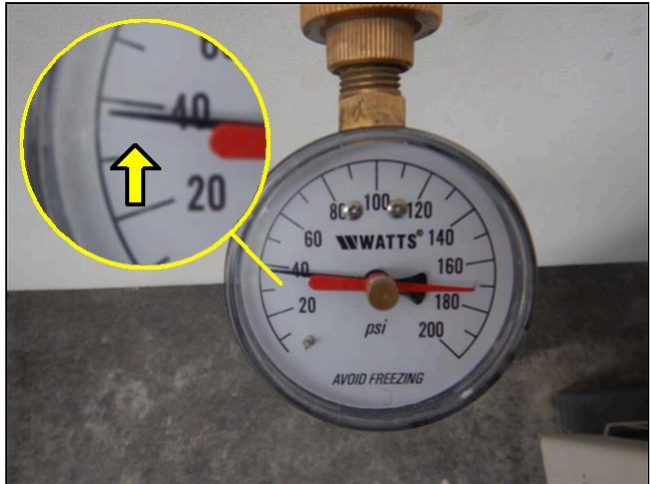
7.2 Item 1(Picture)

The water pressure was checked with a water pressure gauge and was measured to be less than 45 PSI at the time of the inspection. This is to low and corrections are needed. We recommend further evaluation by a qualified licensed plumber for necessary repairs or corrections.

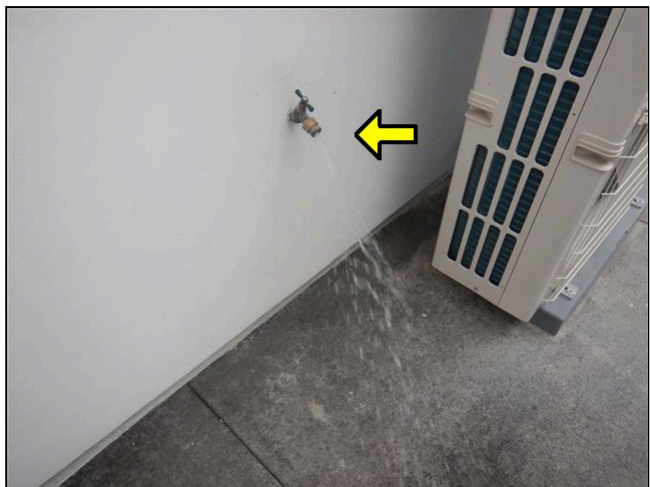
7.3 Item 1(Picture)

(1) The accessible hose spigots were tested and were found to be operational at the time of the inspection. Note: Some hose spigots may leak or drip when a watering hose is connected due to back pressure.

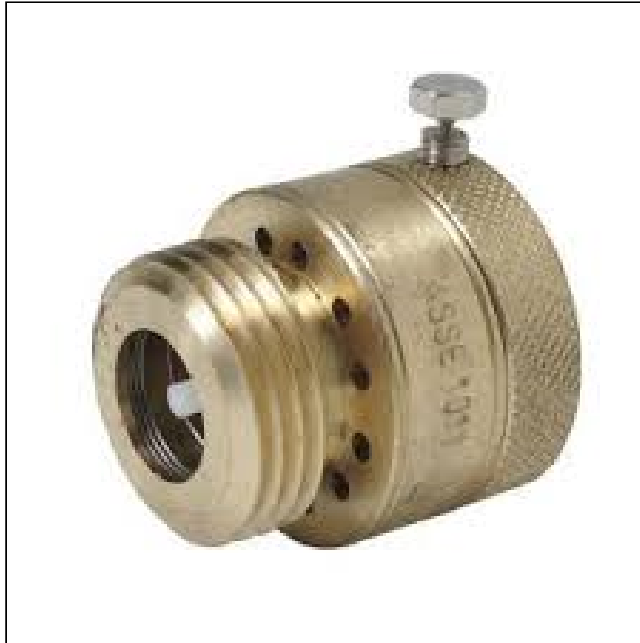
7.3 Item 2(Picture)

on them. These anti-siphon or anti-backflow devices help prevent contaminated water from flowing back into the the house water supply system. We recommend installing anti-siphon or anti-backflow devices at the every exterior hose spigots by a qualified person.

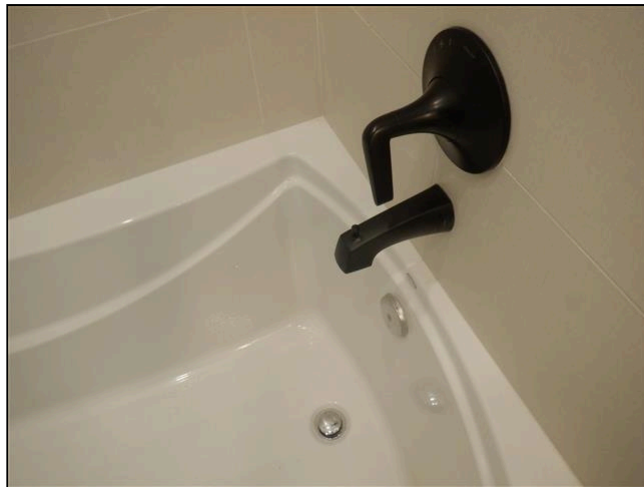
8.0.B Item 1(Picture)

(1) There is no water present at the tub/shower at the time of the inspection. There may be underlying issues. We recommend further evaluation by a qualified licensed plumber and have repairs where needed prior to the end of your contingency period.

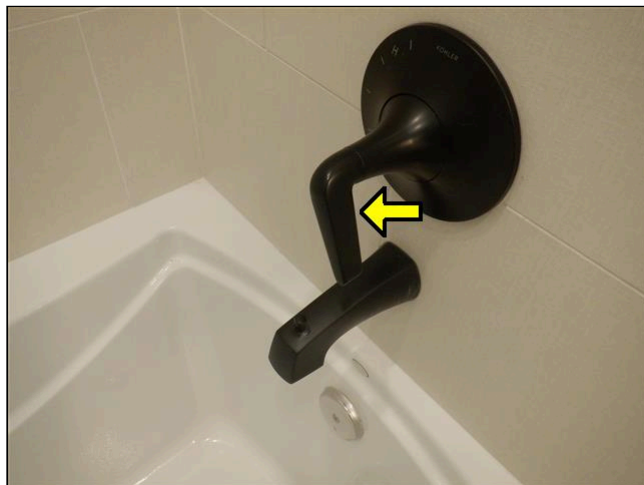
8.0.B Item 2(Picture)

(2) The tub faucet valve does not back stop. This condition allows the tub faucet valve to turn past the off position without stopping. We recommend necessary repairs or replacement by a qualified licensed plumber.

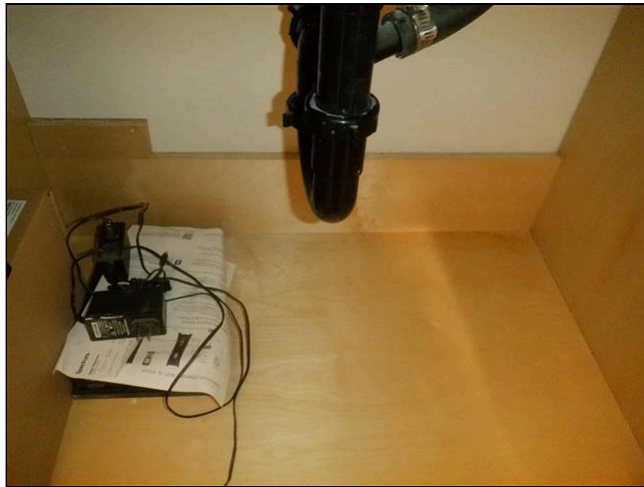
8.0.C Item 1(Picture)

An active leak is present at the drain pipe under the sink. We recommend necessary repairs by a qualified licensed plumber.

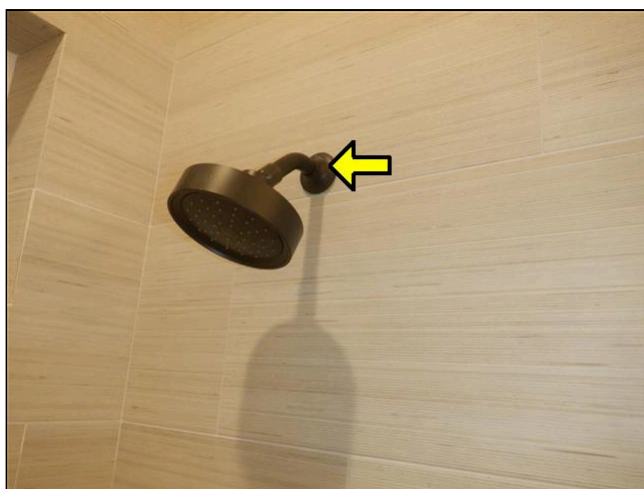
8.1.C Item 2(Picture)

(2) The shower head arm is loose in the wall. This condition could allow water to enter behind the tub/shower wall and could put unwanted stress on the water supply pipes. We recommend necessary repairs by a qualified licensed plumber.

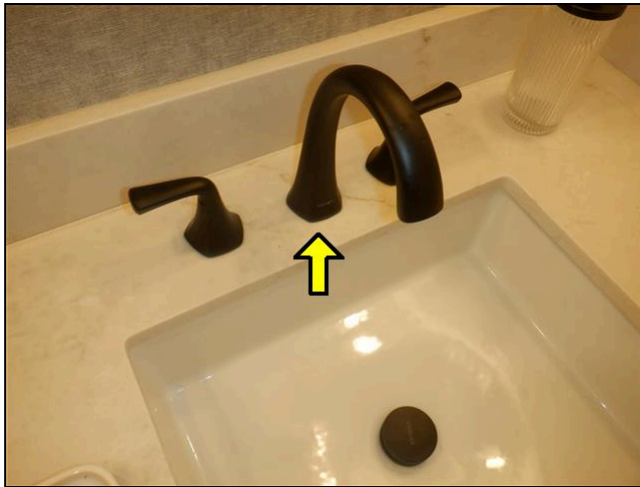
8.0.D Item 1(Picture)

The sink faucet is loose. We recommend necessary repairs by a qualified licensed plumber.

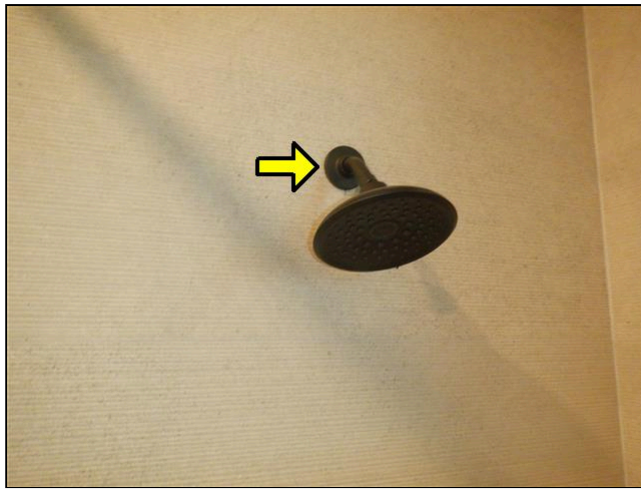
8.0.E Item 1(Picture)

The shower head arm is loose in the wall. This condition could allow water to enter behind the tub/shower wall and could put unwanted stress on the water supply pipes. We recommend necessary repairs by a qualified licensed plumber.

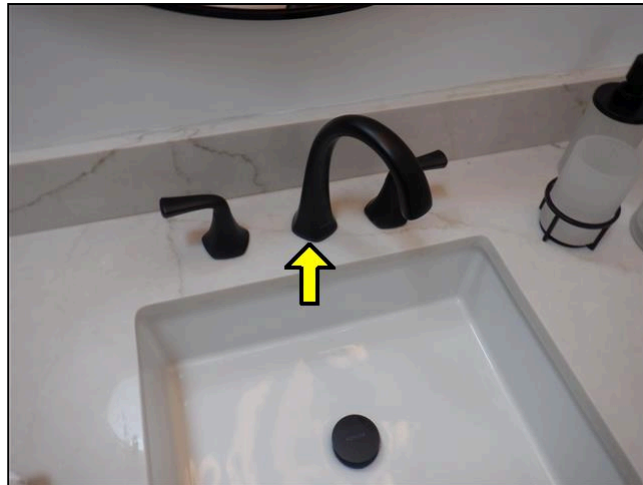
8.0.F Item 1(Picture)

The sink faucet is loose. We recommend necessary repairs by a qualified licensed plumber.

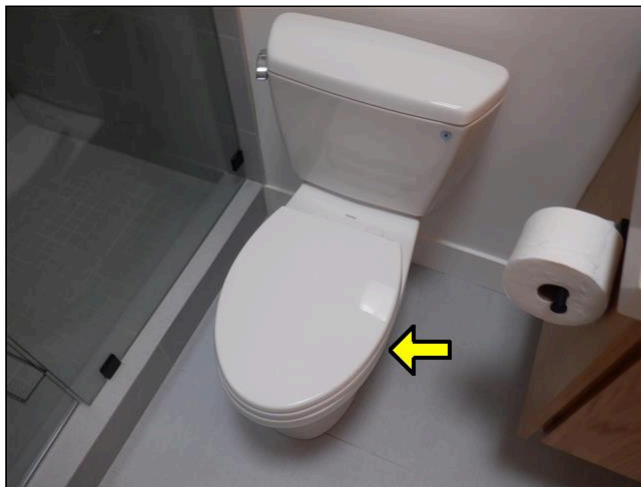
8.2.F Item 1(Picture)

The toilet is loose on the floor. This condition could damage the wax ring under the toilet. We recommend necessary repairs by a licensed plumber.

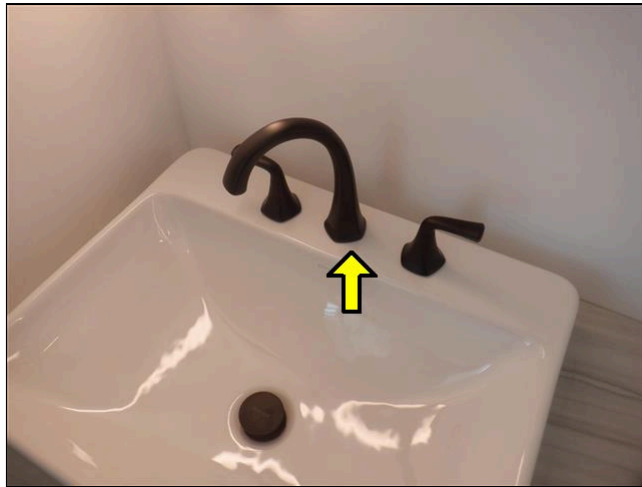
8.0.G Item 1(Picture)

The faucets are loose. We recommend necessary repairs or replacement by a qualified licensed plumber.

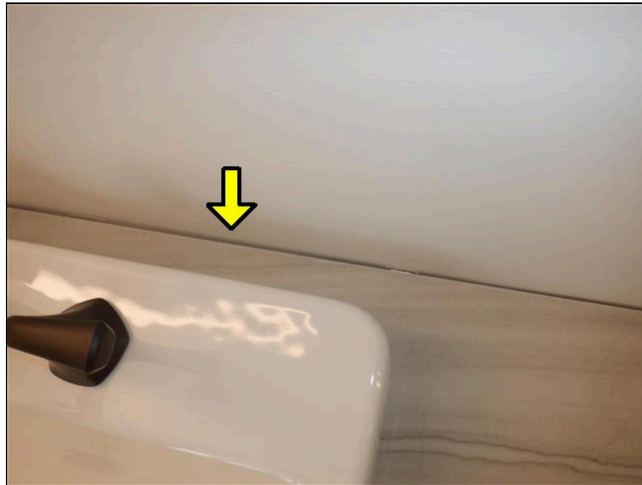
8.3.G Item 1(Picture)

There is a gap between the counter top and back splash. We recommend having this gap sealed by a qualified person to help prevent water/ moisture intrusion to the cabinet below.
