# Inspection Report

**Property Address:**  
123 Main Street  
San Diego CA 92129

**The Property Inspection Pros**

<b>Date:</b> 11/23/2024	<b>Time:</b> 09:00 AM	<b>Report ID:</b>
<b>Property:</b> 123 Main Street San Diego CA 92129	<b>Customer:</b> Jon Smith	<b>Real Estate Professional:</b>

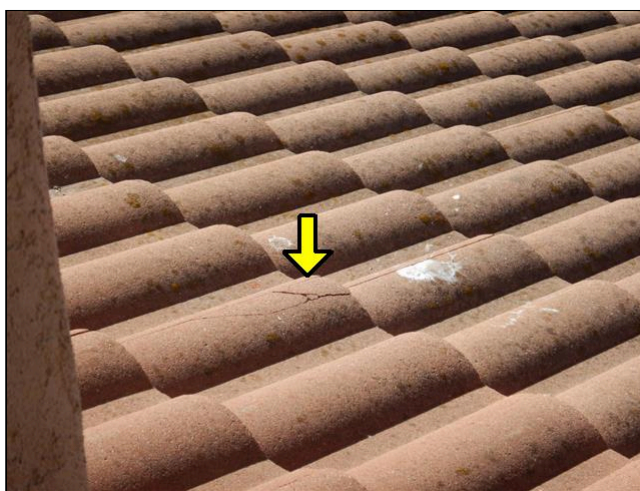
1.1 Item 4(Picture)

(4) There is a cracked roof tile observed at the front lower roof. We recommend necessary repairs by a licensed roof contractor.

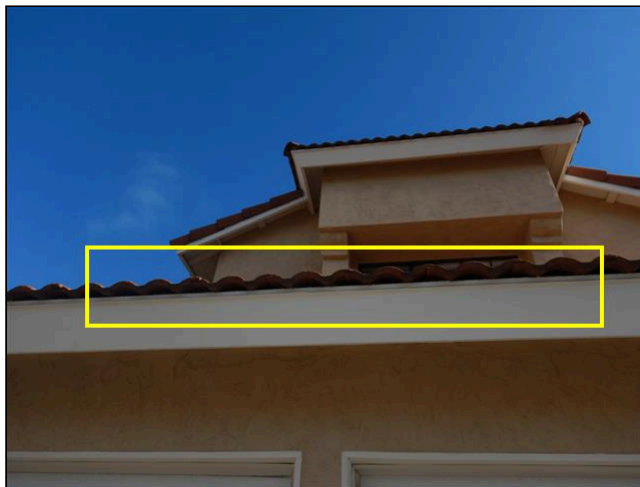
1.2 Item 1(Picture)

(1) This tiled roof does not have "bird stop" installed at the end of the roof at the eaves. While this may have been a common installation at the time of construction, the lack of this end cap can allow pest(s) to enter under the tiles and damage the underlayment "tar paper". It also exposes the underlayment "tar paper" to the sun, weather and the elements. These roofs commonly have deteriorated underlayment paper at the eaves because of the exposure. We recommend further evaluation of the roof and having a "bird stop" added by a licensed roof contractor.

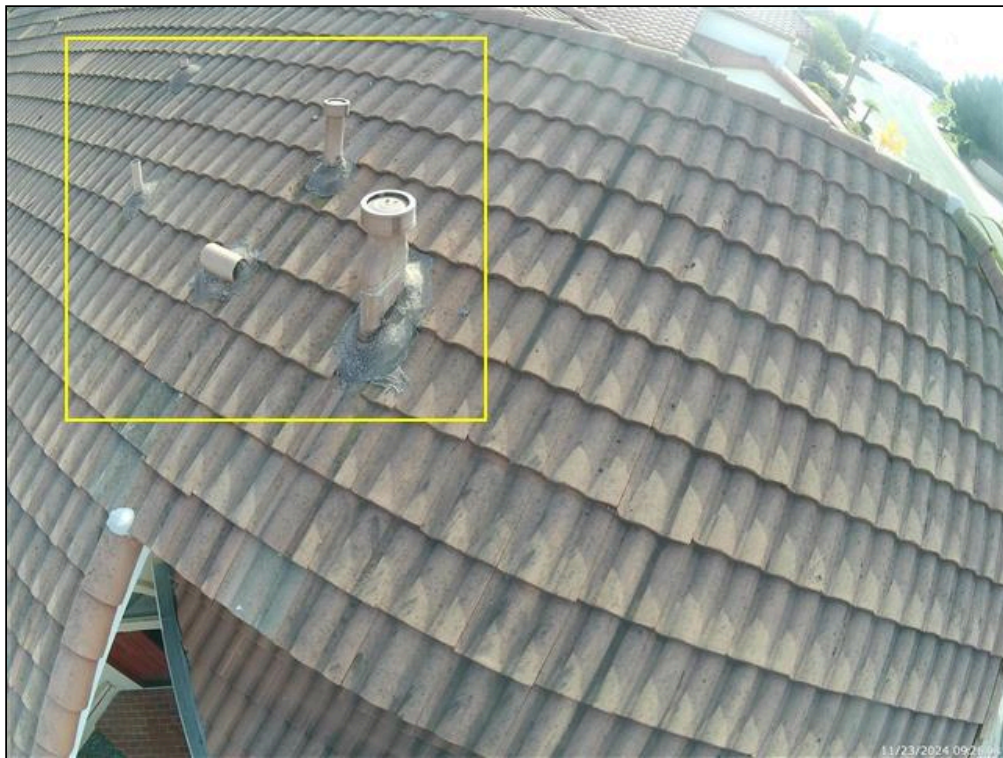
1.2 Item 3(Picture)

(4) Mortar flashings are noted at the roof penetrations. This is an older method of sealing the roof penetrations which is no longer used. Cracks were observed at the mortar flashings which may leak during rain. We recommend having the roof inspected by a licensed roof contractor prior the end of your contingency period.

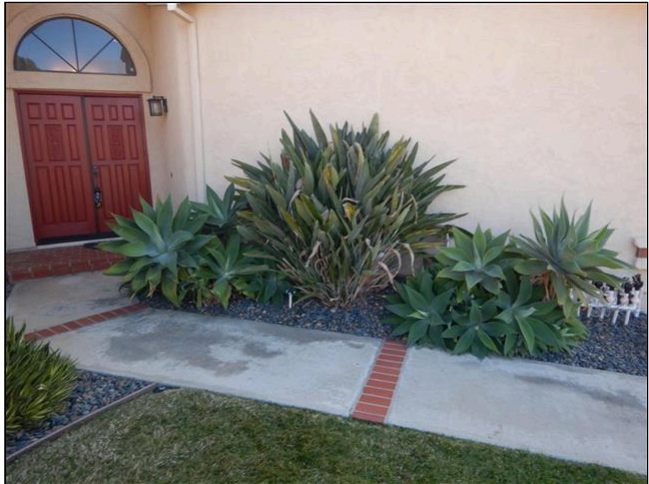
2.1 Item 1(Picture)

(1) Vegetation is in contact with the siding/ stucco at several areas. Vegetation can create moisture problems by preventing siding from drying out. Vegetation also allows rodents to easily access the roof where they can enter through small voids. We recommend removing vegetation from the siding/ stucco. We also recommend referring to the pest control report for their recommendations.

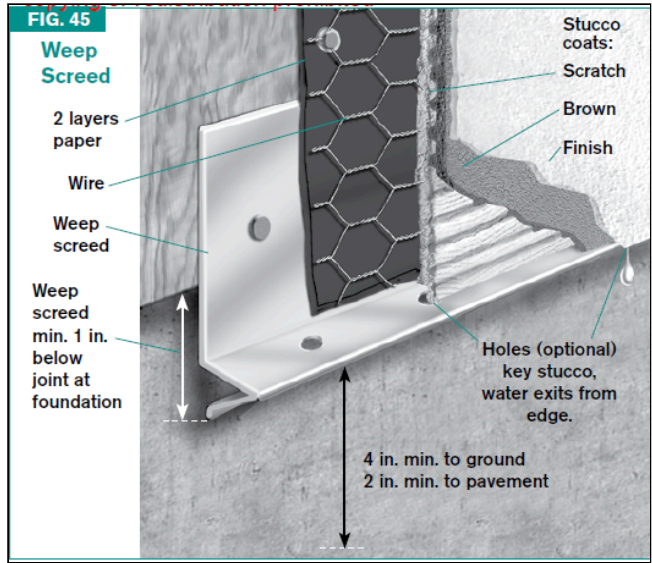
2.2 Item 1(Picture)

(3) The stucco/weep screed is in contact with ground at several areas. The weep screed is the metal band at the base of the stucco which has holes to allow the stucco to "breathe" and water to "weep" from the stucco. Having the soil above the weep screed can lead to stucco damage due to limited air flow. We recommend a ground clearance of four inches where possible allow for proper drainage and for ventilation of the stucco walls. Dirt in contact with the stucco can promote deterioration, including rot, pest infestation, and water intrusion during rain. We recommend further evaluation and

necessary corrections by a qualified licensed contractor.

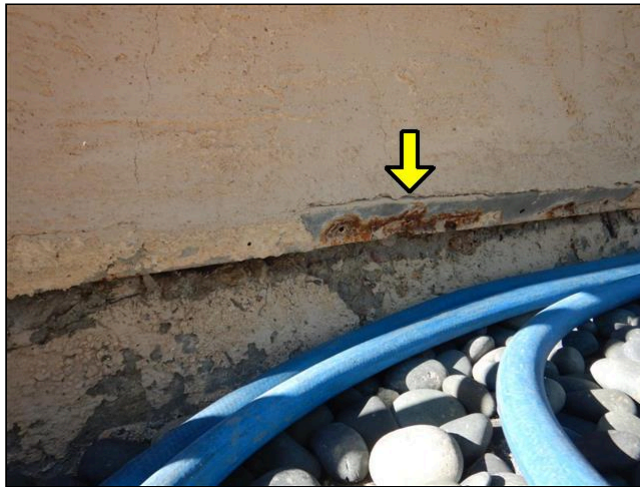
2.3 Item 1(Picture)

(1) The stucco screed flashing is rusted at several areas around the house. The stucco screed flashings may have to much rust and damage and may need to be replaced. We recommend further evaluation by a stucco repair contractor and necessary repairs or replacement made as needed and we recommend adjusting the sprinklers to spray away from the house.

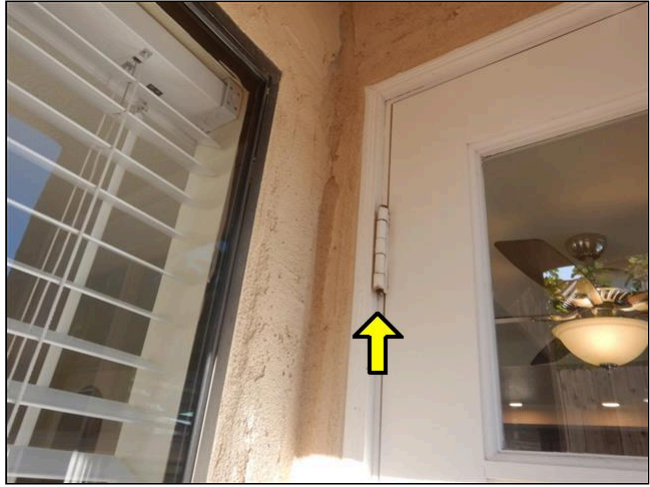
2.5 Item 1(Picture)

**Safety Tip:** The hinges installed at the rear exterior door does not appears to have security hinges. When the hinge pin is accessible from the exterior, the hinge must be specifically intended for this installation so they are tamper proof. Standard hinges are subject to having the pins removed allowing the doors to be opened. We recommend having at least one security hinge installed at each door for security by a qualified contractor.

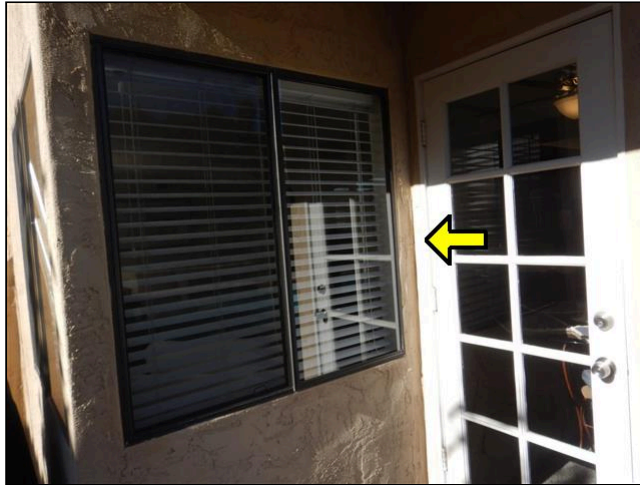
2.7 Item 1(Picture)

A rear window is within 24-inches of an entry exterior door. There is no safety glass markings found on this window glass. The untempered-glass with 24-inches of the front door is a safety hazard. We recommend replacing the window glass with tempered glass for safety by a qualified licensed window contractor.

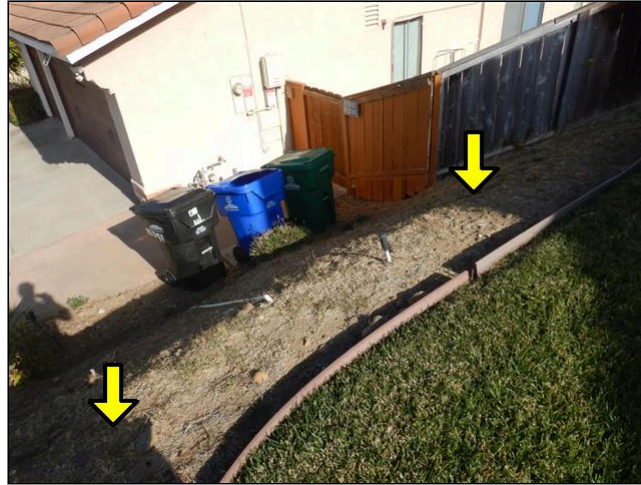
2.10 Item 1(Picture)

(1) A fence, barrier or guard rail is needed at the left front yard. A fall hazard is present at several areas. We recommend installing an approved fence, barrier, or guard rail where needed for safety by a qualified licensed contractor.

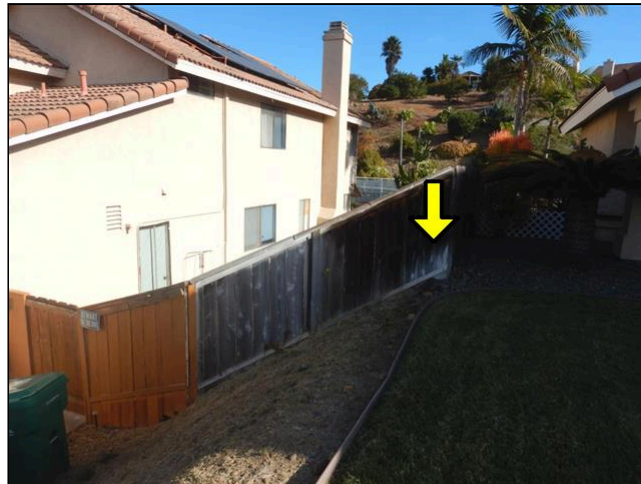
2.10 Item 2(Picture)

(2) The sprinklers appear to be spraying onto the wood fencing in several areas. Long term exposure to water will deteriorate the wood. We recommend adjusting the sprinklers to spray away from the wood fence.

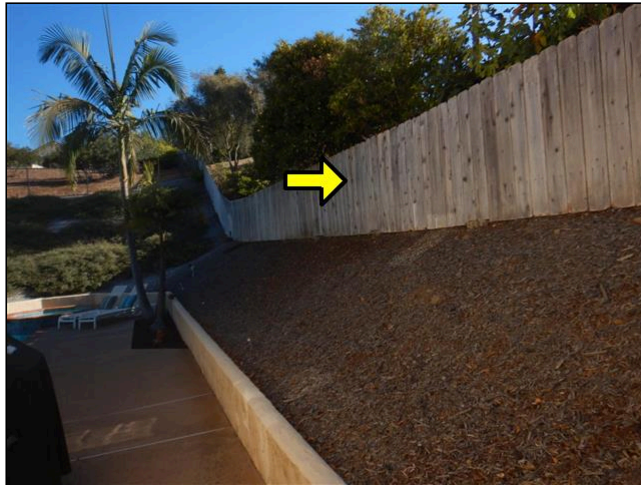
2.10 Item 3(Picture)

(3) The wood fencing is not painted or stained. Maintaining paint and/ or stain is essential to preventing the wood from deteriorating and damage. We recommend prep and painting or staining as needed by a licensed paint contractor.

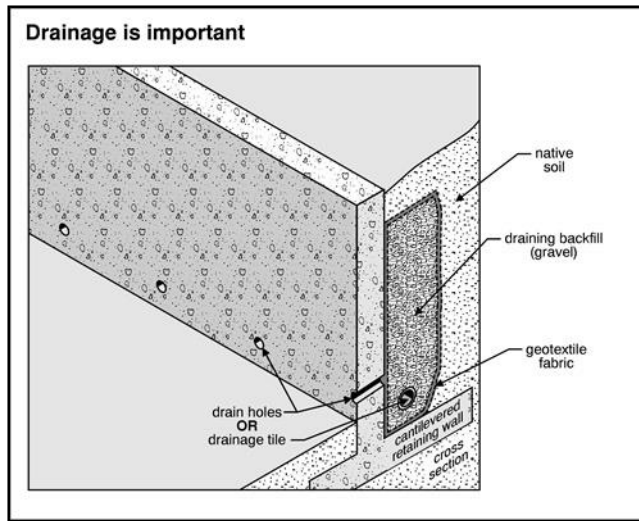
2.13 Item 1(Picture)

(1) The retaining wall does not appear to have weep holes installed. Weep holes allow water to drain from behind wall. Lack of weep holes can create excessive pressure on wall, soil movement, premature deterioration of wall material, and efflorescence which can damage stucco coating. The weep holes may be too low (under top soil) or missing. We recommend having weep holes installed by a qualified contractor.

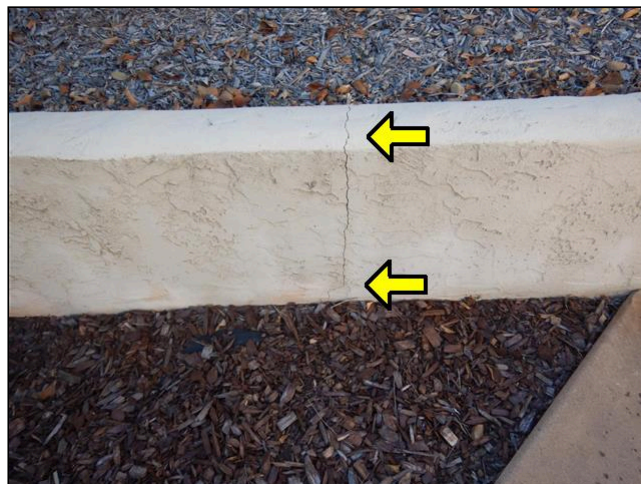
2.13 Item 3(Picture)

(2) There are cracks in the stucco observed at the retaining wall at several areas. We recommend necessary repairs where needed by a licensed stucco contractor.

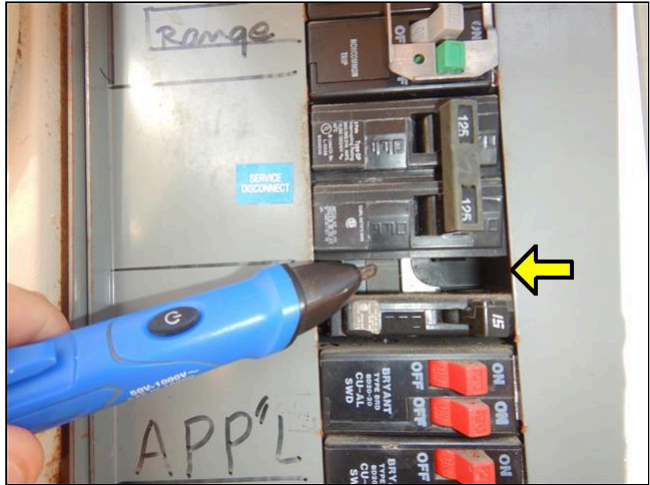
3.0 Item 4(Picture)

(4) A twist out is missing at the main panel dead-front cover. Whenever a twist out is removed and no breaker is present then a cover insert is required to be installed to help prevent shocks and rodent intrusion. We recommend installing cover insert(s) where needed by a qualified person for safety.

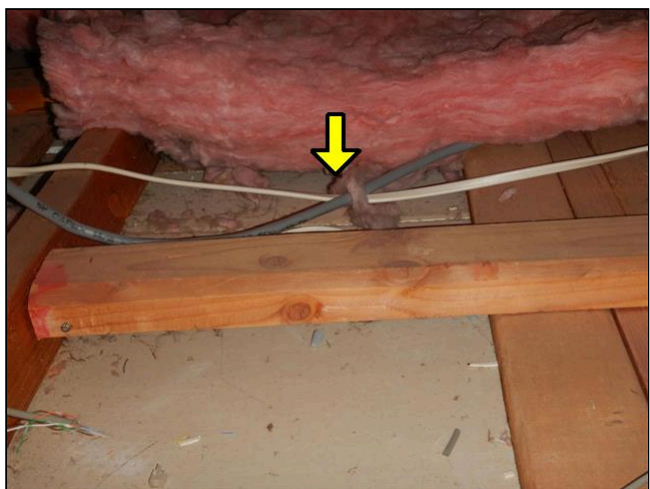
3.2 Item 1(Picture)

(2) Wires for some lighting fixtures in the attic space were observed to be unsecured. We recommend necessary corrections by a qualified licensed electrician.

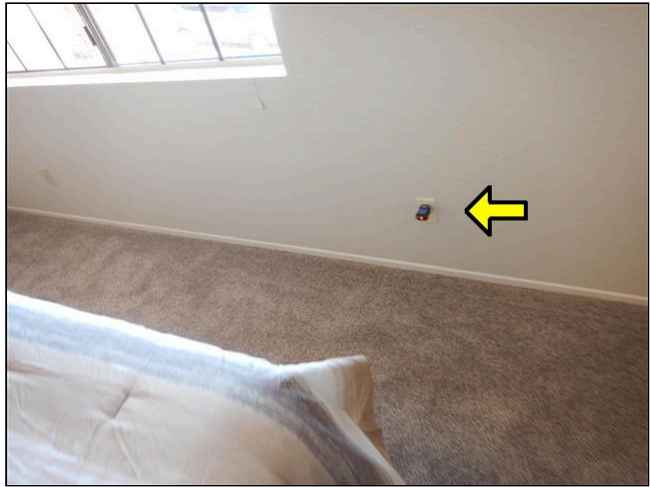
3.6 Item 2(Picture)

(2) The hot and ground wires are reversed at a receptacle in the front bedroom. This is non standard and a safety issue. We recommend necessary repairs by a qualified licensed electrician for safety.

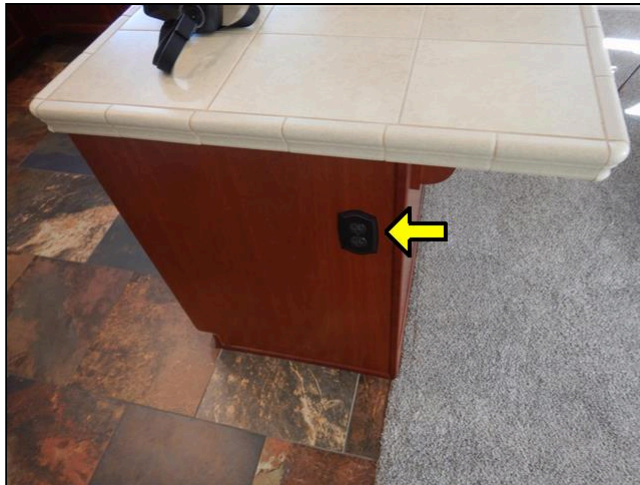
3.9 Item 3(Picture)

(4) We recommend upgrading the receptacles at the kitchen island to GFCI protected receptacles by a qualified licensed electrician for safety.

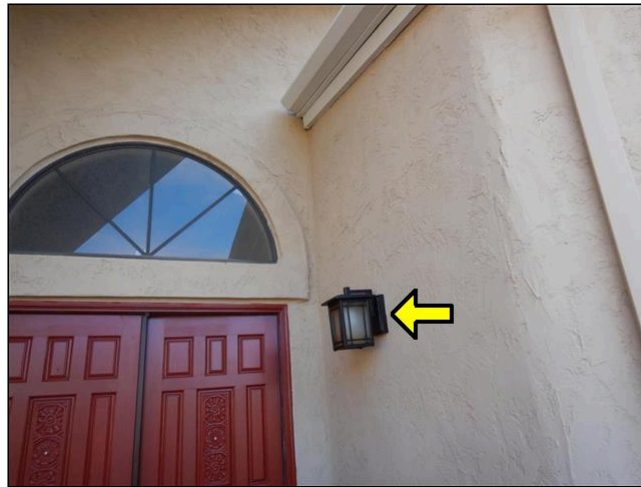
3.12 Item 1(Picture)

- (1) A representative number of exterior lights were tested and were found to be functional at the time of the inspection.
- (2) The exterior light fixtures were not sealed where the fixture meets the wall. This condition could allow moisture intrusion in this area. We recommend sealing exterior light fixtures where they meet the wall by a qualified person.

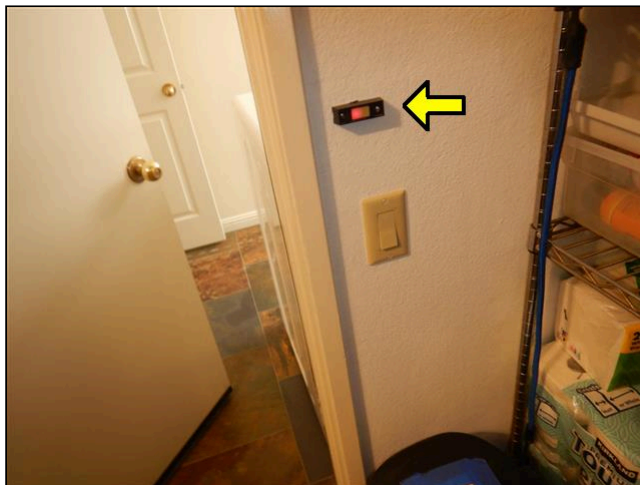
4.1 Item 1(Picture)

(1) The garage door push-button switch is lower than the recommended 5-foot minimum height above the standing surface. This condition is potentially dangerous to children. We recommend that the switch be raised to the 5-foot minimum or higher by a qualified licensed garage door contractor for safety reasons.

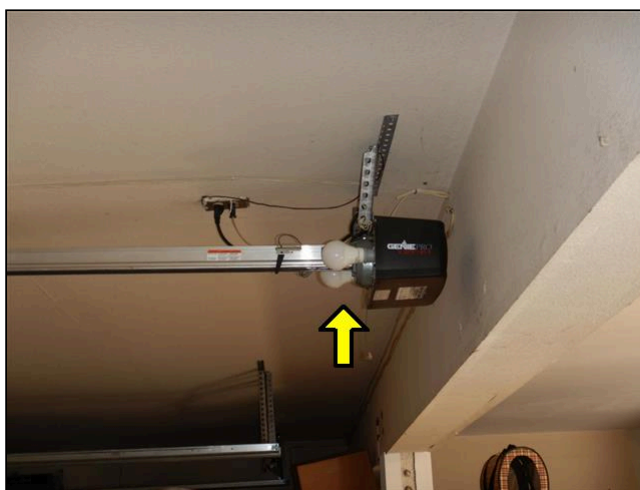
4.1 Item 2(Picture)

(4) The garage door opener light cover is missing. We recommend replacing.

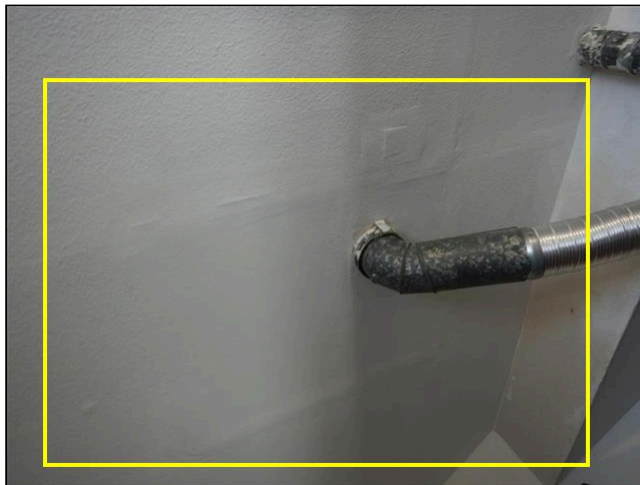
4.2 Item 1(Picture)

- (1) The ceiling has typical cosmetic wear. You may wish to view this for yourself and have necessary repairs made by a qualified person.
- (2) Patching is observed at the garage ceiling in several areas. We recommend asking the seller if they have any knowledge of the repair or cause.

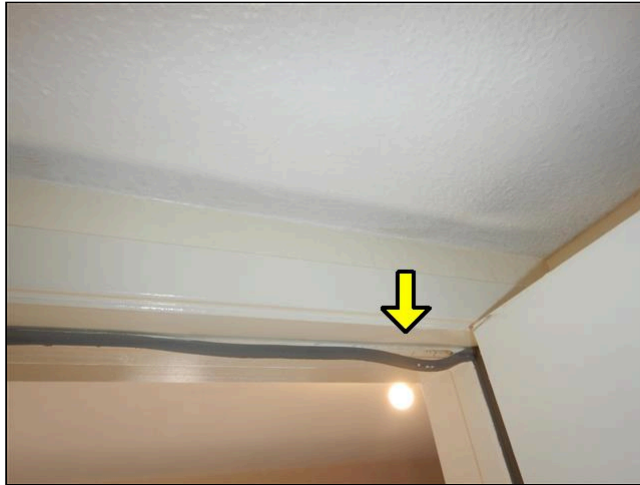
4.5 Item 1(Picture)

(2) The weather-stripping at the fire door is damaged/ loose. We recommend replacing weather-stripping by a qualified person at the fire door to insulate the home and to help keep smoke or Carbon Monoxide from entering the living space.

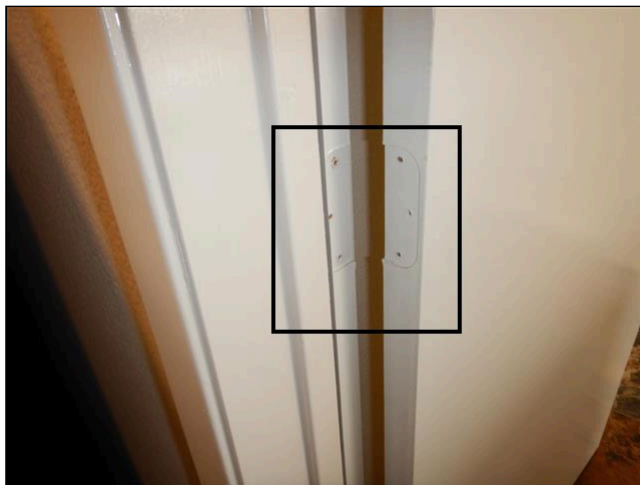
4.6 Item 1(Picture)

(1) One of the required auto-closing hinge was not installed and requires installation at the door to the garage. We recommend installing an auto-closing hinge by a qualified licensed door contractor.

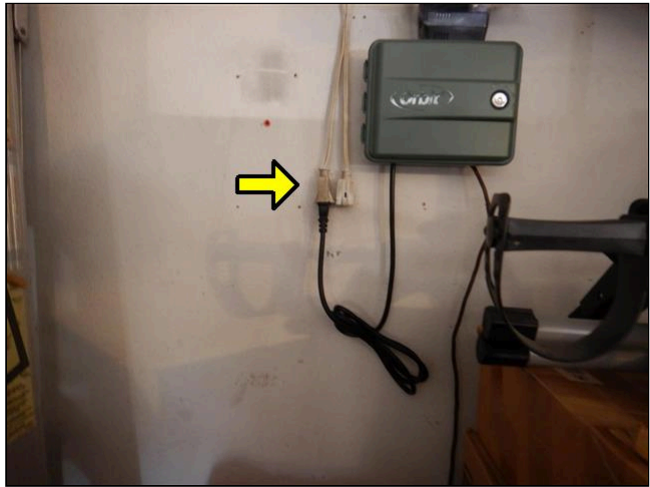
4.8 Item 1(Picture)

There are extension cords that are being used as permanent wiring in the garage. Extension cords are considered for temporary use only and a safety hazard when used long term. We recommend removing the extension cords and replacing with proper wiring by a qualified licensed electrician.

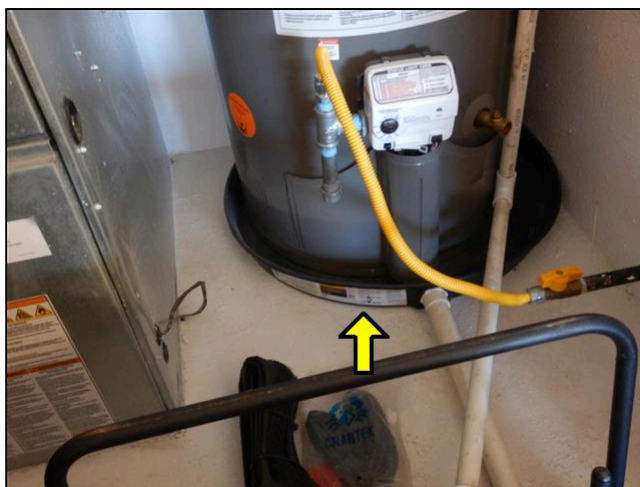
5.0 Item 3(Picture)

(4) There is a plastic drain pan under the gas water heater which is not allowed. Plastic pans are not approved for gas hot water tank use. They are approved for electric hot water tanks. A metal pan should be used under a gas water heater. We recommend removing the plastic pan and installing a metal pan by a licensed plumber.

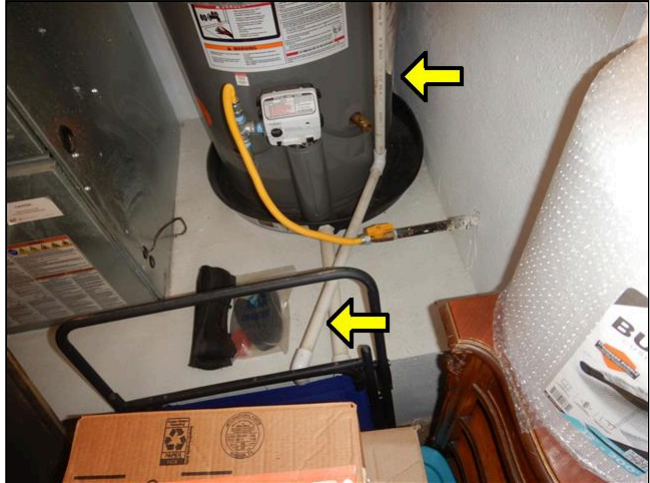
5.3 Item 1(Picture)

The water heater Temperature and Pressure (T&P) relief valve pipe diameter is PVC. This is an incorrect installation. We recommend necessary corrections by a qualified licensed plumber.

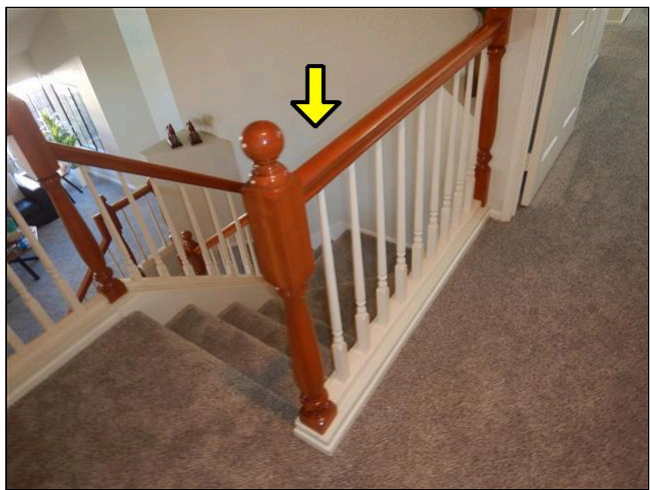
6.4 Item 1(Picture)

The stair/landing railing is loose. This is a safety hazard and corrections are needed. We recommend necessary repairs for safety by a qualified licensed contractor.

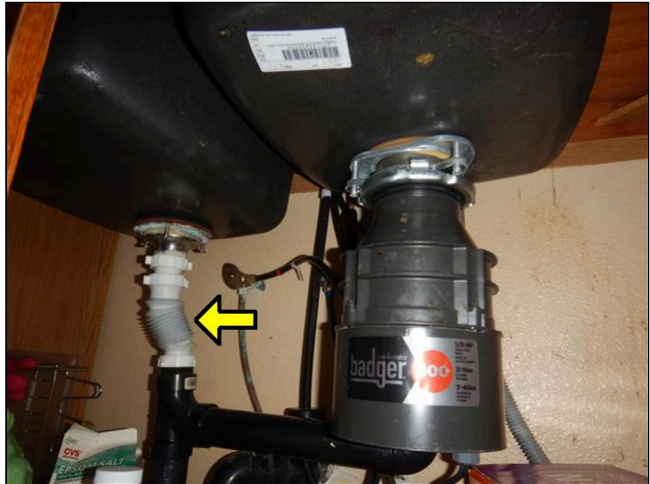
7.0 Item 1(Picture)

(2) A corrugated (flexible) waste pipe is installed at the kitchen sink. This is a non standard installation because this type of material may hold bacteria and is more likely to become clogged. We recommend replacing this corrugated (flexible) waste pipe by a qualified licensed plumber.

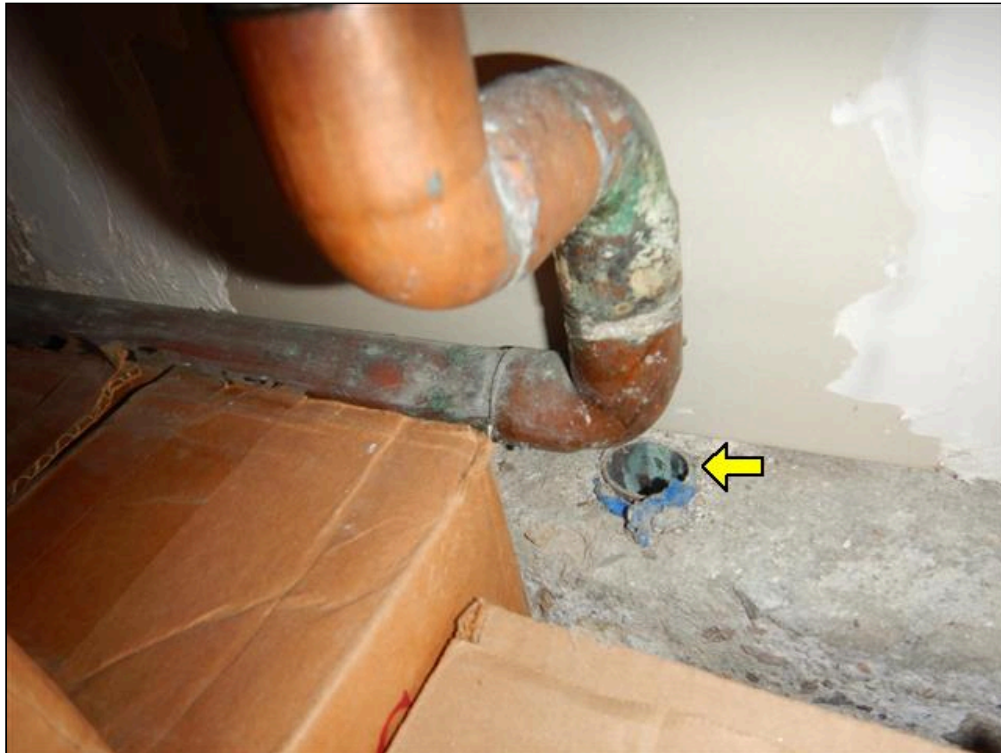
7.1 Item 1(Picture)

(2) This home appears to have had a partial supply re-pipe which indicates past leaks may have occurred in the distribution piping. We recommend asking the seller about the repairs or qualified licensed plumber to evaluate further if concerned.

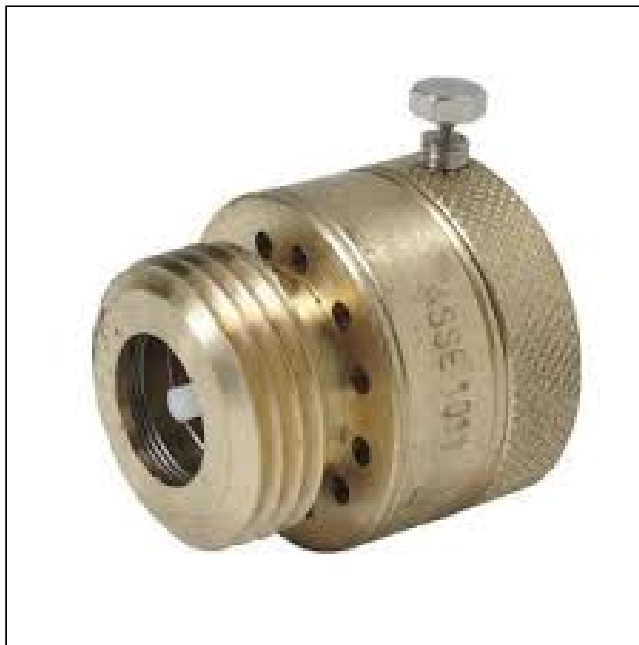
7.3 Item 1(Picture)

(1) Some of the exterior hose spigots do not have anti-siphon or anti-backflow devices installed on them. These anti-siphon or anti-backflow devices help prevent contaminated water from flowing back into the the house water supply system. We recommend installing anti-siphon or anti-backflow devices where needed by a qualified person.

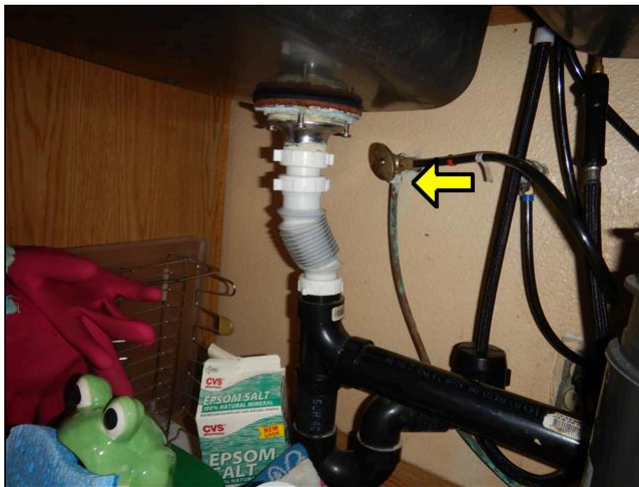
7.5 Item 1(Picture)

Some of the sink angle stop valves are observed with calcium deposits on them. Calcium deposits can corrode or deteriorate these valves and cause potential leaks. We recommend replacing all calcified angle stop valves by a qualified licensed plumber to help prevent leaks.

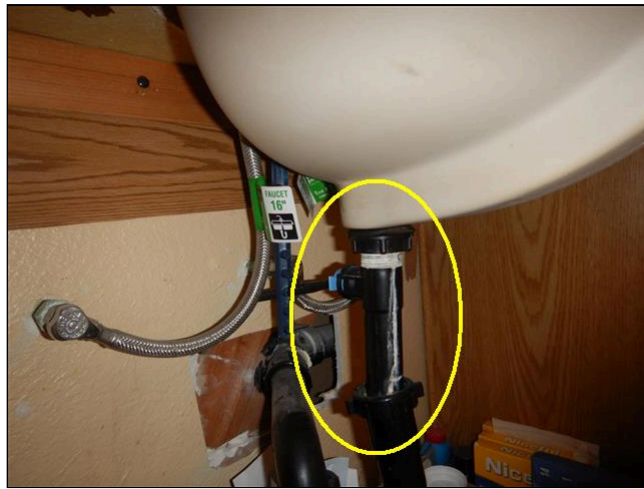
8.0.A Item 1(Picture)

Several waste lines under the sink(s) are stained. Although there are currently no leaks detected, there may be one under certain conditions. We recommend further evaluation by a licensed plumber prior to the end of your contingency.

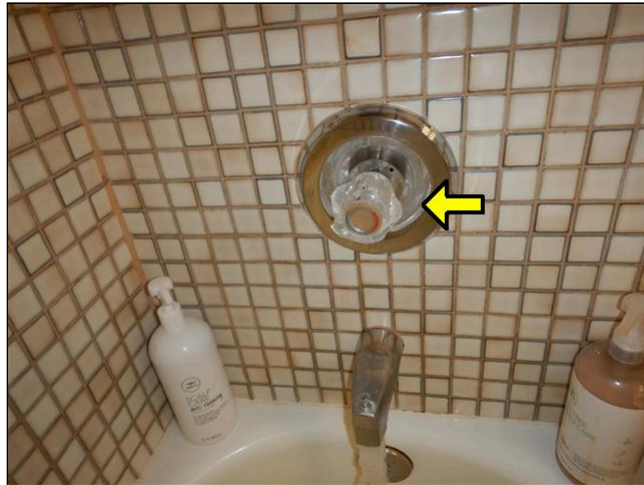
8.1.A Item 1(Picture)

(1) The tub faucet valve does not back stop. This condition allows the tub faucet valve to turn past the off position without stopping. We recommend necessary repairs or replacement by a qualified licensed plumber.

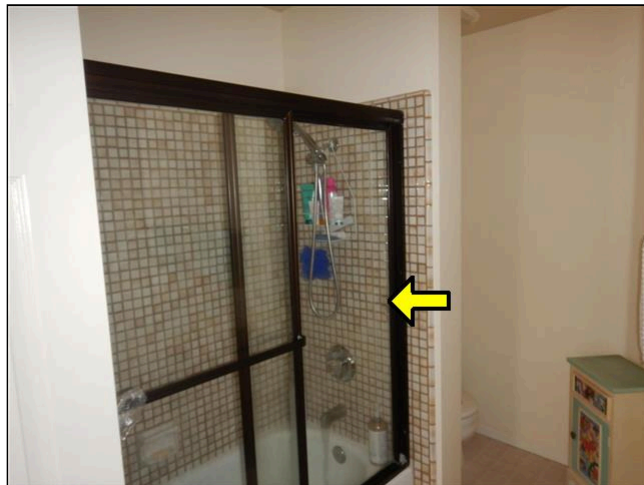
8.1.A Item 2(Picture)

(2) The bathroom tub/ shower glass wall and door do(es) not appear to have safety tempered glass as required. I could not find any markings on the glass which would confirm this safety feature. Having standard plate glass could cause serious injury if the glass breaks. While this may have been standard installation at the time of the original construction. We recommend upgrading the glass to tempered glass by a qualified licensed door contractor as a safety upgrade.

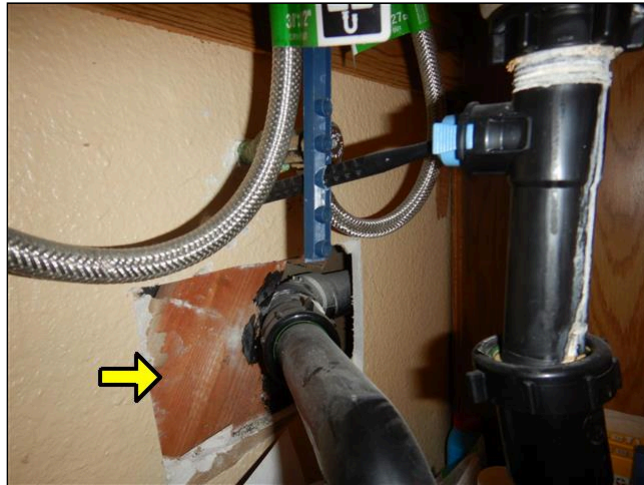
8.2.A Item 1(Picture)

There are several holes/ openings under the bathroom cabinet(s) possible due to plumbing repairs. We recommend necessary repairs where needed by a qualified person.

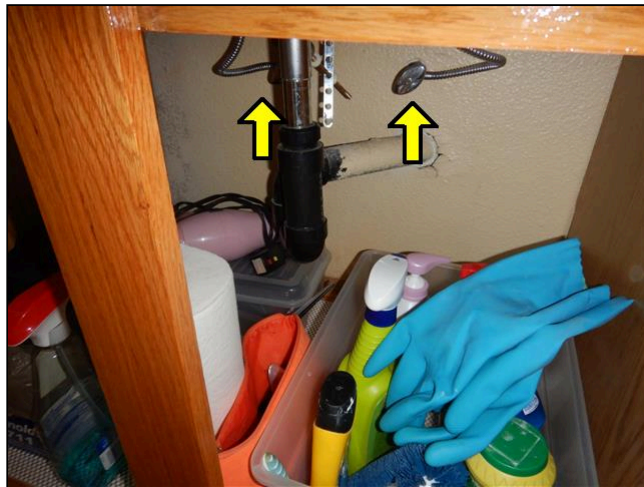
8.0.B Item 1(Picture)

(1) There are older one piece angle stop valve(s)/ supply line(s) observed at the sink. These one piece angle stop valve(s)/ supply line(s) have a reputation to corrode from the inside and possible fail. A white power substance or corrosion/ calcification is observed at the one piece angle stop valve(s)/ supply line(s). We recommend that these one piece angle stop valve(s)/ supply line(s) be replaced by a qualified licensed plumber as an upgrade.

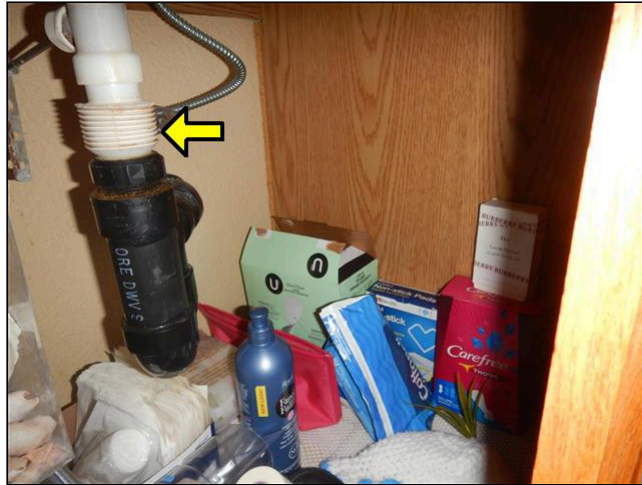
8.0.B Item 2(Picture)

(2) A corrugated (flexible) waste pipe is installed at the sink. This is a non standard installation because this type of material may hold bacteria and is more likely to become clogged. We recommend replacing this corrugated (flexible) waste pipe by a qualified licensed plumber.
