Inspection Report

Property Address:
4123 Main Place
Oceanside CA 92054

The Property Inspection Pros

Date: 7/18/2024	Time: 01:00 PM	Report ID:
Property: 4123 Main Place Oceanside CA 92054	Customer: Jon Rikki	Real Estate Professional:

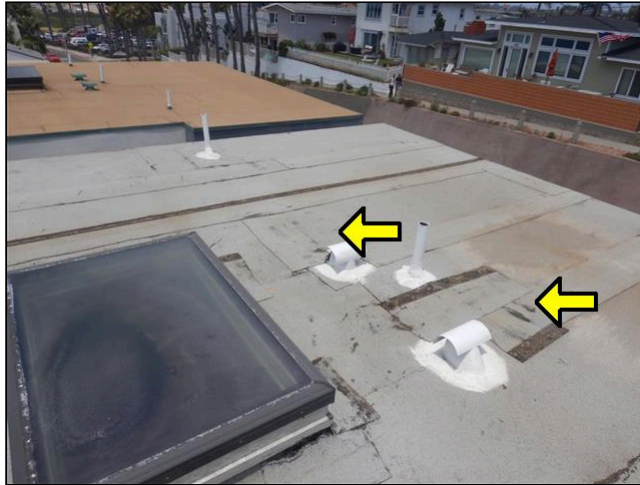
1.0 Item 2(Picture)

(2) The roof has had repairs made to it at several areas. We are unable to determine if these repairs are made correctly and successful. We recommend asking the seller about these repairs, and we recommend further evaluation by a qualified licensed roof contractor.

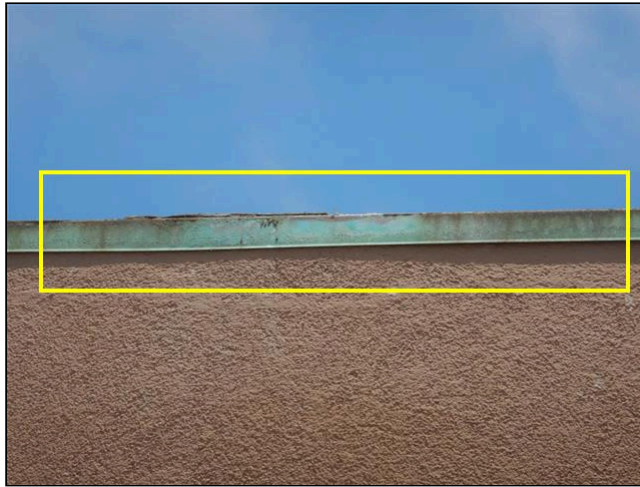
1.1 Item 1(Picture)

The roof metal flashing are rusted/ deteriorated at several areas. We recommend further evaluation of all metal components and necessary maintenance, replacement and repairs as needed by a qualified licensed roof contractor.

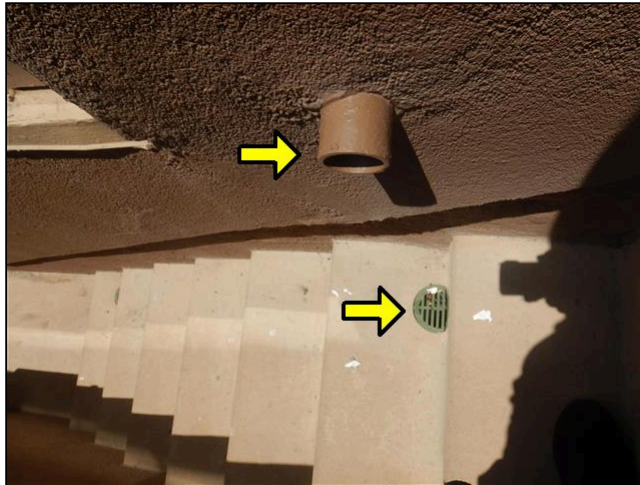
1.2 Item 2(Picture)

(2) Some of the downspouts need extension and/or a buried drain line to carry water away from the home at several areas. We recommend necessary corrections where needed by a qualified contractor.

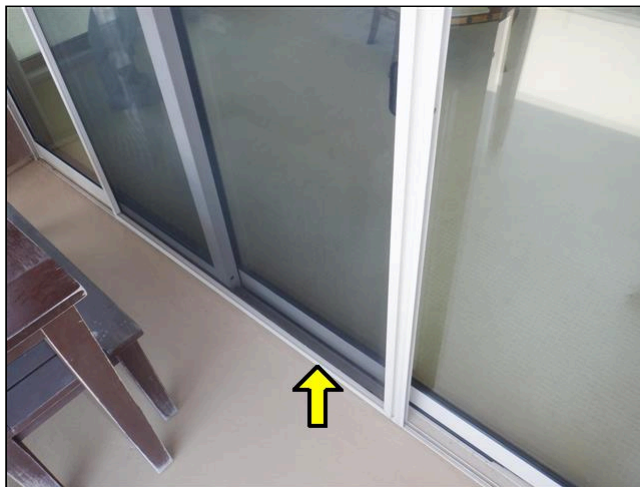
2.4 Item 1(Picture)

(1) Several sliding screen doors sticks the track and are difficult to slide. We recommend making necessary repairs/replacement where needed by a licensed contractor.

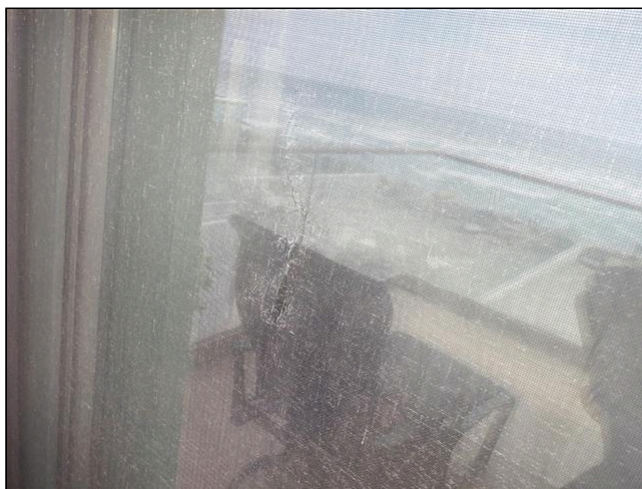
2.4 Item 4(Picture)

(2) The right side guest room sliding screen door has a torn or damaged screen. We recommend repair or replacement by a qualified person.

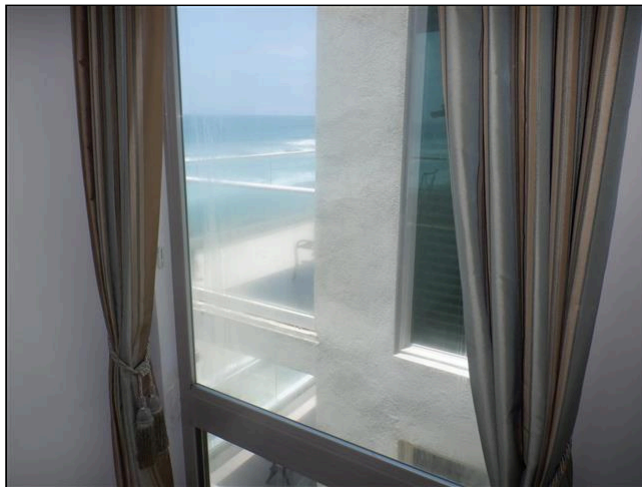
2.5 Item 3(Picture)

(2) Condensation was observed between the panes of glass at several windows throughout the house. This occurs when the seal has failed between the panes of glass, and ambient air has entered the assembly. Replacement of the glass is required. Since some failed windows may not be easily found due to changing ambient conditions (heat, humidity, etc). We recommend having all of the windows reviewed by a licensed window contractor to determine how many windows require repair/replacement. We recommend repairing or replacing all windows that have failed window seals by a licensed window contractor.

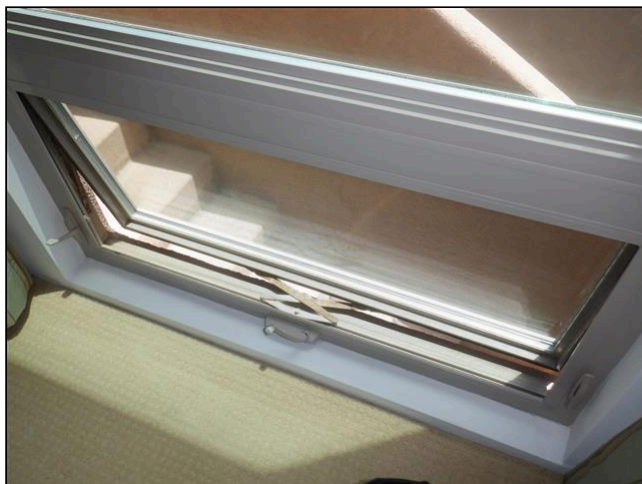
2.5 Item 5(Picture)

(3) There are several windows that are very difficult to open. We recommend necessary repairs where needed by a qualified licensed window contractor.

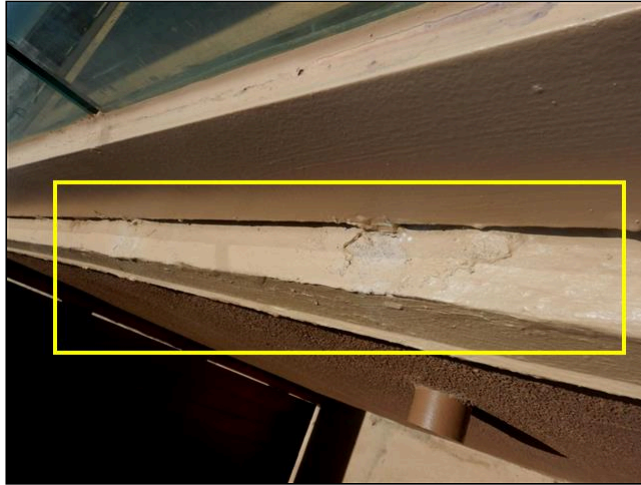
2.11 Item 1(Picture)

(1) The deck metal flashing are rusted/ deteriorated at several areas. We recommend further evaluation of all metal components and necessary maintenance, replacement and repairs as needed by a qualified licensed contractor.

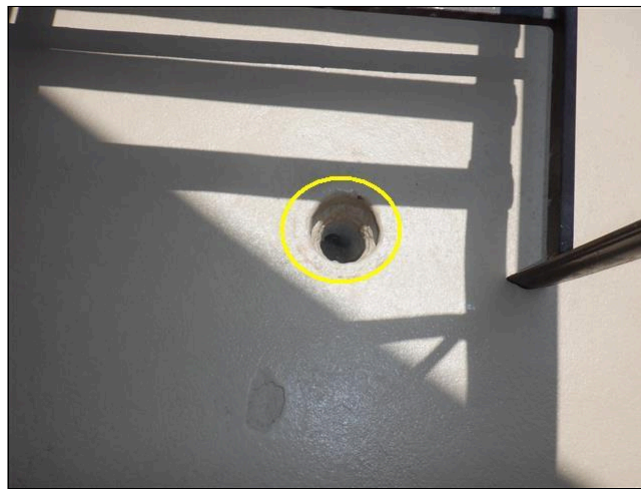
2.11 Item 4(Picture)

(2) One of the middle balcony drain caps is missing. We recommend replacement by a licensed contractor.

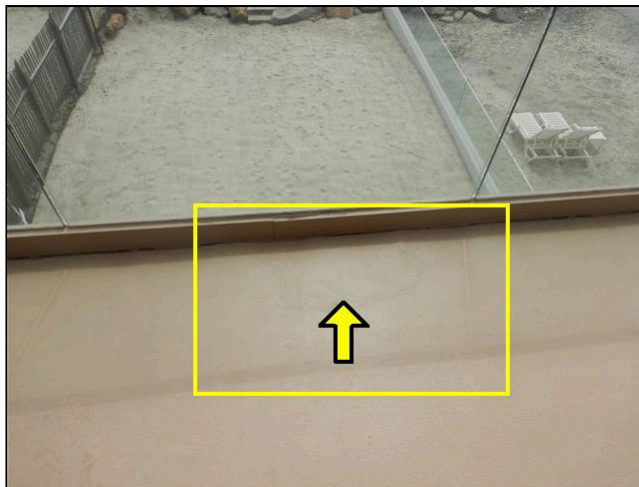
2.11 Item 6(Picture)

(4) There is a soft spot at on of the decks. We recommend further evaluation and necessary repairs by a licensed deck contractor.

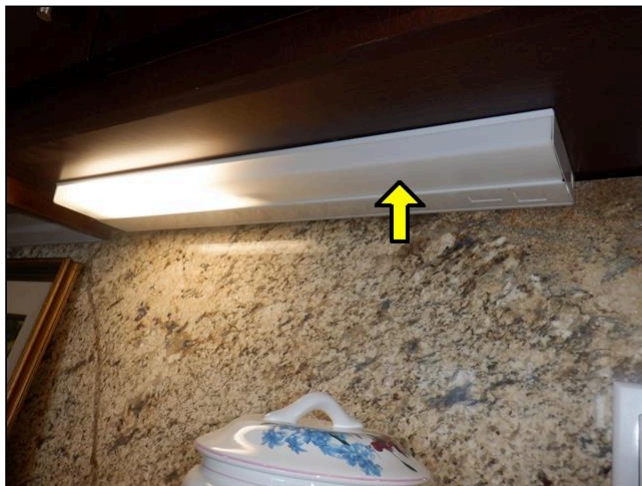
3.5 Item 1(Picture)

(1) Several lights throughout the house/ garage did not function when tested possibly due to bad bulbs or a miss wired fixtures. Occasionally there may something wrong with the fixtures which cannot be determined without a working bulb. We recommend asking the seller to demonstrate that theses lights are working prior to the end of the inspection contingency period, or changing the bulbs and testing again. If these lights do not function we recommend further evaluation by a qualified licensed electrician and necessary repairs or replacement as needed.

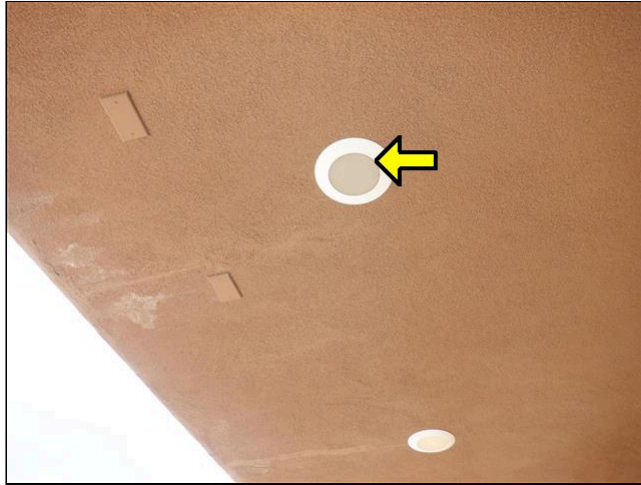
3.11 Item 1(Picture)

(1) There are several exterior light fixtures that did not function when tested. This may be due to bad bulbs or possible electrical problems. We recommend changing the bulbs and re testing these lights. If these lights fail to function, we recommend further evaluation a qualified licensed electrician and repairs or replacement as needed.

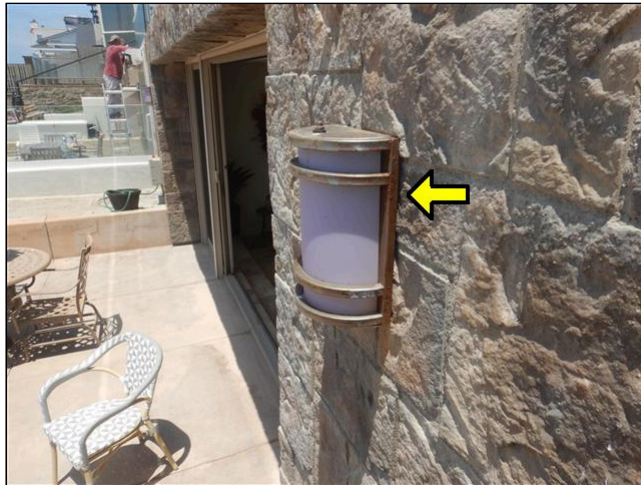
3.11 Item 2(Picture)

(2) The exterior light fixtures were not sealed where the fixture meets the wall. This condition could allow moisture intrusion in this area. We recommend sealing exterior light fixtures where they meet the wall by a qualified person.

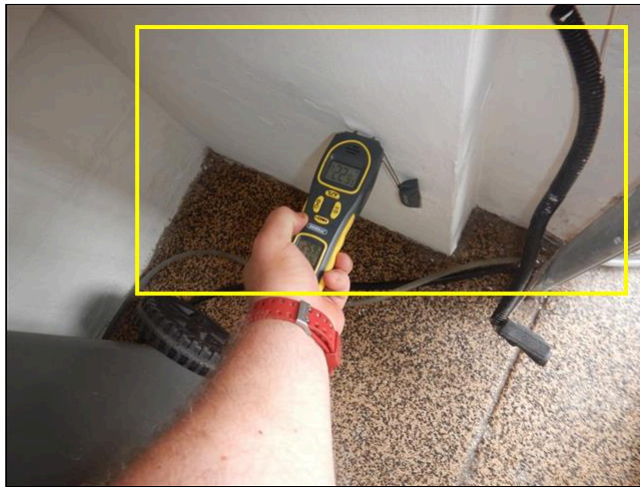
4.3 Item 1(Picture)

(2) Water intrusion is noted at a wall in the garage possibly due to poor installation of siding, trim, or window flashing. The exact cause of the moisture could not be determined with in the scope of this general home inspection. We recommend further evaluation by a qualified licensed contractor prior to the end of your contingency period and necessary repairs made as needed.

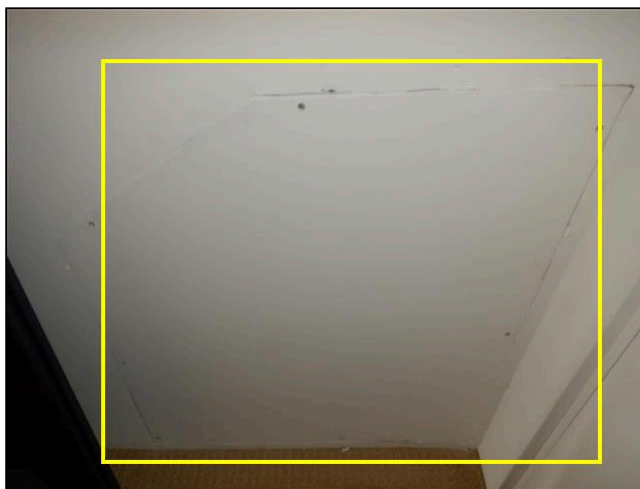
6.0 Item 1(Picture)

(1) The screws are stripped at the access cover underneath the 1st level stairwell preventing the panel to be taken off. Underneath the stairwell and its related components could not be inspected at this time. We recommend that the stripped screw be removed and that this area and it's related components be inspected by this company or a qualified person prior to the end of your contingency period.

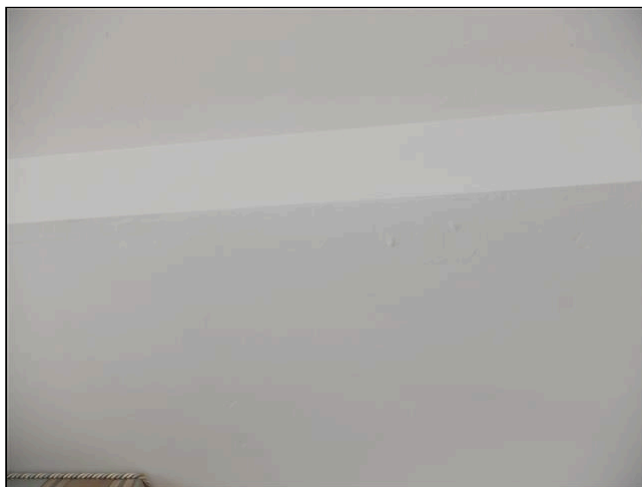
6.1 Item 1(Picture)

(1) Paint was observed to be "bubbling"/failing at the ceiling in the living room. These areas were tested for moisture and were found to be dry at the time of the inspection. No elevated level of moisture was detected which may indicate that the staining is old or from a one-time event (such as a tub/toilet over-flow). The stain were dry at the time of the inspection so I could not determine if the leak is still active. Under certain conditions or regular use there may be an active leak. We recommend further evaluation by a licensed plumber prior to the end of your contingency period if concern.

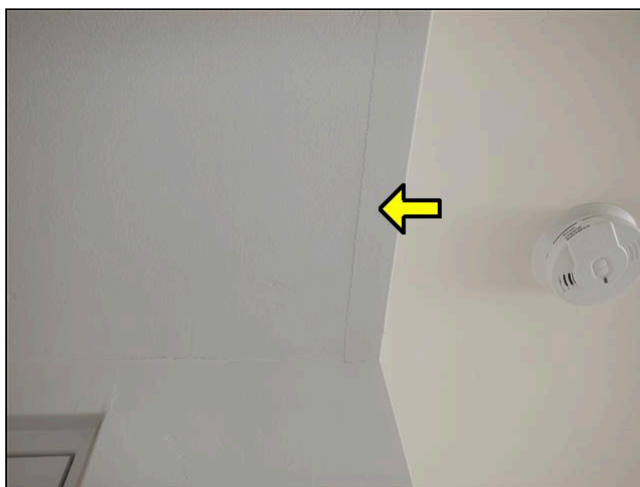
6.1 Item 3(Picture)

(2) Hairline cracking was observed at the ceiling at several locations in the house. These hairline cracks are likely due to material shrinkage or settlement of the structure. We recommend prep and paint by a qualified licensed contractor.

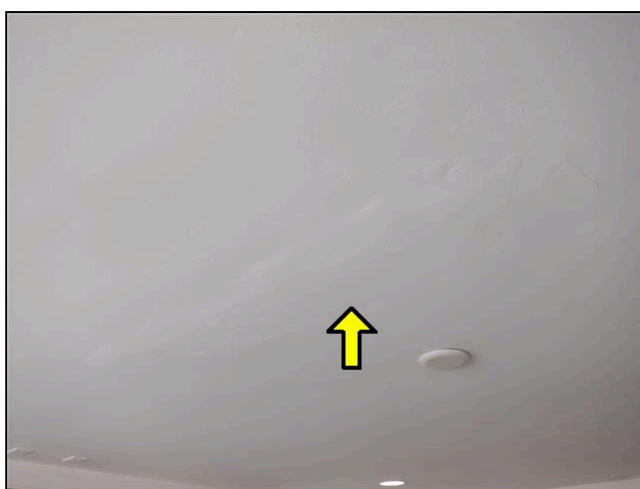
6.1 Item 4(Picture)

(3) Patching was noted at the ceiling in the family room and in the lower level room. We recommend asking the seller if they have knowledge of the repair or cause.

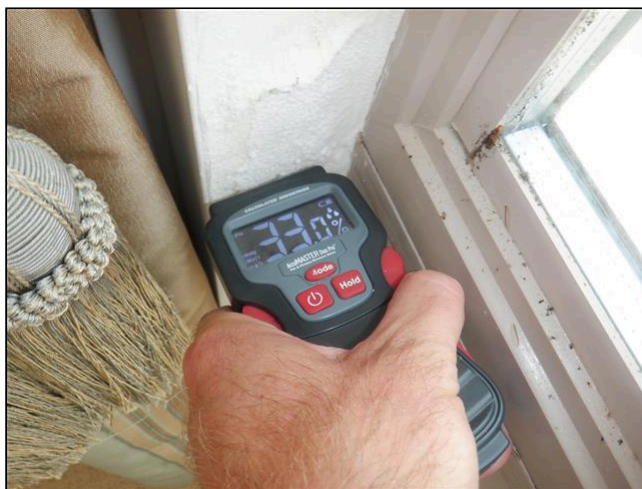
6.2 Item 1(Picture)

(1) Moisture intrusion was observed at a wall adjacent to right side window in the living room, possibly due to poor installation of siding, trim, or window flashing. The exact cause of the moisture could not be determined withing the scope of a home inspection. We recommend further evaluation by a qualified licensed contractor prior to the end of your contingency period and necessary repair made as needed.

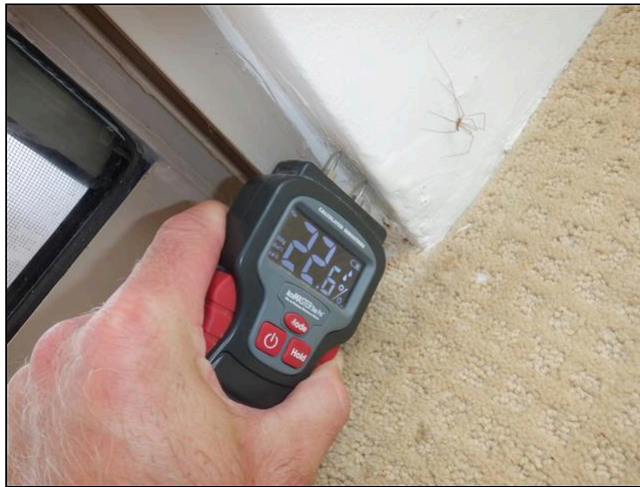
6.2 Item 4(Picture)

(2) Moisture intrusion was observed at a wall to the right side of the middle level sliding , possibly due to poor installation of siding, trim, or window flashing. The exact cause of the moisture could not be determined withing the scope of a home inspection. We recommend further evaluation by a qualified licensed contractor prior to the end of your contingency period and necessary repair made as needed.

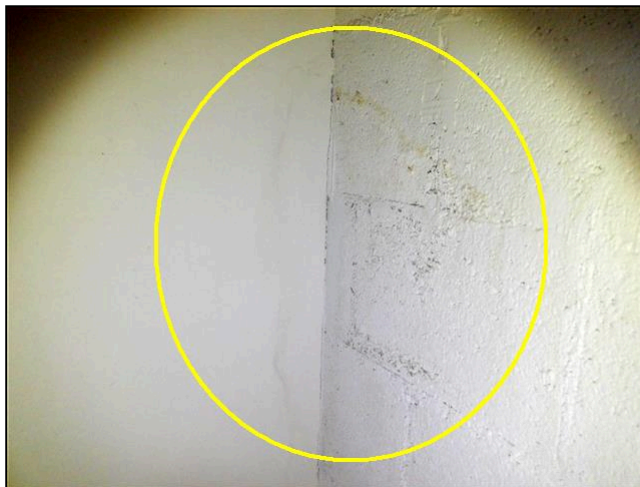
6.2 Item 5(Picture)

(3) Water intrusion observed at a wall in the stairwell closet, possibly due to poor installation of siding, trim, or window flashing. The exact cause of the moisture could not be determined withing the scope of a home inspection. We recommend further evaluation by a qualified licensed contractor prior to the end of your contingency period and necessary repair made as needed.

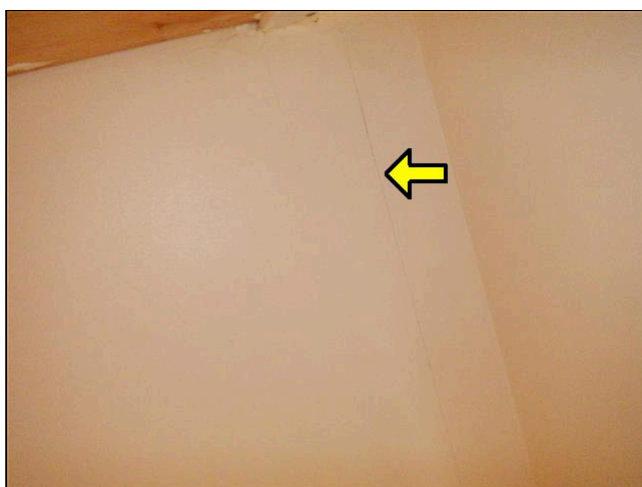
6.2 Item 7(Picture)

(4) Hairline cracking was observed at several locations. These hairline cracks are likely due to material shrinkage or settlement of the structure. We recommend prep and paint by a qualified licensed painter.

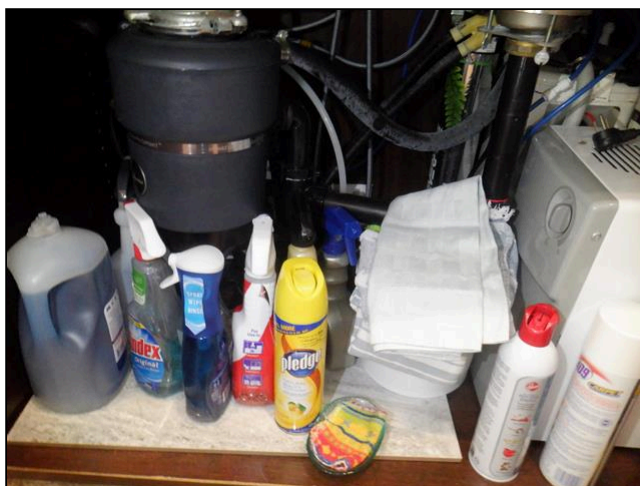
6.5 Item 1(Picture)

(1) At the time of the inspection there was a mold and/ or mildew odor noted below the kitchen sink. This could be a health and safety concern. We recommend obtaining further evaluation from a qualified licensed expert to determine the extent of the necessary corrective measures required.

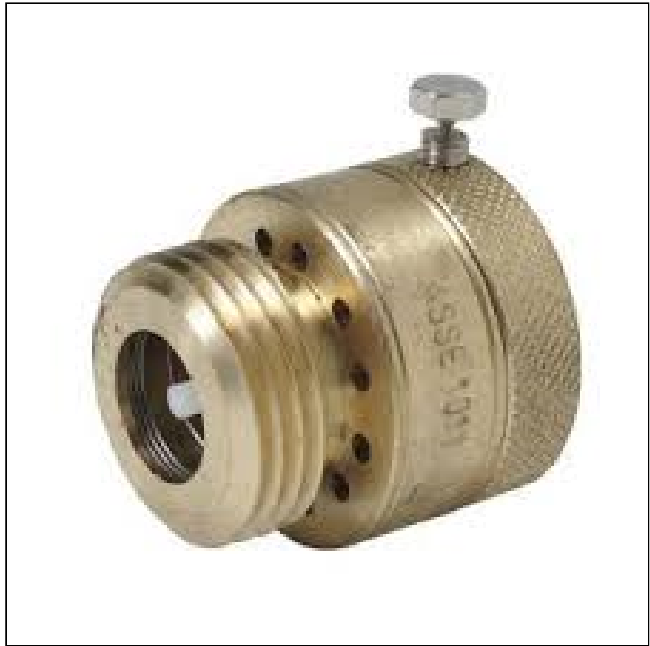
7.3 Item 1(Picture)

from flowing back into the the house water supply system. We recommend installing anti-siphon or anti-backflow devices at the every exterior hose spigots by a qualified person.

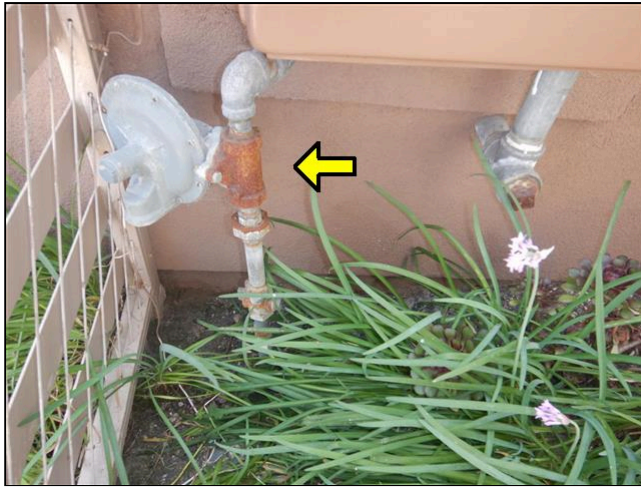
7.4 Item 2(Picture)

(2) The piping at the gas meter is worn/ rusted. We recommend further evaluation by the local gas company for possible replacement prior to the end of your contingency period.

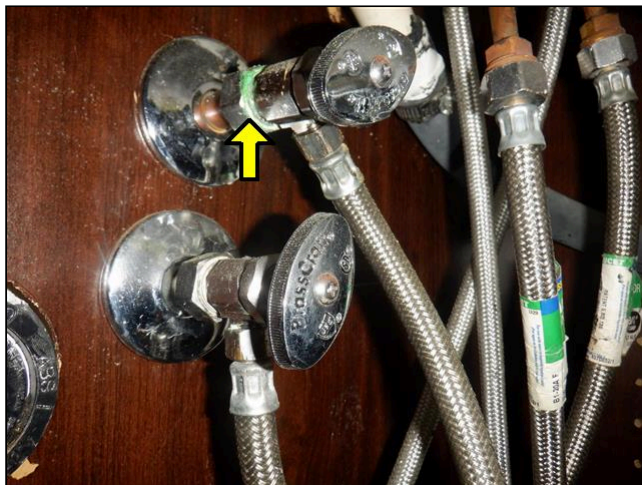
7.5 Item 1(Picture)

Some of the sink angle stop valves are observed with calcium deposits on them. Calcium deposits can corrode or deteriorate these valves and cause potential leaks. We recommend replacing all calcified angle stop valves by a qualified licensed plumber to help prevent leaks.

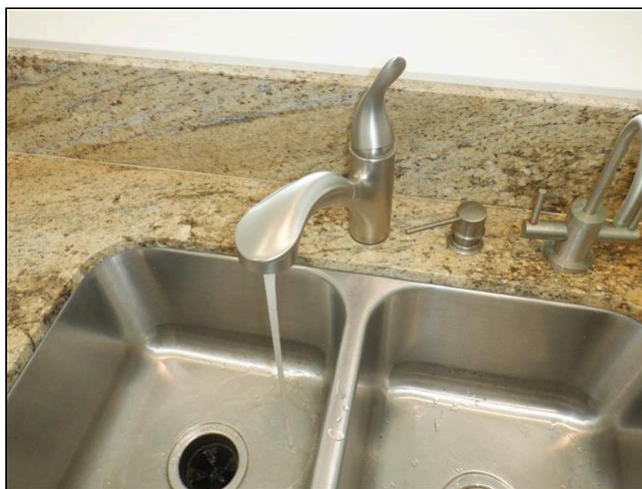
7.6 Item 1(Picture)

(1) The hot and cold water supply is reversed at the kitchen sink. This is considered a scalding and safety hazard. We recommend necessary corrections by a qualified licensed plumber safety.

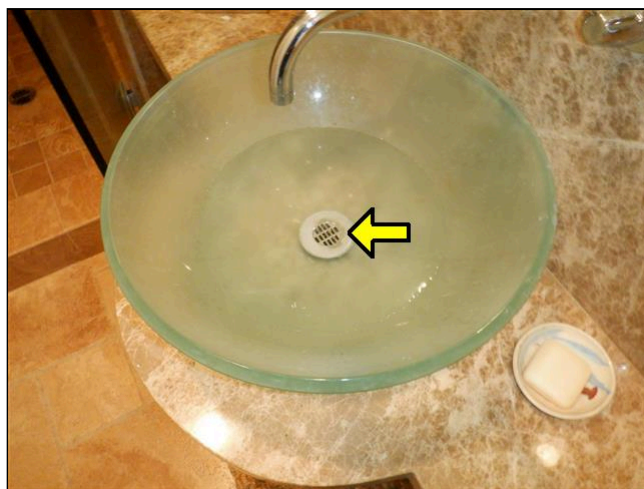
8.0.A Item 1(Picture)

(1) The sink in the bathroom was slow draining at the time of the inspection This may indicate a blockage in the drain line. We recommend further evaluation by a qualified licensed plumber and repairs as needed.

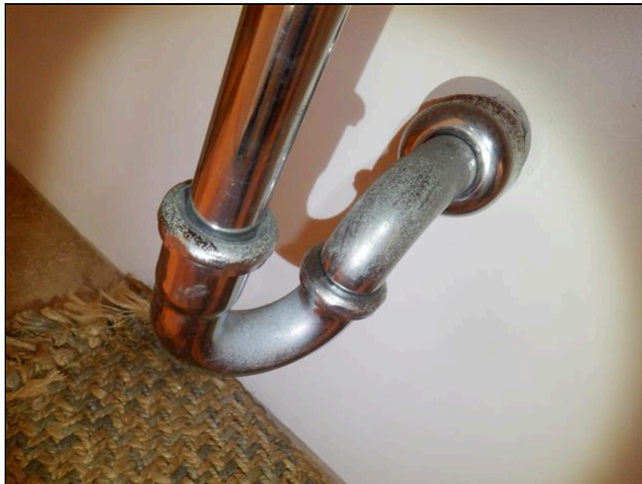
8.0.A Item 4(Picture)

(3) The metal portions of the sink drain are rusted or corroded. A leak was not observed at this sink drain pipe at the time of the inspection. However, we recommend replacing this drain pipe by a qualified licensed plumber to help prevent future leaks or damage.

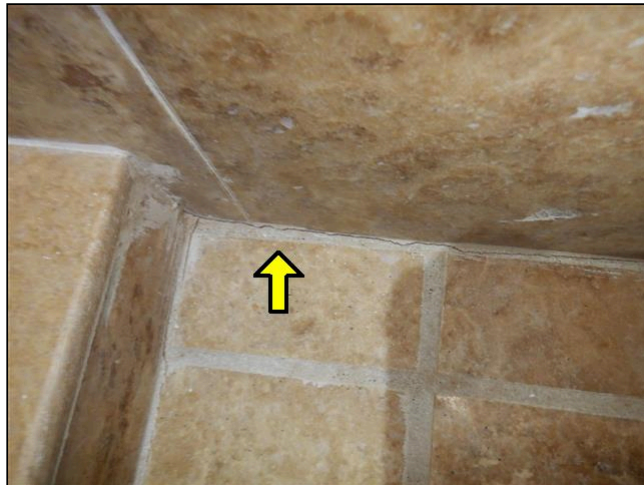
8.0.B Item 1(Picture)

The tile surround has cracked or missing grout between the tiles and needs repair or replace. There may be water damage to the wall behind the tiles which is not visible. Determining if water damage exists in the wall behind tiles is beyond the scope of our general home inspection. We recommend having the tiles repaired by a licensed tile contractor. Additional repairs may be required when tiles are removed. This area should be evaluated further by a qualified licensed tile contractor prior to the end of your contingency period.

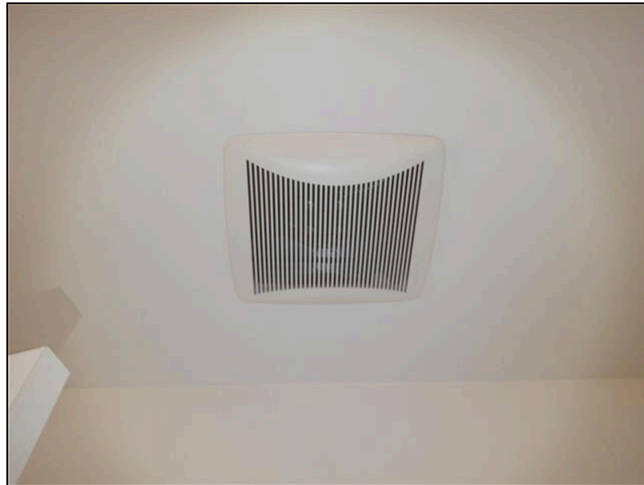
8.1.B Item 1(Picture)

The bathroom vent did not work when tested. It is important to have a functional vent to remove humid air. We recommend necessary repairs or replacement by a qualified licensed contractor.

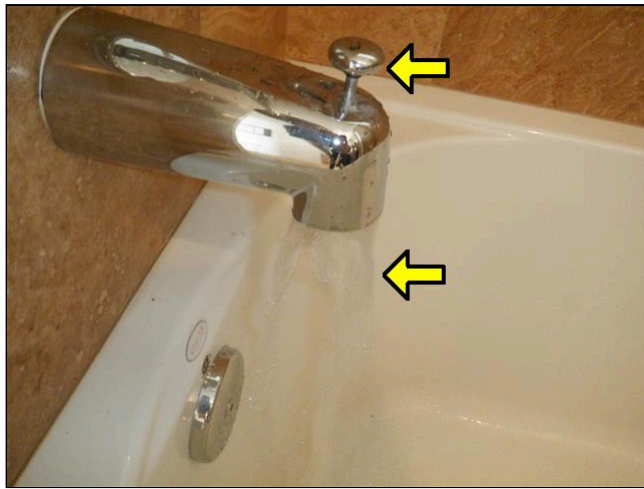
8.0.C Item 1(Picture)

(1) The tub diverter did not operate properly when tested. This is likely due from hard water deposit build up on the tub spout mechanism. We recommend necessary repairs or replacement by a licensed plumber.

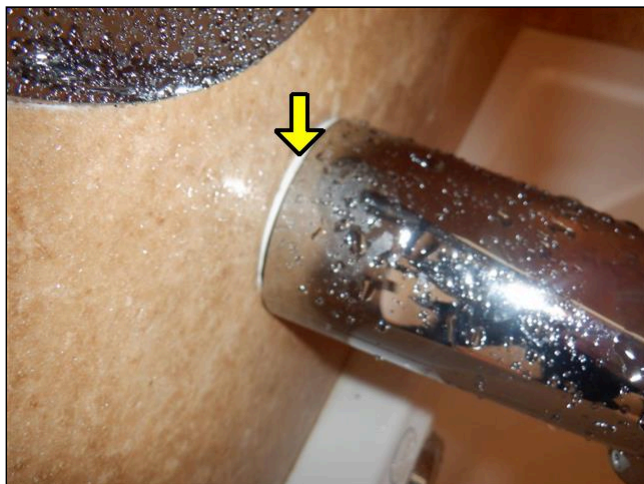
8.0.C Item 3(Picture)

(2) We recommend caulking around the bathroom tub spout to help prevent moisture intrusion.
