# Inspection Report

**Property Address:**  
4312 Main Place  
Coronado CA 92118

**The Property Inspection Pros**

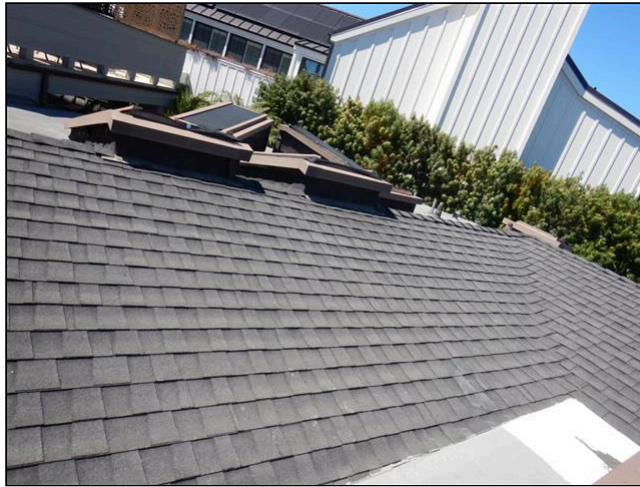
1.0 Item 6(Picture)

(2) The roof material shows normal wear for its age and type; appears to be in serviceable condition.

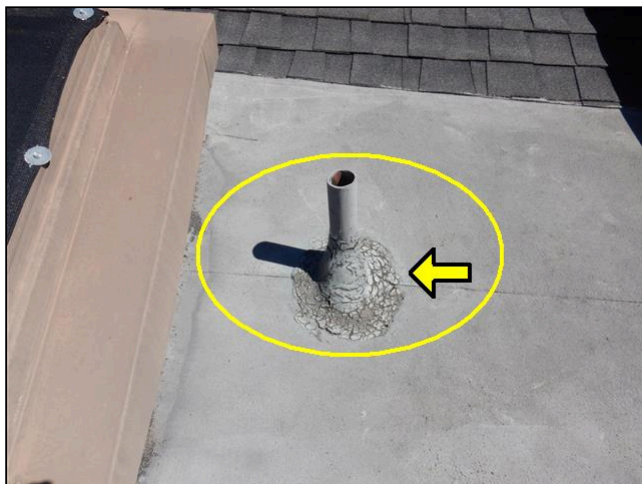
1.2 Item 1(Picture)

(1) Sealant around some of the roof flashings/ penetrations is cracked. We recommend having sealant applied where needed to help prevent roof leaks by a licensed roofer.

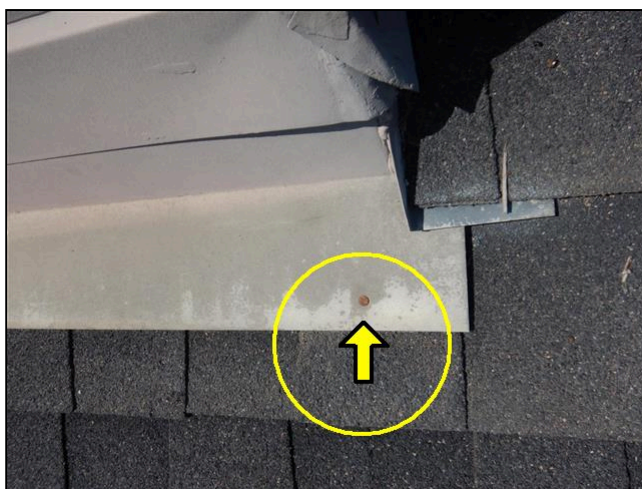
1.2 Item 2(Picture)

(2) There are several exposed nails at the metal flashings and ridge caps. We recommend properly sealing these surfaces by a qualified person to help prevent roof leaks.

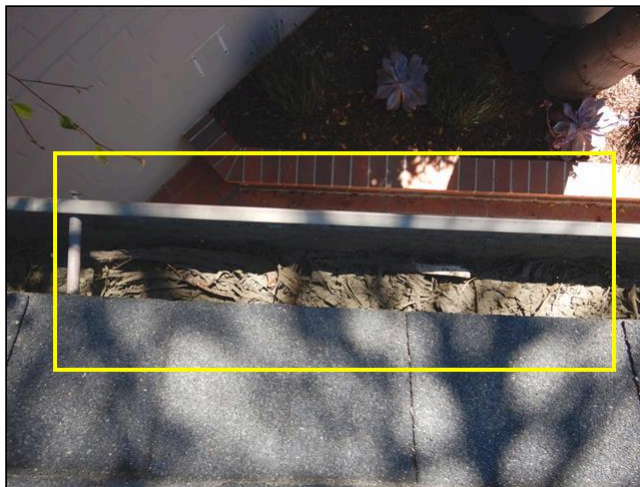
1.3 Item 1(Picture)

(1) Gutters are observed full of debris in areas and need to be cleaned. The debris in gutters can also conceal rust, deterioration or leaks that are not visible until cleaned, and I am unable to determine if such conditions exist. We recommend having the gutters cleaned and checked by a qualified contractor.

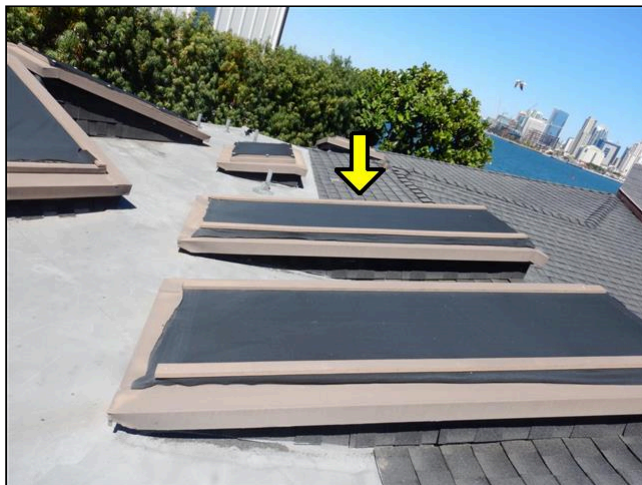
1.5 Item 1(Picture)

(1) The majority of the skylights had a shade cover material installed over them. Due to this condition we could not observe these skylights. We recommend having the shade material removed and these skylights inspected by a licensed roofing contractor prior to the end of your contingency period.

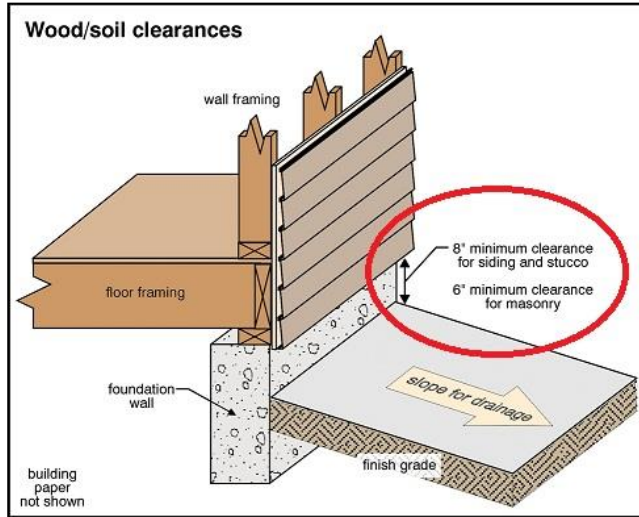
2.2 Item 1(Picture)

(2) The wood siding is in contact with the ground at several areas. Dirt in contact with the siding can promote deterioration, including rot, pest infestation, and water intrusion during rain. We recommend a ground clearance of four to six inches where possible by a qualified contractor.

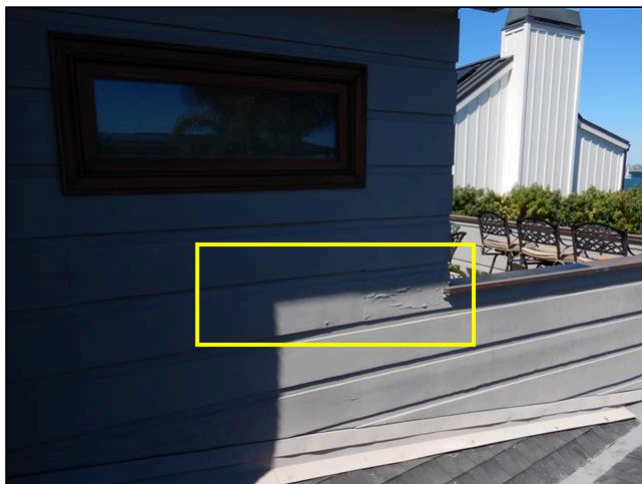
2.3 Item 1(Picture)

(1) Paint is worn and failing at the siding and trim at several areas. We recommend prep and paint as needed to protect the siding and trim by a qualified paint contractor.

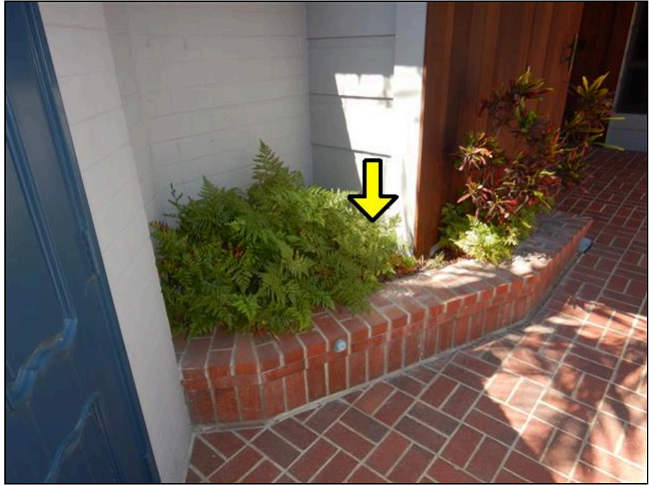
2.3 Item 3(Picture)

(2) Several gaps were observed at the siding. These gaps can allow water to flow behind the siding causing damage. We recommend caulking the gaps as needed to seal the siding and prevent water intrusion.

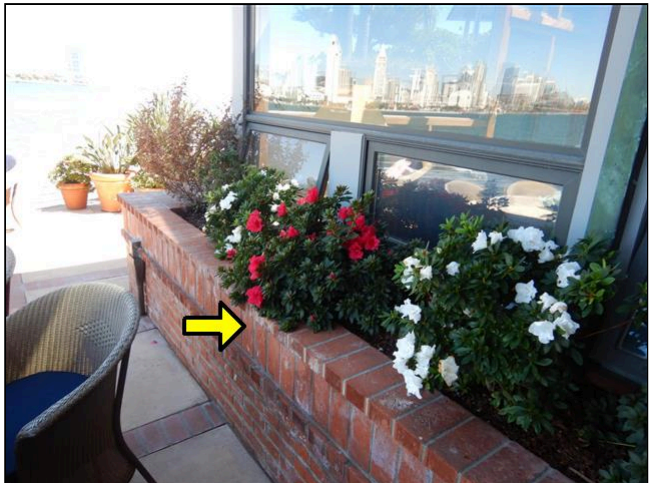
2.3 Item 4(Picture)

(3) Planters are installed on the siding at the front. Watering next to the house causes water damage to the siding and possibly the foundation. We advise removing the planters.

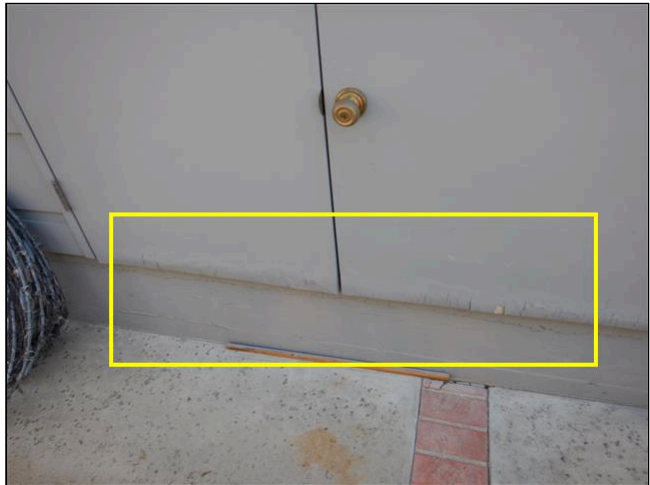
2.5 Item 1(Picture)

(1) Damaged wood is observed at the rear exterior closet doors. We recommend referring to the pest inspection report for a detailed evaluation of the wood and necessary repairs or replacement made by a qualified licensed contractor.

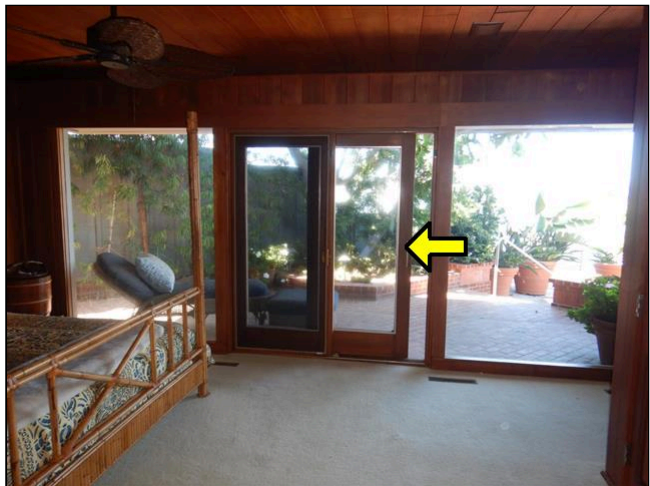
2.5 Item 2(Picture)

(2) Condensation is observed between the panes of glass at door(s). This occurs when the seal has failed between the panes of glass and ambient air has entered the assembly. Replacement of the glass/insulated unit is required. Since some failed doors may not be easily found due to changing ambient conditions (heat, humidity, etc) we recommend having all of the glass doors reviewed by a licensed window/ door contractor to determine how many doors require repair/replacement. We recommend necessary repairs or replacement of all doors with failed seals by a licensed window/ door contractor.

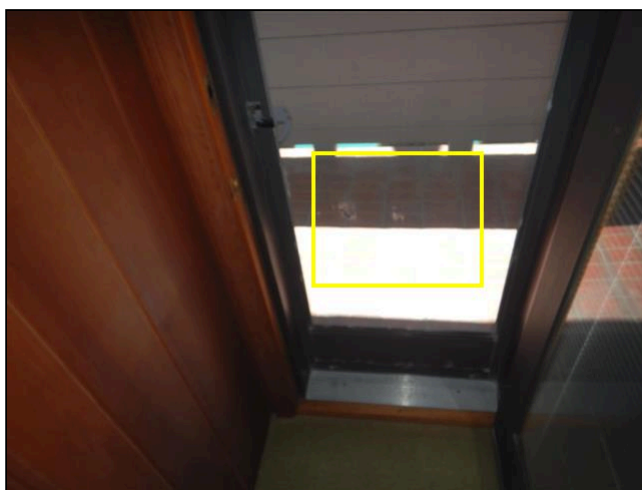
2.5 Item 4(Picture)

(4) The guest house master bedroom screen door has a torn or damaged screen. We recommend repair or replacement by a qualified person.

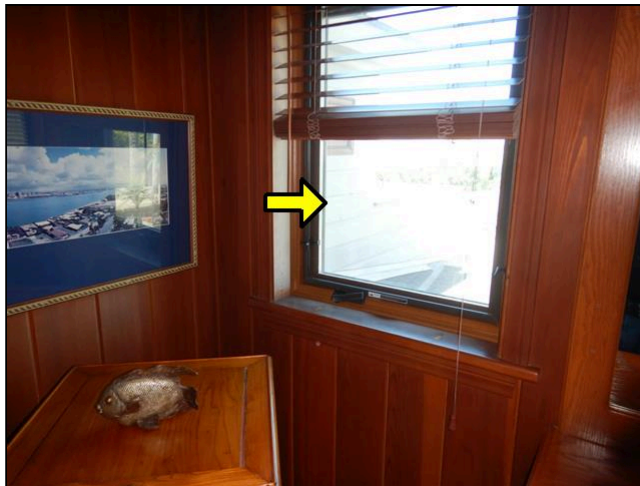
2.6 Item 1(Picture)

(4) A cracked/broken window is observed in the guest house master bedroom. We recommend repair or replacement by a licensed window contractor.

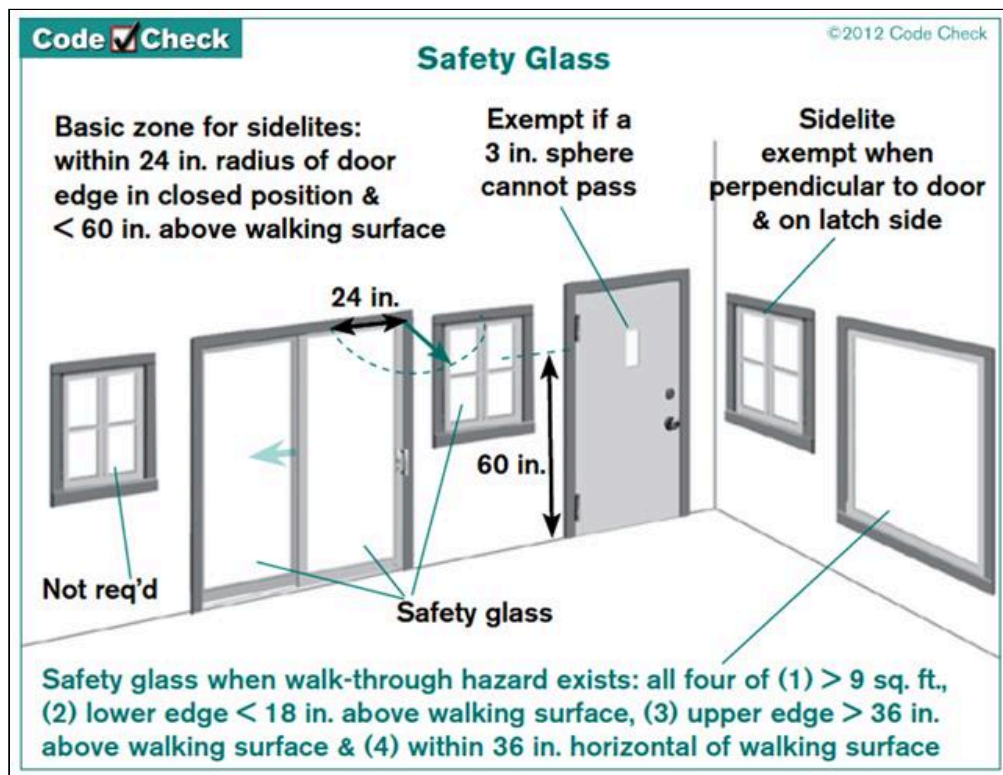
2.7 Item 1(Picture)

Since plate glass was acceptable at the time of construction, home inspectors can only recommend upgrades for safety, but sellers do not have to bring an old house up to today's building code. Also some safety glass cannot be identified without specialty testing equipment which home inspectors do not use. We recommend upgrading doors and windows as needed for safety by a qualified licensed window contractor.

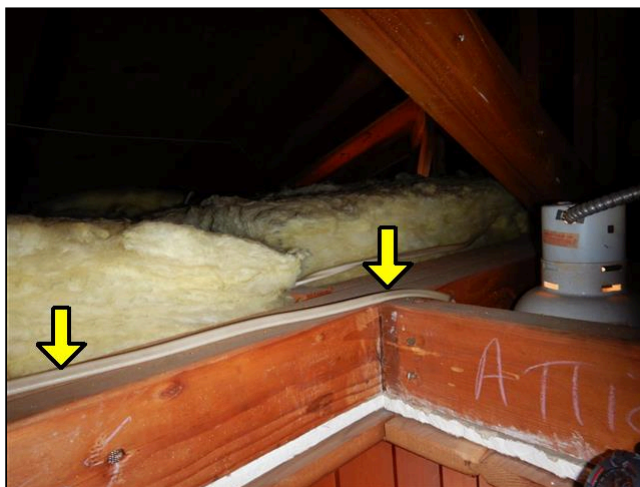
3.3 Item 1(Picture)

(1) Unprotected Romex was present in the guest house attic adjacent to the attic scuttle. Romex located within 6 feet of the attic scuttle must be protected from damage. We recommend adding protection to the Romex in attic by the access a qualified licensed electrician.

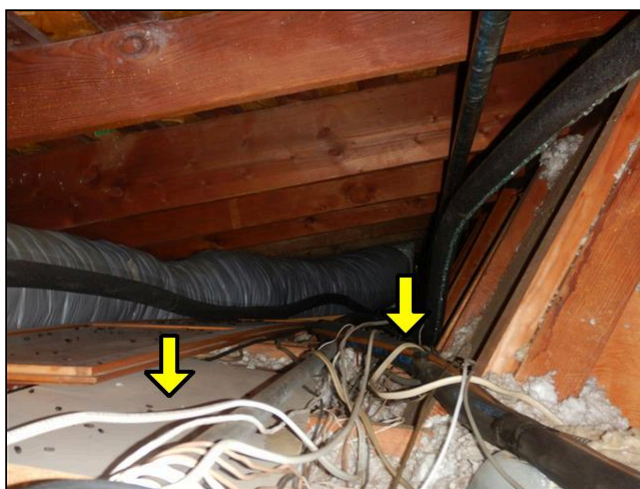
3.3 Item 2(Picture)

(3) Wires for some lighting fixtures in the attic space were observed to be unsecured. We recommend necessary corrections by a qualified licensed electrician.

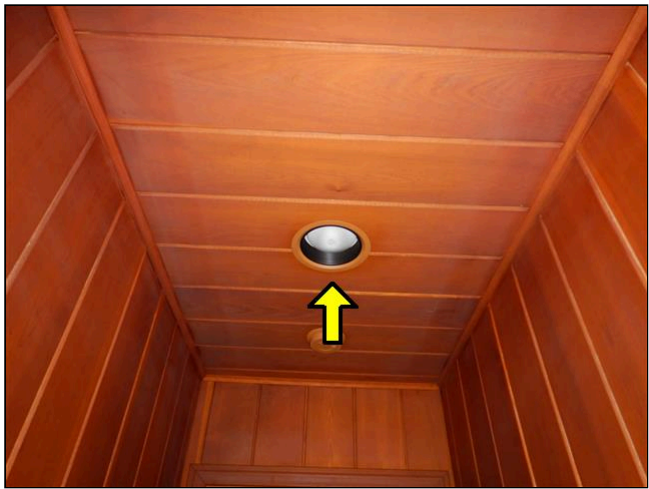
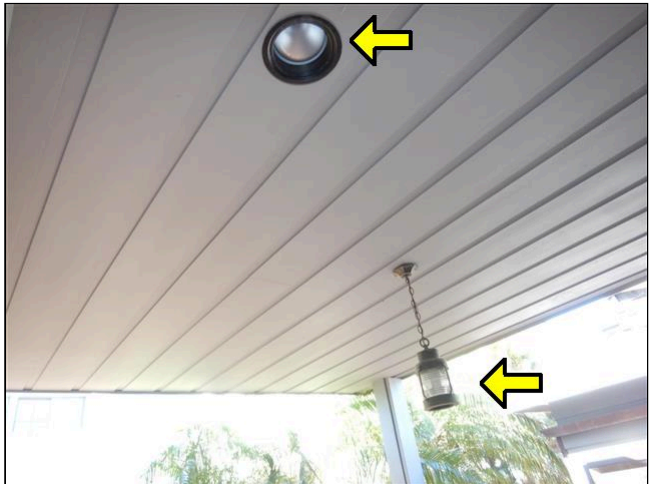
(1) Several lights throughout the interior and exterior of both houses did not function when tested possibly due to bad bulbs or a miss wired fixtures. Occasionally there may something wrong with the fixtures which cannot be determined without a working bulb. We recommend asking the seller to demonstrate that theses lights are working prior to the end of the inspection contingency period, or changing the bulbs and testing again. If these lights do not function we recommend further evaluation by a qualified licensed electrician and necessary repairs or replacement as needed.

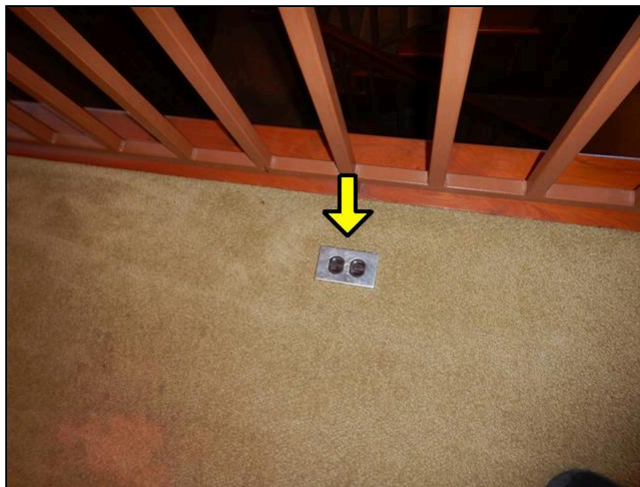
3.8 Item 1(Picture)

There are several outlets installed in the floor that are flush mounted with the face up. Generally outlets in counter tops or floors should not be flush mounted with the face up. For floor outlets, an approved locking cover should be installed. We recommend necessary corrections be made where needed by a licensed electrician for safety.

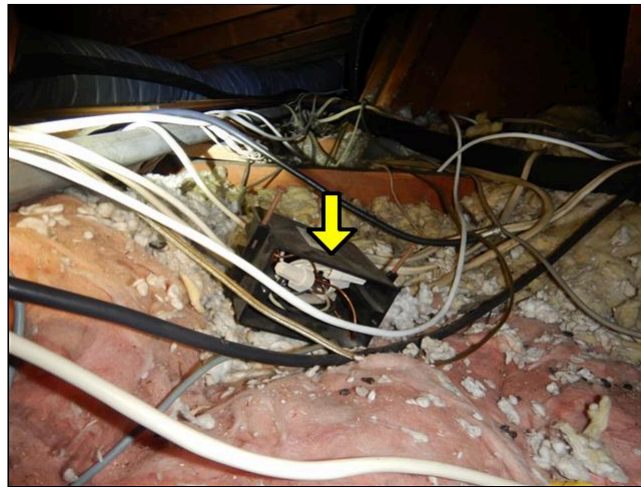
3.12 Item 1(Picture)

Several open junction box are observed in the main house attic. All electrical splices must be enclosed in a junction box. We recommend necessary repairs by a qualified person for safety.

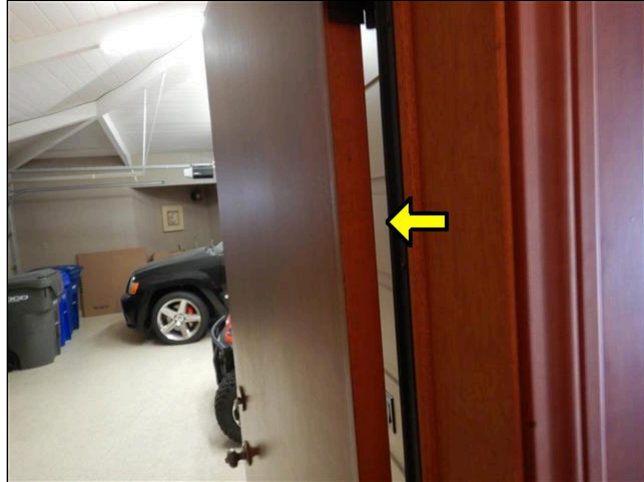
4.5.A Item 1(Picture)

The door between the house and garage did not have a Fire Rating Certificate or Plate. Without a plate, I could not confirm whether the door meets fire code safety requirements. We recommend further evaluation by a licensed door contractor. The "fire door" is required to meet one of the following characteristics: 1-3/8 inch thick solid wood, 1-3/8 inch thick steel shell door with Honeycomb core, Fire-rated (with certificate plate). If the door is not rated as a fire door we recommend replacing by a qualified licensed door contractor for safety.

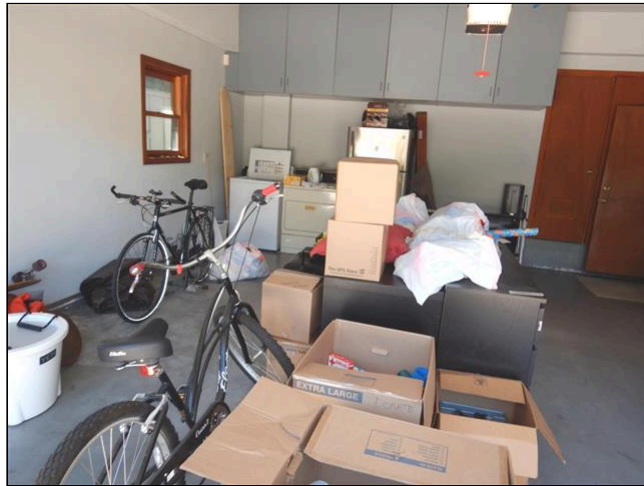
4.4.B Item 1(Picture)

Due to stored personal items not all areas throughout the property were visible and accessible at the time of the inspection. The slab and other areas were obstructed from view and could not be inspected. The home inspector does not move personal items, panels, furniture, equipment, plant life, soil, debris, ect. that obstructs their access or visibility. We recommend that you conduct a careful evaluation during your final walk-through or prior to the end of your contingency period to ensure that there are no hidden defects. All doors, windows, and outlets should be tested and verified for proper operation prior to the end of your contingency period by a qualified person. If any damage is observed we recommend asking the seller about it. We recommend that any damage found be repaired or replaced by a qualified licensed contractor in the appropriate trade.

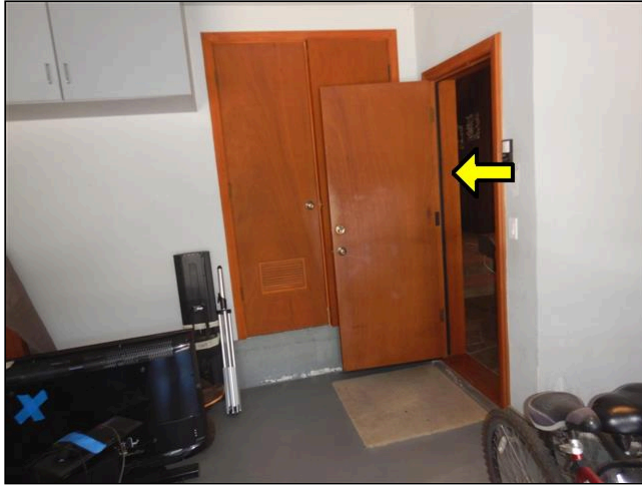
4.5.B Item 1(Picture)

wood, 1-3/8 inch thick steel shell door with Honeycomb core, Fire-rated (with certificate plate). If the door is not rated as a fire door we recommend replacing by a qualified licensed door contractor for safety.

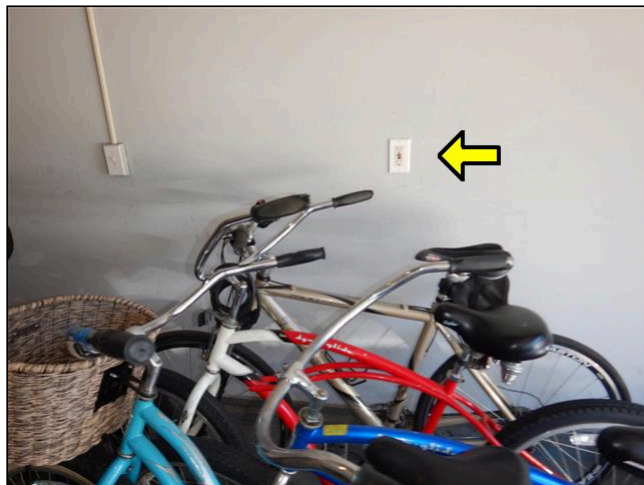
4.9.B Item 1(Picture)

A GFCI receptacle located in the garage on the right side wall is not operating properly, or has failed as it did not trip when tested. The outlet may be defective or mis-wired. We recommend further evaluation by a qualified licensed electrician and necessary repairs or replacement made as needed.

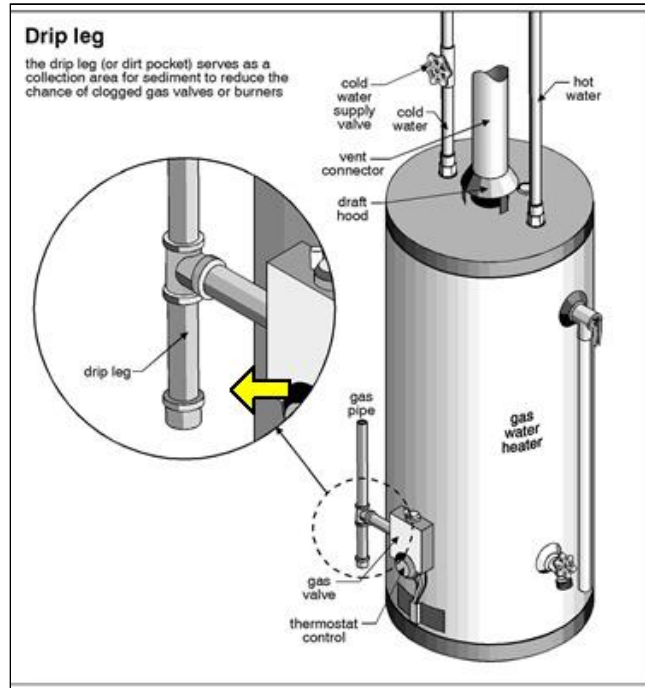
5.0.A Item 3(Picture)

(4) The gas supply pipe at the water heater did not contained a drip leg/ sediment trap. This may have been standard at the time of installation but now is highly recommended. The purpose of a drip leg is to prevent sediment/ debris from entering and clogging the water heater gas valve which could cause the water heater to shut down. We recommend having a drip leg installed by a qualified licensed plumber.

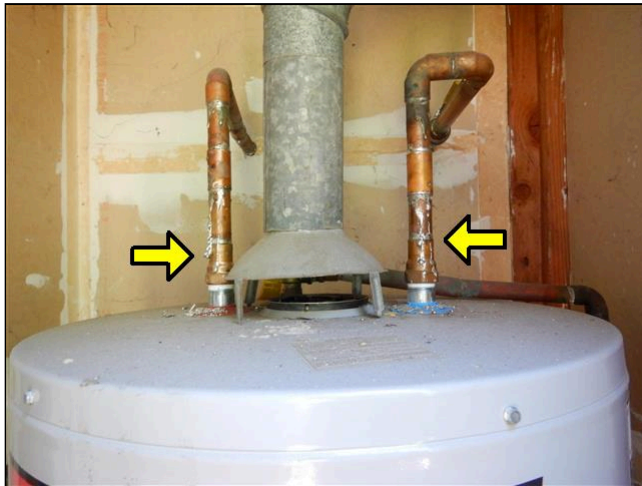
5.0.A Item 6(Picture)

(7) The water heater is connected to the water supply using rigid supply piping. The present standard for this installation calls or recommends the use of flexible water supply lines. We recommend upgrading/ installing flexible water supply pipes at the water heater by a licensed plumber.

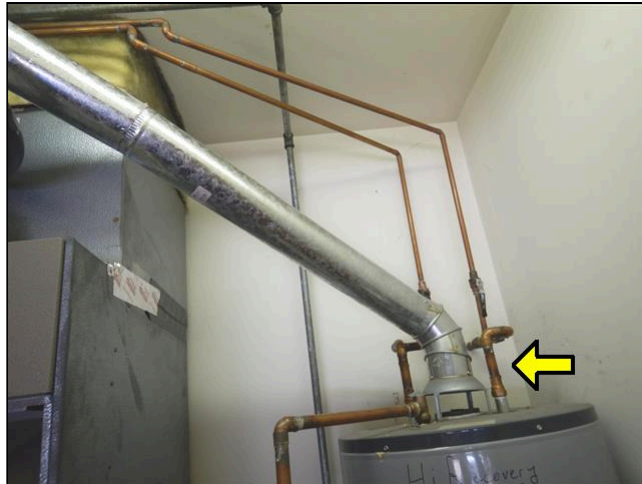
5.0.B Item 2(Picture)

(7) The water heater is connected to the water supply using rigid supply piping. The present standard for this installation calls or recommends the use of flexible water supply lines. We recommend upgrading/ installing flexible water supply pipes at the water heater by a licensed plumber.

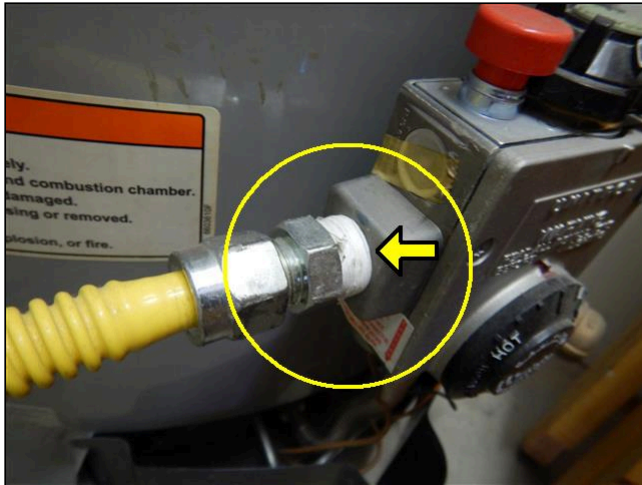
5.0.B Item 3(Picture)

(8) The water heater gas pipe fittings appear to have white teflon tape installed on them. This is non standard. White teflon tape is intended for use on water pipe fittings. We recommend necessary corrections by a qualified licensed plumber.

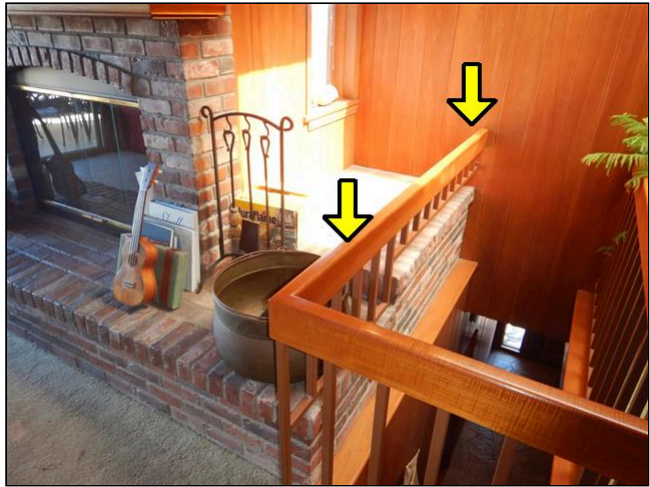
6.4 Item 1(Picture)

The guest house interior stair handrail height to the right of the fireplace and stairwell is incorrect. The handrail at the stairs must measure between 34" and 38 inches from the tread. We recommend correction by a qualified licensed contractor.

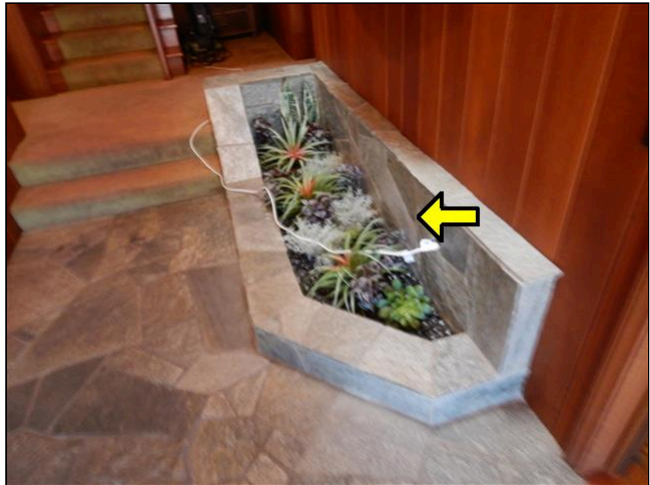
6.8 Item 1(Picture)

(1) A planters is installed at the interior of the guest house. Watering plants in this location could cause water damage. We advise removing the planter.

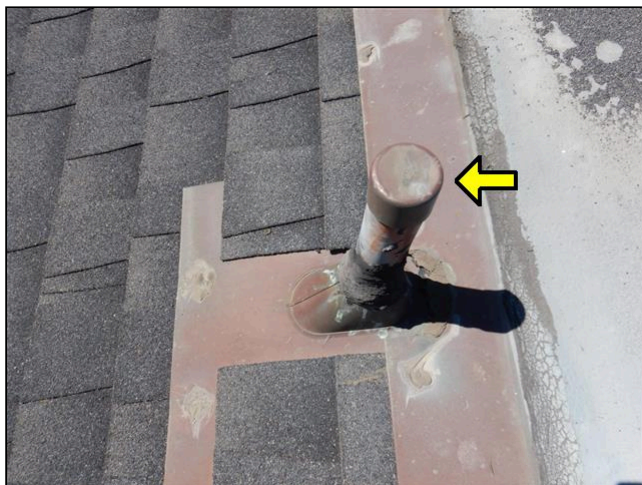
7.0 Item 1(Picture)

(1) There is a plumbing rough in cap still present at a vent pipe. This cap could prevent proper drain function which can lead to sewer odors in the house. We recommend removing this cap by a qualified person.

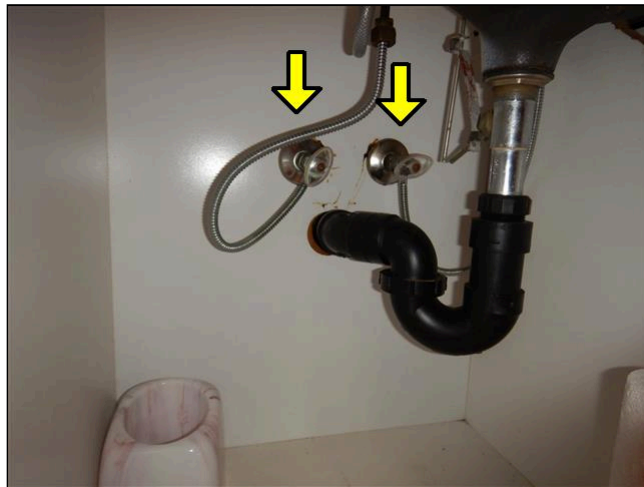
8.0.A Item 1(Picture)

There are older one piece angle stop valve(s)/ supply line(s) observed at the sink. These one piece angle stop valve(s)/ supply line(s) have a reputation to corrode from the inside and possible fail. A white power substance or corrosion/ calcification is observed at the one piece angle stop valve(s)/ supply line(s). We recommend that these one piece angle stop valve(s)/ supply line(s) be replaced by a qualified licensed plumber as an upgrade.

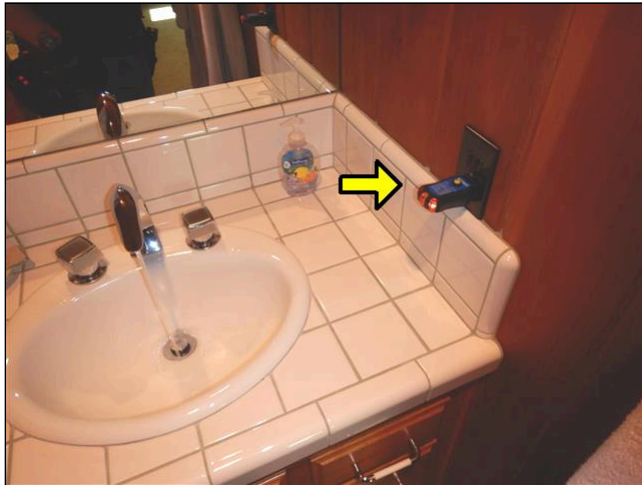
8.2.A Item 1(Picture)

There is no GFCI protected receptacles in the bathroom. We recommend upgrading the bathroom receptacles to GFCI protected receptacles by a qualified licensed electrician for safety.

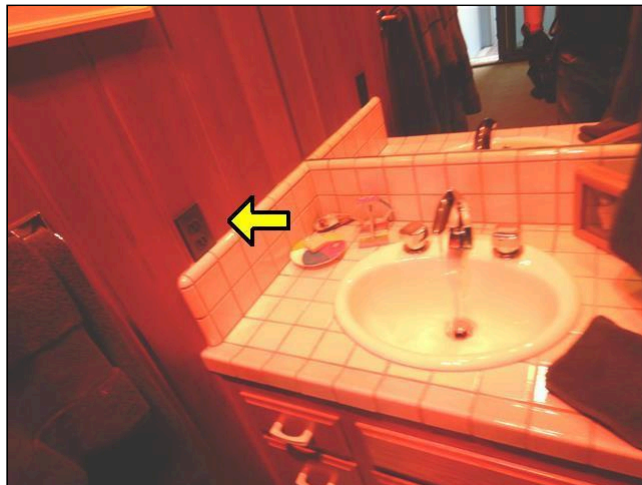
8.1.B Item 1(Picture)

There is no GFCI protected receptacles in the bathroom. We recommend upgrading the bathroom receptacles to GFCI protected receptacles by a qualified licensed electrician for safety.

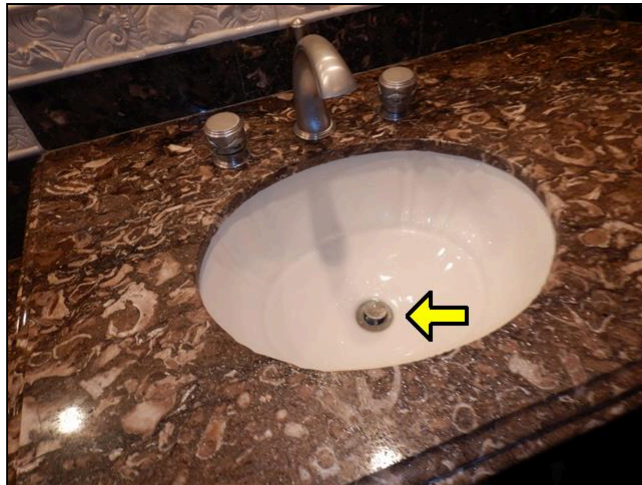
8.0.D Item 1(Picture)

The right side sink, sink stopper was inoperable when tested. We recommend necessary repairs or replacement by a qualified person.

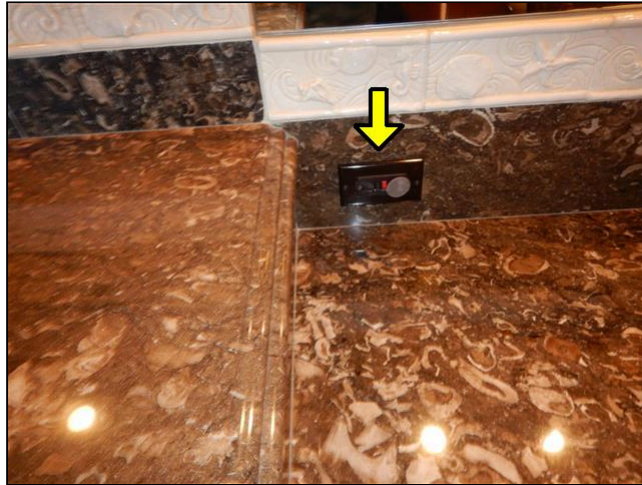
8.1.D Item 1(Picture)

The GFCI receptacle located in the bathroom is not operating properly, or has failed as it did not trip when tested. The outlet may be defective or mis-wired. We recommend further evaluation by a qualified licensed electrician and necessary repairs or replacement made as needed.

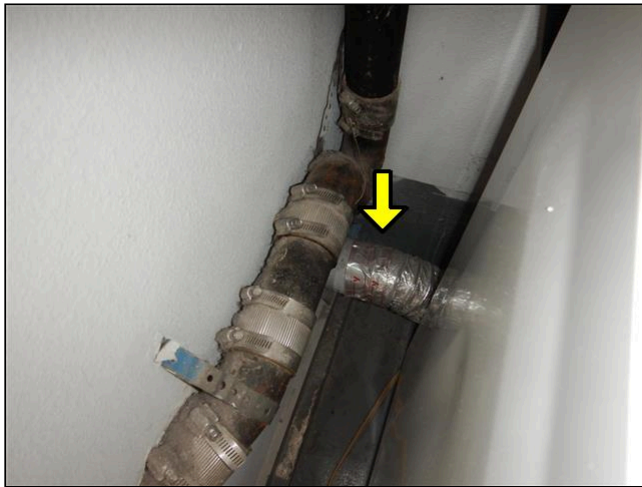
9.1.B Item 1(Picture)

(1) The dryer is equipped with a foil, accordion-type duct. The U.S. Consumer Product Safety Commission considers these types of ducts to be unsafe and a fire hazard. The flexible foil type duct can more easily trap lint and is more susceptible to kinks or crushing, which can greatly reduce the airflow. We recommend replacing the duct with a rigid or corrugated semi-rigid metal duct.

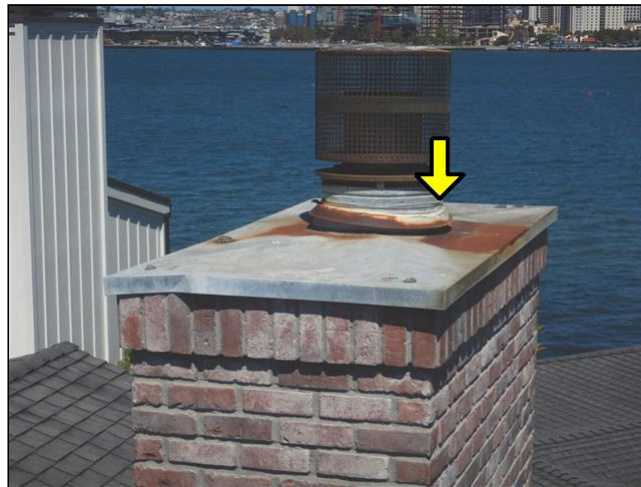
10.0 Item 1(Picture)

- (1) We recommend having all of the fireplaces and chimneys cleaned and inspected by a licensed chimney sweep for safety prior to using.
- (2) The metal chimney cap for the guest house is rusted. We recommend further evaluation by a licensed chimney contractor for necessary repairs or replacement.
