Inspection Report

Property Address:
4312 Smith Drive
Small Building, 4 Units
El Cajon CA 92019

The Property Inspection Pros

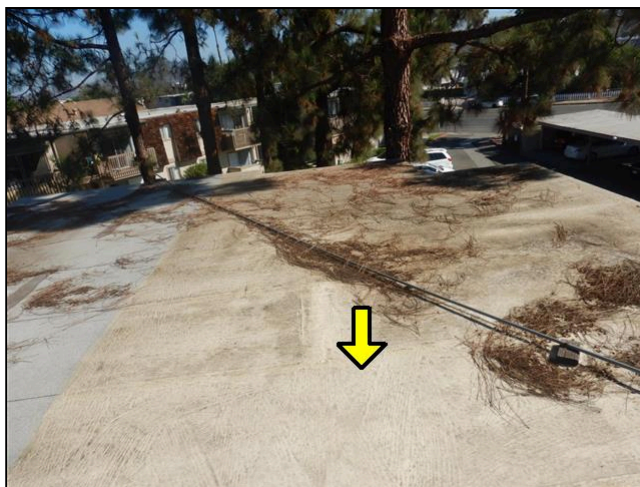
1.1 Item 7(Picture)

(4) The roof has had repairs made to it at several areas. We are unable to determine if these repairs are made correctly and successful. We recommend asking the seller about these repairs, and if concerned we recommend further evaluation by a qualified licensed roof contractor.

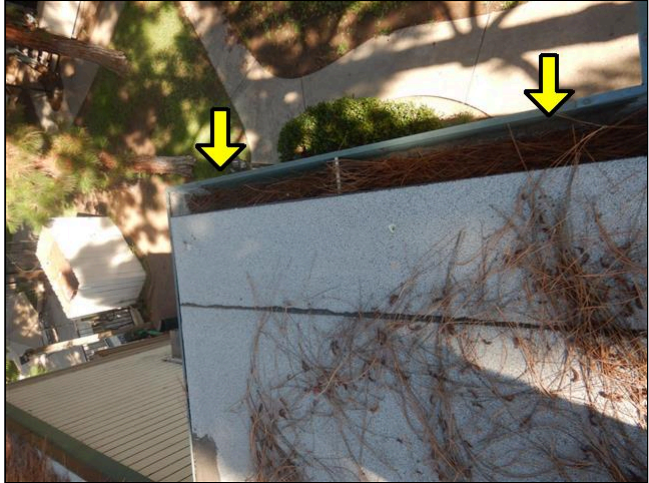
1.3 Item 1(Picture)

(1) Gutters are observed full of debris in areas and need to be cleaned. The debris in gutters can also conceal rust, deterioration or leaks that are not visible until cleaned, and I am unable to determine if such conditions exist. We recommend having the gutters cleaned and checked by a qualified contractor.

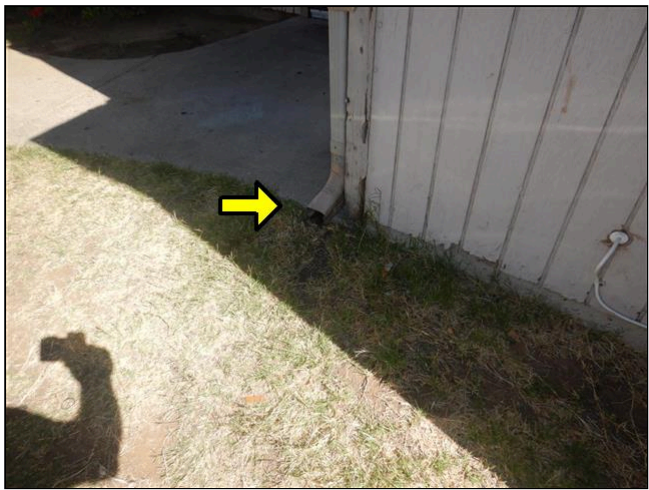
1.3 Item 2(Picture)

(2) Some of the downspouts need extension and/or a buried drain line to carry water away from the home at several areas. We recommend necessary corrections where needed by a qualified contractor.

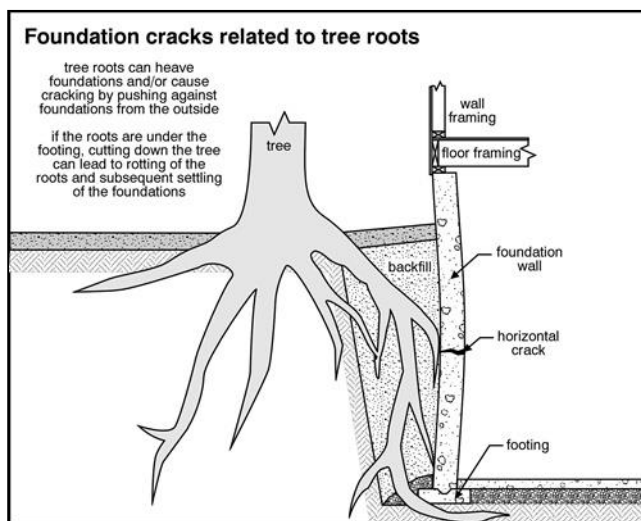
2.1 Item 1(Picture)

Large trees located close to the building can cause damage to underground plumbing, hardscape, and the foundation of the house or a neighboring structure. Tree(s) are located near enough to these buildings to cause concern for potential damage. We recommend contacting a licensed arborist to obtain a quotation for tree removal where needed prior to the end of your contingency period.

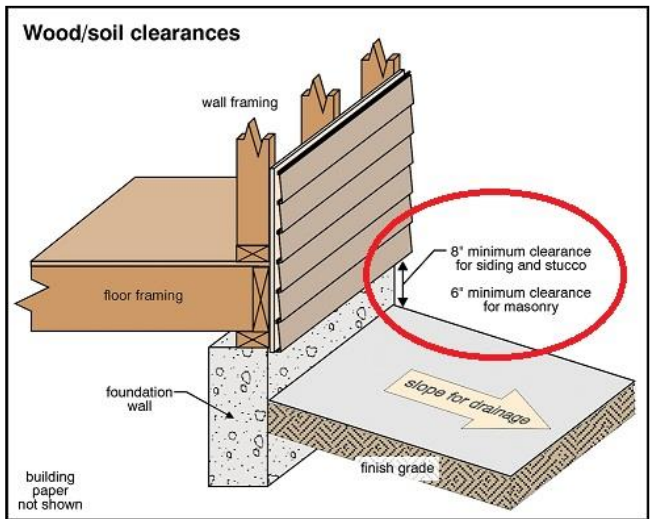
2.2 Item 1(Picture)

(1) Siding is in contact with the ground at several areas around the apartment and laundry buildings. Dirt in contact with the siding can promote deterioration, including rot, pest infestation, and water intrusion during rain. We recommend a ground clearance of four to six inches where possible by a qualified contractor.

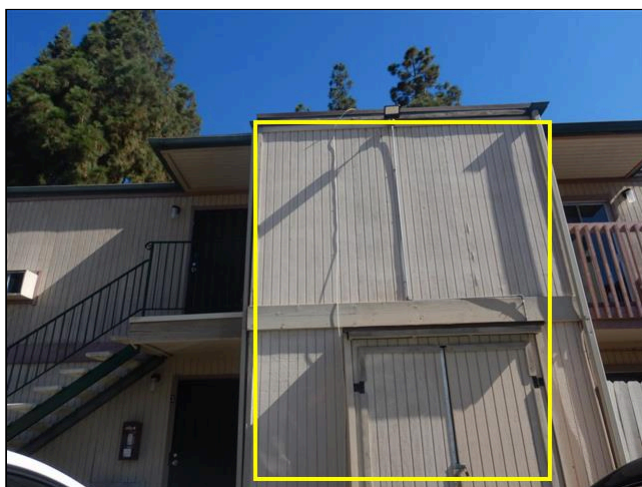
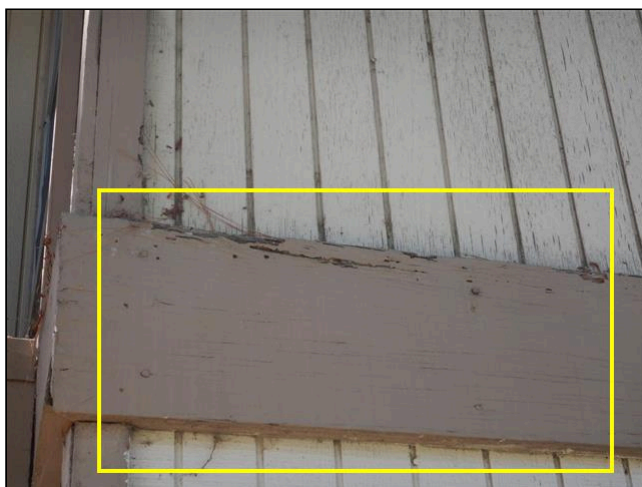
(4) The wood trim and siding covering at the exterior walls of the building exhibited major weathering, wear, and deterioration and appeared to be at or near the end of its useful life. We recommend replacing by a qualified licensed contractor.

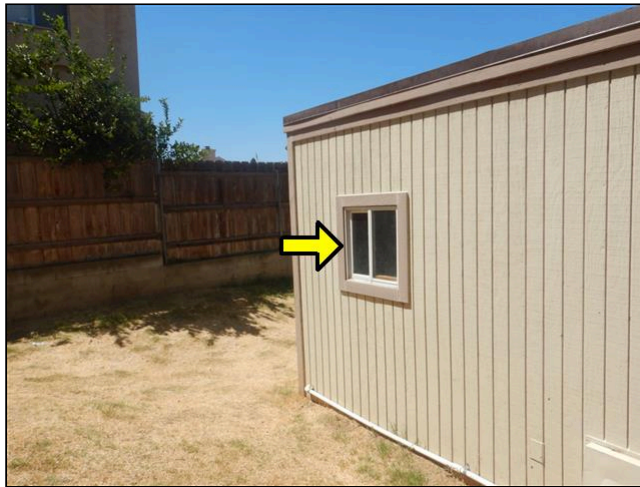
2.6 Item 1(Picture)

(1) There are several window screens that are missing or damaged throughout the property/ all units and laundry building. We recommend repair or replace as needed by a qualified person.

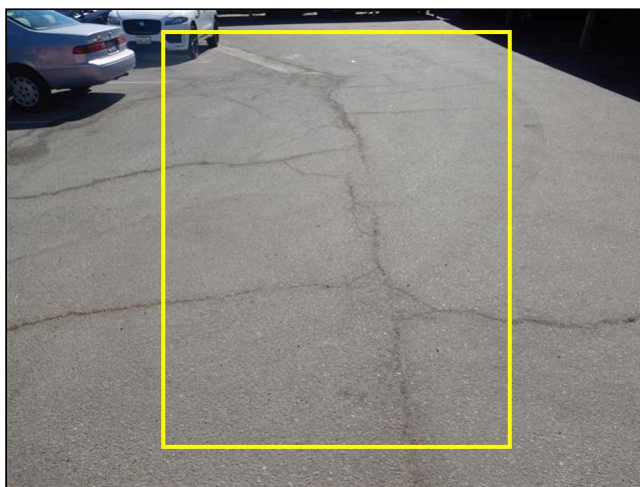
2.8 Item 1(Picture)

(1) The asphalt driveway is cracked and deteriorated throughout. We recommend that you obtain a quotation for necessary repairs or replacement prior to the end of your contingency period.

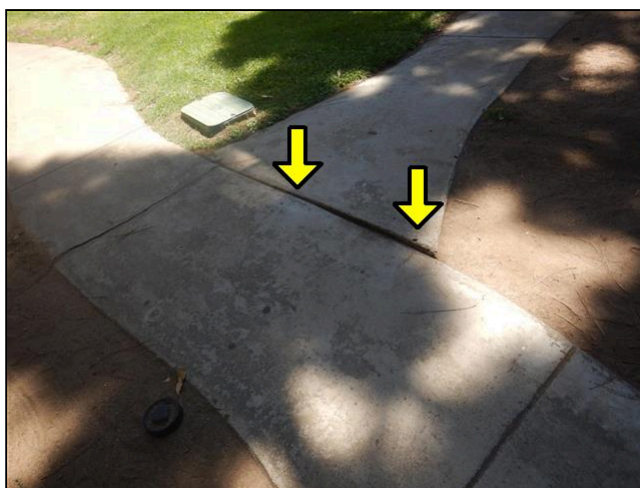
2.8 Item 2(Picture)

(2) A tripping hazard exists at several concrete walkways throughout the property. We recommend necessary repairs where needed by a qualified licensed contractor to avoid injuries.

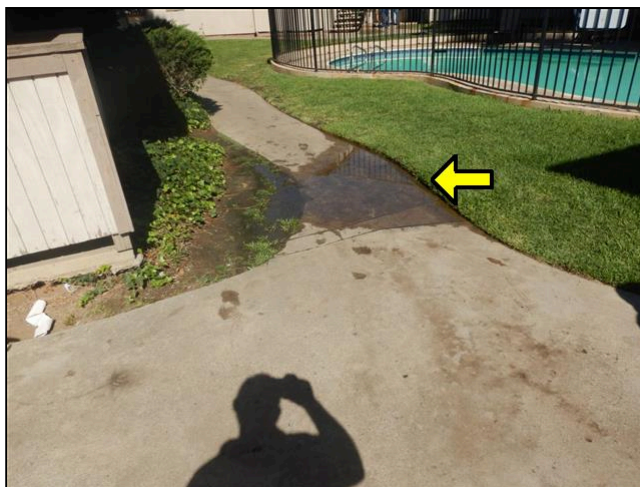
2.8 Item 6(Picture)

(4) The walkway slope in several areas is such that water does not run off and is ponding. All walkways should slope to allow water to run away/ off. We recommend further evaluation by a qualified contractor to obtain quotations for repairs or corrections where needed prior to the end of your contingency period.

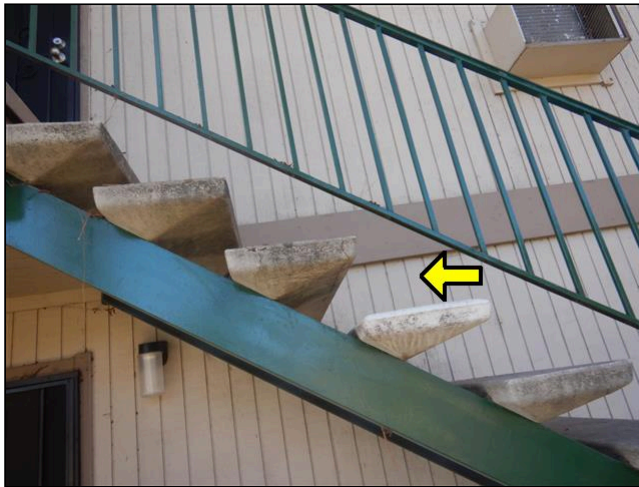
2.9 Item 1(Picture)

(1) While the railing/baluster spacing may have been standard at time of construction, it does not comply with current safety standards. The large openings can allow pets or children to fall through. We recommend installing additional pickets, or other form of barrier to prevent injuries by a qualified licensed contractor.

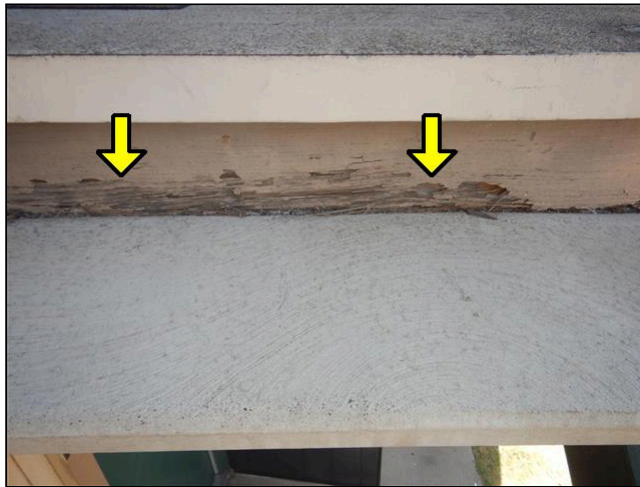
2.9 Item 2(Picture)

(2) Dry rot/ damaged wood was observed at the stairs at several areas. This condition is a safety concern. Home inspectors do not have the authority to comment on termites or dry rot, which is the responsibility of a state licensed pest inspector. However, we recommend necessary repairs or replacement of the damaged wood by a qualified licensed contractor for safety.

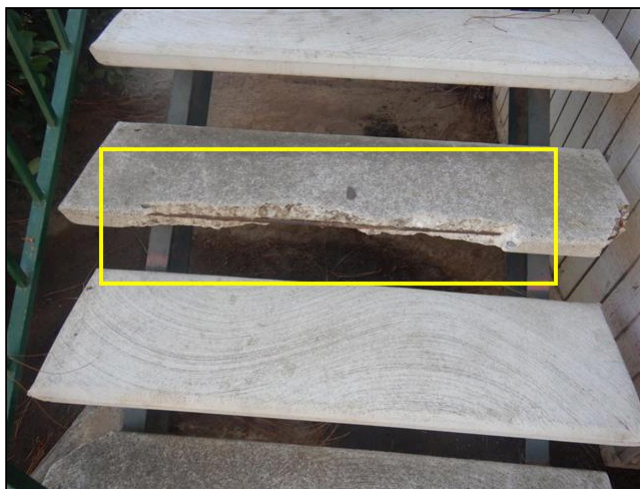
2.9 Item 3(Picture)

(3) There is a damaged step at the left side stairs which is a trip and safety hazard. We recommend replacing by a qualified licensed contractor.

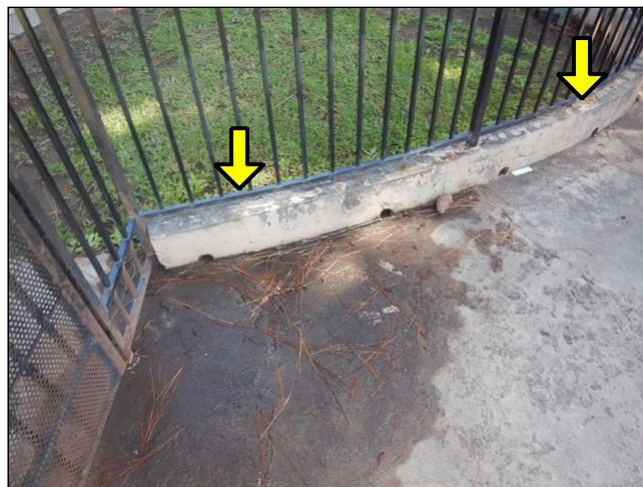
2.10 Item 3(Picture)

(4) The concrete under the wrought iron fence is damaged in several areas. We recommend necessary repairs or replacing as needed by a licensed fence contractor.

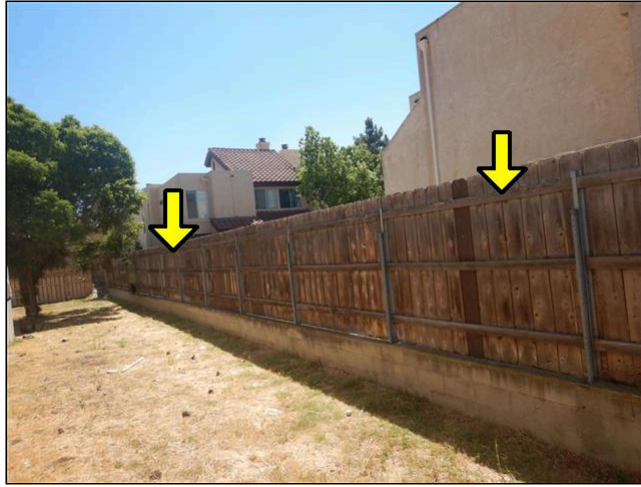
2.10 Item 5(Picture)

(5) The fence around the pool is loose, leaning and deteriorated in several areas. We recommend necessary repairs or replacing as needed by a licensed fence contractor.
(6) The wood fencing is not painted or stained at several areas. Maintaining paint and/or stain is essential to preventing the wood from deteriorating and damage. We recommend prep and painting or staining as needed by a licensed paint contractor.

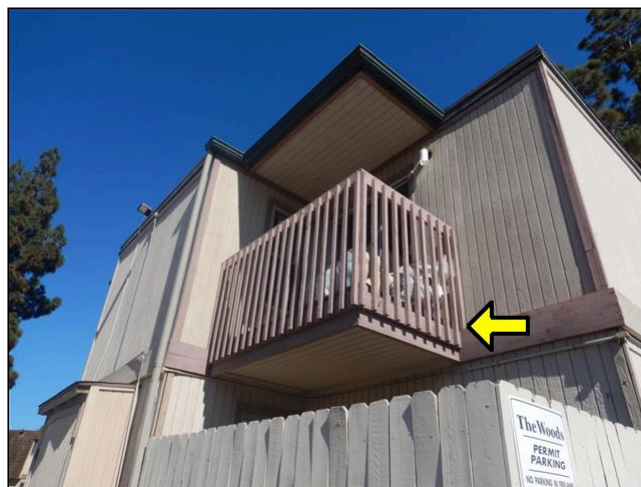
2.13 Item 1(Picture)

(1) Current building standards do not allow deck joists to cantilever more than 24 inches beyond a support beam or girder. This deck does not meet this standard. Depending on date of construction, this indicates the deck may have been built without a permit. We recommend further evaluation of the entire deck by a licensed deck contractor or qualified engineer prior to the close of your contingency period.

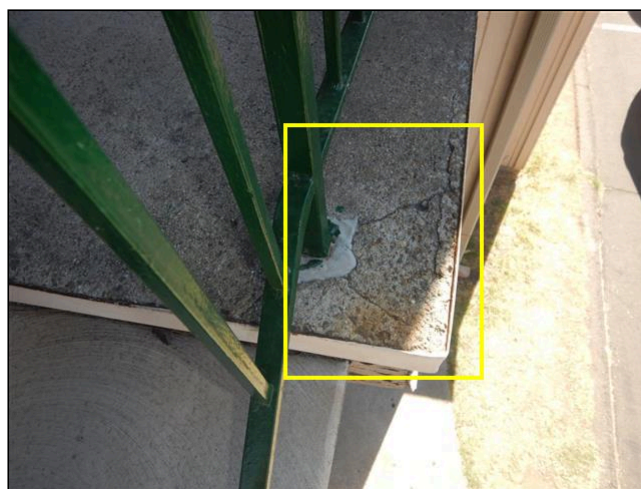
2.13 Item 2(Picture)

(3) The decking material/water proof membrane is worn and cracked at several decks. The effectiveness of the material may be compromised. We recommend having the decking material repaired or replaced by a licensed decking contractor.

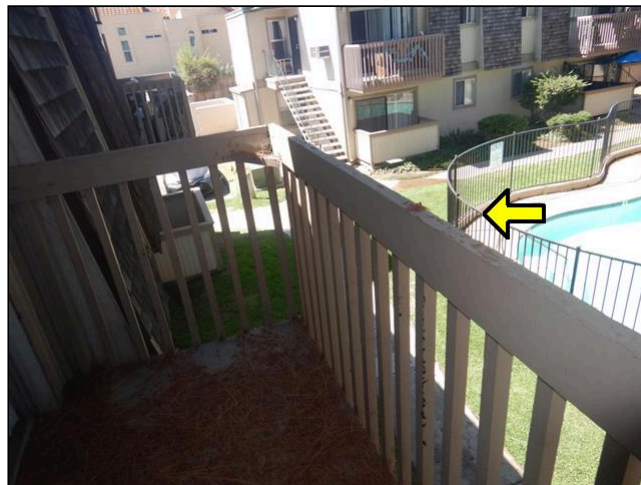
2.13 Item 4(Picture)

- (4) Incorrect installation of guard rail post(s) is observed at the deck. The post(s) should be spaced no more than 6 feet apart. Incorrect installation is a safety hazard. Depending on date of construction, this indicates the deck may have been built without a permit. We recommend further evaluation of the all decks by a licensed deck contractor or qualified engineer prior to the close of your contingency period
- (5) Due to all the deck issues we recommend having all the decks and all related components inspected by a licensed deck contractor prior to the end of your contingency period and necessary repairs or replacement made as needed.
- (6) The deck guard rail is to loose at Unit 2 which is a safety hazard. We recommend necessary repairs or replacement by a licensed deck contractor.

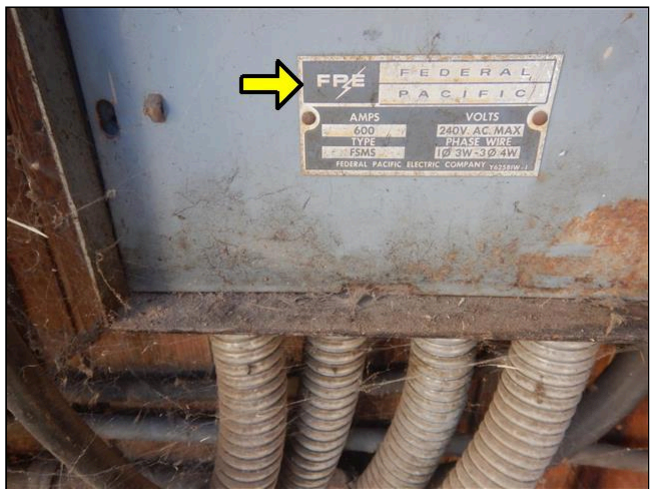
3.0 Item 1(Picture)

There is a Federal Pacific brand main electrical panel installed for each unit. This type of main electrical panel has had a reputation of the breakers not tripping when needed. We recommend further evaluation of all main electric panels by a qualified licensed electrician prior to the end of your contingency period for necessary repairs or replacement options.

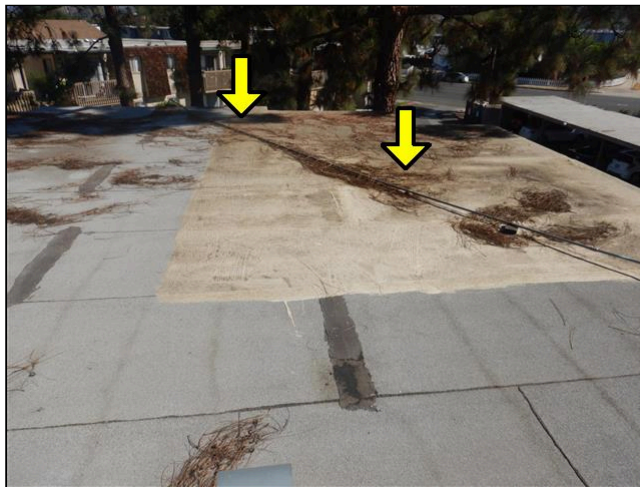
3.3 Item 1(Picture)

(2) There is an electrical conduit in contact with the roof. This is non standard. We recommend necessary corrections by a qualified licensed electrician.

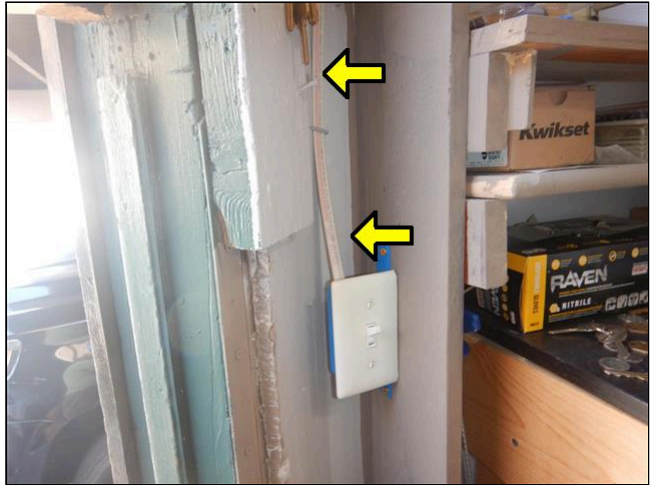
3.3 Item 2(Picture)

(3) There is exposed Romex type wires noted in the maintenance building in several areas. This is a safety concern if used where it could be subject to physical damage. Romex wires are normally used in attics, inside walls, or inside conduit. We recommend necessary corrections by a qualified licensed electrician for safety.

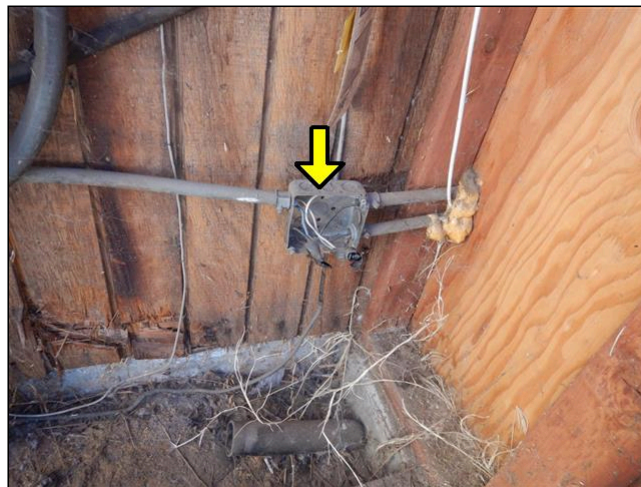
3.11 Item 1(Picture)

An open junction box is observed in the exterior electrical closet. All electrical splices must be enclosed in a junction box. We recommend necessary repairs by a qualified person for safety.

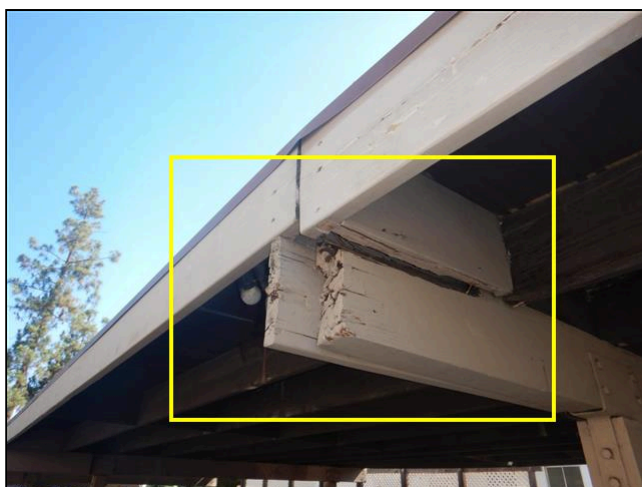
4.0 Item 1(Picture)

(1) Some damaged wood is observed at the carport(s) in several areas. We recommend referring to the pest inspection report for a detailed evaluation of the wood. We also recommend necessary repairs or replacing the wood as needed by a qualified licensed contractor.

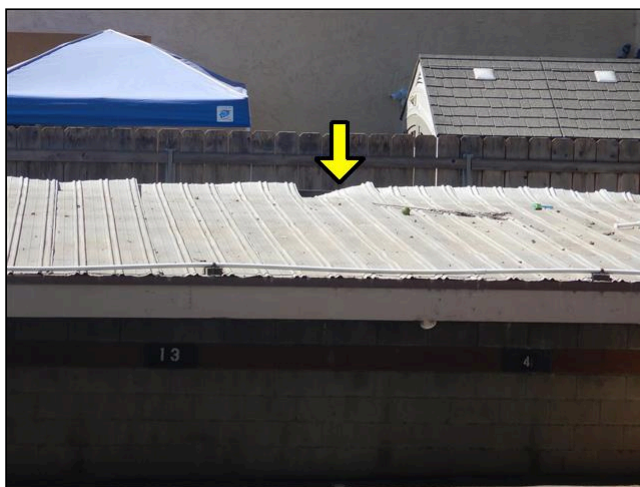
4.0 Item 3(Picture)

(2) The carport(s) roof is damaged at several areas. We recommend further evaluation of all the carport(s) roof(s) by a licensed roof contractor and necessary repairs or replacement made as needed.

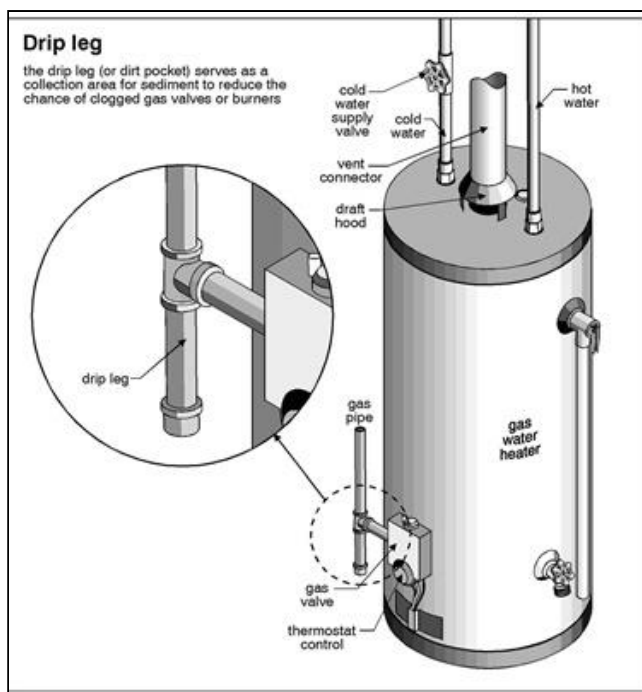
5.0 Item 1(Picture)

- (4) The gas supply pipe at the water heater in the laundry building did not contained a drip leg/ sediment trap. This may have been standard at the time of installation but now is highly recommended. The purpose of a drip leg is to prevent sediment/ debris from entering and clogging the water heater gas valve which could cause the water heater to shut down. We recommend having a drip leg installed by a qualified licensed plumber.

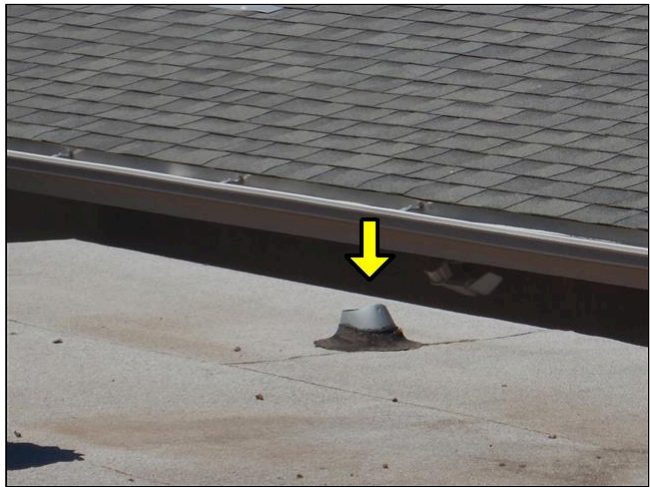
5.2 Item 1(Picture)

The laundry building water heater flue cap is missing. We recommend replacement by a qualified licensed plumber.

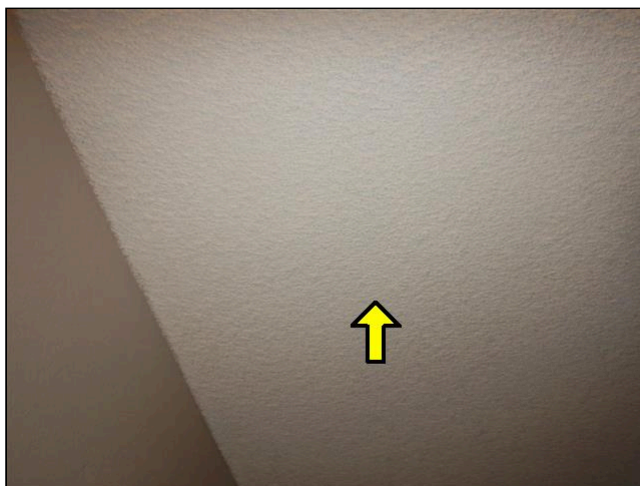
6.0 Item 1(Picture)

(1) There is acoustic texture present at the ceiling in each unit. Some of this acoustic texture installed before the 1980's has been known to contain asbestos. It is beyond the scope of this general home inspection for us to test for asbestos. The only way to confirm the presence or absence of asbestos is by having it tested by a qualified person. We recommend having the acoustic texture tested by a qualified person if concerned.

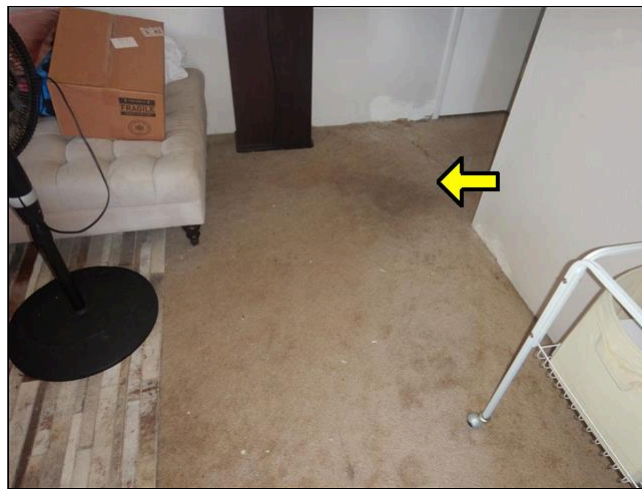
6.3 Item 1(Picture)

(1) Carpets throughout Unit 3 and 4 are dirty. We recommend having them professional cleaned or replaced by a qualified licensed flooring contractor.

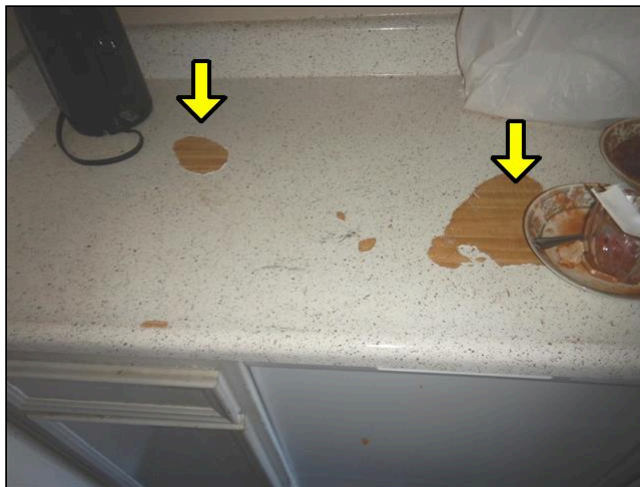
6.4 Item 1(Picture)

(1) The kitchen countertop surface in unit 1 is damaged. We recommend necessary repairs by a qualified licensed contractor.

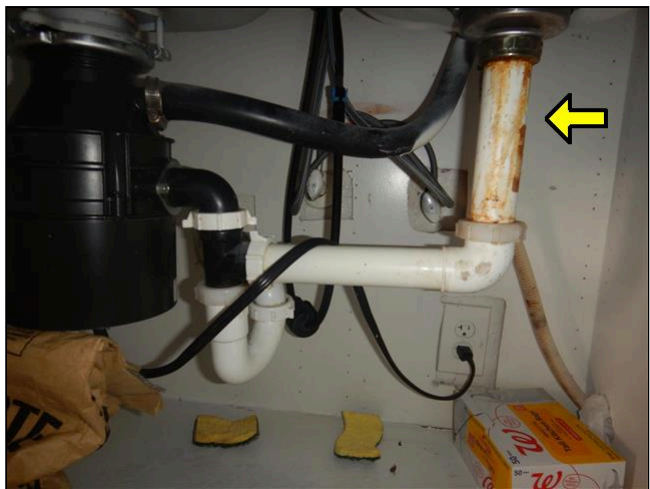
7.0 Item 1(Picture)

(3) Stains are observed on the waste pipes under the kitchen sink in Unit 3. Although there are currently no leaks detected, there may be one under certain conditions. We recommend further evaluation by a licensed plumber prior to the end of your contingency if concerned.

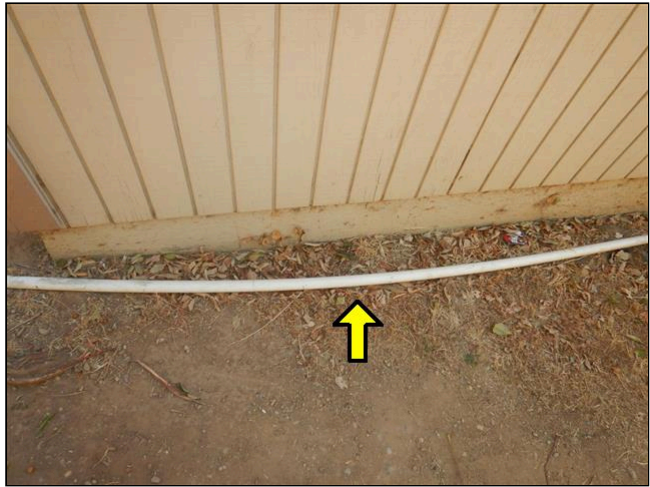
7.1 Item 1(Picture)

A pipe is loose/ not properly secured at the right side of the laundry building We recommend further evaluation by a qualified licensed plumber and necessary repairs made.

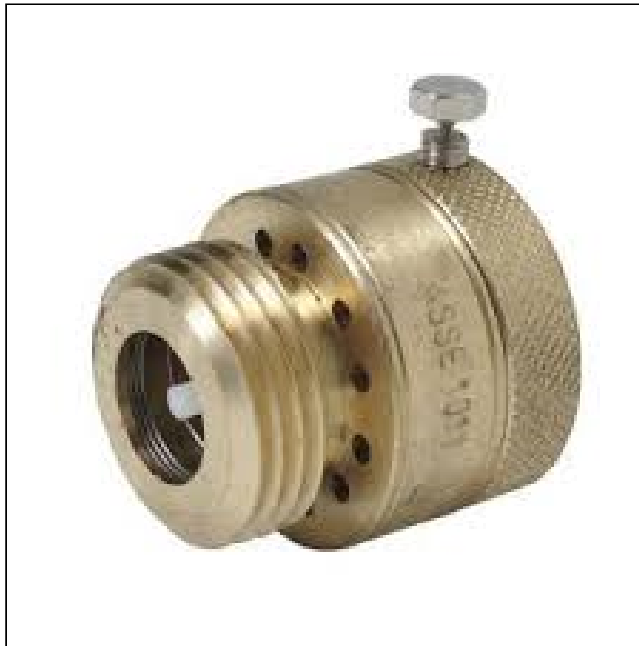
7.3 Item 1(Picture)

(1) The exterior hose spigots do not have anti-siphon or anti-backflow devices installed on them. These anti-siphon or anti-backflow devices help prevent contaminated water from flowing back into the the house water supply system. We recommend installing anti-siphon or anti-backflow devices at the every exterior hose spigots by a qualified person.

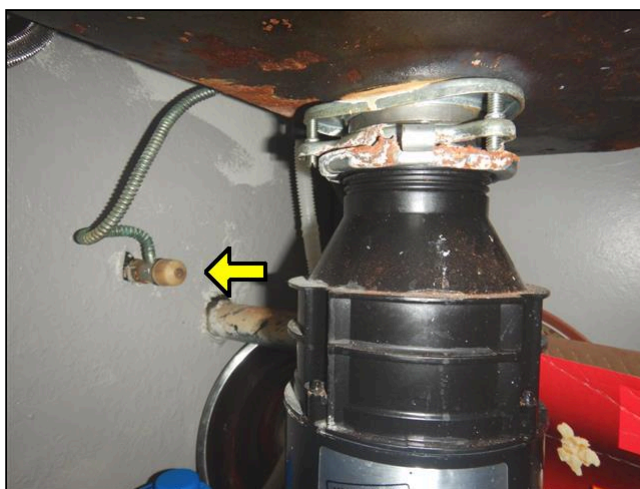
7.5 Item 2(Picture)

(2) There is an older one piece angle stop valve/ supply line observed at the kitchen sink cold water line in Unit 1. These one piece angle stop valve/ supply lines have a reputation to corrode from the inside and possible fail. A white power substance or corrosion/ calcification is observed at the one piece angle stop valve/ supply line. We recommend that this one piece angle stop valve/ supply line be replaced by a qualified licensed plumber as an upgrade.

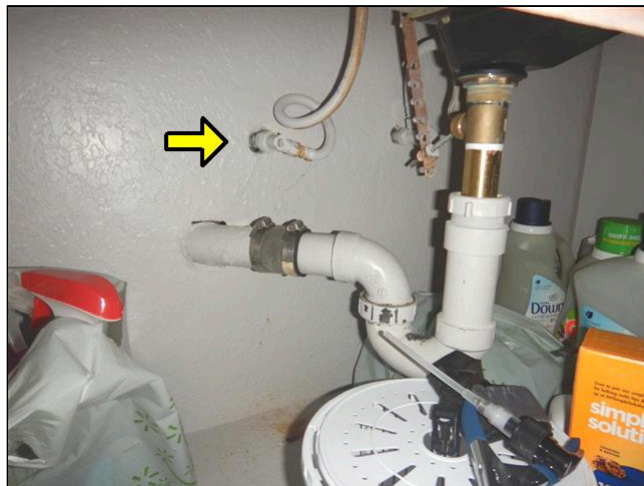
8.0.A Item 1(Picture)

- (1) The sink stopper is missing in Unit 1,2 and 4. We recommend replacement where missing by a qualified person.
- (2) The hot water shut off valve handle is missing in Unit 4. We recommend replacement by a qualified licensed plumber.

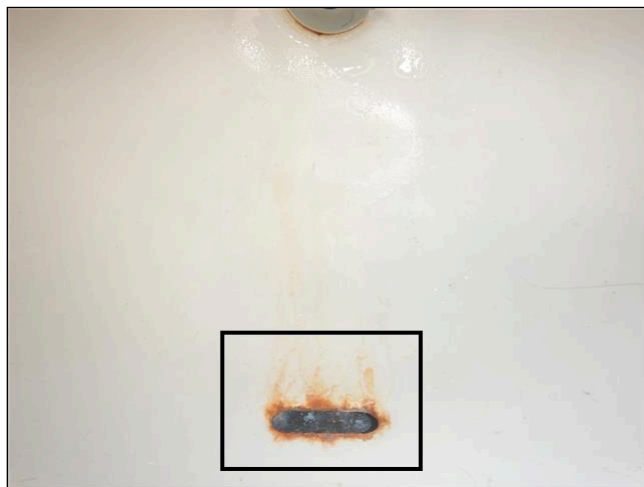
8.0.A Item 2(Picture)

- (3) The sink overflow channel is rusted in Unit 4. We recommend replacing this sink by a qualified licensed plumber.

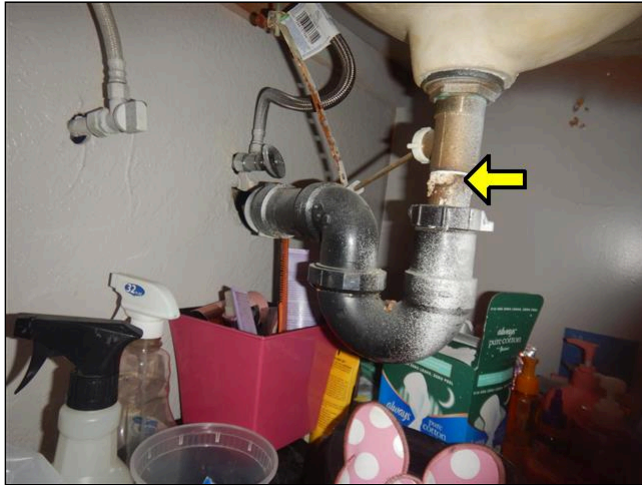
8.0.A Item 3(Picture)

(4) The metal portions of the sink drain are rusted or corroded under Unit 2 sink. A leak was not observed at this sink drain pipe at the time of the inspection. However, we recommend replacing this drain pipe by a qualified licensed plumber to help prevent future leaks or damage.

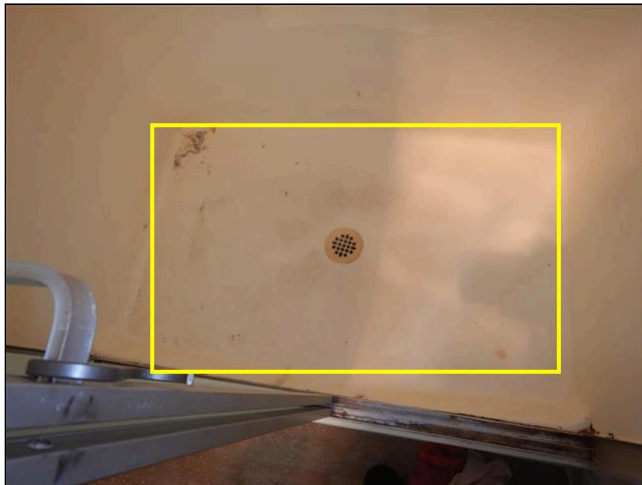
8.1.A Item 1(Picture)

(1) The shower floor surface is cracked in Unit 4. There may be moisture damage below the shower pan which is not visible. We recommend further evaluation by a qualified licensed contractor and necessary repairs made as needed.

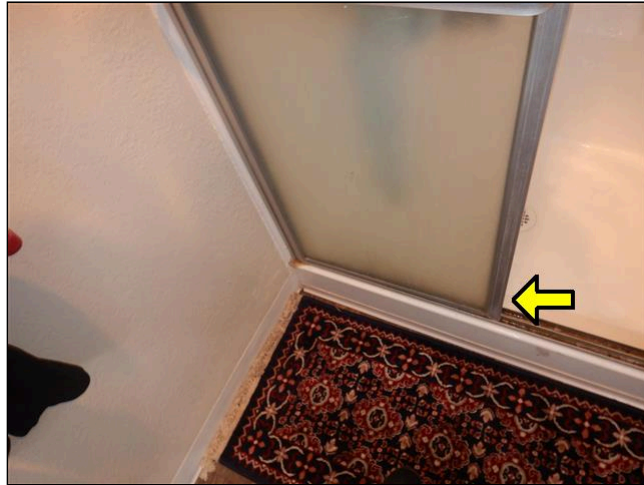
8.1.A Item 2(Picture)

(3) The shower door in Unit 1 needs adjusting. We recommend having the door adjusted by a qualified person.

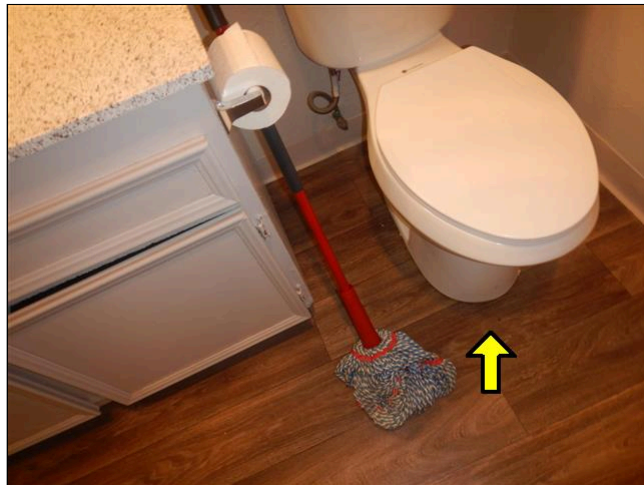
8.3.A Item 1(Picture)

The bathroom toilet is loose on the wood sub floor in Unit 2. This condition could cause damage to the wax ring, leaks, and damage to the wood sub floor. There could be damage to the wood sub floor which is not visible. We highly recommend further evaluation by a qualified licensed plumber or qualified licensed contractor prior to the end of your contingency period and necessary repairs made as needed.

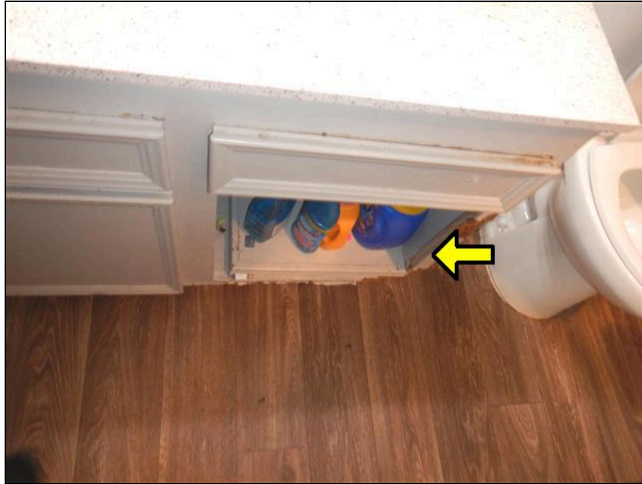
8.4.A Item 1(Picture)

A cabinet door is missing from a cabinet in Unit 1. We recommend replacing by a qualified person.

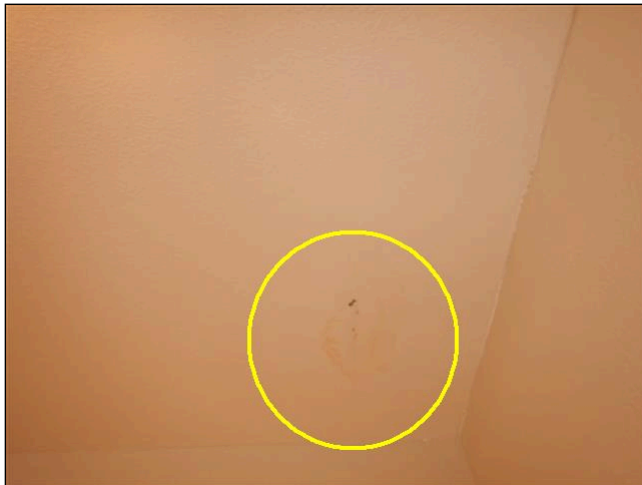
8.5.A Item 1(Picture)

Damaged was observed at the ceiling in Unit 1. We recommend necessary repairs by a qualified person.

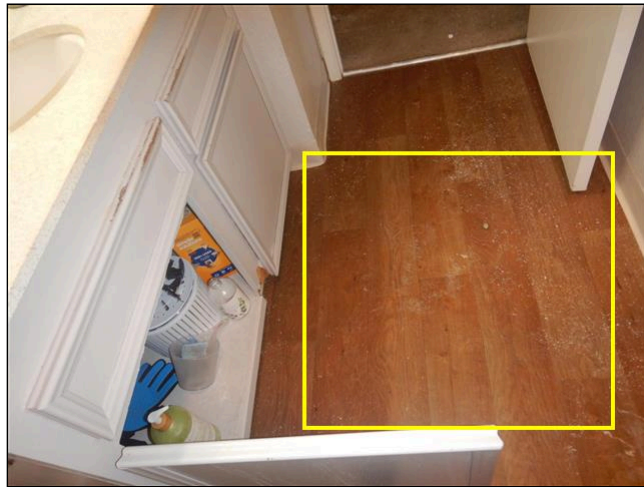
8.6.A Item 1(Picture)

The bathroom floor in Unit 4 is soft/ appeared to have a lot of movement in it when walked on. There may be damage to the sub floor in this area which is concealed. We therefore cannot report on the presence of wood damage, if any. This area should be carefully evaluated by a licensed pest inspector and repairs made by a qualified licensed contractor.

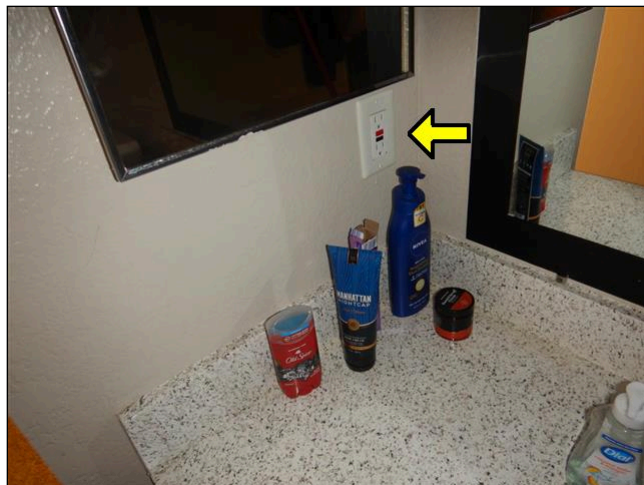
8.7.A Item 1(Picture)

- (1) There is more than one GFCI receptacle installed on the bathroom circuit in Unit 3. This condition is not a hazard but can cause confusion to reset if one trips. Only one GFCI is required to protect all of the receptacles past the GFCI. We recommend necessary corrections by a qualified licensed electrician.
- (2) The GFCI outlet in Unit 2 bathroom is a non-grounded outlet which is legal, but not as safe as a grounded GFCI. Non-grounded GFCI protected receptacles require a label stating "No Equipment Ground". We recommend labeling for safety or having this outlet grounded by a qualified licensed electrician.

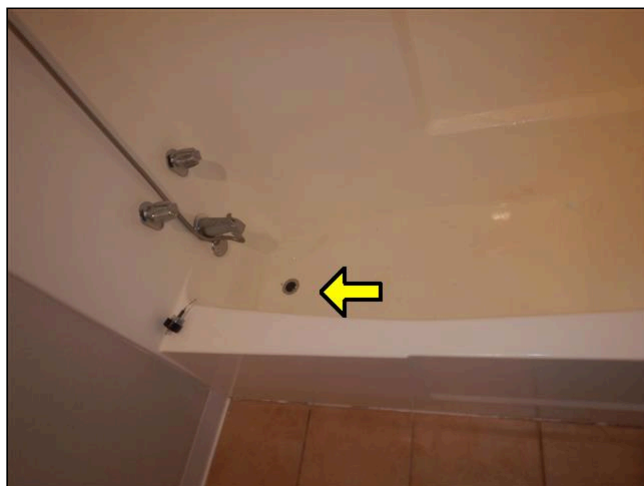
8.1.B Item 1(Picture)

The tub/ shower drain was slow draining in Unit 3 at the time of the inspection This may indicate a blockage in the drain line. We recommend further evaluation by a qualified licensed plumber and repairs as needed.
