Inspection Report

Property Address:
3212 Main Pl
Rancho Santa Fe CA 92067

The Property Inspection Pros

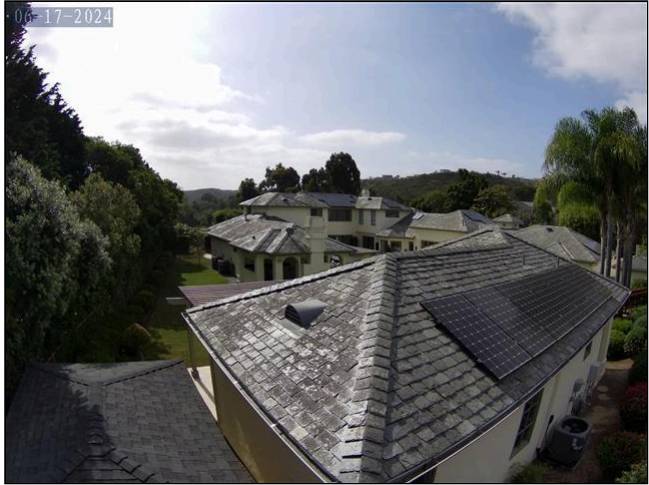
1.6 Item 4(Picture)

(2) There are several cracked and slipped roof tiles noted at several areas. We recommend further evaluation of the entire roof prior to the end of your contingency period by a licensed roof contractor and necessary repairs or replacement made.

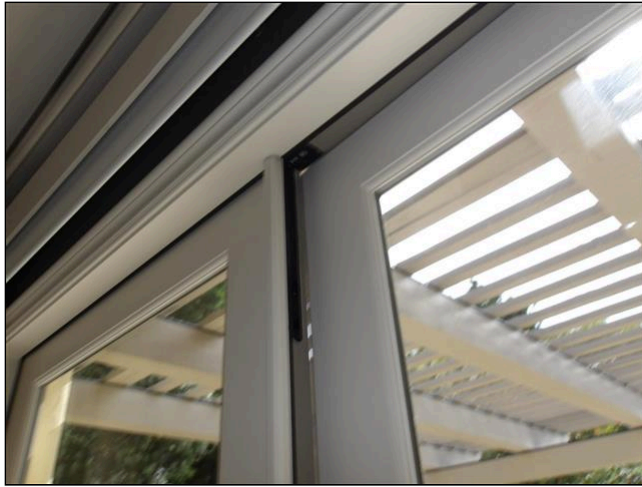
2.5.A Item 1(Picture)

(1) The french doors at the detached guest house rub each other. This can be caused by several factors including poor installation or settlement of the house. We recommend necessary repairs by a qualified licensed door contractor.

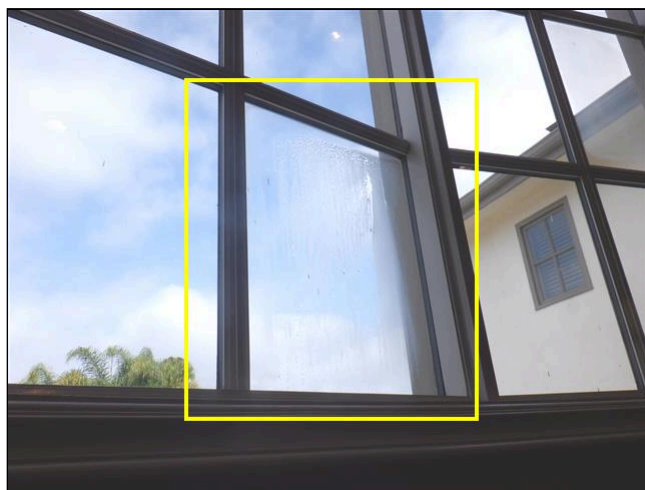
2.6.A Item 2(Picture)

(4) Condensation was observed between the panes of glass at several windows throughout the house. This occurs when the seal has failed between the panes of glass, and ambient air has entered the assembly. Replacement of the glass is required. Since some failed windows may not be easily found due to changing ambient conditions (heat, humidity, etc). We recommend having all of the windows reviewed by a licensed window contractor to determine how many windows require repair/ replacement. We recommend repairing or replacing all windows that have failed window seals by a licensed window contractor.

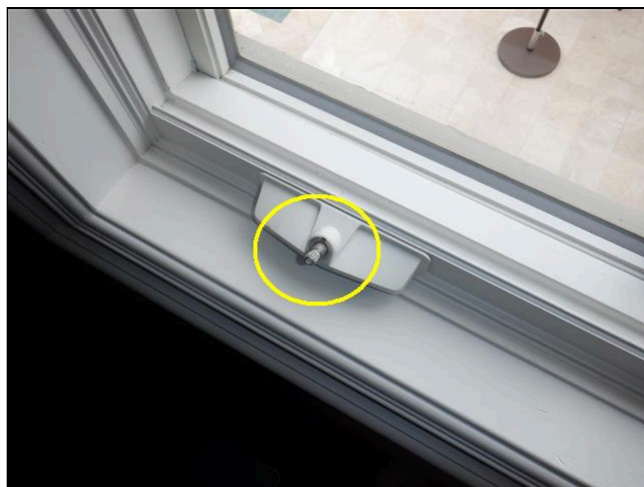
2.6.A Item 5(Picture)

(5) Casement window(s) had missing crank handles at several windows throughout the house. These windows could not be tested for proper operation. We recommend replacing the handles and testing these windows for proper operation prior to the end of your contingency period.

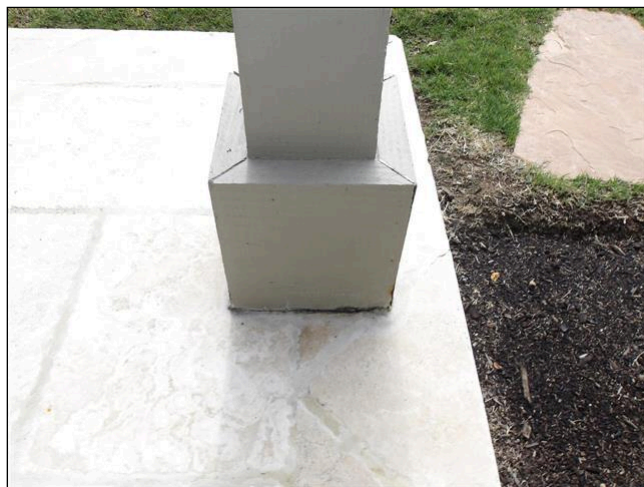
2.8.A Item 1(Picture)

Some damaged wood is observed at the patio cover at several areas. We recommend referring to the pest inspection report for a detailed evaluation of the wood. We also recommend necessary repairs or replacing the damaged wood as needed by a qualified licensed contractor.

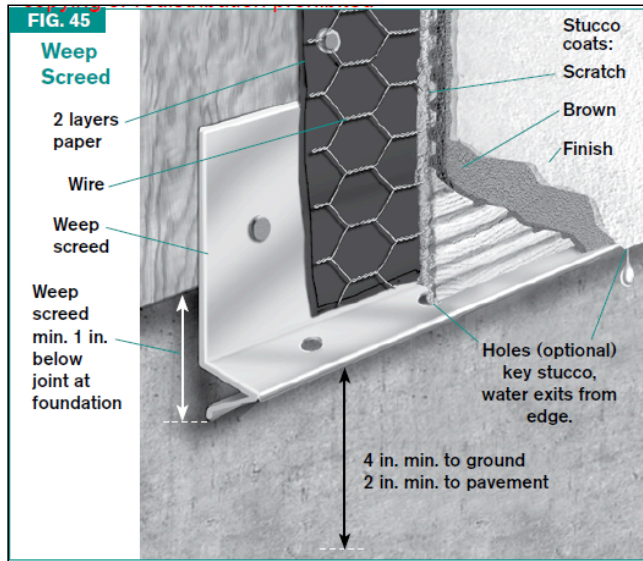
2.2.B Item 1(Picture)

to "breathe" and water to "weep" from the stucco. Having the soil above the weep screed can lead to stucco damage due to limited air flow. We recommend a ground clearance of four inches where possible allow for proper drainage and for ventilation of the stucco walls. Dirt in contact with the stucco can promote deterioration, including rot, pest infestation, and water intrusion during rain. We recommend further evaluation and necessary corrections by a qualified licensed contractor.

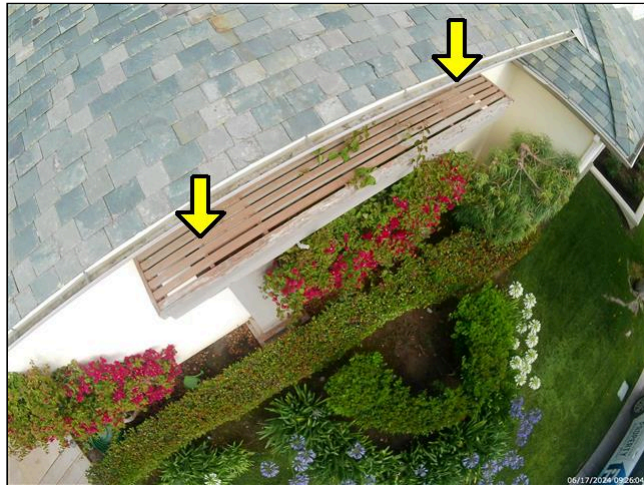
2.3.B Item 1(Picture)

(1) Some damaged wood is observed at several areas. We recommend referring to the pest inspection report for a detailed evaluation of the wood. We also recommend necessary repairs or replacing the wood siding as needed by a qualified licensed contractor.

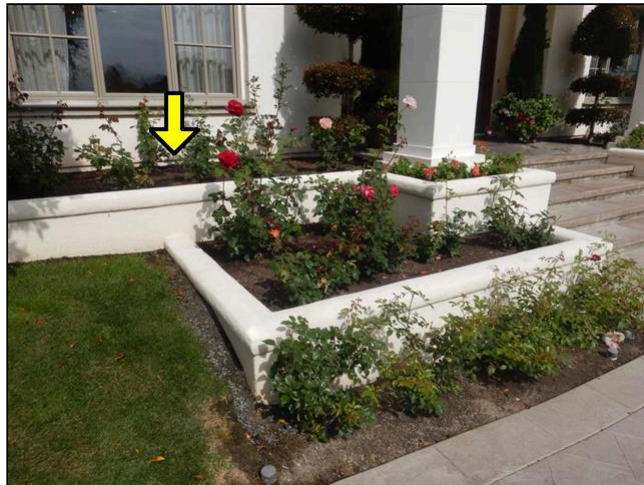
2.3.B Item 3(Picture)

(3) Planter boxes are installed against the home. Earth to siding contact is observed. We advise referring to the pest control report. Watering near the home can cause water damage and structural settlement. We recommend necessary corrections such as installing zero scape, drought tolerate plants or removing the planter boxes.

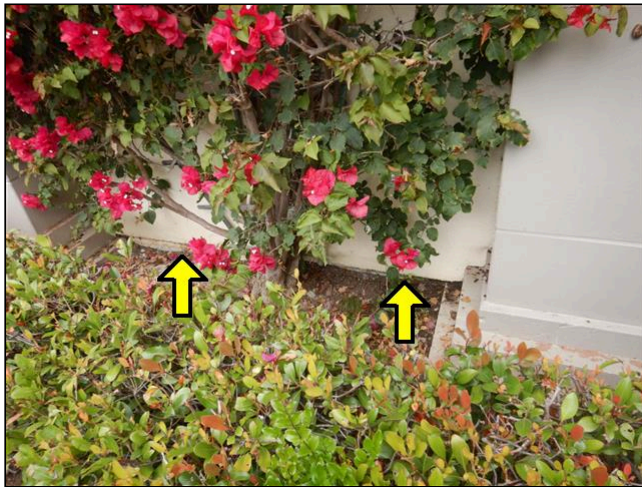
2.3.B Item 4(Picture)

(4) The stucco screed flashing is rusted at several areas around the house. The stucco screed flashings may have too much rust and damage and may need to be replaced. We recommend further evaluation by a stucco repair contractor and necessary repairs or replacement made as needed and we recommend adjusting the sprinklers to spray away from the house.

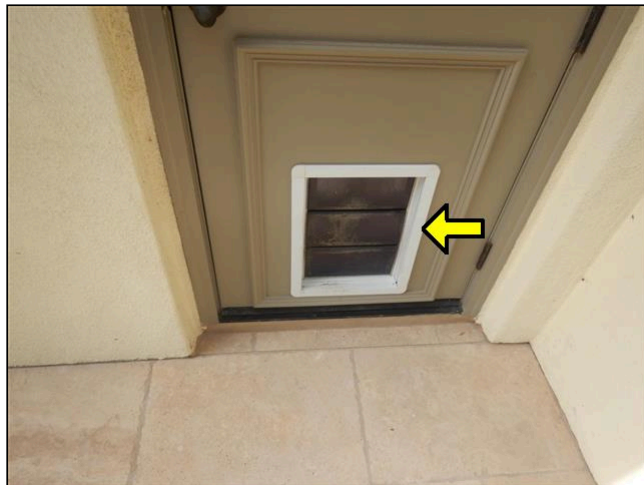
2.5.B Item 1(Picture)

(1) A pet door is present at and exterior left side door. These modifications can cause damage to the door by letting in rain. These modifications can also reduce the security of the door by making it easier for someone to enter or reach inside and unlock the door. We recommend sealing the door or replacing the door by a qualified person

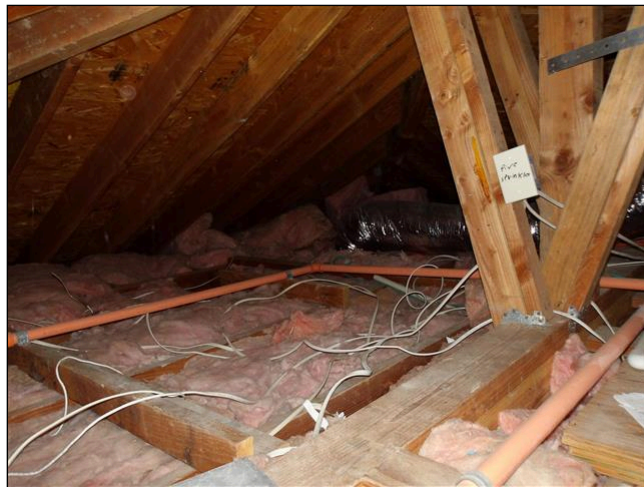
3.2.A Item 1(Picture)

(1) Wires for some lighting fixtures in the attic space were observed to be unsecured. We recommend necessary corrections by a qualified licensed electrician.

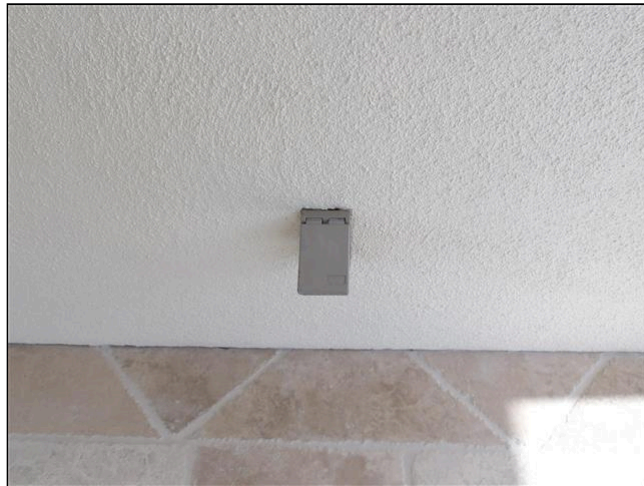
3.7.A Item 1(Picture)

Several receptacles were found to be loose in the wall at several areas throughout the interior/exterior of the detached house. We recommend necessary repairs where needed by a licensed electrician.

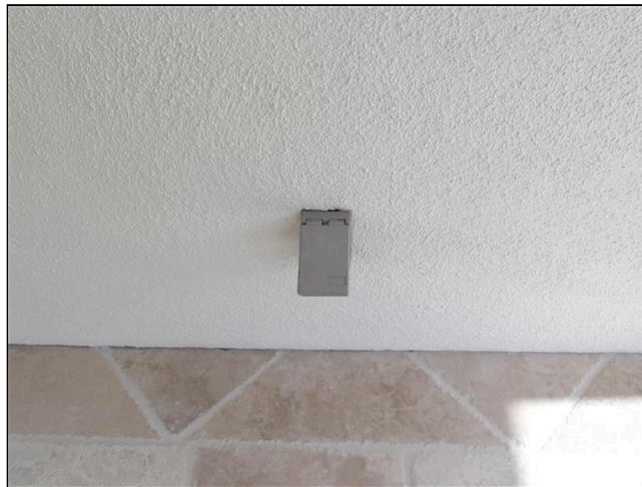
3.9.A Item 2(Picture)

(2) The GFCI receptacles located at the exterior of the detached house are not operating properly, or has failed as it did not trip when tested. The outlet may be defective or mis-wired. We recommend replacement by a qualified licensed electrician.

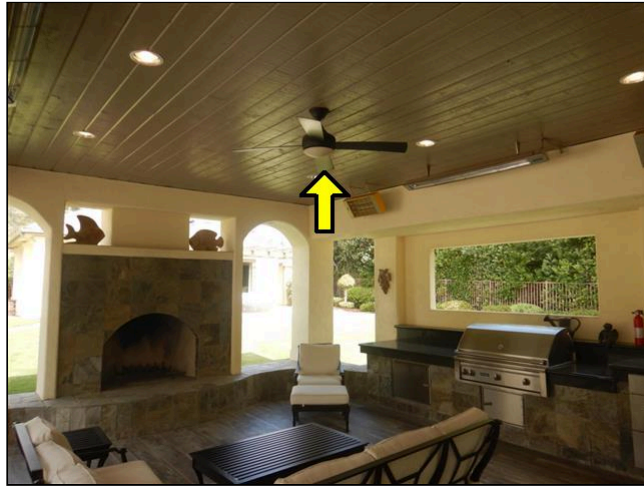
3.5.B Item 1(Picture)

(1) The BBQ area ceiling fan did not work when tested at the time of the inspection. We recommend further evaluation by a qualified person and repairs or replacement made as necessary.

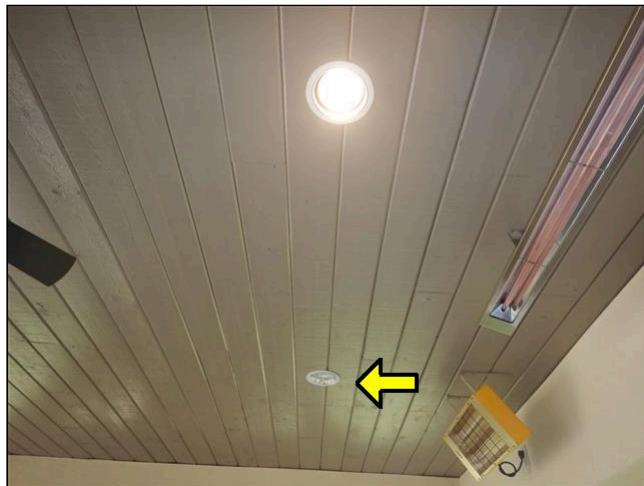
3.5.B Item 2(Picture)

(2) A light at the BBQ area did not function when tested possibly due to a bad bulb or a miss wired fixture. Occasionally there may something wrong with the fixture which cannot be determined without a working bulb. We recommend asking the seller to demonstrate that the light is working prior to the end of the inspection contingency period, or changing the bulb and testing again. If the light does not function we recommend further evaluation by a qualified licensed electrician and necessary repairs or replacement as needed.

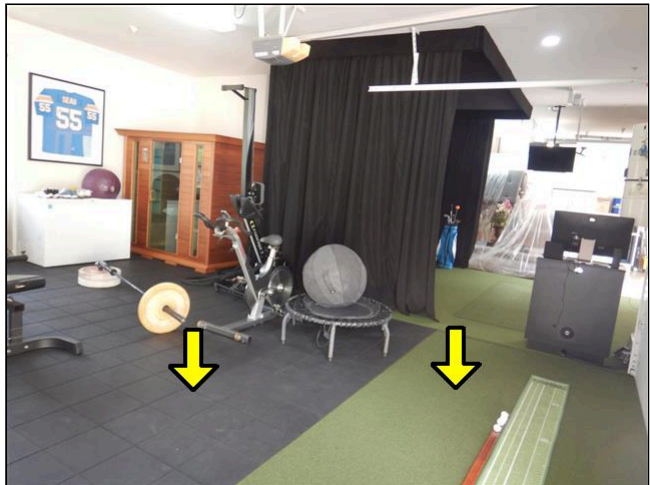
4.4 Item 1(Picture)

(1) There is turf and rubber tiles installed on/ over the garage slab. The garage slab is not visible to inspect. These materials can trap spilled flammable liquids. This condition is a fire and a safety hazard. We recommend removing the carpet and inspecting the slab prior to the end of your contingency period.

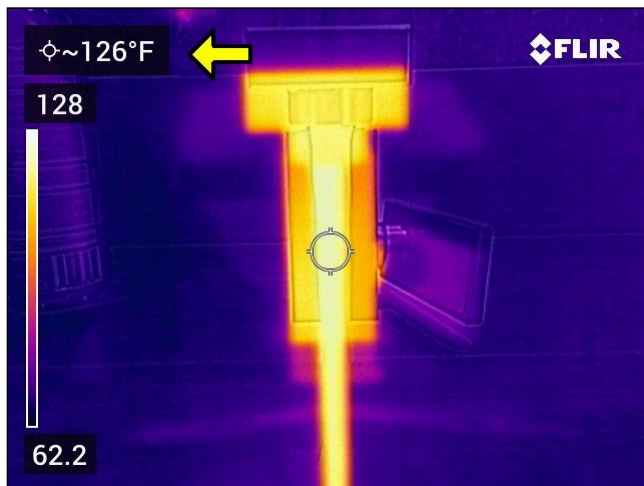
5.0.A Item 3(Picture)

The temperature of the water was tested using a thermal camera at the time of the inspection and found to be above 125 degrees. Water temperatures above 125 degrees can cause scalding or burns. Most water heater manufacturers recommend setting the water heater controls at 120 degrees for optimum efficiency. We recommend setting the water heater controls at 120 degrees by a qualified person for optimum efficiency.

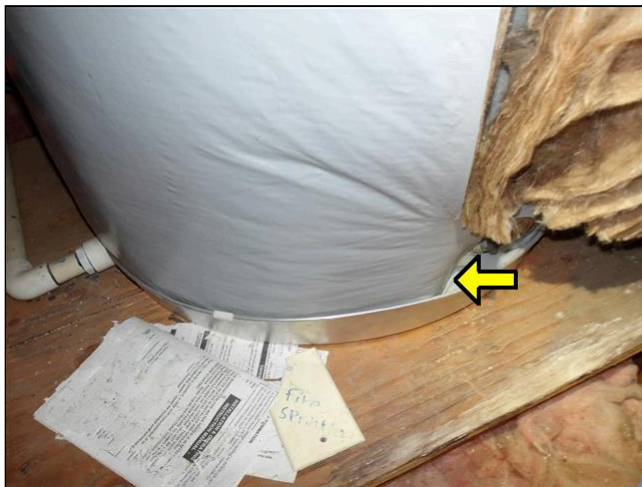
5.0.A Item 5(Picture)

(6) The leak pan under the water heater is too small because the insulating blanket was installed into the leak pan which took up the entire space of the pan. The leak pan should be 2 inches larger in diameter than the water heater. The current installation may not function properly in the event of a leak. We recommend replacing this leak pan with an appropriate sized leak pan by a qualified licensed plumber.

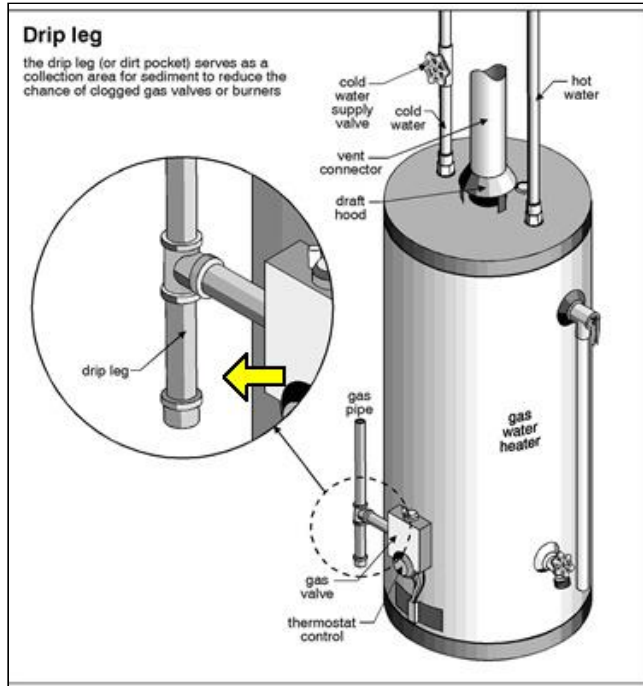
5.0.B Item 3(Picture)

(5) The gas supply pipe at the water heater did not contain a drip leg/ sediment trap. This may have been standard at the time of installation but now is highly recommended. The purpose of a drip leg is to prevent sediment/ debris from entering and clogging the water heater gas valve which could cause the water heater to shut down. We recommend having a drip leg installed by a qualified licensed plumber.

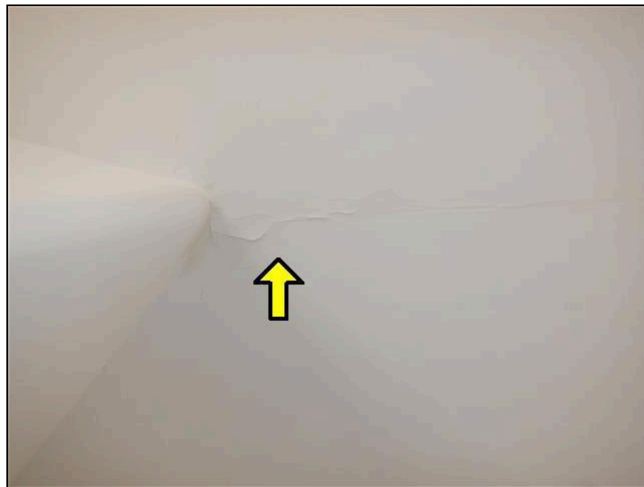
6.1.B Item 1(Picture)

(1) Hairline cracking was observed at the ceiling at several locations in the house. These hairline cracks are likely due to material shrinkage or settlement of the structure. We recommend prep and paint by a qualified licensed contractor.

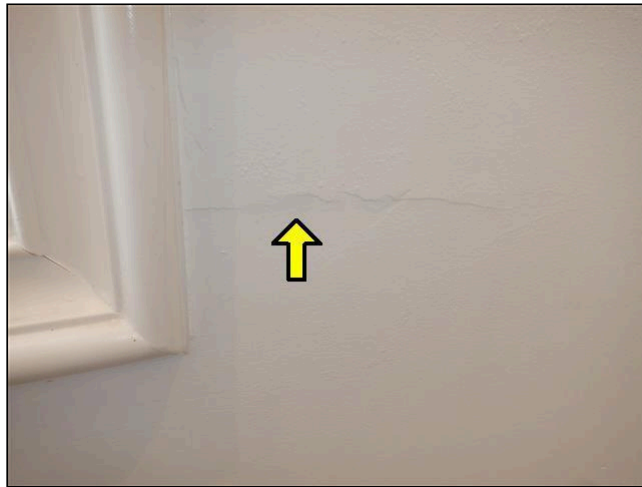
6.2.B Item 1(Picture)

- (1) The walls have typical cosmetic wear. You may wish to view this for yourself and have necessary repairs made as needed by a qualified person.
- (2) Hairline cracking was observed at several locations. These hairline cracks are likely due to material shrinkage or settlement of the structure. We recommend prep and paint by a qualified licensed painter.

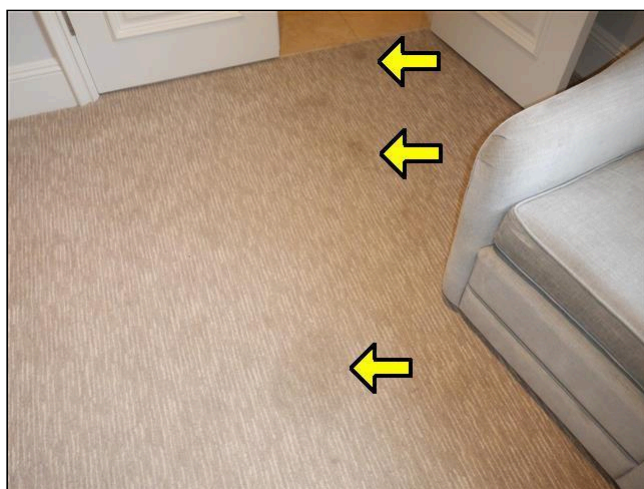
6.3.B Item 1(Picture)

(1) Carpets throughout the house are dirty. We recommend having them professional cleaned or replaced by a qualified licensed flooring contractor.

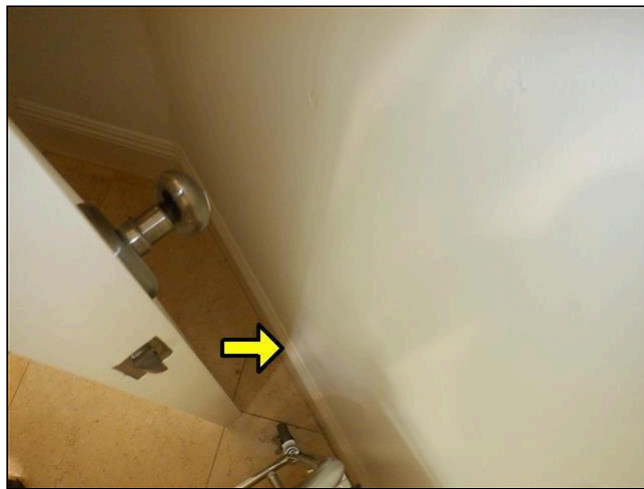
6.6.B Item 1(Picture)

- (1) Door stoppers are missing at several doors. Door stoppers are recommended where door handles contact walls. We recommend adding door stops and repair of any walls by a qualified person.

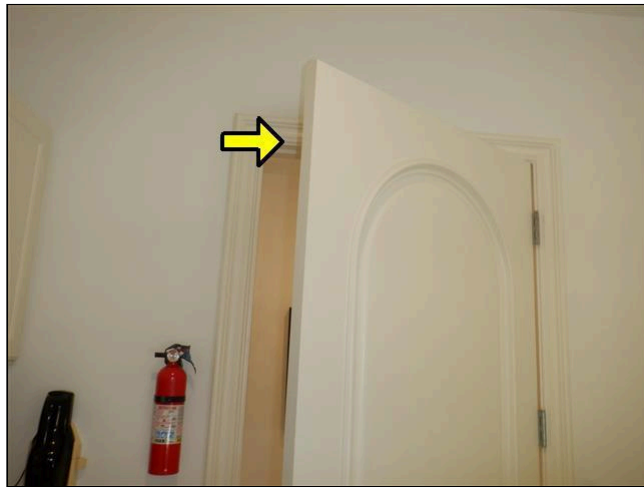
6.6.B Item 3(Picture)

(2) The laundry room door rubs at the frame. We recommend necessary corrections by a qualified person.

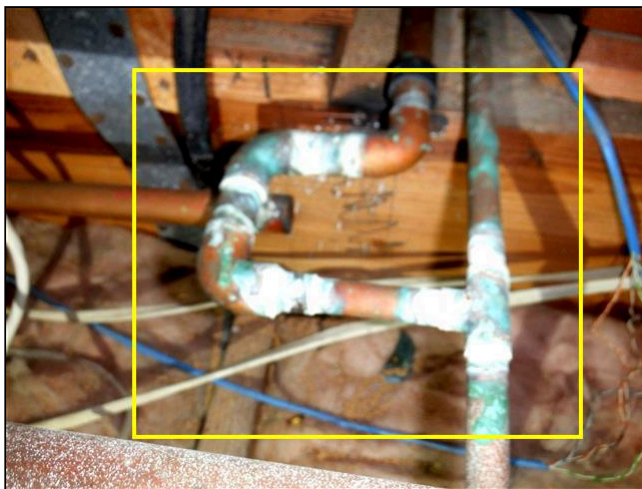
7.1.B Item 1(Picture)

(1) A corroded pipe is observed in the attic. We recommend further evaluation by a qualified licensed plumber and necessary repairs made.

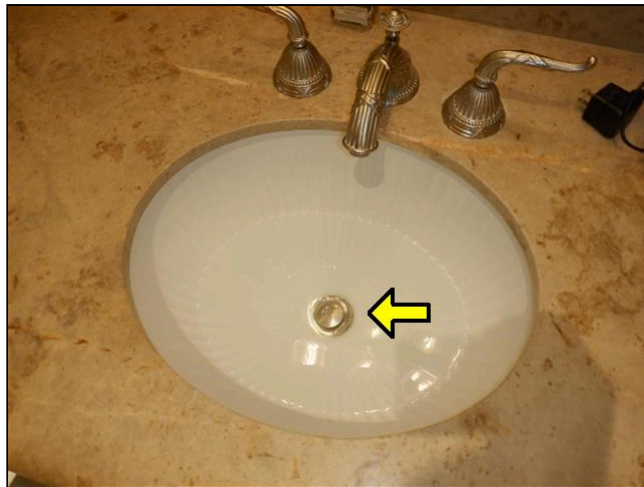
8.0.B Item 1(Picture)

(1) The left side sink in the bathroom was slow draining at the time of the inspection This may indicate a blockage in the drain line. We recommend further evaluation by a qualified licensed plumber and repairs as needed.

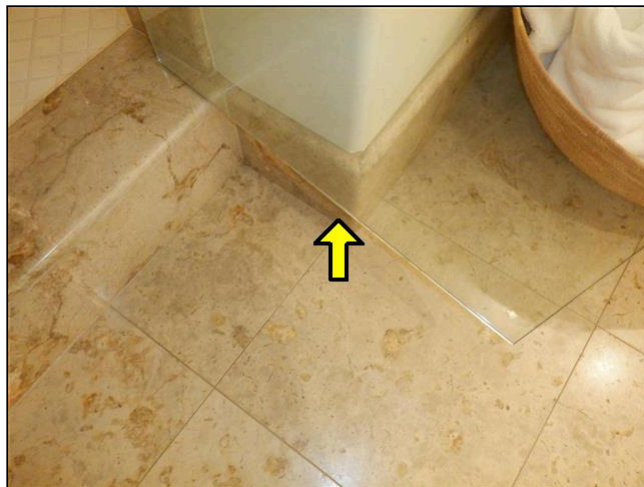
8.1.B Item 1(Picture)

(1) The bottom shower door seal is missing at the shower door. This is allowing water to splash out of the shower and onto the bathroom floor. We recommend installing a bottom shower door seal by a qualified person.

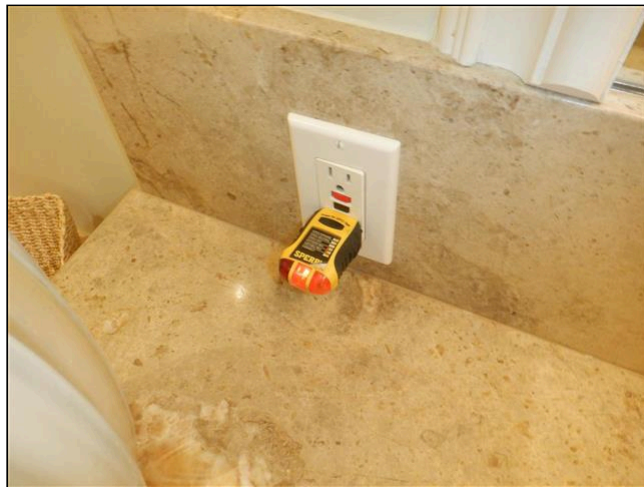
8.2.B Item 1(Picture)

The left side GFCI outlet in this bathroom is a non-grounded outlet which is legal, but not as safe as a grounded GFCI. Non-grounded GFCI protected receptacles require a label stating "No Equipment Ground". We recommend labeling for safety or having this outlet grounded by a qualified licensed electrician.

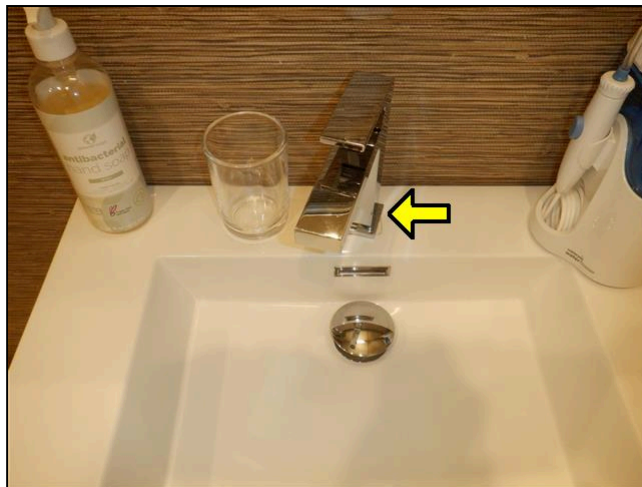
8.0.D Item 1(Picture)

The sink faucet is loose. We recommend necessary repairs by a qualified licensed plumber.

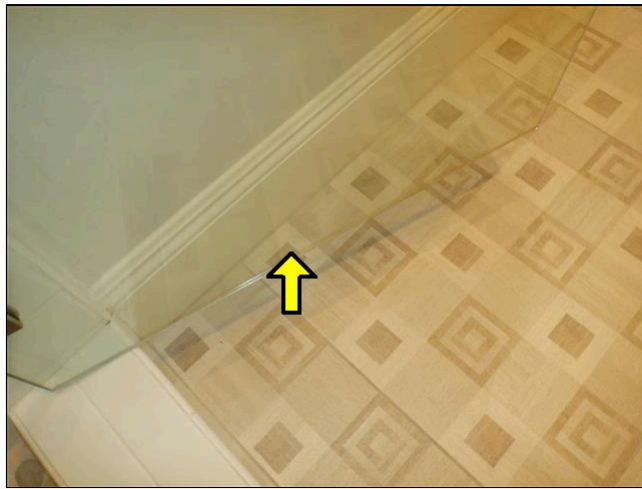
8.0.G Item 1(Picture)

The bottom shower door seal is missing at the shower door. This is allowing water to splash out of the shower and onto the bathroom floor. We recommend installing a bottom shower door seal by a qualified person.

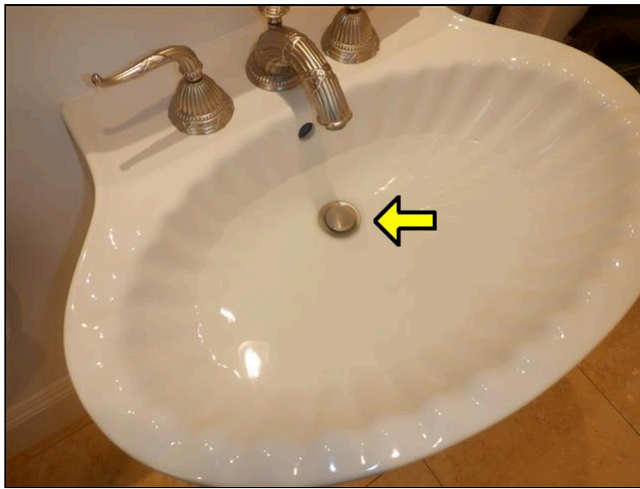
8.0.H Item 1(Picture)

The sink in the bathroom was slow draining at the time of the inspection This may indicate a blockage in the drain line. We recommend further evaluation by a qualified licensed plumber and repairs as needed.

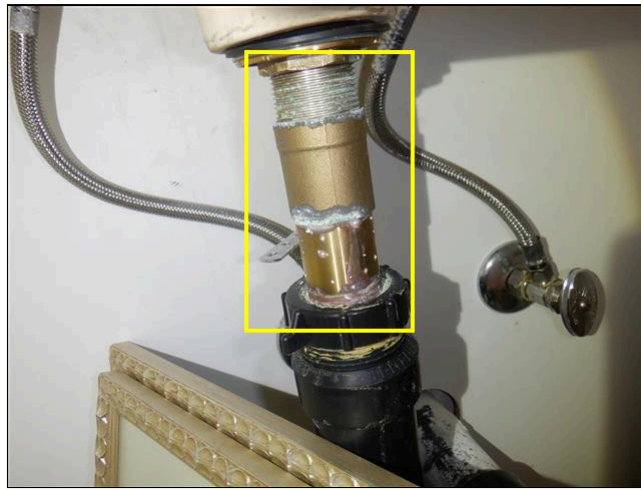
8.0.I Item 1(Picture)

The metal portions of the sink drain are rusted or corroded. A leak was not observed at this sink drain pipe at the time of the inspection. However, we recommend replacing this drain pipe by a qualified licensed plumber to help prevent future leaks or damage.
