Inspection Report

12345 Main Ave. Escondido CA 92026

The Property Inspection Pros

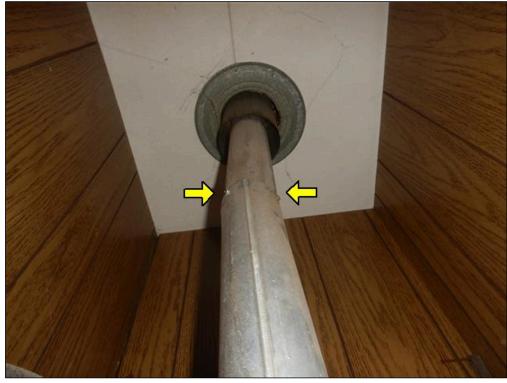
4.2 Item 1(Picture)

Sections of the water heater flue were improperly installed. The lower sections should fit inside the upper sections so that exhaust gases cannot escape. The flue pipe connections must also be fastened with 3 sheet metal screws per connection. Incorrect installation is a possible Carbon Monoxide hazard. We recommend necessary corrections by a qualified licensed plumber.

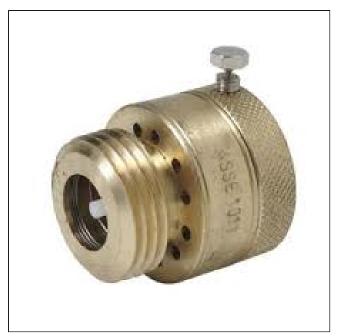
6.3 Item 2(Picture)

(2) The exterior hose spigots do not have anti-siphon or anti-backflow devices installed on them. These anti-siphon or anti-backflow devices help prevent contaminated water from flowing back into the the house water supply system. We recommend installing anti-siphon or anti-backflow devices at the every exterior hose spigots by a qualified person.

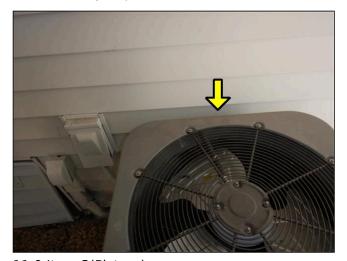
11.0 Item 3(Picture)

(4) The AC condenser was located too close to a wall. This condition may impede airflow and limit the ability of the unit to adequately dissipate heat. Although installation requirements vary with manufacturer, the condenser should maintain a minimum of 6 inches of clearance from any obstacle to air flow. Inadequate airflow can result in a reduced compressor life span and higher operating costs. We recommend necessary corrections by a qualified licensed HVAC contractor.

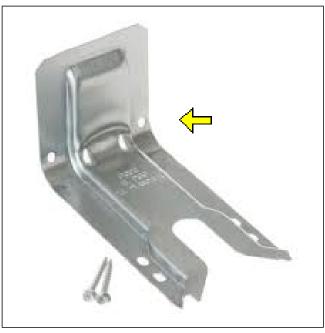
14.4 Item 4(Picture)

(3) An anti tip bracket was not installed at the range. This bracket prevents the range from tipping forward which could cause the range to fall over. We recommend installation of an anti tip bracket by a qualified person for safety and to help prevent injury.
