Inspection Report

Property Address: 1234 Main Street Santee CA 92071

The Property Inspection Pros

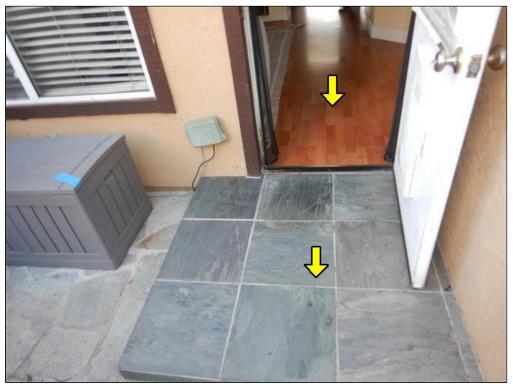
2.2 Item 1(Picture)

(2) The rear platform has been built at the same level as the interior slab/ floor. The ideal building will have interior floors that will be several inches higher than the exterior grade. This property does not meet this ideal requirement. Repairs may be need to prevent damage/moisture intrusion. We recommend further evaluation and necessary repairs by a licensed landscaping contractor.

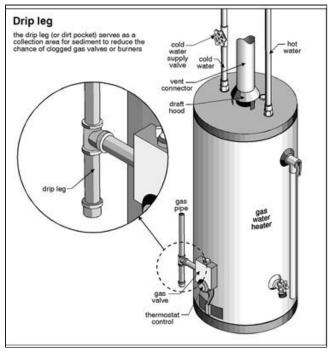
5.0 Item 3(Picture)

(3) The gas supply pipe at the water heater did not contained a drip leg/ sediment trap. This may have been standard at the time of installation but now is highly recommended. The purpose of a drip leg is to prevent sediment/ debris from entering and clogging the water heater gas valve which could cause the water heater to shut down. We recommend having a drip leg installed by a qualified licensed plumber.

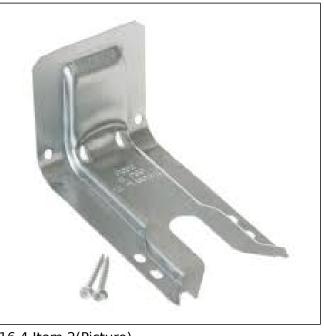
16.4 Item 2(Picture)

(2) An anti tip bracket was not installed at the range. This bracket prevents the range from tipping forward which could cause the range to fall over. We recommend installation of an anti tip bracket by a qualified person for safety and to help prevent injury.
