# **Inspection Report**

1123 Smith Road Vista CA 92083

## **The Property Inspection Pros**

<b>Date:</b> 10/4/2024	<b>Time:</b> 01:00 PM	Report ID:
Property: 1123 Smith Road Vista CA 92083	<b>Customer:</b> Jonny Smyth	Real Estate Professional:

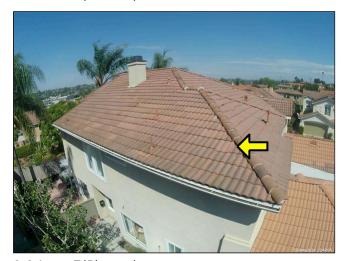
1.1 Item 6(Picture)

(2) Slipped tiles are noted at several areas. We recommend further evaluation and necessary repairs by a licensed roof contractor.

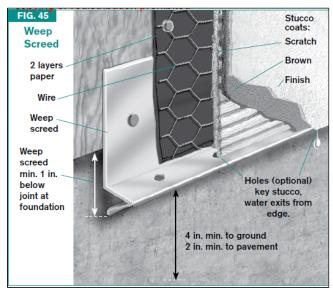
2.2 Item 1(Picture)

(2) The stucco/weep screed is in contact with ground, concrete at several areas. The weep screed is the metal band at the base of the stucco which has holes to allow the stucco to "breath" and water to "weep" from the stucco. Having the soil above the weep screed can lead to stucco damage due to limited air flow. We recommend a ground clearance of four inches where possible allow for proper drainage and for ventilation of the stucco walls. Dirt in contact with the stucco can promote deterioration, including rot, pest infestation, and water intrusion during rain. We recommend further evaluation and necessary corrections by a qualified licensed contractor.

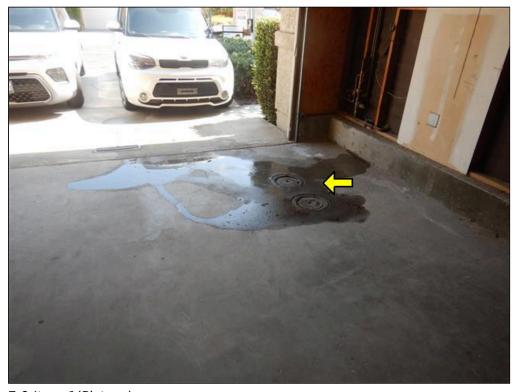
7.0 Item 1(Picture)

(1) Water backed up out of the waste piping in the garage at the time of the inspection. This condition could be caused by a blockage in the main waste pipe. We recommend further evaluation by a licensed plumber prior to the end of your contingency period and necessary repairs made as needed.

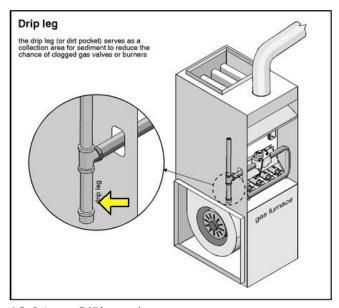
12.0 Item 3(Picture)

- (3) The gas supply pipe at the furnace did not contained a drip leg/ sediment trap. This may have been standard at the time of installation but now is highly recommended. The purpose of a drip leg is to help prevent sediment/ debris from entering and clogging the furnace gas valve which could cause the furnace to shut down. We recommend having a drip leg installed by a qualified licensed HVAC contractor.

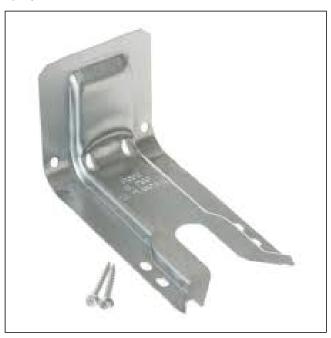
16.4 Item 3(Picture)

(2) An anti tip bracket was not installed at the range. This bracket prevents the range from tipping forward which could cause the range to fall over. We recommend installation of an anti tip bracket by a qualified person for safety and to help prevent injury.
