Inspection Report

Property Address:
1234 Unknown Street
Carlsbad CA 92010

The Property Inspection Pros

Date: 8/23/2016	Time: 01:00 PM	Report ID: 20160823-1234-Unknown Street
Property: 1234 Unknown Street Carlsbad CA 92010	Customer: John Smith	Real Estate Professional: Jesse Salas Harcourts

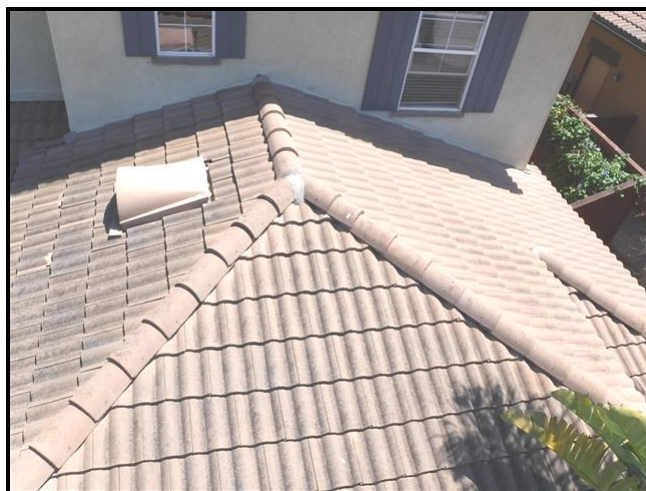
1.0 Item 1(Picture)

The roof shows normal wear for its age and type; appears to be in serviceable condition. However, a slipped roof tile is observed at the right side upper roof area. We recommend necessary corrections by a licensed roof contractor.

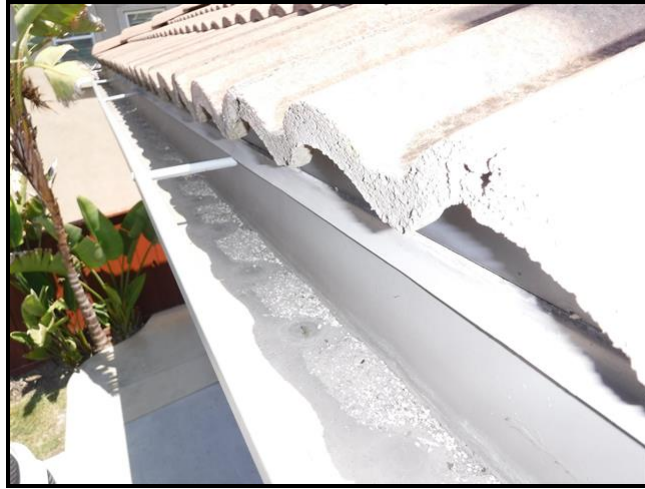
1.2 Item 1(Picture)

Gutters appear intact but due to the lack of recent rain I am unable to determine if the gutters leak at seams or drain properly.

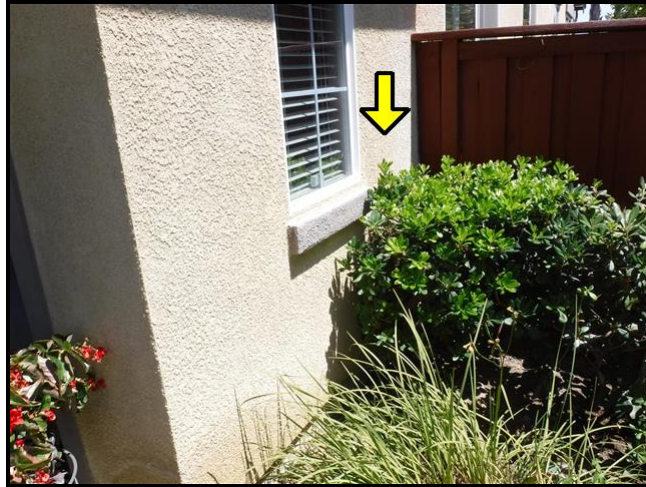
2.1 Item 1(Picture)

(1) Vegetation is in contact with the siding/ stucco at several areas. Vegetation can create moisture problems by preventing siding from drying out. Vegetation also allows rodents to easily access the roof where they can enter through small voids. We recommend removing vegetation from the siding/ stucco. We also recommend referring to the pest control report for their recommendations.

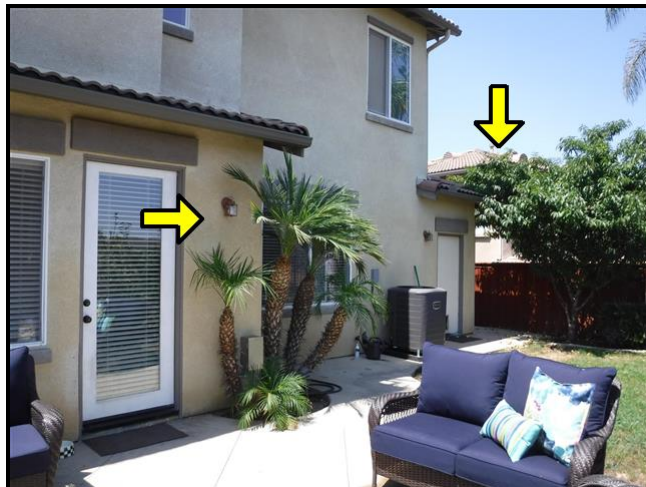
2.1 Item 2(Picture)

(2) Tree(s) and/or large plants are located too close to the house. Tree limbs/vegetation that are too close to the house can cause damage in several ways. Limbs or vines in contact with roof or hanging near roof should be trimmed to prevent damage to roof and/or to prevent rodent infestation. Also, as the plants grow, damage can occur to the siding, concrete flat work and to the foundation. We recommend having the foliage removed or trimmed by a qualified professional to prevent damage to the house as soon as possible.

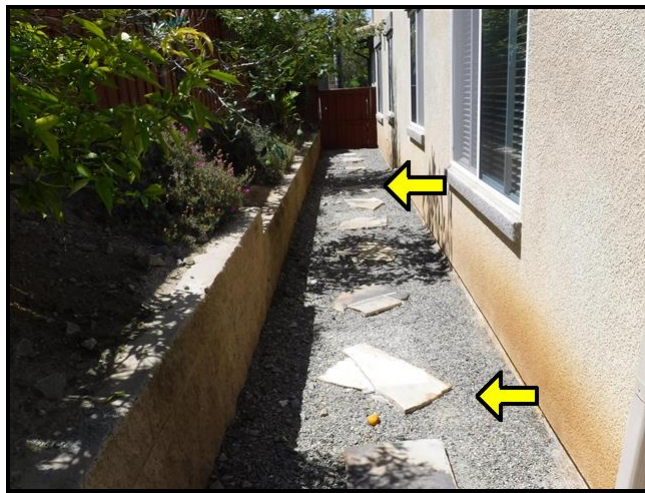
2.2 Item 1(Picture)

(2) Landscape at the right side of the house may require a trench or drain if water stands or puddles after heavy rain. I am unable to determine due to no rain during inspection period. We recommend further evaluation and necessary corrections by a licensed landscape contractor.

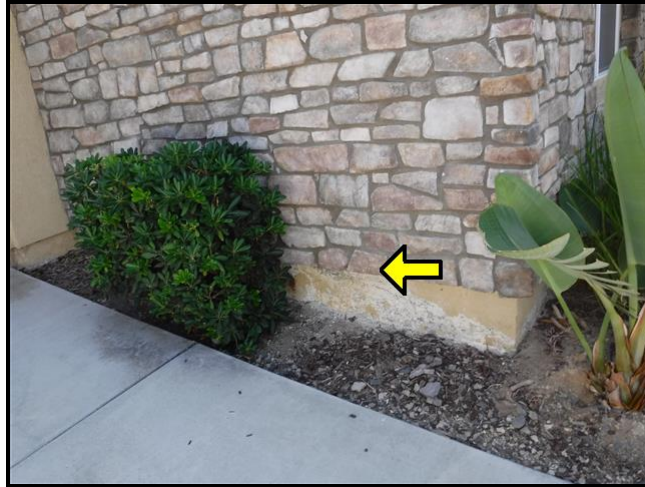
2.3 Item 1(Picture)

(1) Sprinklers appear to be spraying onto the stucco in several areas. Long term exposure to water will deteriorate the stucco. There may already be some damage to the underlayment behind the stucco that is not visible. Determining if there is damage to the underlayment is not possible due to the limited visual nature of a home inspection. We recommend adjusting the sprinklers to spray away from the house, convert the sprinkler heads to a drip system, or create a hardscape zone around the house.

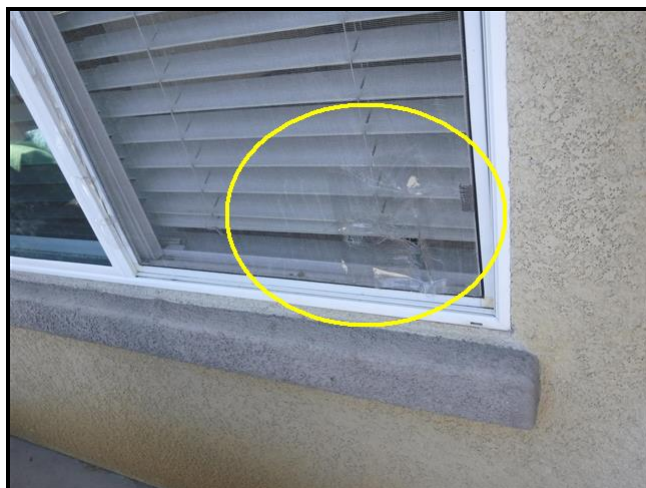
2.6 Item 1(Picture)

(1) There are several window screens that are torn or damaged throughout the house. We recommend repair or replace as needed by a qualified person.

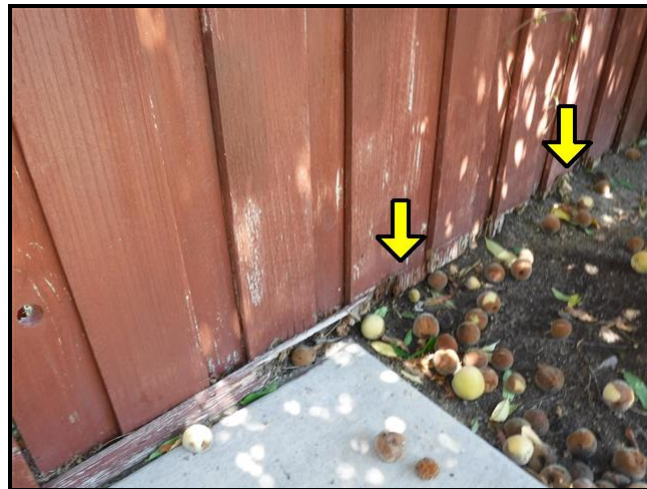
2.9 Item 1(Picture)

The wood fence is damaged at the bottom at several areas. We recommend necessary repairs or replacing as needed by a licensed fence contractor.

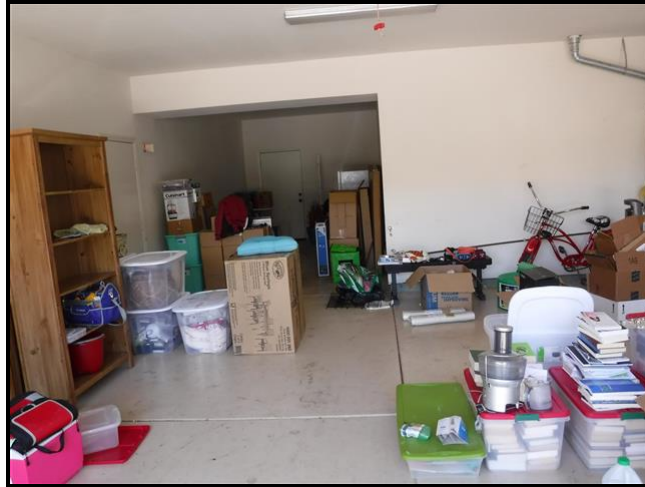
3.3 Item 1(Picture)

Due to occupants personal items, not all areas of the garage were visible. We recommend a careful evaluation of the entire garage during your final walk-through. If any damage is observed we recommend asking the seller about it. We recommend that any damage found be repaired or replaced by a qualified licensed contractor in the appropriate trade.

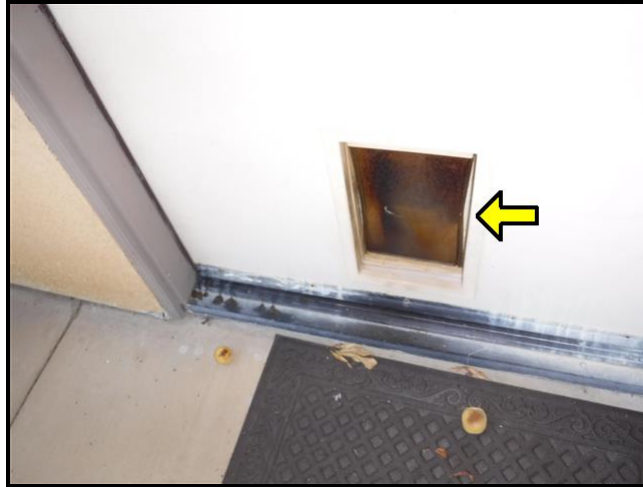
3.5 Item 1(Picture)

A pet door is present at the exterior garage door. These modifications can cause damage to the door by letting in rain. These modifications can also reduce the security of the door by making it easier for someone to enter or reach inside and unlock the door. We recommend sealing the door or replacing the door by a qualified person

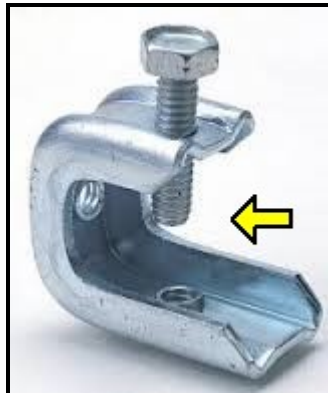
5.1 Item 1(Picture)

A damper clamp is not installed at the family room fireplace damper door. A damper clamp is required to be installed at a damper door when there is a gas supply to the fireplace(s). This damper clamp help prevents the damper from closing all the way as a safety precaution. If the damper is closed, Carbon Monoxide gas could enter the living space easier which is undetectable. SDG&E now requires damper clamps at all fireplaces damper doors. We recommend installation of a damper clamp by a qualified person.

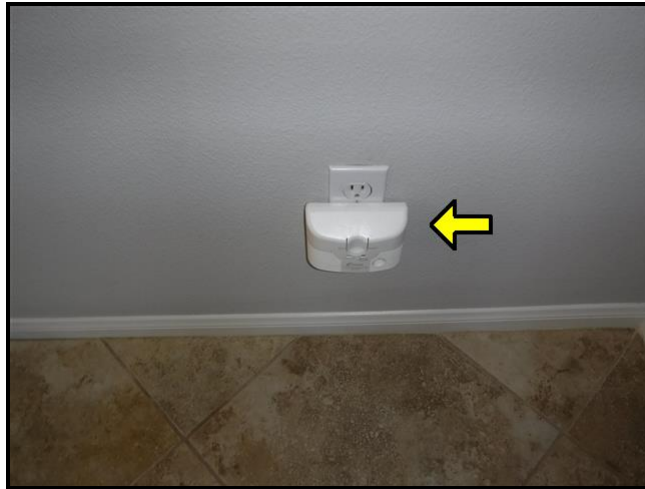
6.1 Item 1(Picture)

This house has a Carbon Monoxide detector installed as required. The CO detector was tested and operated when tested at the time of the inspection.

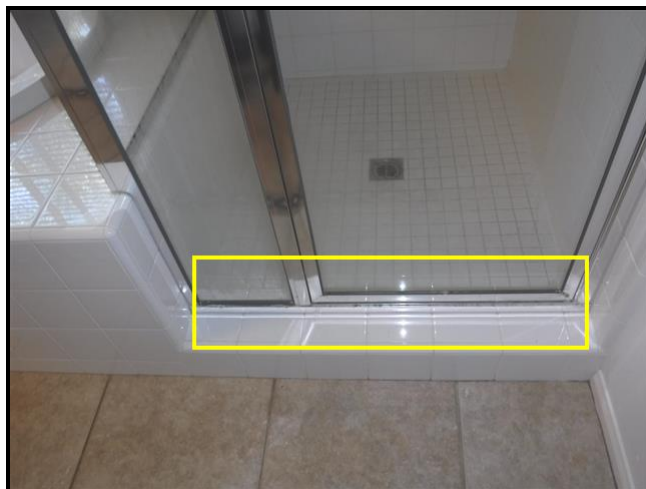
7.3 Item 1(Picture)

Corrosion is noted at the master shower doors. We recommend cleaning or replacing the doors by a qualified person.

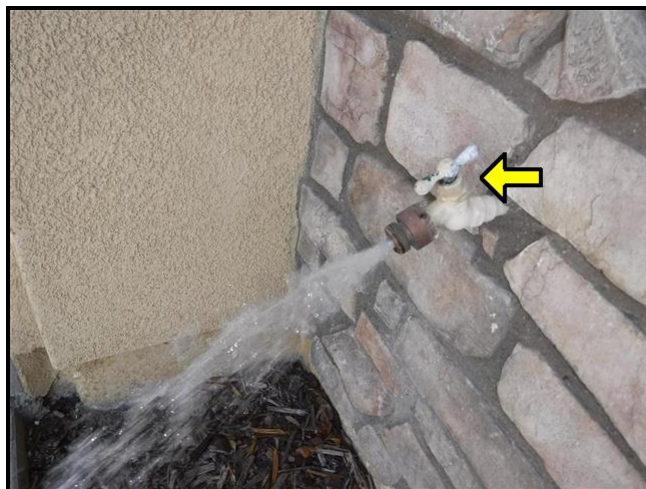
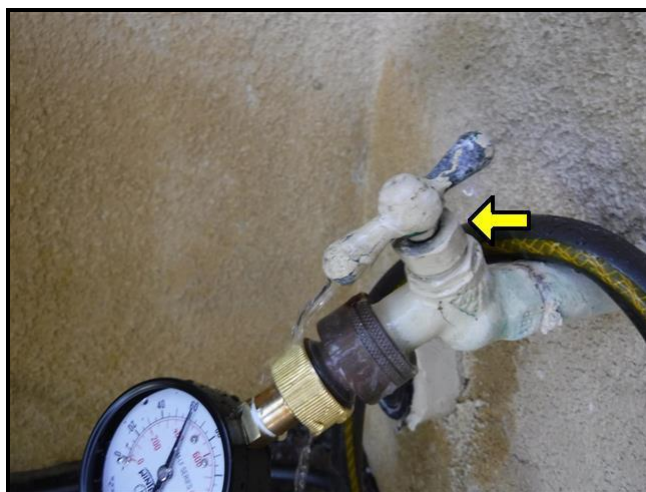
7.6 Item 1(Picture)

The front and rear hose spigot handles leak when turned on. We recommend necessary repairs or replacement by a qualified licensed plumber.

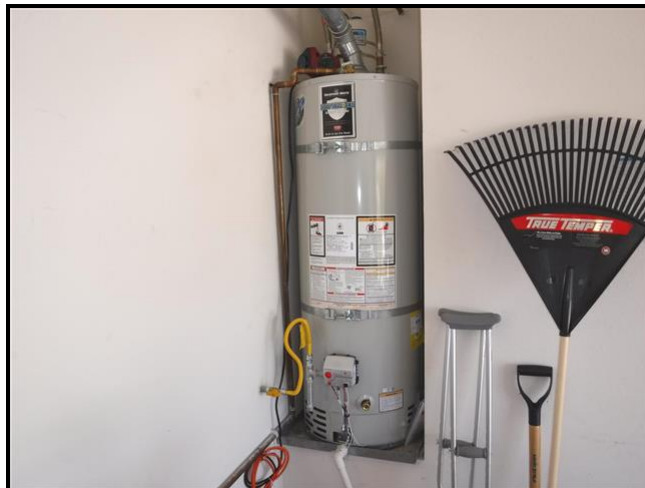
8.0 Item 1(Picture)

(1) The water heater was inspected and was found to be operational at the time of the inspection. We did not evaluate the efficiency or recover rate of the water heater which is beyond the scope of a general home inspection. If concerned we recommend you consult a licensed plumber. We recommend flushing the water heater routinely flushed as regular maintenance.

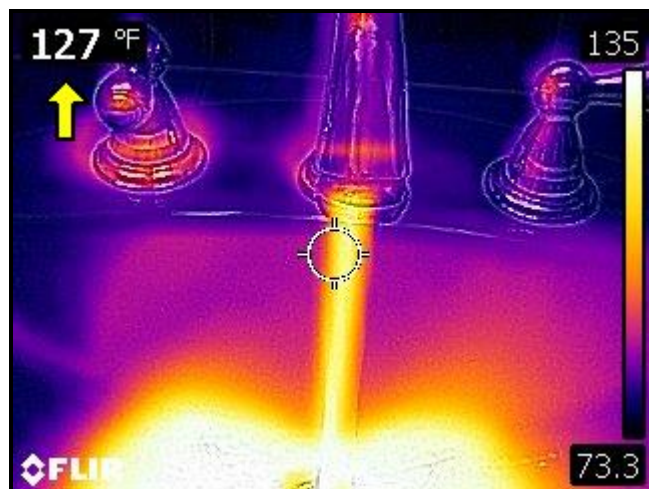
8.0 Item 2(Picture)

(2) The temperature of the water was tested using a thermal camera at the time of the inspection and found to be above 125 degrees. Water temperatures above 125 degrees can cause scalding or burns. We recommend setting the water heater controls at 120 degrees for optimum efficiency.

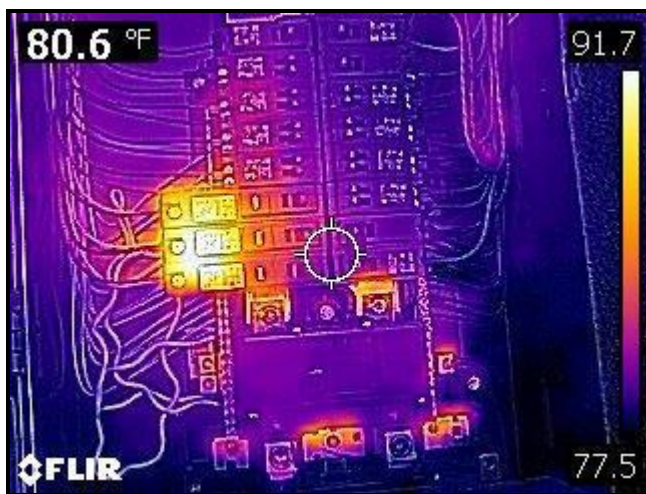
9.2 Item 1(Picture)

Picture inside of the main electrical panel. The dead front cover was removed at the time of the inspection and the breakers, wiring and grounding were inspected. Appears to be functioning as intended.

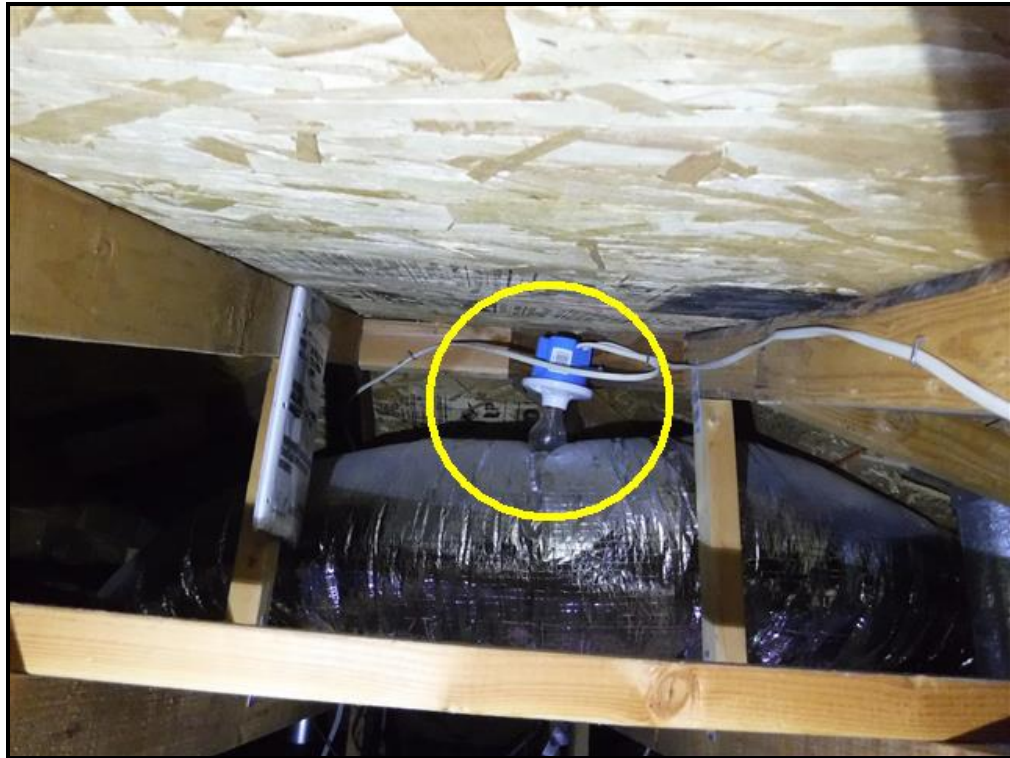
9.4 Item 1(Picture)

The light in the attic space is in direct contact with a duct. This is a potential fire hazard. We recommend necessary corrections by a qualified person.

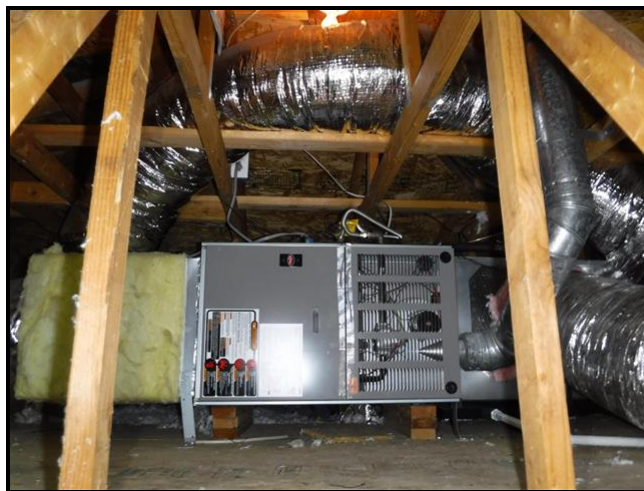
10.0 Item 1(Picture)

(1) Picture of the furnace.

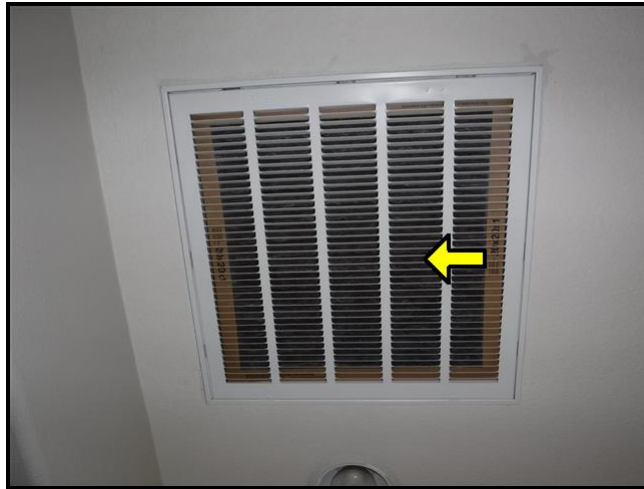
10.3 Item 1(Picture)

The air filter for the HVAC system is dirty. We recommend recommend replacing by a qualified person.

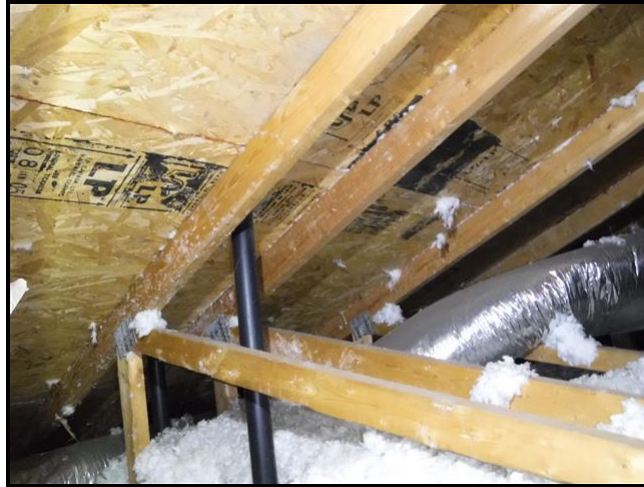
12.0 Item 1(Picture)

At the time of the inspection, the Inspector observed no visual defects in the condition of the homes structure. A general home inspection does not include the evaluation of any structural components that are hidden behind floors, walls, or ceiling coverings. Such as anchor bolts, shear walls and seismic hardware, but is visual and non-invasive only.

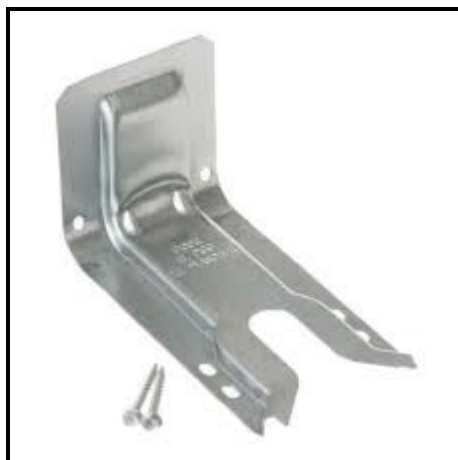
14.2 Item 1(Picture)

(1) An anti tip bracket was not installed at the range. This bracket prevents the range from tipping forward which could cause the range to fall over. We recommend installation of an anti tip bracket by a qualified person for safety and to help prevent injury.

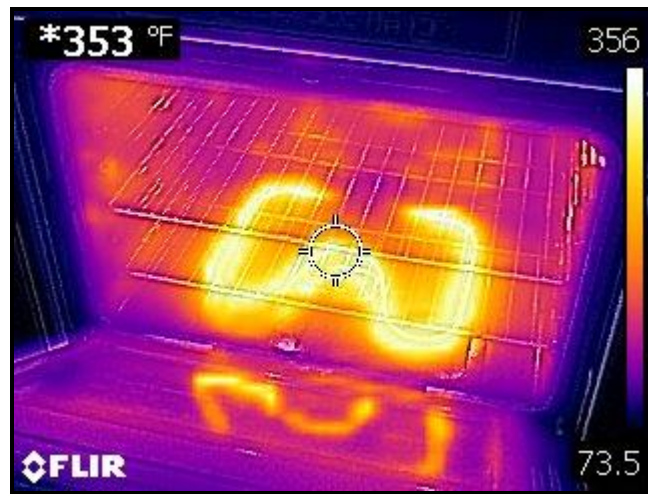
14.2 Item 3(Picture)

(2) The oven was tested and was functional at the time of the inspection. This test is not exhaustive and does not confirm the performance, accuracy, or effectiveness of the oven.

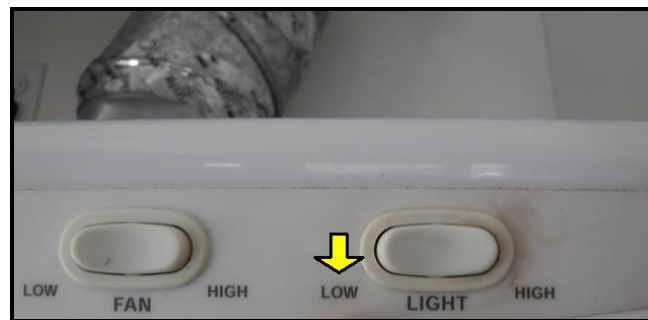
14.3 Item 1(Picture)

The low light level at the exhaust range hood did not work when tested. We recommend necessary repairs or replacement.

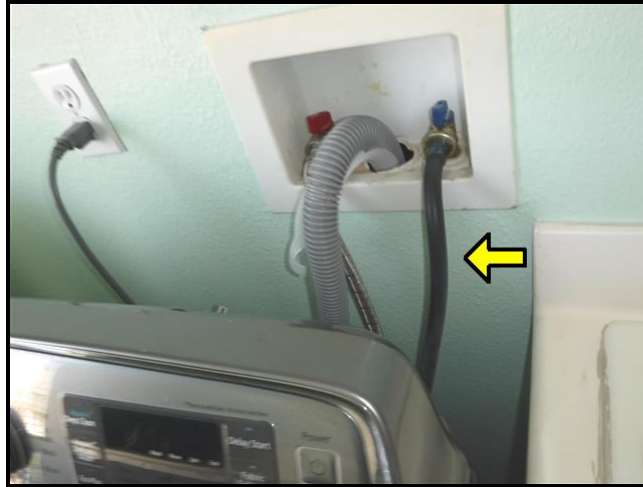
14.6 Item 1(Picture)

(2) Washer hoses are a common source of flooding in a home. Prior to connecting the washing machine we recommend installing new braided steel washer hoses to help reduce leaks caused by failed hoses. If any hoses are left in the house they should be replaced. The washing machine and dryer are not part of our general home inspection.

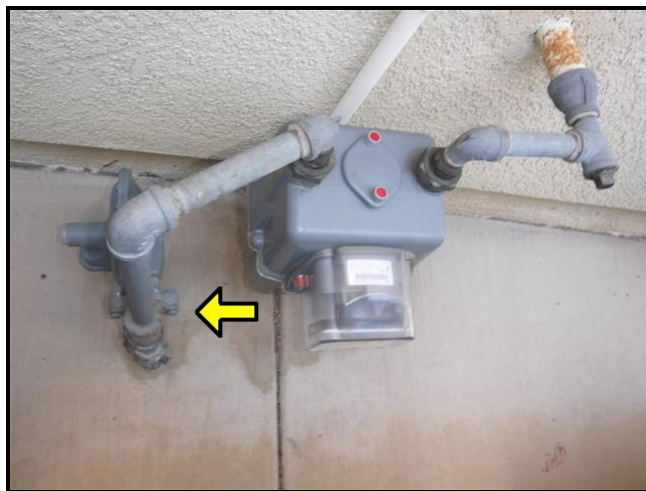
15.0 Item 1(Picture)

The main gas shut off valve is located at the gas meter at the left exterior side of the house (facing front).

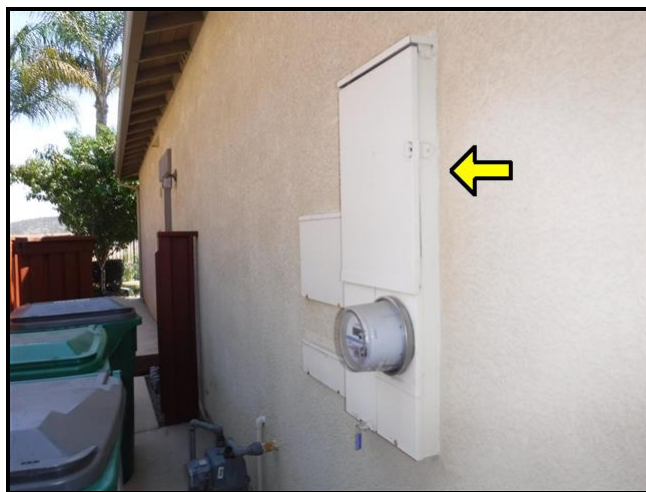
15.1 Item 1(Picture)

The Main Electrical Panel is located at the left exterior side of the house (facing front).

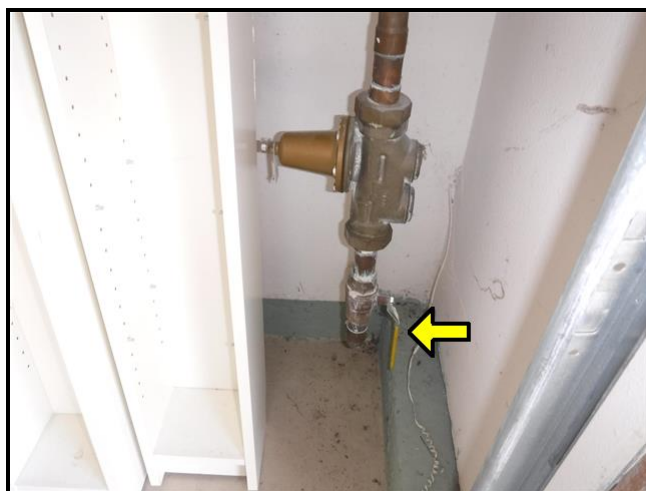
15.2 Item 1(Picture)

The main water shut off valve is located in the garage.
