Inspection Report

Property Address:
321 Main Street
San Marcos CA 92078

The Property Inspection Pros

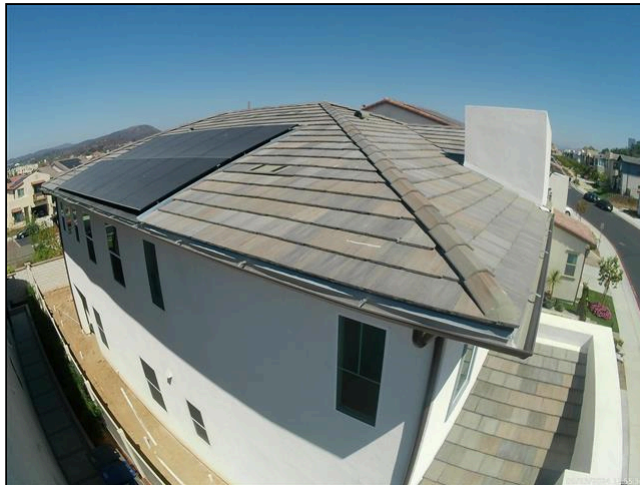
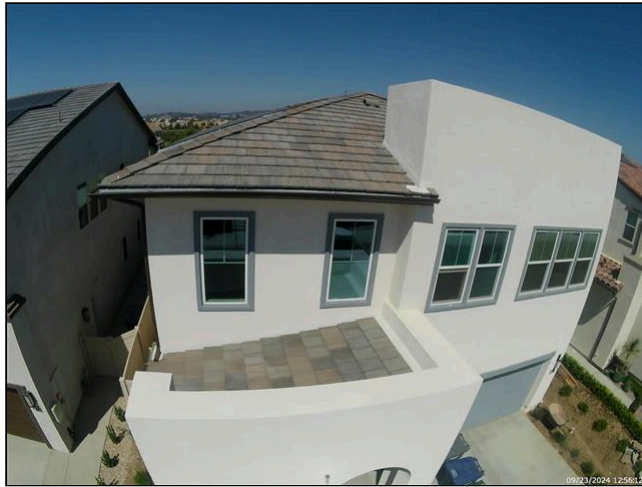
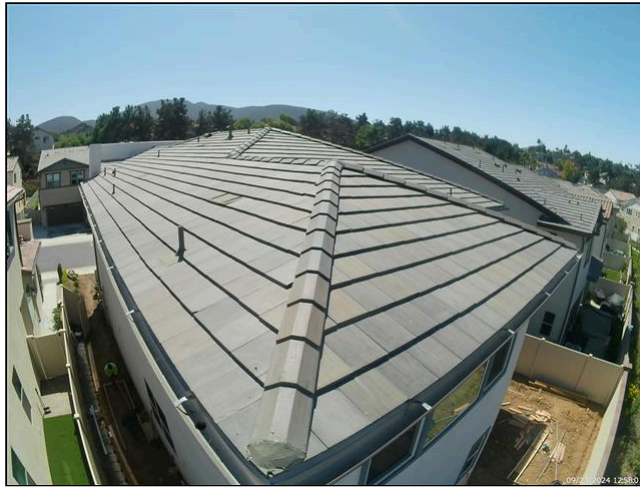
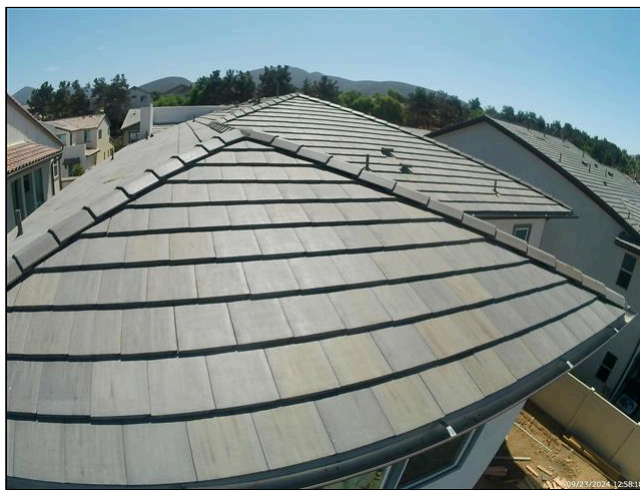
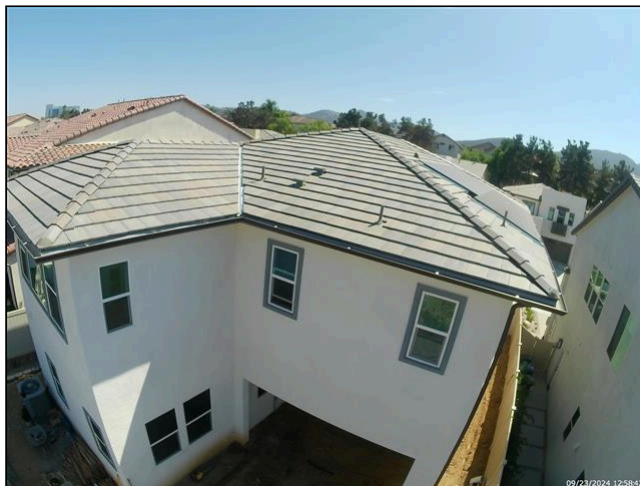
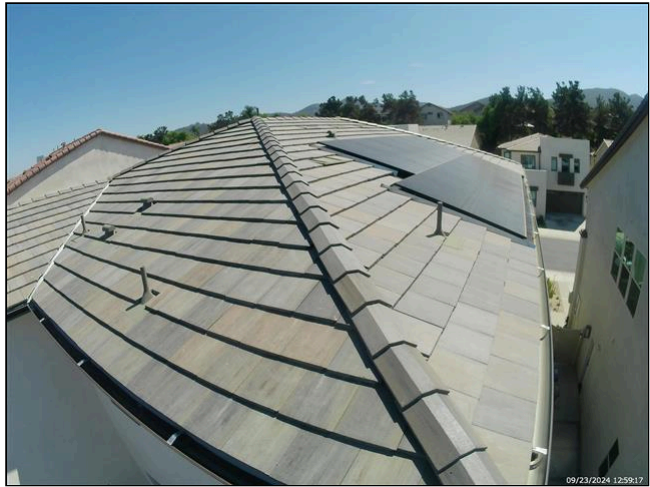
1.1 Item 1(Picture)

Comments:
 (1) **Photo(s) of the roof.**

(2) The roof covering was inspected from the ground, windows, attic and remotely with the use of a pole-mounted camera to avoid damaging the roof covering and possibly voiding any manufacture warranties and safety for the inspector. This is not a comprehensive inspection of the roof and is in accordance with the InterNACHI standards of practice we follow. All of the flashings and/pipe penetrations were not fully visible from our vantage point. I cannot guarantee that all of the pipe penetrations and flashings are in good condition. If you want a more comprehensive roof inspection, we recommend that you have the roof inspected by a licensed roof contractor prior to the end of your contingency. Be advised that a licensed roof contractor with the added benefit of walking the roof may find additional defects not listed in this report.

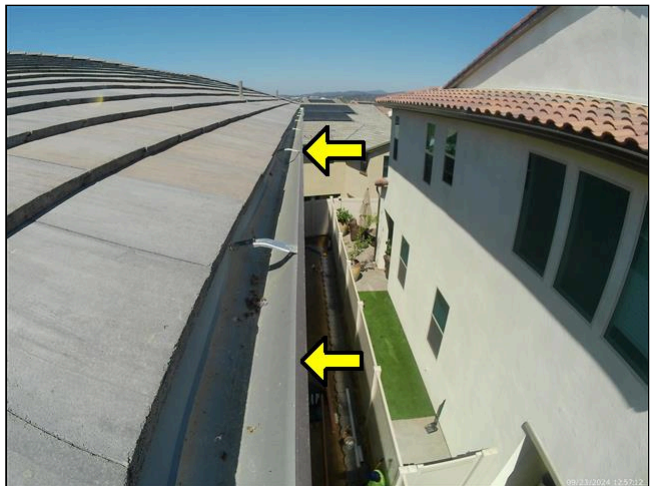
1.3 Item 1(Picture)

Gutters appear intact but due to the lack of recent or current rain I am unable to determine if the gutters leak at seams or drain properly.

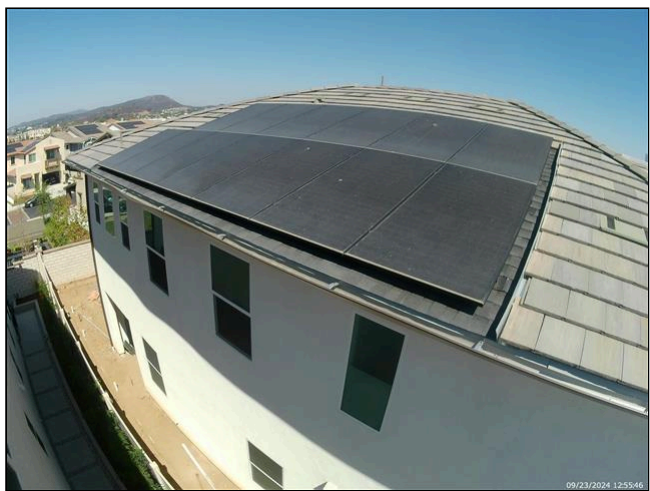
1.5 Item 1(Picture)

The electric solar system and its related components are beyond the scope of the home inspection and was not inspected. We recommend verifying that the electric solar system is operational prior to the end of your contingency period.

We also recommend having all the solar panels cleaned by a qualified person.

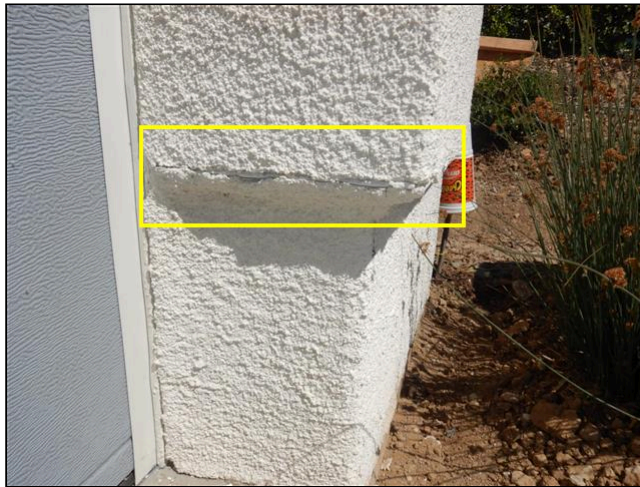
2.3 Item 1(Picture)

(1) Hairline cracking was observed at the stucco at several areas. The cracks are less than 1/8 inch in width, and generally considered common in this material. These cracks should be caulked and painted where possible. If cracks increase in width, it may indicate that structural movement is occurring. Determining this is beyond the scope of a home inspection.

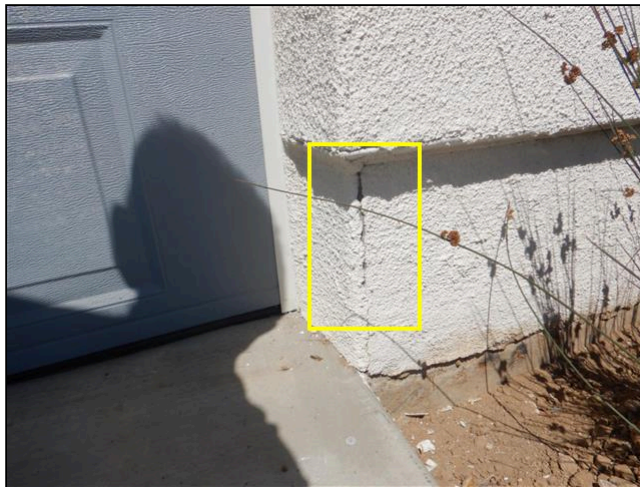
2.3 Item 2(Picture)

(2) The stucco skim-coat is deteriorating in areas around the foundation stemwall. This is typical cosmetic damage. If concerned we recommend necessary repairs by a licensed qualified contractor.

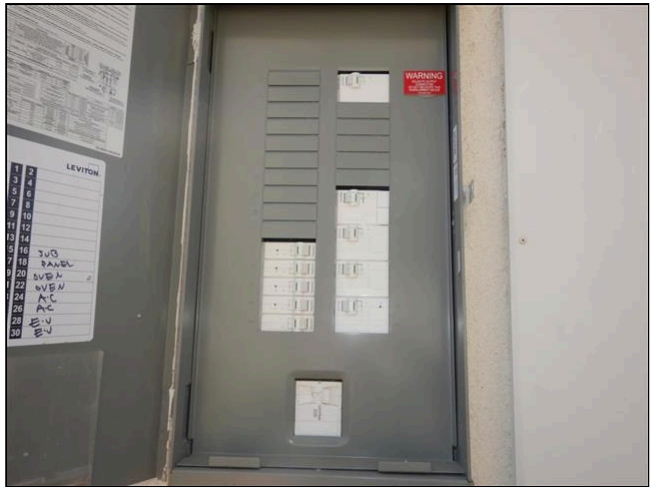
3.0 Item 1(Picture)

- (1) **Photo of the main electrical panel.**

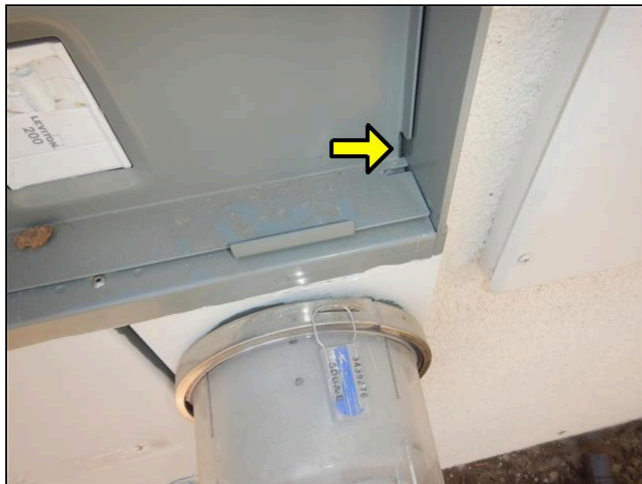
3.0 Item 2(Picture)

(2) The dead front cover screw is missing from the main electric panel. We recommend installing screw(s) where needed by a qualified person for safety.

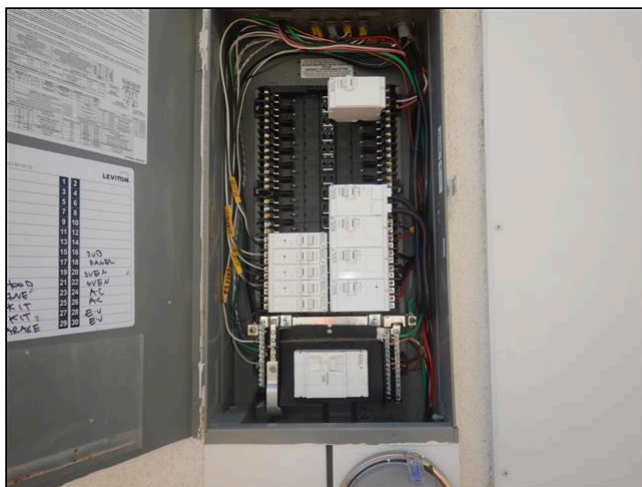
3.2 Item 1(Picture)

(1) [Photo inside of the main electrical panel.](#)

The dead front cover was removed at the time of the inspection and the breakers, wiring and grounding were inspected. Appears to be functioning as intended.

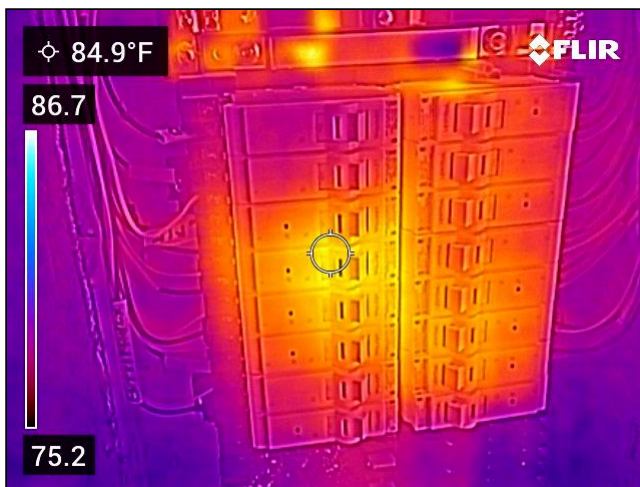
3.2 Item 3(Picture)

(2) **Photo inside of the sub electrical panel.**

The dead front cover was removed at the time of the inspection and the breakers, wiring and grounding were inspected. Appears to be functioning as intended.

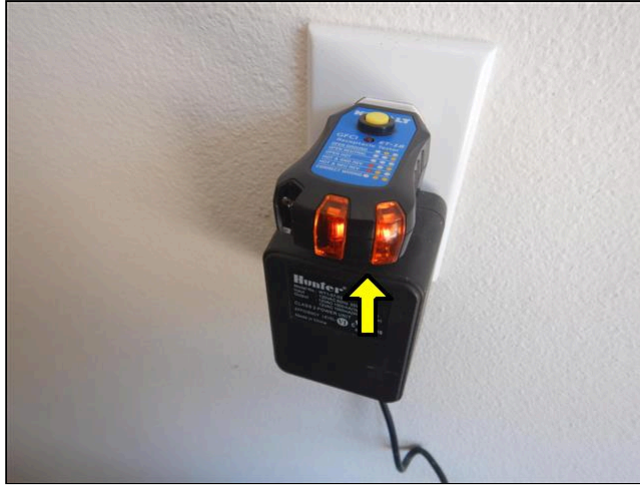
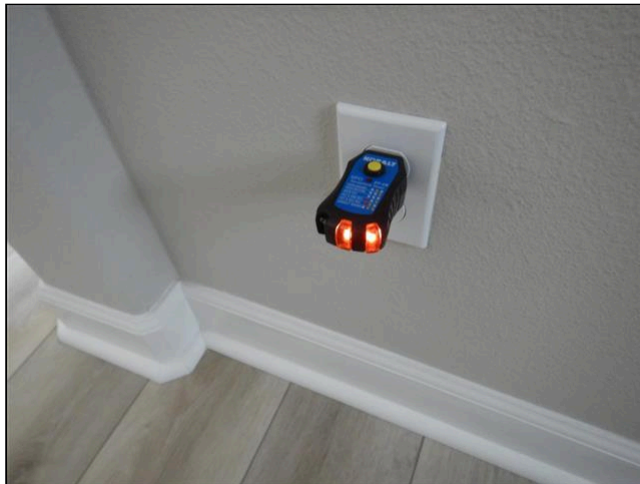
3.7 Item 1(Picture)

Photo of a receptacle being tested.

A representative number of receptacles throughout the property were tested for power, polarity and grounding according to our standards-of-practice. These receptacles observed to be ok at the time of the inspection unless otherwise noted.

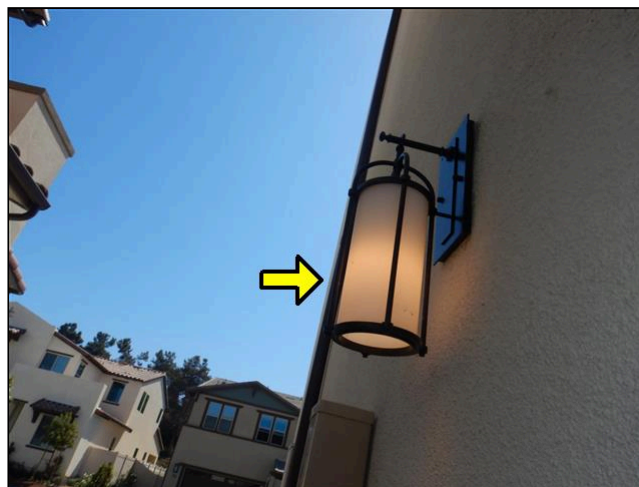
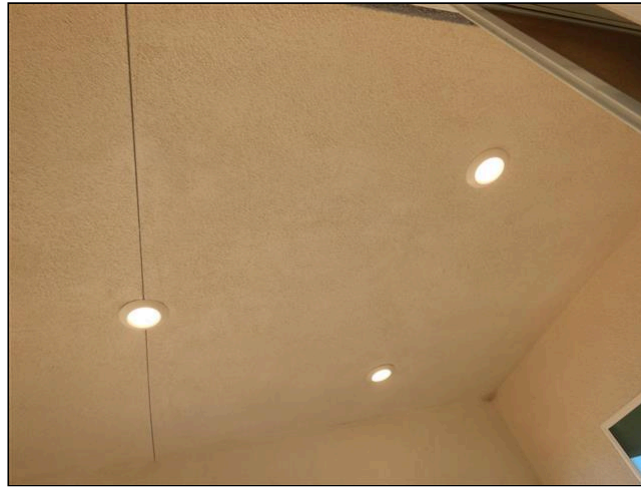
3.13 Item 1(Picture)

A representative number of exterior lights were tested and were found to be functional at the time of the inspection.

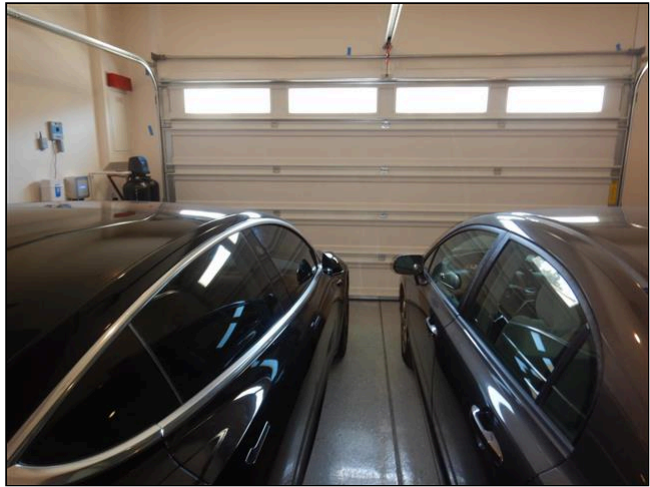
4.0 Item 1(Picture)

[Garage door photo\(s\).](#)

The garage vehicle door hardware including the door, track, and springs appear to be functioning as intended.

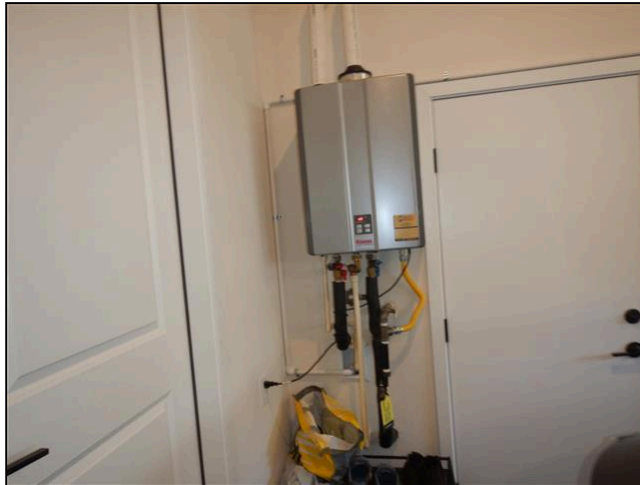
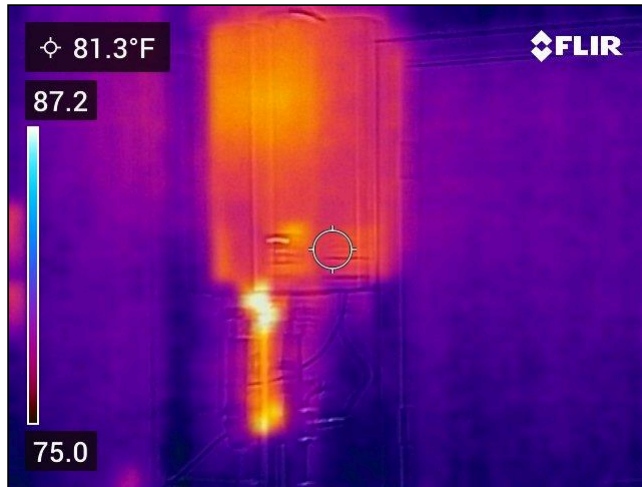
5.0 Item 1(Picture)

- (1) [Photo of the water heater.](#)

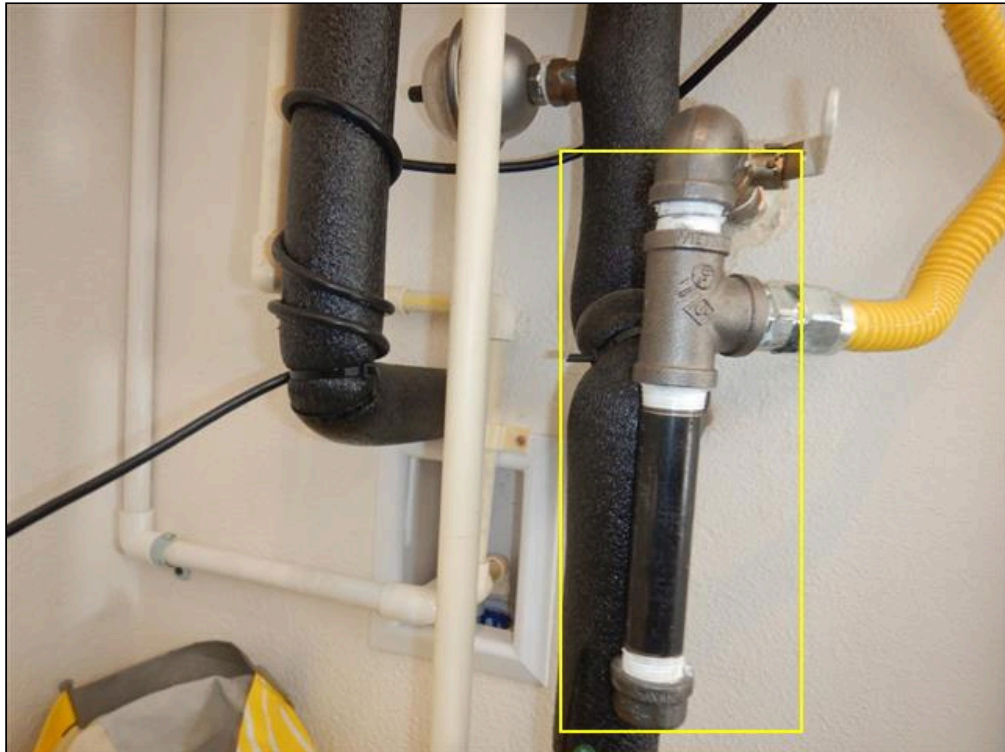
5.0 Item 3(Picture)

(4) The water heater gas pipe fittings appear to have white teflon tape installed on them. This is non standard. White teflon tape is intended for use on water pipe fittings. We recommend necessary corrections by a qualified licensed plumber.

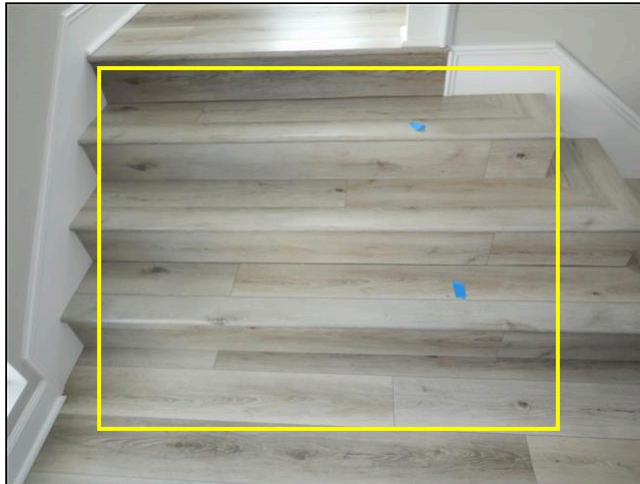
6.6 Item 1(Picture)

Several interior steps squeak when walked on. We recommend necessary corrections by a qualified licensed contractor.

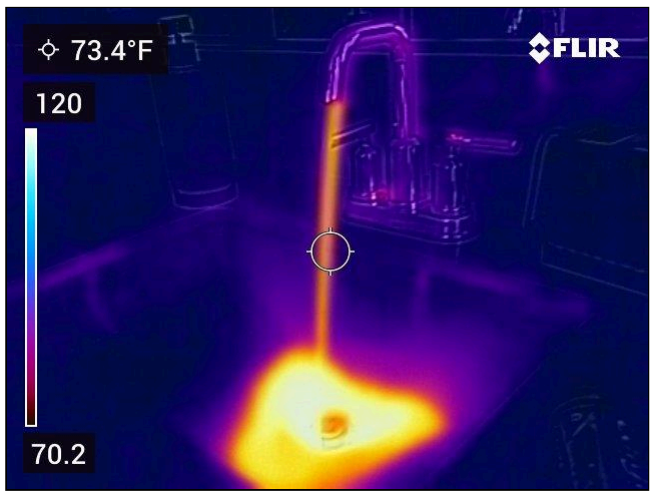
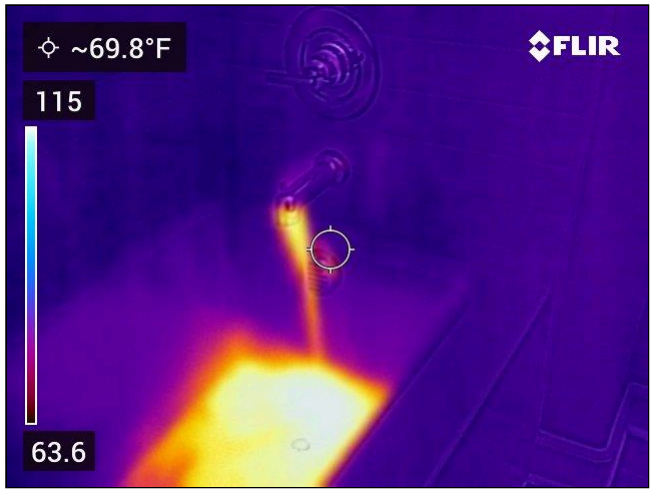
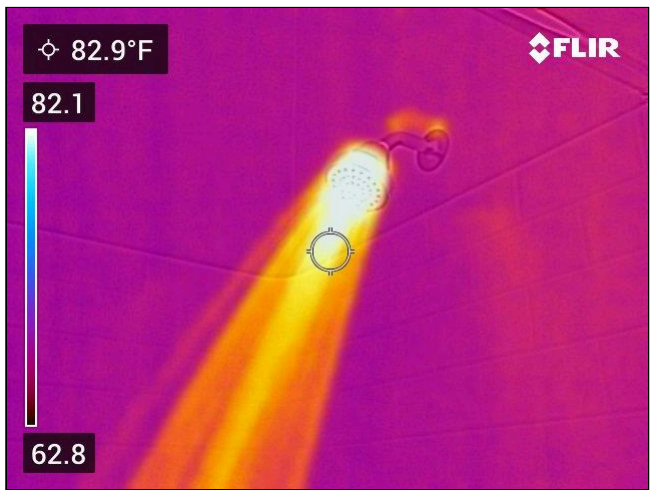
6.7 Item 1(Picture)

(1) [Infrared Camera Thermal Photos.](#)

(2) An infrared (thermal imaging) scan was performed throughout the property at the time of the inspection using a hand held infrared (thermal imaging) inspection camera. No anomalies were found at the time of the inspection using this camera.

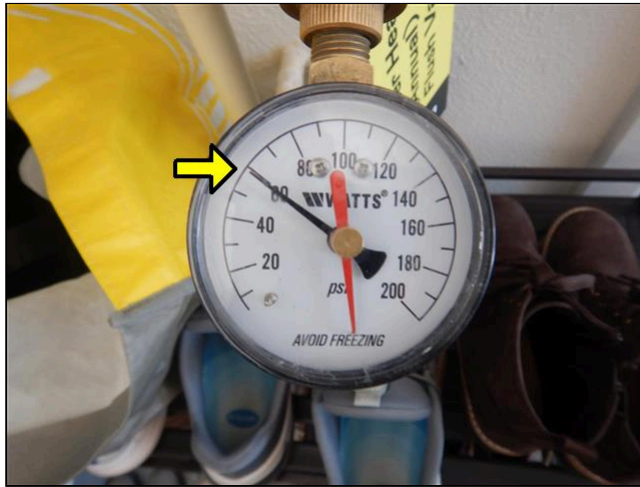
7.2 Item 1(Picture)

The water pressure was checked with a water pressure gauge and was measured and was found to be within the acceptable range at the time of the inspection.

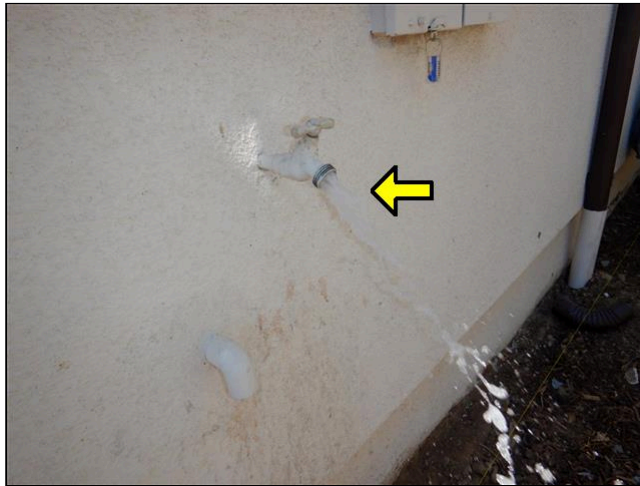
7.3 Item 1(Picture)

(1) The accessible hose spigots were tested and were found to be operational at the time of the inspection. Note: Some hose spigots may leak or drip when a watering hose is connected due to back pressure.

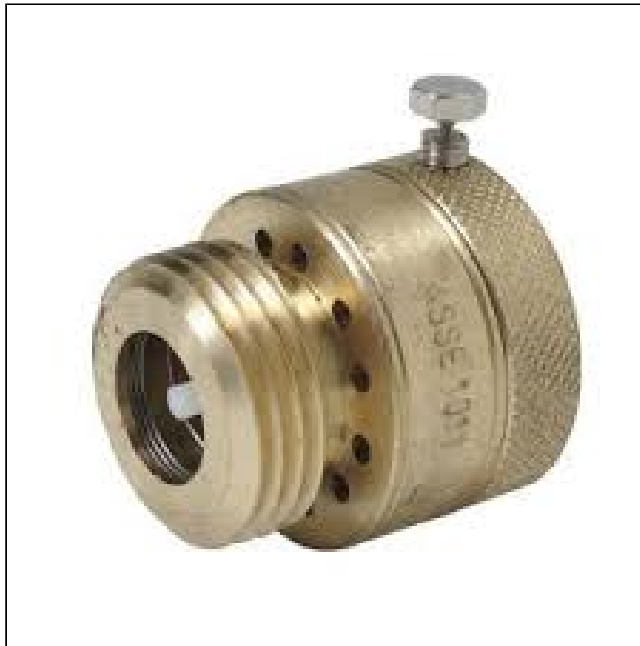
7.3 Item 2(Picture)

(2) Some of the exterior hose spigots do not have anti-siphon or anti-backflow devices installed on them. These anti-siphon or anti-backflow devices help prevent contaminated water from flowing back into the the house water supply system. We recommend installing anti-siphon or anti-backflow devices where needed by a qualified person.

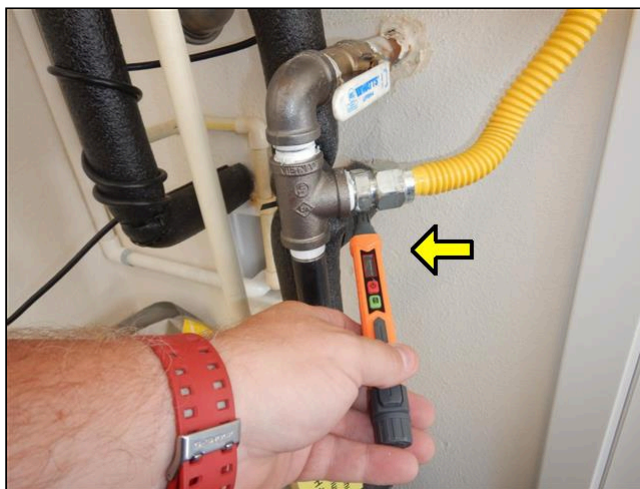
7.4 Item 1(Picture)

A gas leak test was conducted at accessible gas fittings and appliances using a gas leak detector. There were no gas leaks detected at the time of the inspection.

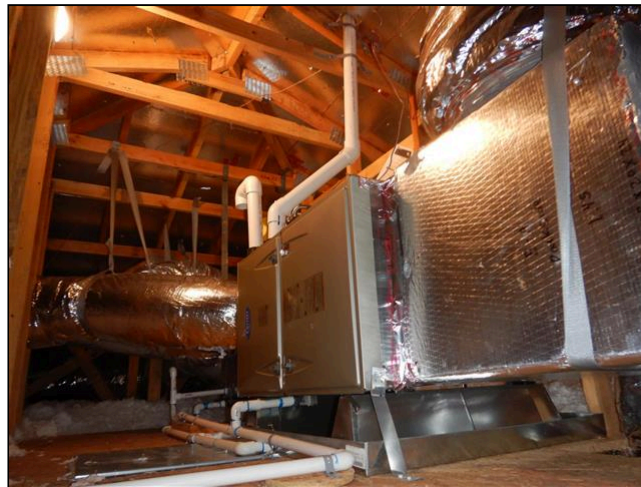
11.0 Item 1(Picture)

(1) The furnace was tested and was functional/ operated at the time of the inspection.

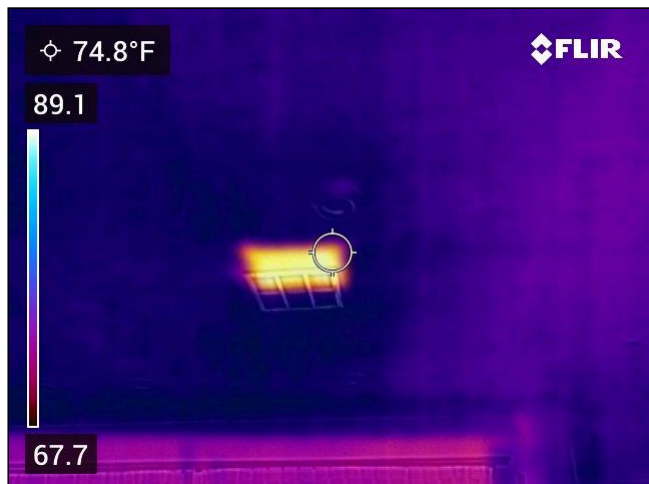
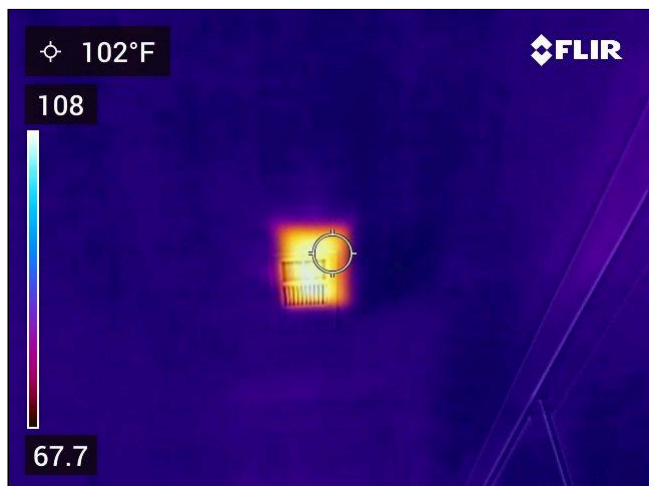
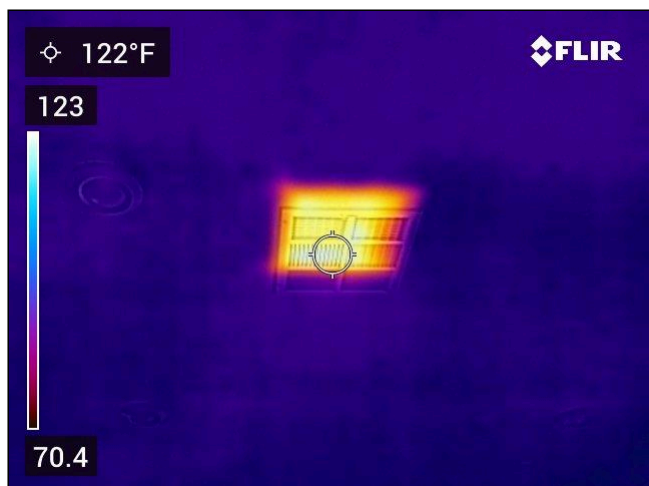
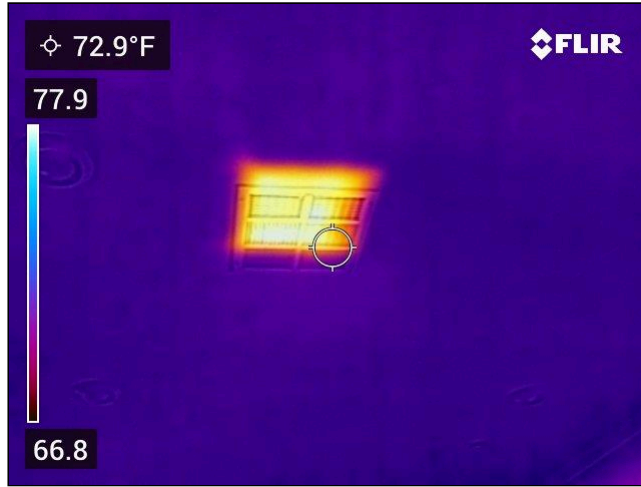
11.0 Item 2(Picture)

(2) Infrared Thermal photo of the furnace(s) being tested.

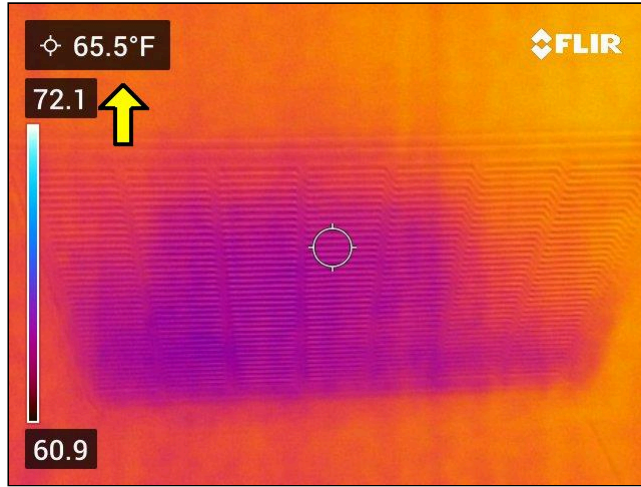
12.0 Item 1(Picture)

The air returning to the system (return) was measured at **70 degrees**.

This indicates that the range in temperature drop is normal. This is not an exhaustive test and cannot predict the performance of the AC systems on extremely hot or humid days.

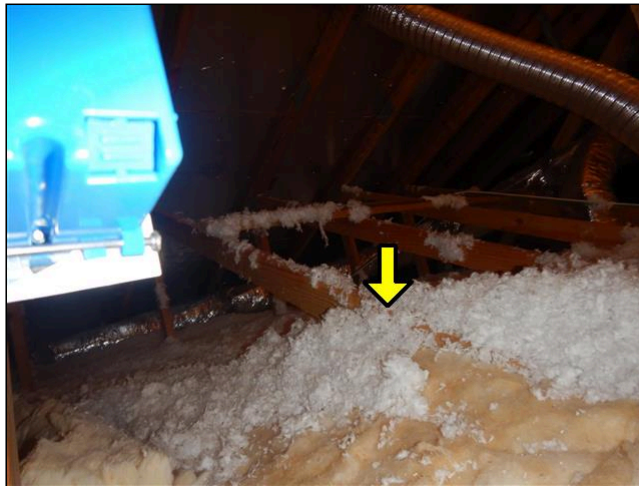
13.0 Item 1(Picture)

- (1) **Photo of the insulation.**

- (2) The insulation in the attic appears to be functioning as intended.

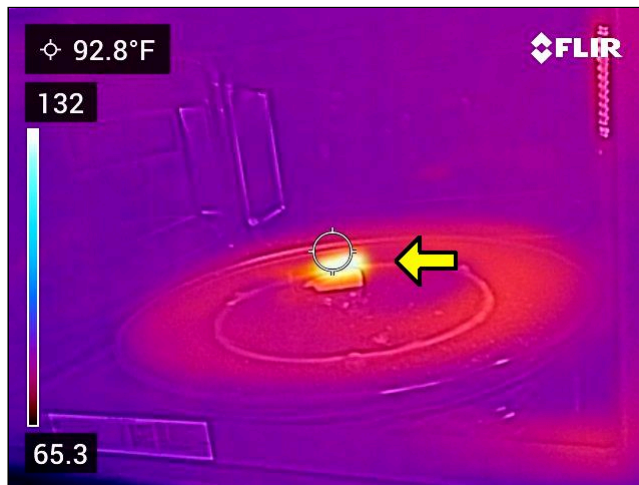
15.0 Item 1(Picture)

Photo of microwave being tested.

The built in microwave was tested with a microwave testing device and was functional at the time of the inspection. This is not an exhaustive test, and does not predict the performance of the microwave.

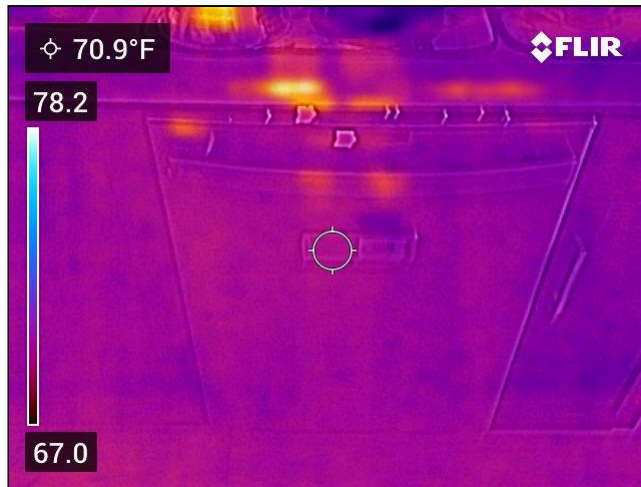
15.1 Item 1(Picture)

Infrared Thermal photo of the dishwasher being tested.

The dishwasher was tested and functioned properly at the time of the inspection. This is not an exhaustive test and does not verify the cleaning efficiency of the dishwasher.

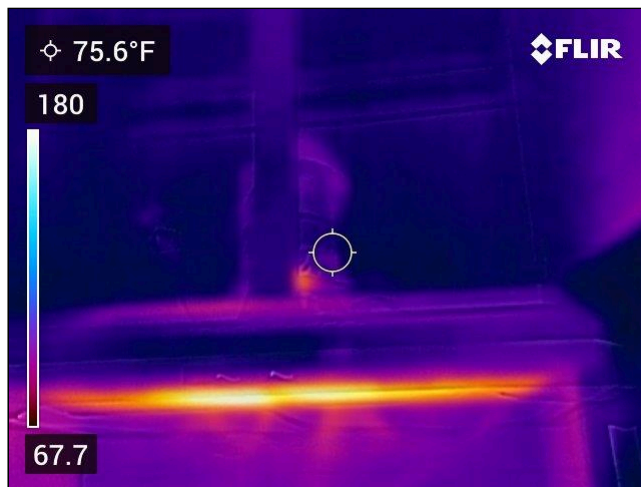
15.3 Item 1(Picture)

The range exhaust vent was tested and was functional at the time of the the inspection. This is not an exhaustive test, and does not evaluate the performance or effectiveness of the unit.

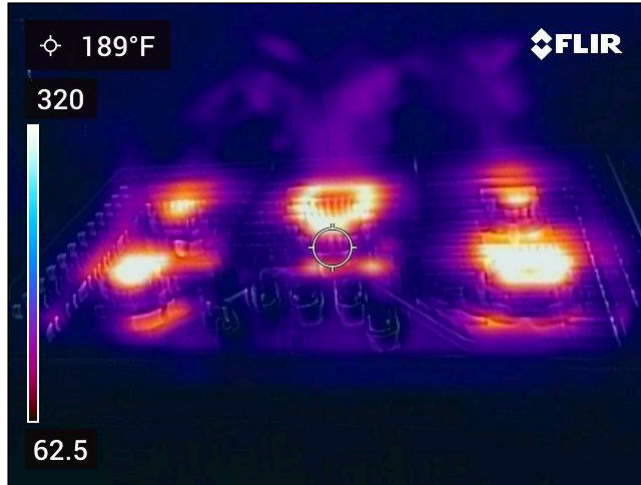
15.4 Item 1(Picture)

Infrared Thermal photo of the cooktop being tested.

The cooktop was tested and was functional at the time of the inspection. This test is not exhaustive and does not confirm the performance, accuracy, or effectiveness of the cooktop.

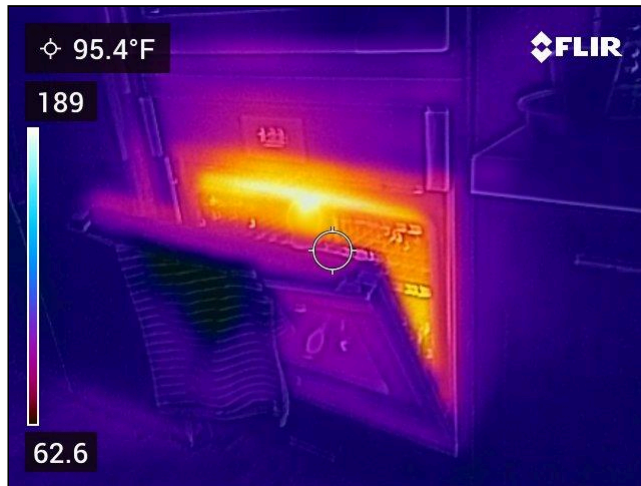
15.5 Item 1(Picture)

Infrared Thermal photo of the wall oven(s) being tested.

The wall oven was tested and was functional at the time of the inspection. This test is not exhaustive and does not confirm the performance, accuracy, or effectiveness of the wall oven.

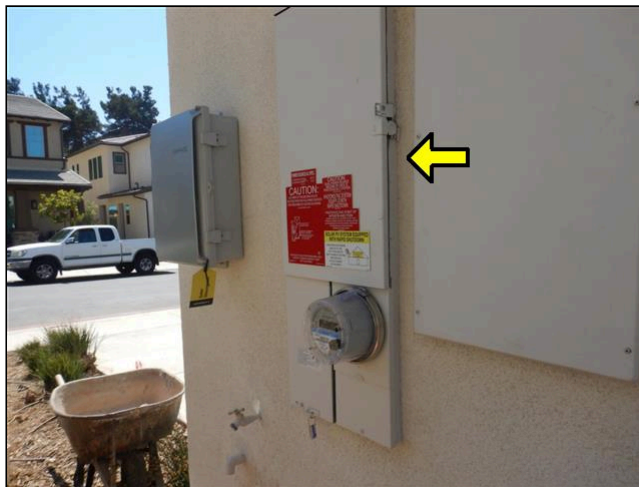
16.1 Item 1(Picture)

The Main Electrical panel is located at the right exterior side of the property (facing front).

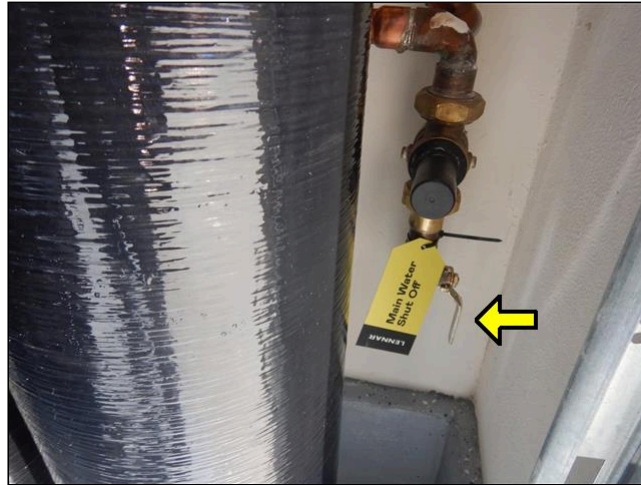
16.2 Item 1(Picture)

The main water shut off valve is located in the garage.

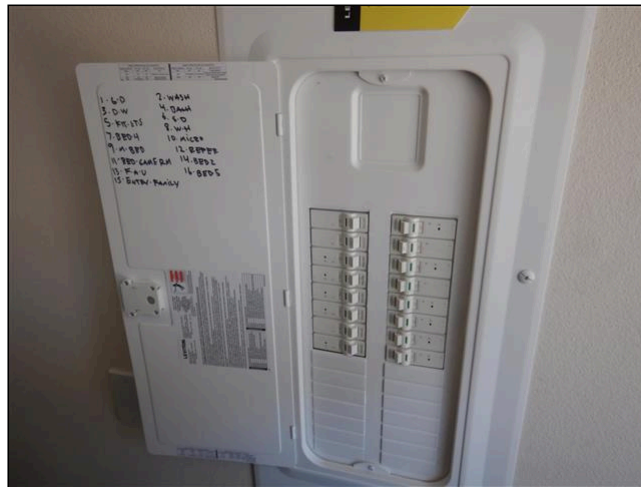
16.3 Item 1(Picture)

The sub-panel is located in the garage.
