Inspection Report

Property Address:
1241 Main Ct
Menifee CA 92584

The Property Inspection Pros

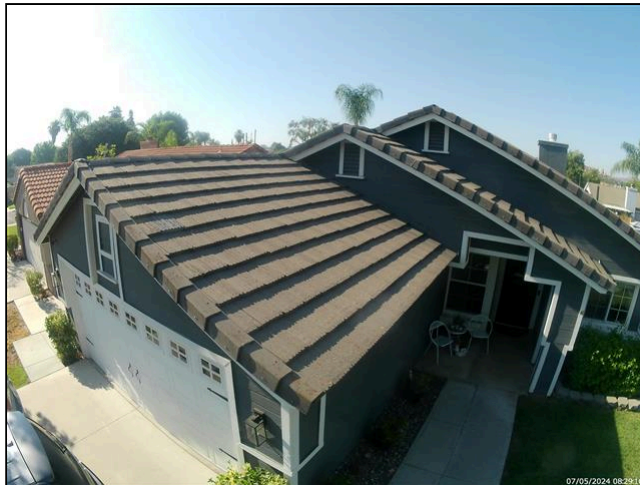
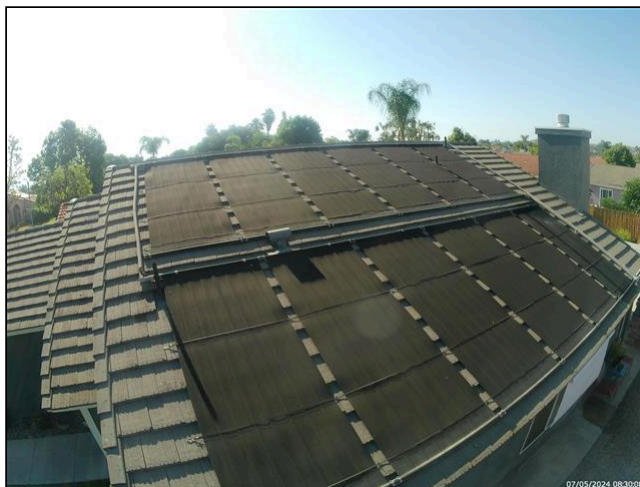
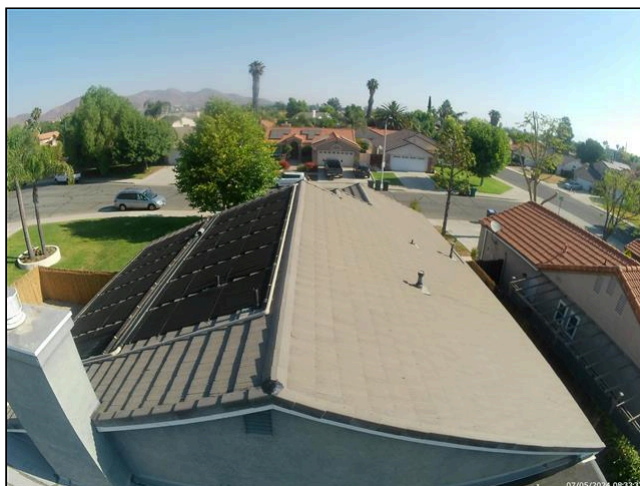
1.1 Item 1(Picture)

Comments:
 (1) **Photo(s) of the roof.**

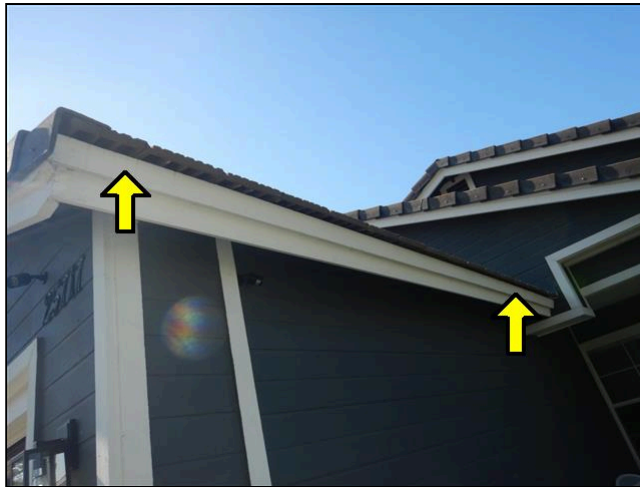
1.2 Item 1(Picture)

Drip edge flashing was not installed at the roof. Lack of roof drip edge flashing leaves the edges/eaves of roof sheathing, fascia and underlayment exposed to potential moisture damage from wood decay and/or delamination. We recommend having drip edge flashing installed by a licensed roof contractor.

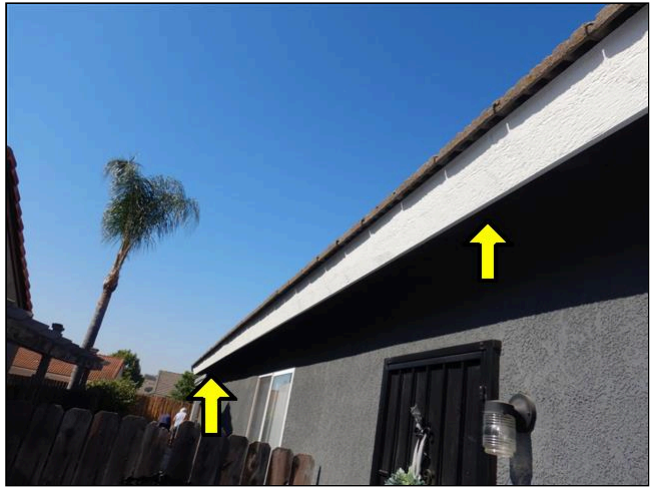
1.3 Item 1(Picture)

Gutters, downspouts and drain lines are not installed. We recommend installing gutters and downspouts to prevent erosion or water intrusion around the house by diverting run off away from the house by a qualified licensed contractor.

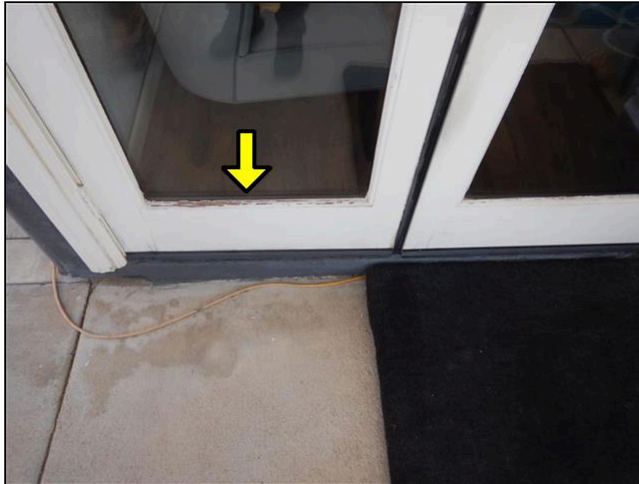
2.5 Item 1(Picture)

Paint is worn and failing at the wood doors at several areas. We recommend prep and

paint as needed to protect the siding and trim by a qualified paint contractor.

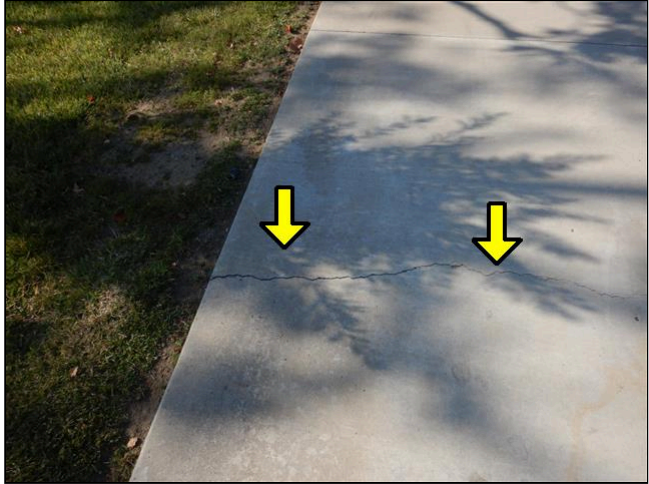
2.8 Item 1(Picture)

(1) There is a crack in the concrete driveway. We recommend necessary repairs by a licensed concrete contractor.

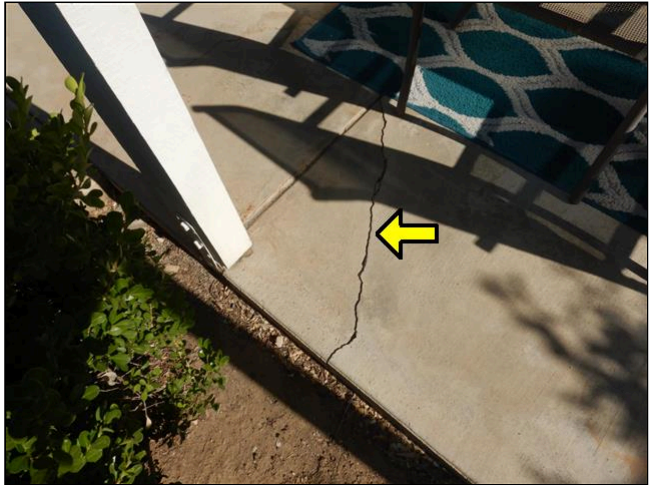
2.8 Item 2(Picture)

(2) There are several cracks in the concrete patio. We recommend necessary repairs by a licensed concrete contractor.

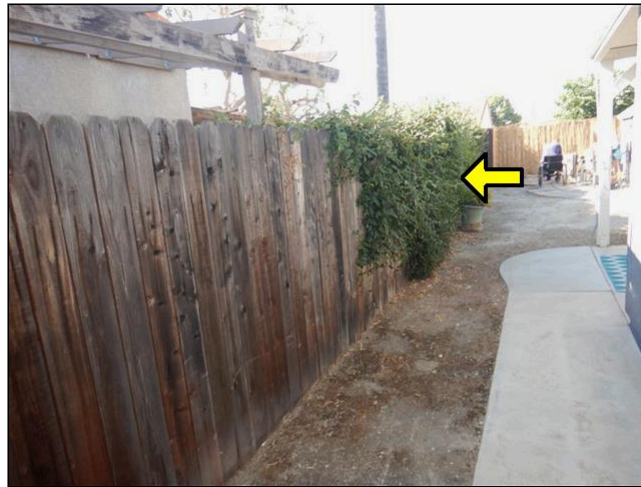
2.10 Item 1(Picture)

(4) Vegetation is growing on the fence in several areas. Vegetation can hold moisture to the fence and cause excessive weight and damage. We recommend trimming back and removing the vegetation by a qualified licensed landscaper.

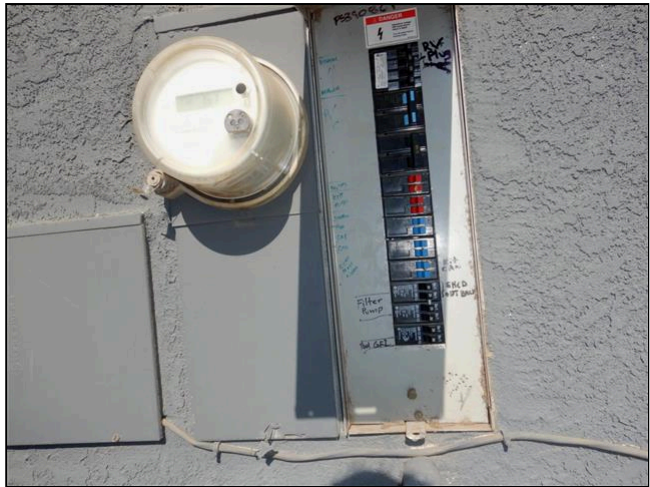
3.0 Item 1(Picture)

Comments:
Photo of the main electrical panel.

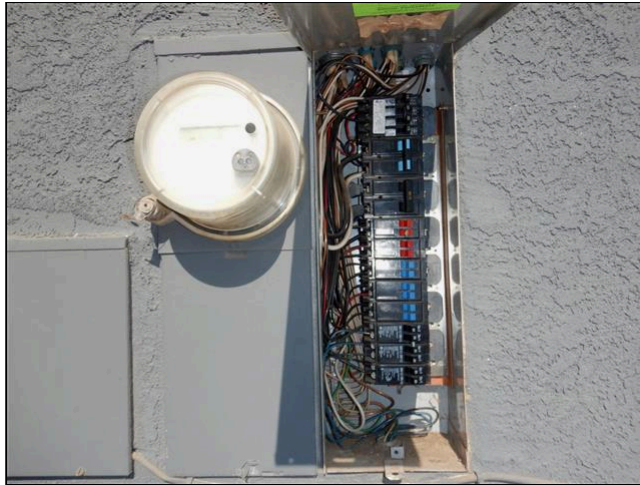
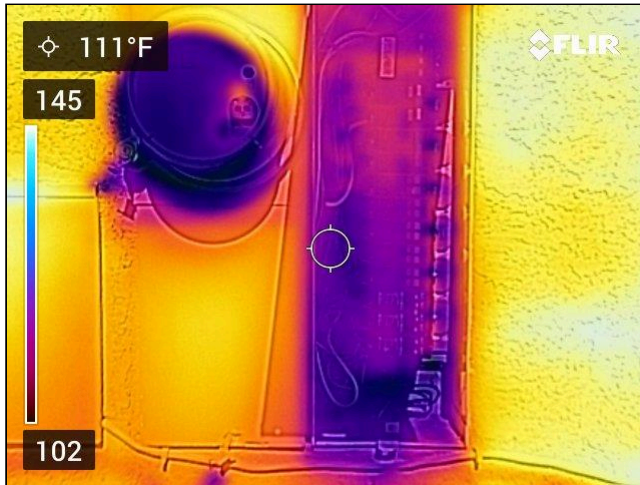
3.2 Item 1(Picture)

(2) Breakers were observed in the main panel which are from a manufacturer that is different than the panel manufacture. Most panel manufacturers require like-kind breakers to be installed from the same manufacture. Having breakers from another manufacturer could void the UL listing. We recommend further evaluation by a qualified licensed electrician and necessary corrections as needed.

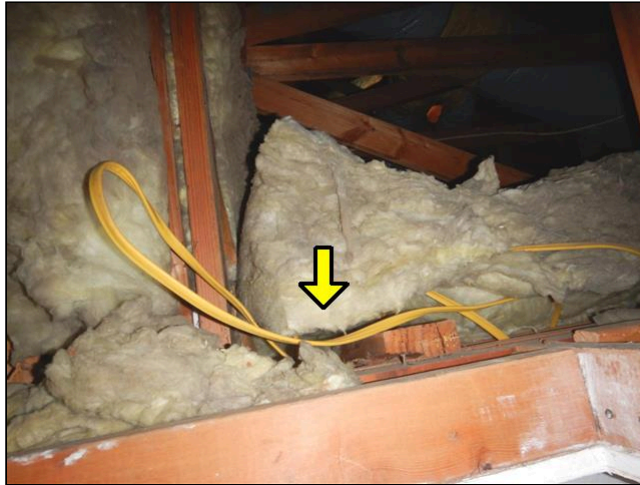
3.3 Item 3(Picture)

(3) Unprotected Romex was present in the attic adjacent to the attic scuttle. Romex located within 6 feet of the attic scuttle must be protected from damage. We recommend adding protection to the Romex in attic by the access a qualified licensed electrician.

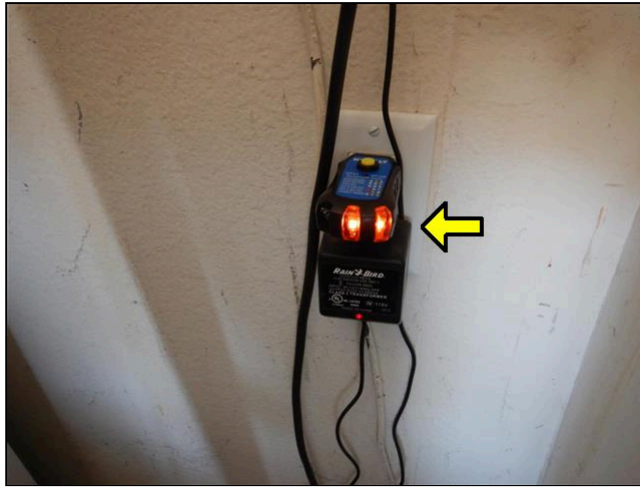
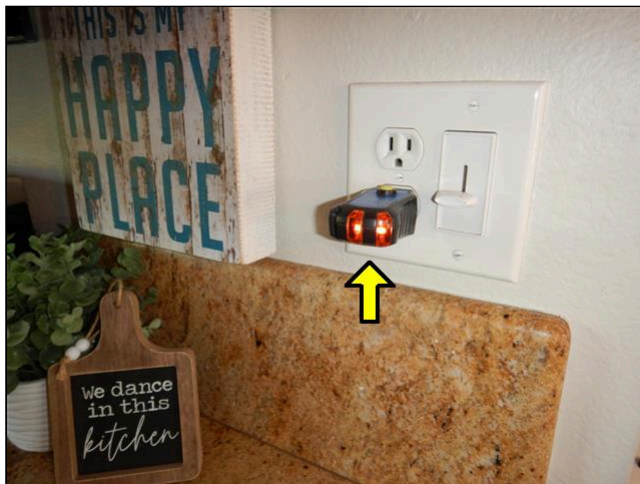
3.7 Item 1(Picture)

(1) **Photo of a receptacle being tested.**

A representative number of receptacles throughout the property were tested for power, polarity and grounding according to our standards-of-practice. These receptacles observed to be ok at the time of the inspection unless otherwise noted.

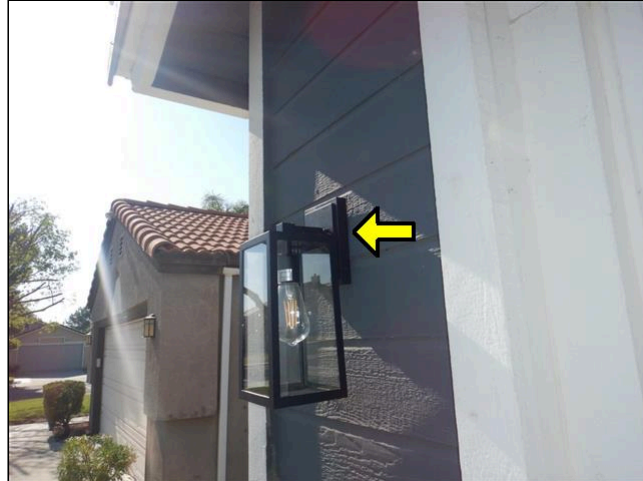
3.11 Item 1(Picture)

(1) The exterior light fixtures were not sealed where the fixture meets the wall. This condition could allow moisture intrusion in this area. We recommend sealing exterior light fixtures where they meet the wall by a qualified person.

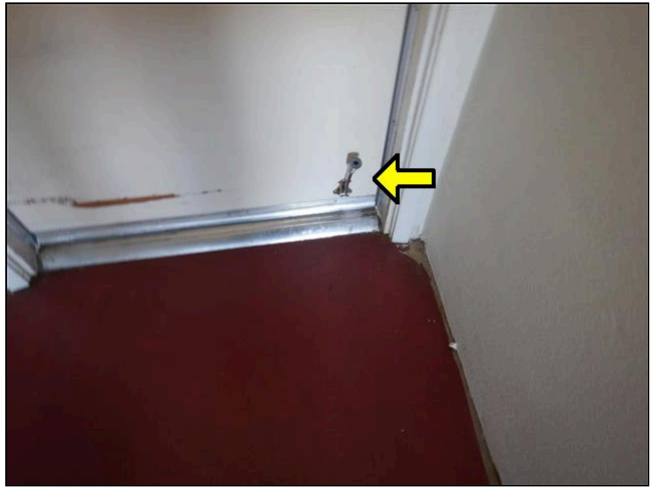
4.6 Item 2(Picture)

(2) The door to the garage has a door stopper installed at the bottom of the door. The door stopper defeats the auto closer, which is required. We recommend removal of the door stopper to maintain the integrity of the fire wall and fire door.

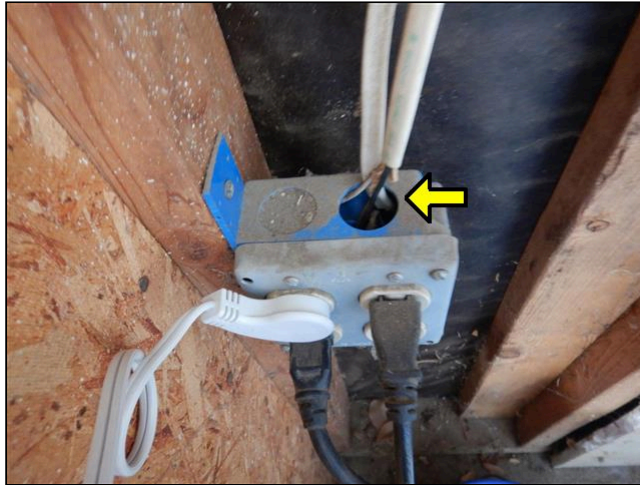
4.9 Item 3(Picture)

(2) Wire clamps are missing at a junction box located in the garage. This is non standard. A plastic bushing or wire clamp protects and secures the wiring as it enters into the junction box. We recommend installing plastic bushings or wire clamps by a qualified licensed electrician.

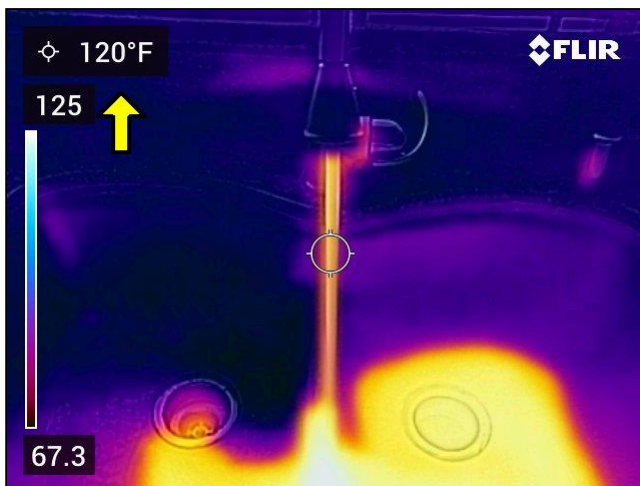
5.0 Item 1(Picture)

The temperature of the water was tested using a thermal camera during the inspection and was found to be operating within normal range.

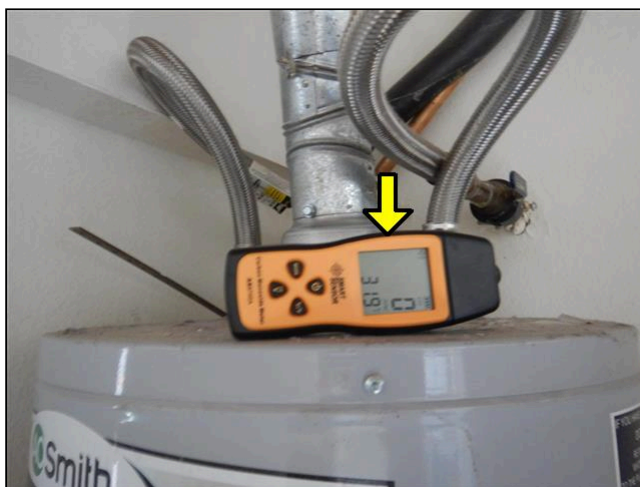
5.0 Item 2(Picture)

(3) A carbon monoxide test was performed using a hand help carbon monoxide detector during the inspection while testing the gas water heater. Carbon monoxide was not detected at the time of the inspection.

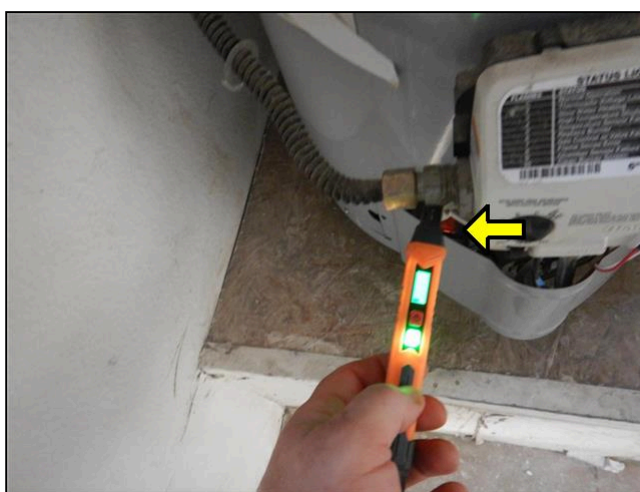
5.0 Item 3(Picture)

(5) A gas leak test was conducted at accessible gas fittings at the water heater using a gas leak detector. There were no gas leaks detected at the time of the inspection.

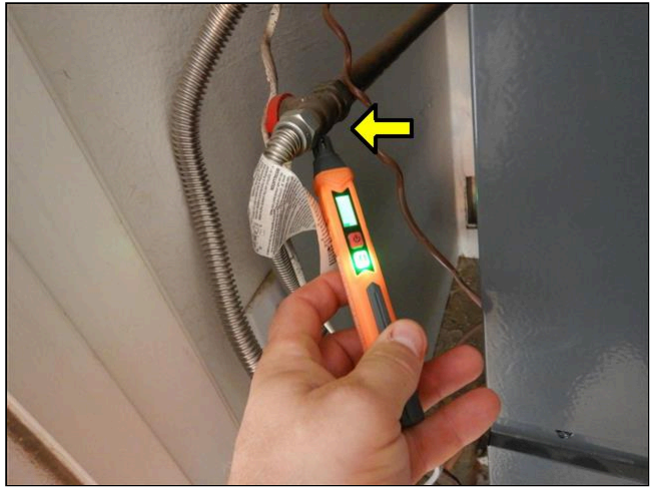
5.0 Item 4(Picture)

(6) A carbon monoxide test was performed using a hand help carbon monoxide detector during the inspection while testing the gas water heater. Carbon monoxide was not detected at the time of the inspection.

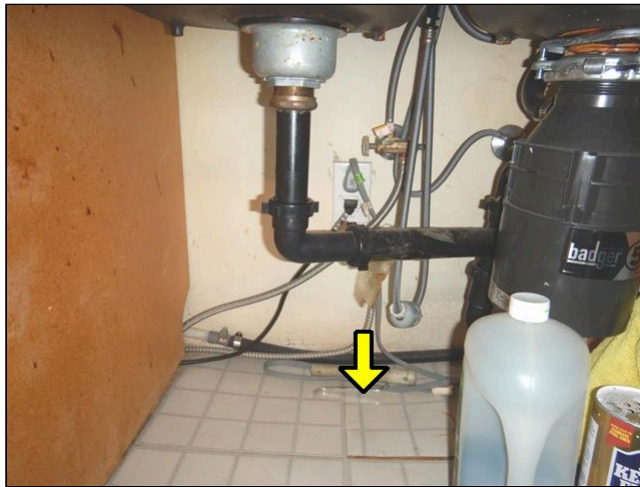
6.5 Item 1(Picture)

(2) The bottom shelf in the cabinet below the kitchen sink is bowed/ damaged. We recommend necessary repairs or replacement by a qualified licensed qualified contractor.

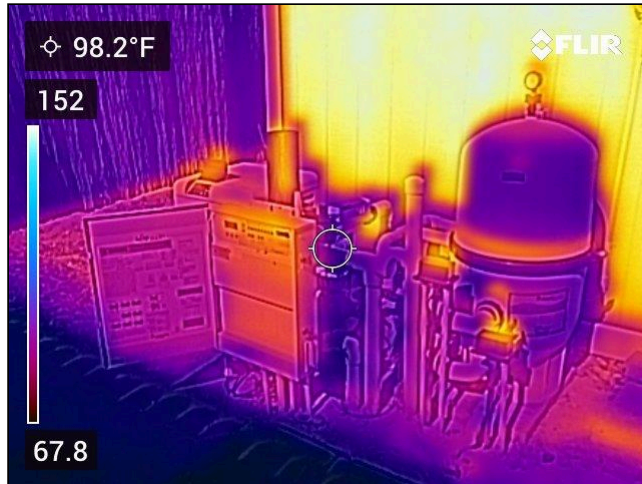
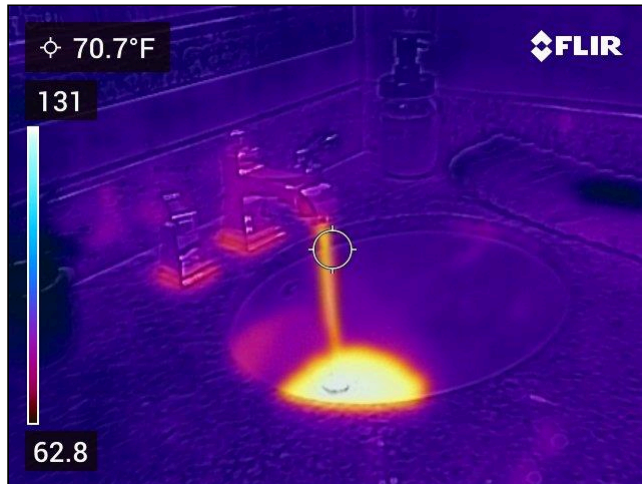
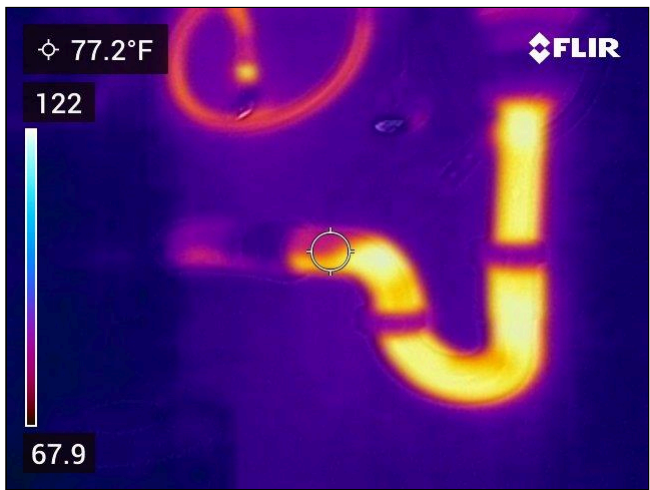
6.7 Item 1(Picture)

(1) Infrared Camera Thermal Photos.

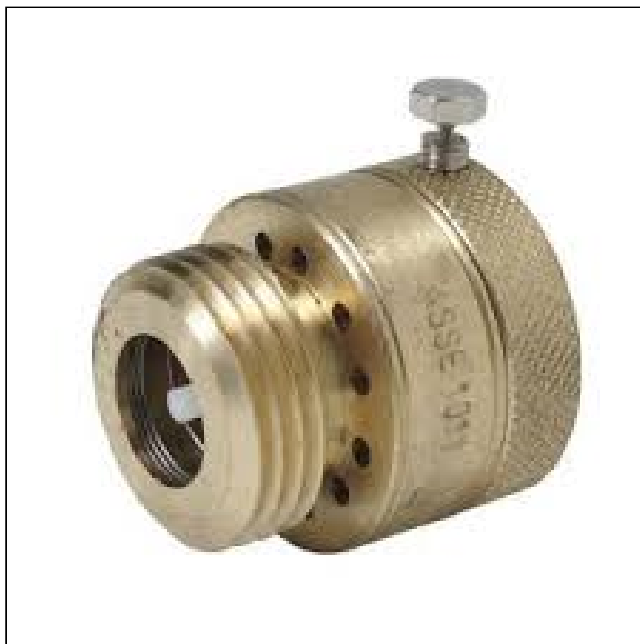
7.3 Item 1(Picture)

- (1) The accessible hose spigots were tested and were found to be operational at the time of the inspection. Note: Some hose spigots may leak or drip when a watering hose is connected due to back pressure.
- (2) The exterior hose spigots do not have anti-siphon or anti-backflow devices installed on them. These anti-siphon or anti-backflow devices help prevent contaminated water from flowing back into the the house water supply system. We recommend installing anti-siphon or anti-backflow devices at the every exterior hose spigots by a qualified person.

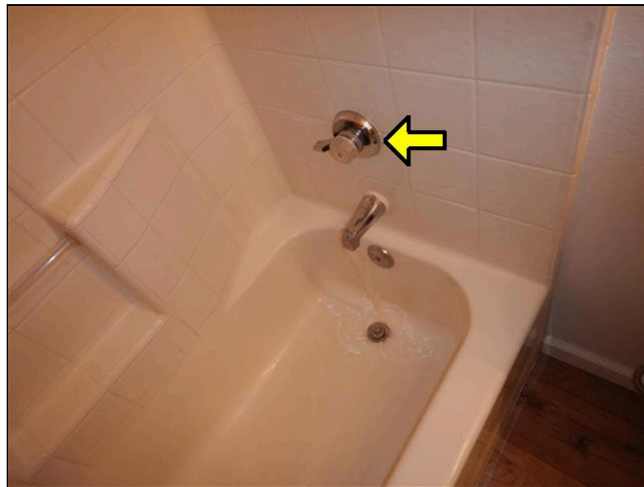
8.0.A Item 1(Picture)

The tub/ shower faucet valve does not back stop. This condition allows the tub faucet valve to turn past the off position without stopping. We recommend necessary repairs or replacement by a qualified licensed plumber.

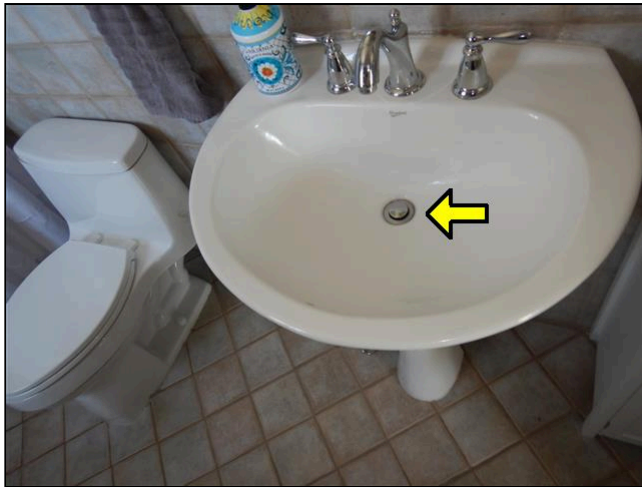
8.0.B Item 1(Picture)

The sink stopper was inoperable when tested. We recommend necessary repairs or replacement by a qualified person.

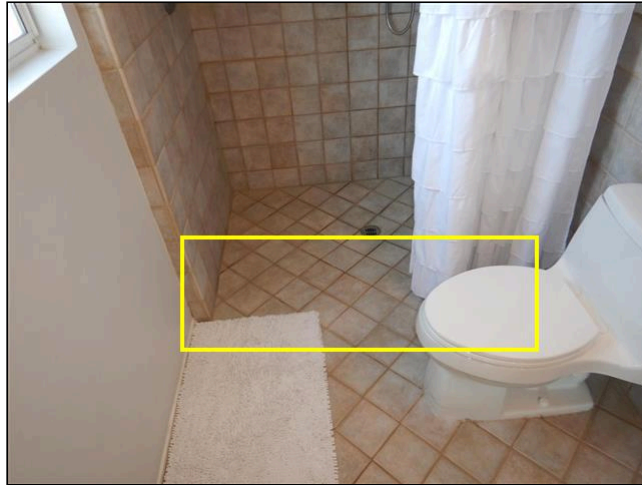
8.1.B Item 1(Picture)

Non-standard height was observed at the shower curb/ threshold. Normally a shower curb/ threshold is a minimum 2" above the drain. (usually a 4" threshold, with a maximum allowable of 9"). We recommend further evaluation by a qualified licensed contractor and repairs made as needed.

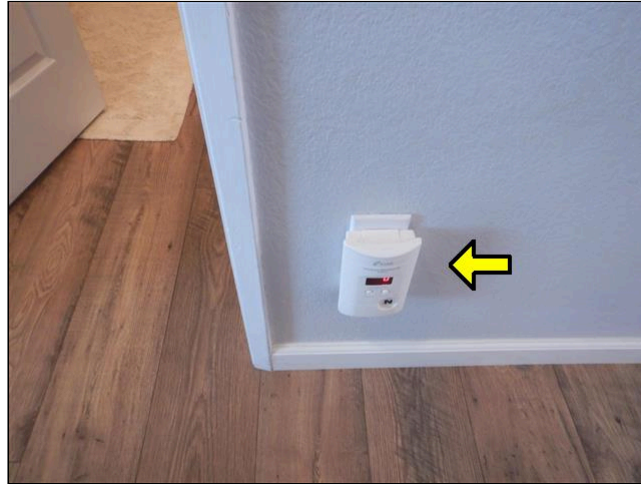
11.1 Item 1(Picture)

(1) **Photo of carbon monoxide detector(s).**

(2) The quantity of Carbon Monoxide detectors that are required to be installed varies with each house. Larger houses, or those with multiple levels are required to have more CO detectors. A Carbon Monoxide detector is required on each level of a multi-level house and adjacent to each cluster of bedrooms. We recommend installing additional Carbon Monoxide detectors where needed.

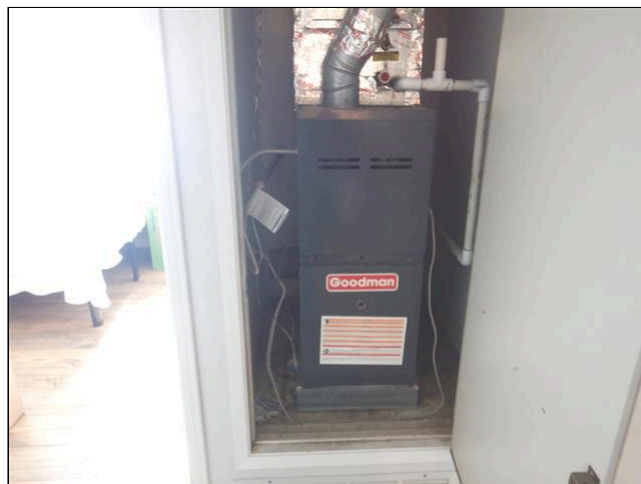
12.0 Item 1(Picture)

(1) The furnace was tested and was functional/ operated at the time of the inspection.

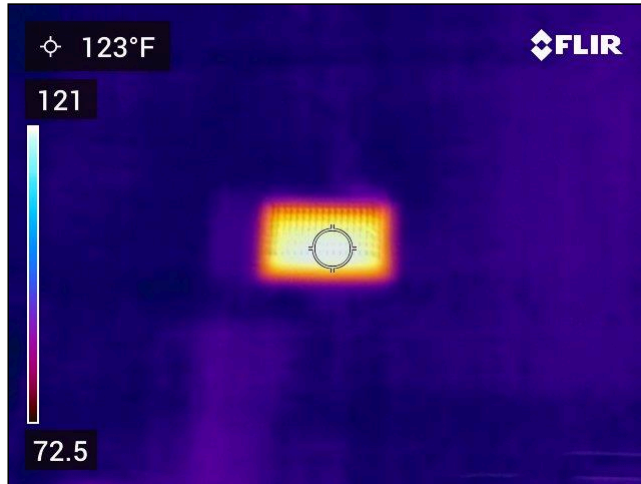
12.0 Item 2(Picture)

(2) Infrared Thermal photo of the furnace(s) being tested.

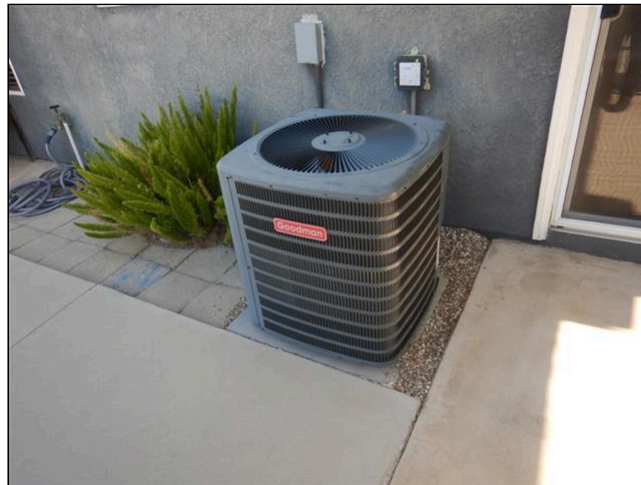
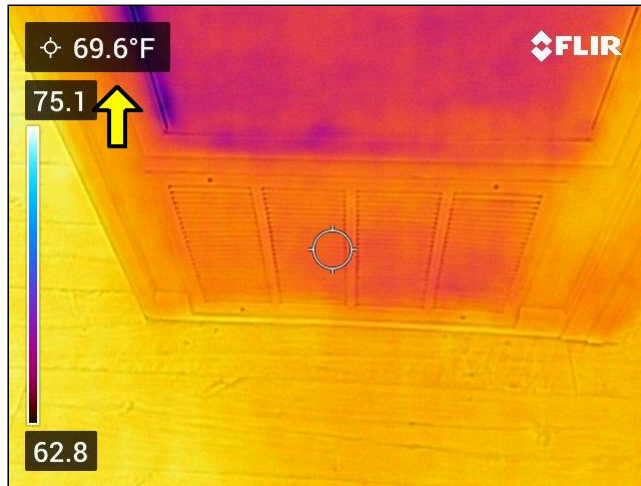
13.0 Item 1(Picture)

- (1) **Photo of the A/C unit(s).**

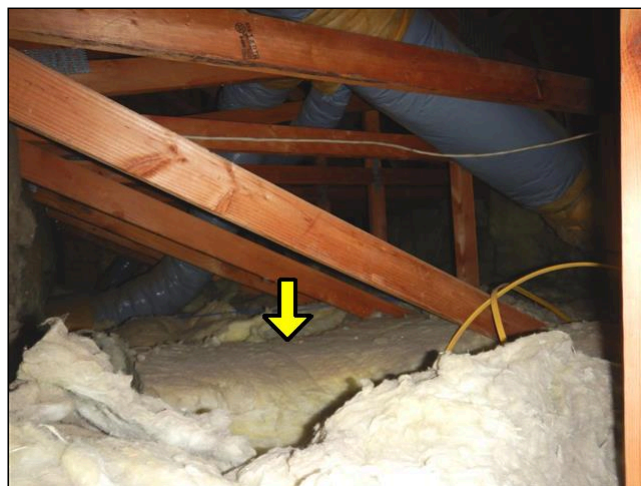
14.0 Item 1(Picture)

- (1) [Photo of the insulation.](#)

- (2) The insulation in the attic appears to be functioning as intended.
- (3) The attic space access hatch cover is not insulated. We recommend insulating the attic access hatch cover to reduce unwanted heat loss/gain by a qualified person.

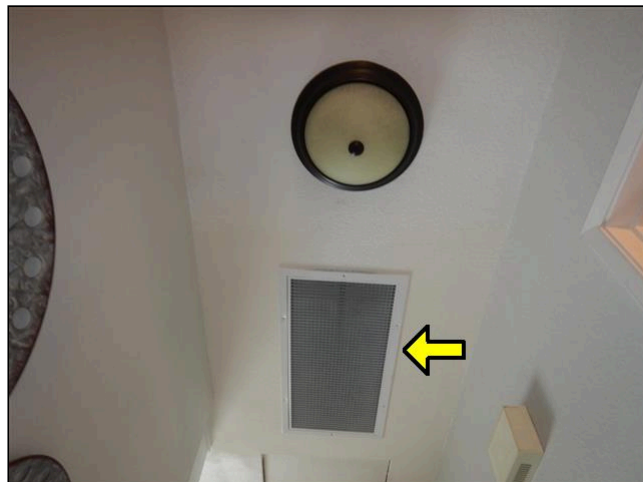
14.3 Item 1(Picture)

The whole house fan did operate when tested at the time of the inspection.

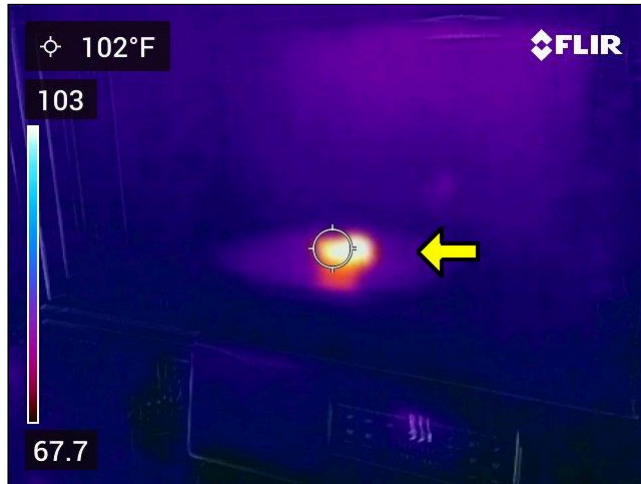
16.0 Item 1(Picture)

- (1) **Photo of microwave being tested.**

The built in microwave was tested with a microwave testing device and was functional at the time of the inspection. This is not an exhaustive test, and does not predict the performance of the microwave.

- (2) The built in microwave was installed too close to the cooktop burners. This condition could cause damage to the plastic covering and the electronic control panel due to excessive heat. We recommend replacing the microwave with a low-profile microwave or relocating it which would allow at least 18 inches of clearance between the bottom of the microwave and the cooktop burners. Lower clearances may be allowed per manufacturers listing.

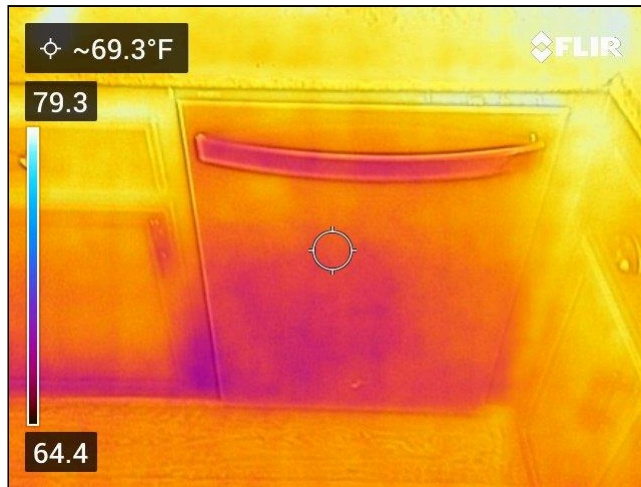
16.1 Item 1(Picture)

Infrared Thermal photo of the dishwasher being tested.

The dishwasher was tested and functioned properly at the time of the inspection. This is not an exhaustive test and does not verify the cleaning efficiency of the dishwasher.

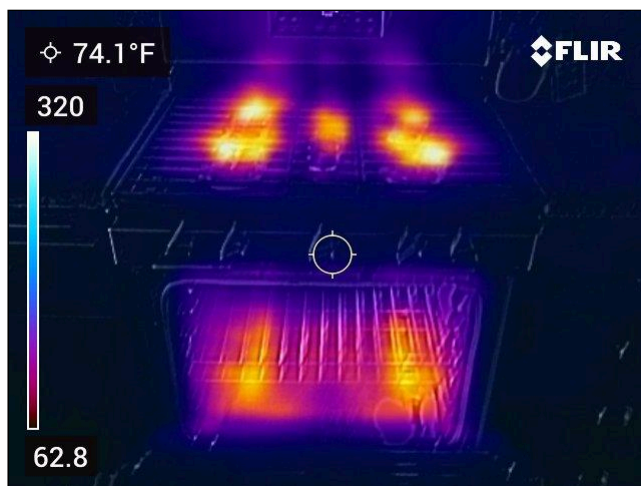
16.4 Item 1(Picture)

Infrared Thermal photo of the oven being tested.

The oven was tested and was functional at the time of the inspection. This test is not exhaustive and does not confirm the performance, accuracy, or effectiveness of the oven.

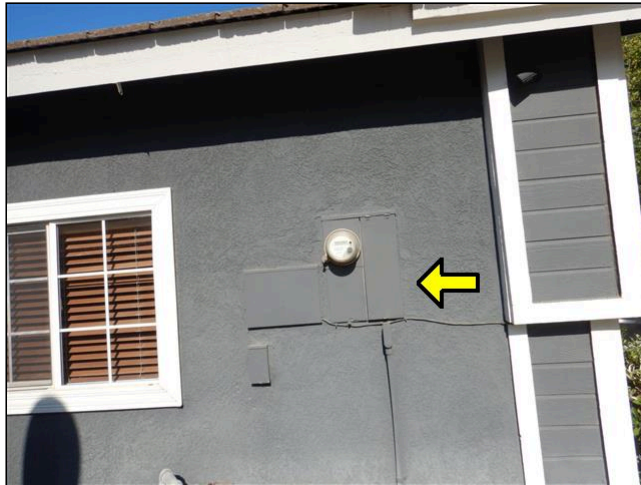
17.1 Item 1(Picture)

The Main Electrical panel is located at the left exterior side of the property (facing front).

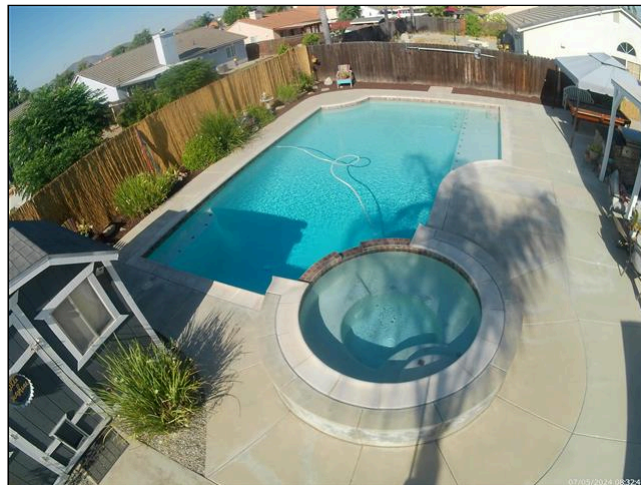
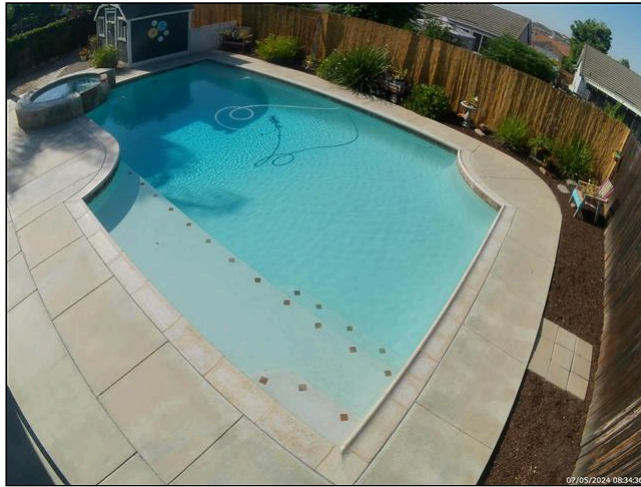
18.0 Item 1(Picture)

(1) Photo of the pool/ spa.

(2) There is no visible rescue/ safety equipment placed around the pool/ spa area. This is a safety concern. We recommend placing the required rescue/ safety equipment where needed around the pool as a safety upgrade.

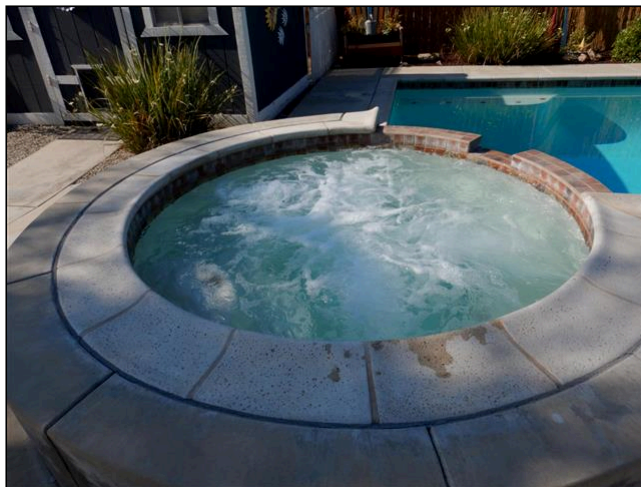
18.1 Item 1(Picture)

The spa jets functioned when tested.

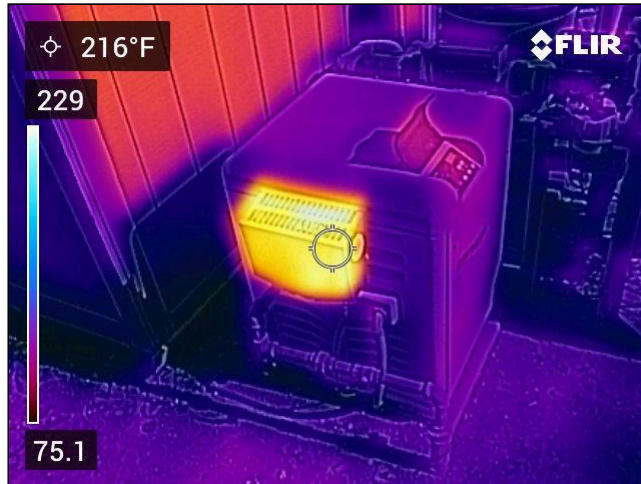
18.6 Item 1(Picture)

Infrared Thermal photo of the pool/ spa furnace being tested.

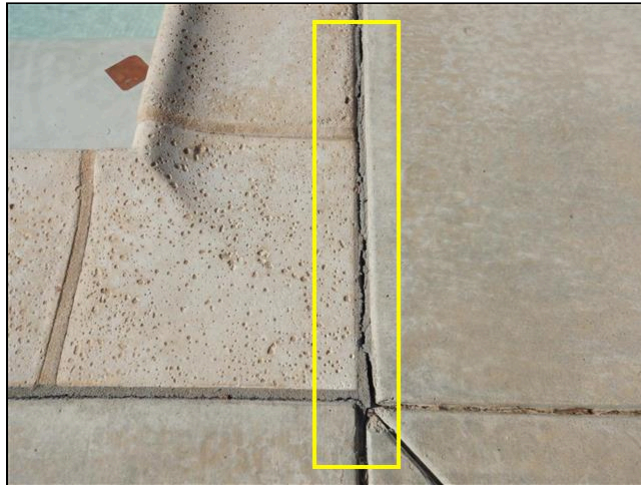
18.11 Item 1(Picture)

The elastomeric compound (Deck-O-Seal) between the pool/ spa deck and coping is cracked/ missing in several areas. We recommend re sealing between the pool/ spa deck and coping as needed by a qualified pool contractor.

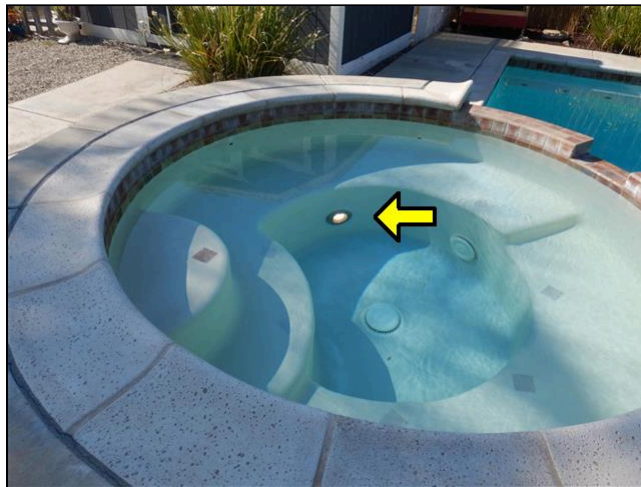
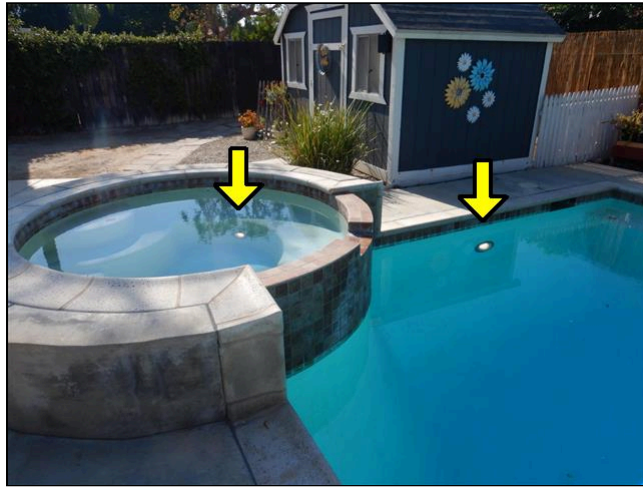
18.13 Item 1(Picture)

(1) Photo of pool/ spa light(s) on.

(2) Pool and spa light(s) are not taken out and we did not observe the condition of the wiring to the pool and spa light(s). This is out of the scope of a general home inspection. If concerned about the wiring to these lights we recommend further evaluation by a licensed pool contractor prior to the end of your contingency period.

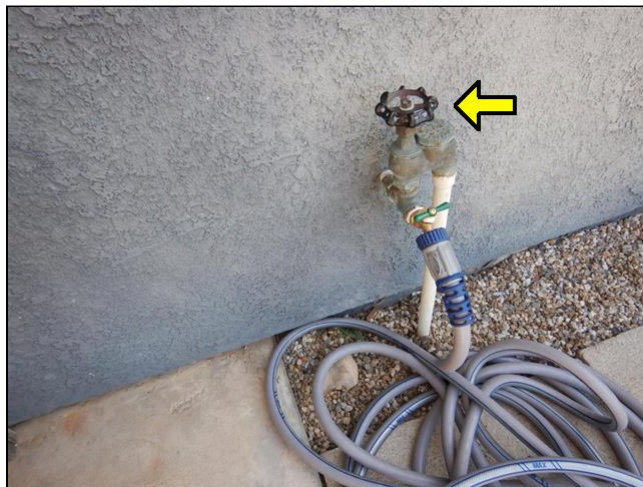
18.14 Item 1(Picture)

The pool fill device was tested and was operational at the time of the inspection.

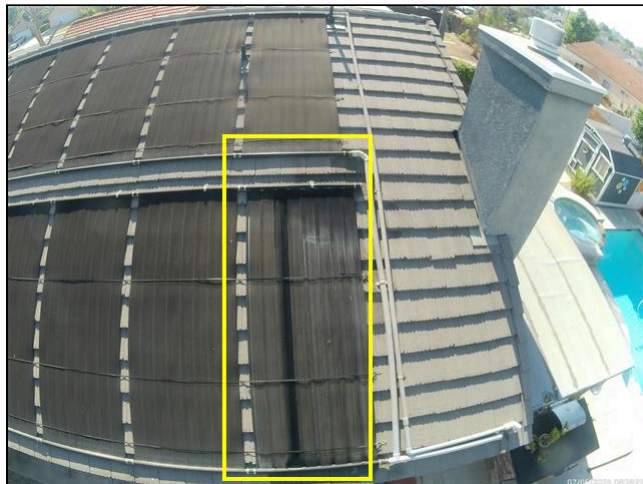
18.18 Item 1(Picture)

The solar heating system on roof was observed to be leaking. We recommend recommend necessary repairs or replacement by a qualified licensed pool contractor.
