Inspection Report

Property Address:
1123 Main Road
Rancho Santa Fe CA 92067

The Property Inspection Pros

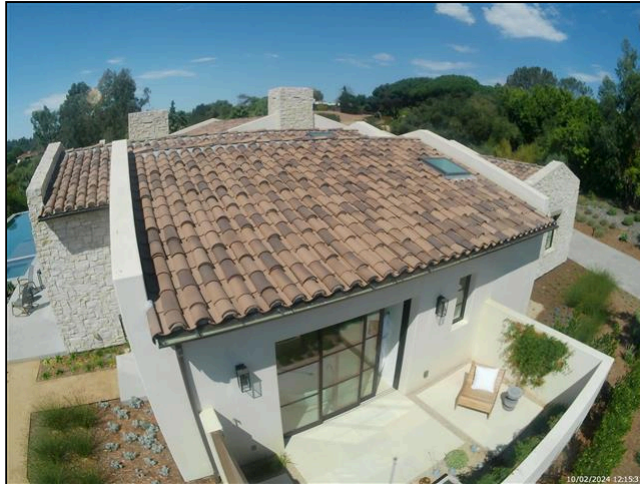
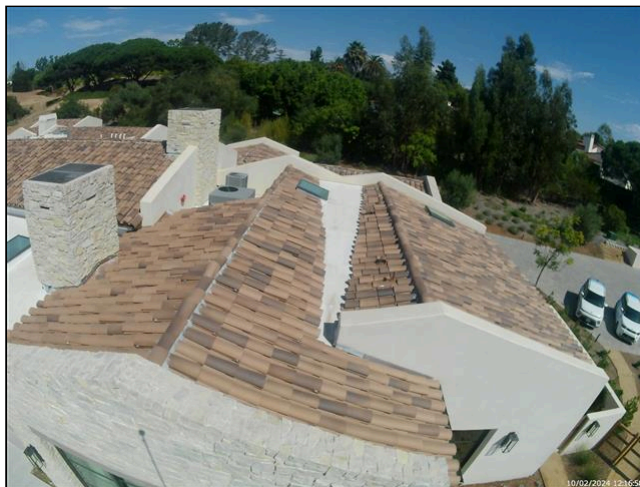
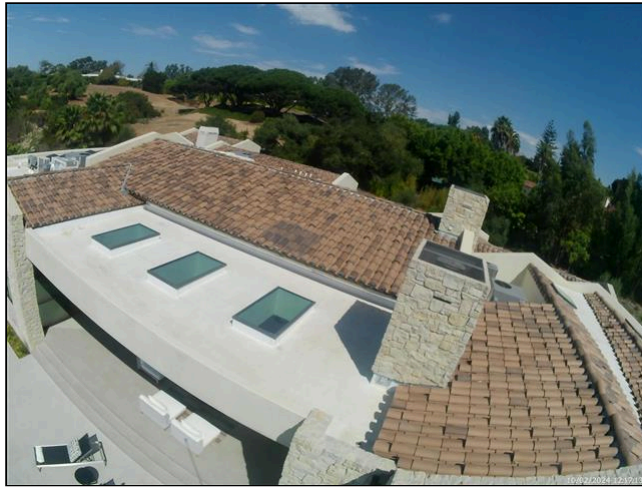
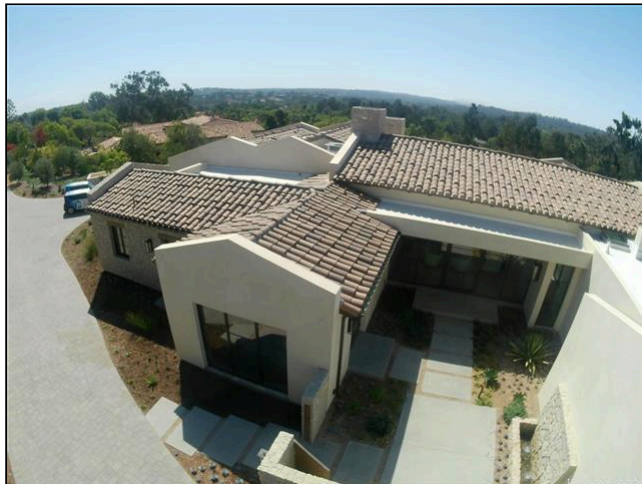
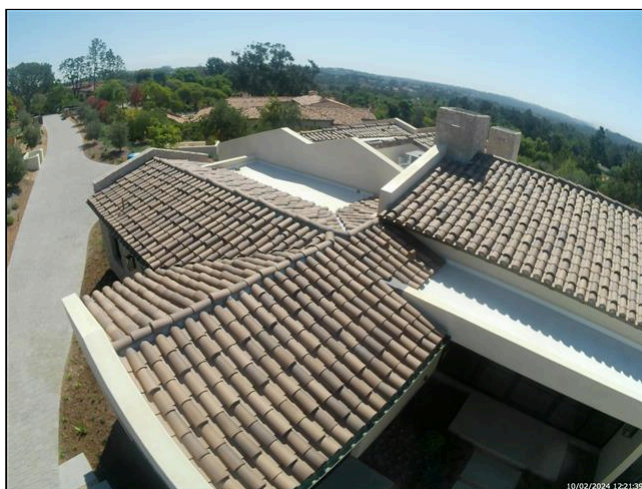
(1) [Photo\(s\) of the roof.](#)

(2) The roof material shows normal wear for its age and type; appears to be in serviceable condition.

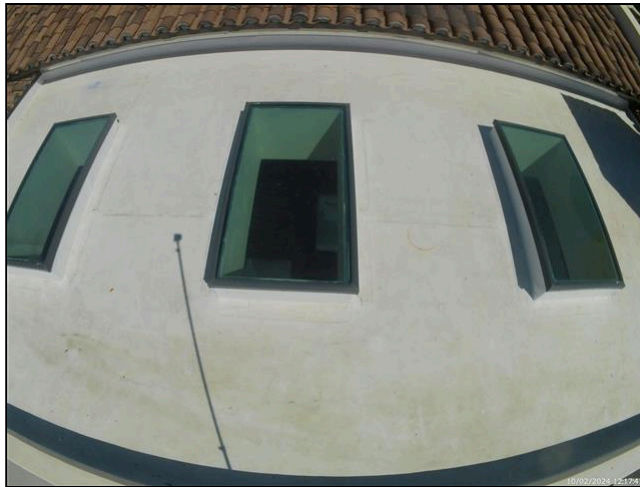
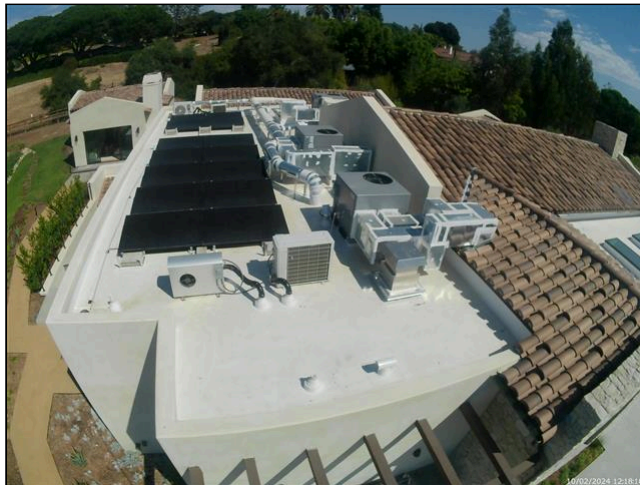
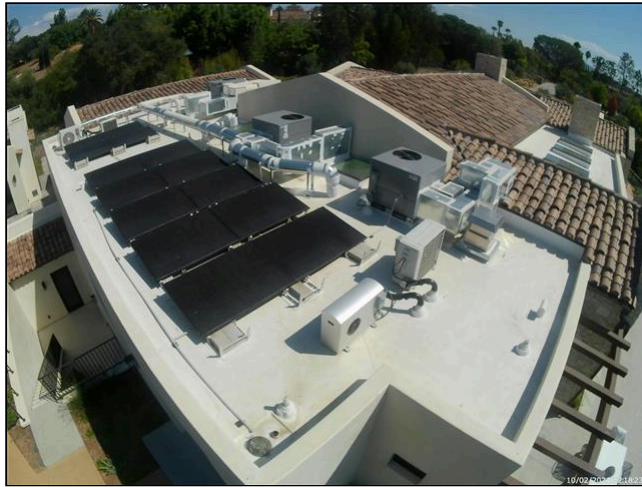
The flat roof material shows normal wear for its age and type; appears to be in serviceable condition.

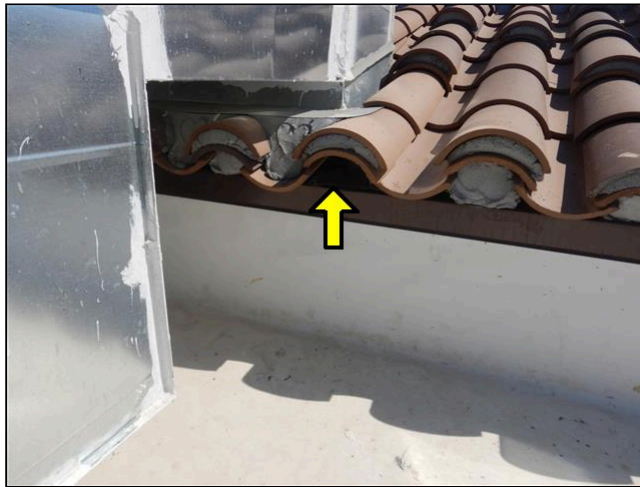
1.2 Item 1(Picture)

(1) Several tiles roof do not have "bird stop" installed at the end of the roof at the eaves. The lack of this end cap can allow pest(s) to enter under the tiles and damage the underlayment "tar paper". It also exposes the underlayment "tar paper" to the sun, weather and the elements. We recommend having a "bird stop" added where needed by a licensed roof contractor.

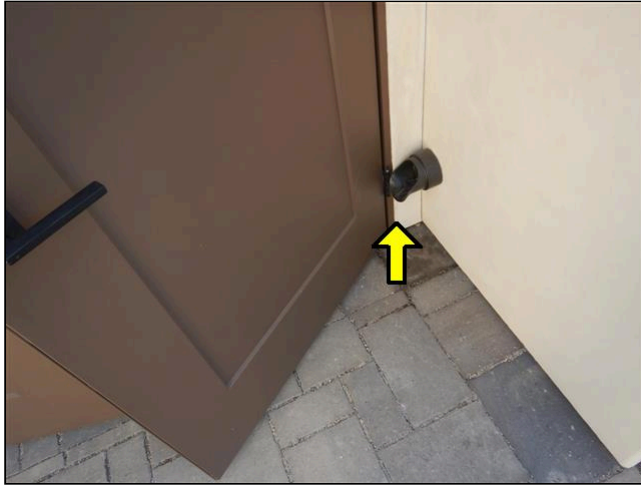
1.3 Item 1(Picture)

(1) Some of the downspouts and drains need extension and/or a buried drain line to carry water away from the home at several areas. We recommend necessary corrections where needed by a qualified contractor.

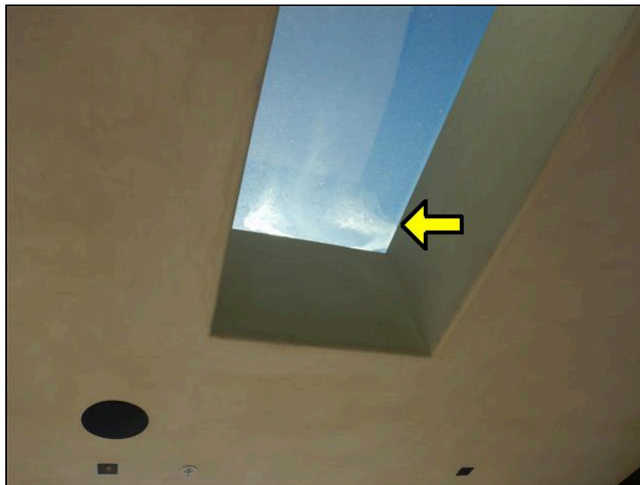
1.5 Item 2(Picture)

There is a screen observed on the roof. We recommend removal by a qualified person.

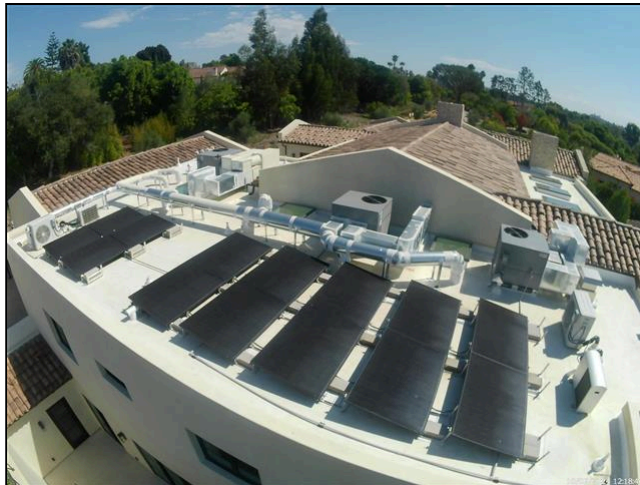
1.7 Item 1(Picture)

However, the solar panels were observed not to be fastened to the roof. We recommend further evaluation by a licensed solar contractor and necessary corrections made as needed.

We also recommend having all the solar panels cleaned by a qualified person.

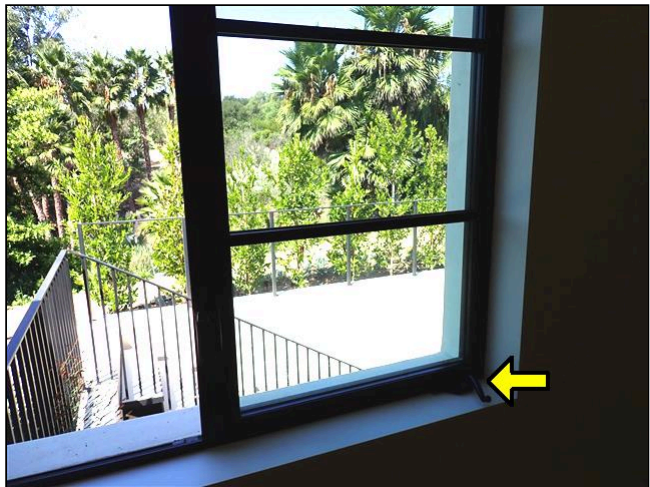
2.6 Item 1(Picture)

(1) Unable to open the window in the 2nd bedroom as it appears to be stuck in the closed position. We recommend necessary repairs or replacement by a licensed window contractor.

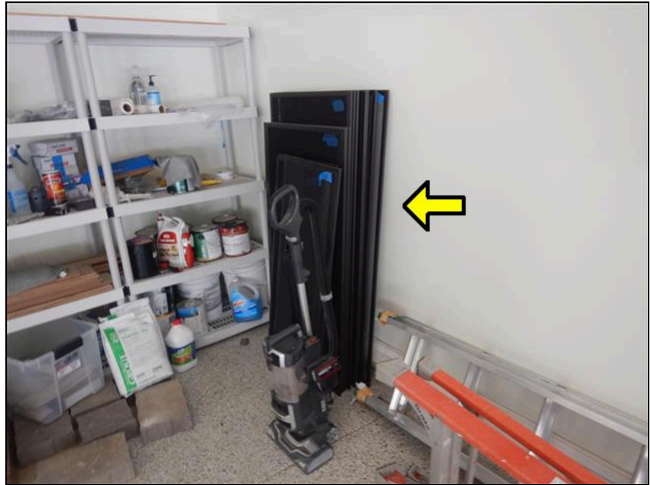
2.6 Item 2(Picture)

(2) All of the window screens throughout the house were not installed at the time of the inspection. There are window screens located in the garage. We recommend verifying that all the window screens are accounted for, serviceable, and that they fit prior to the end of your contingency period.

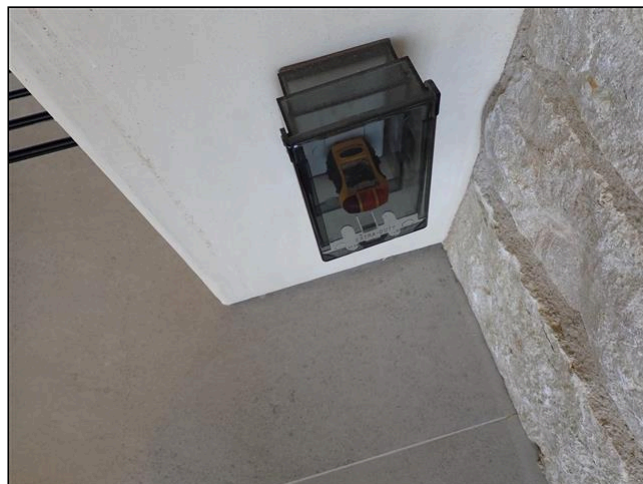
2.11 Item 1(Picture)

A receptacle at the rear of the house did not operate when tested. We recommend further evaluation and necessary repairs by a licensed electrician.

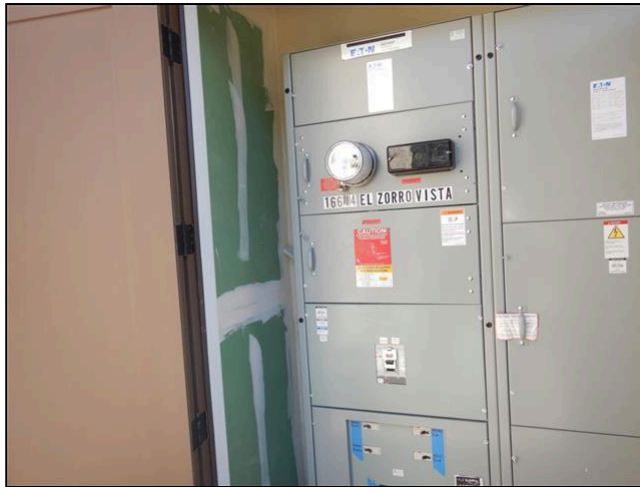
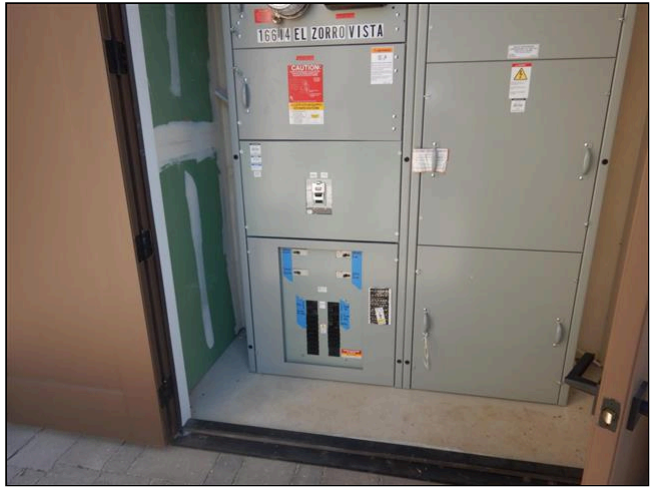
- (1) [Photo of the main electrical panel.](#)

(2) A twist out is missing at the main panel dead-front cover. Whenever a twist out is removed and no breaker is present then a cover insert is required to be installed to help prevent shocks and rodent intrusion. We recommend installing cover insert(s) where needed by a qualified person for safety.

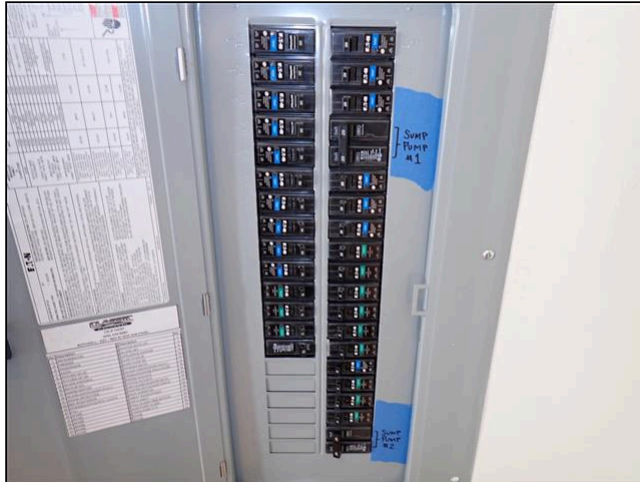
3.1 Item 1(Picture)

Photo of the sub electrical panels.

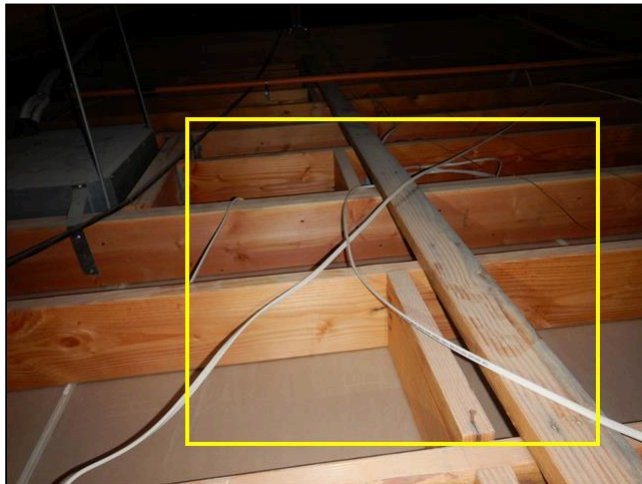
3.3 Item 1(Picture)

(2) Wires for some lighting fixtures in the attic space were observed to be unsecured. We recommend necessary corrections by a qualified licensed electrician.

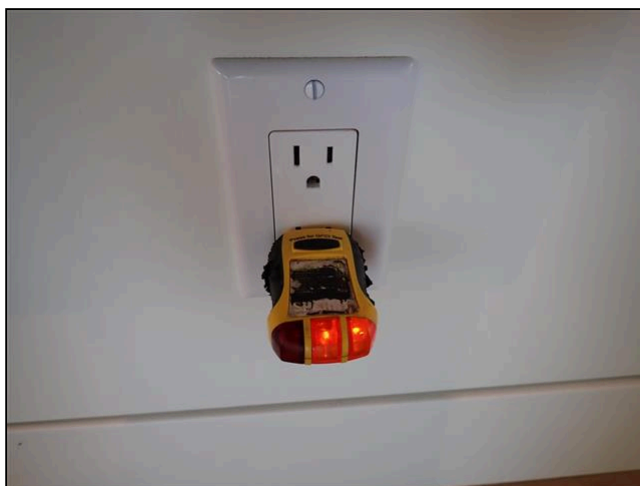
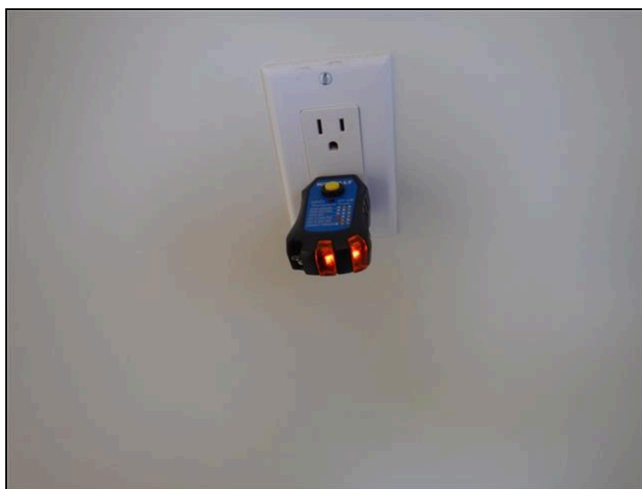
Photo of a receptacle being tested.

A representative number of receptacles throughout the property were tested for power, polarity and grounding according to our standards-of-practice. These receptacles observed to be ok at the time of the inspection unless otherwise noted.

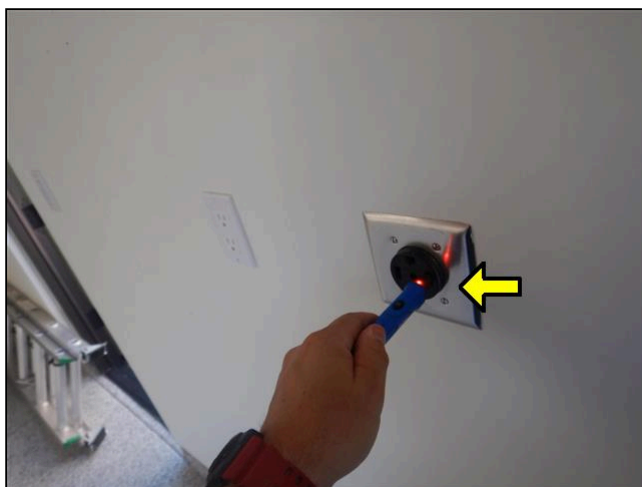
3.9 Item 1(Picture)

The 220V outlet in the garage functioned when tested at the time of the inspection.

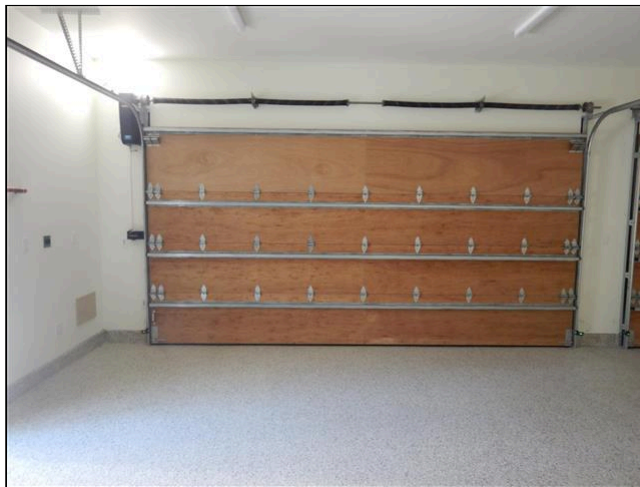
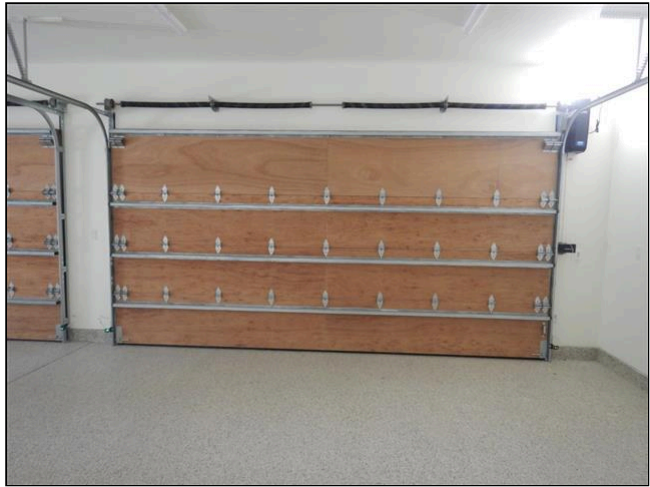
Interior garage door(s) photo.

The garage vehicle door hardware including the doors, tracks, and springs appear to be functioning as intended.

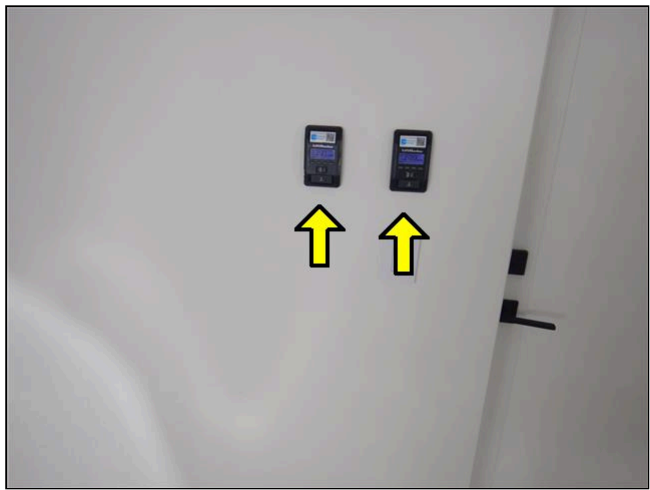
4.1 Item 1(Picture)

(1) The garage door push-buttons are lower than the recommended 5-foot minimum height above the standing surface. This condition is potentially dangerous to children. We recommend that the switch be raised to the 5-foot minimum or higher by a qualified licensed garage door contractor for safety reasons.

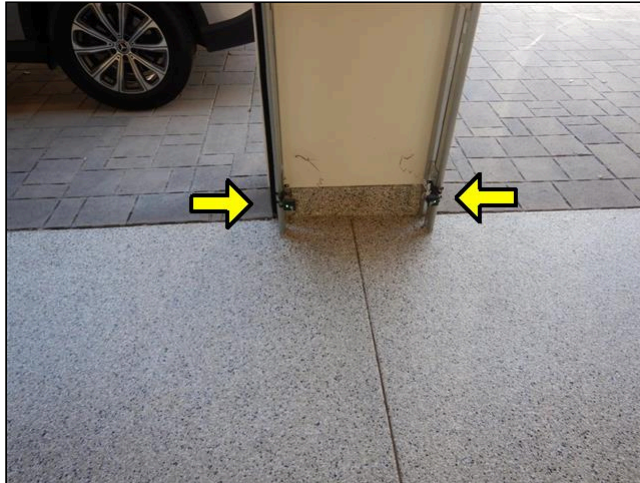
4.1 Item 2(Picture)

(2) The safety reverse photo-eyes are mounted at an incorrect height from the ground at both garage doors. Most manufacturers recommend mounting these devices at about 4"-6" from the ground for safety. We recommend necessary corrections by a qualified licensed garage door contractor.

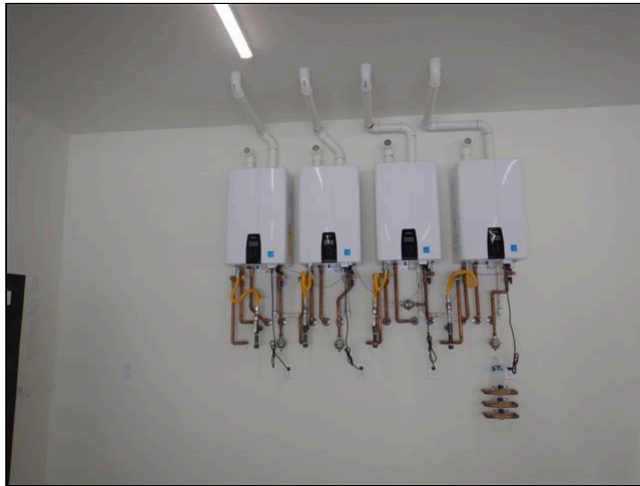
5.0 Item 1(Picture)

- (1) [Photo of the water heaters.](#)

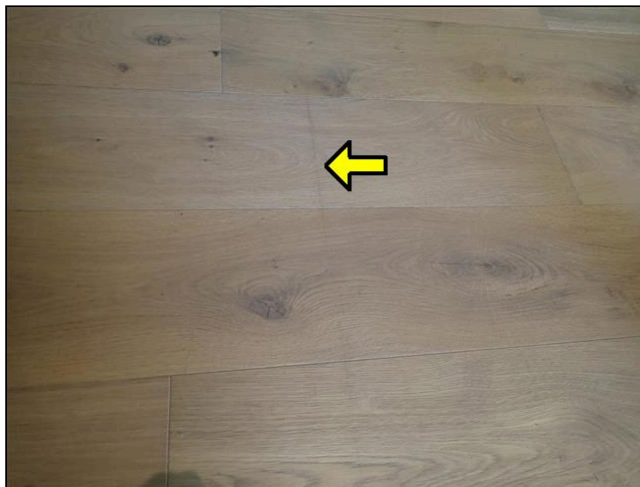
6.3 Item 1(Picture)

The flooring was observed to be "scuffed" entering the master bedroom. We recommend cleaning/repairing where needed by a qualified person.

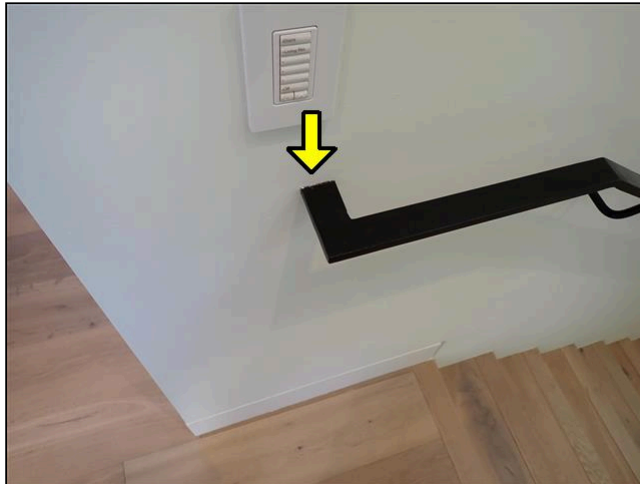
6.4 Item 1(Picture)

The stair/landing railing is loose. This is a safety hazard and corrections are needed. We recommend necessary repairs for safety by a qualified licensed contractor.

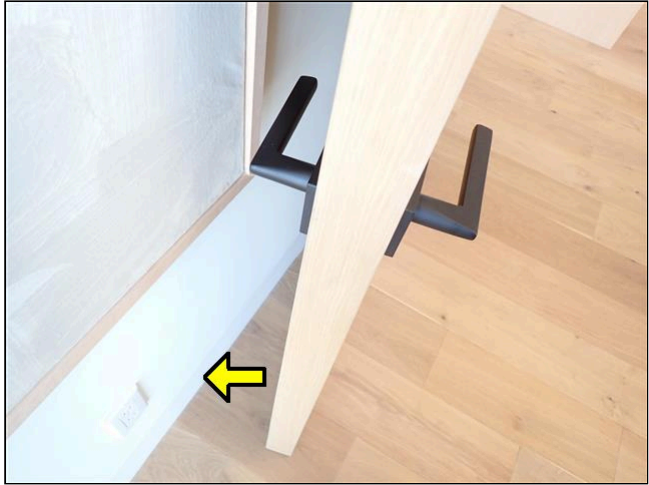
6.6 Item 2(Picture)

(2) Door stoppers are missing at several doors. Door stoppers are recommended where door handles contact walls. We recommend adding door stops and repair of any walls by a qualified person.

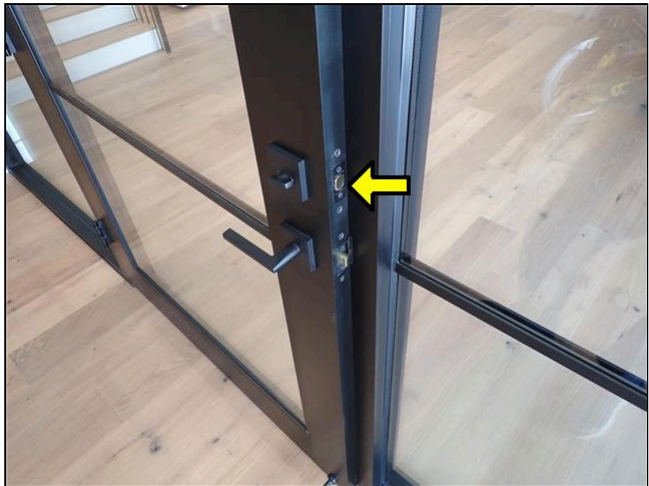
6.6 Item 3(Picture)

(3) The downstairs gym glass door upper locking latch is difficult to operate. We recommend further evaluation by a licensed contractor and have repairs made where needed.

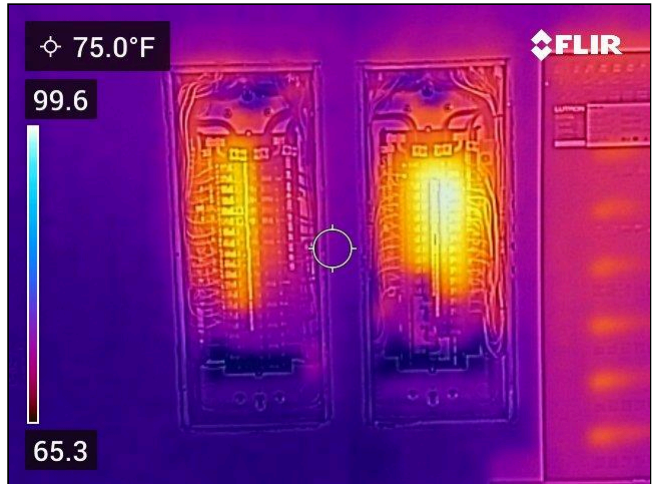
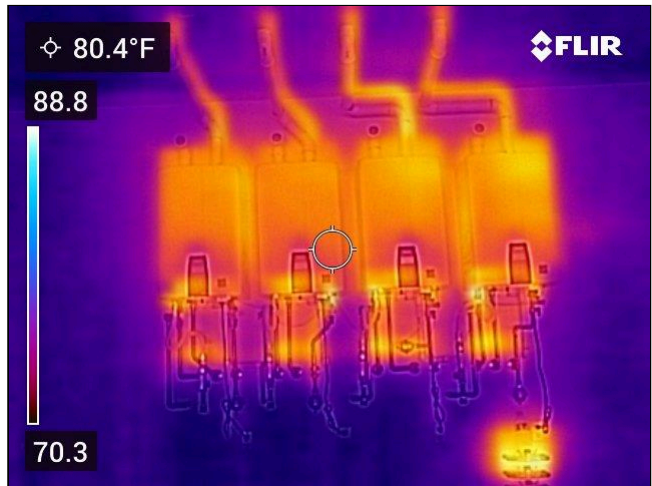
(1) Infrared Camera Thermal Photos.

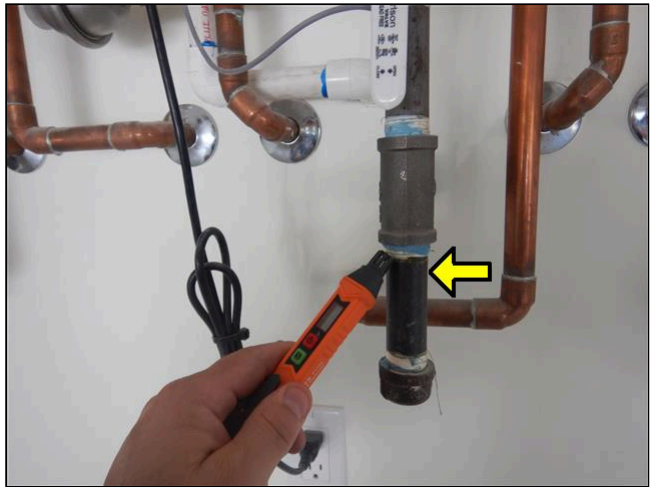
7.4 Item 1(Picture)

A gas leak test was conducted at accessible gas fittings and appliances using a gas leak detector. There were no gas leaks detected at the time of the inspection.

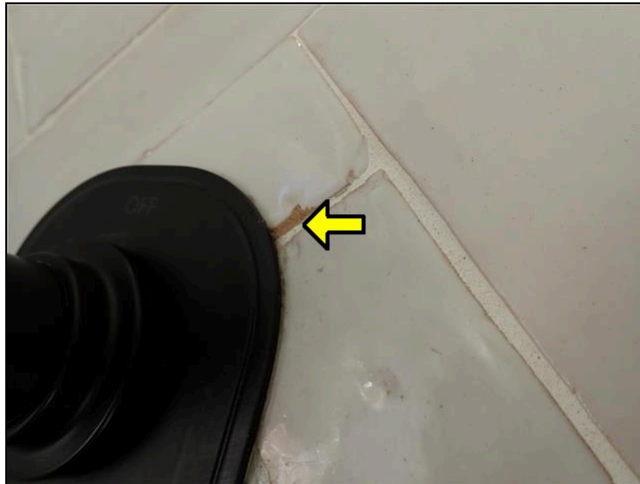
8.0 Item 5(Picture)

(3) A tile in the master bathroom shower was observed to be chipped. We recommend repairs where needed by a licensed contractor.

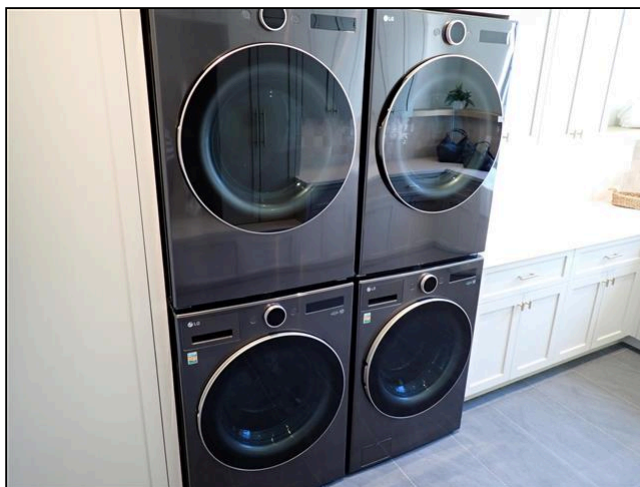
9.3 Item 1(Picture)

The clothes washer and dryer are not part of our general inspection and were not inspected or commented on. If concerned about there serviceability and functionality we recommend further evaluation by a qualified licensed appliance contractor prior to the end of your contingency period.

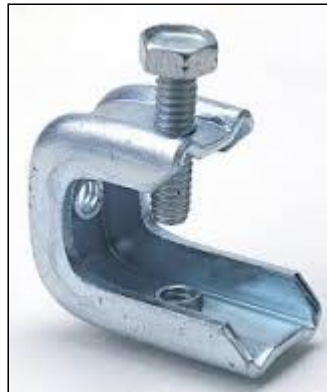
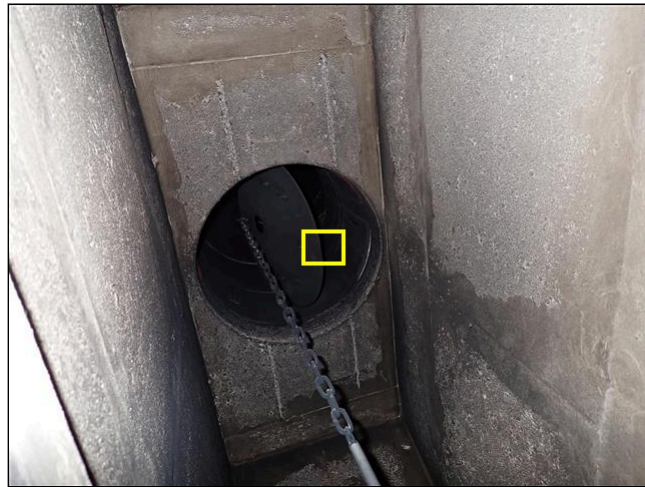
10.2 Item 1(Picture)

This damper clamp help prevents the damper from closing all the way as a safety precaution. If the damper is closed, Carbon Monoxide gas could enter the living space easier which is undetectable. SDG&E now requires damper clamps at all fireplaces damper doors. We recommend installation of a damper clamp at each fireplace damper door by a qualified person.

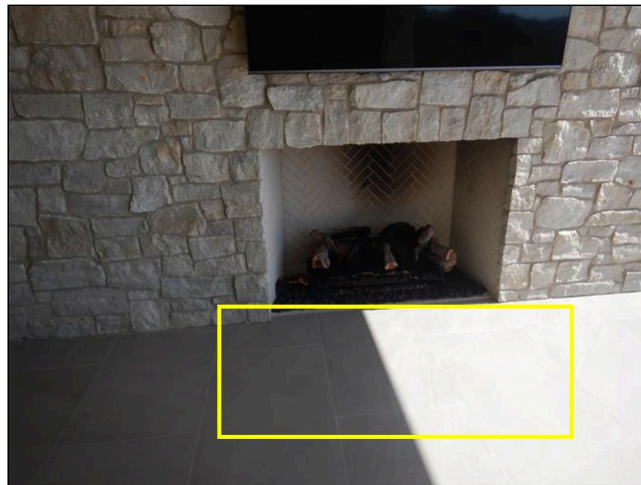
10.3 Item 1(Picture)

The hearth at the front of the exterior fireplace is non-distinguishable from the surrounding floor tiles. Currently, hearth extensions in the front of factory built fireplaces are required to be distinguishable from the surrounding floor. The floor tiles were replaced and non-combustible, but was not distinguishable from the surrounding floor. This installation is not consistent with current building standards. We recommend necessary corrections by a qualified licensed contractor.

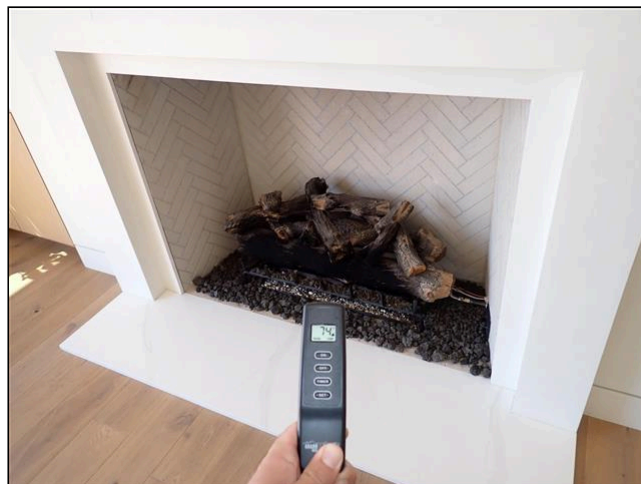
10.4 Item 1(Picture)

of the inspection. We recommend making repairs where needed by a licensed fireplace contractor.

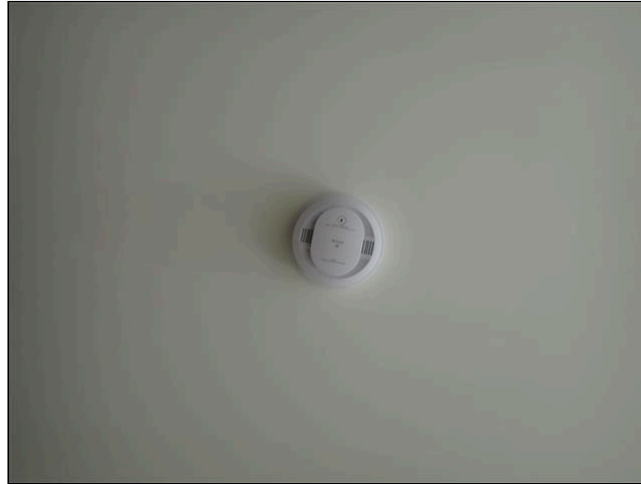
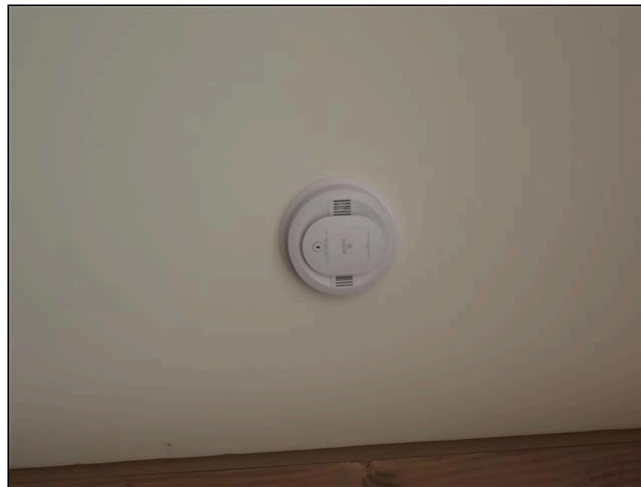
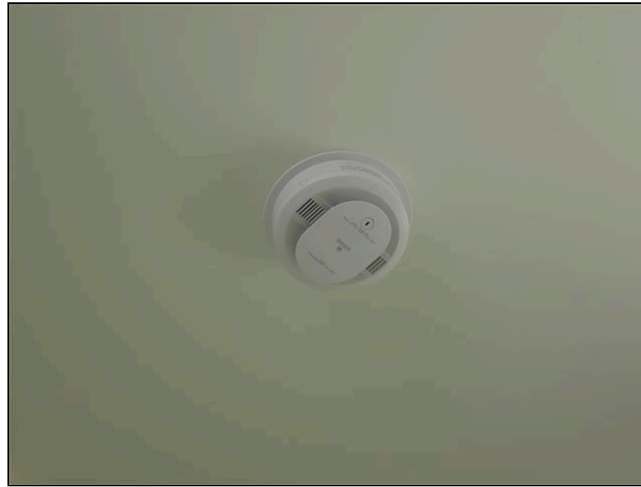
11.1 Item 1(Picture)

Photo of carbon monoxide detector(s).

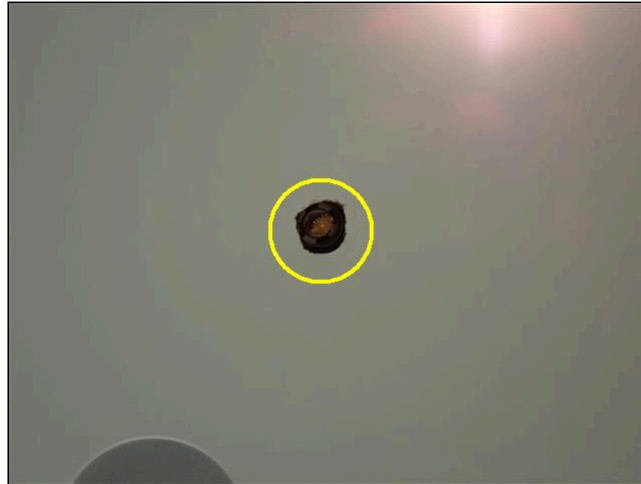
11.3 Item 1(Picture)

- (1) There is a fire sprinkler system installed in the house and was not inspected by this company at the time of the home inspection. Inspecting fire sprinkler systems is beyond the scope of our general home inspection. We recommend having the fire sprinkler system inspected by a qualified licensed contractor prior to the end of your contingency period.
- (2) A fire sprinkler cover cap is missing from a sprinkler head located in the living room ceiling. We recommend replacement by a licensed contractor.

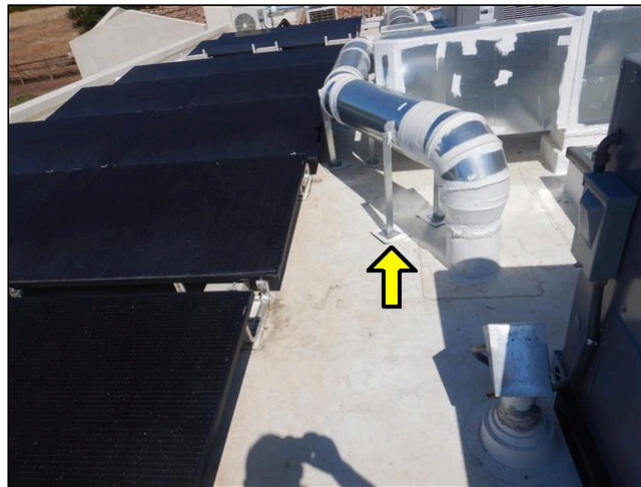
12.3 Item 1(Picture)

(1) The roof top duct mounting brackets are not properly secured to the roof as required. We recommend necessary corrections made by a licensed HVAC contractor.

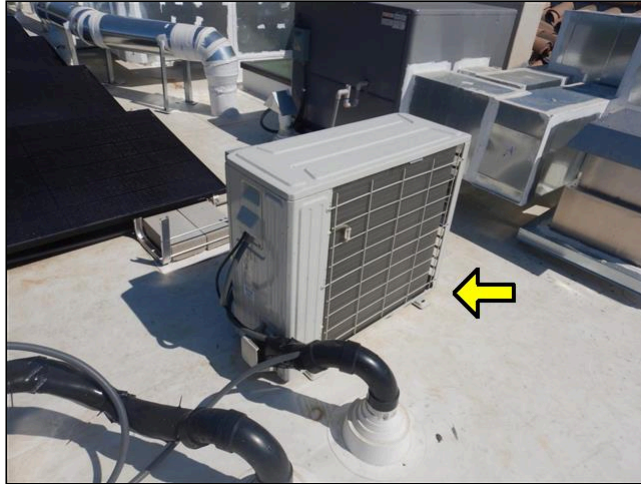
13.0 Item 2(Picture)

(2) The AC condensers are not properly secured to the roof as required. We recommend necessary corrections made by a licensed HVAC contractor.

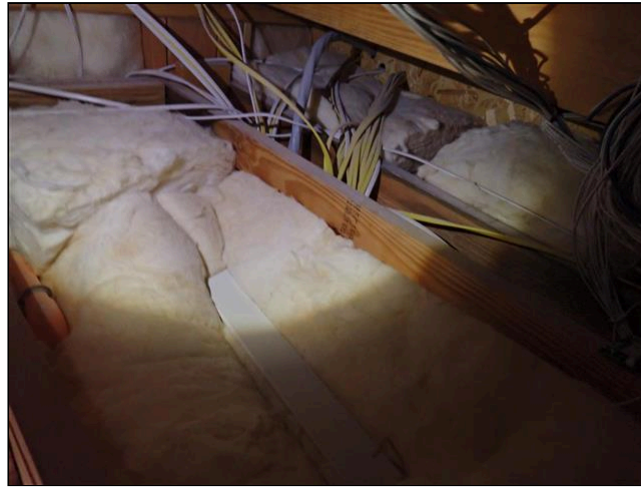
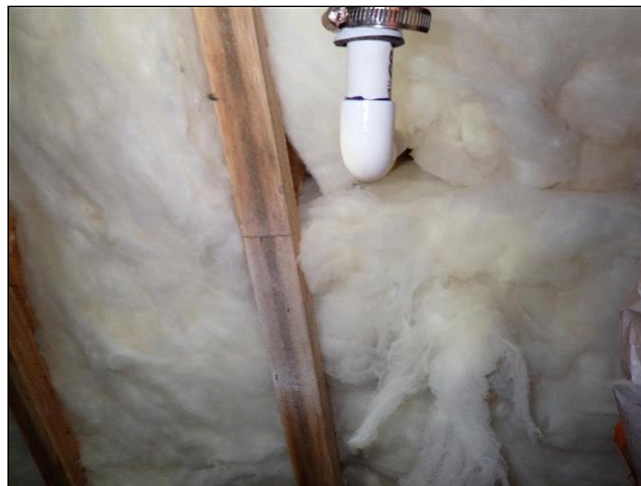
14.0 Item 1(Picture)

- (1) [Photo of the insulation.](#)

- (2) The insulation in the attic appears to be functioning as intended.

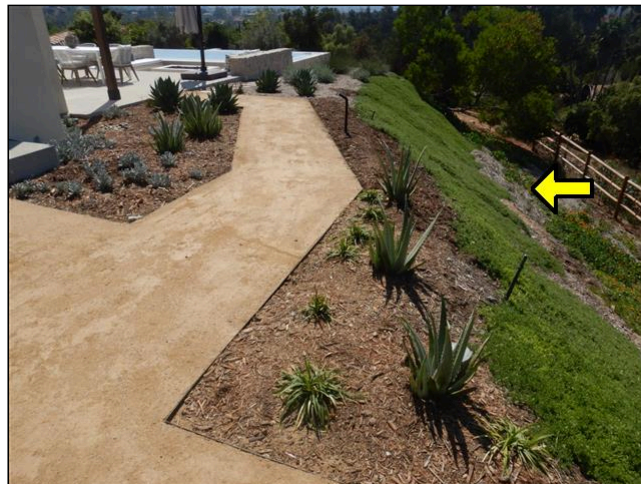
15.0 Item 1(Picture)

(2) This house is located within a sloped or hillside setting. Geological evaluations are beyond the scope of our inspection. We recommend further evaluation with a geotechnical engineer if concerned.

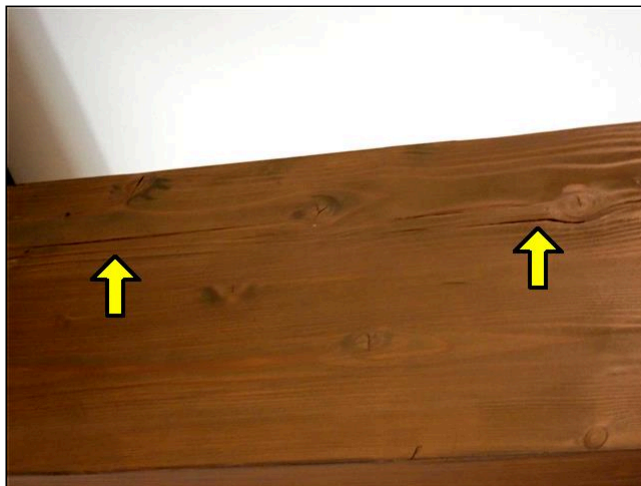
15.1 Item 1(Picture)

- (1) Due to the structure of the roof/ framing and forced air handling components, some areas of the attic space could not be inspected.
- (2) The beam in the living room has horizontal cracks. This condition could be caused by the wood drying out sometimes referred to as "checking". Large check cracks or cracks that extend to the bottom of a beam typically require repair. These cracks appear to be typical. If concerned we recommend further evaluation by a structural engineer prior to the end of your contingency period.

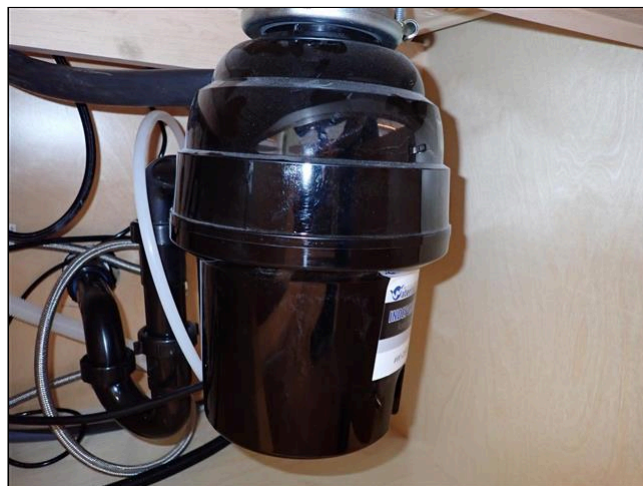
16.2 Item 1(Picture)

(1) The food waste disposer was tested and functioned properly at the time of the inspection. This is not an exhaustive test and does not verify the efficiency of the unit.

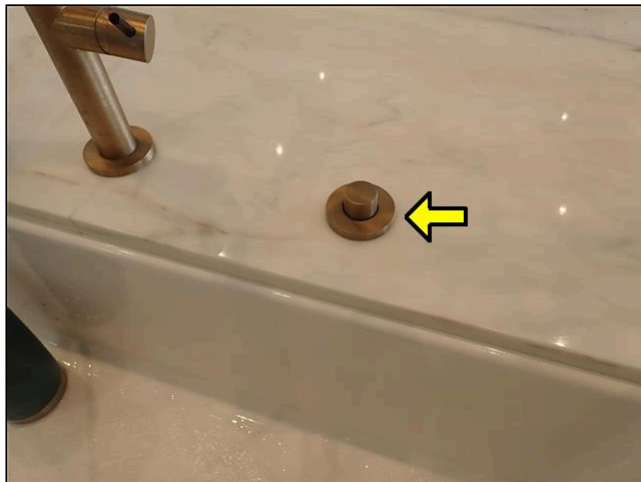
16.2 Item 2(Picture)

(2) The button for the garage disposer is loose on the countertop. We recommend re securing where needed by a qualified person.

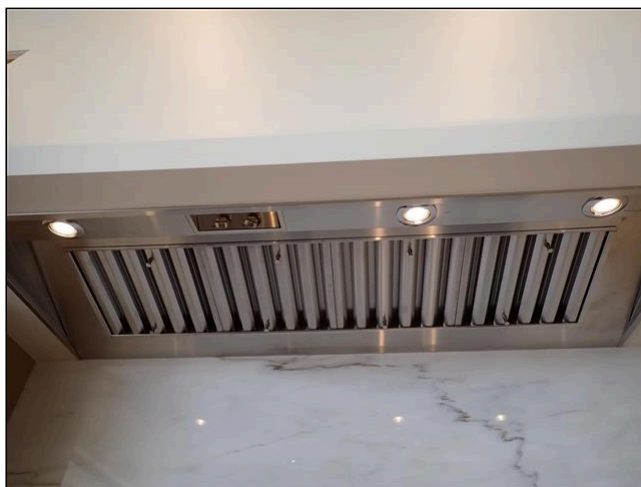
16.3 Item 1(Picture)

The range exhaust vent was tested and was functional at the time of the the inspection. This is not an exhaustive test, and does not evaluate the performance or effectiveness of the unit.

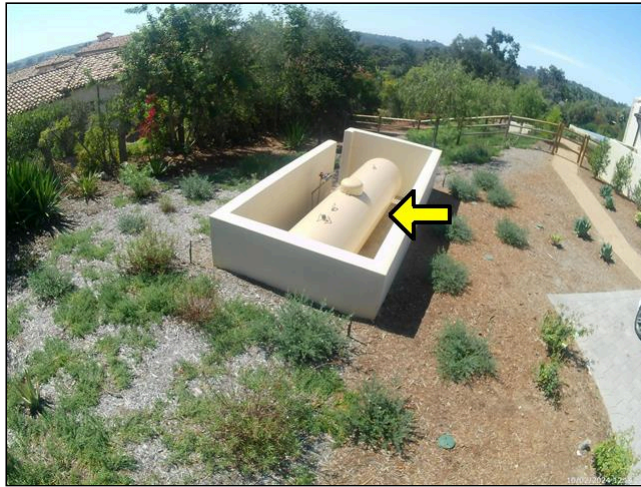
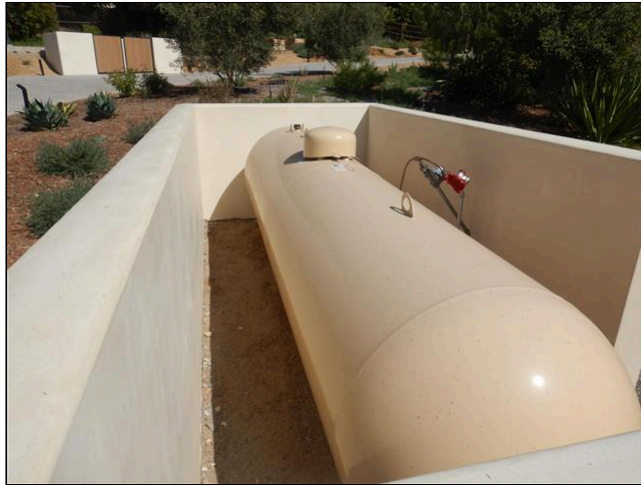
17.0 Item 1(Picture)

(1) The source for fuel is an above ground propane tank. I recommend further research to determine if the tank is leased or owned and whether or not it conveys with the sale of property.

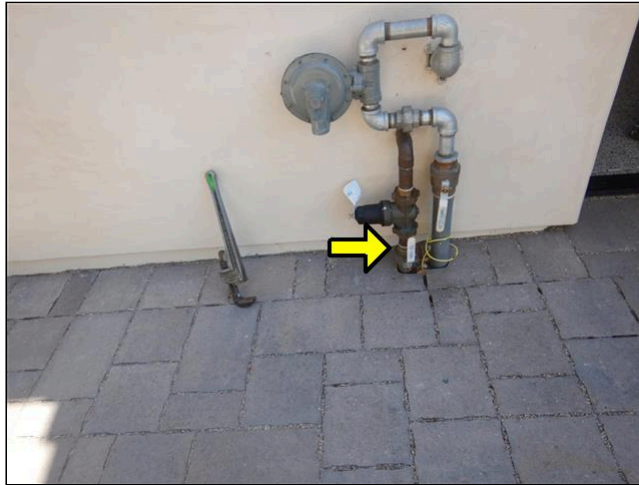
17.2 Item 1(Picture)

The main water shut-off valve is located at the right exterior side of the property (facing front).

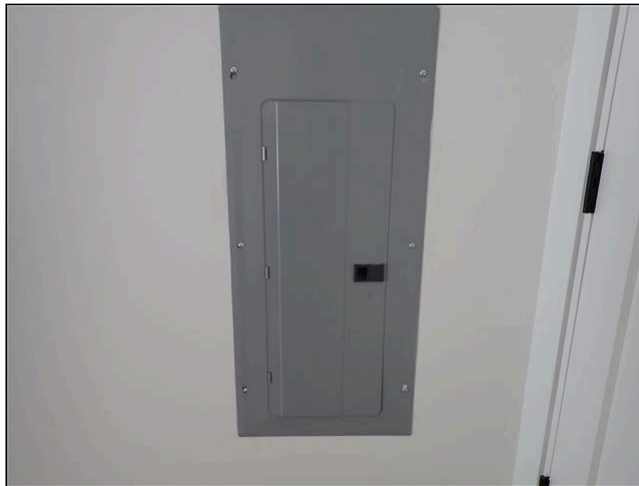
17.3 Item 1(Picture)

(1) The sub-panel is located in a bedroom.

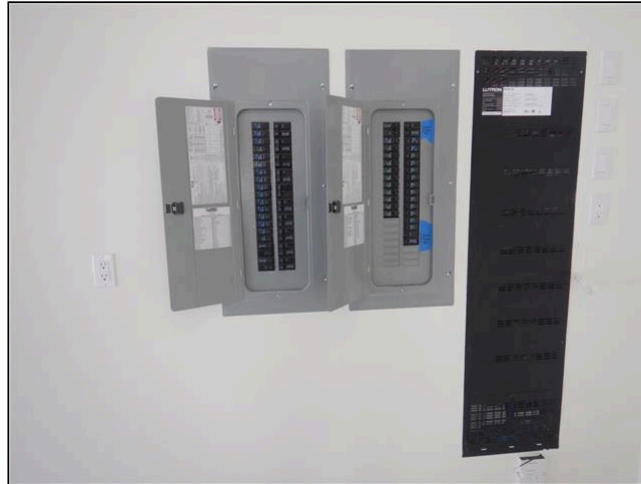
17.3 Item 2(Picture)

(2) Sub-panels are located in the garage.

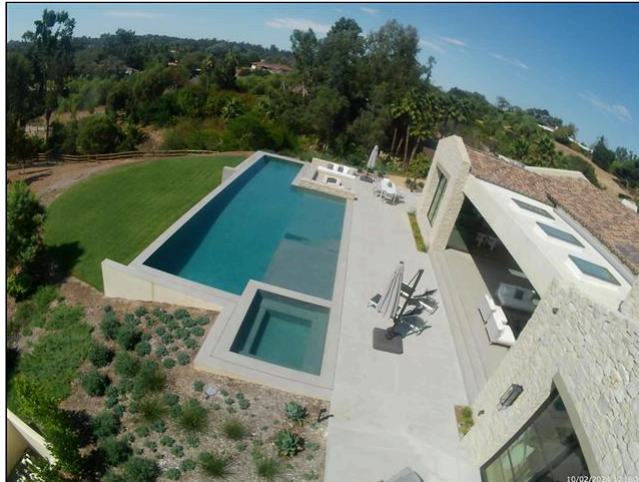
18.0 Item 1(Picture)

(1) Photo of the pool/ spa.

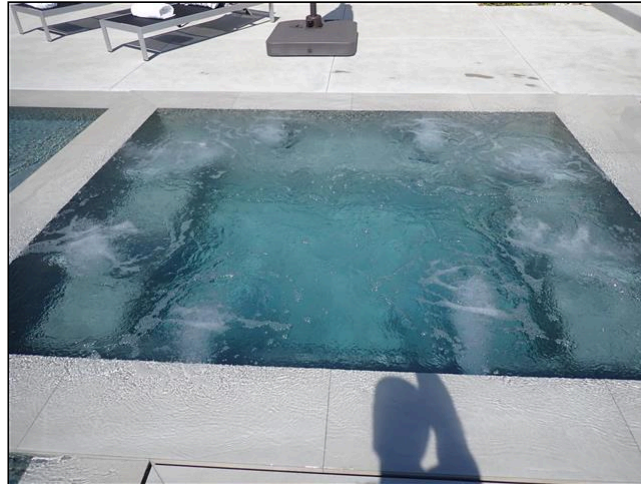
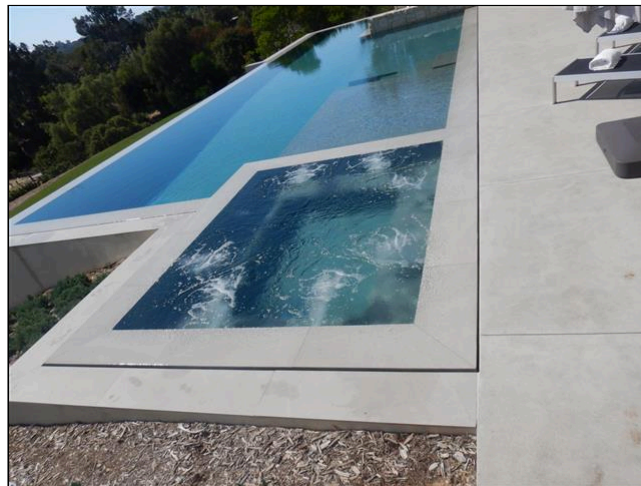
18.1 Item 1(Picture)

The spa jets functioned when tested.

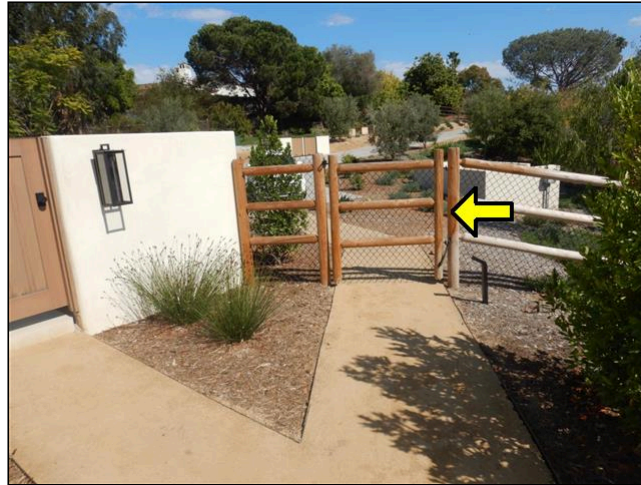
18.2 Item 1(Picture)

(1) The latest safety standards call for the fencing/gates/access points to be more child-proof around pools. These items can include the height of the fence, any openings, and the latch. We recommend upgrading the fencing by a qualified licensed fence contractor for child safety.

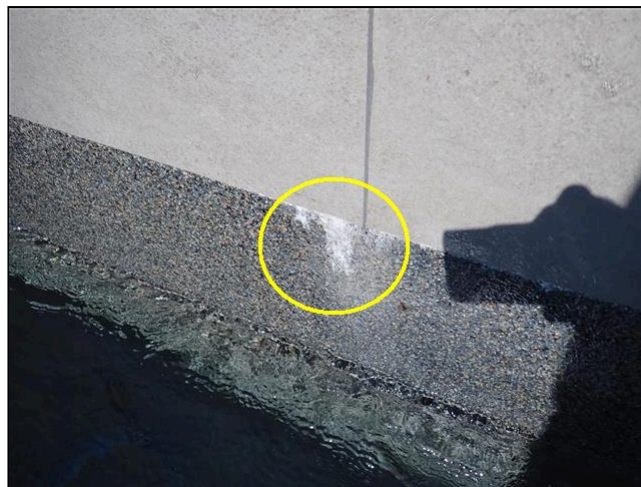
18.3 Item 1(Picture)

Calcium nodules are observed at the pool surface. This can be caused by poor chemical maintenance or unbalanced Ph levels. We recommend further evaluation by a qualified licensed pool contractor prior to the end of your contingency period.

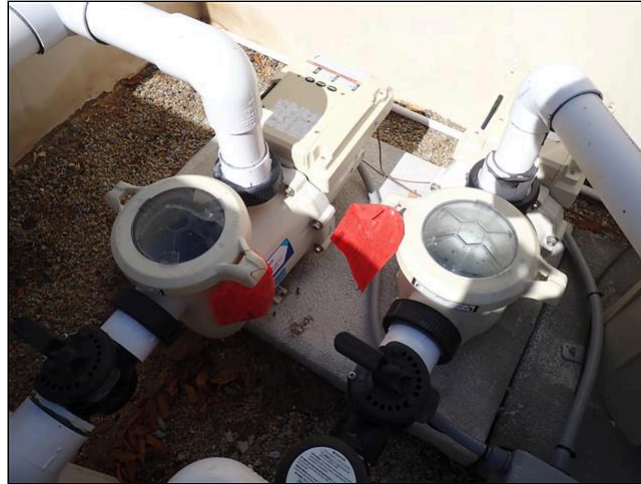
18.5 Item 1(Picture)

(1) The pool/spa pump(s) were tested and were found to be operational at the time of the inspection. Pumps are not evaluated for capacity, efficiency, flow rate or pressure.

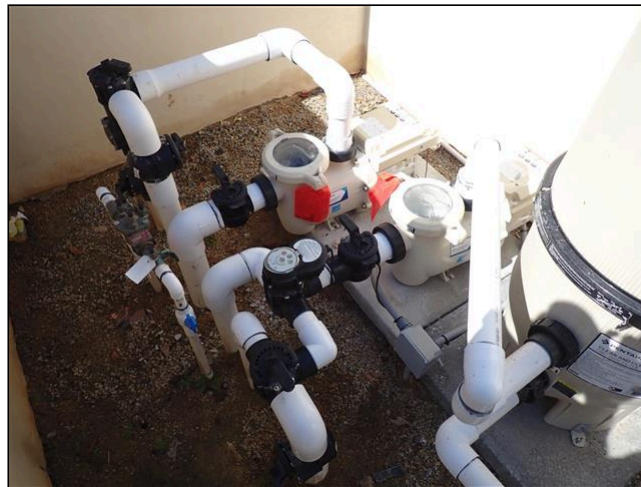
18.5 Item 2(Picture)

(2) Portions of the exposed PVC pool piping is not painted. Paint the PVC piping protects the piping and prevents premature deterioration from exposure to ultraviolet light. We recommend painting the exposed PVC piping where needed.
