Inspection Report

Property Address:
1123 Main Road
Rancho Santa Fe CA 92067

The Property Inspection Pros

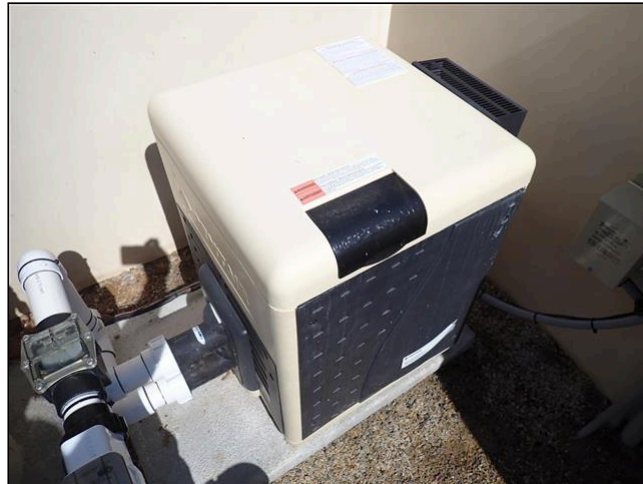
18.6 Item 1(Picture)

(1) The pool furnace was tested and was operational at the time of the inspection. This is not an exhaustive test and does not verify the efficiency of the unit.

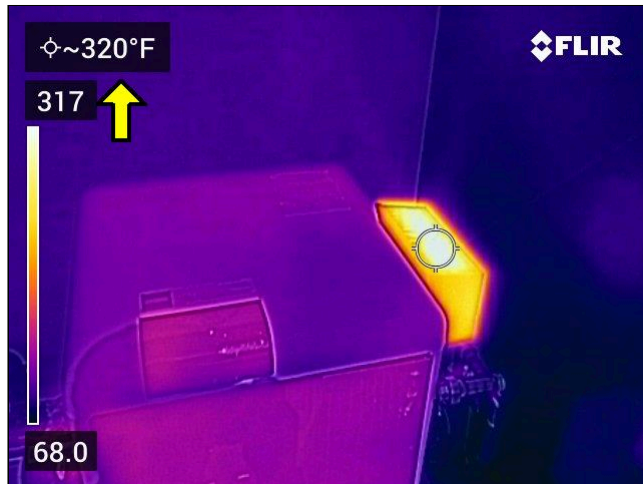
18.6 Item 2(Picture)

(2) **Infrared Thermal photo of the pool/ spa furnace being tested.**

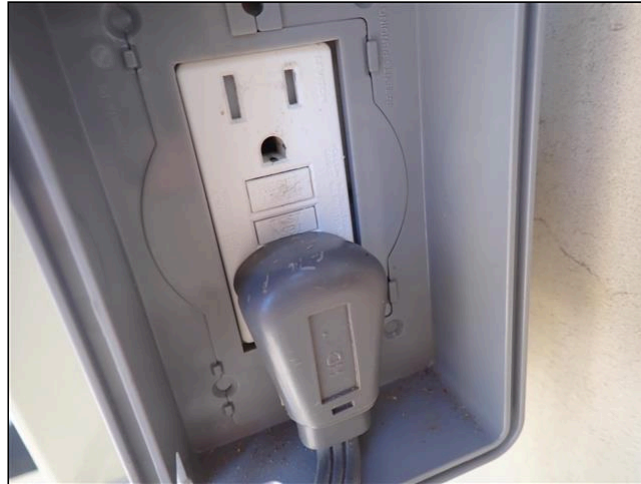
18.9 Item 1(Picture)

The GFCI outlet was tested and was found to be operable at the time of the inspection.

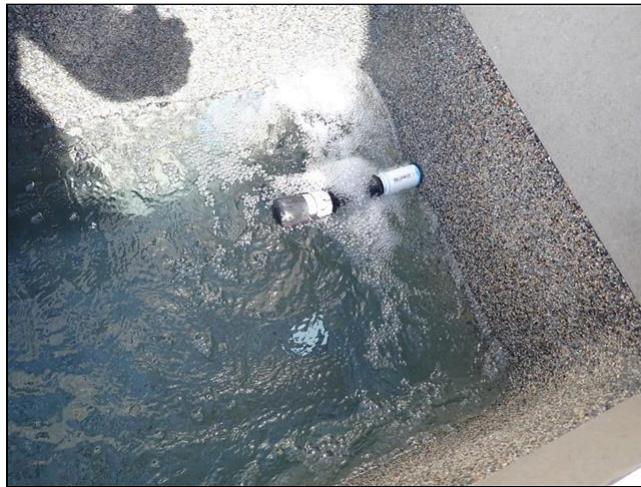
18.13 Item 1(Picture)

The pool fill device was tested and was operational at the time of the inspection.

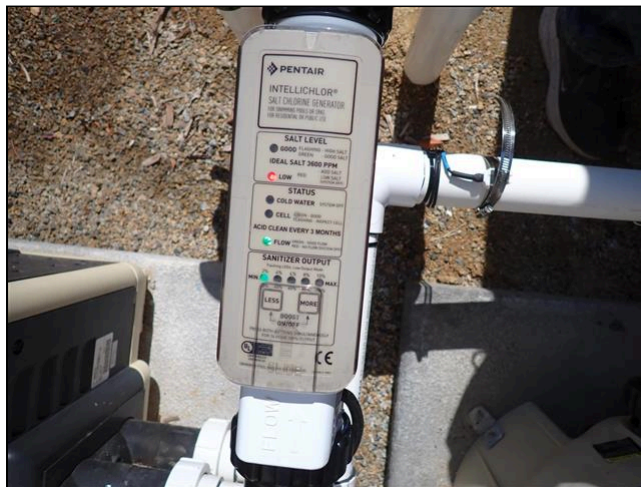
18.14 Item 1(Picture)

The chlorinator appears to be functioning as intended.

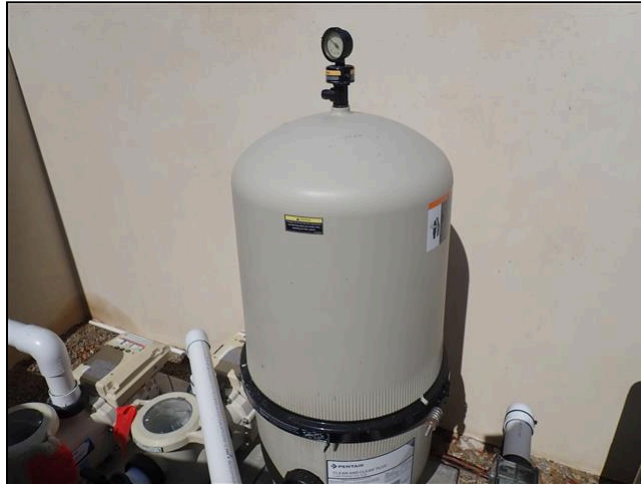
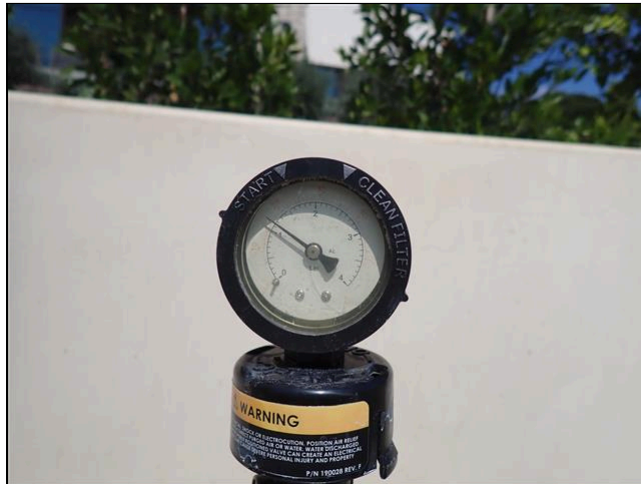
18.16 Item 1(Picture)

exhaustive test and does not verify the cleaning efficiency of the unit.
