# Inspection Report

1243 Main Lane  
San Diego CA 92128

## The Property Inspection Pros

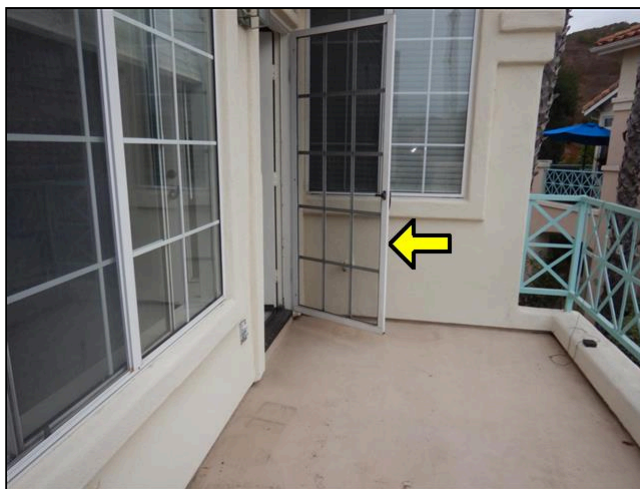
2.2 Item 1(Picture)

(1) The door has a torn or damaged screen. We recommend repair or replacement by a qualified person.

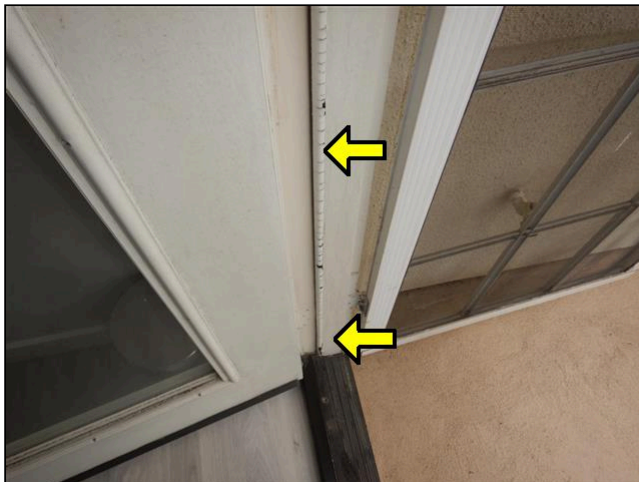
2.2 Item 2(Picture)

(2) The deck door weather-stripping is damaged. We recommend replacement by a qualified person.

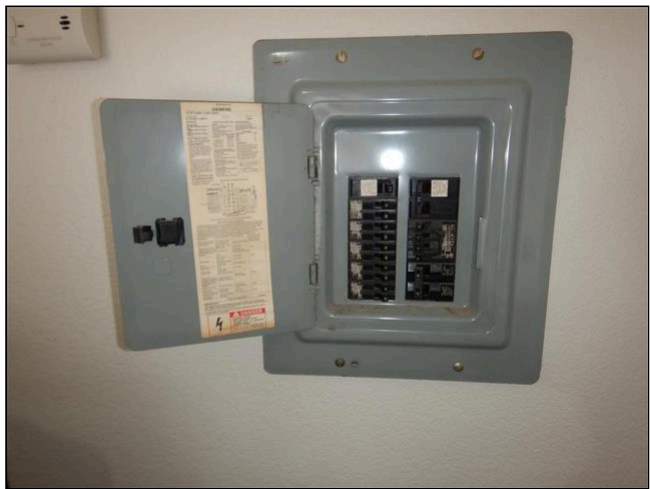
3.0 Item 1(Picture)

**Photo of the sub electrical panel.**

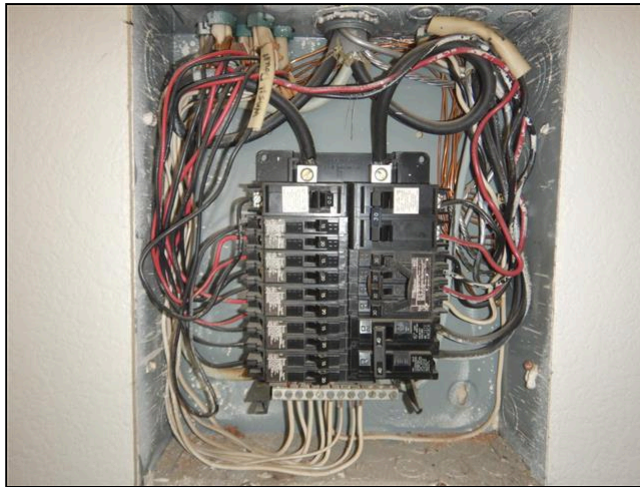
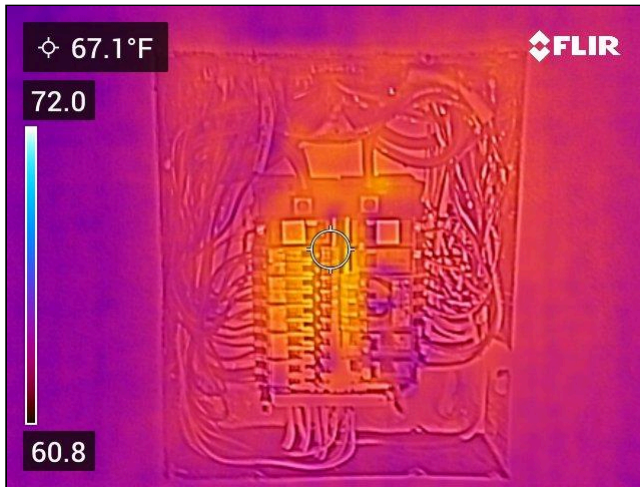
3.1 Item 1(Picture)

The dead front cover was removed at the time of the inspection and the breakers, wiring and grounding were inspected. Appears to be functioning as intended.

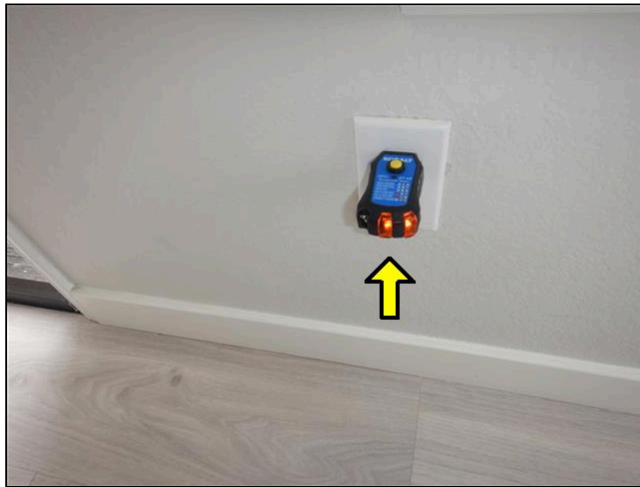
3.6 Item 1(Picture)

A representative number of receptacles throughout the property were tested for power, polarity and grounding according to our standards-of-practice. These receptacles observed to be ok at the time of the inspection unless otherwise noted.

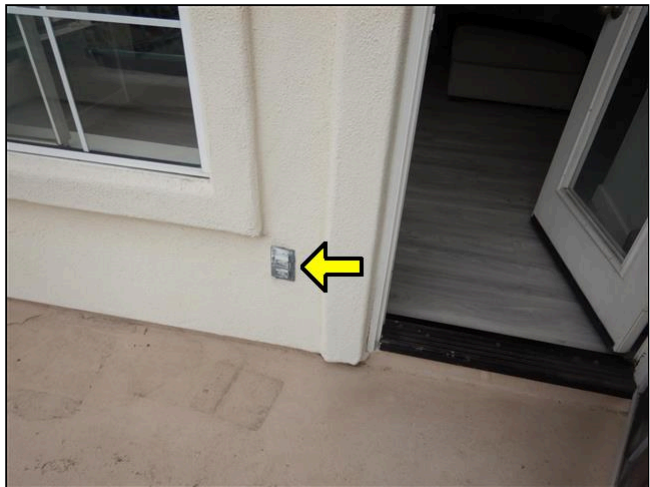
3.9 Item 2(Picture)

(2) We recommend upgrading all receptacles within 6 feet of any plumbing fixtures, outside/ exterior, in the garage, and any non fixed appliance receptacles in the kitchen to GFCI protected receptacles by a qualified licensed electrician for safety.

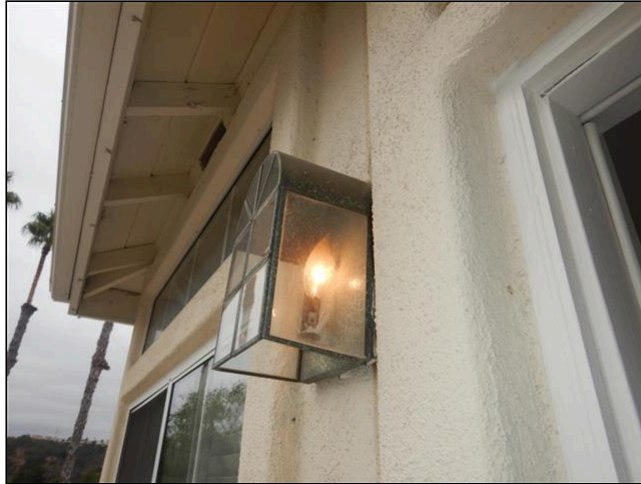
3.12 Item 1(Picture)

A representative number of exterior lights were tested and were found to be functional at the time of the inspection.

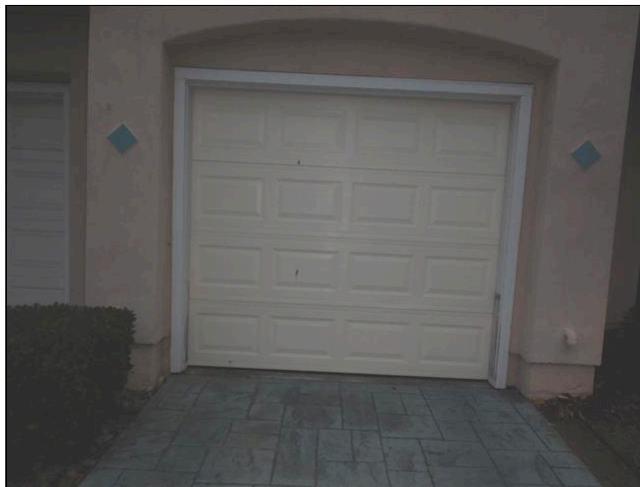
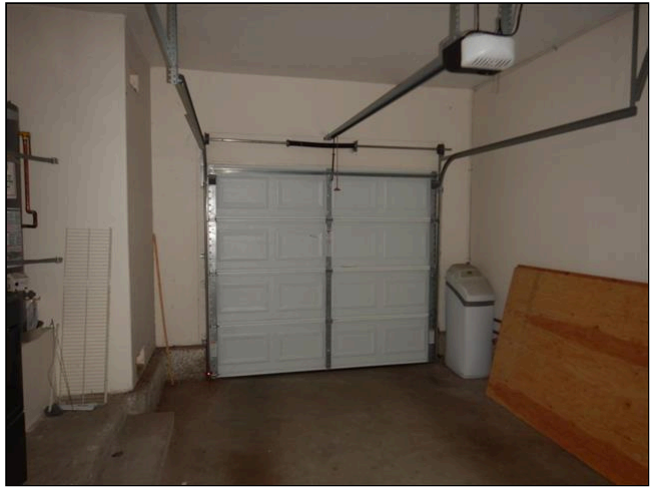
4.0 Item 1(Picture)

The garage vehicle door hardware including the door, track, and springs appear to be functioning as intended.

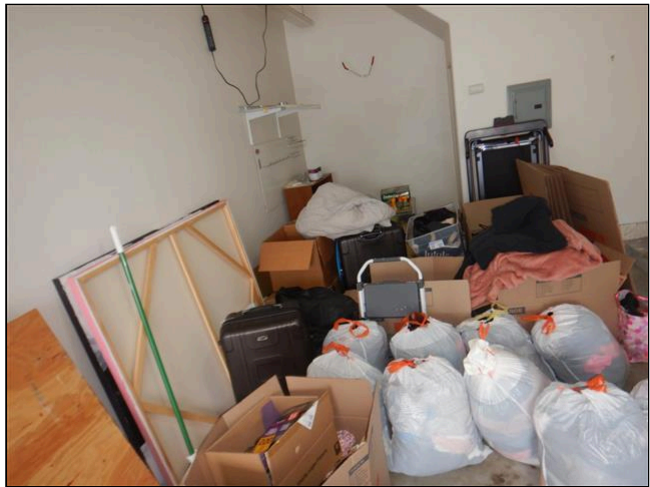
4.3 Item 1(Picture)

(1) Due to occupants personal items, not all areas of the property were visible and accessible at the time of the inspection. Several windows, doors, outlets, walls, flooring, and other areas were obstructed from view and could not be inspected. The home inspector does not move personal items, panels, furniture, equipment, plant life, soil, debris, ect. that obstructs their access or visibility. We recommend that you conduct a careful evaluation during your final walk-through or prior to the end of your contingency period to ensure that there are no hidden defects. All doors, windows, and outlets should be tested and verified for proper operation prior to the end of your contingency period by a qualified person. If any damage is observed we recommend asking the seller about it. We recommend that any damage found be repaired or replaced by a qualified licensed contractor in the appropriate trade.

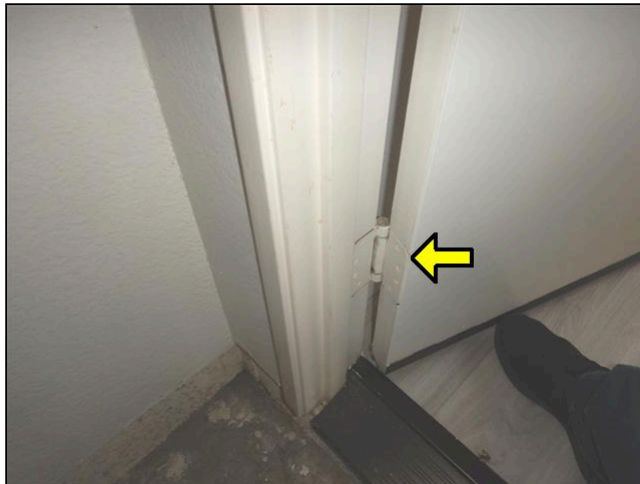
4.6 Item 1(Picture)

A self-closing device was present at the fire door and was operating properly when tested. The door closes and latches within 3 seconds without assistance as required.

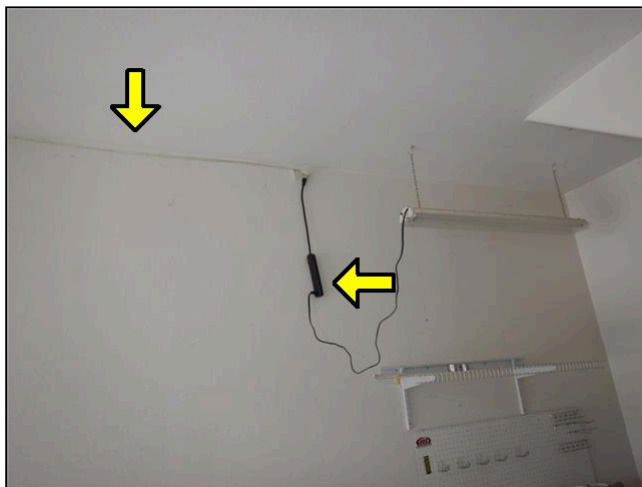
4.7 Item 1(Picture)

There is an extension cord being used as wiring at the garage door opener. This is a non standard installation. We recommend having a permanent receptacle installed for use by the garage door opener by a qualified licensed electrician.

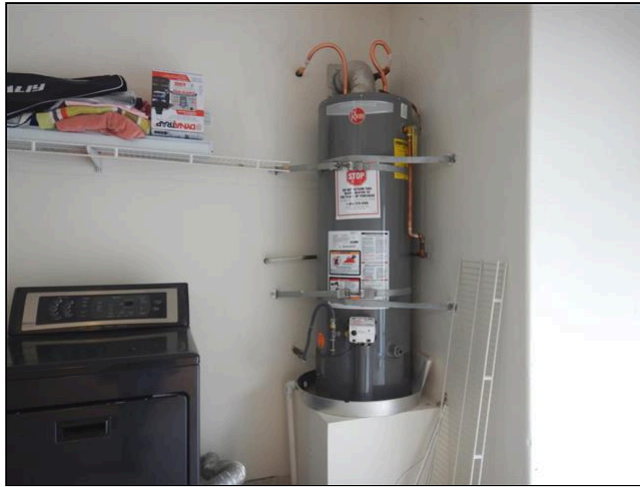
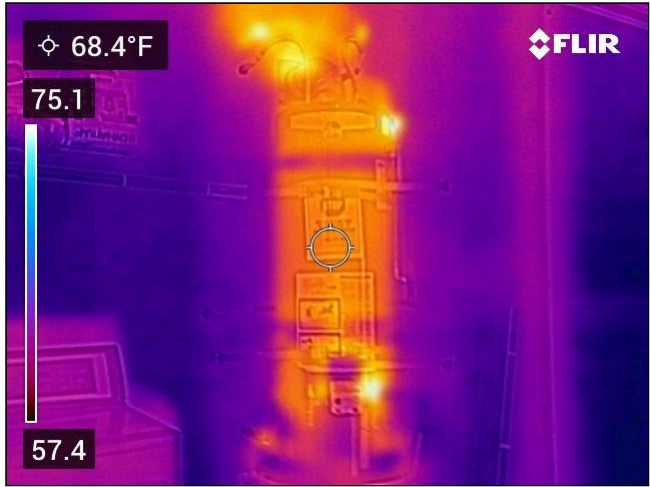
5.0 Item 1(Picture)

- (1) [Photo of the water heater.](#)

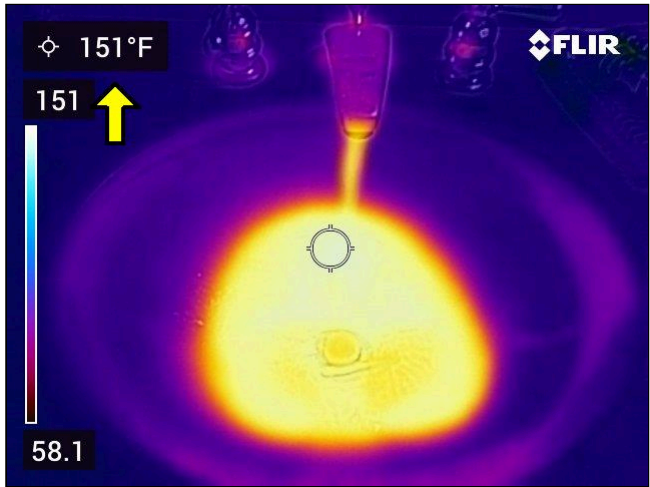
5.0 Item 3(Picture)

The temperature of the water was tested using a thermal camera at the time of the inspection and found to be above 125 degrees. Water temperatures above 125 degrees can cause scalding or burns. Most water heater manufacturers recommend setting the water heater controls at 120 degrees for optimum efficiency. We recommend setting the water heater controls at 120 degrees by a qualified person for optimum efficiency.

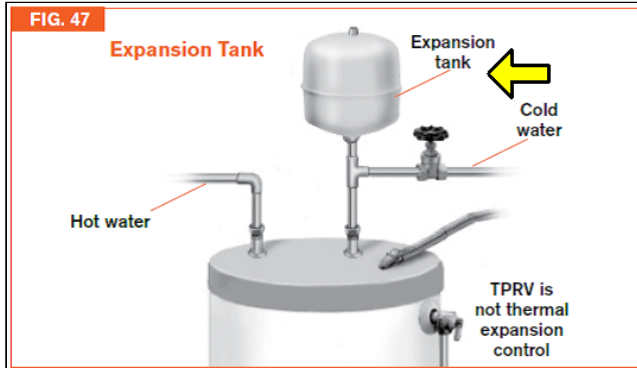
5.0 Item 4(Picture)

(4) The water heater does not have a "Thermal Expansion Tank" installed to prevent a possible leak at the T&P or "pop-off" valve. Recent changes in code require one when a new water heater is installed. This change is not retroactive on older previously installed Gas/LP water heaters. There were no leaks or drips at the T&P valve during inspection. If your water heater does begin to drip or leak, then a thermal expansion tank may be needed. We recommend installing a thermal tank by a qualified licensed plumber as an upgrade.

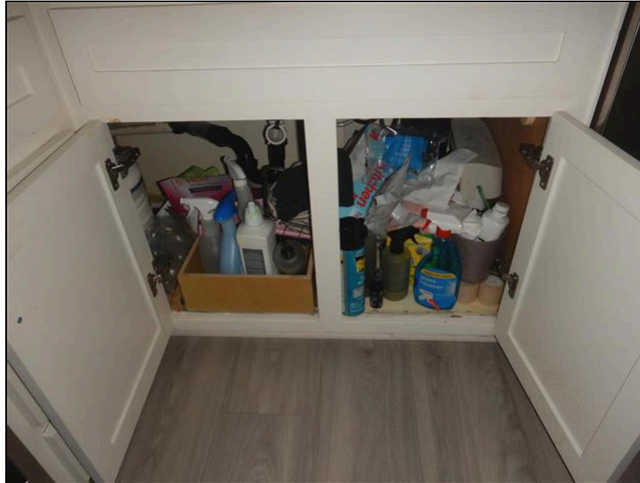
6.5 Item 1(Picture)

(1) Due to stored personal items such as towels, clothing, personal items, hygiene and/ or cleaning products, a full evaluation of the cabinets and closets could not be made. We recommend that you carefully inspect all cabinets and closets prior to the end of your contingency period or during your final walk through. The home inspector does not move personal items, panels, furniture, equipment, plant life, soil, debris, ect. that obstructs their access or visibility. If any damage is observed we recommend asking the seller about it. We recommend that any damage found be repaired or replaced by a qualified licensed contractor in the appropriate trade..

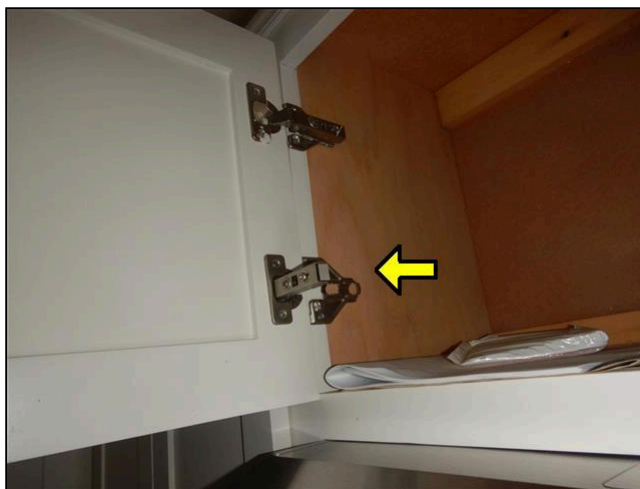
6.5 Item 2(Picture)

(2) Cabinet door hardware is noted to be loose at a kitchen cabinet doors. We recommend necessary corrections where needed by a qualified person.

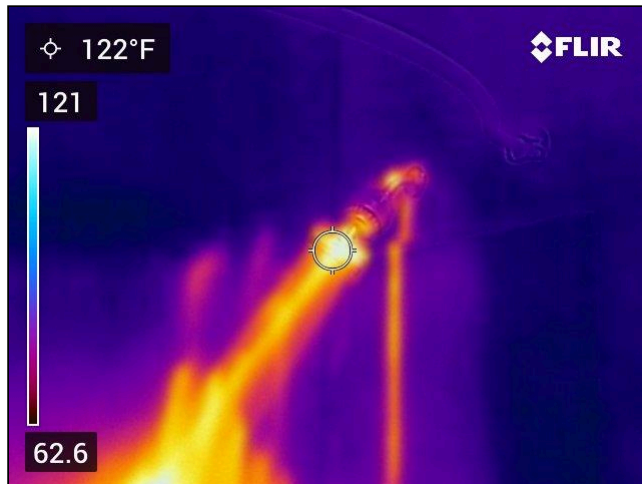
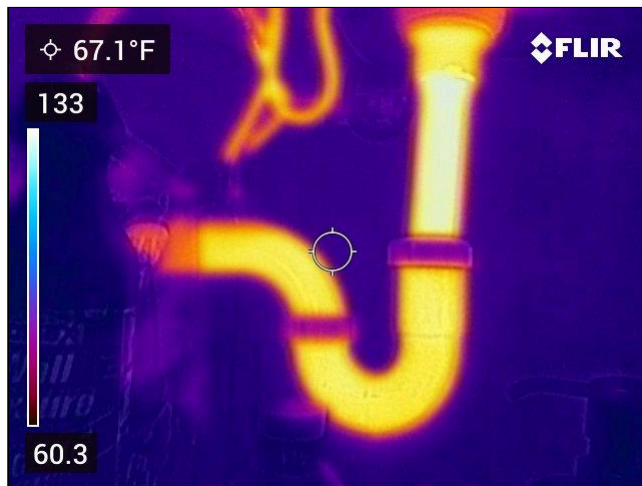
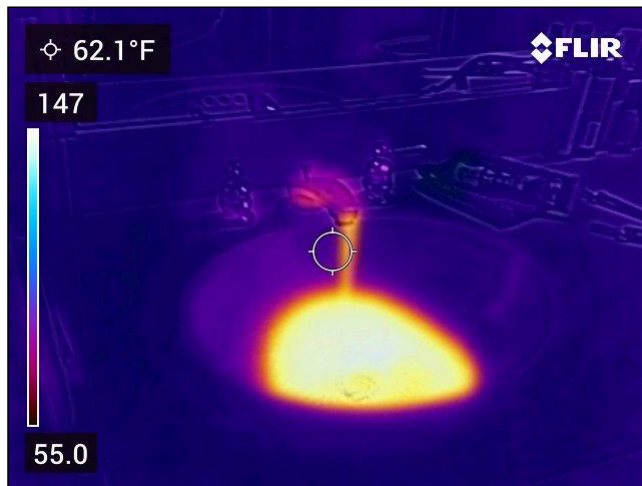
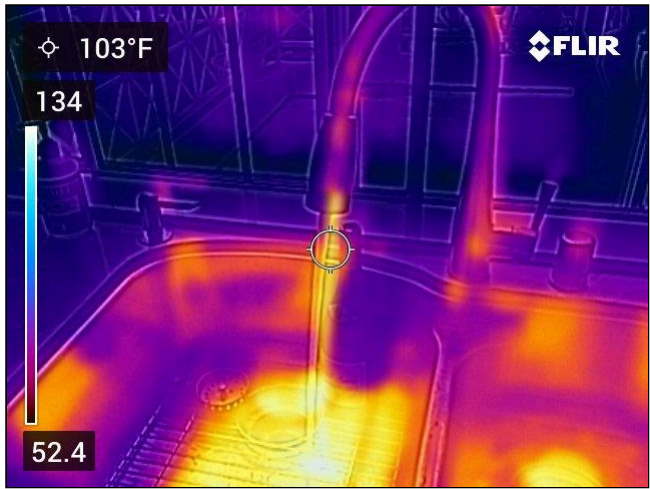
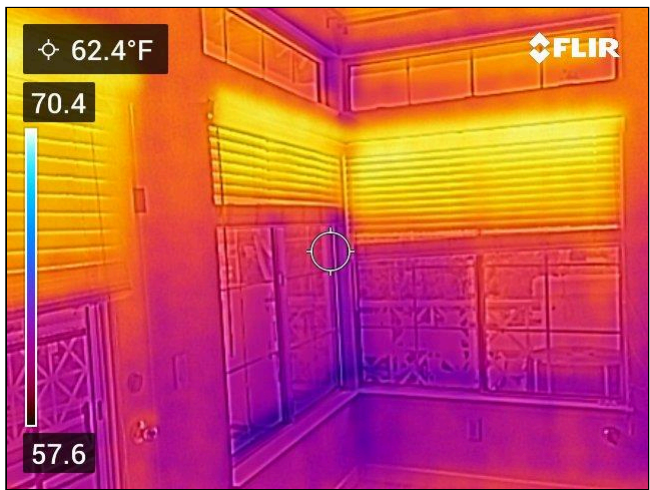
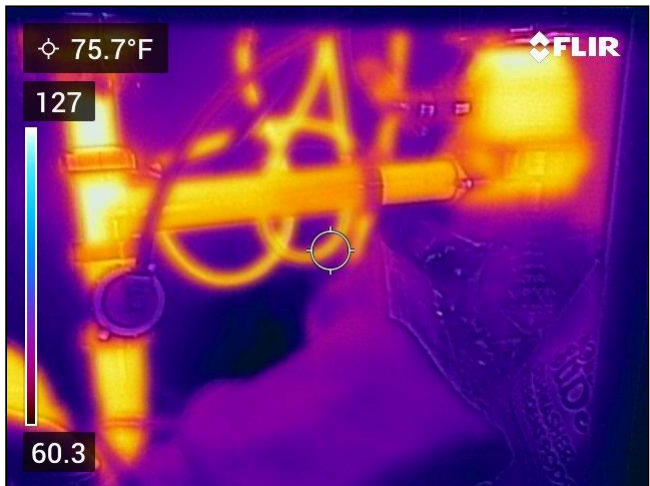
6.7 Item 1(Picture)

(1) Infrared Camera Thermal Photos.

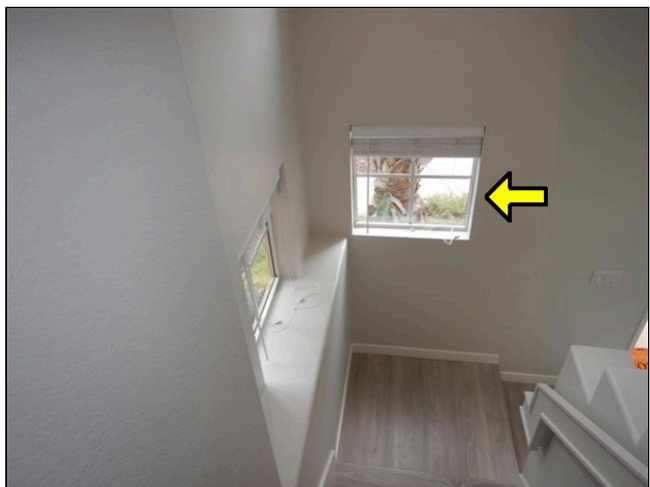
6.8 Item 1(Picture)

The windows located with in the stairwell landing do not appear to have safety tempered glass as required. I could not find any markings on the glass which would confirm this safety feature. Having standard plate glass could cause serious injury if the glass breaks. While this may have been standard installation at the time of the original construction. We recommend upgrading the glass to tempered glass by a qualified licensed window contractor as a safety upgrade.

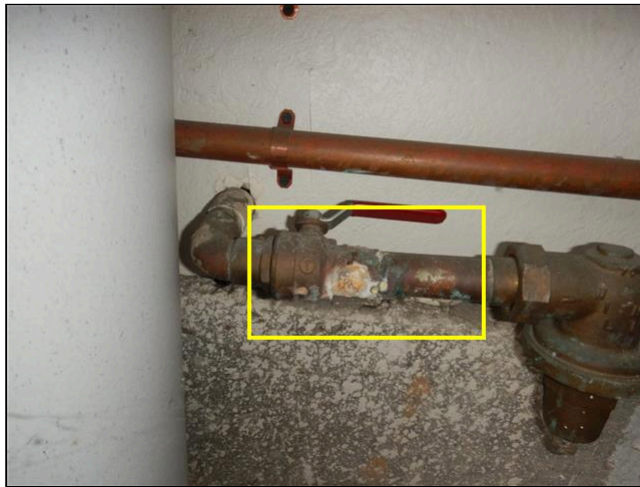
7.2 Item 1(Picture)

(2) A corroded pipe is observed in the garage. We recommend further evaluation by a qualified licensed plumber and necessary repairs made.

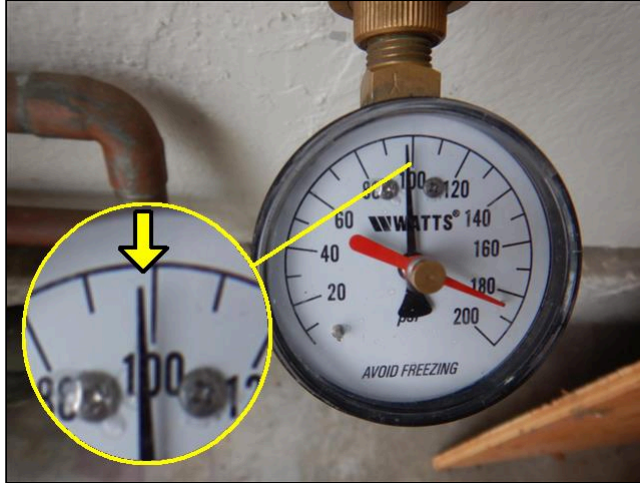
7.3 Item 1(Picture)

The water pressure was checked with a water pressure gauge and was measured to be higher than 80 PSI at the time of the inspection. This is to high and corrections are needed. We recommend further evaluation by a qualified licensed plumber for necessary repairs or corrections.

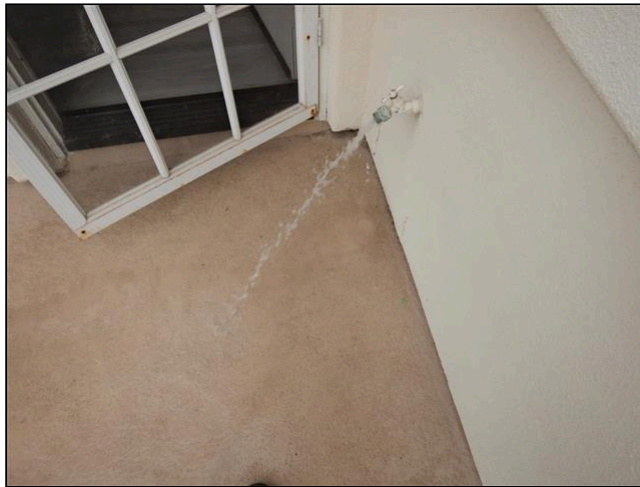
7.4 Item 1(Picture)

(1) The accessible hose spigots were tested and were found to be operational at the time of the inspection. Note: Some hose spigots may leak or drip when a watering hose is connected due to back pressure.

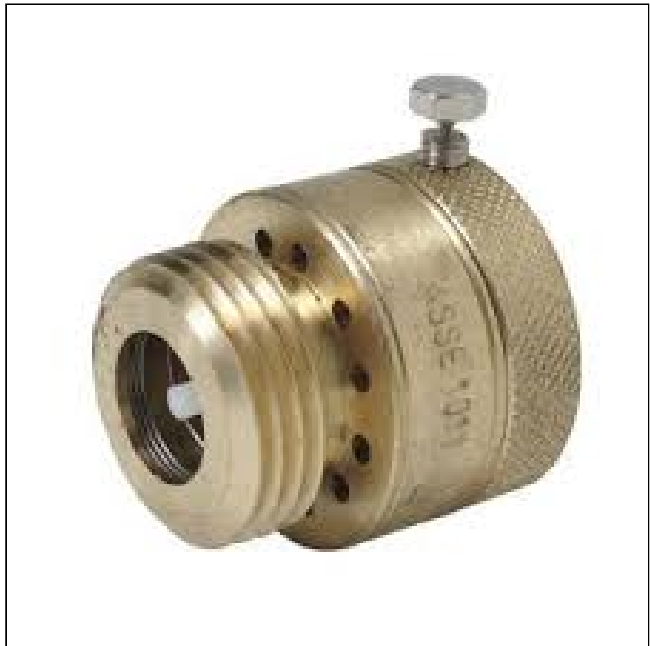
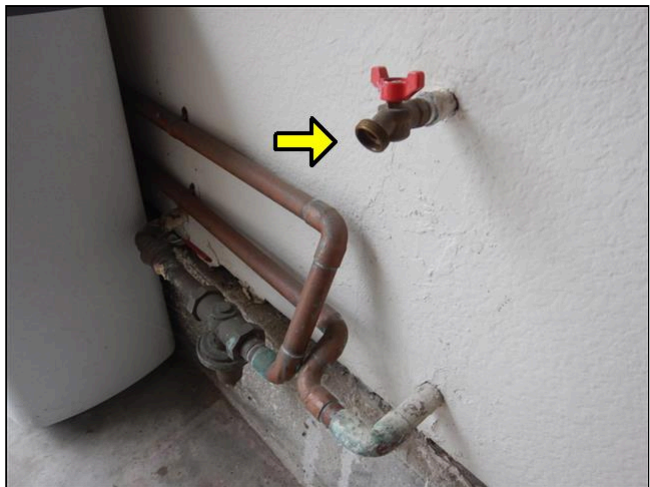
7.4 Item 2(Picture)

(2) The exterior hose spigots do not have anti-siphon or anti-backflow devices installed on them. These anti-siphon or anti-backflow devices help prevent contaminated water from flowing back into the the house water supply system. We recommend installing anti-siphon or anti-backflow devices at the every exterior hose spigots by a qualified person.

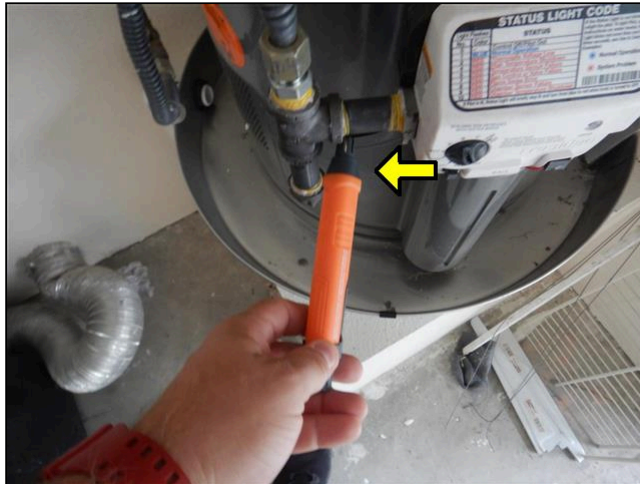
7.5 Item 1(Picture)

A gas leak test was conducted at accessible gas fittings and appliances using a gas leak detector. There were no gas leaks detected at the time of the inspection.

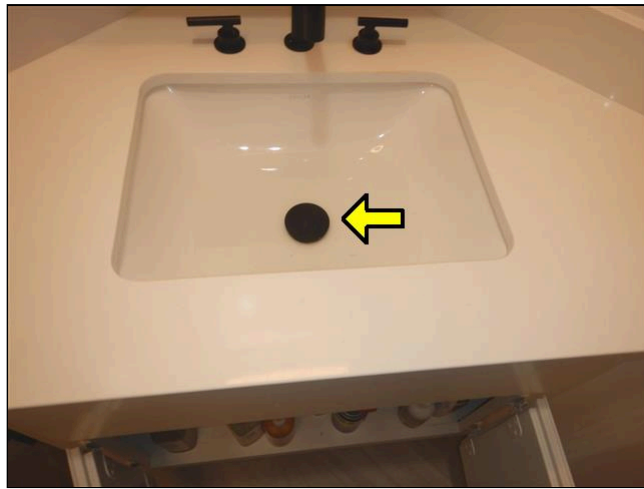
8.0.A Item 1(Picture)

The sink in the bathroom was slow draining at the time of the inspection This may indicate a blockage in the drain line. We recommend further evaluation by a qualified licensed plumber and repairs as needed.

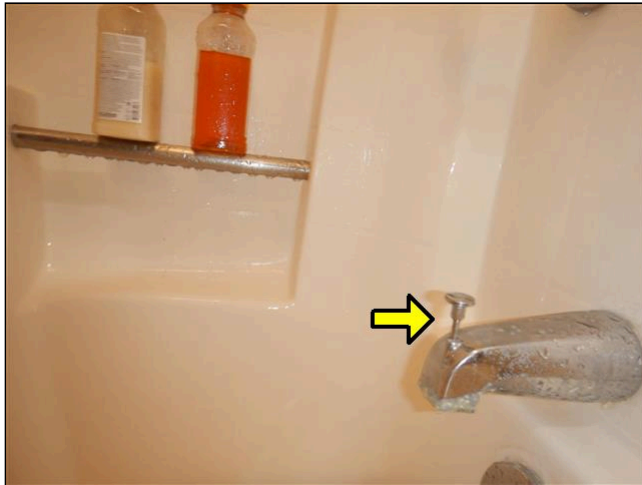
8.2.A Item 1(Picture)

(1) The tub diverter did not operate properly when tested. This is likely due from hard water deposit build up on the tub spout mechanism. We recommend necessary repairs or replacement by a licensed plumber.

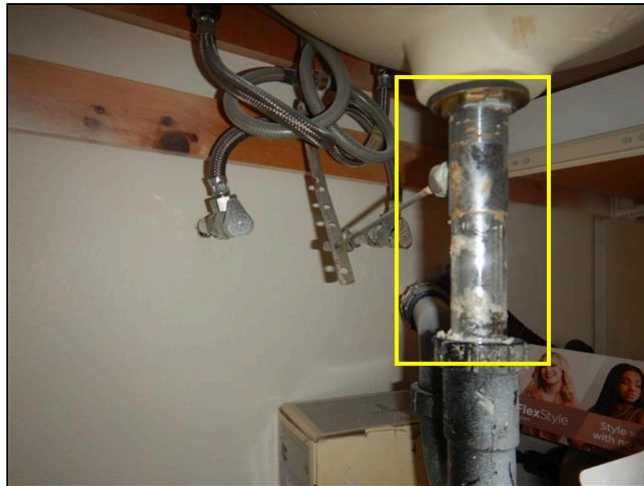
8.0.B Item 1(Picture)

(1) The metal portions of the sink drain are rusted or corroded. A leak was not observed at this sink drain pipe at the time of the inspection. However, we recommend replacing this drain pipe by a qualified licensed plumber to help prevent future leaks or damage.

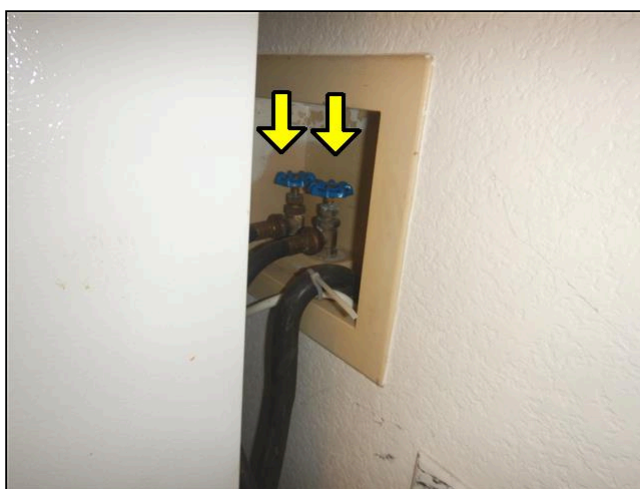
9.0 Item 1(Picture)

(3) The hot and cold laundry water shut off valves are older gate valves. These gate valves can become "seized" due to lack of regular use and/ or calcium build up. Home inspectors do not test these valves as they may leak if turned. We recommend replacing these gate valves with ball type water shut off valves by a qualified licensed plumber.

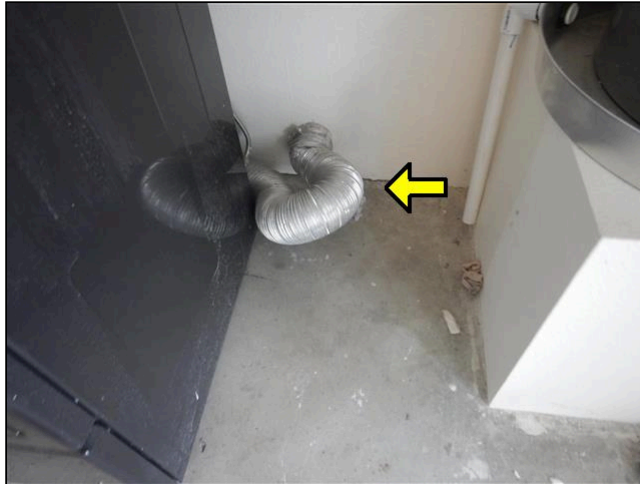
9.1 Item 1(Picture)

We recommend having the dryer vent cleaned by a qualified person.

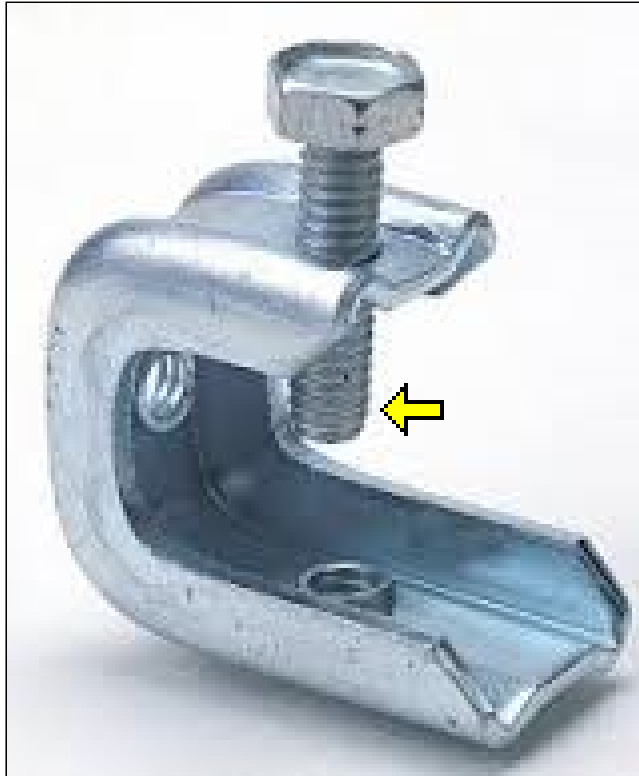
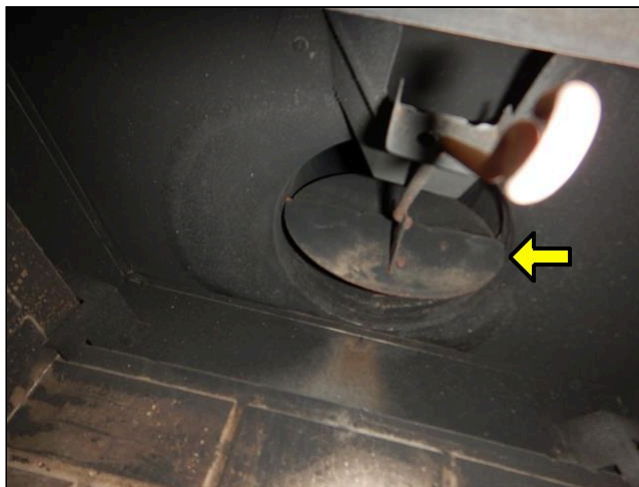
10.2 Item 1(Picture)

A damper clamp is not installed at the family room fireplace damper door. A damper clamp is required to be installed at a damper door when there is a gas supply to the fireplace(s). This damper clamp help prevents the damper from closing all the way as a safety precaution. If the damper is closed, Carbon Monoxide gas could enter the living space easier which is undetectable. SDG&E now requires damper clamps at all fireplaces damper doors. We recommend installation of a damper clamp by a qualified person.

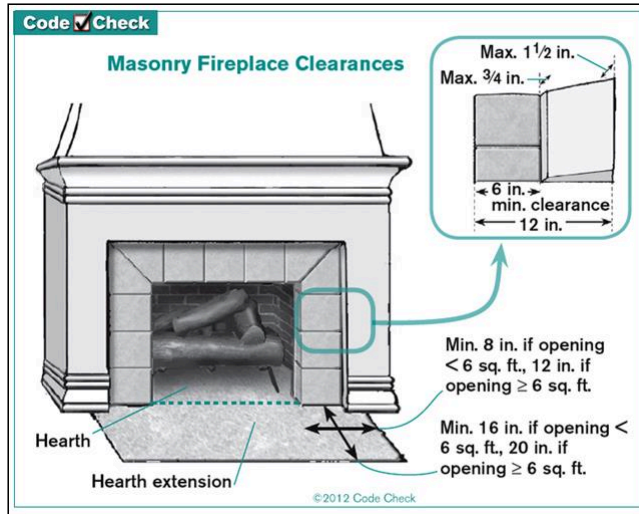
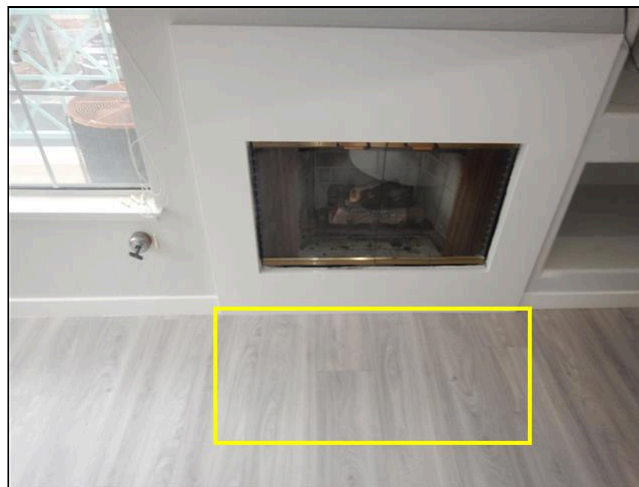
10.3 Item 1(Picture)

The hearth at the front of the fireplace is missing/ of inadequate size/ or an improper material. This condition does not comply with current building and fire and safety requirements. We recommend installation of a properly sized hearth by a qualified licensed contractor.

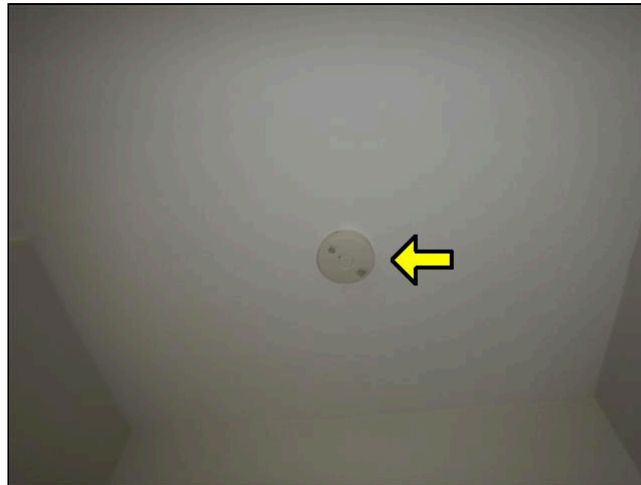
11.0 Item 1(Picture)

(2) The smoke detectors in the property are older. Studies show that detectors that are more than 10 years old have a high rate of failure. Many old detectors do not have battery back-up, and will not work if the electricity is off. We recommend that all old detectors be replaced prior to occupancy of the house for safety.

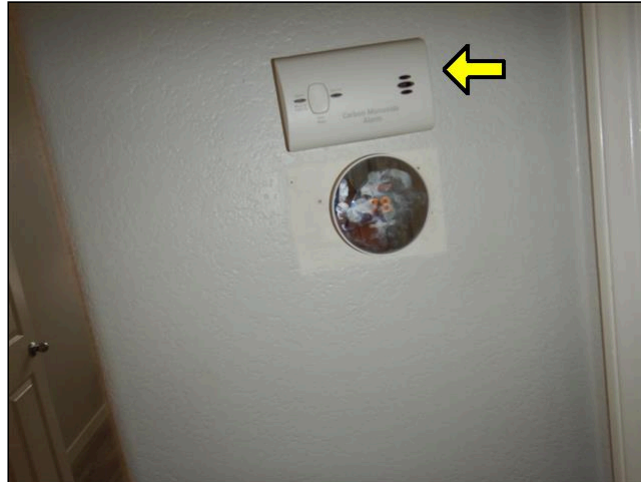
11.1 Item 1(Picture)

(1) **Photo of carbon monoxide detector(s).**

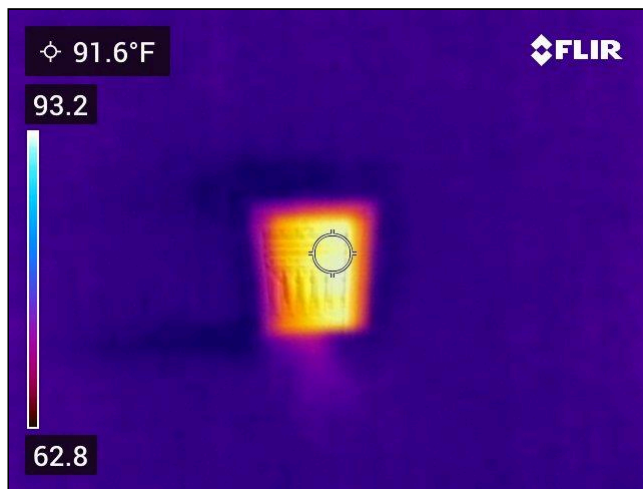
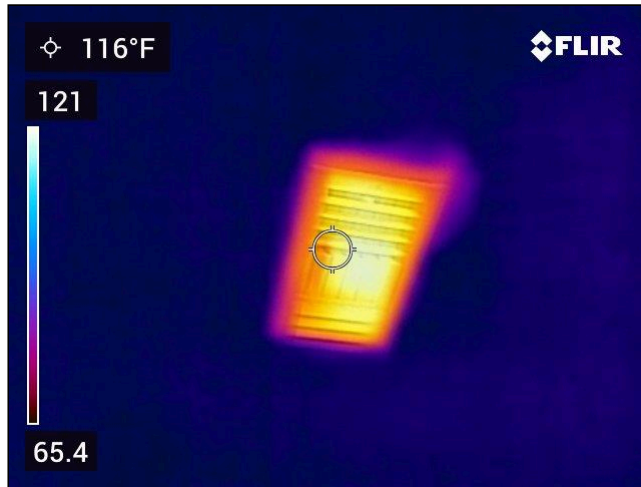
12.0 Item 1(Picture)

(1) **Infrared Thermal photo of the furnace(s) being tested.**

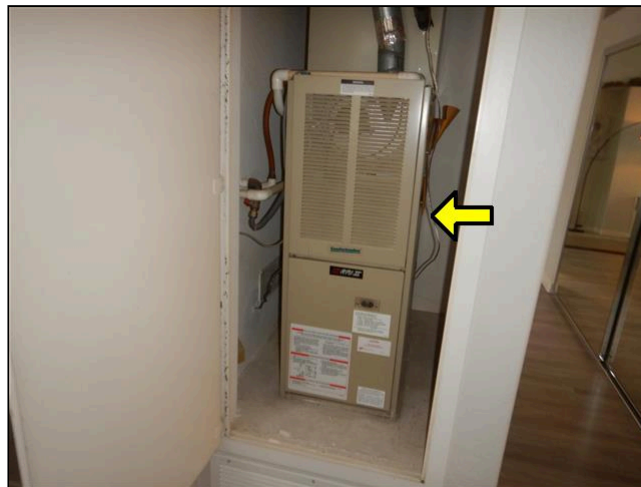
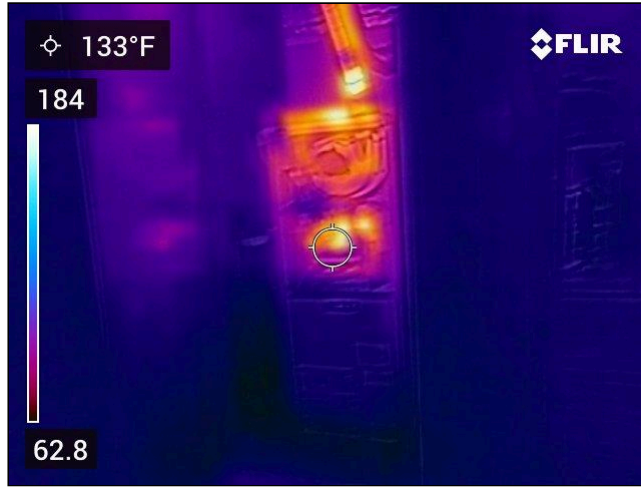
12.0 Item 3(Picture)

(2) The furnace is older but did work at the time of the inspection. I was unable to determine life remaining. Most HVAC contractors state that furnaces that are 20 years old or older are more likely be at the end of their useful life. We therefore recommend that you have this furnace inspected and serviced by a qualified licensed HVAC contractor to make sure that it is safe, and to obtain an estimate of life remaining, and a cost of replacement prior to the end of your contingency period. We also recommend that you keep a good home warranty in place, which covers the furnace.

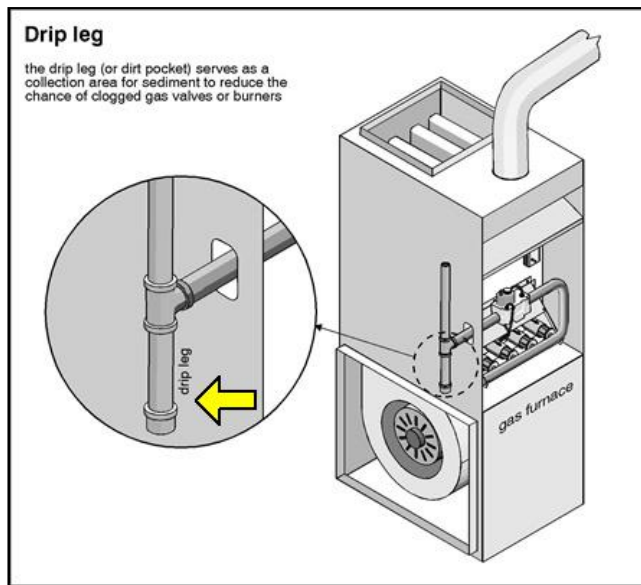
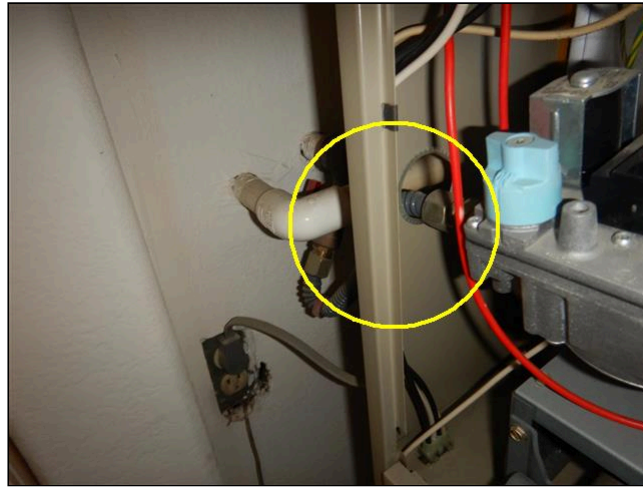
12.0 Item 5(Picture)

(3) The gas supply pipe at the furnace did not contain a drip leg/ sediment trap. This may have been standard at the time of installation but now is highly recommended. The purpose of a drip leg is to help prevent sediment/ debris from entering and clogging the furnace gas valve which could cause the furnace to shut down. We recommend having a drip leg installed by a qualified licensed HVAC contractor.

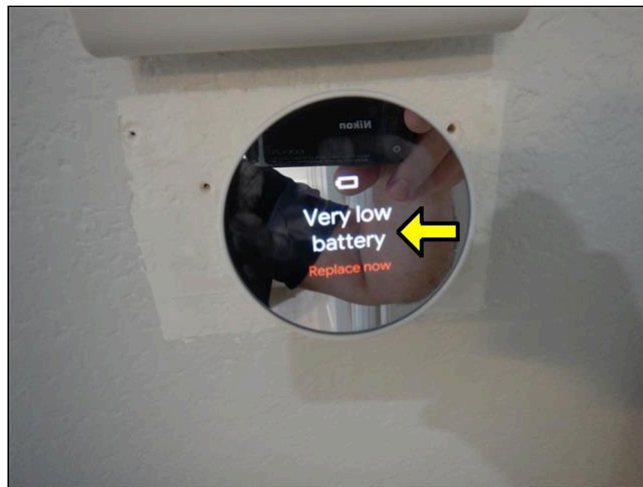
12.1 Item 1(Picture)

- (1) The thermostat was operational when used to operate the HVAC system at the time of the inspection. Programmable thermostats are not adjusted and no testing is done to check the accuracy or programmed settings of the thermostat. If concerned we recommend verifying proper operation of the programmable settings prior to the end of your contingency period by a qualified person.
- (2) The the thermostat batteries are weak or dead. We recommend replacement by a qualified person.

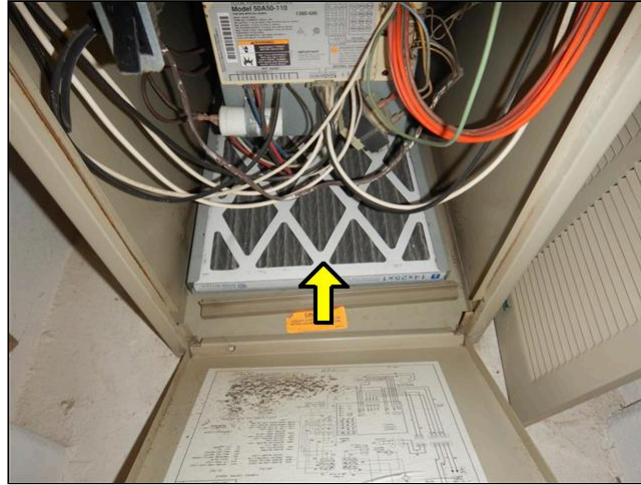
12.3 Item 1(Picture)

The air filter(s) for the HVAC system is dirty. We recommend recommend replacing by a qualified person.

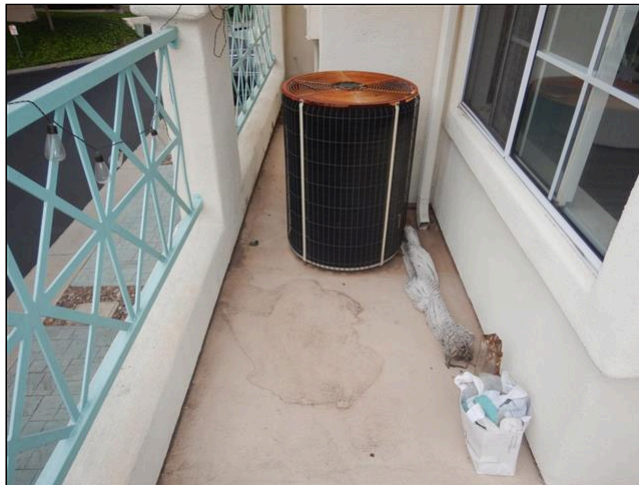
13.0 Item 1(Picture)

- (1) **Photo of the A/C unit(s).**

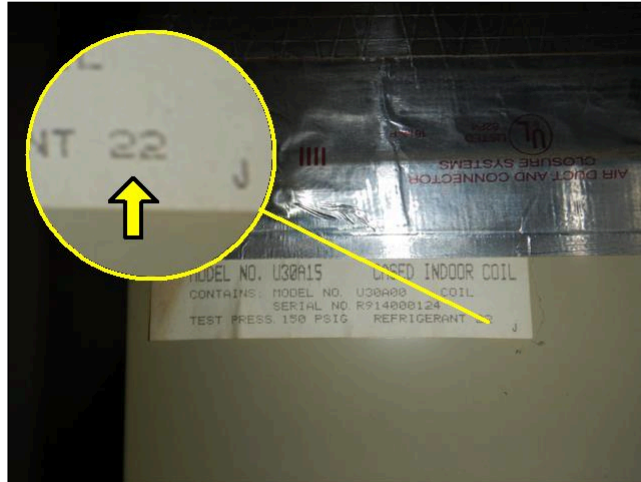
13.0 Item 2(Picture)

(2) The air conditioning system in this property is an older system which may have R 22 freon. Effective January 1, 2020 the Department of Energy mandates that all manufactured air conditioner condensing units use R 410-A freon. The older R 22 freon will no longer be allowed. We recommend further evaluation by a licensed HVAC contractor prior to the end of your contingency period to check the freon level and for upgrade or replacement options. If the repair requires adding R22 refrigerant to the system, the only options will be reclaimed and previously-produced R22 refrigerant. Once there is no more R22 refrigerant available the compressor must be replaced. We also recommend budgeting for replacement and obtaining and keeping a Home Warranty that covers this HVAC system.

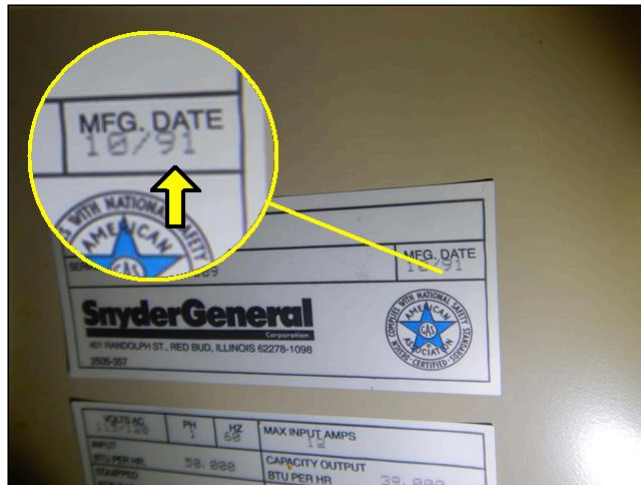
13.0 Item 3(Picture)

(3) The AC system is 15 or more years old and may be near the end of its useful life. The average life of an AC system is approximately 10-15 years. We recommend further evaluation and servicing by a qualified licensed HVAC contractor to determine life remaining and potential cost to replace so that you can budget accordingly. We also recommend that you keep a good home warranty in place, which covers the AC system.

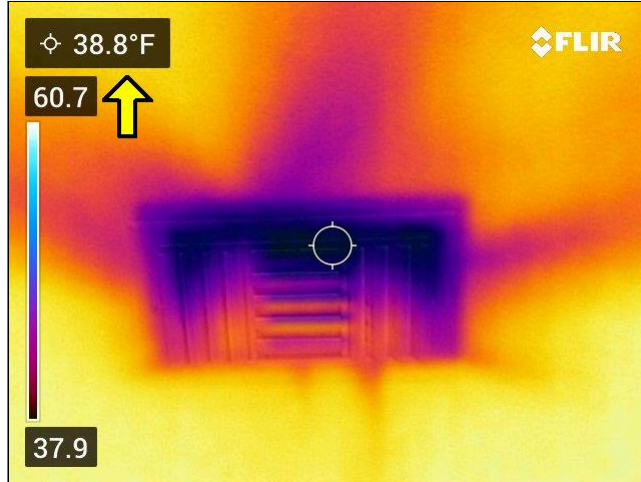
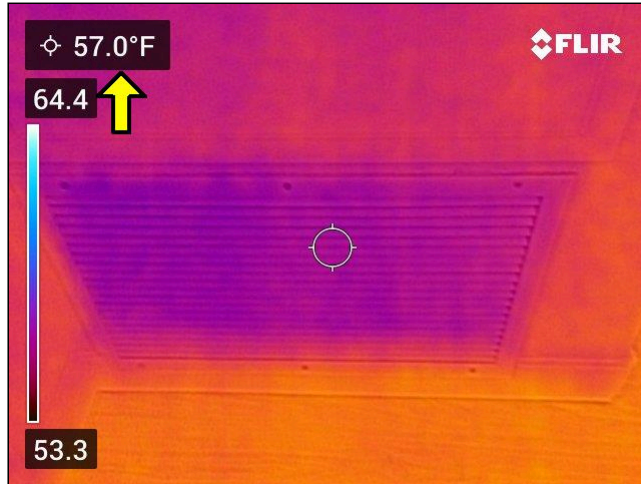
13.0 Item 4(Picture)

This indicates that the range in temperature drop is normal. This is not an exhaustive test and cannot predict the performance of the AC systems on extremely hot or humid days.

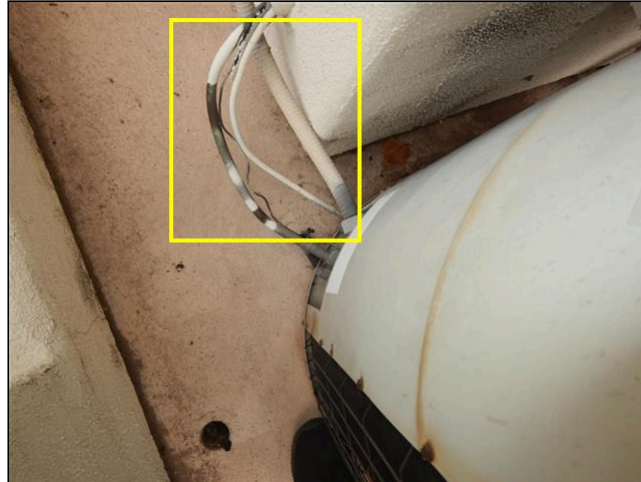
13.0 Item 6(Picture)

(5) The insulation is missing at the exterior refrigerant lines. We recommend replacing the missing insulation by a qualified person.

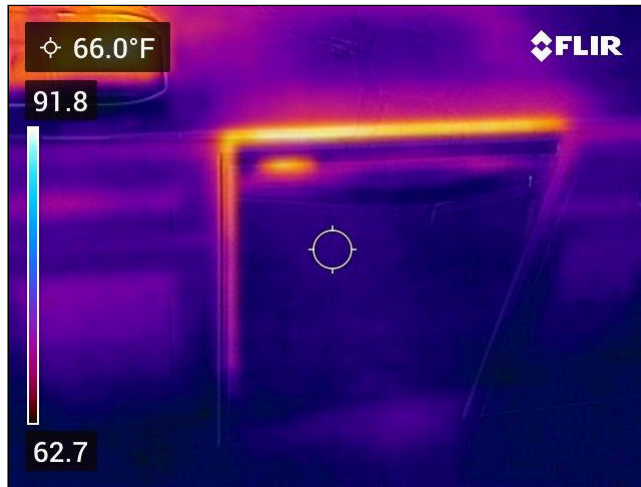
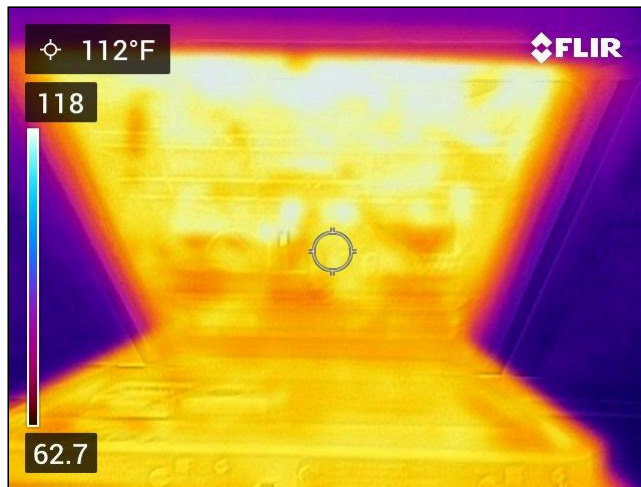
16.0 Item 1(Picture)

The dishwasher was tested and functioned properly at the time of the inspection. This is not an exhaustive test and does not verify the cleaning efficiency of the dishwasher.

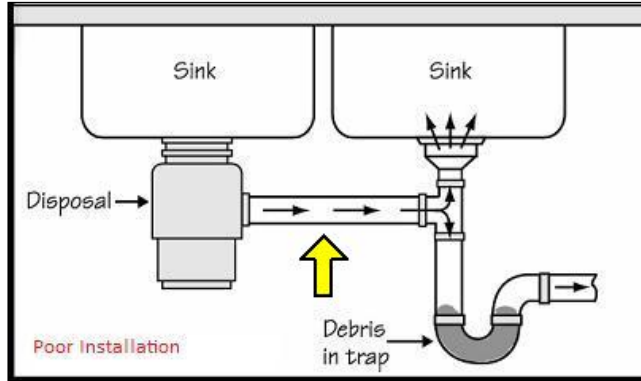
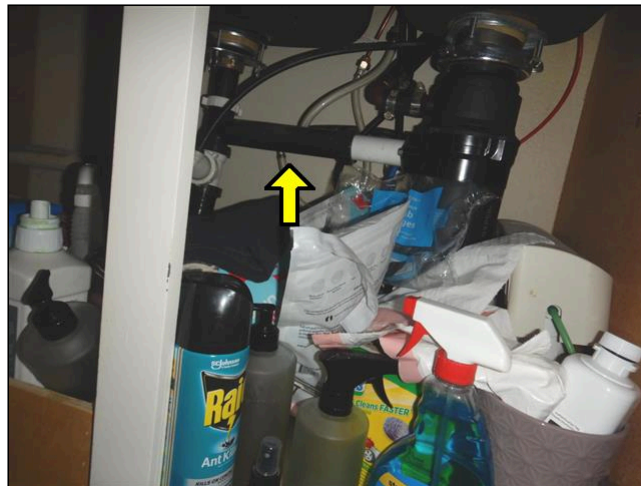
16.1 Item 1(Picture)

- (1) The food waste disposer was tested and functioned properly at the time of the inspection. This is not an exhaustive test and does not verify the efficiency of the unit.
- (2) The food waste disposal drain is installed in a non-standard manner. The drain tube exiting the disposer is installed horizontally and intersects the drain line of the other sink basin with a "T" fitting, then down to the P-trap. This can cause waste from the disposer to rise into the opposite sink basin before draining. We recommend necessary corrections by a qualified licensed plumber.
