# Inspection Report

1243 Main Lane  
San Diego CA 92128

## The Property Inspection Pros

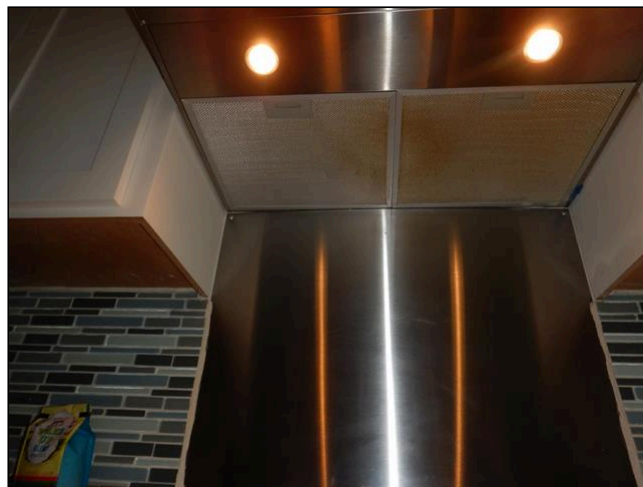
16.2 Item 1(Picture)

The range exhaust vent was tested and was functional at the time of the the inspection. This is not an exhaustive test, and does not evaluate the performance or effectiveness of the unit.

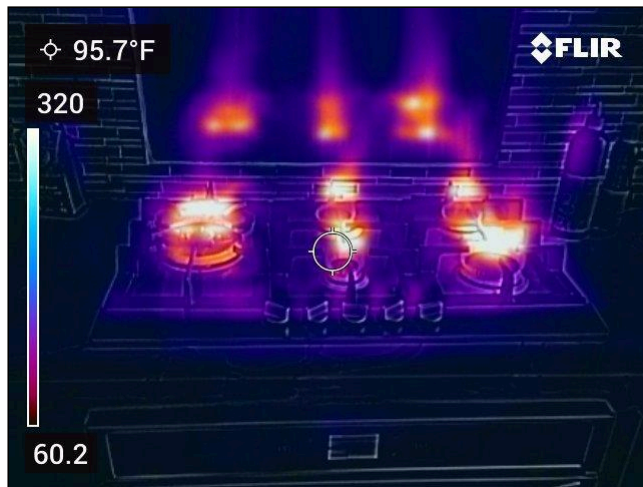
16.3 Item 1(Picture)

The cooktop was tested and was functional at the time of the inspection. This test is not exhaustive and does not confirm the performance, accuracy, or effectiveness of the cooktop.

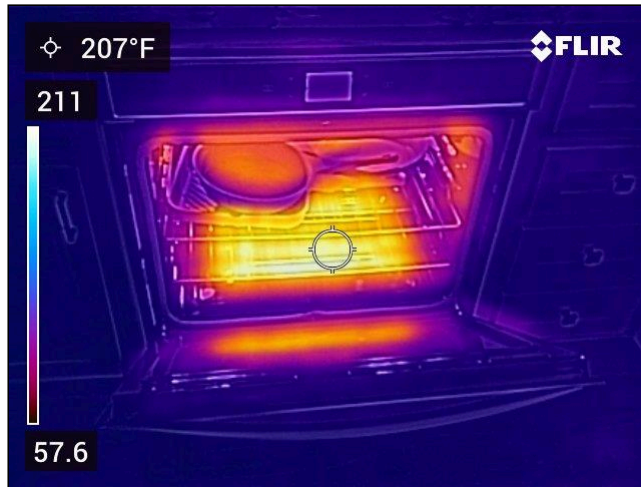
16.4 Item 1(Picture)

The wall oven was tested and was functional at the time of the inspection. This test is not exhaustive and does not confirm the performance, accuracy, or effectiveness of the wall oven.

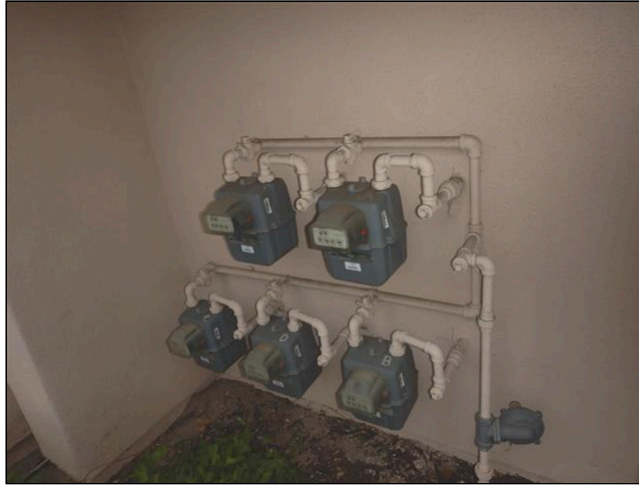
17.0 Item 1(Picture)

The main gas shut off valve is located at the gas meter at the right exterior side of the property (facing front).

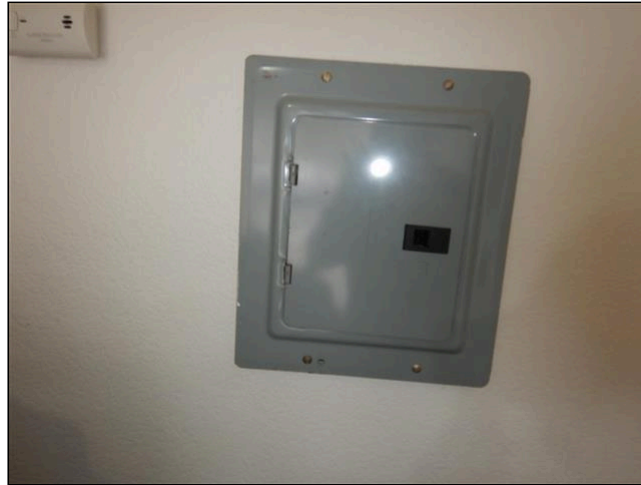
17.2 Item 1(Picture)

The sub-panel is located in the garage.
