Inspection Report

Property Address:
4321 Smth Dr
La Mesa CA 91941

The Property Inspection Pros

Date: 6/13/2024	Time: 09:00 AM	Report ID:
Property: 4321 Smth Dr La Mesa CA 91941	Customer: Jimmy Johns	Real Estate Professional:

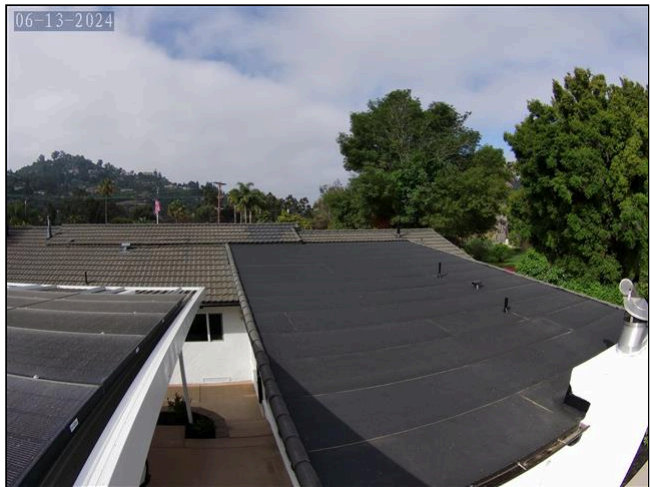
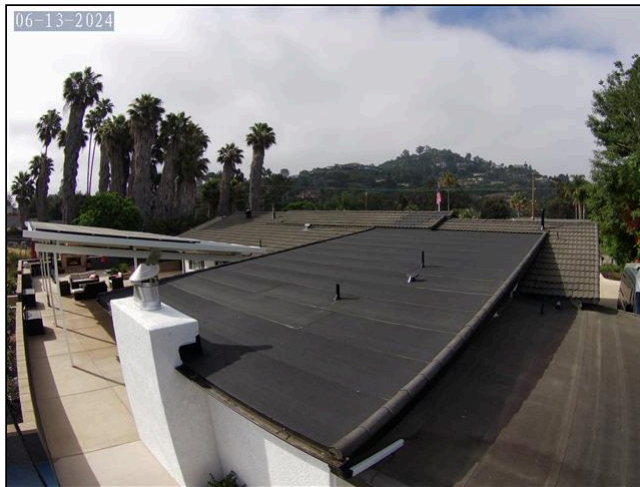
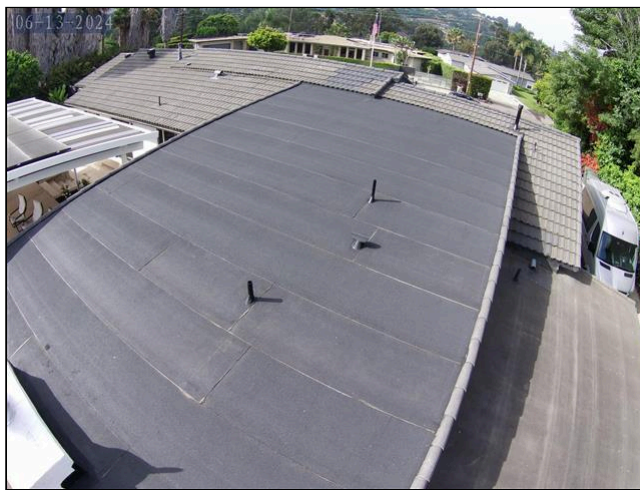
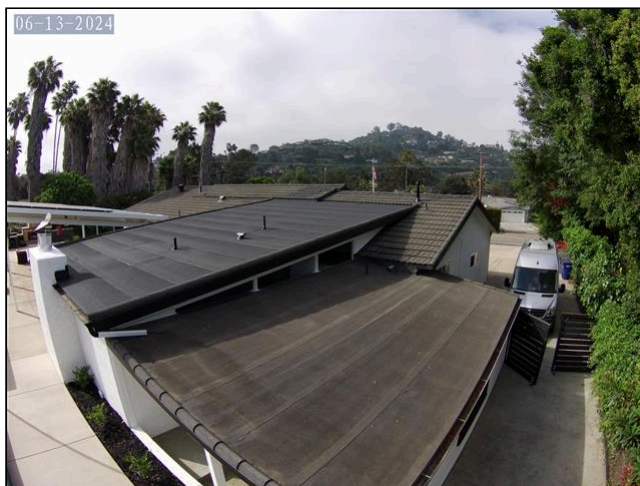
1.1 FLAT ROOF COVERINGS/ MATERIALS
Comments:
 (1) Pictures of the roof.

(2) The flat roofing material shows normal wear for its age and type and appears to be in serviceable condition.

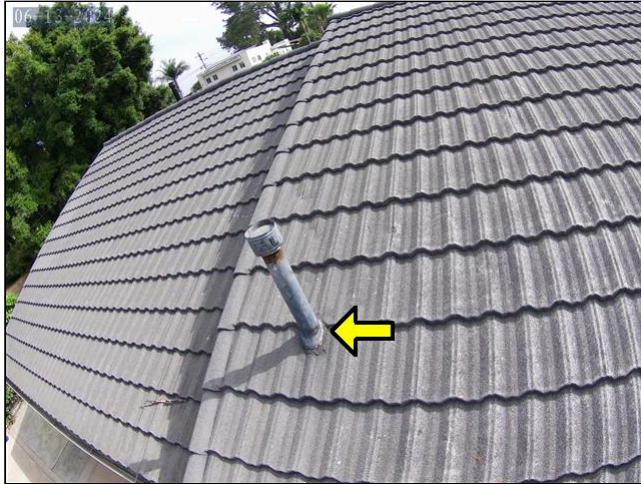
1.2 Item 1(Picture)

(1) Sealant around some of the roof flashings/ penetrations is cracked. We recommend having sealant applied where needed to help prevent roof leaks by a licensed roofer.

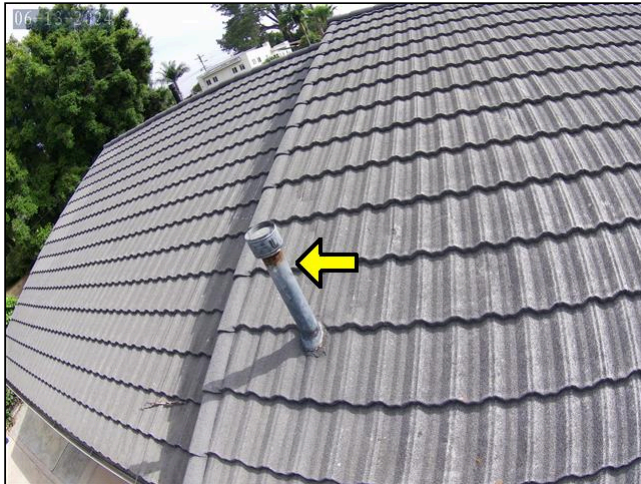
1.2 Item 2(Picture)

(2) There are several metal roof flashings/vents that are rusted. We recommend they be cleaned, painted and/ or replaced as needed by a qualified licensed roof contractor.

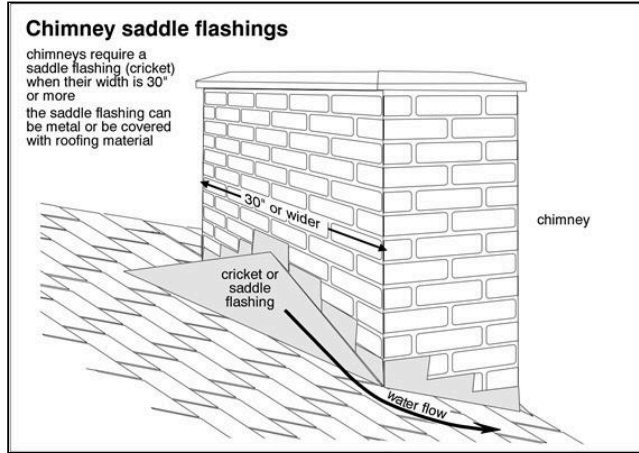
1.2 Item 3(Picture)

(4) No saddle or cricket flashing was installed at the chimney. This is required when chimneys are 30 inches wide or more. We recommend further evaluation and necessary corrections by a licensed roof contractor.

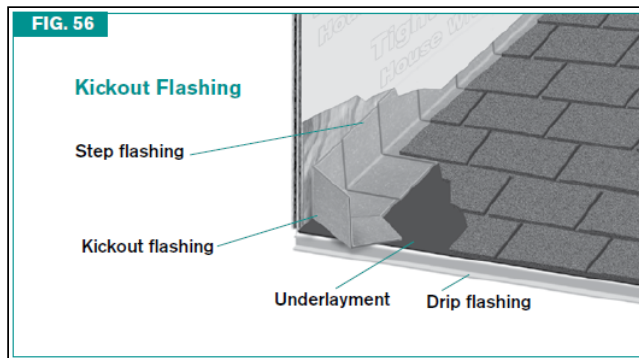
1.2 Item 4(Picture)

(5) There are no kickout flashings installed at the roof/wall junction. This was standard at the time of construction but are now installed. Kickout flashing help prevent rain water from entering behind the siding/ stucco. We recommend having kickout flashings installed where needed by a licensed roof contractor.

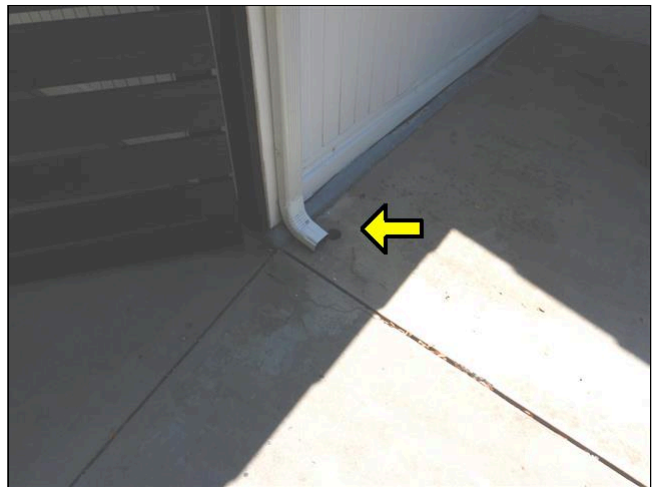
1.3 Item 3(Picture)

(2) Some of the downspouts need extension and/or a buried drain line to carry water away from the home at several areas. We recommend necessary corrections where needed by a qualified contractor.

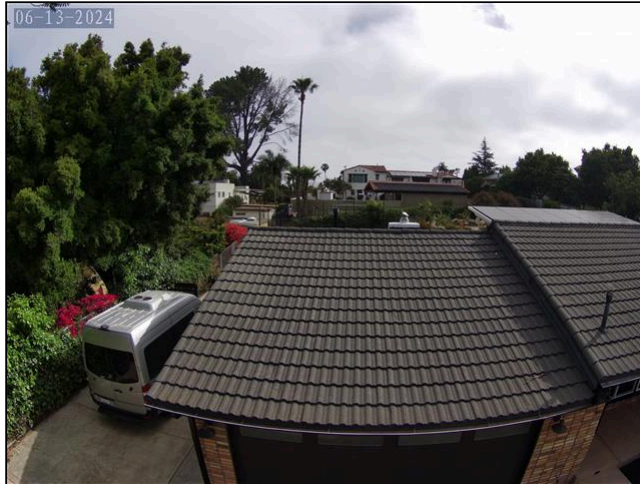
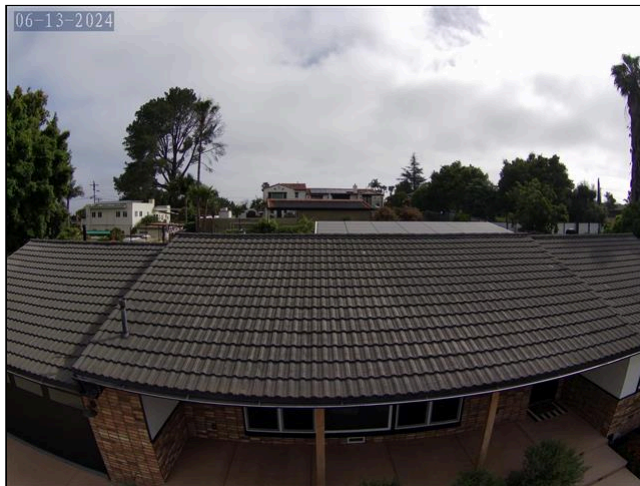
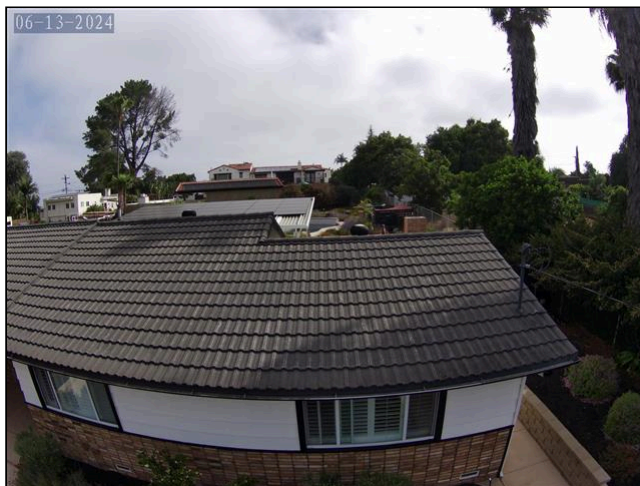
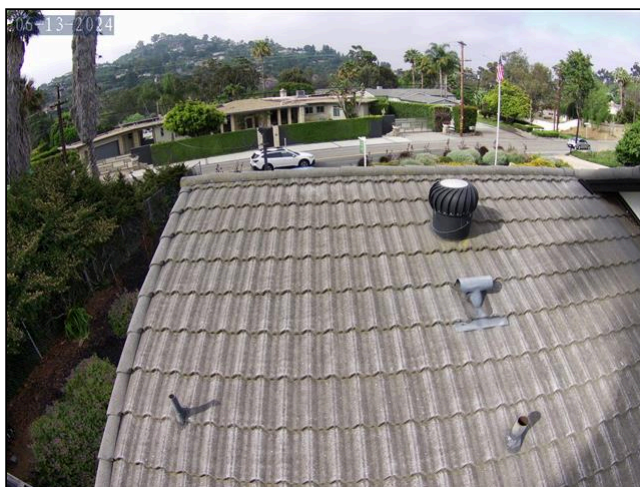
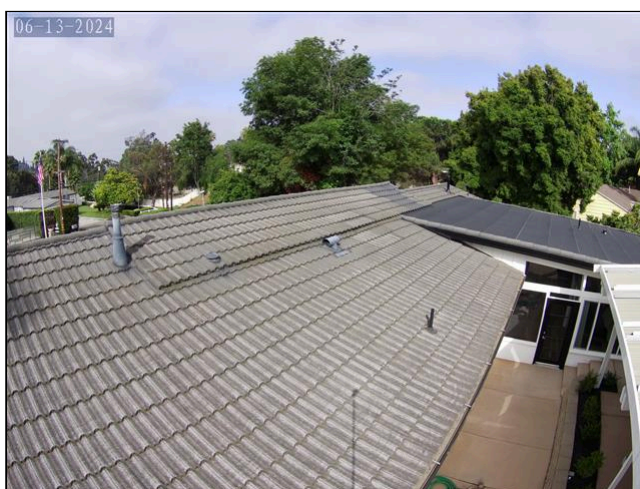
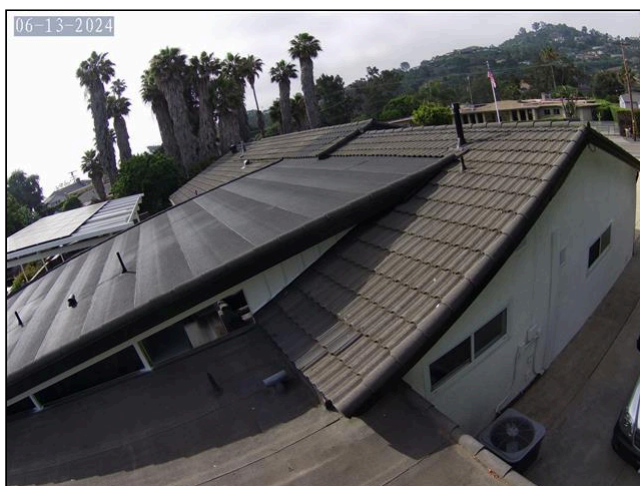
(1) Pictures of the roof.

(2) The roof has had repairs made to it at several areas. We are unable to determine if these repairs are made correctly and successful. We recommend asking the seller about these repairs, and if concerned we recommend further evaluation by a qualified licensed

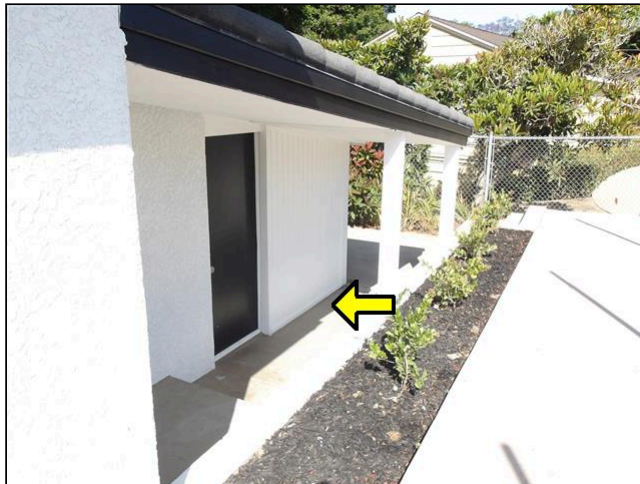
2.2 Item 2(Picture)

(2) This home has a slab which has been built at the same level or slightly above the soil outside. The ideal building will have interior floors that will be several inches higher than the exterior grade, and the building will have gutters and downspouts and a system of drainage designed to prevent any moisture from threatening the foundation or the living space. This property does not meet this ideal requirement. Repairs may be need to prevent damage/moisture intrusion. We recommend further evaluation and necessary repairs by a licensed landscaping contractor.

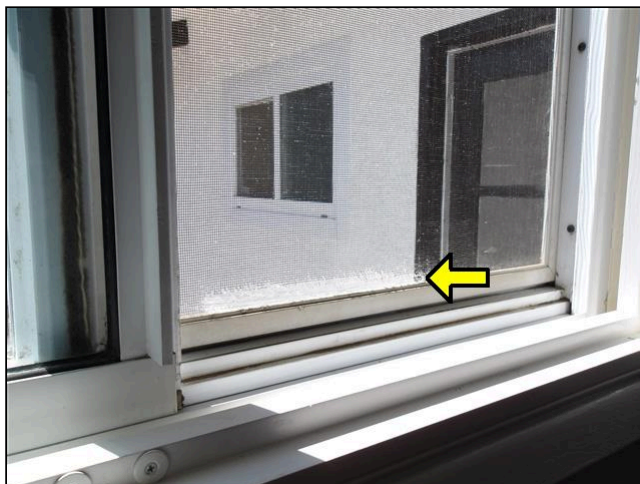
2.6 Item 1(Picture)

(1) There are several window screens that are missing or damaged throughout the house. We recommend repair or replace as needed by a qualified person.

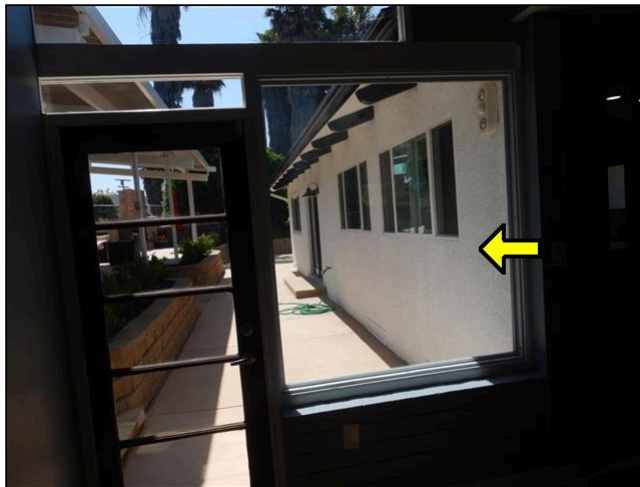
2.6 Item 3(Picture)

(2) Condensation was observed between the panes of glass at several windows throughout the house. This occurs when the seal has failed between the panes of glass, and ambient air has entered the assembly. Replacement of the glass is required. Since some failed windows may not be easily found due to changing ambient conditions (heat, humidity, etc). We recommend having all of the windows reviewed by a licensed window contractor to determine how many windows require repair/replacement. We recommend repairing or replacing all windows that have failed window seals by a licensed window contractor.

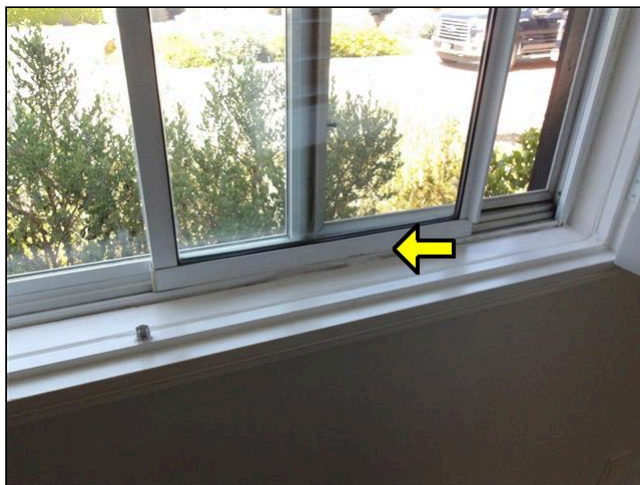
2.6 Item 5(Picture)

(4) The window glides for several sliding windows are worn. This causes metal-on-metal friction. The added force required to open and close the windows can lead to breakage. We recommend replacing all of the window glides by a qualified person.

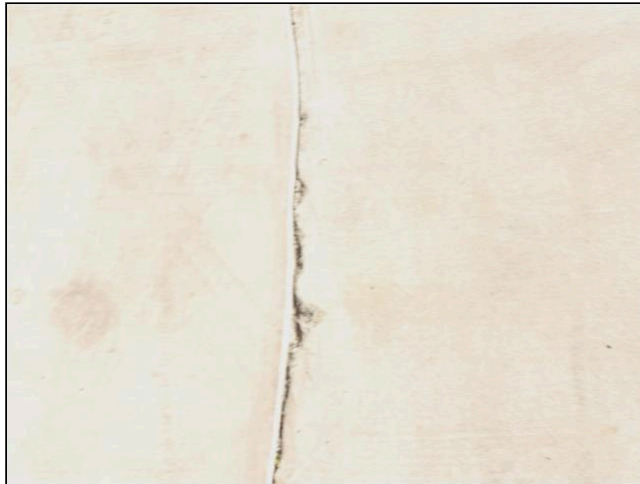
2.8 Item 1(Picture)

(1) There is a crack/damage in the concrete driveway. We recommend necessary repairs by a licensed concrete contractor.

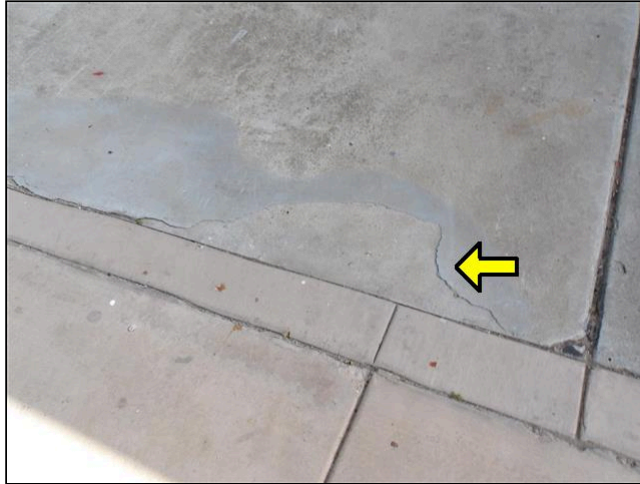
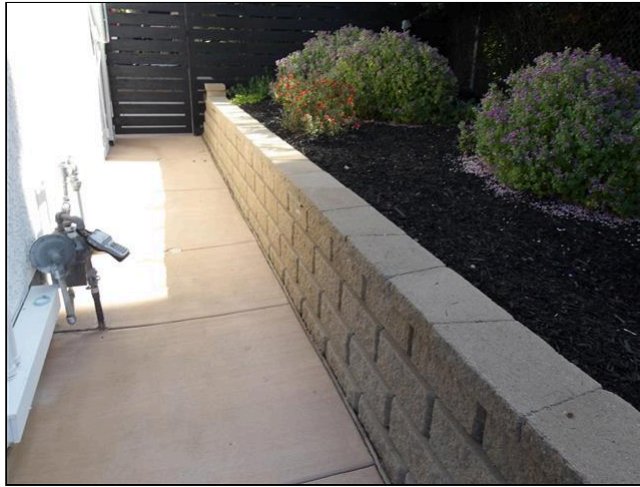
(3) There is a crack in the walkway. We recommend necessary repairs by a licensed concrete contractor.

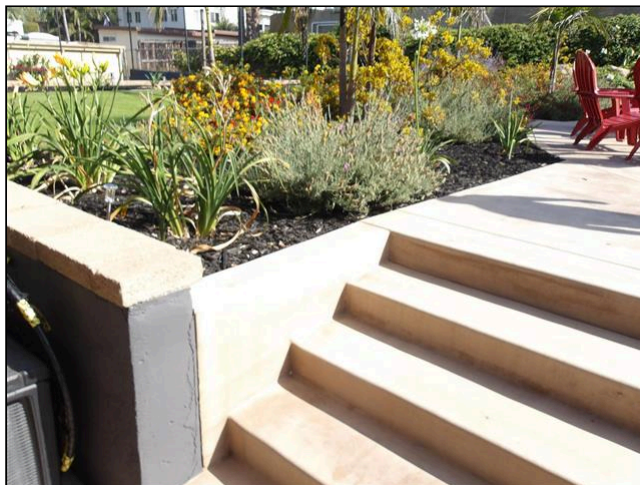
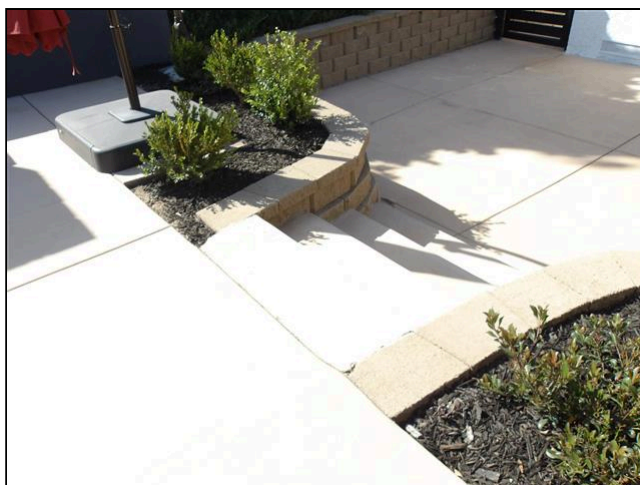
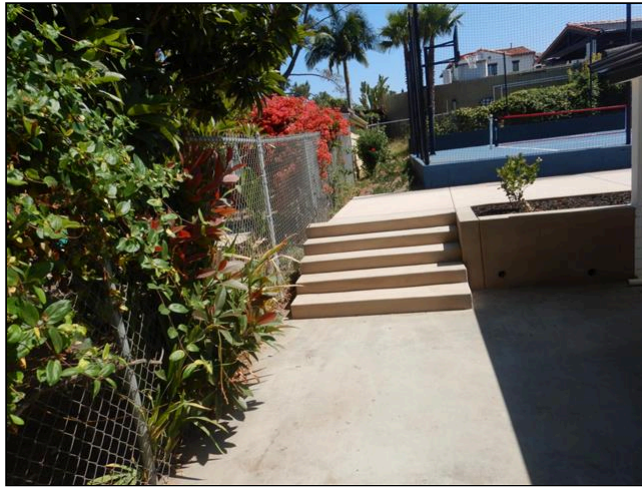
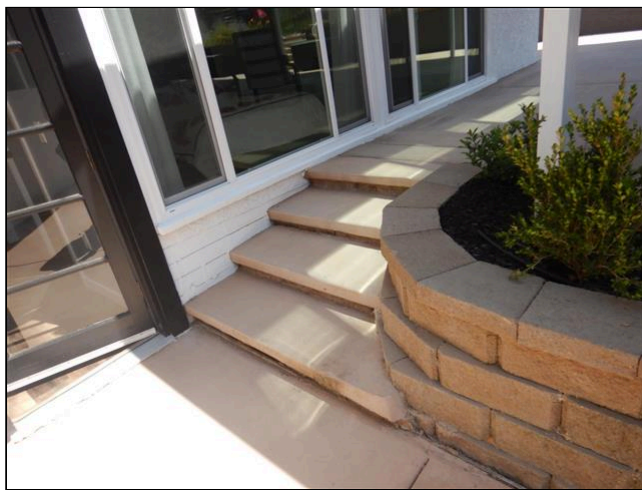
There are no handrails installed at several exterior yard stairs/ steps. A handrail is required at least one side of the stairs when four or more steps are present. This is a safety hazard and corrections are needed. We recommend installing handrails where needed for safety by a qualified licensed contractor.

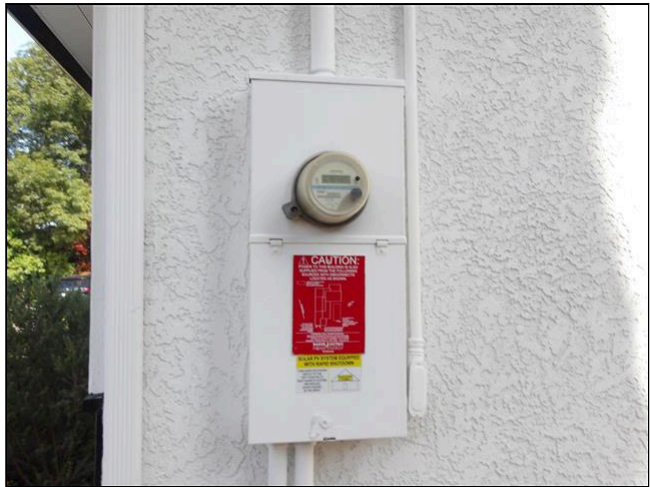
3.0 Item 1(Picture)

Photo of the main electrical panel.

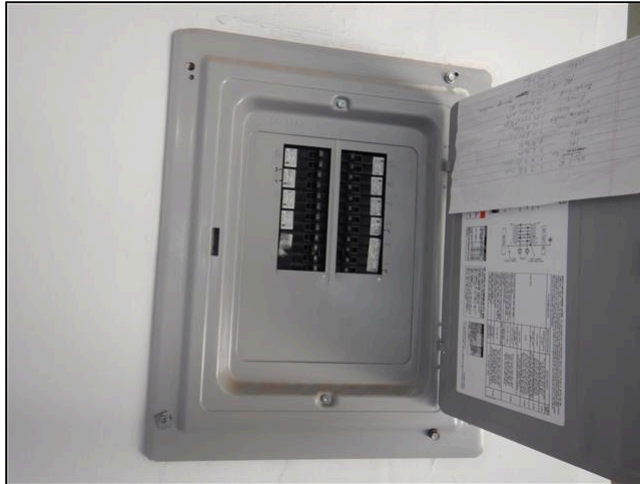
3.1 Item 1(Picture)

(1) [Photo of the sub electrical panel.](#)

(2) Some of the sub panel screws are missing from the sub electric panel. We recommend installing screw(s) where needed by a qualified person for safety.

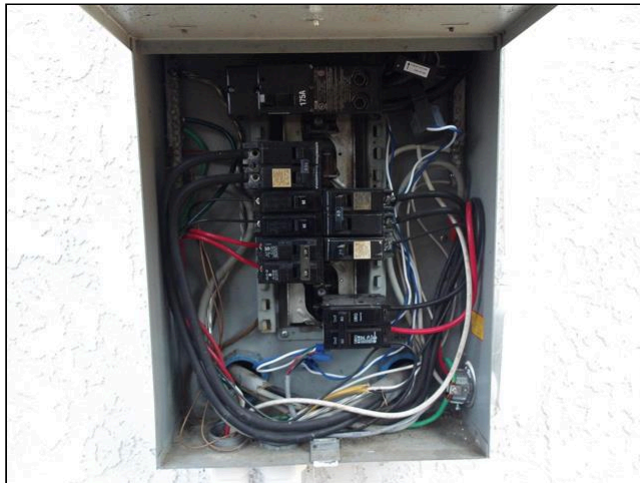
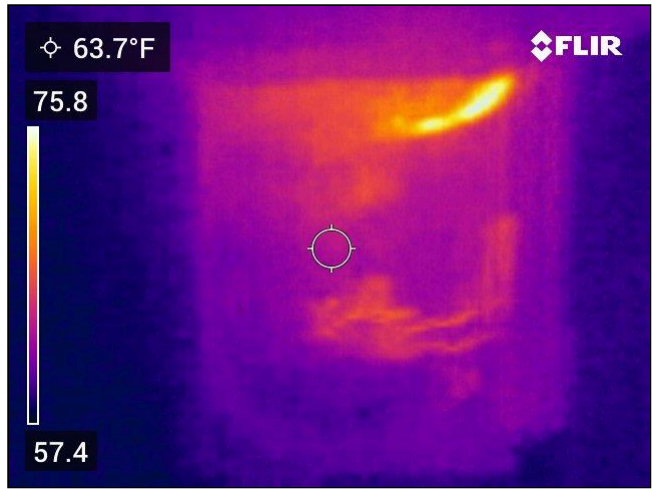
(1) [Photo inside of the main electrical panel.](#)

The dead front cover was removed at the time of the inspection and the breakers, wiring and grounding were inspected. Appears to be functioning as intended.

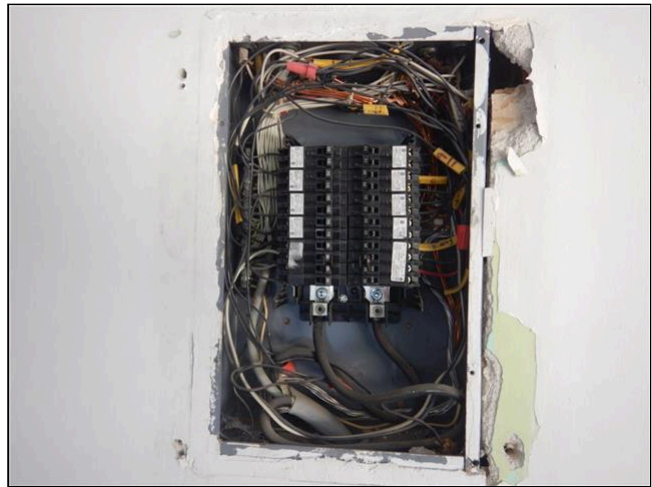
3.2 Item 3(Picture)

(2) **Photo inside of the sub electrical panel.**

The dead front cover was removed at the time of the inspection and the breakers, wiring and grounding were inspected. Appears to be functioning as intended.

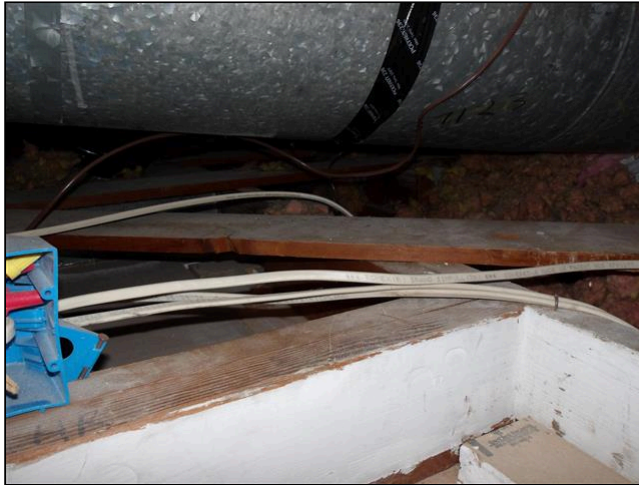
3.3 Item 1(Picture)

(1) Unprotected Romex was present in the attic adjacent to the attic scuttle. Romex located within 6 feet of the attic scuttle must be protected from damage. We recommend adding protection to the Romex in attic by the access a qualified licensed electrician.

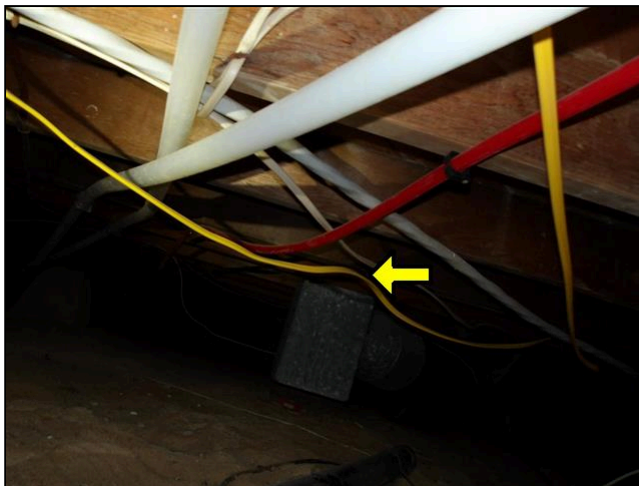
3.3 Item 2(Picture)

(2) Some wires in the crawlspace are not properly secured as required. We recommend necessary corrections by a qualified licensed electrician.

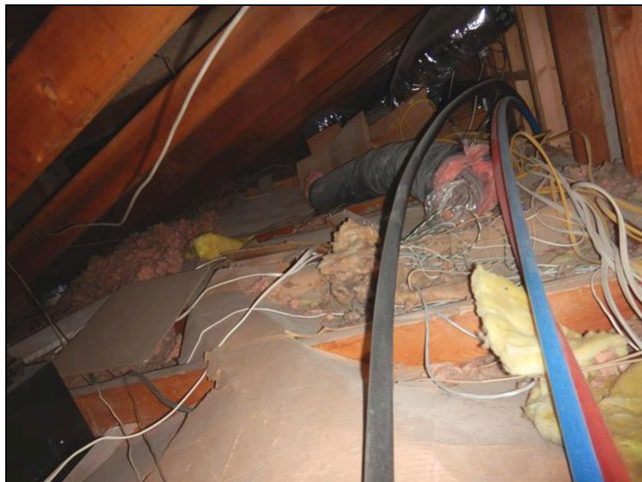
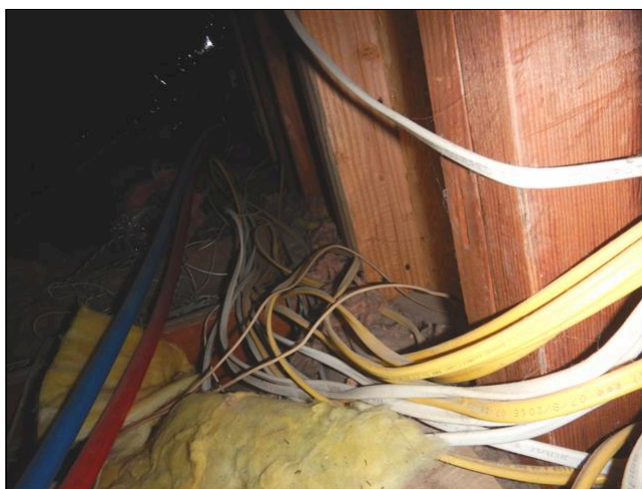
(3) Wires for some lighting fixtures in the attic space were observed to be unsecured. We recommend necessary corrections by a qualified licensed electrician.

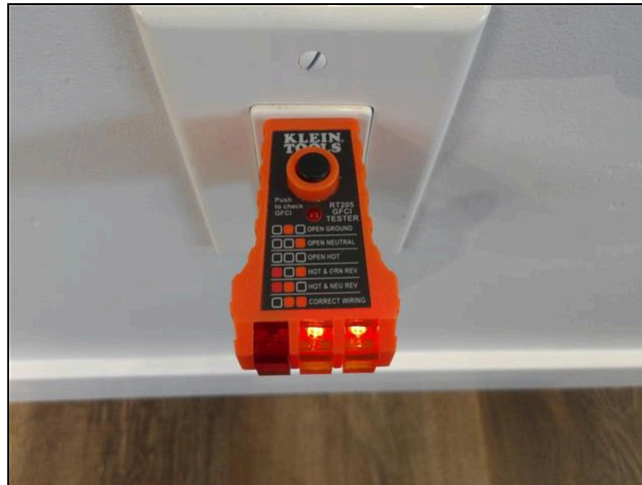
3.7 Item 1(Picture)

(1) [Photo of a receptacle being tested.](#)

A representative number of receptacles throughout the property were tested for power, polarity and grounding according to our standards-of-practice. These receptacles observed to be ok at the time of the inspection unless otherwise noted.

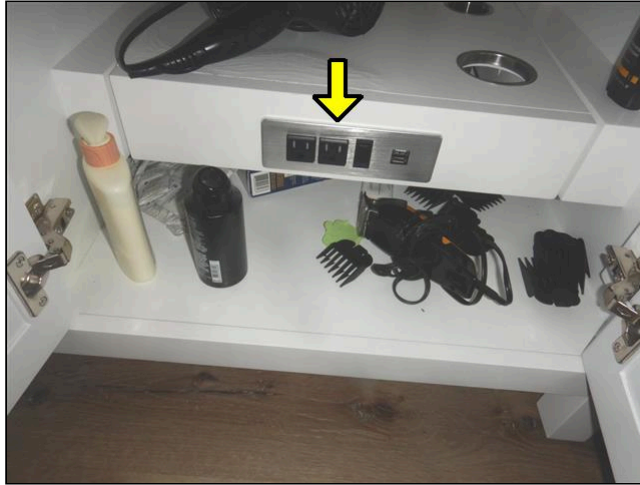
3.7 Item 2(Picture)

(2) Several receptacles in the house were non operational when tested at the time of the inspection. We recommend further evaluation and necessary repairs by a qualified licensed electrician.

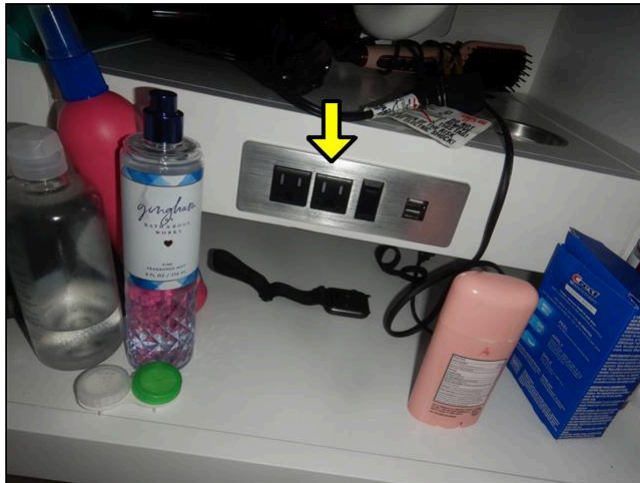
3.7 Item 3(Picture)

(3) The receptacles inside the master bathroom sink cabinets were non operational when tested at the time of the inspection. We recommend further evaluation and necessary repairs by a qualified licensed electrician.

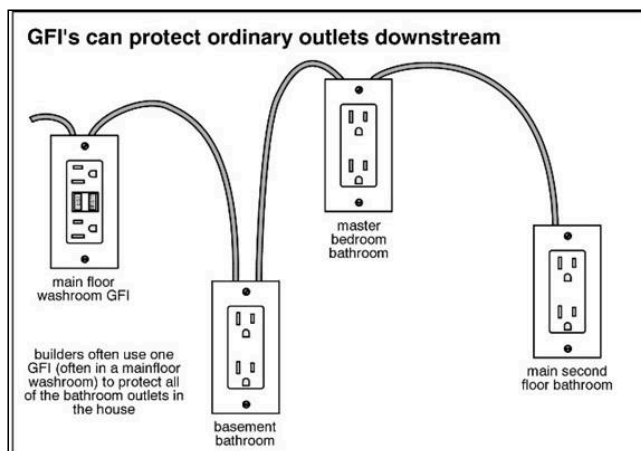
3.10 Item 1(Picture)

(1) All accessible GFCI receptacles were tested and were functioning properly at the time of the inspection unless otherwise reported. Sometimes a tripped GFCI receptacle may be difficult to find. If you do not have power at certain receptacles please check all GFCI's and reset the tripped GFCI receptacle. If the GFCI doesn't reset than replacement of the GFCI receptacle will be required.

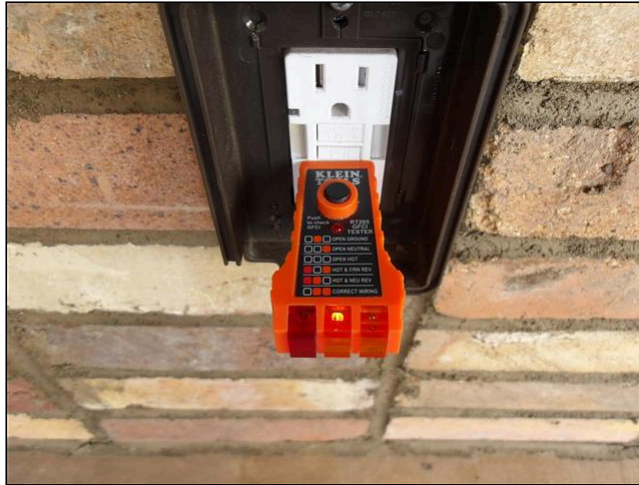
3.10 Item 3(Picture)

(3) Several GFCI receptacles located at the exterior walls of the house are not operating properly, or have failed as they did not trip when tested. The outlets may be defective or mis-wired. We recommend replacement where needed by a qualified licensed electrician.

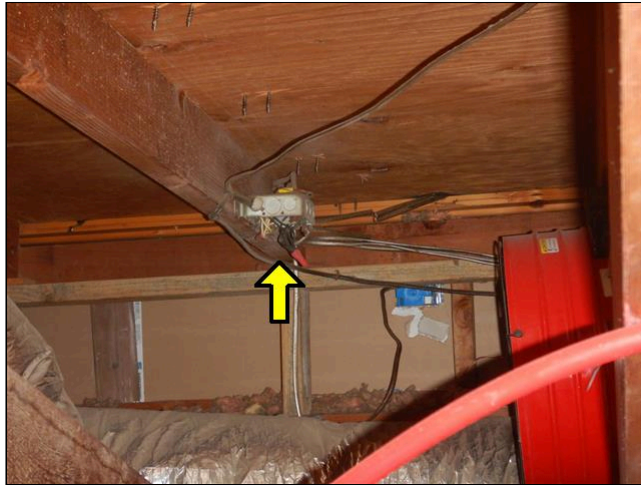
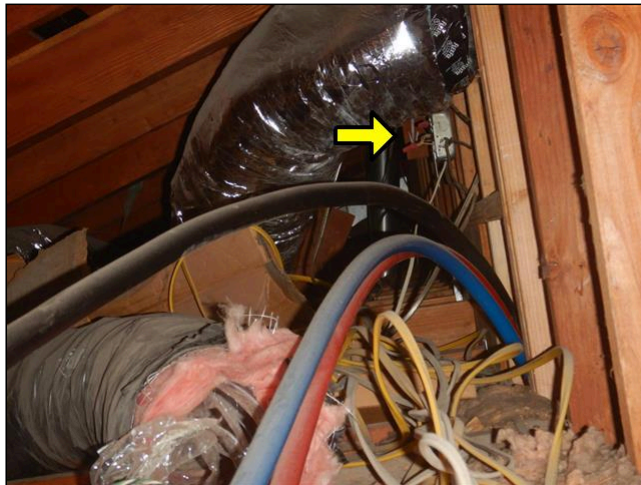
(1) Several open junction boxes observed in the attic. All electrical splices must be enclosed in a junction box. We recommend necessary repairs by a qualified person for safety.

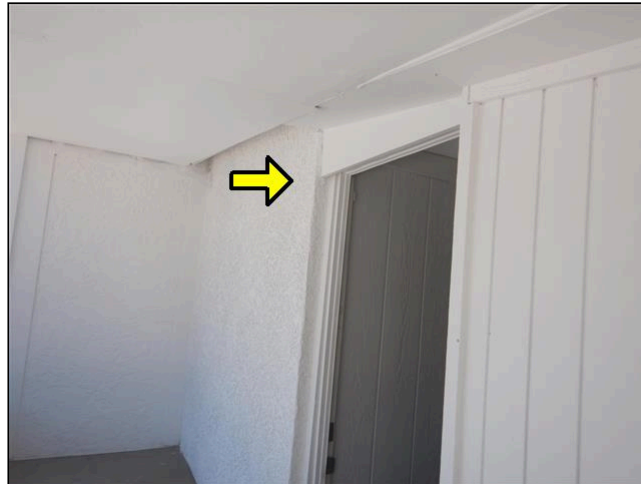
3.13 Item 2(Picture)

- (1) A representative number of exterior lights were tested and were found to be functional at the time of the inspection.
- (2) The exterior light fixtures were not sealed where the fixture meets the wall. This condition could allow moisture intrusion in this area. We recommend sealing exterior light fixtures where they meet the wall by a qualified person.

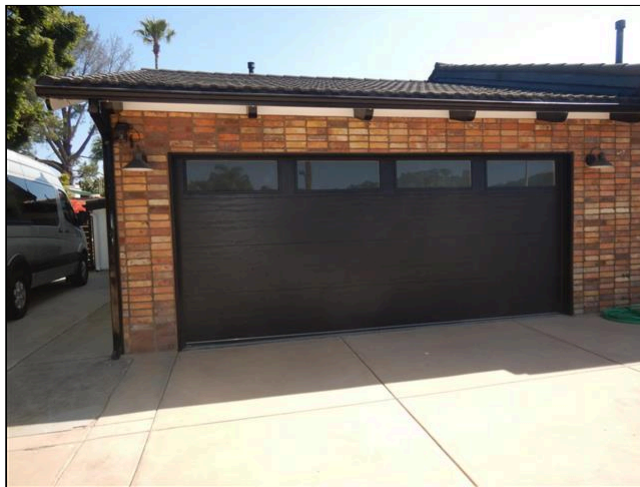
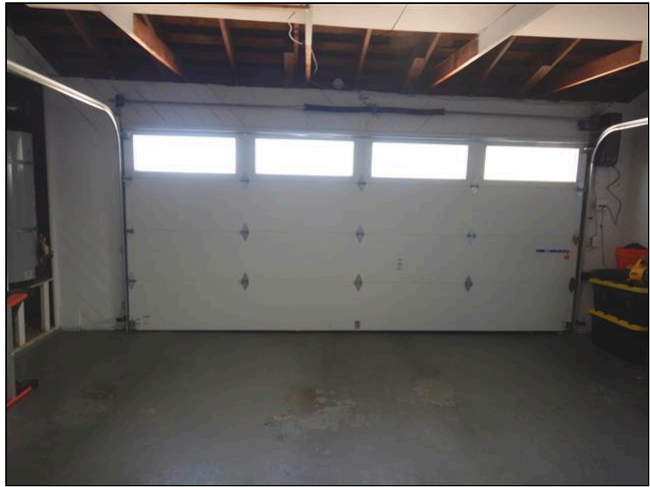
The garage vehicle door hardware including the door, track, and springs appear to be functioning as intended.

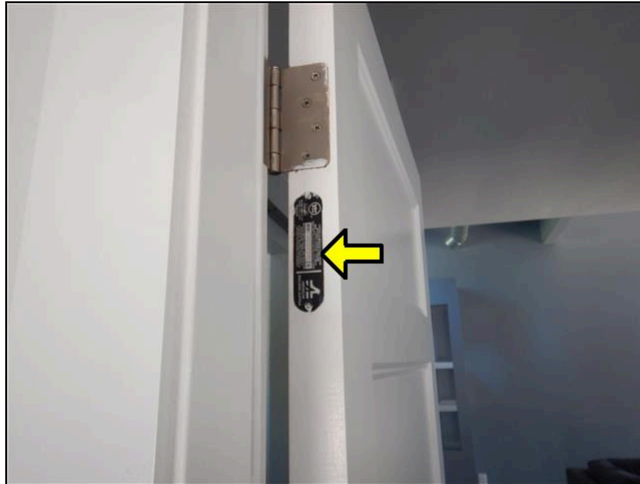
4.5 Item 1(Picture)

The door between the house and the garage appears to be a fire rated door.

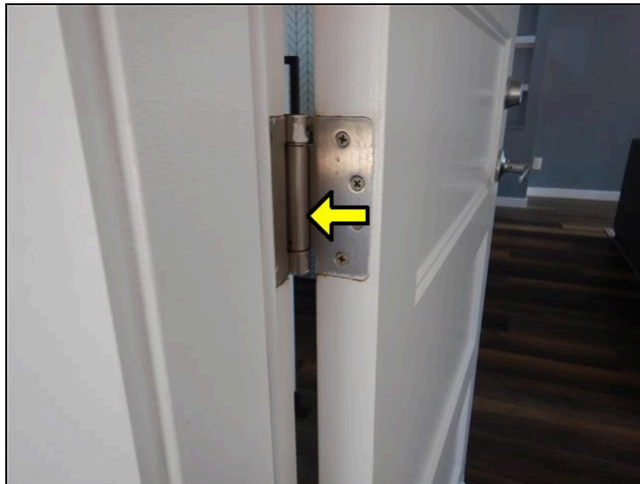
4.6 Item 1(Picture)

The required auto-closing hinge(s) did not work when tested. We recommend necessary repairs or replacement by a qualified licensed door contractor.

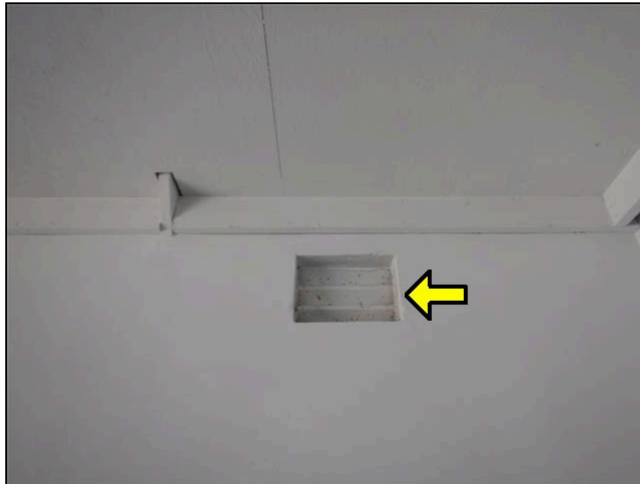
4.7 Item 1(Picture)

The screen material in the garage vents is missing at some vents. This can allow rodent intrusion. We recommend replacing the screens as necessary by a qualified contractor.

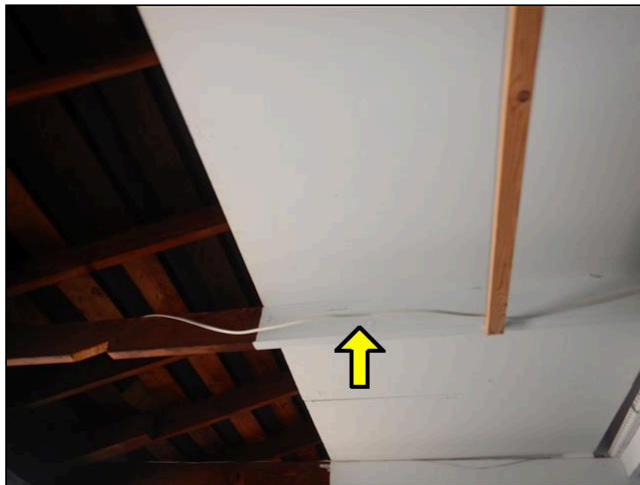
4.8 Item 1(Picture)

(1) There is exposed Romex type wires noted in the garage in several areas. This is a safety concern if used where it could be subject to physical damage. Romex wires are normally used in attics, inside walls, or inside conduit. We recommend necessary corrections by a qualified licensed electrician for safety.

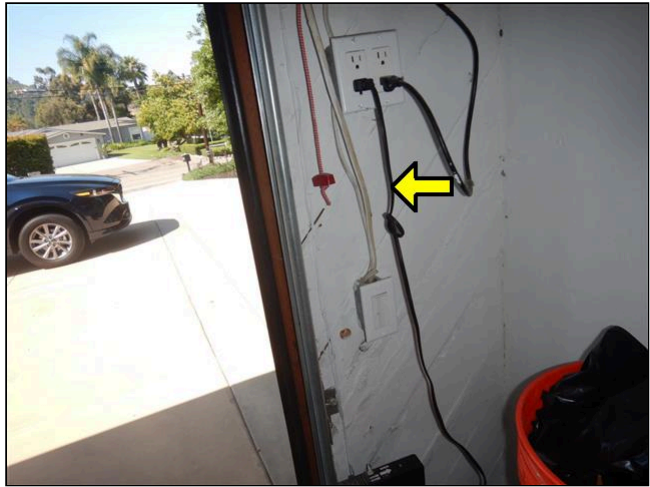
4.8 Item 2(Picture)

(2) Some wires in the garage are not properly secured as required. We recommend necessary corrections by a qualified licensed electrician.

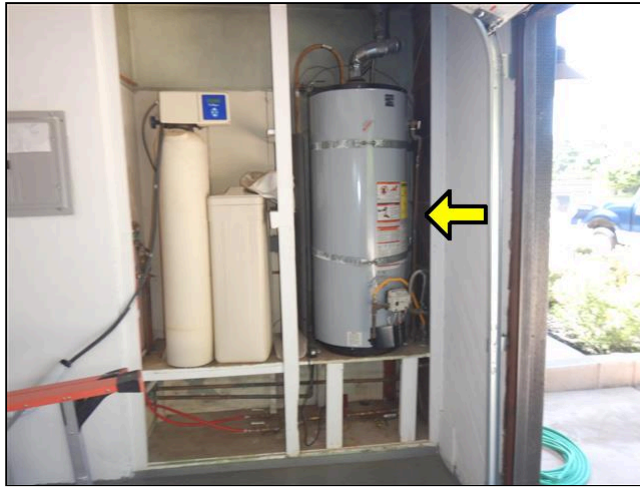
5.0 Item 1(Picture)

- (1) [Photo of the water heater.](#)

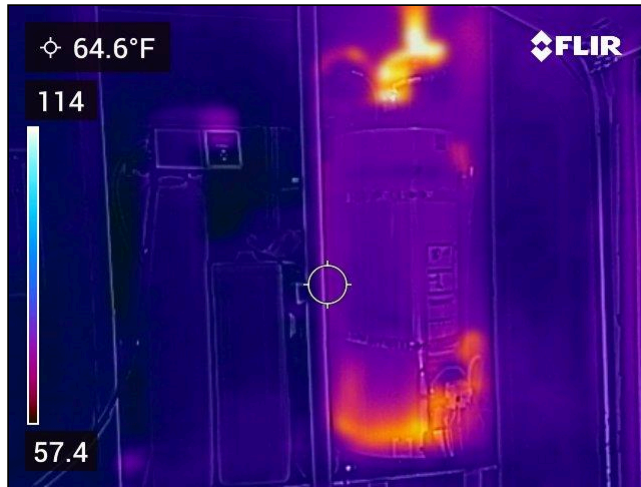
5.0 Item 2(Picture)

(2) The water heater was inspected and was found to be operational at the time of the inspection. We did not evaluate the efficiency or recover rate of the water heater which is beyond the scope of a general home inspection. If concerned we recommend you consult a licensed plumber. We recommend flushing the water heater routinely as regular maintenance.

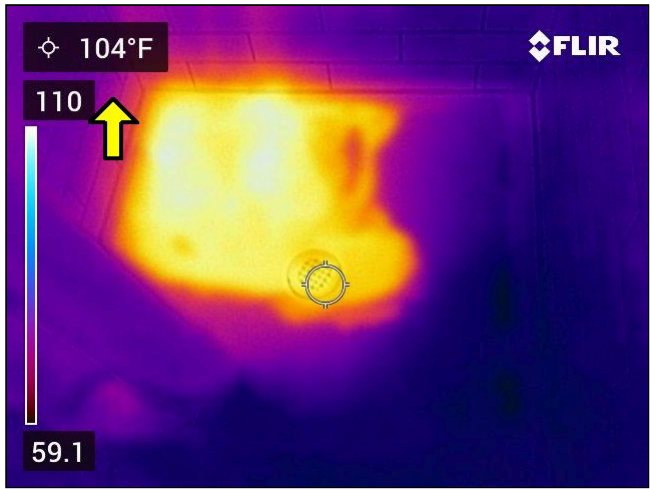
5.0 Item 5(Picture)

(5) The water heater was inspected and was found to be operational at the time of the inspection. We did not evaluate the efficiency or recover rate of the water heater which is beyond the scope of a general home inspection. If concerned we recommend you consult a licensed plumber. We recommend flushing the water heater routinely as regular maintenance.

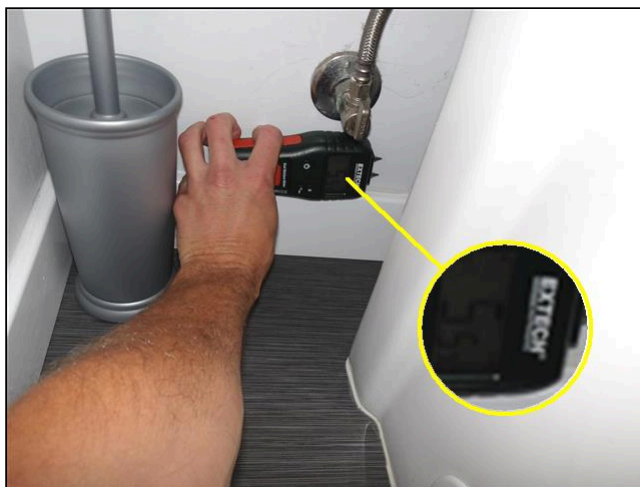
6.0 Item 1(Picture)

(1) A representative sampling for moisture was preformed at accessible interior walls using a moisture meter. (*areas prone to moisture, such as kitchens, bathrooms, below grade walls, exterior walls with doors/windows*). An elevated moisture was not detected at the time of the inspection.

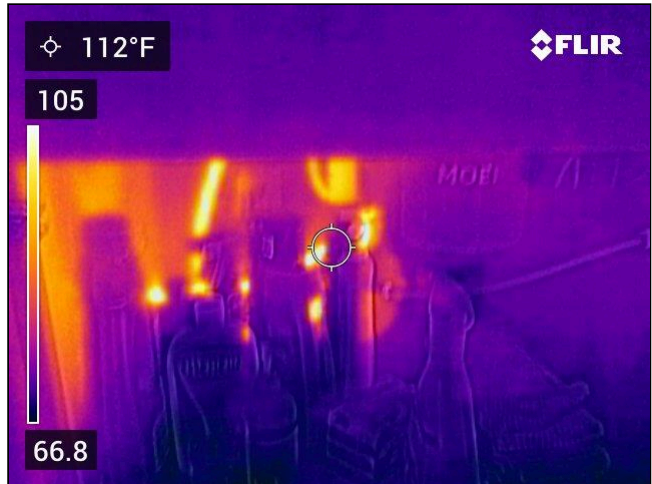
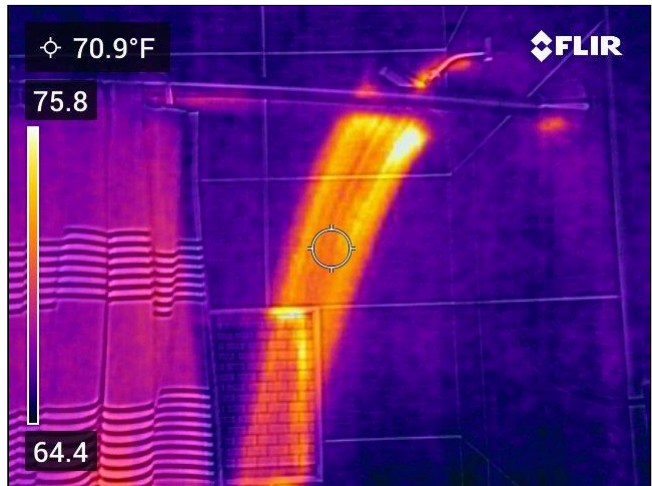
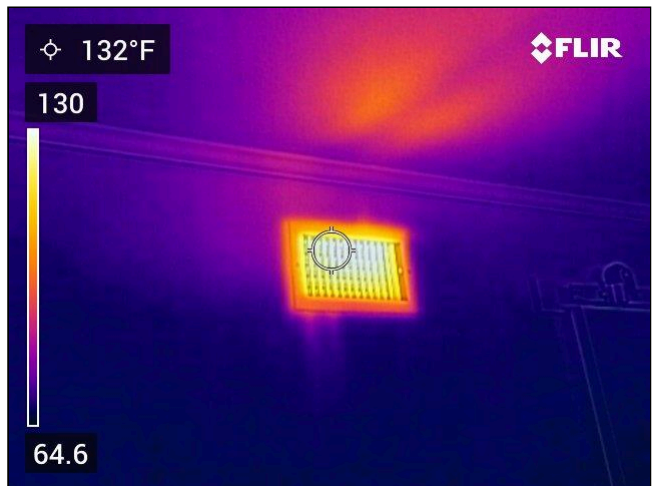
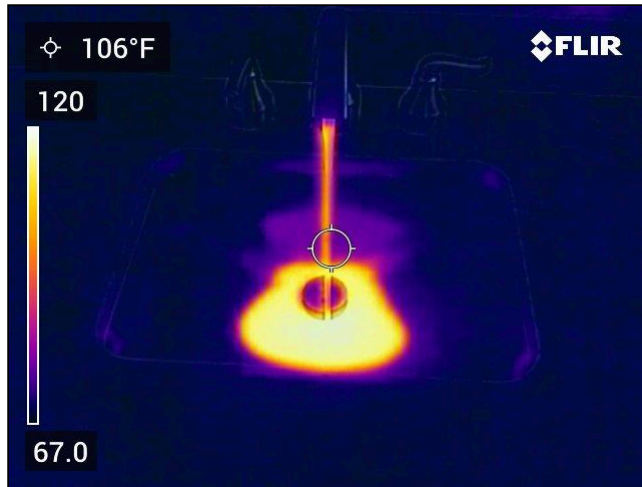
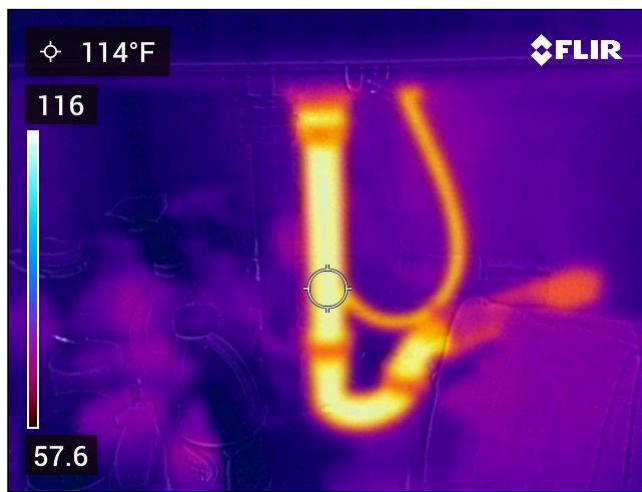
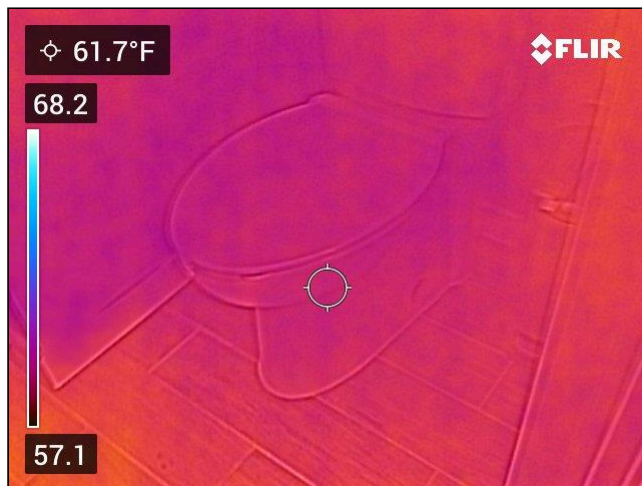
(1) Infrared Camera Thermal Photos.

(2) An infrared (thermal imaging) scan was performed throughout the property at the time of the inspection using a hand held infrared (thermal imaging) inspection camera. No anomalies were found at the time of the inspection using this camera.

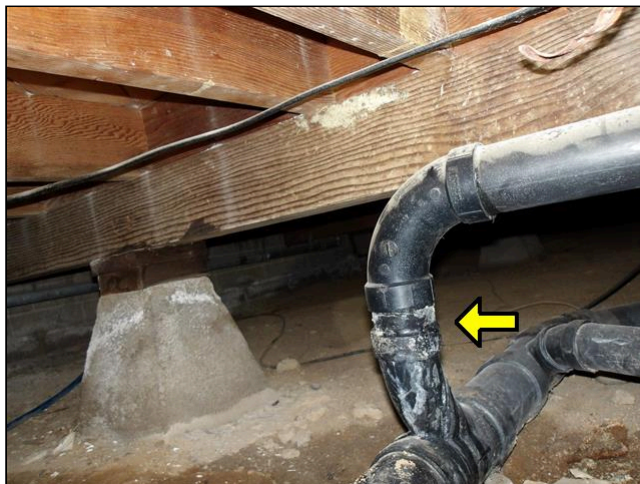
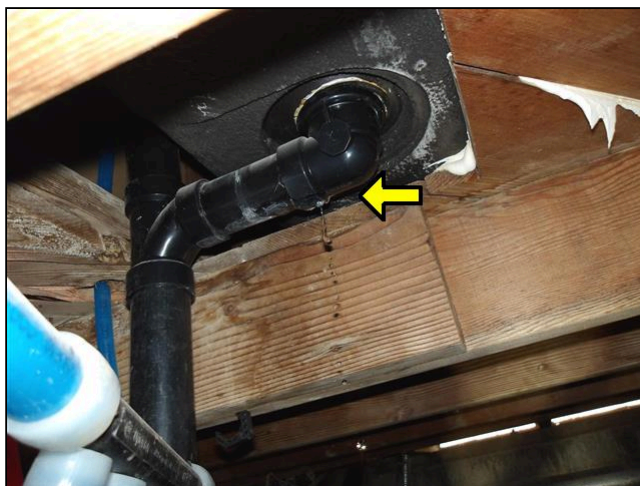
- (1) Some of the original drain, waste and vent system has been replaced with ABS plastic piping and some of the original cast iron piping is still present. Cast iron lines typically have a life span of about 50-60 years. Due to this fact, we highly recommend that you have the remaining cast iron waste piping system evaluated by a qualified licensed plumber, to include a video scope, prior to the end of your contingency period.
- (2) Several leaks were observed in the crawl space drain lines. We recommend further evaluation and any necessary repairs made by a qualified licensed plumber.

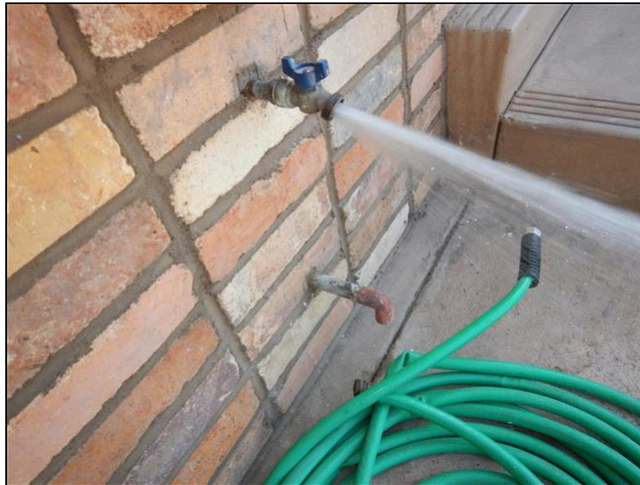
7.3 Item 1(Picture)

(1) The accessible hose spigots were tested and were found to be operational at the time of the inspection. Note: Some hose spigots may leak or drip when a watering hose is connected due to back pressure.
