Inspection Report

Property Address:
4321 Smth Dr
La Mesa CA 91941

The Property Inspection Pros

Date: 6/13/2024	Time: 09:00 AM	Report ID:
Property: 4321 Smth Dr La Mesa CA 91941	Customer: Jimmy Johns	Real Estate Professional:

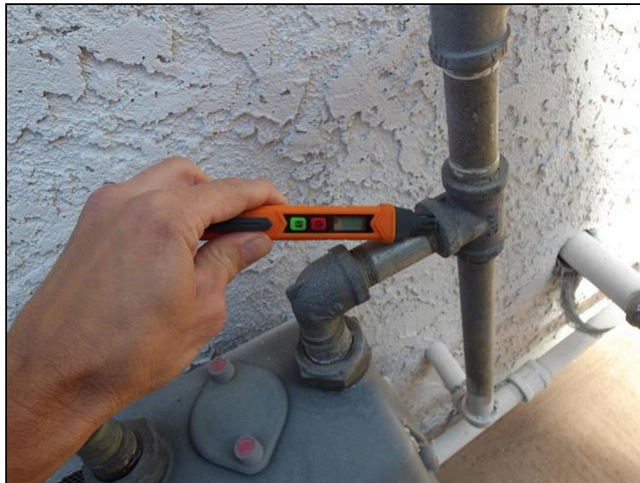
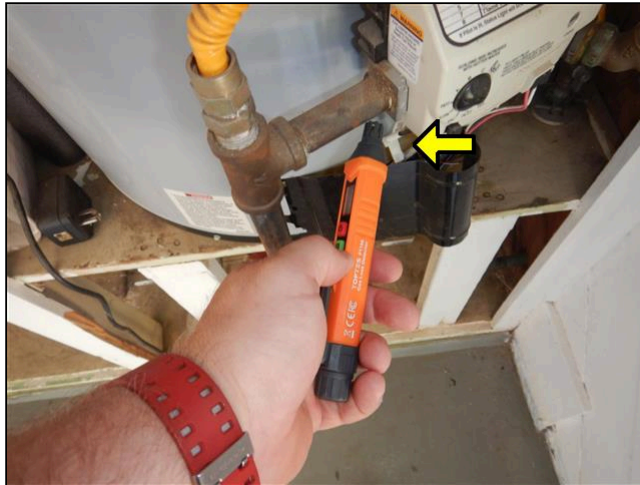
A gas leak test was conducted at accessible gas fittings and appliances using a gas leak detector. There were no gas leaks detected at the time of the inspection.

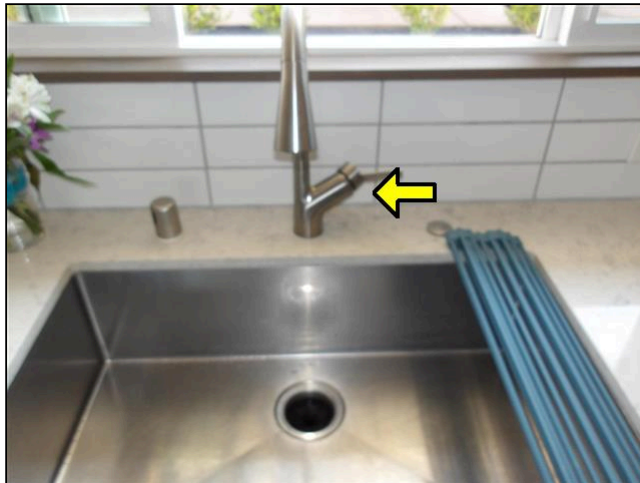
7.5 Item 1(Picture)

The kitchen faucet is loose. We recommend necessary repairs or replacement by a qualified licensed plumber.

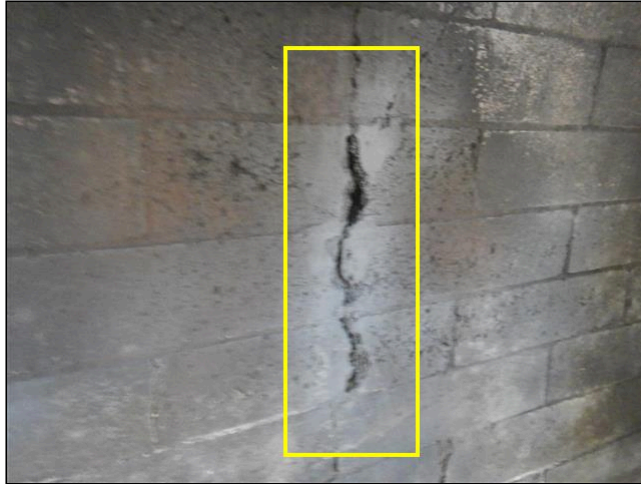
10.1 Item 1(Picture)

- (1) There are no glass doors or a screen installed at the fireplace. We recommend having glass doors and a screen installed by a qualified licensed chimney contractor as a safety upgrade.
- (2) Cracking and some deterioration is observed in the master bedroom fireplace. We recommend necessary repairs by a qualified licensed chimney contractor.

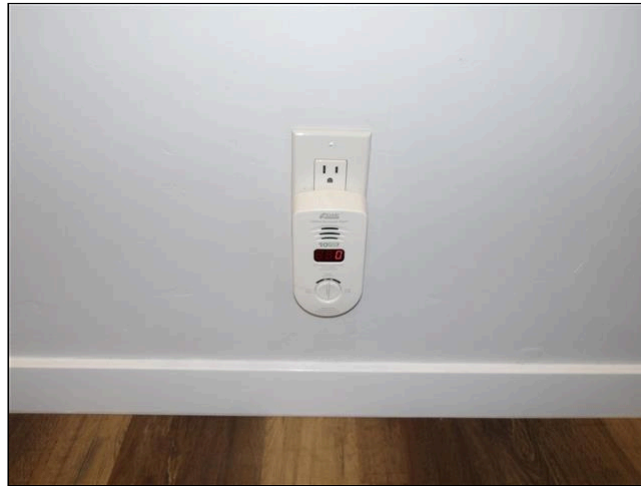
11.1 Item 1(Picture)

Photo of carbon monoxide detector(s).

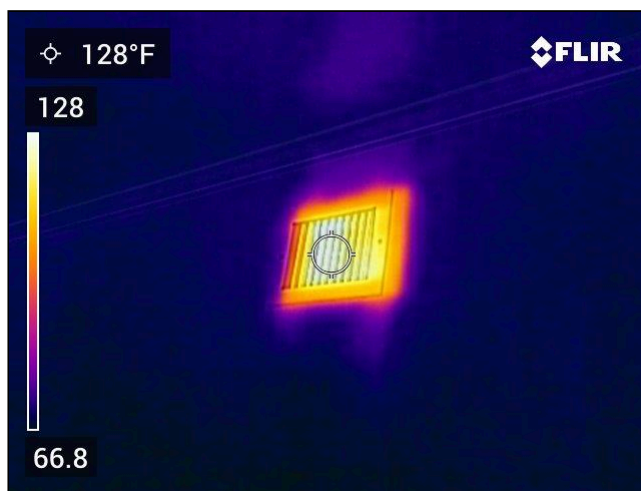
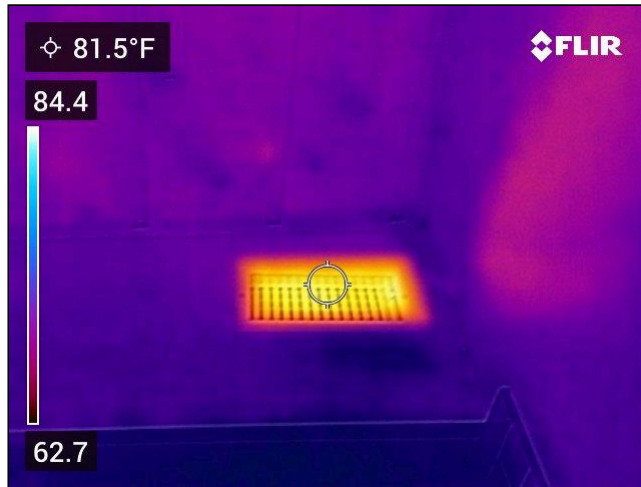
(1) **Infrared Thermal photo of the furnace(s) being tested.**

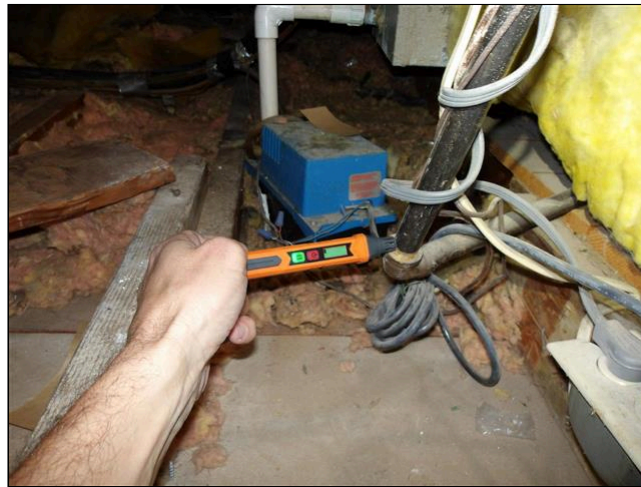
12.0 Item 3(Picture)

(2) A gas leak test was conducted at accessible gas fittings at the furnace using a gas leak detector. There were no gas leaks detected at the time of the inspection.

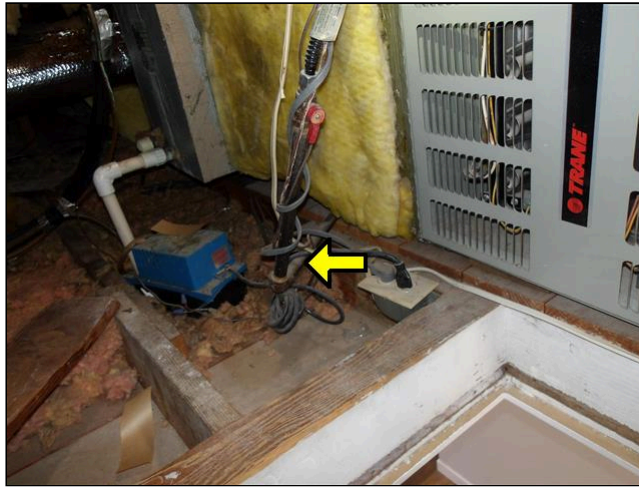
12.0 Item 6(Picture)

(5) The flexible gas supply pipe passes through the furnace housing. Vibration from the furnace can wear through flexible gas pipe which could cause a gas leak. SDG&E is "Red Tagging" this condition as they considered it to be unsafe. Due to this condition we recommend a rigid cast pipe be installed from the gas regulator through furnace housing, to the exterior of furnace housing by a qualified licensed HVAC contractor.

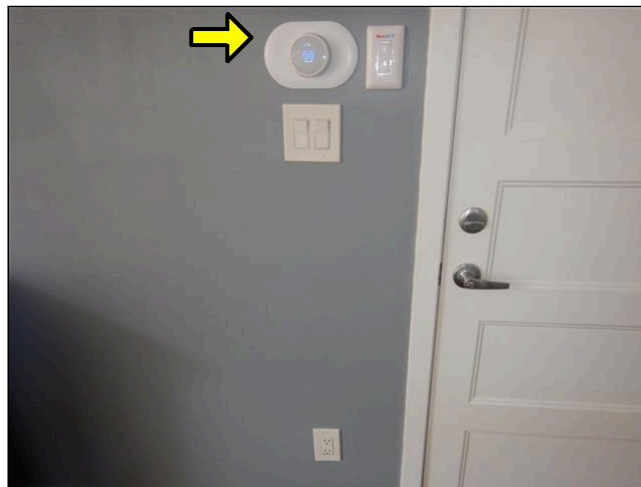
12.1 Item 1(Picture)

Both of the thermostats in the house were operational when used to operate the HVAC systems at the time of the inspection. Programmable thermostats are not adjusted and no testing is done to check the accuracy or programmed settings of the thermostat. If concerned we recommend verifying proper operation of the programmable settings prior to the end of your contingency period by a qualified person.

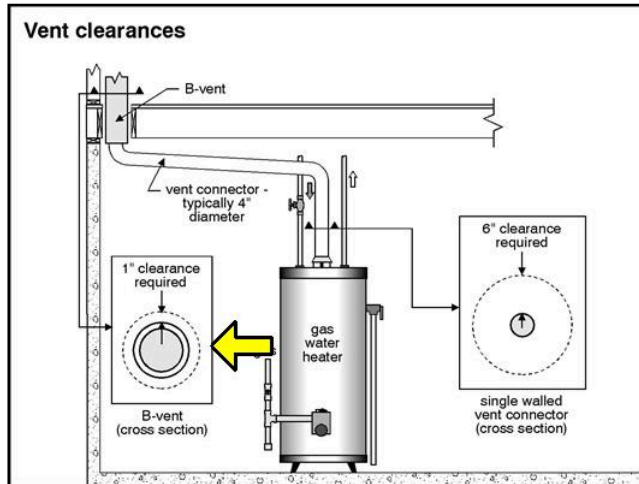
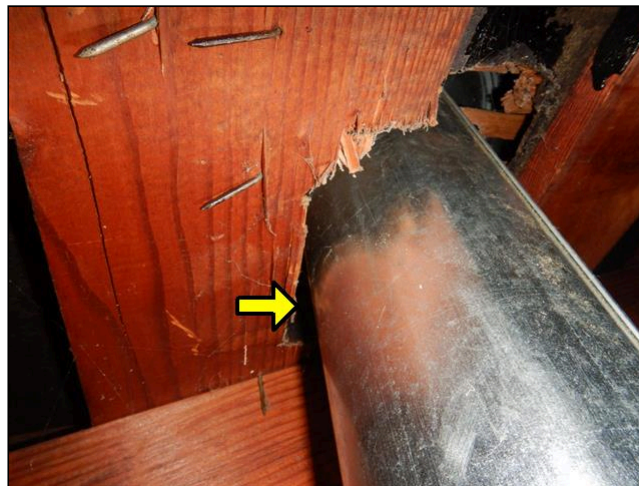
There is insufficient clearance at the left side furnace, furnace flue. With a double wall flue, a 1 inch clearance must be maintained between the flue and combustible materials. The furnace flue is in direct contact with or to close to combustible materials. We recommend necessary corrections by a qualified licensed HVAC contractor.

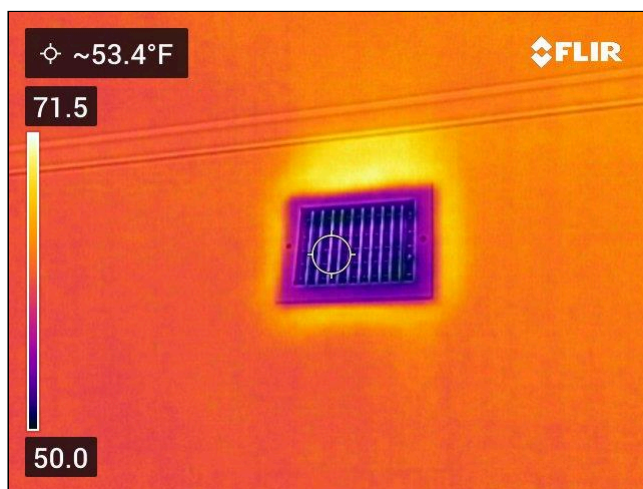
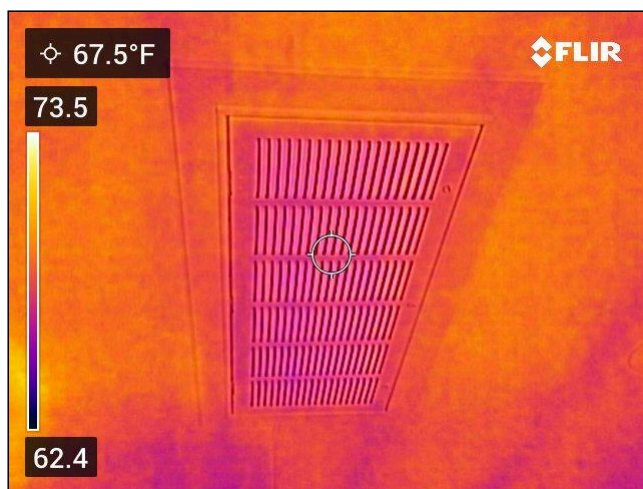
The air returning to the system (return) to the right side of the house was measured at **67 degrees**.

This indicates that the range in temperature drop is normal at both AC systems. This is not an exhaustive test and cannot predict the performance of the AC systems on extremely hot or humid days.

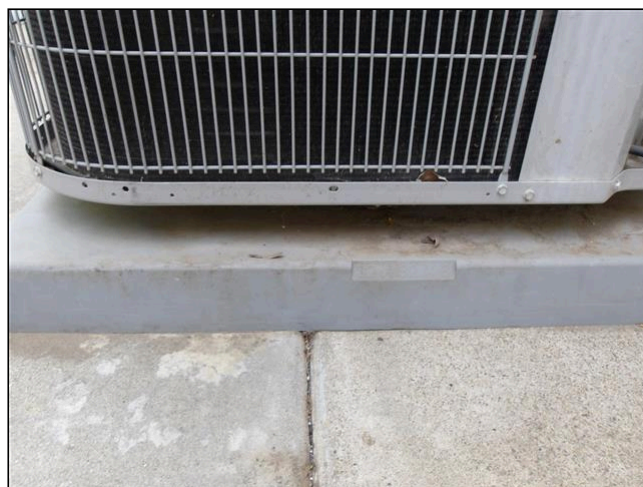
13.0 Item 5(Picture)

(3) The AC unit(s) are not strapped to pad(s). Most manufacturers installation

instructions require strapping condensers to the pads. Movement of the units due to internal vibration (or earthquake) can damage the refrigerant lines and their connections. We advise repair with qualified person.

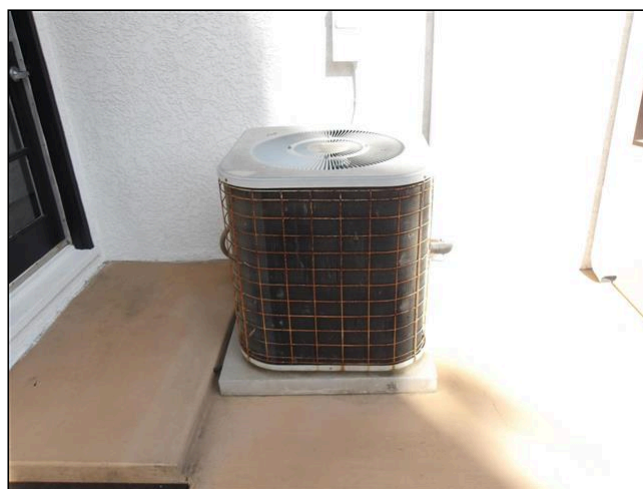
13.0 Item 6(Picture)

(4) The right side air conditioning system in this property is an older system which may have R 22 freon. Effective January 1, 2020 the Department of Energy mandates that all manufactured air conditioner condensing units use R 410-A freon. The older R 22 freon will no longer be allowed. We recommend further evaluation by a licensed HVAC contractor prior to the end of your contingency period to check the freon level and for upgrade or replacement options. If the repair requires adding R22 refrigerant to the system, the only options will be reclaimed and previously-produced R22 refrigerant. Once there is no more R22 refrigerant available the compressor must be replaced. We also recommend budgeting for replacement and obtaining and keeping a Home Warranty that covers this HVAC system.

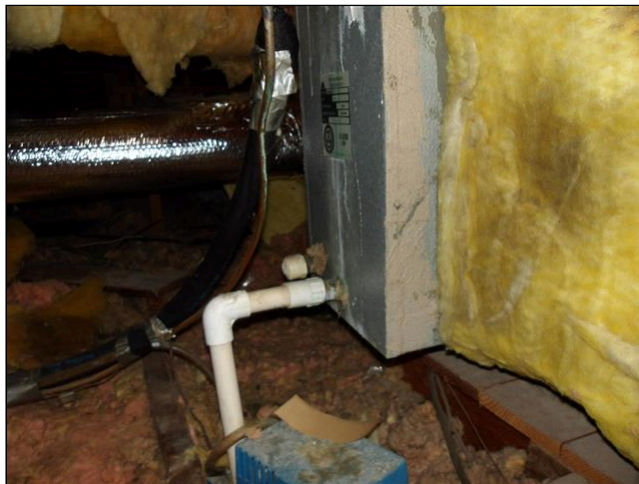
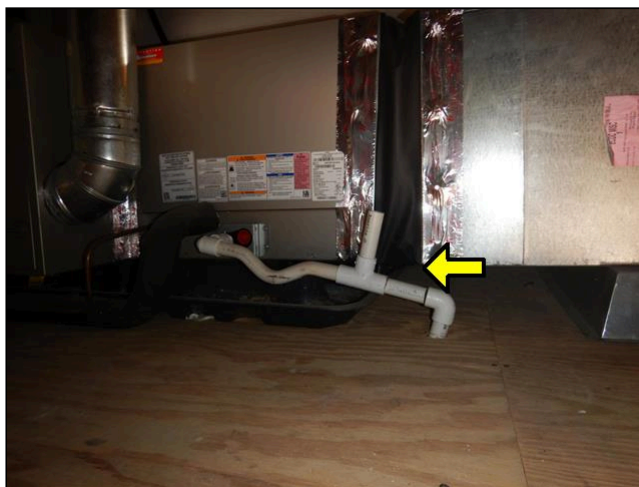
There is no secondary AC condensation drain installed at the right and left side units. This may have been acceptable at time of installation. However, today a secondary drain or alternate device is required to prevent damage in case of a clog in the primary drain. We recommend installing a secondary drain or alternate device by a qualified licensed HVAC contractor.

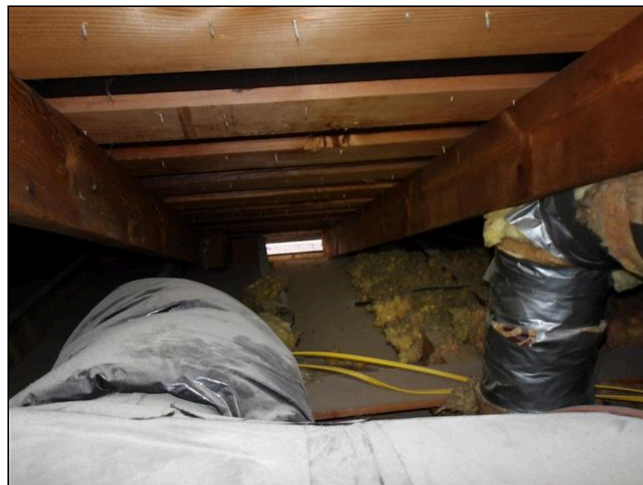
14.0 Item 2(Picture)

(2) Some of the batt insulation has been moved in the attic space. This insulation was not put back into position where needed. We recommend having the insulation distributed properly/ put back into place to improve the thermal efficiency of the house by a qualified person.

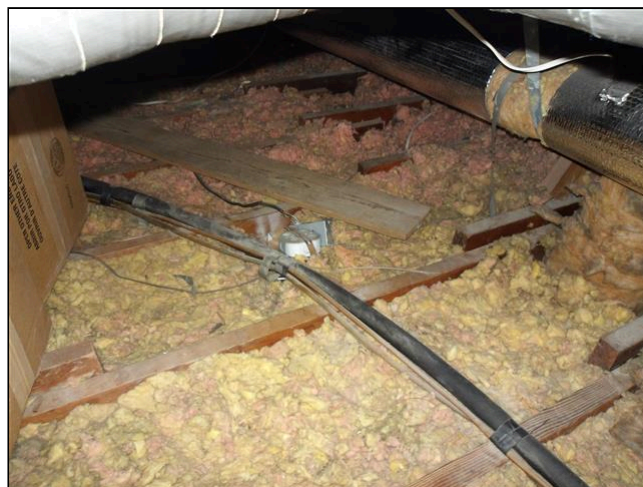
14.0 Item 3(Picture)

(3) The insulation in the attic is compressed. We recommend increasing the amount of insulation to improve the thermal efficiency of the house by a qualified licensed contractor.

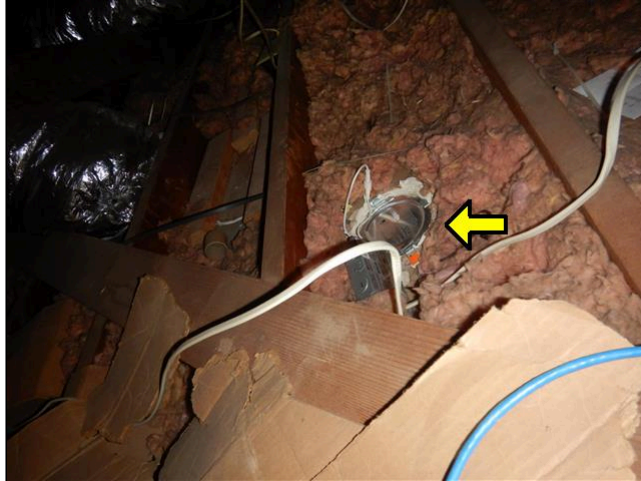
14.0 Item 4(Picture)

(5) Insulation was noted to be in contact with several recessed lights in the attic area. This is a safety/ fire hazard. We recommend removal/ necessary corrections by a qualified person.

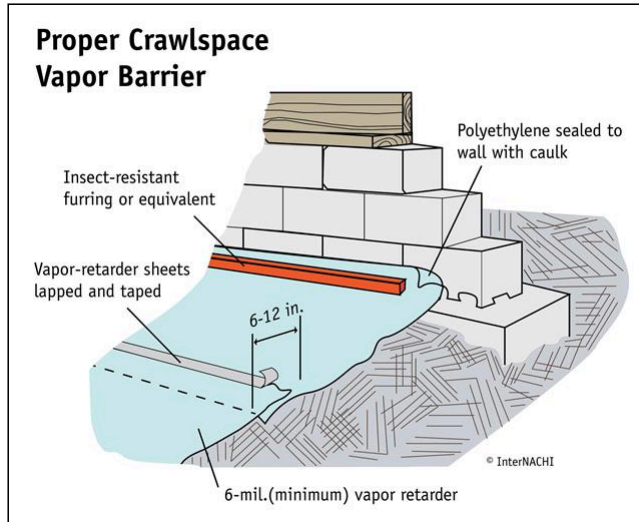
14.3 Item 1(Picture)

A vapor barrier is not installed on the crawl space ground under the house. This condition is conducive to wood destroying insects and organisms due to the likelihood of water evaporating into the wood structure from the soil. We recommend having a vapor barrier installed by a qualified person.

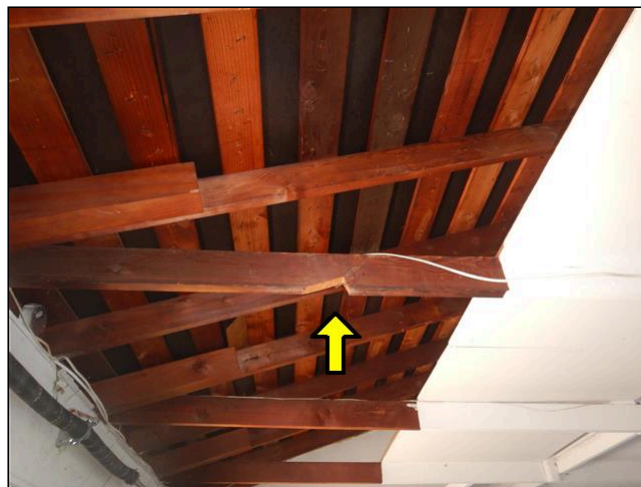
15.1 Item 1(Picture)

(1) A rafter support was removed in the garage. We recommend further evaluation by a licensed roof contractor prior to the end of your contingency period.

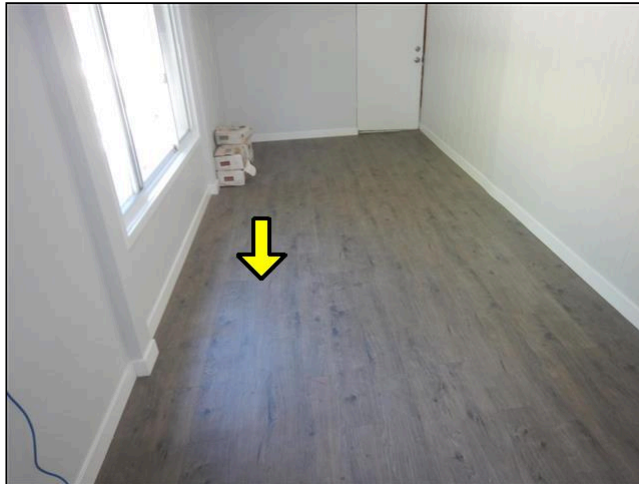
15.2 Item 1(Picture)

(1) The floor in the far left room is sloping excessively in several areas throughout the house. This condition could be due to age and settlement. The exact cause and evaluation is beyond the scope of a general home inspection. We recommend further evaluation by a licensed foundation contractor or structural engineer prior to the end of your contingency period.

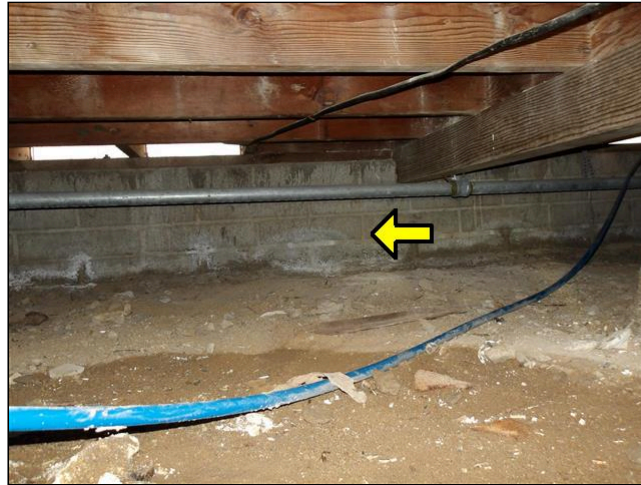
15.3 Item 1(Picture)

(2) There is white efflorescence (powder substance) observed on the concrete foundation wall in some areas. This condition indicates that moisture is in contact with the masonry. We recommend checking the gutters, downspouts, and drain lines for proper operation. A water proofing paint could be applied the foundation if necessary. Efflorescence is found on many homes without water intrusion occurring. We recommend necessary corrections to help this condition from occurring.

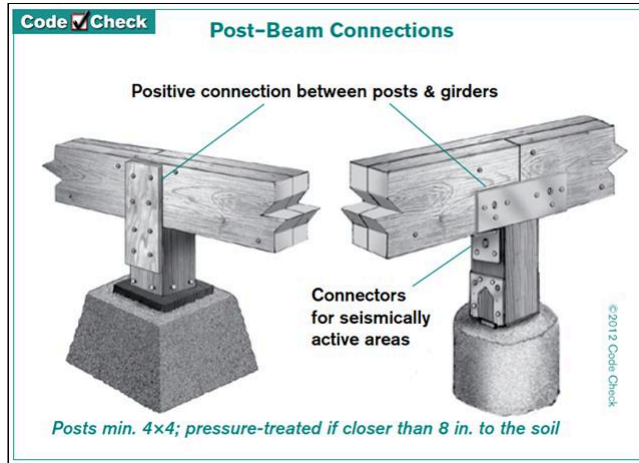
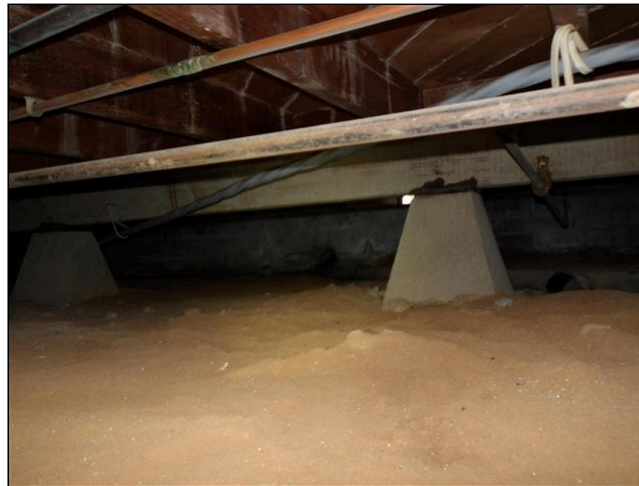
The wood posts are not strapped/ bolted to the floor beams or concrete piers. At time of construction, and until 1994 this was acceptable. We recommend having the post and pier system strapped/ bolted for stability and seismic resilience. We recommend necessary repairs by a qualified licensed foundation contractor.

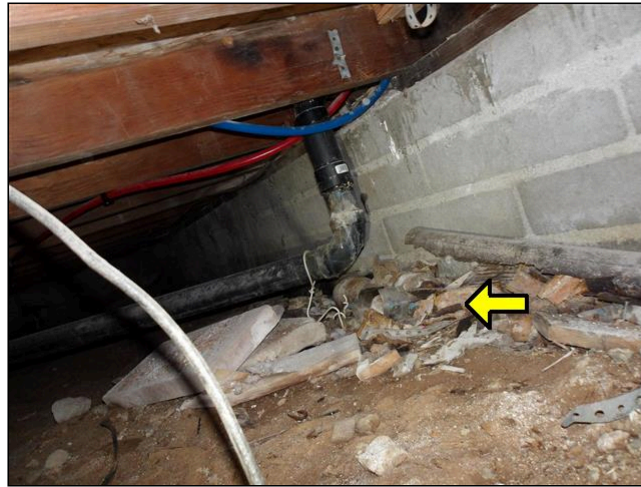
15.7 Item 1(Picture)

(1) Debris was present in the crawlspace which prevent complete access to all areas of the crawlspace. This prevented a complete evaluation of the foundation, footings, piers, and plumbing or electrical components that are present in those areas that could not be accessed. We recommend removing this debris and/or items stored under the house and having all these areas and related components be inspected by this company or qualified person prior to the end of your contingency period.

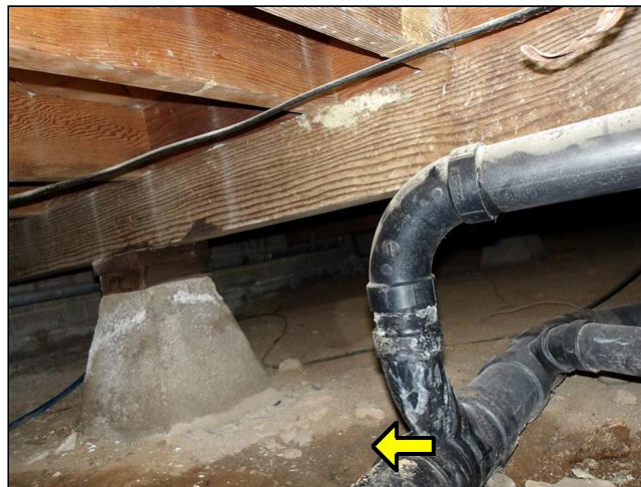
15.7 Item 2(Picture)

(2) The ground/ dirt in the crawlspace under the house was excessively moist at the time of the inspection. Due to this condition this area and it's related components could not be inspected. We recommend having the entire crawlspace and related components inspected by this company or a qualified contractor once the ground is dry and prior to the end of your contingency period.

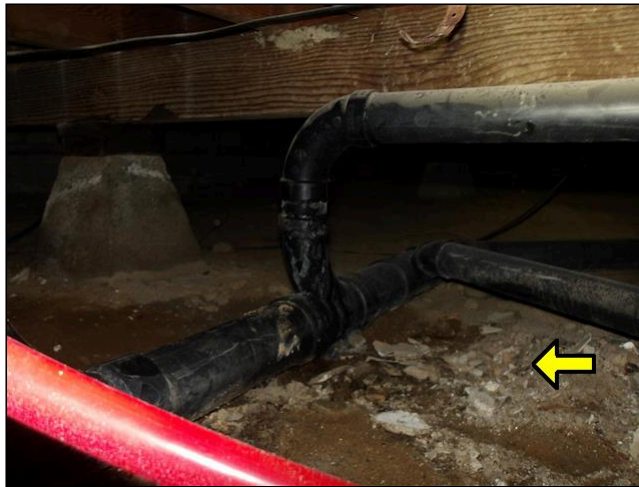
15.7 Item 3(Picture)

(3) Desiccated soil "Dry Lake Bed" Is noted under the house. This condition results when water intrusion occurs under a house and then dries out. This can be caused by a high water table, water intrusion during heavy rain or irrigation, or a past/ present plumbing leak. I was unable to determine the cause. We recommend further evaluation or monitoring for water intrusion and necessary corrections as needed.

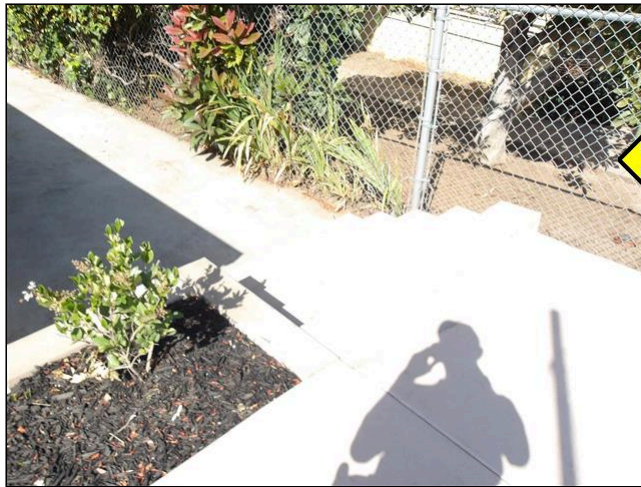
18.2 Item 1(Picture)

- (1) Door alarms should be installed on all house doors that lead to the pool area due to no barrier between the house and the pool. We recommend installing door alarms in accordance with your local building requirements by a qualified licensed contractor.
- (2) A portion of the fence at the pool area is climbable and non standard when a pool/ spa is present. We recommend installing an appropriate fence by a licensed fence contractor.

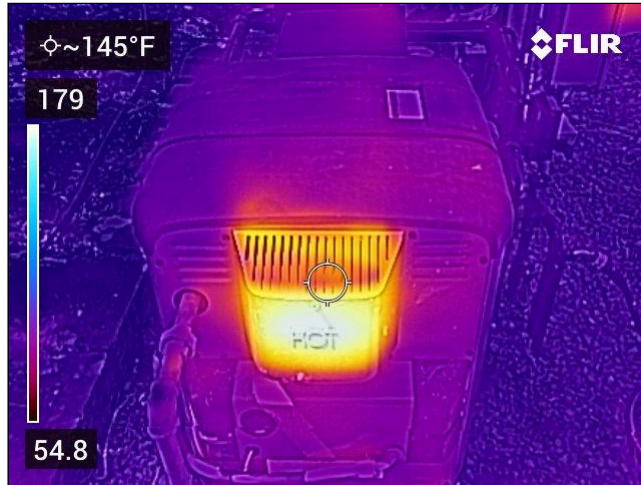
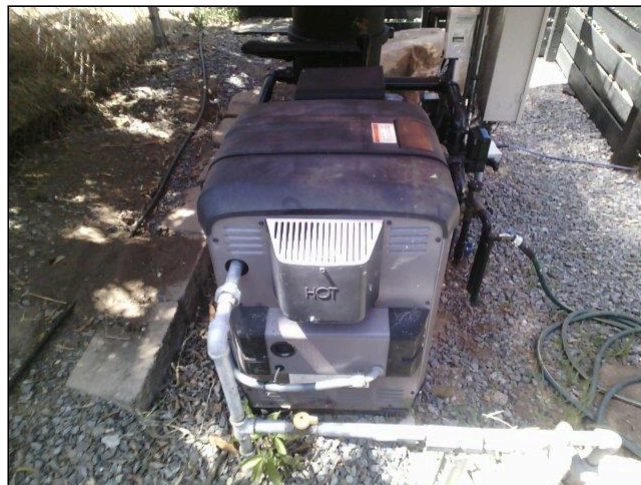
(1) **Infrared Thermal photo of the pool/ spa furnace being tested.**

(2) The pool furnace was tested and was operational at the time of the inspection. This is not an exhaustive test and does not verify the efficiency of the unit.

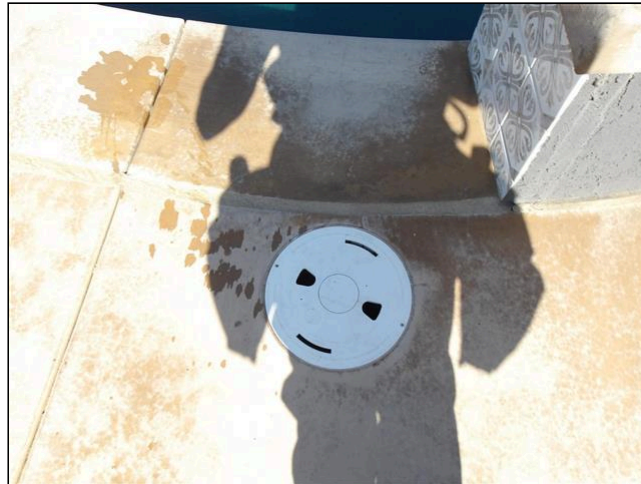
18.9 Item 1(Picture)

The weir door in one of the skimmers is missing and should be replaced to prevent

objects from entering into the skimmer. We recommend replacing the weir door by a qualified licensed pool contractor.

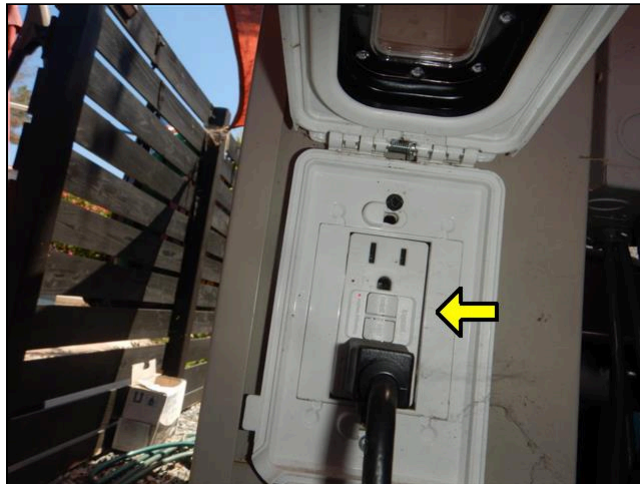
18.10 Item 1(Picture)

The GFCI outlet was tested and was found to be operable at the time of the inspection.

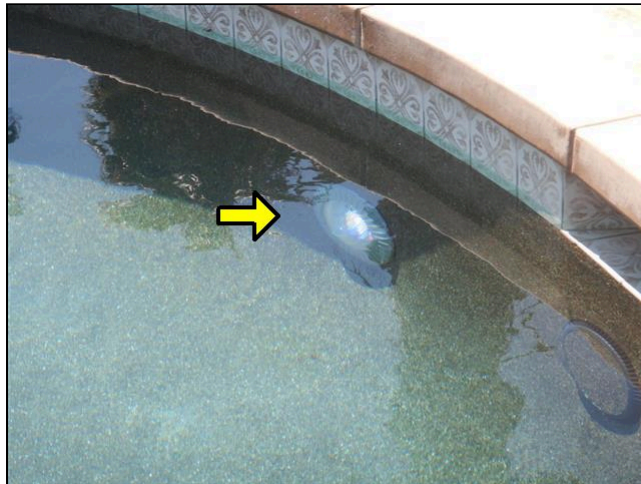
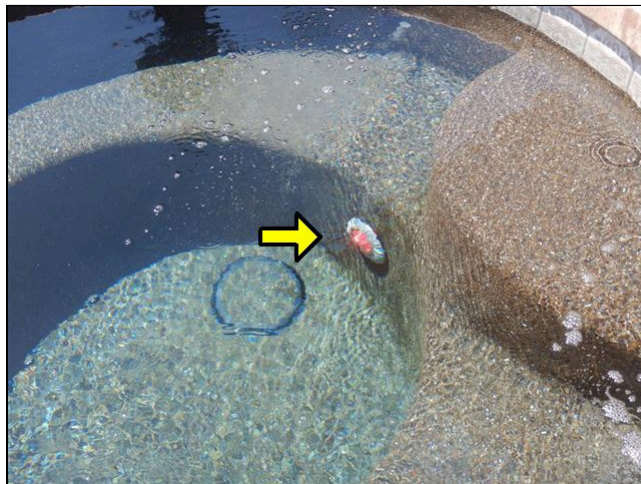
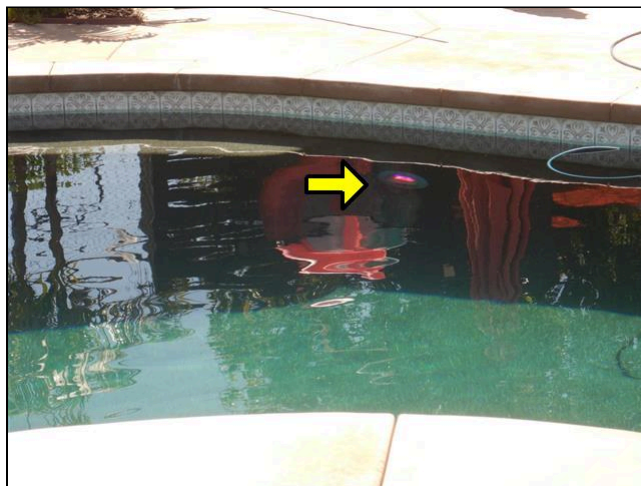
(1) Photo of pool/ spa light(s) on.

(2) Pool and spa light(s) are not taken out and we did not observe the condition of the wiring to the pool and spa light(s). This is out of the scope of a general home

inspection. If concerned about the wiring to these lights we recommend further evaluation by a licensed pool contractor prior to the end of your contingency period.

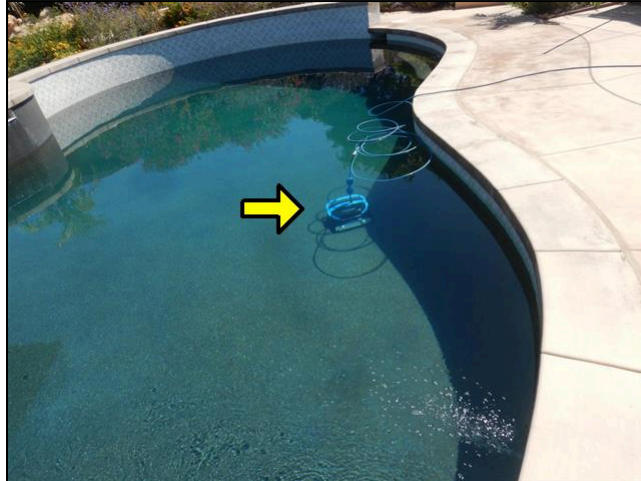
18.15 Item 1(Picture)

(1) The pool sweep functioned at the time of the inspection. This is not an exhaustive test and does not verify the cleaning efficiency of the unit.

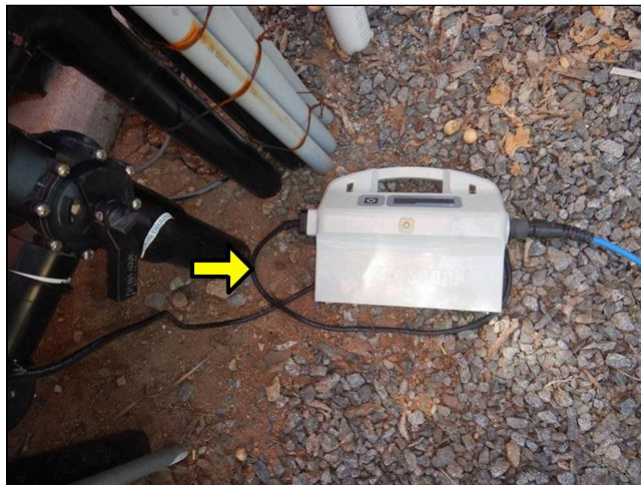
18.15 Item 2(Picture)

(2) The control/ power box for the pool sweep is on the ground. We recommend properly securing it off the deck.
