Inspection Report

Property Address:
1221 Main Ave.
Oceanside CA 92056

The Property Inspection Pros

Date: 9/24/2024	Time: 01:00 PM	Report ID:
Property: 1221 Main Ave. Oceanside CA 92056	Customer: John Smitty	Real Estate Professional:

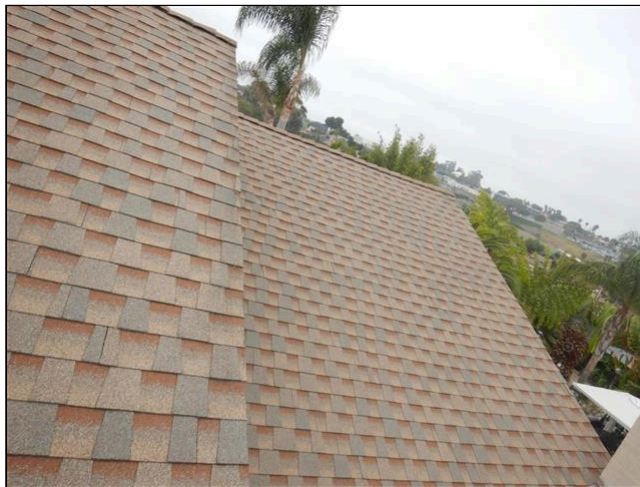
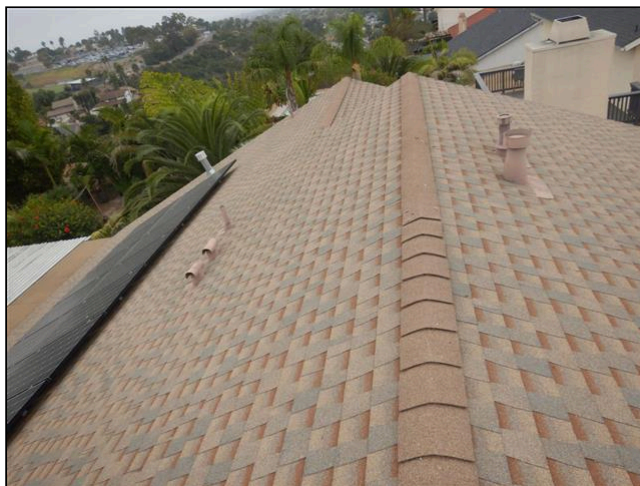
(1) [Photo\(s\) of the roof.](#)

(2) The roof material shows normal wear for its age and type; appears to be in serviceable condition.

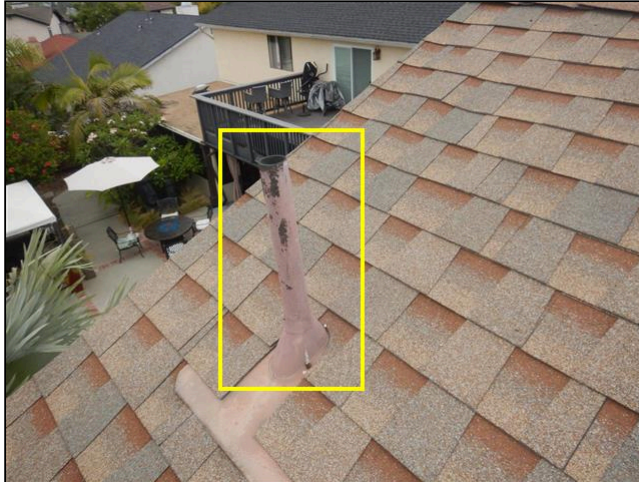
1.2 Item 1(Picture)

(1) The paint at the ABS plumbing vents is worn. We recommend having the ABS vents painted by a qualified licensed contractor.

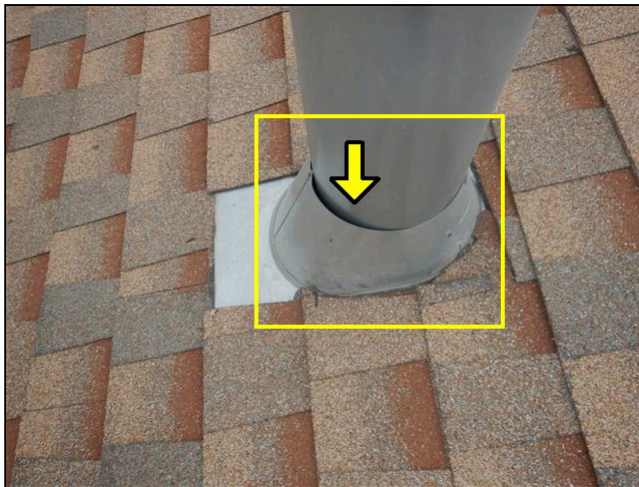
1.2 Item 2(Picture)

(2) Sealant around some of the roof flashings/ penetrations is cracked or missing. We recommend having sealant applied where needed to help prevent roof leaks by a licensed roofer.

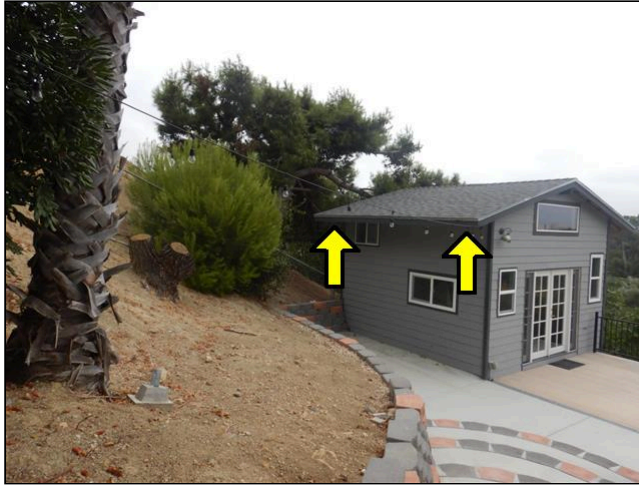
1.3 Item 3(Picture)

(4) Gutters are not installed at the rear ADU. We recommend installing gutters and downspouts to prevent erosion or water intrusion around the ADU by diverting run off away from the house by a qualified licensed contractor.

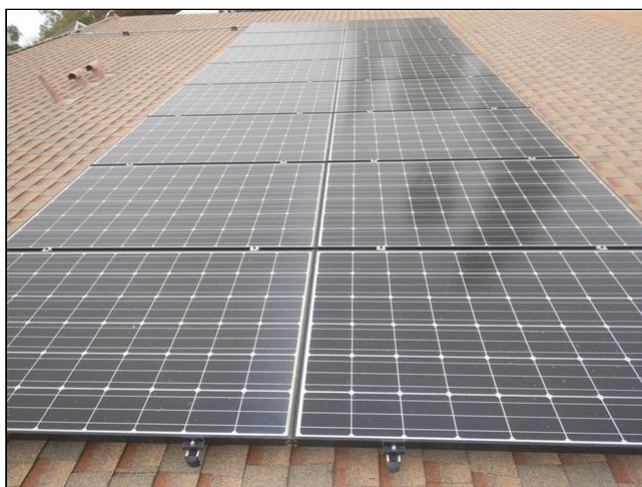
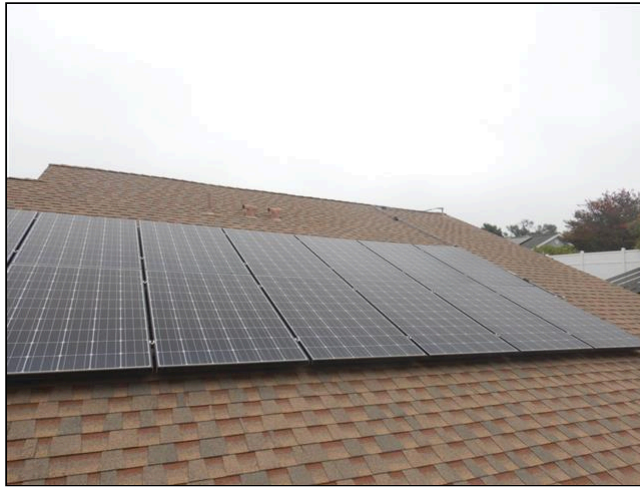
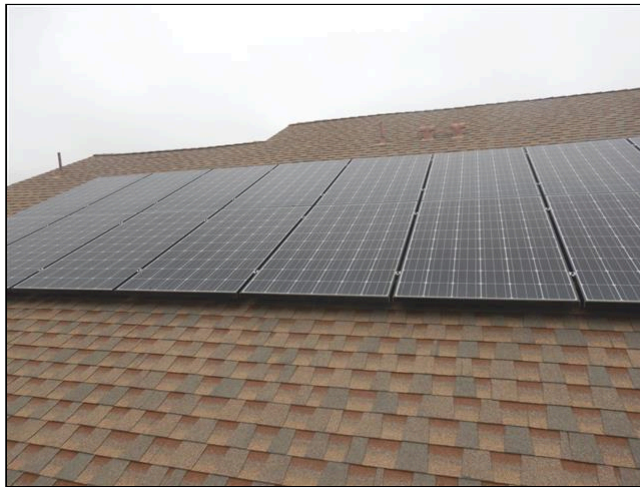
The electric solar system and its related components are beyond the scope of the home inspection and was not inspected. We recommend verifying that the electric solar system is operational prior to the end of your contingency period.

We also recommend having all the solar panels cleaned by a qualified person.

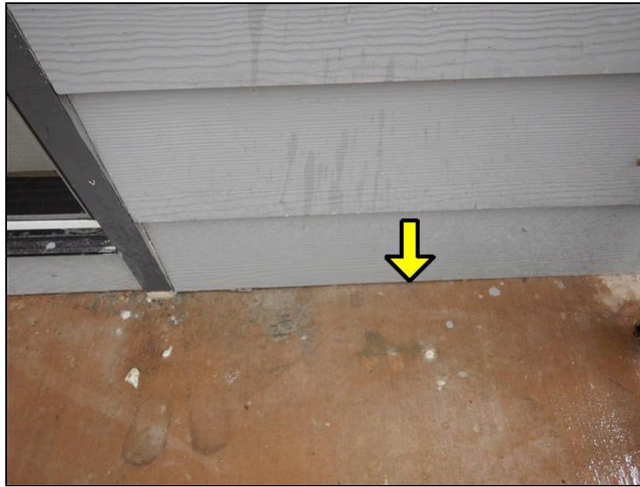
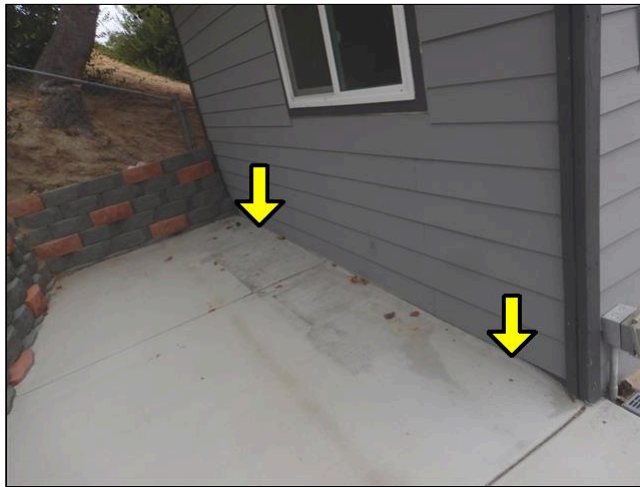
(2) Siding at the ADU is in contact with the ground at several areas. Dirt in contact with the siding can promote deterioration, including rot, pest infestation, and water intrusion during rain. We recommend a ground clearance of four to six inches where possible by a qualified contractor.

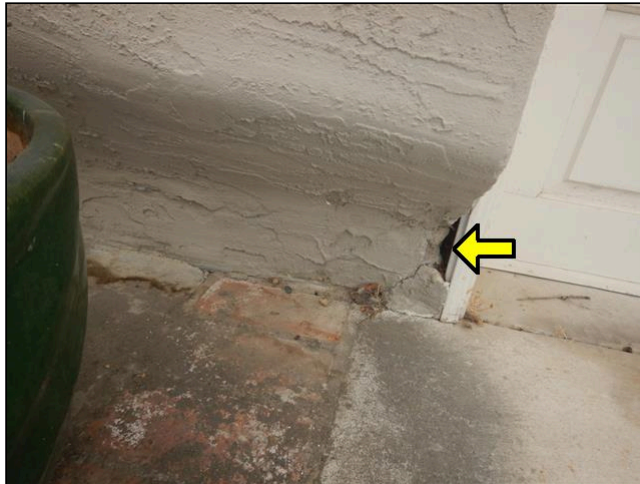
2.3 Item 1(Picture)

(1) There is damaged/ deteriorated stucco observed at several areas. We recommend necessary repairs where needed by a licensed stucco contractor.

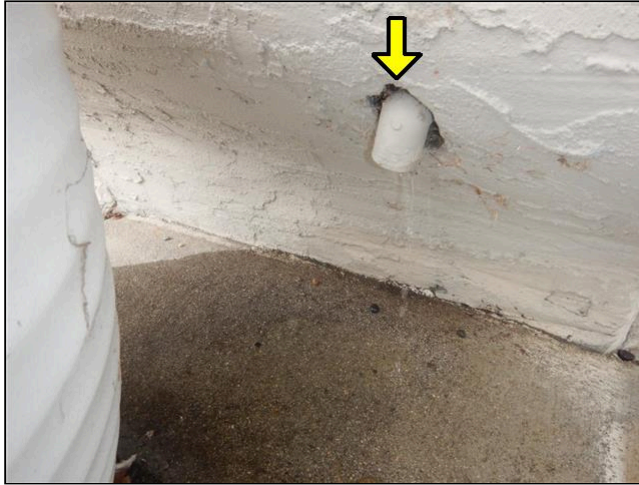
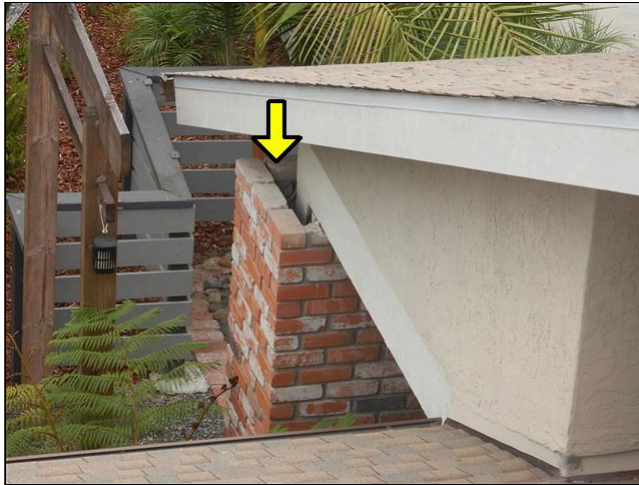
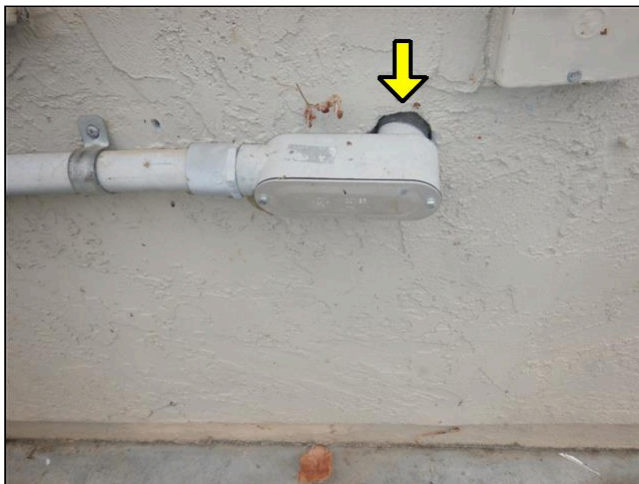
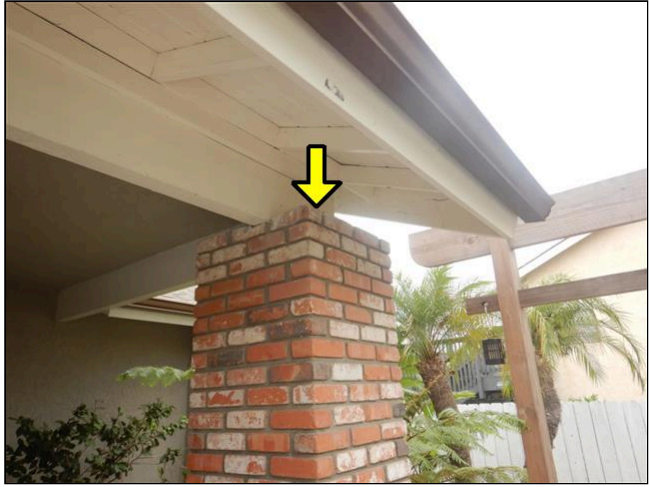
(3) Several gaps were observed at the siding. These gaps can allow water to flow behind the siding causing damage. We recommend caulking the gaps as needed to seal the siding and prevent water intrusion.

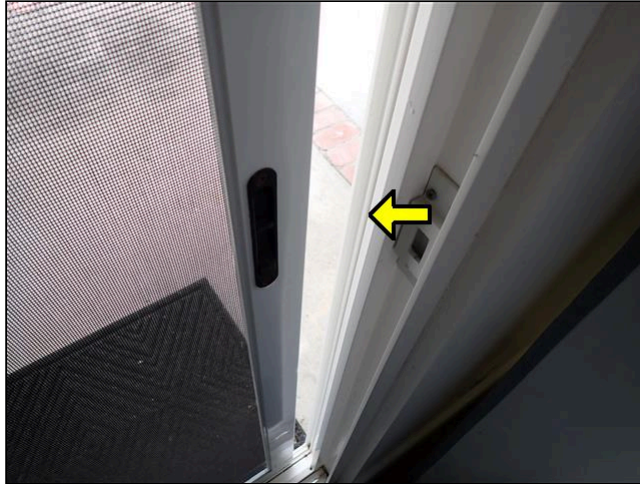
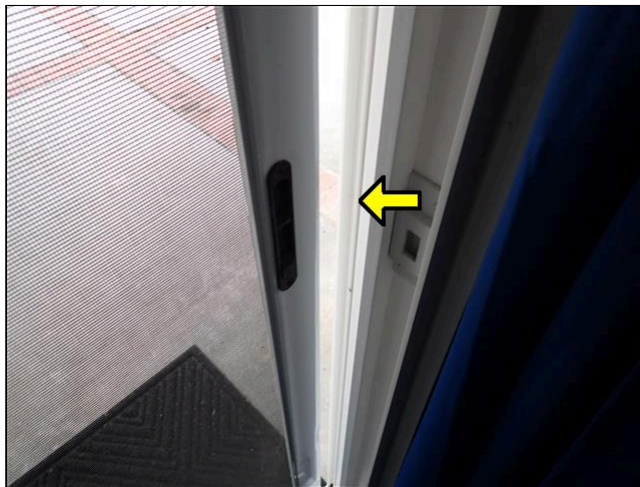
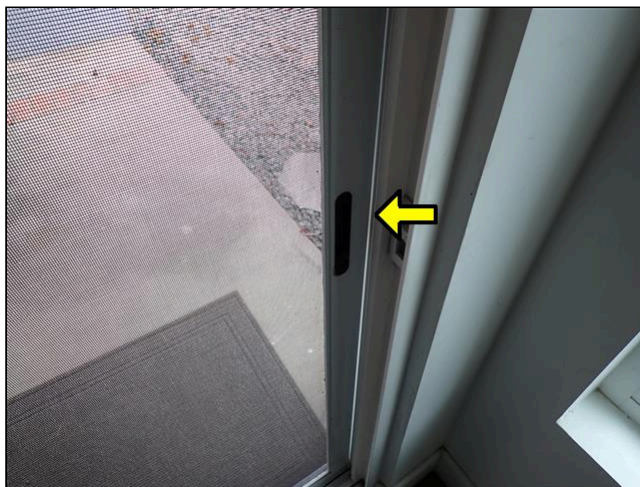
(1) All of the sliding screen door latches are missing. We recommend replacement where needed by a qualified licensed door contractor.

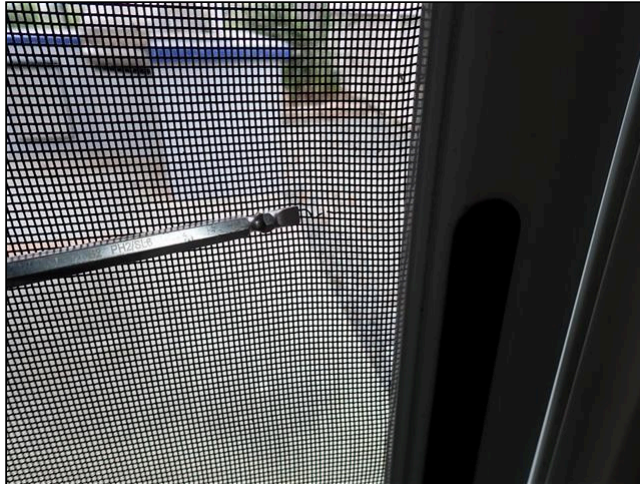
2.5 Item 4(Picture)

(2) The kitchen sliding screen door has a torn or damaged screen. We recommend repair

or replacement by a qualified person.

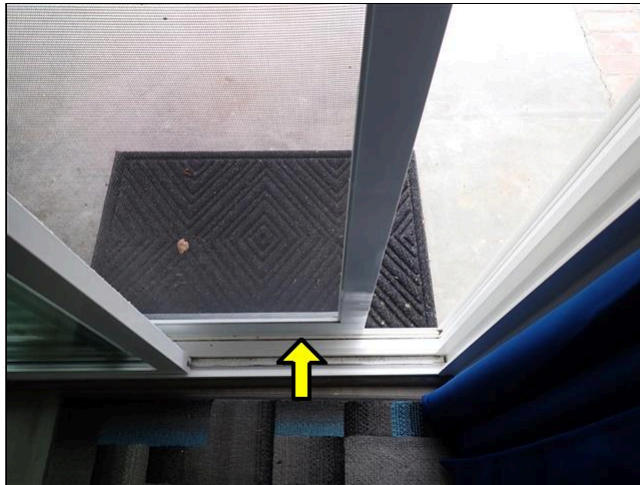
2.5 Item 5(Picture)

(3) The master bedroom sliding screen door sticks and is difficult to slide. We recommend necessary repairs or replacement by a qualified person.

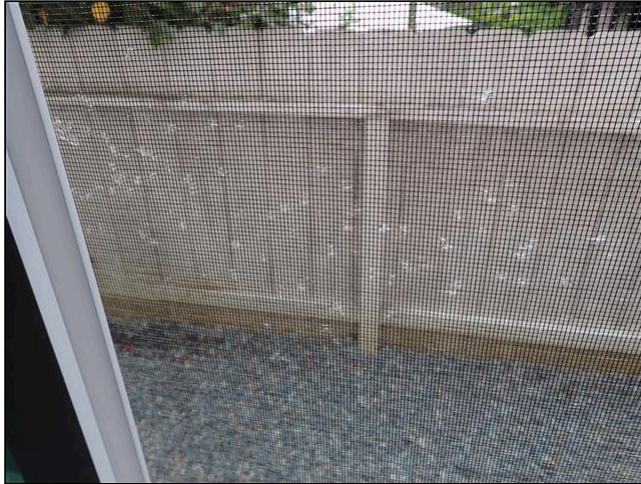
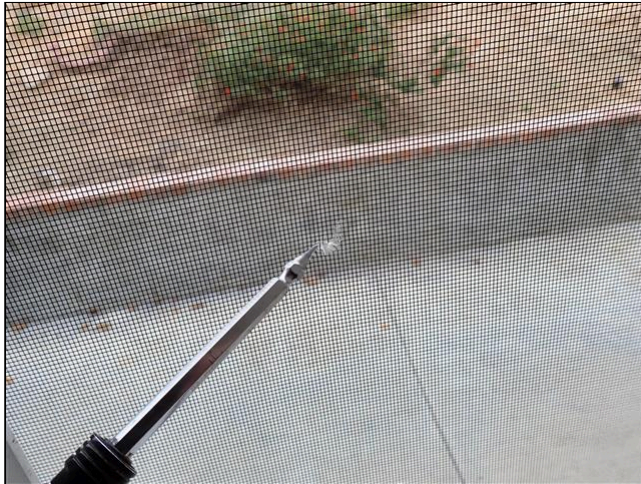
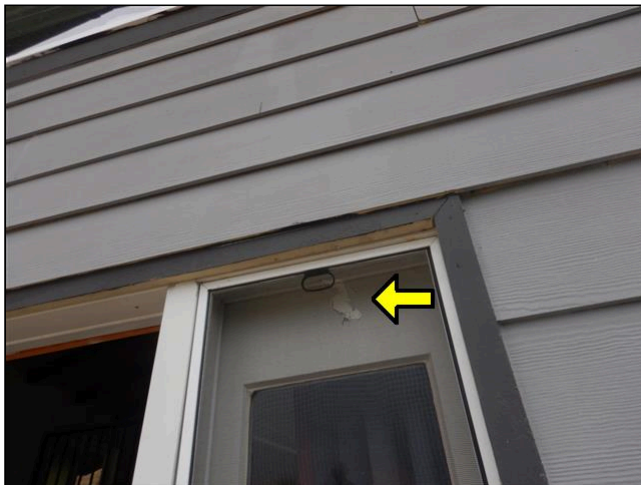
(1) There are several window screens that are damaged throughout the house and ADU. We recommend repair or replace as needed by a qualified person.

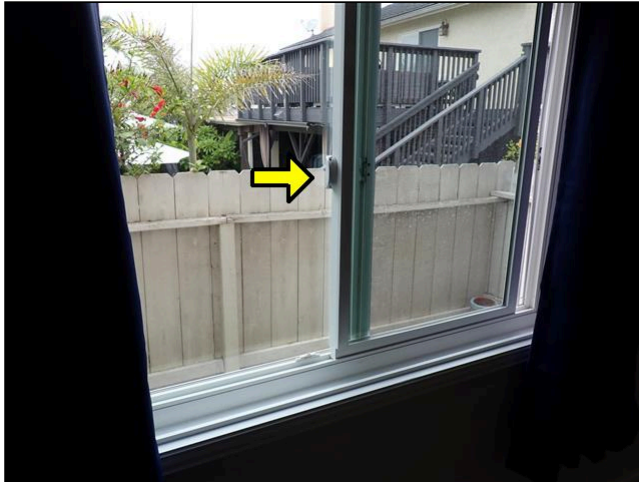
2.6 Item 4(Picture)

(2) A window latch was found to be inoperable at a family room window. We recommend

necessary repair or replacement by a qualified licensed window contractor.

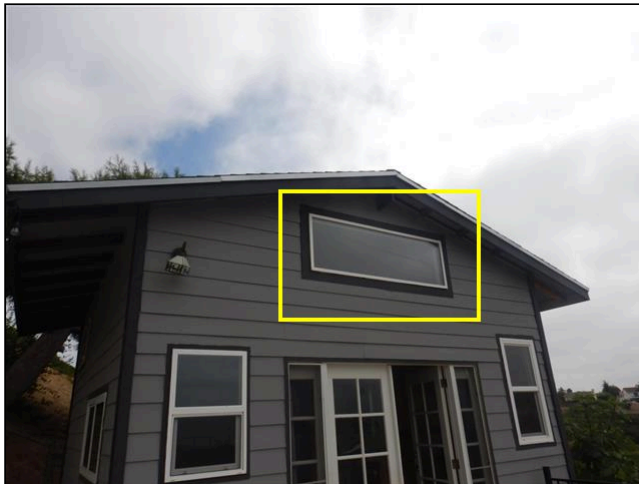
2.6 Item 5(Picture)

(4) A cracked/broken window is observed in the ADU. We recommend repair or replacement by a licensed window contractor.

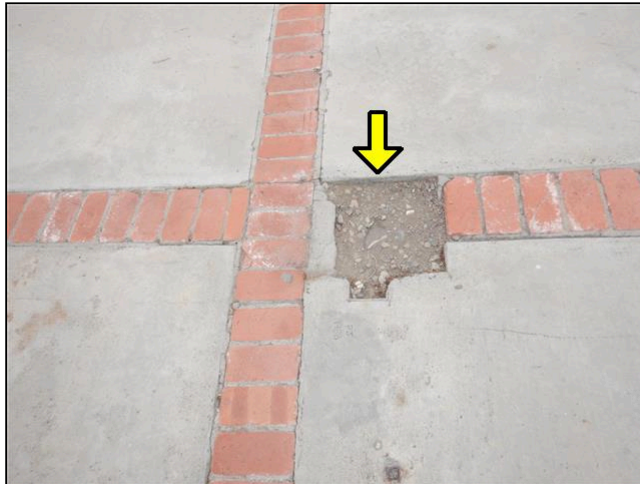
2.8 Item 1(Picture)

(1) There are missing bricks observed at the driveway. We recommend necessary repair by a licensed contractor.

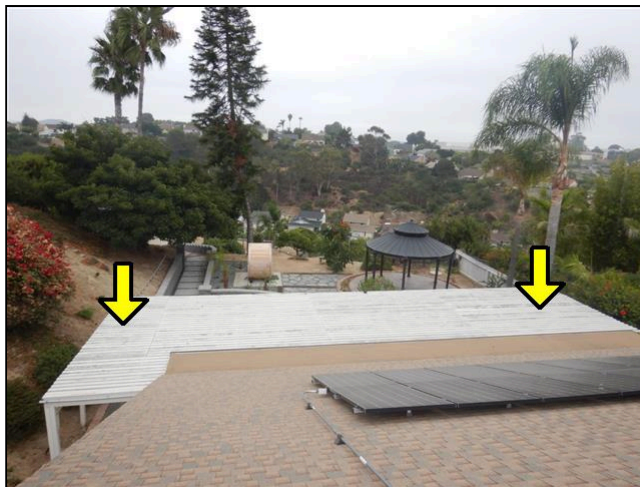
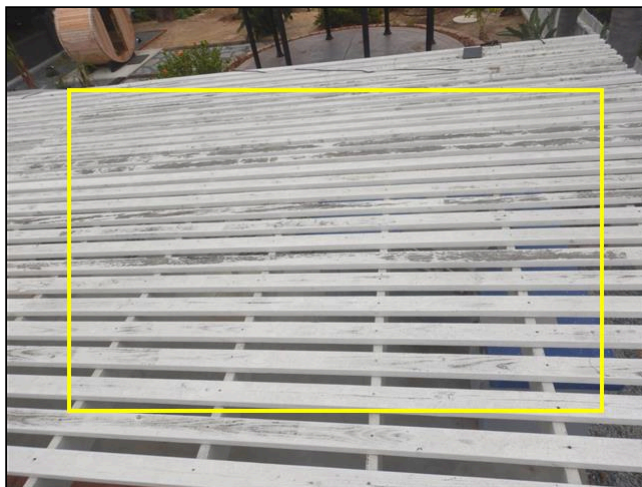
(2) Paint is worn/ failing at the wood patio cover and needs prep and paint. We recommend prep and paint where needed by a licensed paint contractor.

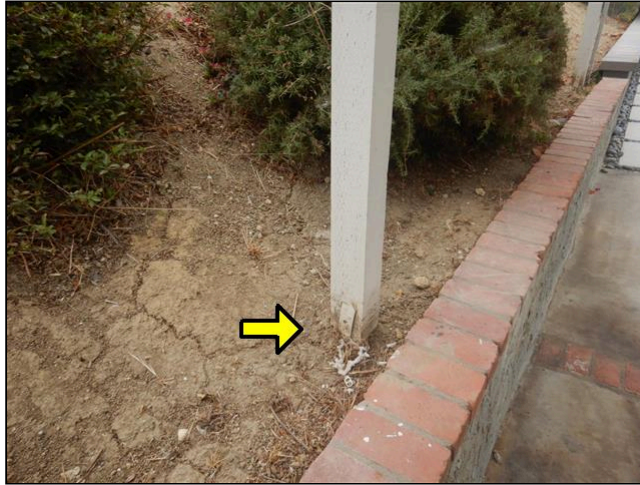
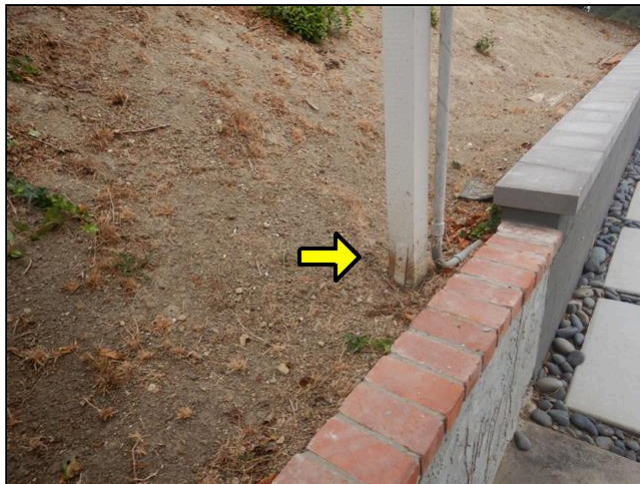
(4) Wood post(s) are in contact with ground/ soil at the patio cover. This can cause deterioration and attract wood eating insects. You should refer to the pest inspection report for a complete evaluation. Home inspectors do not have the authority to comment on termites or dry rot which is the responsibility of a state licensed pest inspector. We recommend necessary corrections/ moving the soil away from the post(s) as preventive maintenance by a qualified licensed contractor.

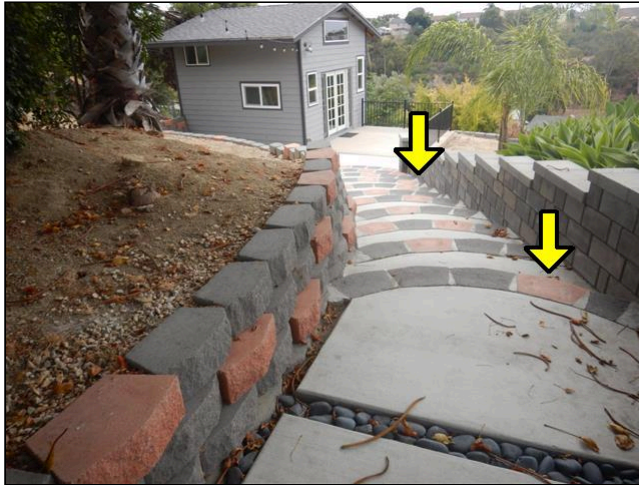
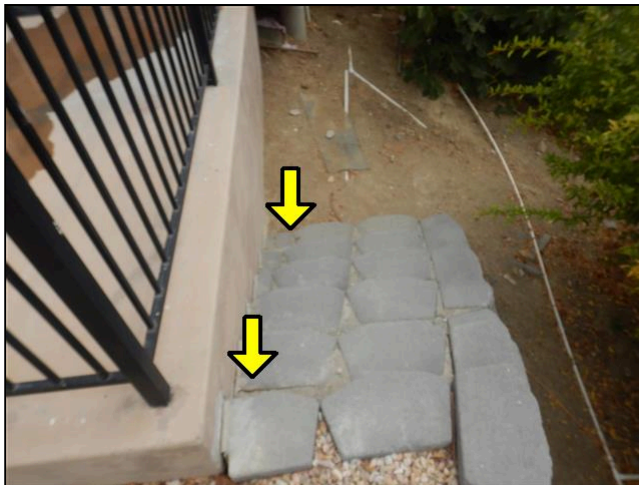
There is no handrail installed at the rear yard exterior stairs/ steps. A handrail is required at least one side of the stairs when four or more steps are present. This is a safety hazard and corrections are needed. We recommend installing a handrail for safety by a qualified licensed contractor.

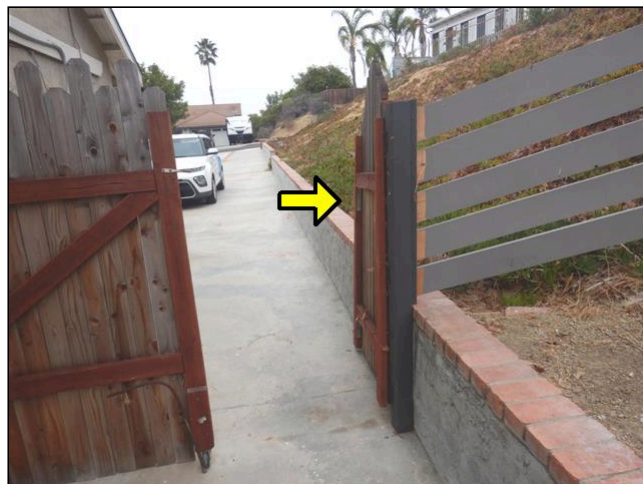
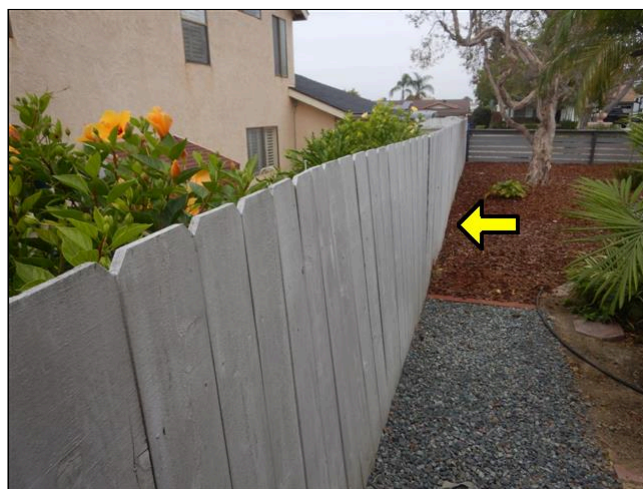
(1) The fence/ gates are loose and leaning at several areas. We recommend necessary repairs or replacing as needed by a licensed fence contractor.

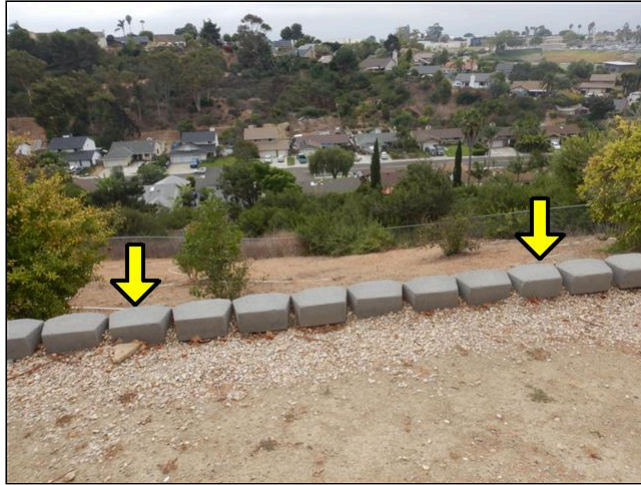
2.10 Item 5(Picture)

(4) A fence, barrier or guard rail is needed at several areas around the yard. A fall hazard is present at several areas. We recommend installing an approved fence, barrier, or guard rail where needed for safety by a qualified licensed contractor.

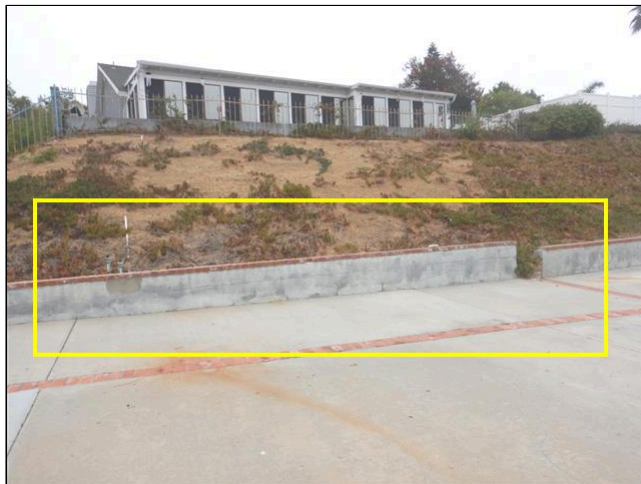
2.13 Item 2(Picture)

(2) There is damaged/ deteriorated and cracked stucco observed at the retaining wall at several areas. We recommend necessary repairs where needed by a licensed stucco contractor.

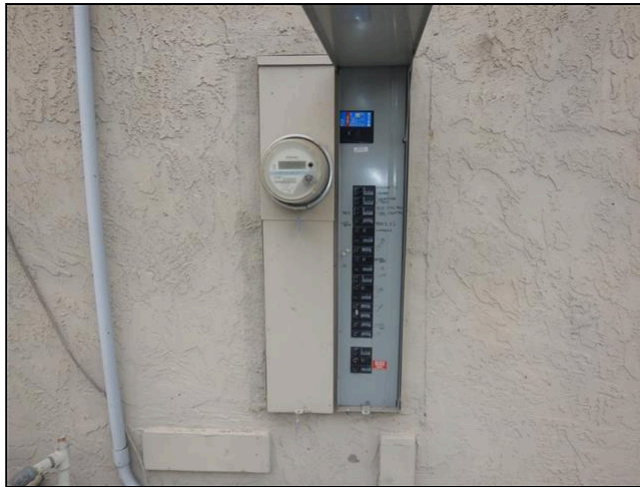
3.0 Item 1(Picture)

- (1) [Photo of the main electrical panel.](#)

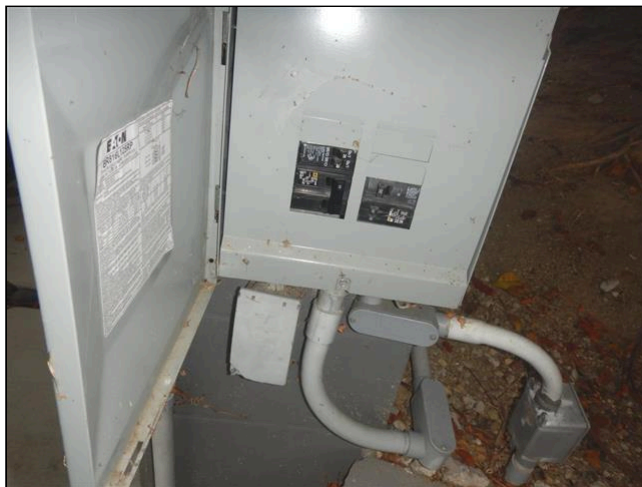
3.1 Item 1(Picture)

- (1) [Photo of the sub electrical panel.](#)

- (2) The sub panel breakers are not labeled. We recommend having the breakers properly labeled for safety by a qualified person.

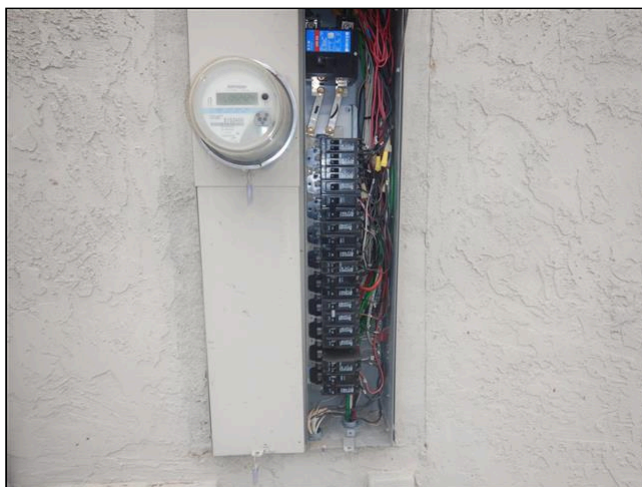
3.2 Item 1(Picture)

- (1) [Photo inside of the main electrical panel.](#)

The dead front cover was removed at the time of the inspection and the breakers, wiring and grounding were inspected.

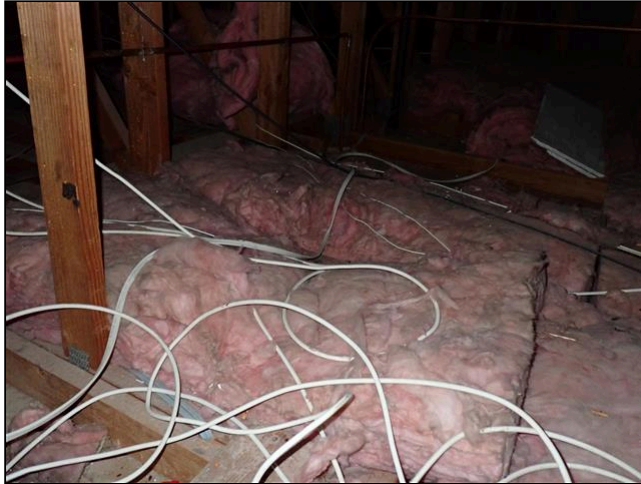
3.3 Item 1(Picture)

(1) Wires for some lighting fixtures in the attic space were observed to be unsecured. We recommend necessary corrections by a qualified licensed electrician.

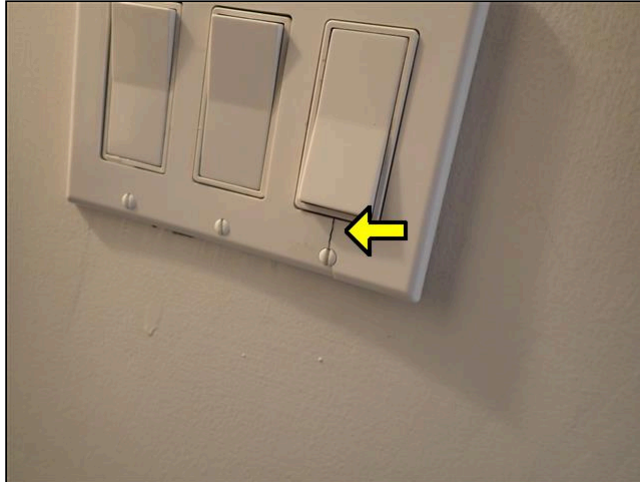
3.6 Item 1(Picture)

A light cover is damaged located in the master bathroom. We recommend replacement where needed by a qualified person.

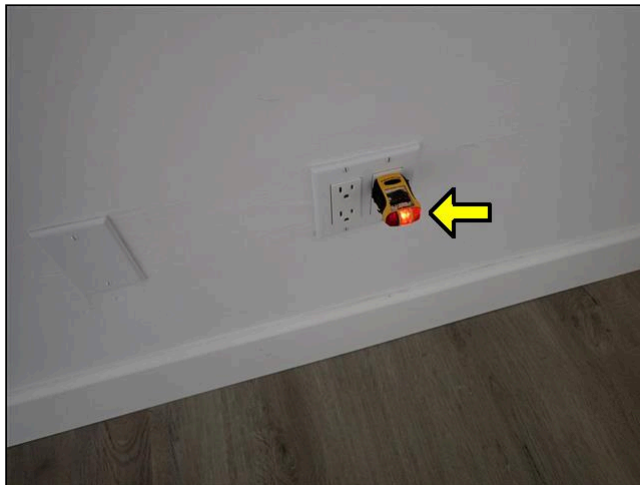
3.7 Item 1(Picture)

(1) An interior outlet in the master bedroom was found to be wired with no ground connection. We recommend necessary corrections by a qualified licensed electrician.

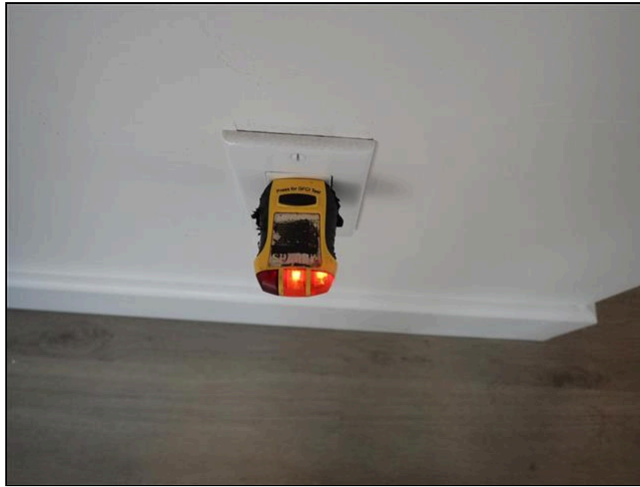
3.7 Item 2(Picture)

(2) **Photo of a receptacle being tested.**

A representative number of receptacles throughout the property were tested for power, polarity and grounding according to our standards-of-practice. These receptacles observed to be ok at the time of the inspection unless otherwise noted.

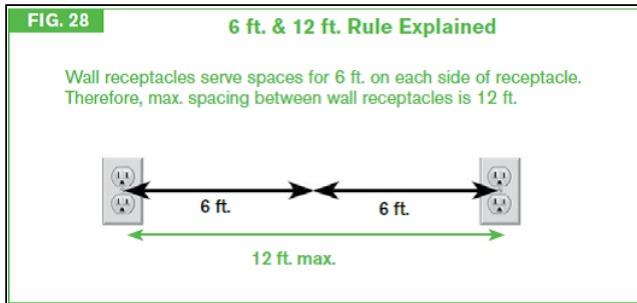
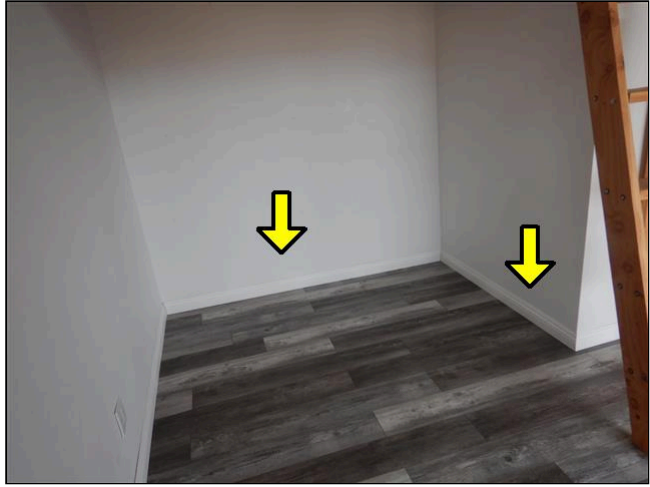
Wall receptacles are required within 6 feet of any point along the floor line measured horizontally. A single wall receptacle serves spaces for 6 feet on each side of receptacle. Interior wall(s) in the ADU were found with no or fewer wall receptacles than this standard. We recommend having additional receptacles installed by a qualified licensed electrician if additional receptacles are desired.

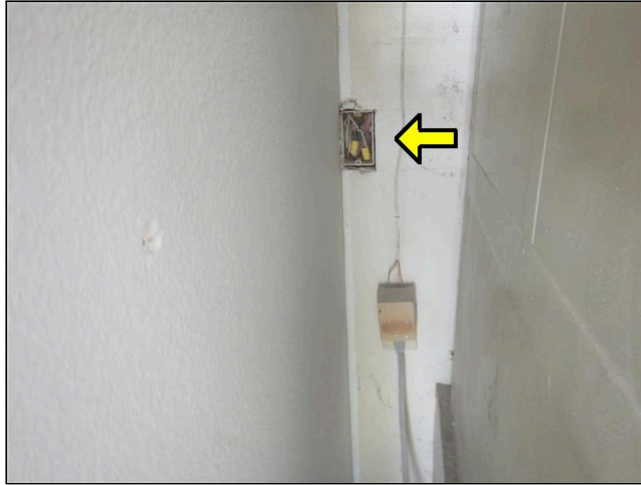
3.10 Item 1(Picture)

(1) An open junction box is observed in the garage. All electrical splices must be enclosed in a junction box. We recommend necessary repairs by a qualified person for safety.

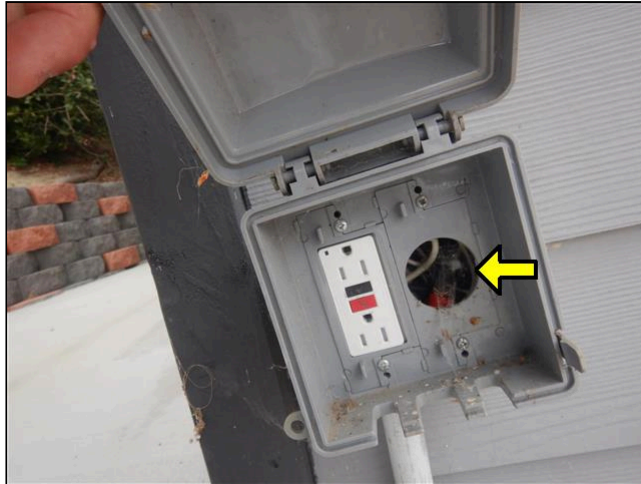
3.10 Item 2(Picture)

(2) An open junction box is observed at the ADU exterior wall. All electrical splices must be enclosed in a junction box. We recommend necessary repairs by a qualified person for safety.

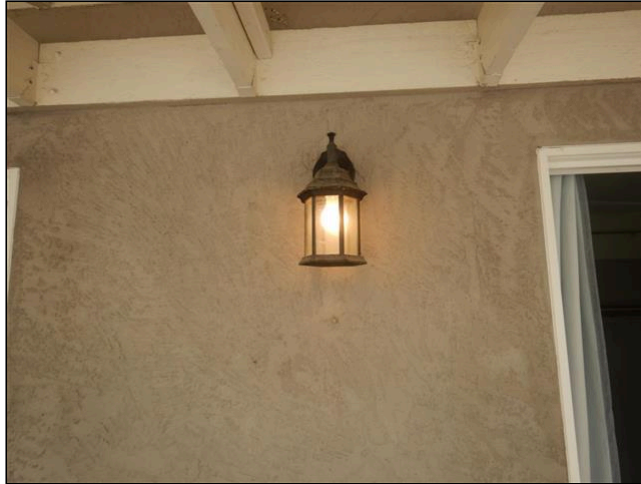
3.11 Item 1(Picture)

(1) A representative number of exterior lights were tested and were found to be functional at the time of the inspection.

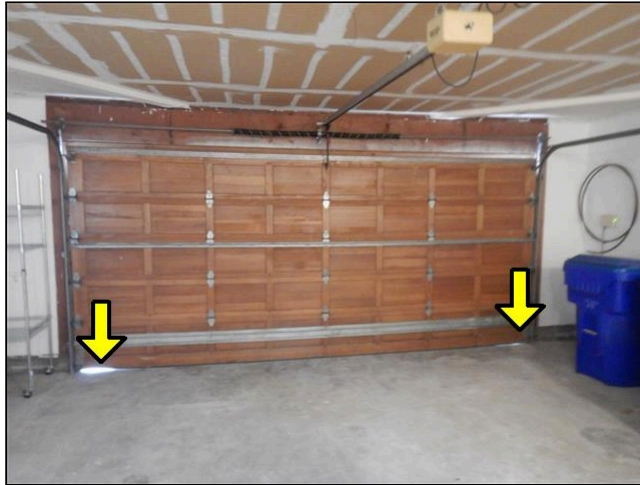
4.0 Item 2(Picture)

(2) Several gaps were observed at the bottom of the garage vehicle door when fully closed. This is non standard and could allow unwanted moisture/pests to intrude. We recommend making necessary corrections where needed by a licensed garage door contractor.

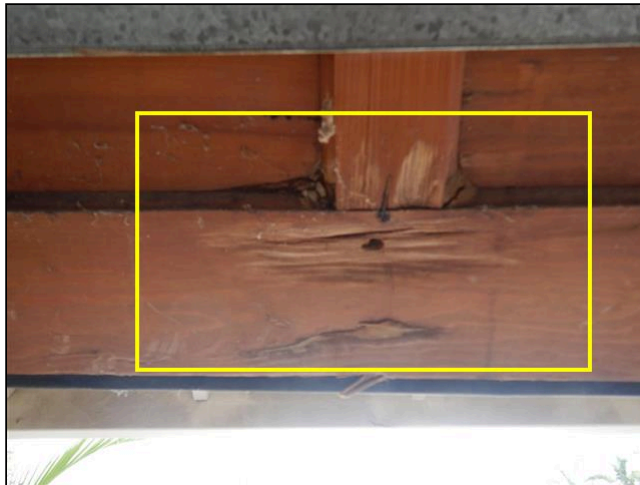
4.0 Item 3(Picture)

(3) The bottom weather seal is damaged at the garage vehicle door. The weather seal is needed at garage vehicle door to properly seal the bottom of this door. We recommend replacing the weather seal by a qualified licensed garage door contractor.

(4) The wood garage door is damaged in several areas. We recommend necessary repairs or replacing by a qualified licensed garage door contractor.

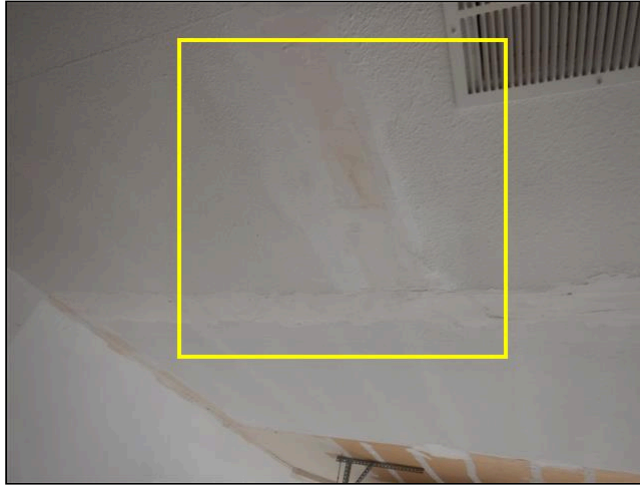
4.2 Item 1(Picture)

(2) Water stains are observed at the garage ceiling which can be from a roof leak. These stains were tested for moisture and were found to be dry at the time of the inspection. Due to lack of recent rain, determining the presence of an active roof leak was not possible. We recommend asking the seller if leaks exist, or if repairs have been performed. Otherwise, we recommend further evaluation by a licensed roof contractor prior to the end of your contingency period.

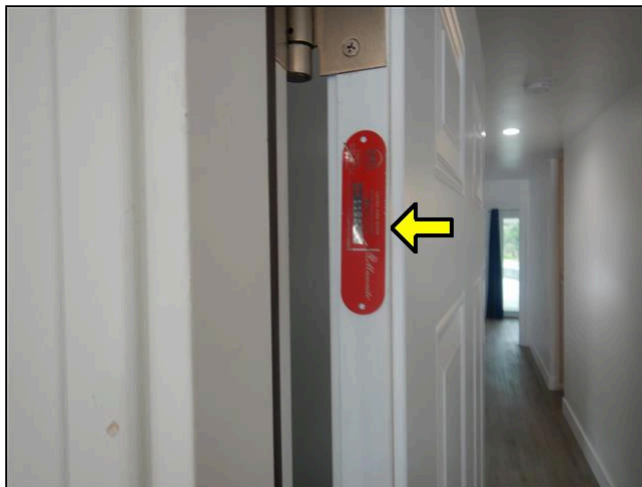
4.5 Item 1(Picture)

The door between the house and the garage appears to be a fire rated door.

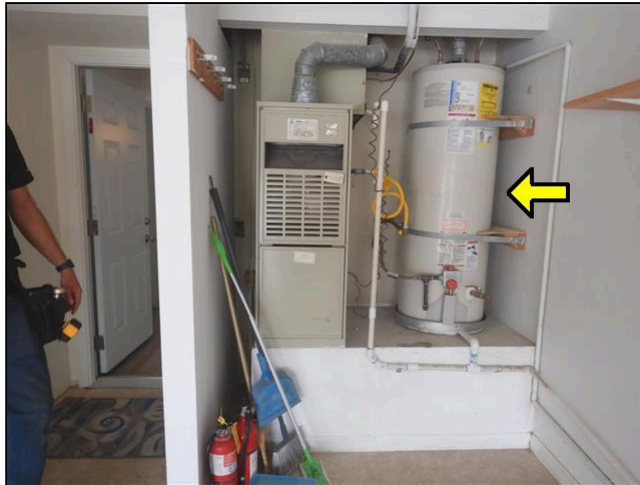
5.0 Item 1(Picture)

- (1) [Photo of the water heater.](#)

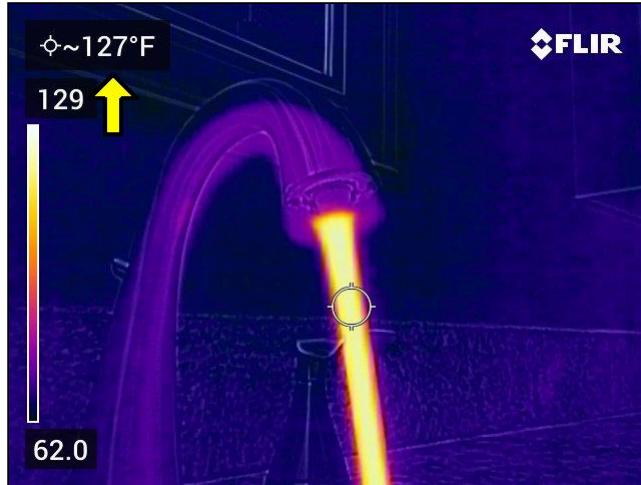
5.0 Item 2(Picture)

(2) **Thermal Photo of the water temperature.**

The temperature of the water was tested using a thermal camera at the time of the inspection and found to be above 125 degrees. Water temperatures above 125 degrees can cause scalding or burns. Most water heater manufacturers recommend setting the water heater controls at 120 degrees for optimum efficiency. We recommend setting the water heater controls at 120 degrees by a qualified person for optimum efficiency.

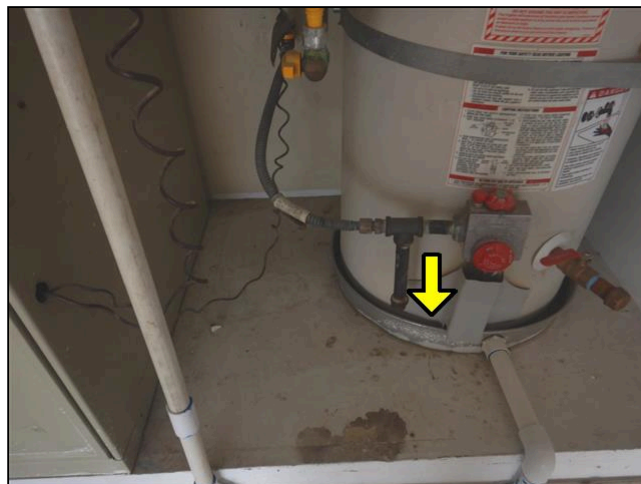
5.0 Item 3(Picture)

(4) The leak pan under the water heater is too small. The leak pan should be 2 inches larger in diameter than the water heater. The current installation may not function properly in the event of a leak. We recommend replacing this leak pan with an appropriate sized leak pan by a qualified licensed plumber.

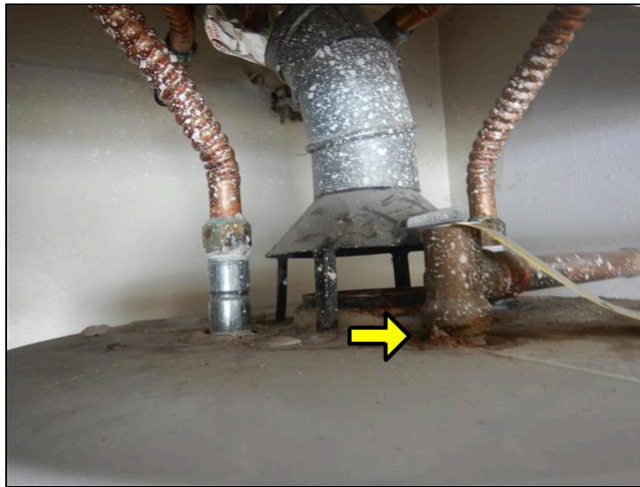
5.0 Item 4(Picture)

- (5) The water heater is an older unit/ 10 plus years, and repairs or even failure can be expected. Based on manufacture's statistics the average life of a water heater is 7-10 years. We recommend replacing the water heater by a qualified licensed plumber.
- (6) Rust/corrosion is observed at the top of the water heater. We recommend necessary repair or replacement by a qualified licensed plumber to help prevent leaks.

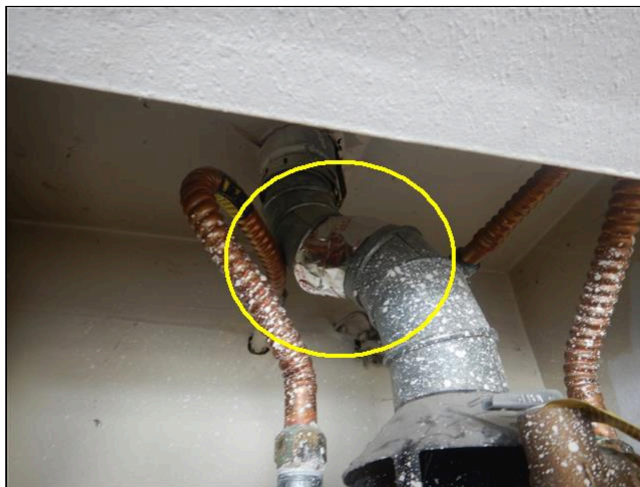
5.2 Item 1(Picture)

Foil tape was observed at the water heater flue connections. This is non standard. A physical connection with screws are required. We recommend making necessary corrections by a licensed plumber.

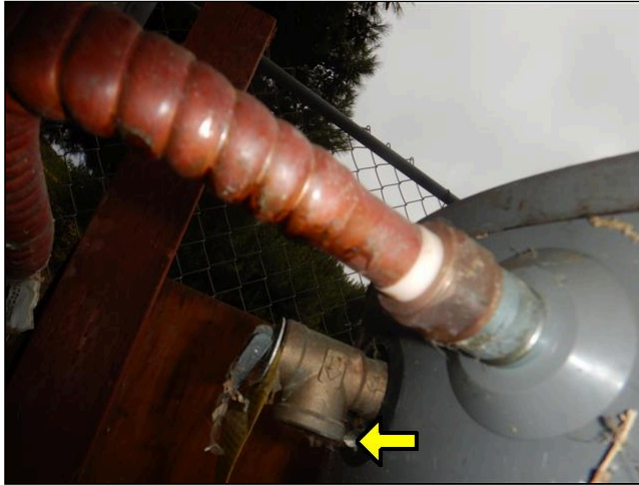
5.3 Item 1(Picture)

There is no discharge pipe connected to the ADU water heater Temperature and Pressure (T&P) relief valve. This is non standard and a potential scalding hazard. A metal discharge pipe must be installed which drains water to within 6 inches of the ground in the event of an over-heat/ pressure scenario. We recommend that a metal discharge pipe be installed at the water heater temperature pressure relief valve by a qualified licensed plumber for safety.

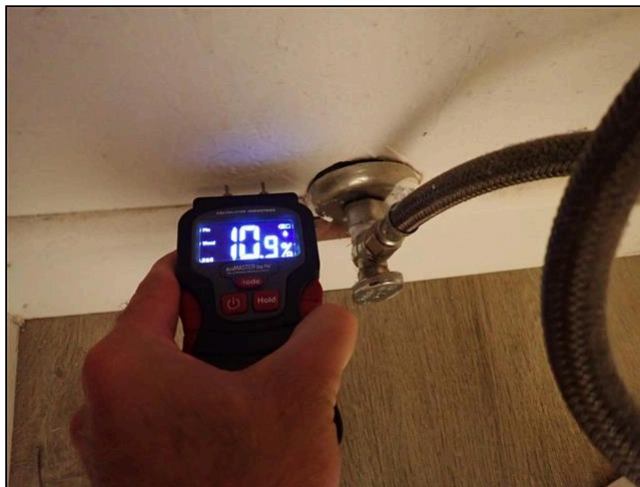
6.0 Item 1(Picture)

(1) A representative sampling for moisture was preformed at accessible interior walls using a moisture meter. (*areas prone to moisture, such as kitchens, bathrooms, below grade walls, exterior walls with doors/windows*). An elevated moisture was not detected at the time of the inspection.

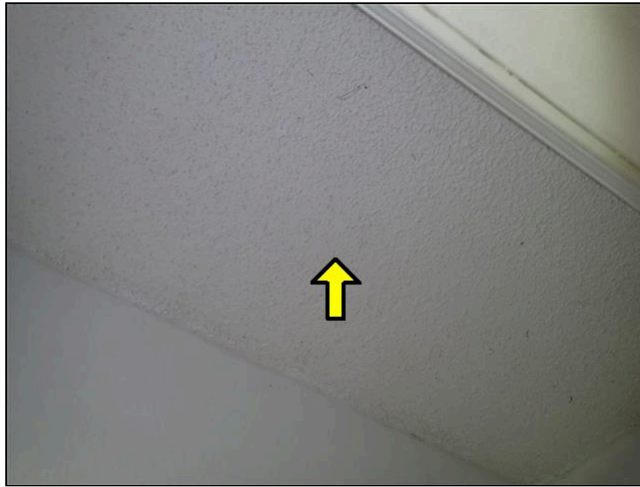
6.0 Item 3(Picture)

(4) There is acoustic texture present at the ceilings in several areas. Some of this acoustic texture installed before the 1980's has been known to contain asbestos. It is beyond the scope of this general home inspection for us to test for asbestos. The only way to confirm the presence or absence of asbestos is by having it tested by a qualified person. We recommend having the acoustic texture tested by a qualified person if concerned.

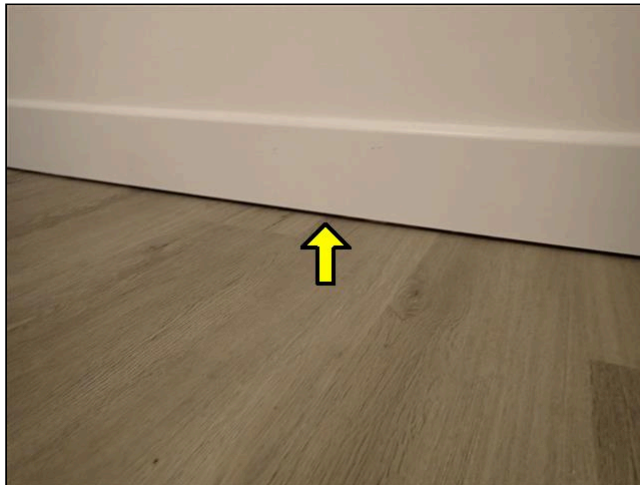
6.2 Item 1(Picture)

(1) Baseboards are not flush with the flooring in several areas throughout the house. We recommend making necessary repairs where needed by a licensed contractor.

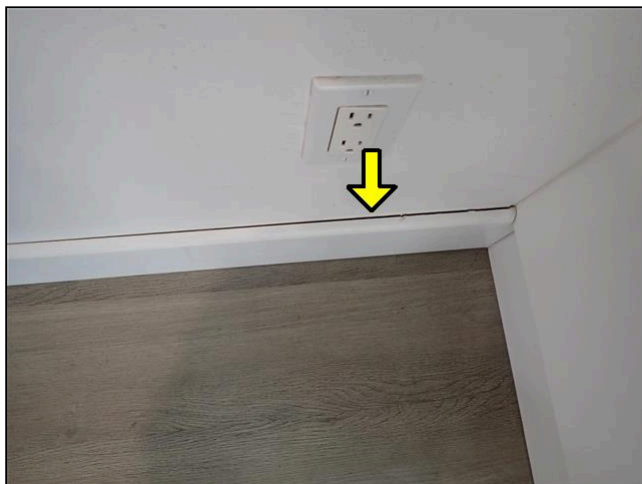
6.2 Item 2(Picture)

(2) Baseboards were observed to be loose on the wall in several areas throughout the house. We recommend repairs where needed by a licensed contractor.

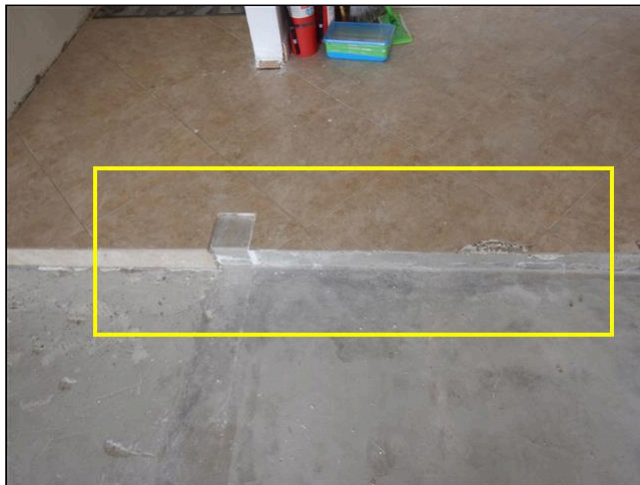
6.3 Item 1(Picture)

(1) The laminate flooring is bridging or bulging in the family room. This is typically caused by a poor installation which did not leave an expansion gap around the perimeter of the floor. Variations in humidity can cause the wood floor to expand. Without a proper gap, the laminated flooring material will bulge. We recommend further evaluation and necessary corrections or replacement by a qualified licensed flooring contractor.

(2) There are several loose floor tiles missing or damaged in the garage area. We recommend necessary repairs or replacement by a qualified licensed flooring contractor.
