Inspection Report

Property Address:
1221 Main Ave.
Oceanside CA 92056

The Property Inspection Pros

Date: 9/24/2024	Time: 01:00 PM	Report ID:
Property: 1221 Main Ave. Oceanside CA 92056	Customer: John Smitty	Real Estate Professional:

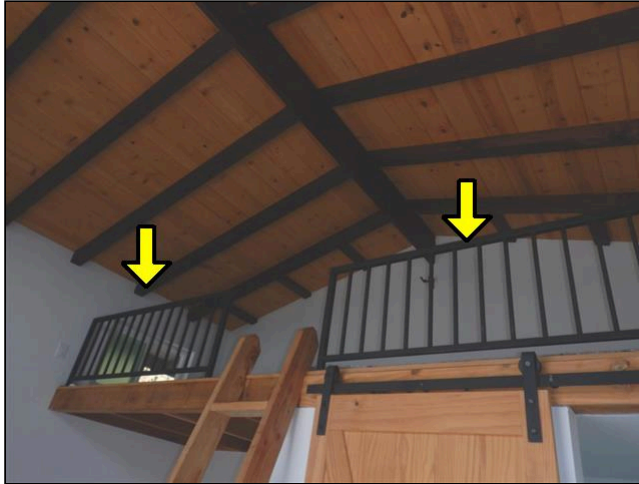
6.4 Item 1(Picture)

The ADU loft area guardrail is to low which is a safety concern. We recommend correction by a qualified licensed contractor.

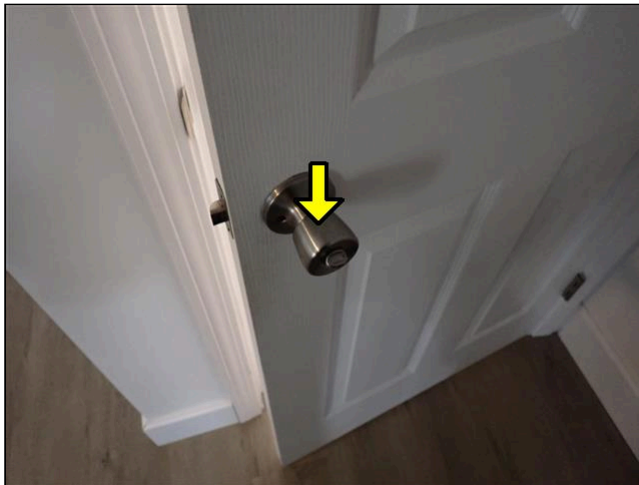
6.6 Item 1(Picture)

(1) The master bedroom door handle is loose. We recommend necessary repairs by a qualified person.

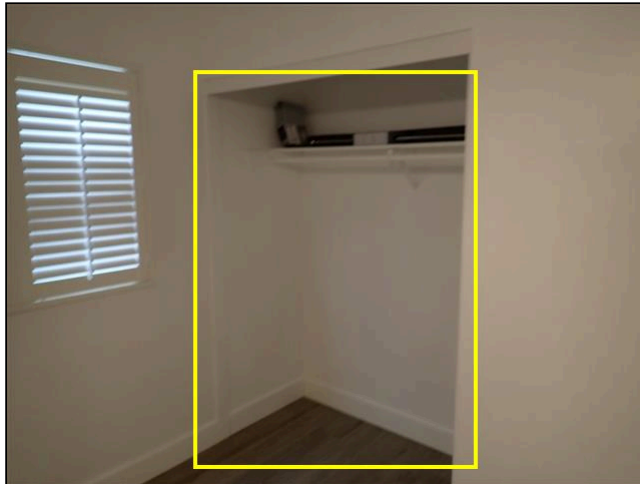
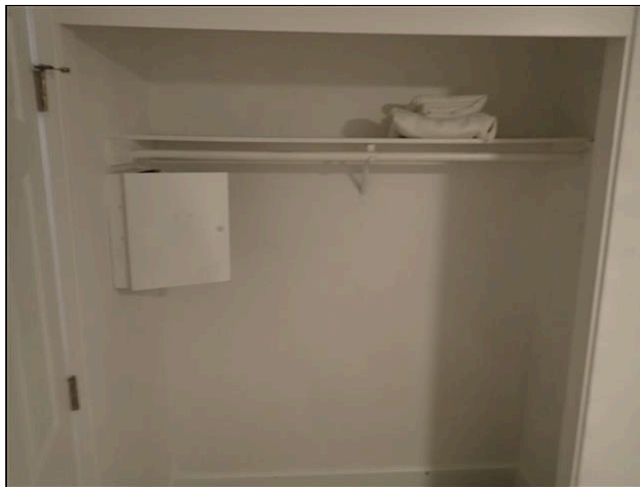
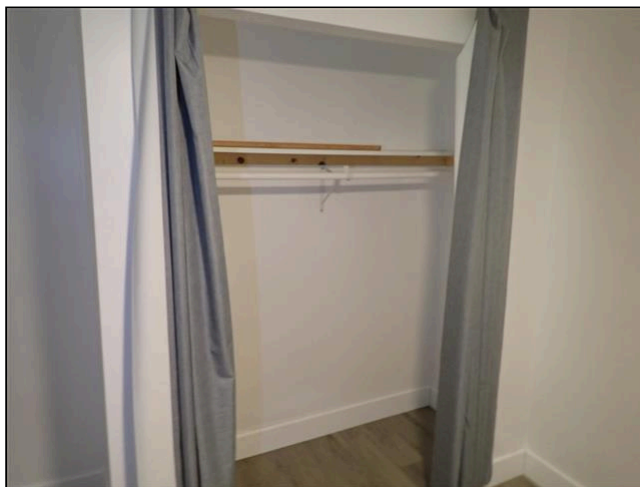
6.6 Item 2(Picture)

(2) Several bedroom closet doors are missing. We recommend replacing where needed by a qualified person.

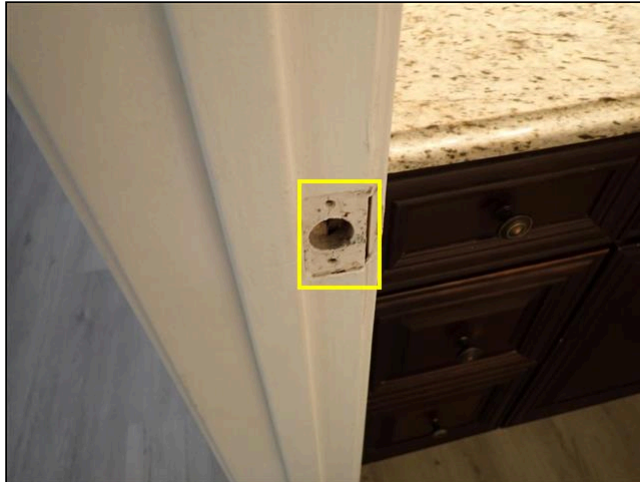
6.6 Item 5(Picture)

(3) The metal strike plate is missing from the door frame at the hall bathroom. We

recommend replacement where needed by a licensed contractor.

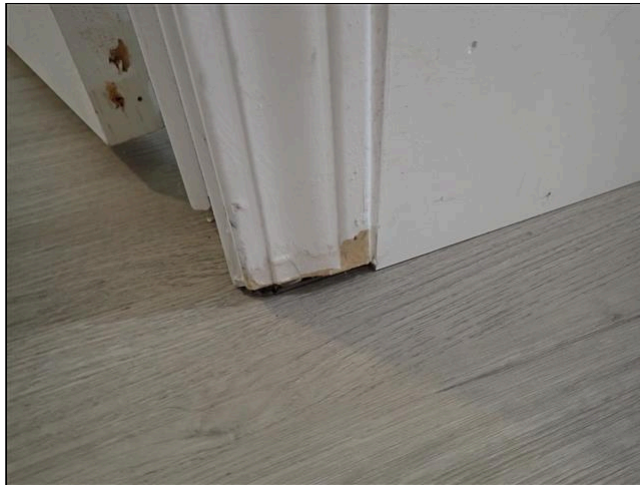
6.6 Item 6(Picture)

(4) Door frame trim was observed to be damaged. We recommend making repairs/ replacement where needed by a licensed contractor.

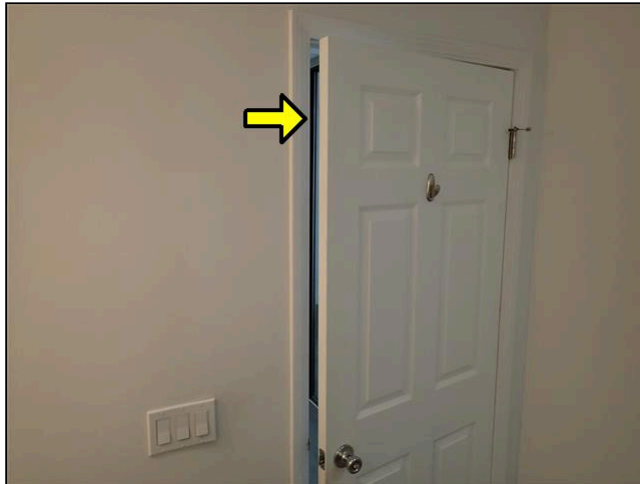
6.6 Item 7(Picture)

(5) The master bathroom door rubs at the frame. We recommend necessary corrections by a qualified person.

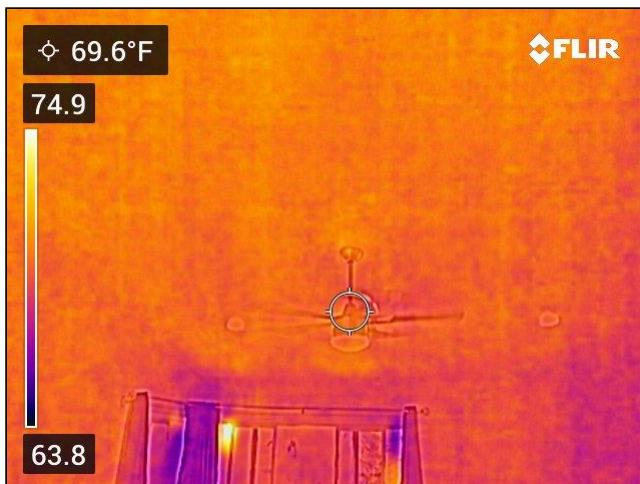
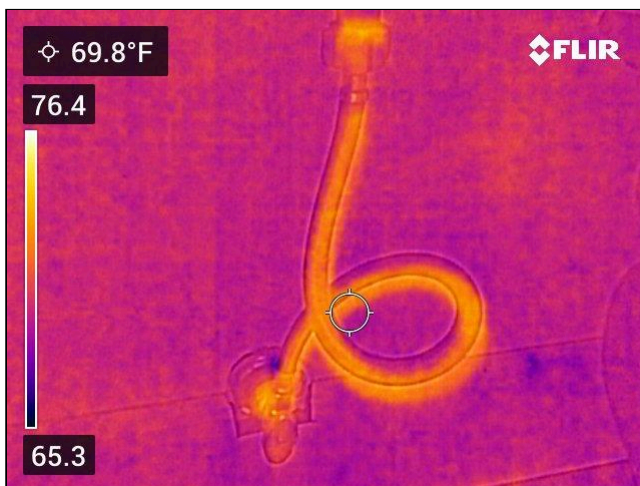
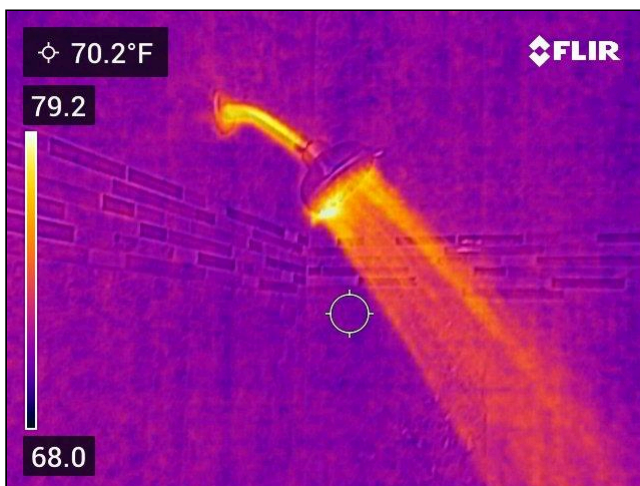
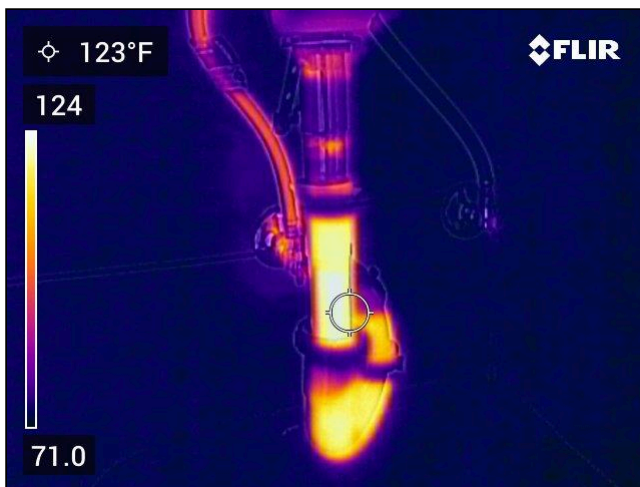
6.7 Item 1(Picture)

(1) **Infrared Camera Thermal Photos.**

(2) An infrared (thermal imaging) scan was performed throughout the property at the time of the inspection using a hand held infrared (thermal imaging) inspection camera. No anomalies were found at the time of the inspection using this camera.

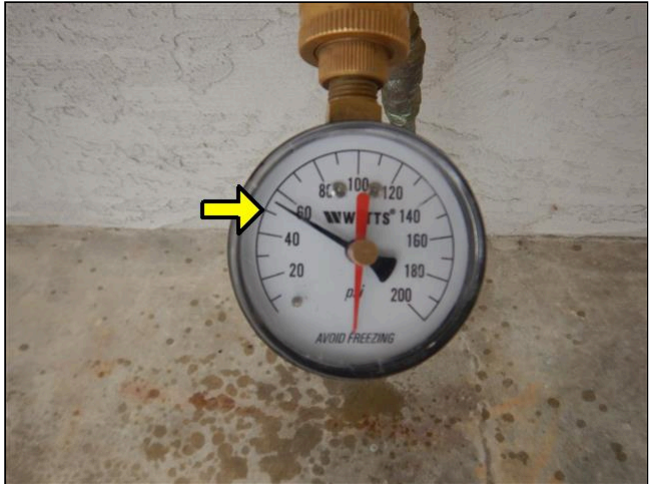
7.2 Item 1(Picture)

(1) The main house water pressure was checked with a water pressure gauge and was measured and was found to be within the acceptable range at the time of the

inspection.

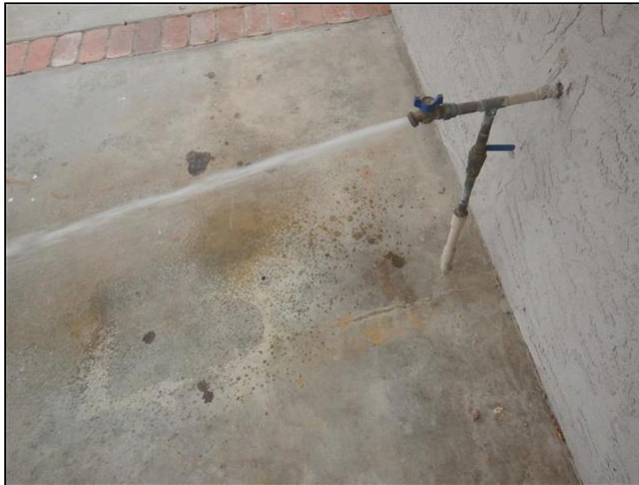
7.3 Item 1(Picture)

(1) The accessible hose spigots were tested and were found to be operational at the time of the inspection. Note: Some hose spigots may leak or drip when a watering hose is connected due to back pressure.

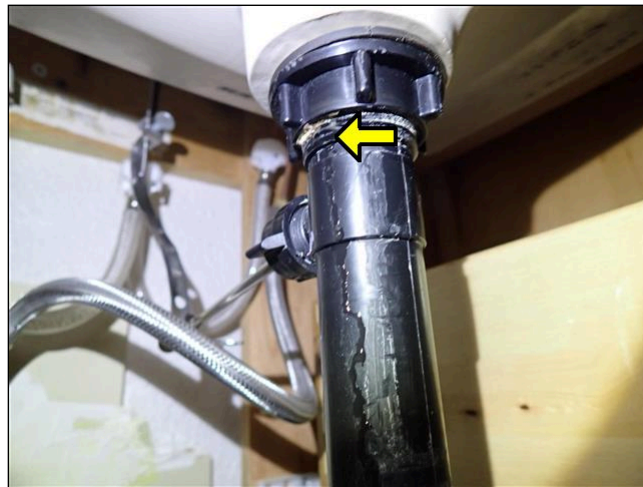
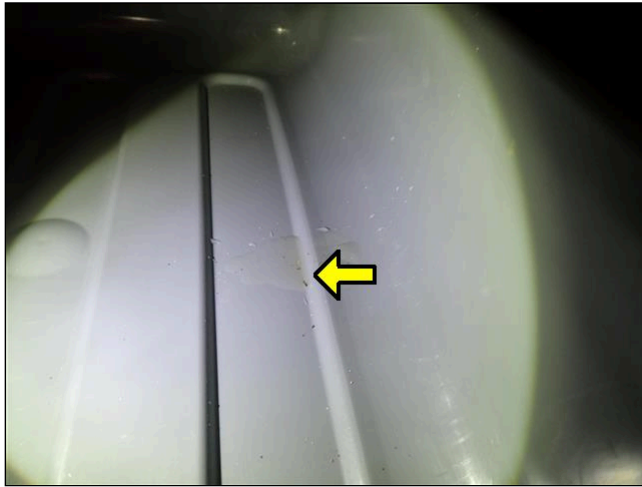
8.0.A Item 2(Picture)

(1) An active leak is present at the drain pipe under the sink. We recommend necessary repairs by a qualified licensed plumber.

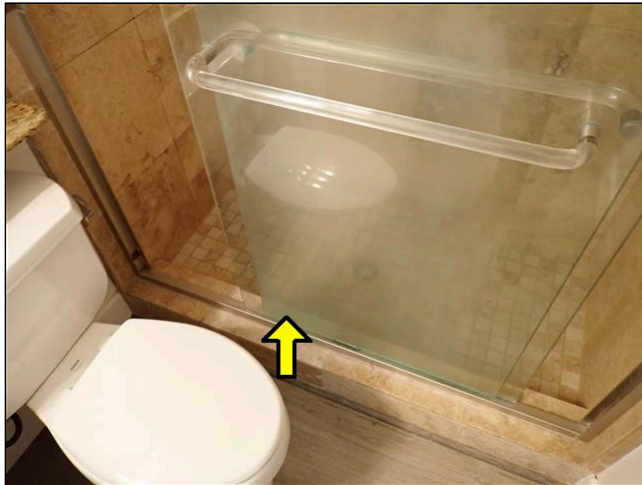
8.1.A Item 1(Picture)

(1) One of the shower doors was difficult to slide when tested. This is a potential safety hazard. We recommend making necessary repairs/replacement where needed by a licensed contractor.

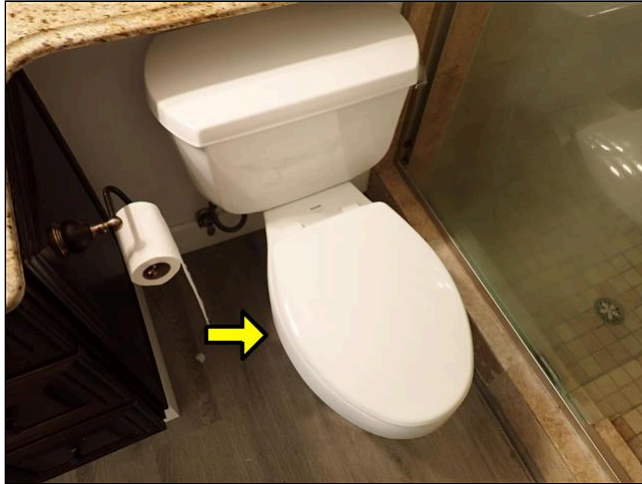
8.2.A Item 1(Picture)

The toilet is loose on the floor. This condition could damage the wax ring under the toilet. We recommend necessary repairs by a licensed plumber.

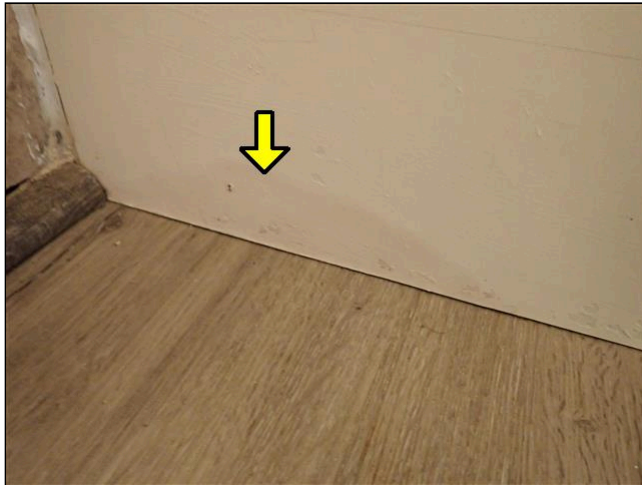
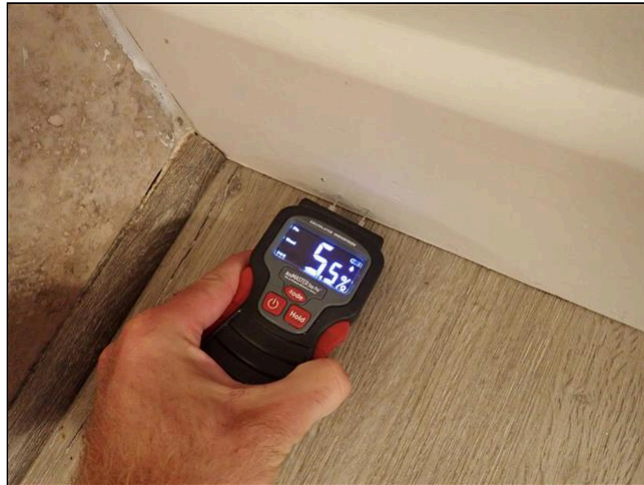
8.3.A Item 1(Picture)

Moisture damaged is noted at the baseboard. These baseboards were tested for moisture and were found to be dry at the time of the inspection. We recommend further evaluation by a licensed termite inspector and repair as needed.

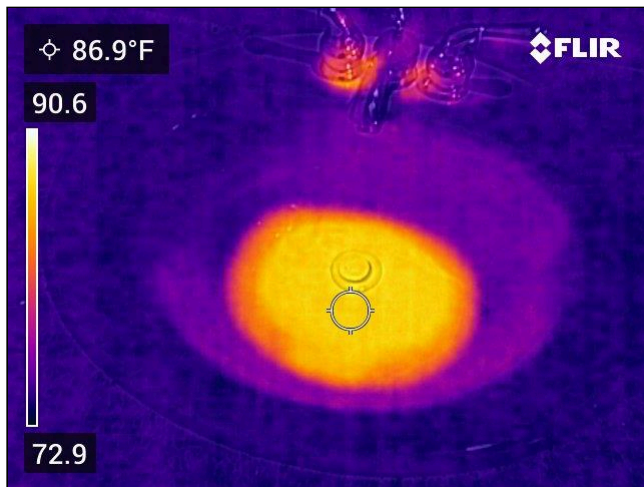
8.0.B Item 2(Picture)

The left side sink in the bathroom was slow draining at the time of the inspection This may indicate a blockage in the drain line. We recommend further evaluation by a qualified licensed plumber and repairs as needed.

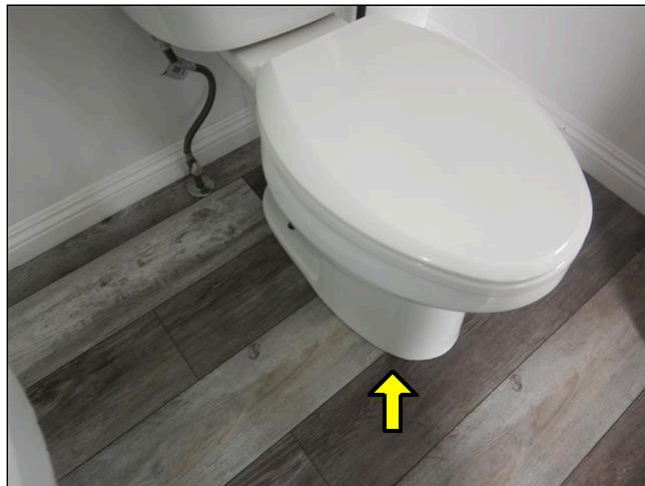
8.2.C Item 1(Picture)

The bathroom toilet is loose on the wood sub floor. This condition could cause damage to the wax ring, leaks, and damage to the wood sub floor. There could be damage to the wood sub floor which is not visible. We highly recommend further evaluation by a qualified licensed plumber or qualified licensed contractor prior to the end of your contingency period and necessary repairs made as needed.

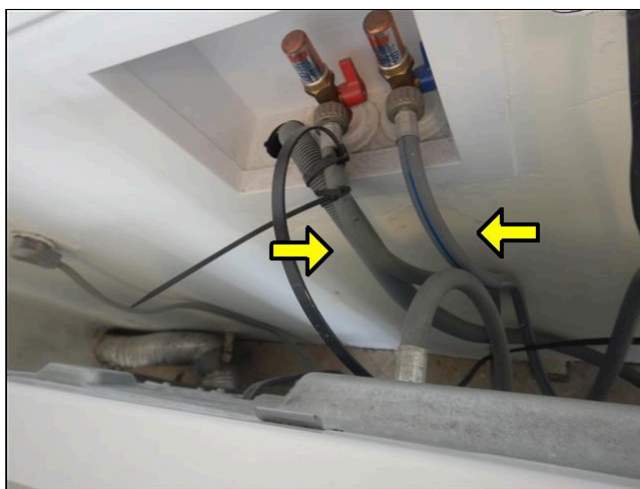
9.0 Item 1(Picture)

(1) **MAINTENANCE RECOMMENDATION:** Washer hoses are a common source of flooding in a home. Prior to connecting the washing machine we recommend installing new braided steel washer hoses to help reduce leaks caused by failed hoses. If any hoses are left in the house they should be replaced. The washing machine and dryer are not part of our general home inspection.

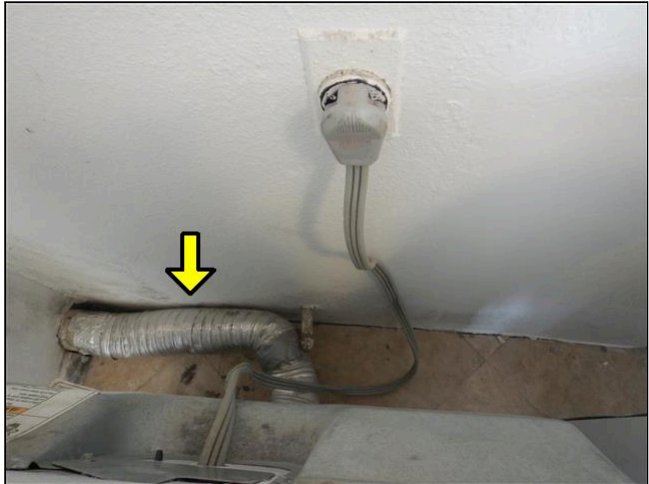
9.1 Item 1(Picture)

We recommend having the dryer vent cleaned by a qualified person.

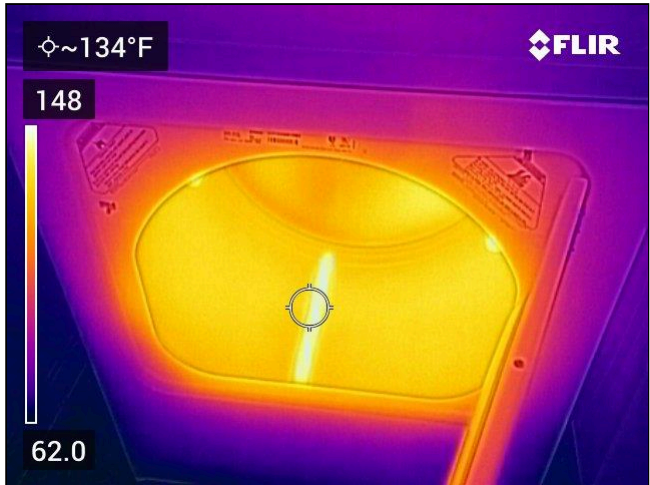
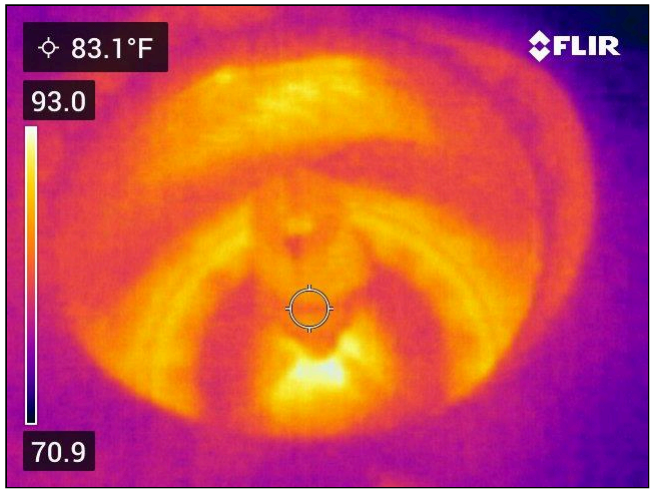
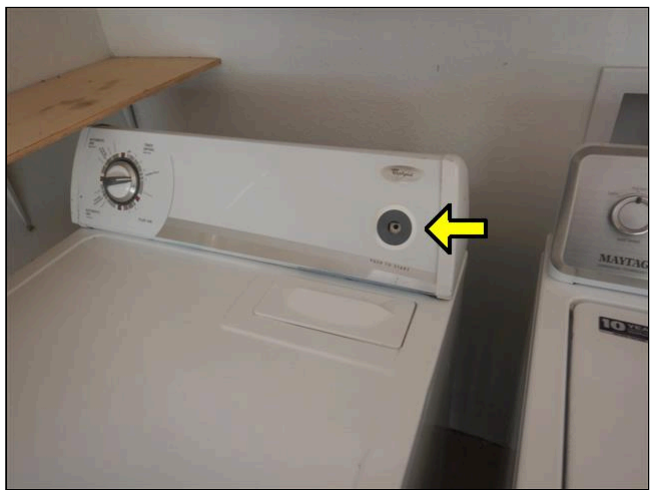
9.3 Item 1(Picture)

However, the dryer control knob is observed to be missing. We recommend replacing.

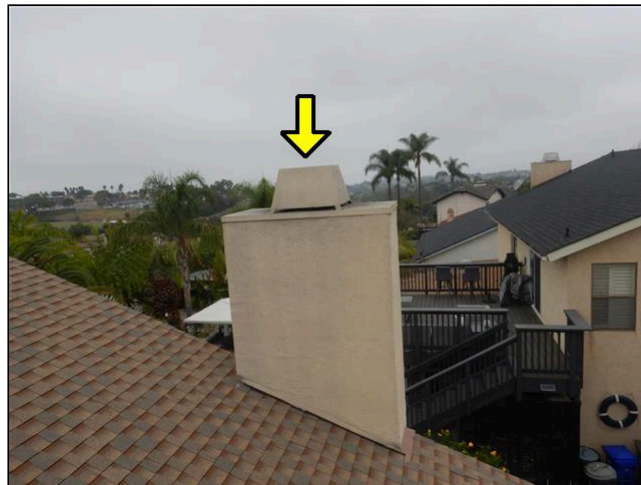
10.0 Item 1(Picture)

(1) We recommend having the fireplace and chimney cleaned and inspected by a licensed chimney sweep for safety prior to using.

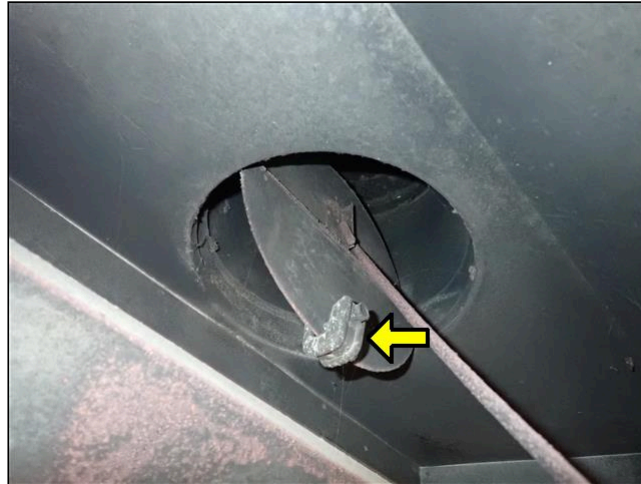
10.2 Item 1(Picture)

There is a damper clamp installed at the family room fireplace for safety.

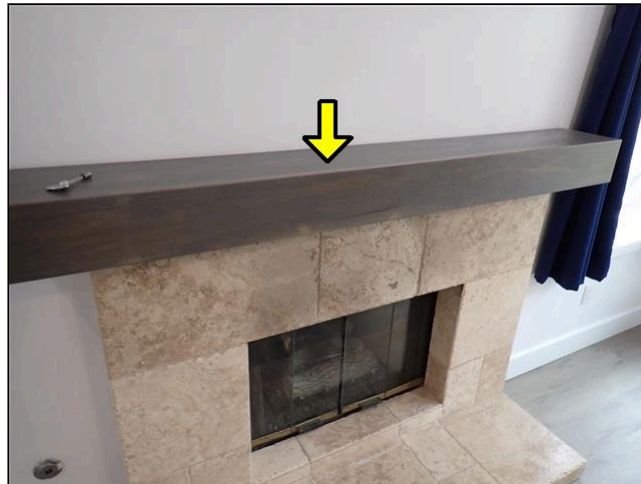
10.3 Item 1(Picture)

(1) The wood mantel is loose. We recommend making necessary repairs where needed by a licensed contractor.

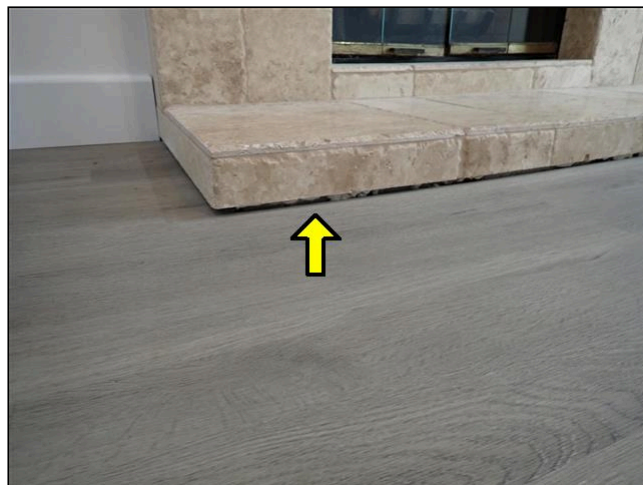
10.3 Item 2(Picture)

(2) A gap was observed where the front hearth extends over the flooring. We recommend sealing this gap up or making repairs/adjustments where needed by a qualified licensed contractor.

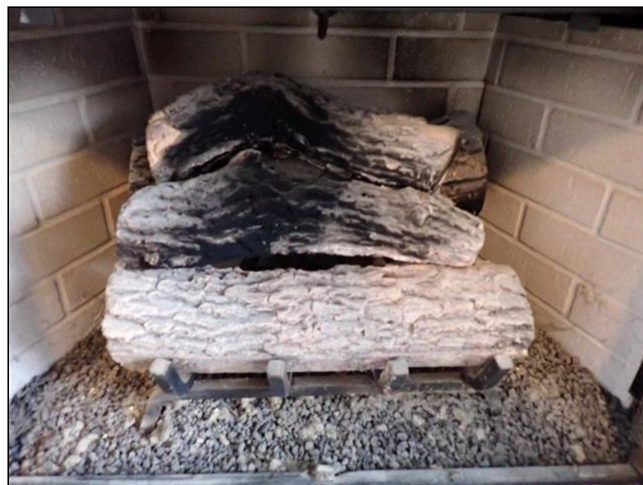
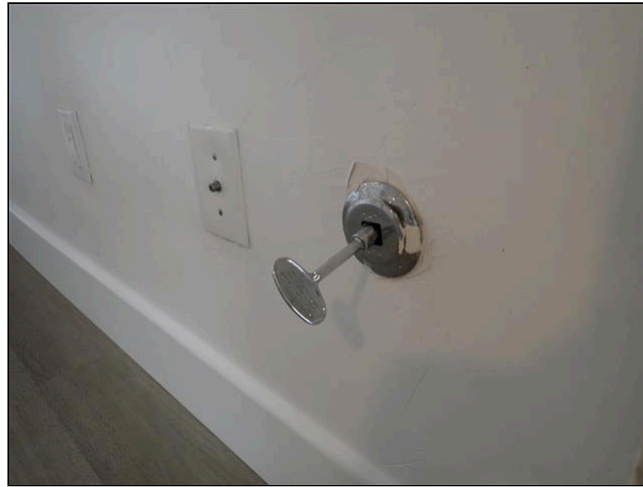
10.4 Item 1(Picture)

We do not light gas log lighters or concrete log kits installed at the fireplace. This is beyond the scope of the home inspection. However, the fireplace gas valve was tested and gas was noted to come out of the fireplace gas pipe.

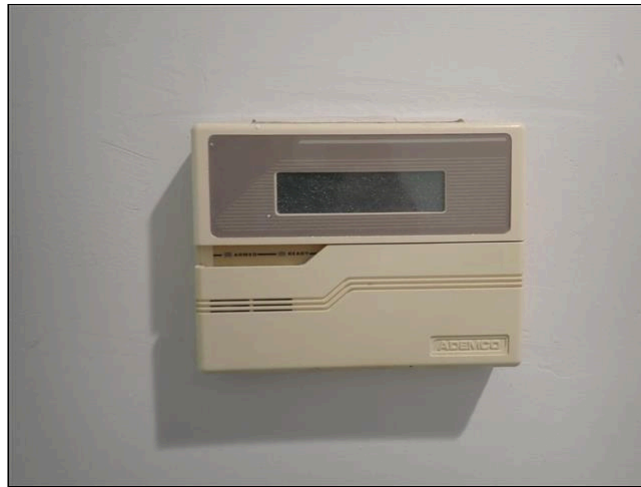
11.3 Item 1(Picture)

There is a security system installed in the house and was not inspected by this company at the time of the home inspection. Inspecting security systems is beyond the scope of a general home inspection. We recommend having the security system inspected by a qualified licensed contractor prior to the end of your contingency period.

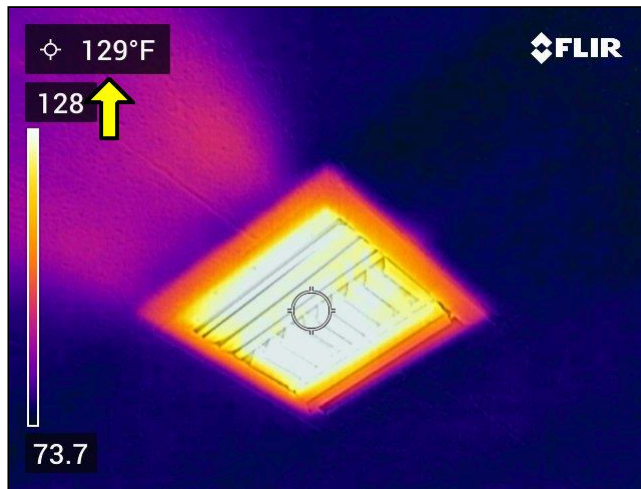
12.0 Item 1(Picture)

(1) **Infrared Thermal photo of the furnace(s) being tested.**

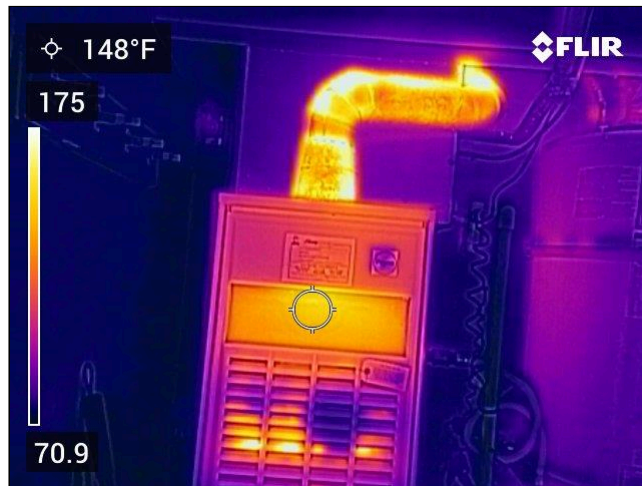
12.0 Item 3(Picture)

(3) The furnace is older but did work at the time of the inspection. I was unable to determine life remaining. Most HVAC contractors state that furnaces that are 20 years old or older are more likely be at the end of their useful life. We therefore recommend that you have this furnace inspected and serviced by a qualified licensed HVAC contractor to make sure that it is safe, and to obtain an estimate of life remaining, and a cost of replacement prior to the end of your contingency period. We also recommend that you keep a good home warranty in place, which covers the furnace.

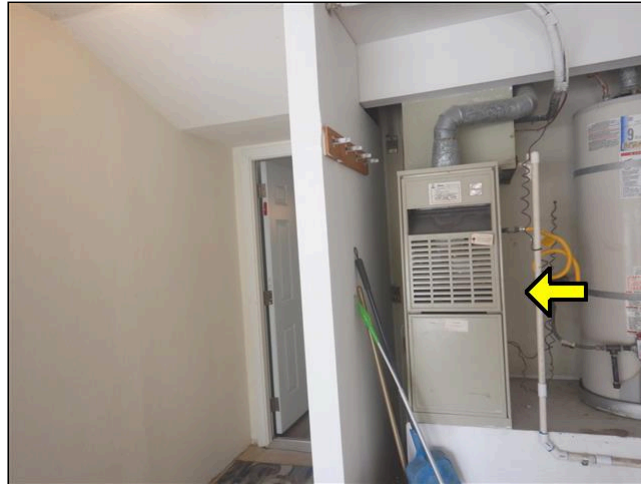
12.0 Item 4(Picture)

(4) The furnace is not sealed around the base of the unit. Current standards and SDG&E require that the base of the unit is sealed to prevent exhaust from mixing with the house air. We recommend having the base of the furnace be sealed by a qualified person.

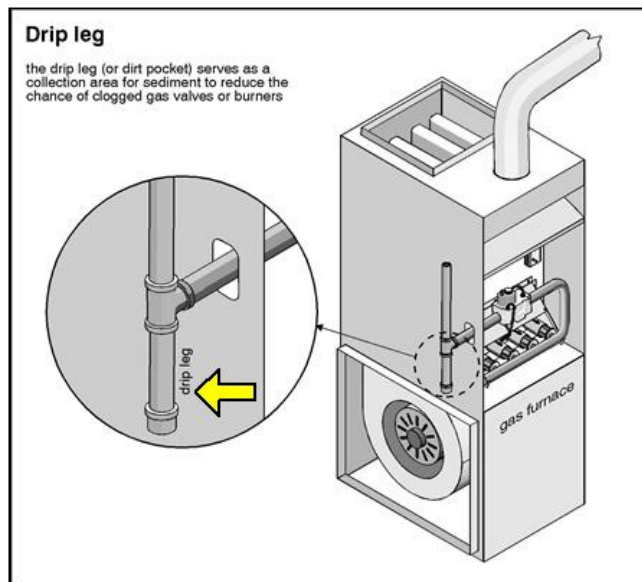
12.0 Item 5(Picture)

(5) The gas supply pipe at the furnace did not contained a drip leg/ sediment trap. This may have been standard at the time of installation but now is highly recommended. The purpose of a drip leg is to help prevent sediment/ debris from entering and clogging the furnace gas valve which could cause the furnace to shut down. We recommend having a drip leg installed by a qualified licensed HVAC contractor.

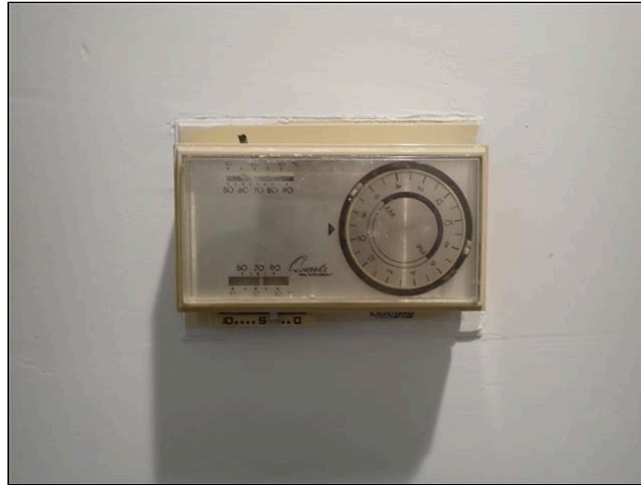
12.1 Item 1(Picture)

(1) There is a mechanical thermostat installed in this house. We recommend replacing with a programmable electronic model.

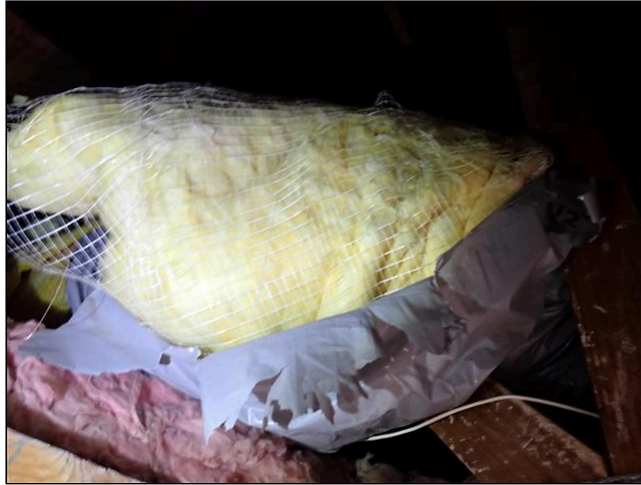
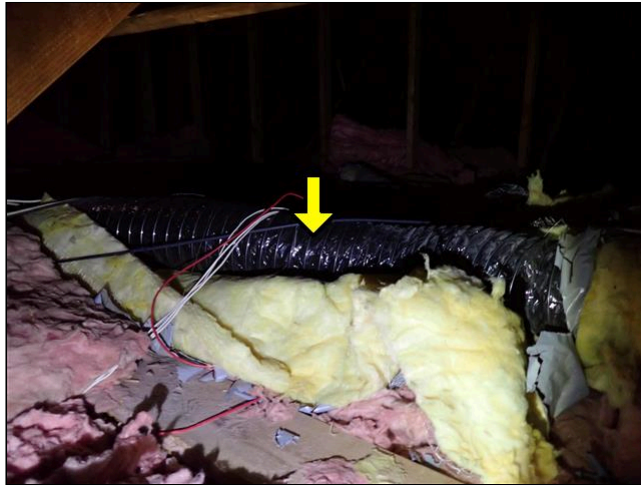
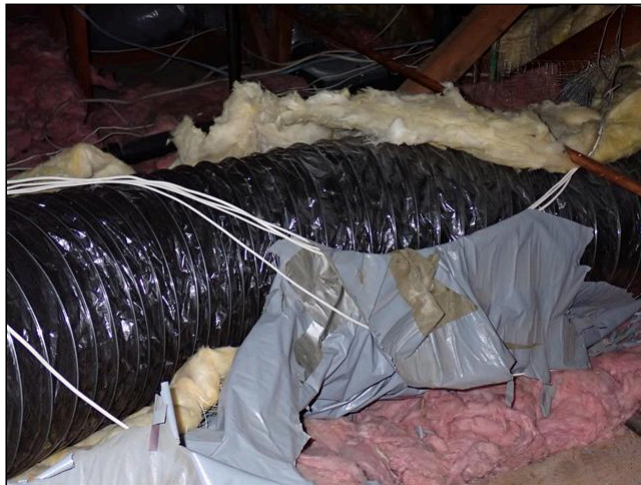
(1) The outer insulation covering on several of the air ducts in the attic space missing/damaged. We recommend repairs or replacing as needed by a qualified licensed HVAC contractor.

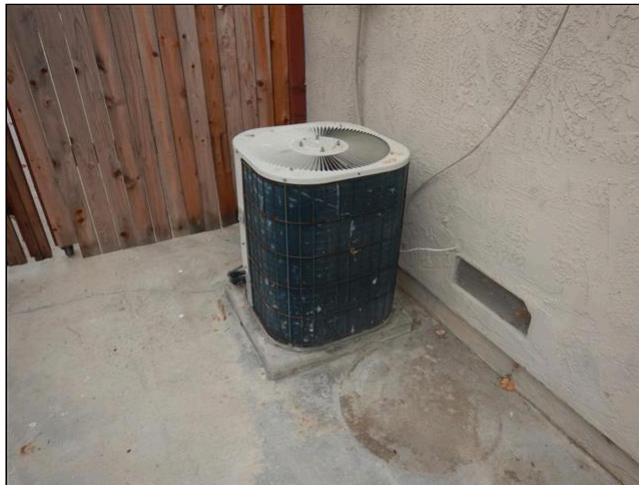
13.0 Item 1(Picture)

(1) [Photo of the A/C unit\(s\).](#)

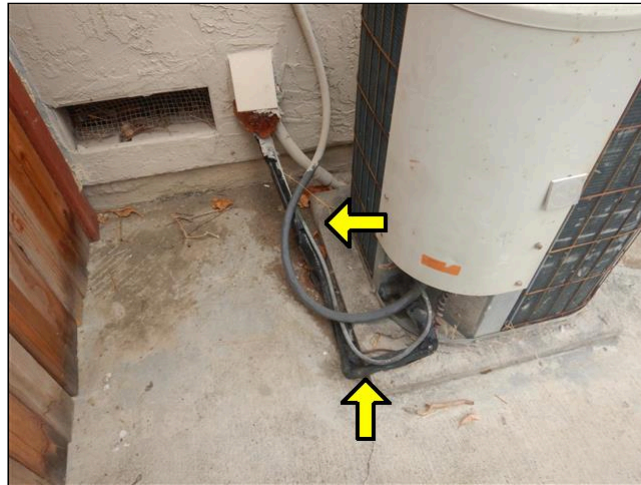
13.0 Item 4(Picture)

(6) The insulation is damaged at the exterior refrigerant lines. We recommend replacing the damaged insulation by a qualified person.

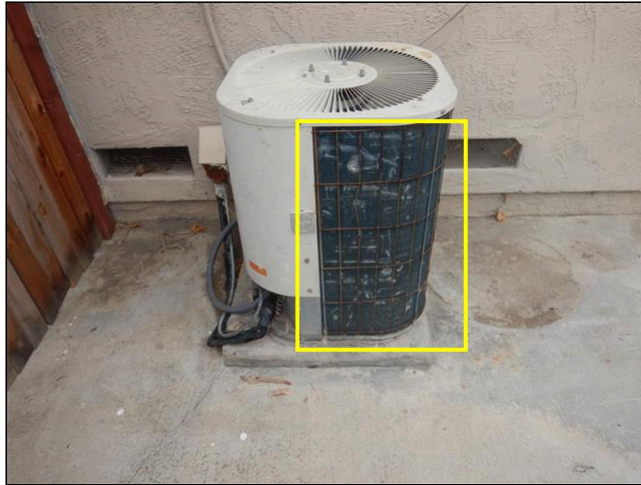
13.0 Item 6(Picture)

(8) Some of the AC condenser cooling fins are damaged. This can affect the performance of the unit, and limit the life of the condenser. We recommend further evaluation by a qualified licensed HVAC contractor to determine life remaining and repair options.

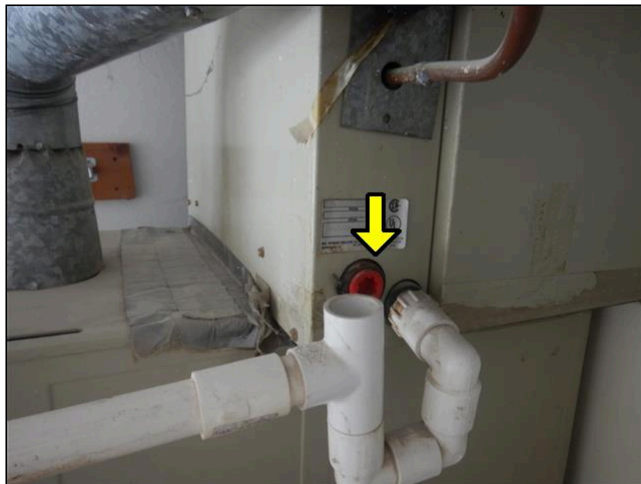
13.1 Item 1(Picture)

There is no secondary AC condensation drain installed. This may have been acceptable at time of installation. However, today a secondary drain or alternate device is required to prevent damage in case of a clog in the primary drain. We recommend installing a secondary drain or alternate device by a qualified licensed HVAC contractor.

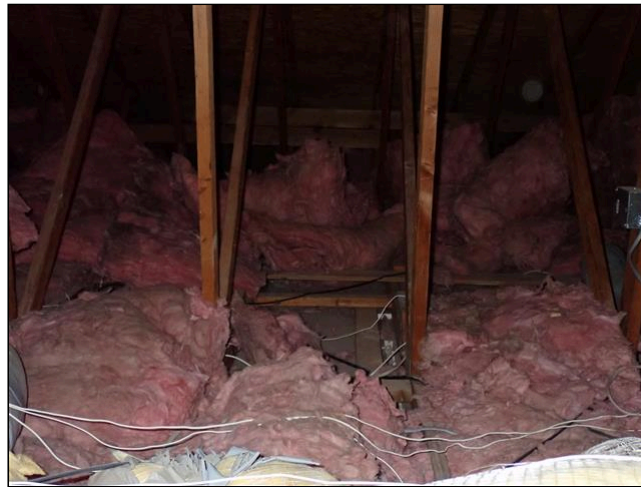
14.0 Item 1(Picture)

- (1) **Photo of the insulation.**
- (2) Some of the batt insulation has been moved in the attic space. This insulation was not put back into position where needed. We recommend having the insulation distributed properly/ put back into place to improve the thermal efficiency of the house by a qualified person.

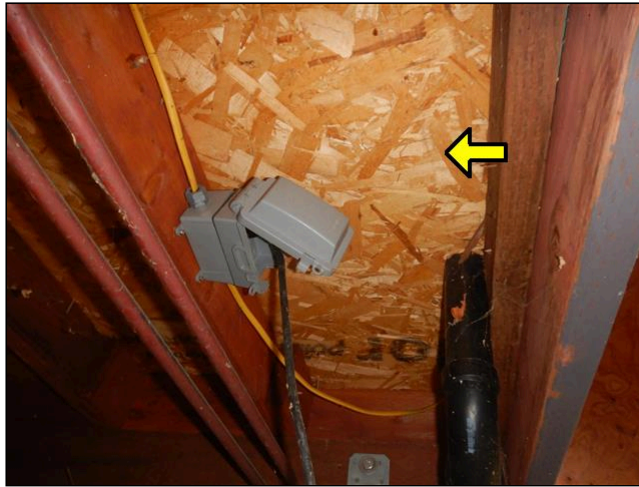
14.2 Item 1(Picture)

The ADU floor system is not insulated. Heat loss can occur more on this home than one that is properly insulated. We recommend adding insulation to the floor system in the crawlspace by a qualified person.

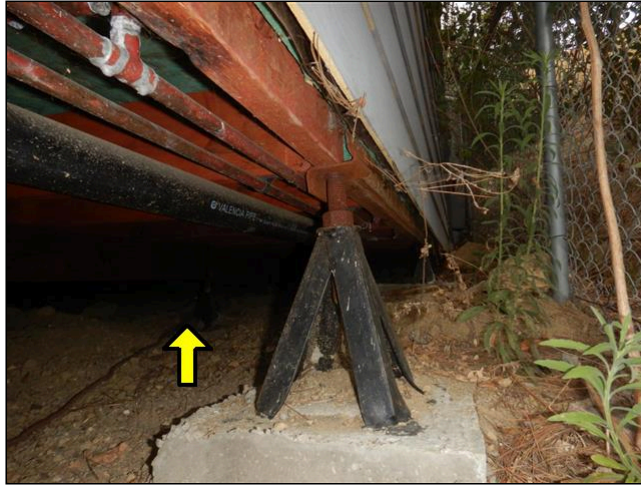
15.5 Item 1(Picture)

The ADU was built on a pier and post foundation with no perimeter foundation walls. This does not meet current building standards as this condition provides inadequate support, allows water intrusion into the sub area, and cannot be adequately retrofitted for earthquake protection. Perimeter foundation consisting of posts and piers should be replaced with a conventional concrete stem wall foundation. We recommend further evaluation by a qualified licensed foundation contractor.

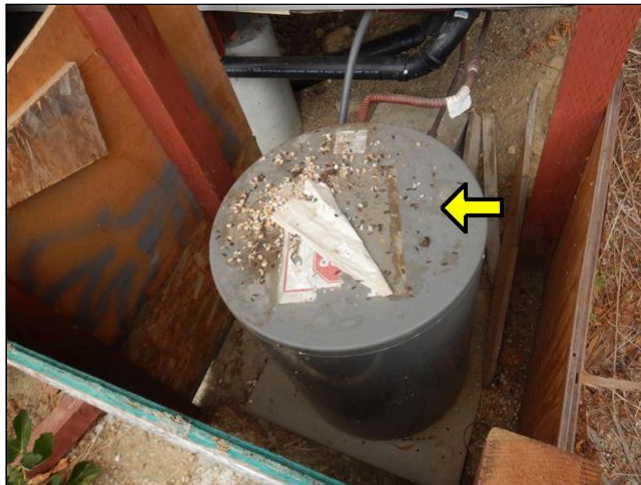
15.6 Item 1(Picture)

There is evidence of rodent activity/ droppings observed in the crawlspace and on top of the water heater. Pests may chew, damage or contaminate components. Rodents have been found throughout San Diego County which have Hantavirus, which is a health hazard. Home inspectors are not licensed pest inspectors and are not qualified to determine the severity of rodent infestation. We recommend further evaluation by a qualified licensed pest exterminator for a complete review and removal of any pests or waste material prior to the end of your contingency period.

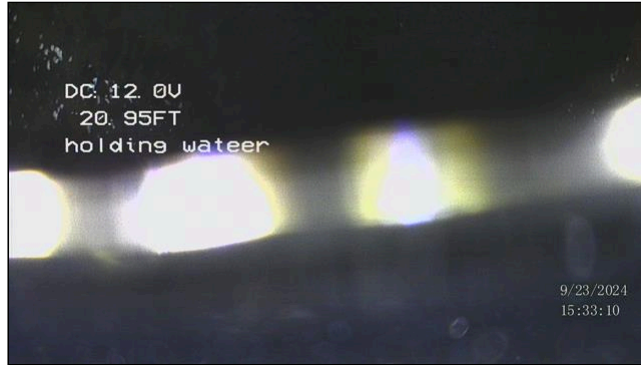
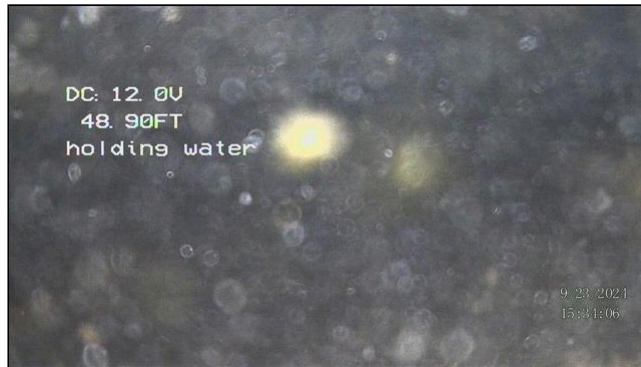
(1) The main sewer pipe was holding water at several areas throughout the main sewer line from the access point. We recommend further evaluation prior to the end of your contingency period by a licensed plumber and necessary repairs or replacement made as needed.

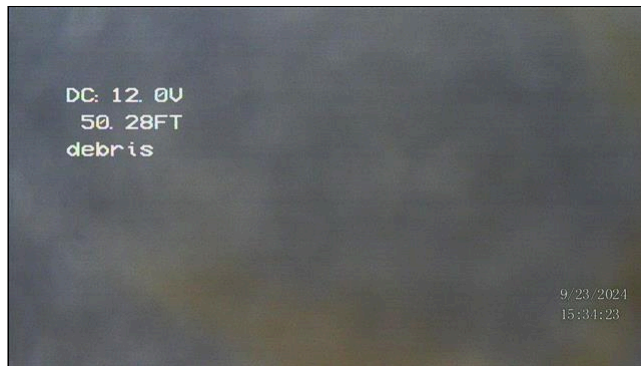
18.4 Item 3(Picture)

(2) Debris build up is observed in the main sewer pipe. We recommend having the debris cleared as needed to prevent further clogging by a licensed plumber.
