# Inspection Report

**Property Address:**  
2234 Main St  
Chula Vista CA 91911

**The Property Inspection Pros**

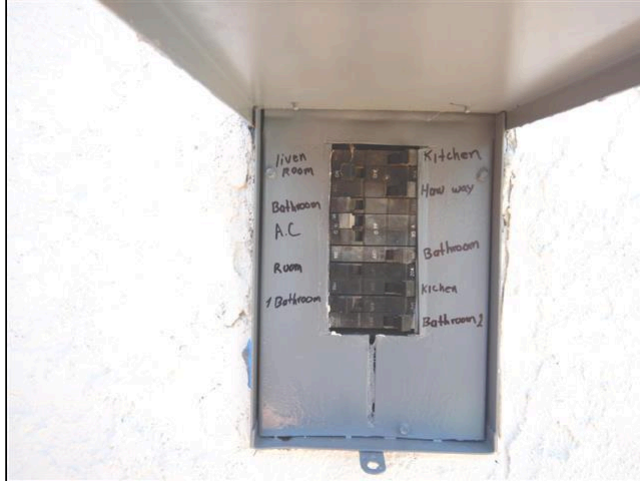
3.1 Item 1(Picture)

(1) [Photo of the main electrical panel.](#)

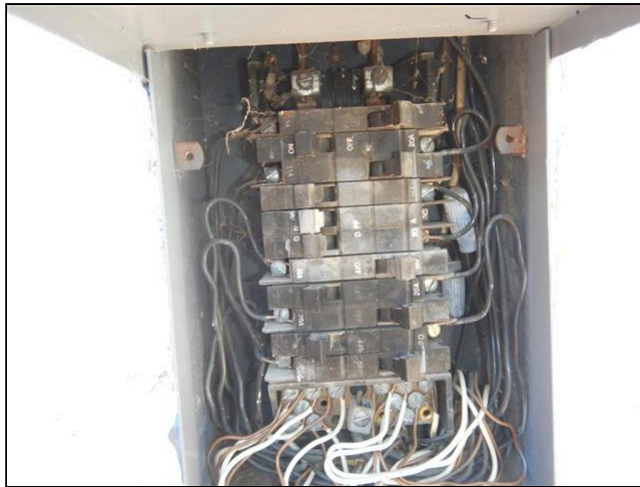
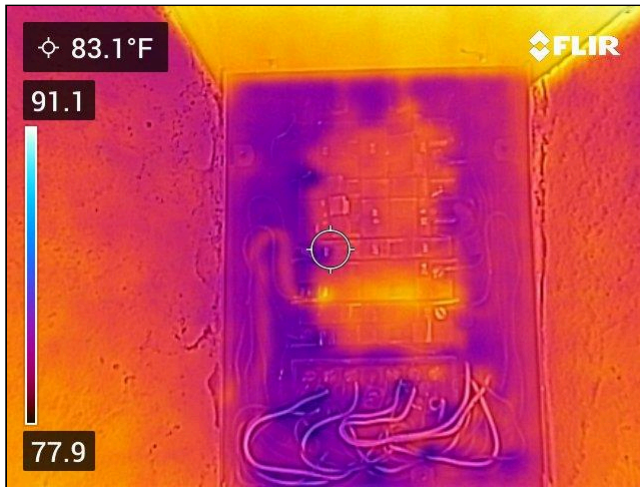
3.2 Item 1(Picture)

Photo inside of the main electrical panel.

The dead front cover was removed at the time of the inspection and the breakers, wiring and grounding were inspected.

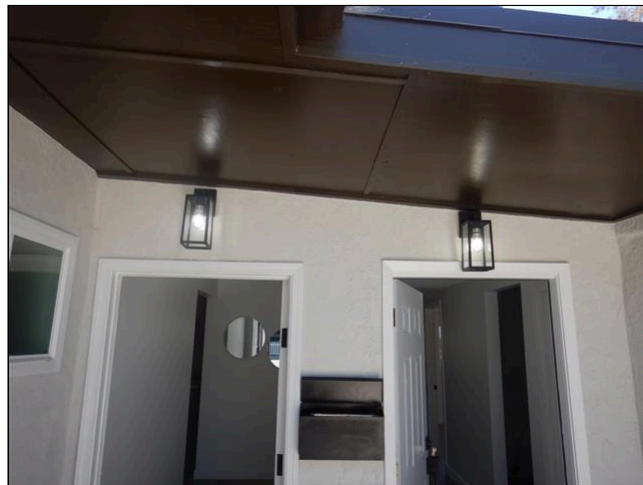
3.12 Item 1(Picture)

(1) A representative number of exterior lights were tested and were found to be functional at the time of the inspection.

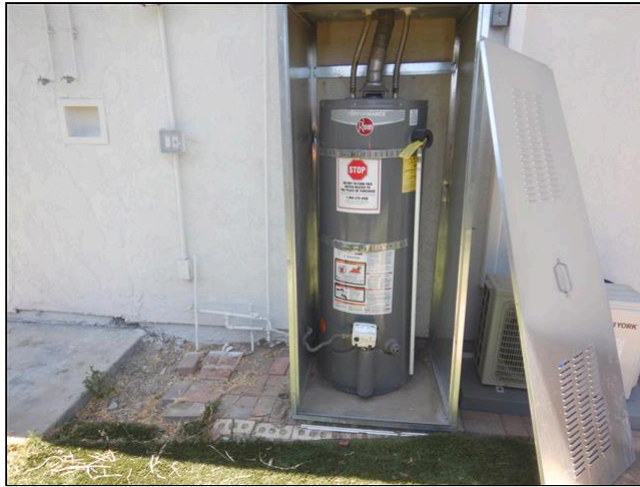
4.0 Item 1(Picture)

- (1) [Photo of the water heater.](#)

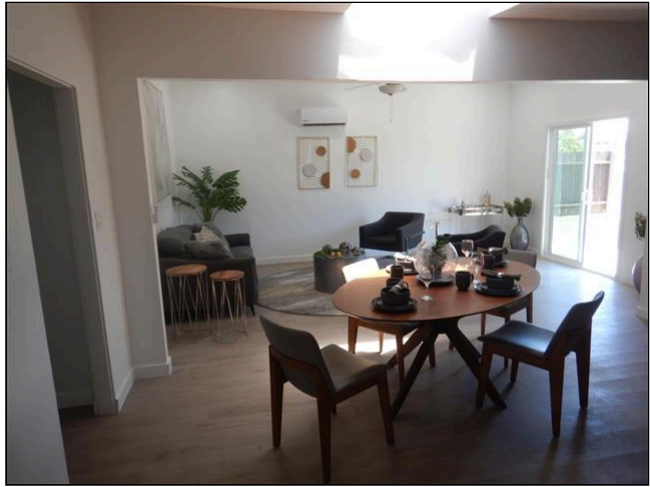
5.2 Item 1(Picture)

Due to stored personal items not all areas throughout the property were visible and accessible at the time of the inspection. The slab and other areas were obstructed from view and could not be inspected. The home inspector does not move personal items, panels, furniture, equipment, plant life, soil, debris, ect. that obstructs their access or visibility. We recommend that you conduct a careful evaluation during your final walk-through or prior to the end of your contingency period to ensure that there are no hidden defects. All doors, windows, and outlets should be tested and verified for proper operation prior to the end of your contingency period by a qualified person. If any damage is observed we recommend asking the seller about it. We recommend that any damage found be repaired or replaced by a qualified licensed contractor in the appropriate trade.

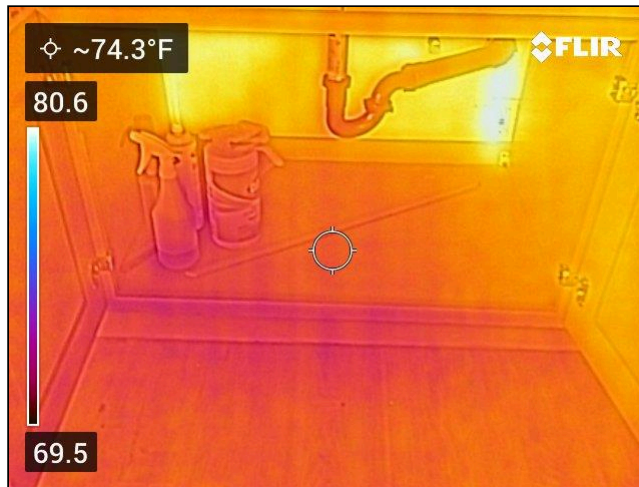
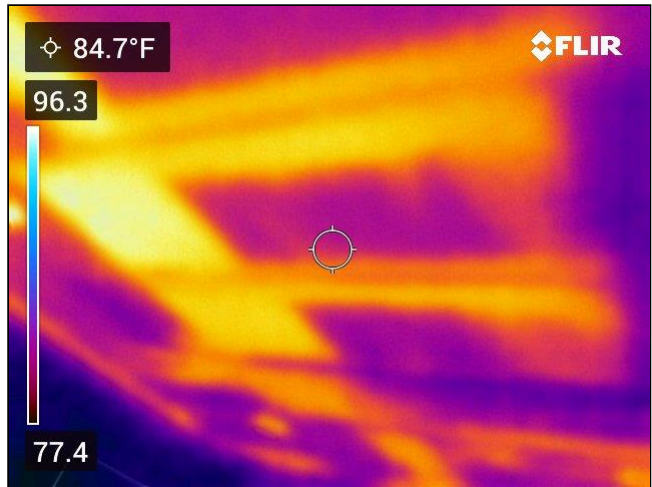
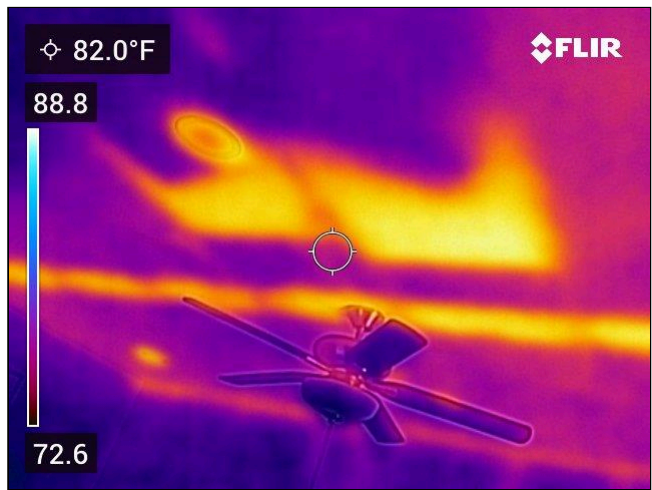
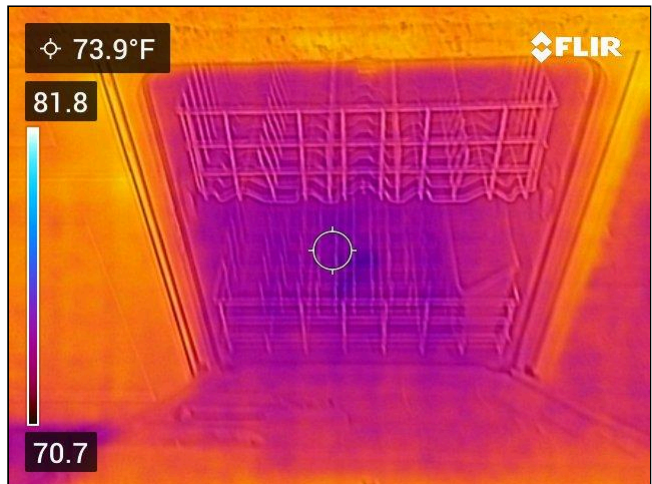
(1) [Infrared Camera Thermal Photos.](#)

(2) An infrared (thermal imaging) scan was performed throughout the property at the time of the inspection using a hand held infrared (thermal imaging) inspection camera. No anomalies were found at the time of the inspection using this camera.

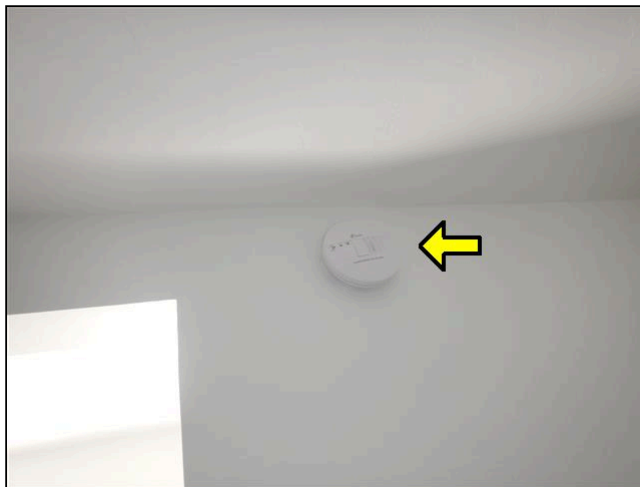
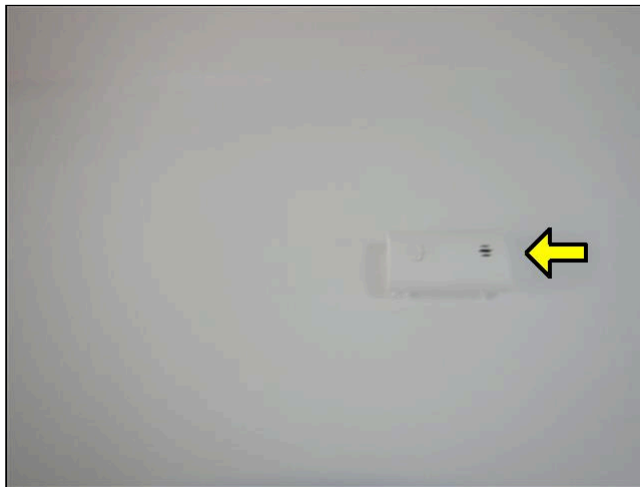
(1) [Photo of carbon monoxide detector\(s\).](#)

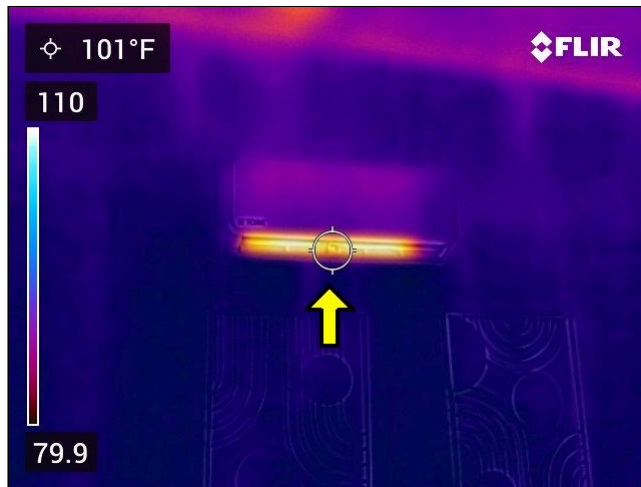
10.0 Item 1(Picture)

(1) The mini split for the main house was tested and was functional/ operated at the time of the inspection.

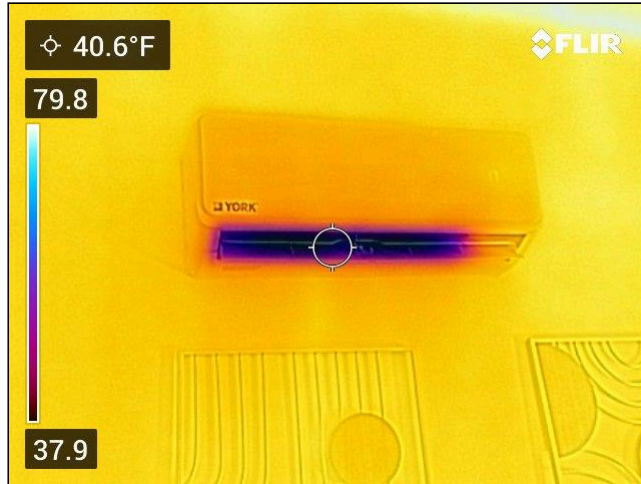
11.0 Item 2(Picture)

(2) The mini split for the main house was tested and was functional/ operated at the time of the inspection.

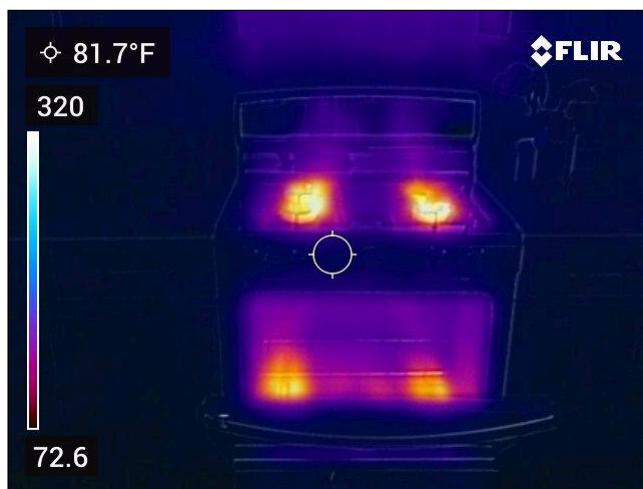
14.4 Item 1(Picture)

**Infrared Thermal photo of the oven being tested.**

The main house oven was tested and was functional at the time of the inspection. This test is not exhaustive and does not confirm the performance, accuracy, or effectiveness of the oven.

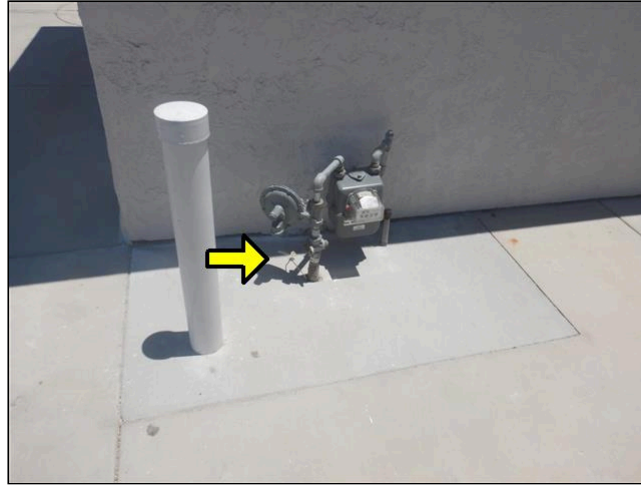
15.0 Item 1(Picture)

The main gas shut off valve is located at the gas meter at the right exterior side of the property (facing front).

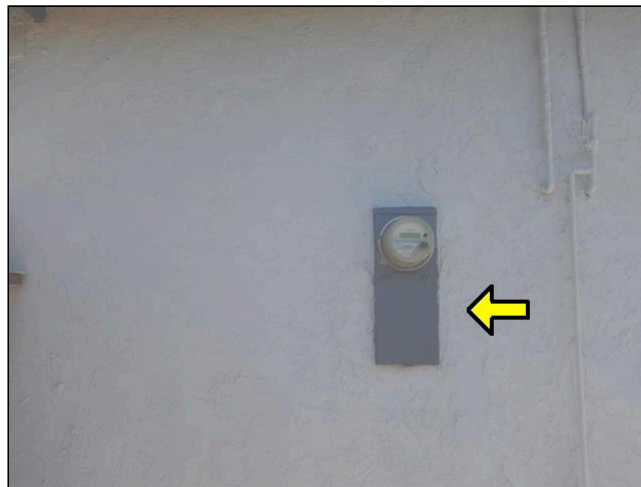
15.1 Item 1(Picture)

The Main Electrical panel is located at the rear exterior side of the property (facing front).
