# Inspection Report

4132 Main Place  
San Diego CA 92037

## **The Property Inspection Pros**

<b>Date:</b> 7/11/2024	<b>Time:</b> 09:00 AM	<b>Report ID:</b>
<b>Property:</b> 4132 Main Place San Diego CA 92037	<b>Customer:</b> Rick Johns	<b>Real Estate Professional:</b>

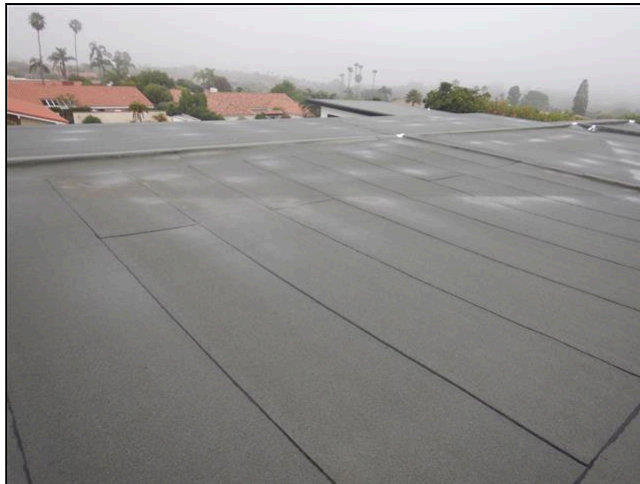
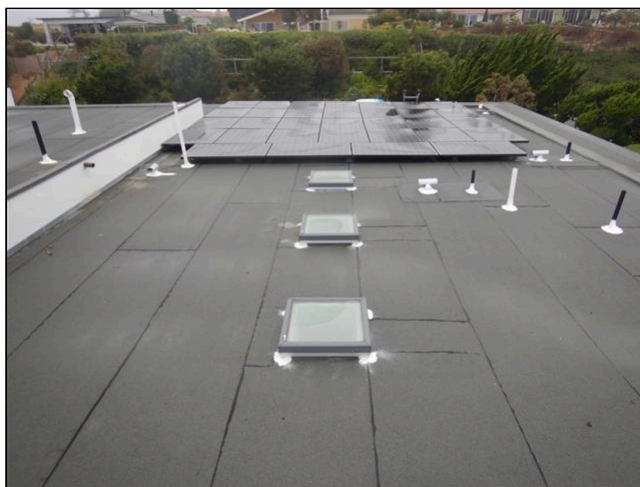
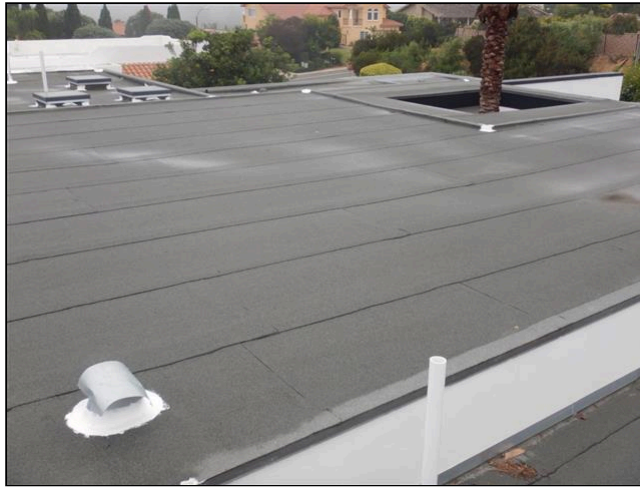
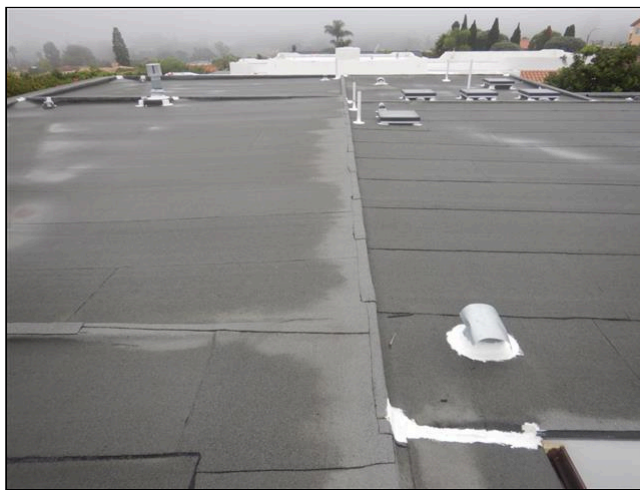
(1) Pictures of the roof.

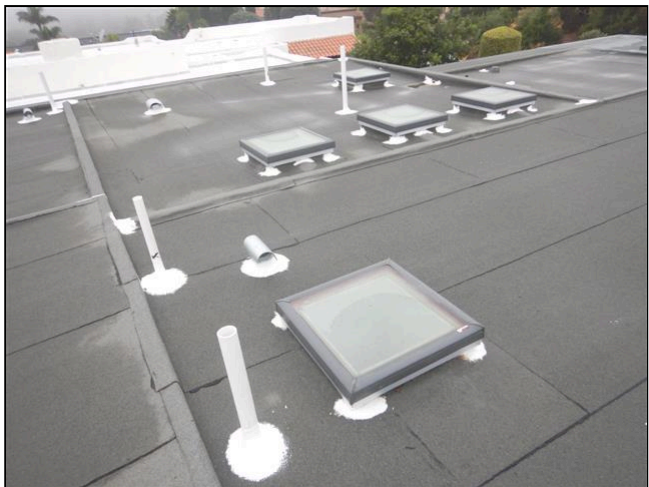
1.0 Item 6(Picture)

- (2) The flat roof material shows normal wear for its age and type; appears to be in serviceable condition.
- (3) The flat roof has had repairs made to it at several areas. We recommend asking the seller about these repairs, and if concerned we recommend further evaluation by a qualified licensed roof contractor.

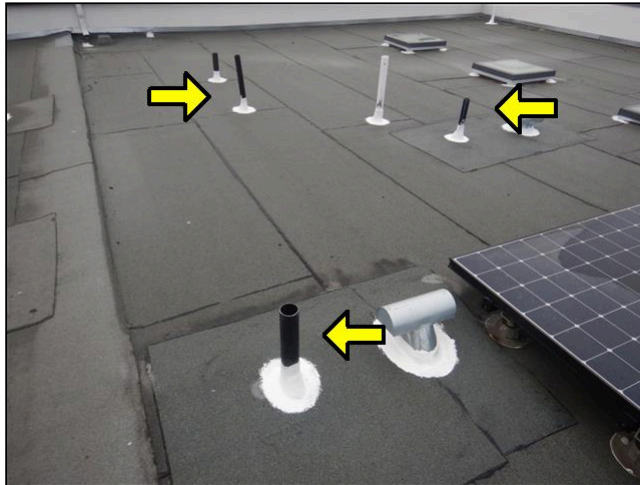
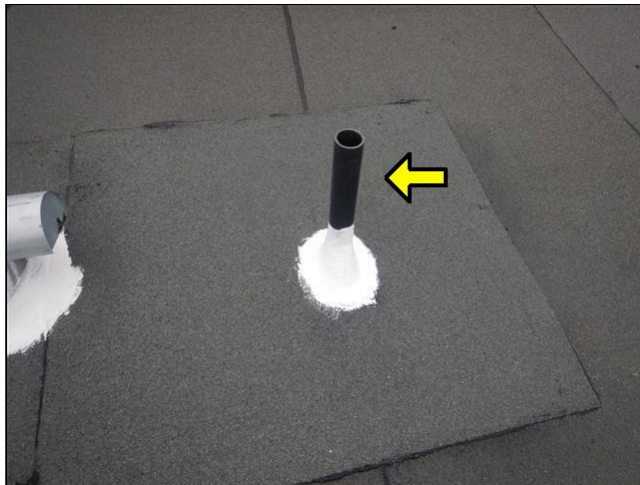
(1) Several of the exposed ABS plumbing vents at the roof area were not painted. Paint is required at the exposed ABS vents. We recommend having the exposed ABS vents painted by a qualified licensed contractor.

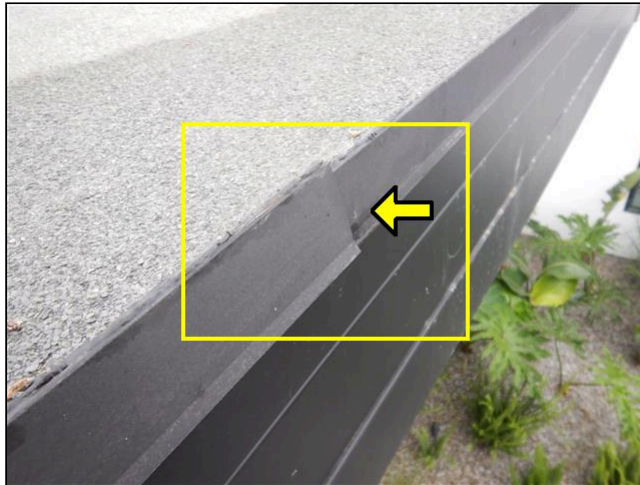
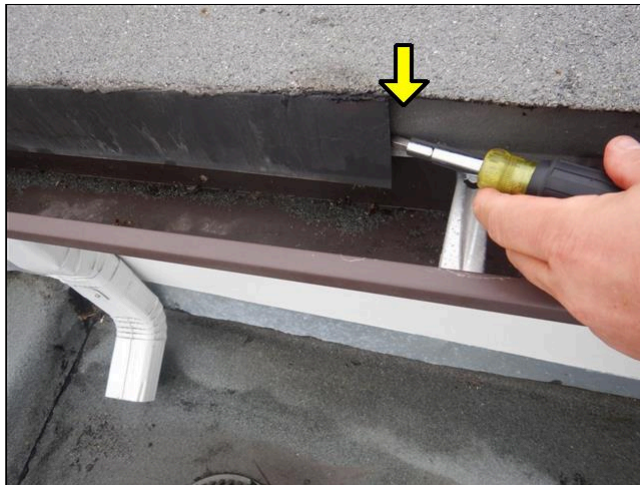
(2) Drip edge flashing was observed not to be sealed at several areas. We recommend having the drip edge flashing properly sealed where needed by a licensed roofing contractor.

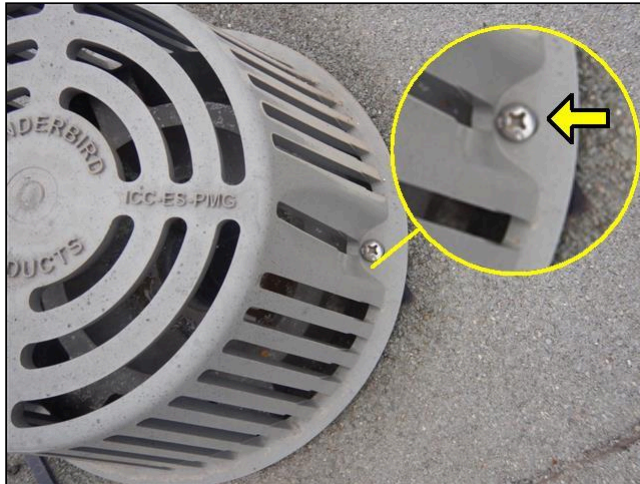
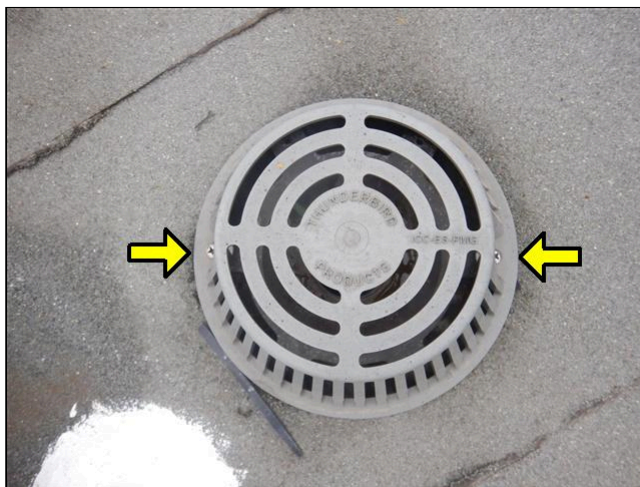
(3) Roof drain mounting screws are not sealed. We recommend having sealant applied where needed by a licensed roof contractor.

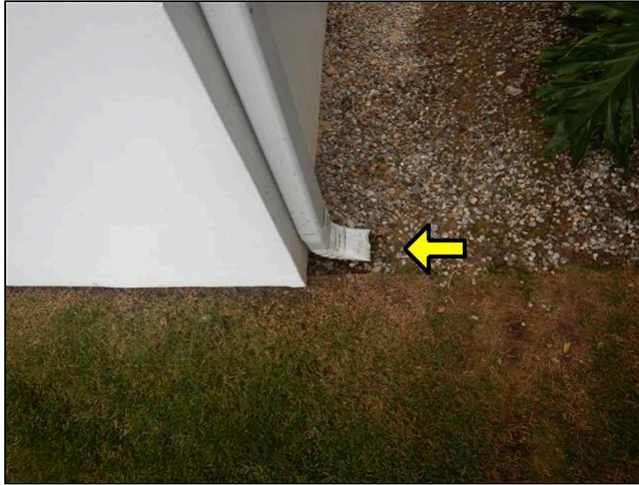
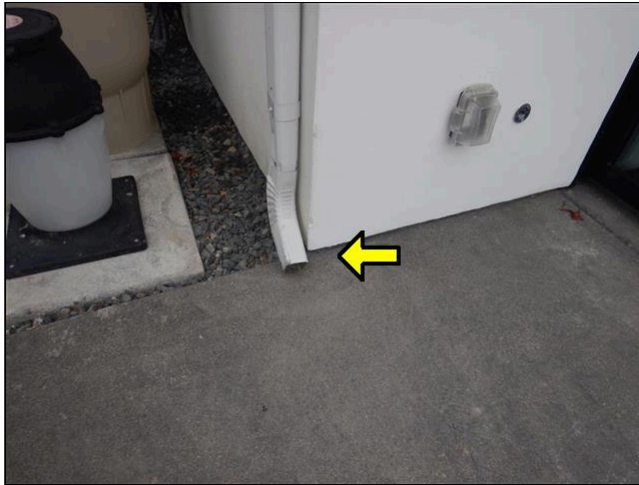
(4) Some of the downspouts around the pool house need extension and/or a buried drain line to carry water away from the home at several areas. We recommend necessary corrections where needed by a qualified contractor.

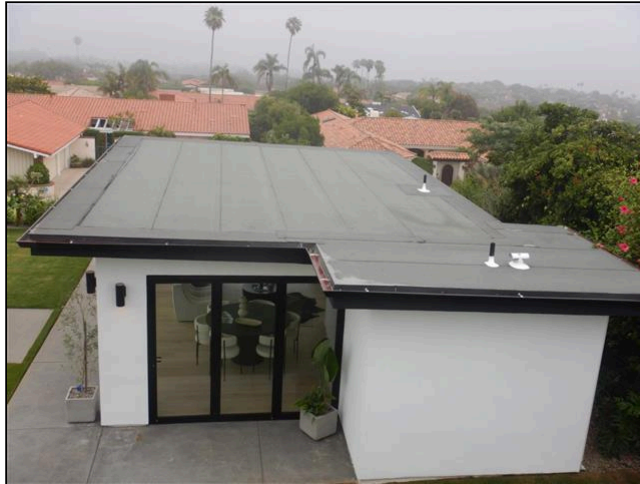
1.5 Item 1(Picture)

(1) Pictures of the pool house roof.

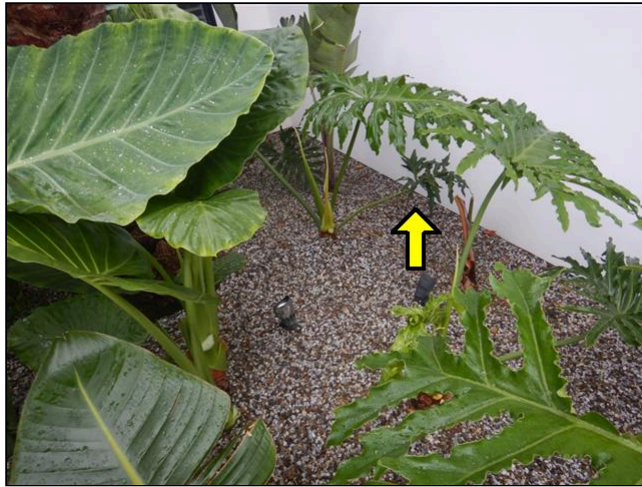
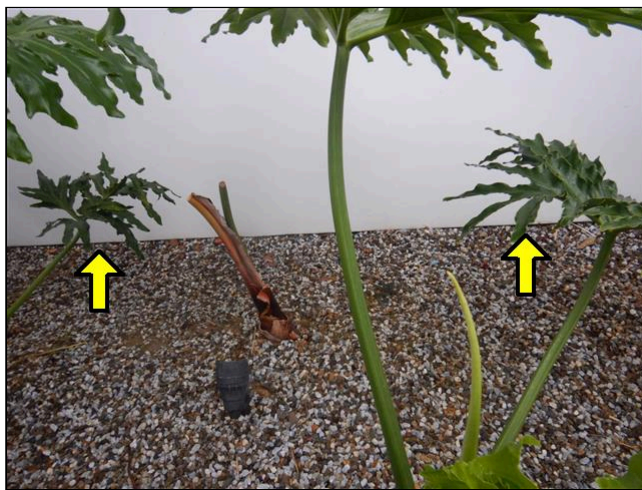
(3) The stucco/weep screed is in contact with ground at several areas. The weep screed is the metal band at the base of the stucco which has holes to allow the stucco to "breathe" and water to "weep" from the stucco. Having the soil above the weep screed can lead to stucco damage due to limited air flow. We recommend a ground clearance of four inches where possible allow for proper drainage and for ventilation of the stucco walls. Dirt in contact with the stucco can promote deterioration, including rot, pest infestation, and water intrusion during rain. We recommend further evaluation and necessary corrections by a qualified licensed contractor.

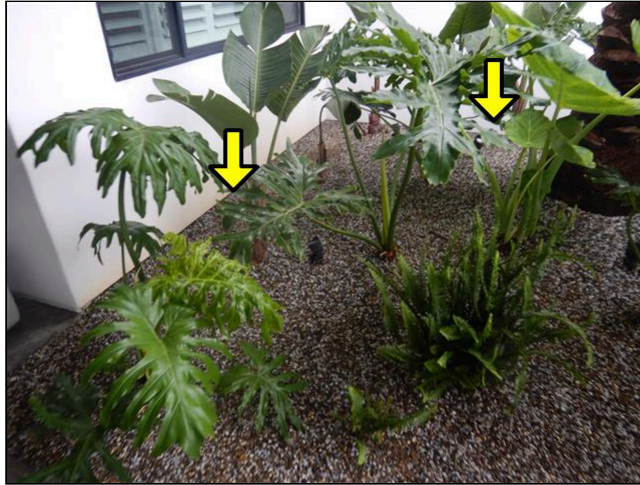
2.2 Item 5(Picture)

(4) There is a negative slope at the front of home and could cause or contribute to water intrusion or deterioration. This area does not appear to drain water away from the home and needs landscaping and drainage corrections. It is important to prevent or minimize standing water near the house to avoid damage to the foundation. This can be accomplished by properly sloping the ground away from the house and/or adding yard drains to carry water away from the low lying areas. Rain gutters can also be an effective method of diverting water away from the low-lying area. Rain gutters should direct water away from this area. We recommend further evaluation and necessary corrections by a qualified landscape contractor.

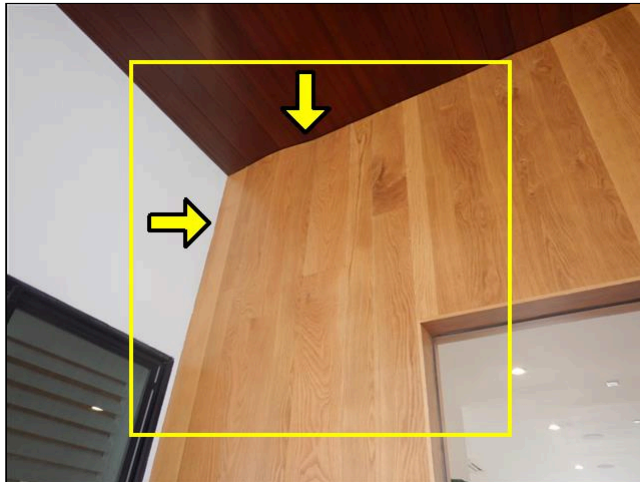
2.3 Item 1(Picture)

(1) Some of the front exterior wood siding is observed to be bowing or buckling at several areas. We recommend necessary repairs or replacing the wood siding as needed by a qualified licensed contractor.

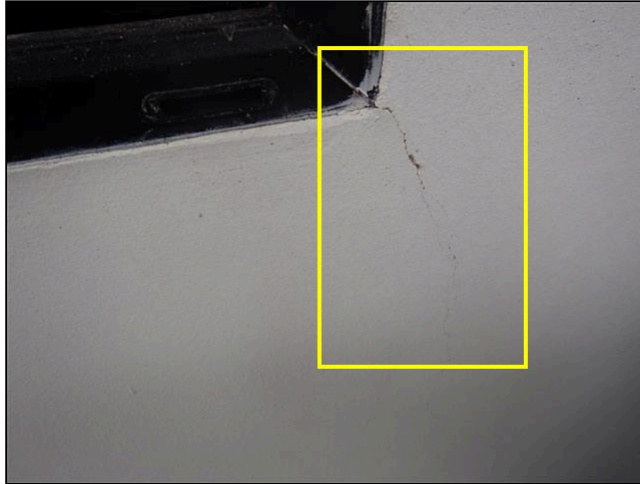
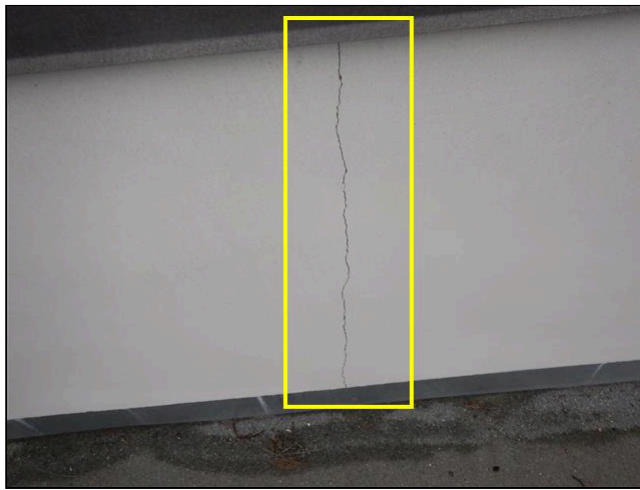
(2) Hairline cracking was observed at the stucco at several areas. The cracks are less than 1/8 inch in width, and generally considered common in this material. These cracks should be caulked and painted where possible. If cracks increase in width, it may

indicate that structural movement is occurring. Determining this is beyond the scope of a home inspection.

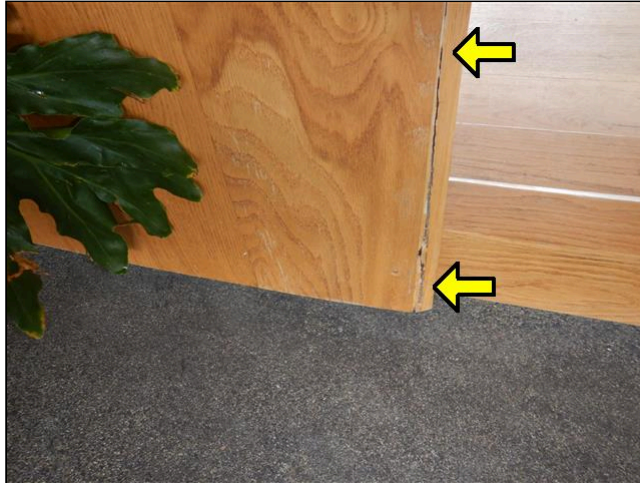
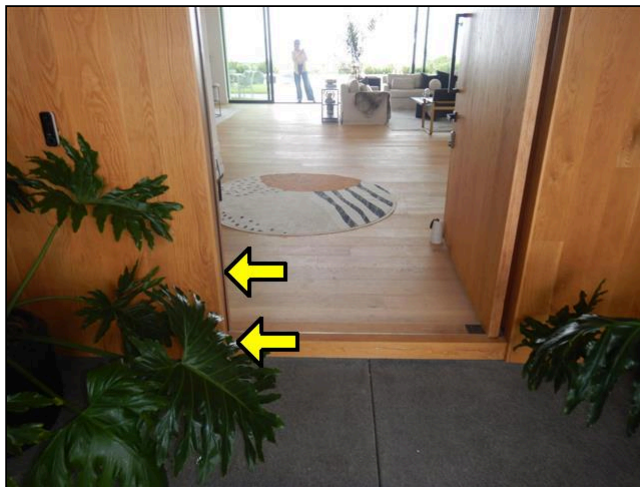
(4) Several gaps were observed at the front wood siding. These gaps can allow water to flow behind the siding causing damage. We recommend caulking the gaps as needed to seal the siding and prevent water intrusion.

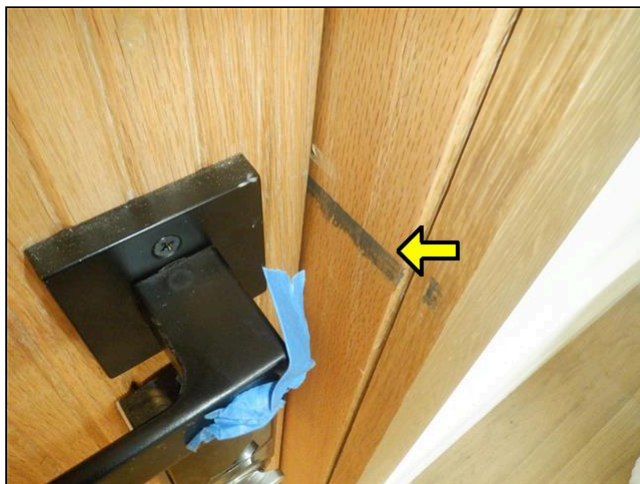
2.5 Item 1(Picture)

(1) The front door metal striker rubs the door frame. We recommend making adjustments/repairs by a licensed contractor.

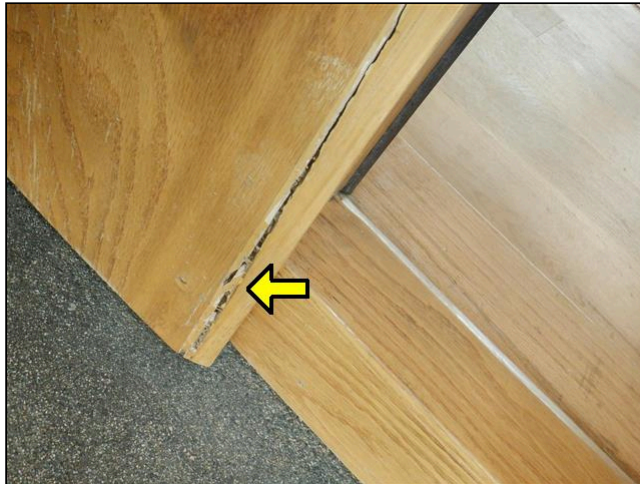
2.5 Item 3(Picture)

(3) The front entry door trim is damaged. We recommend repairs/replacement where needed by a qualified licensed contractor.

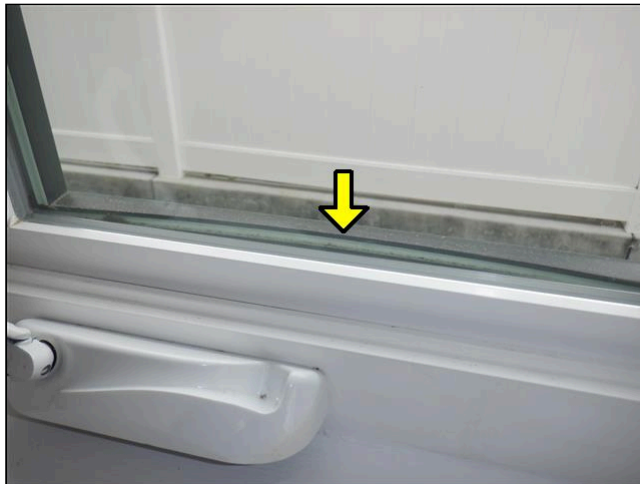
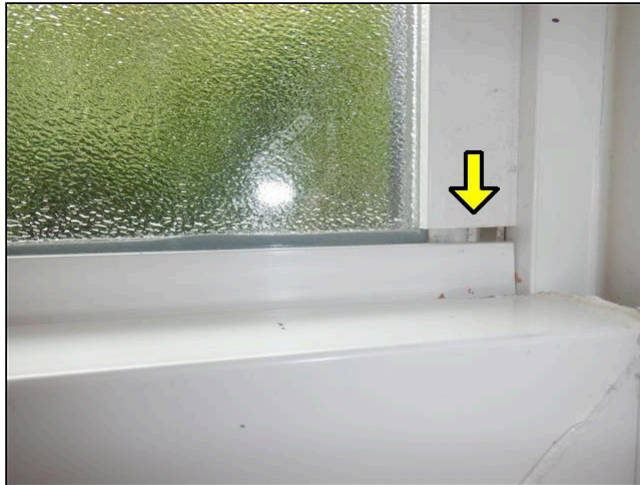
(1) Damaged seals were observed between the panes of glass at several window(s). This can be caused by exposure to the sun (excessive heat) or a manufacturing flaw. Replacement of the insulated unit is needed to restore visibility. We recommend having all of the windows reviewed by a qualified licensed window contractor to determine how many windows require repair/replacement.

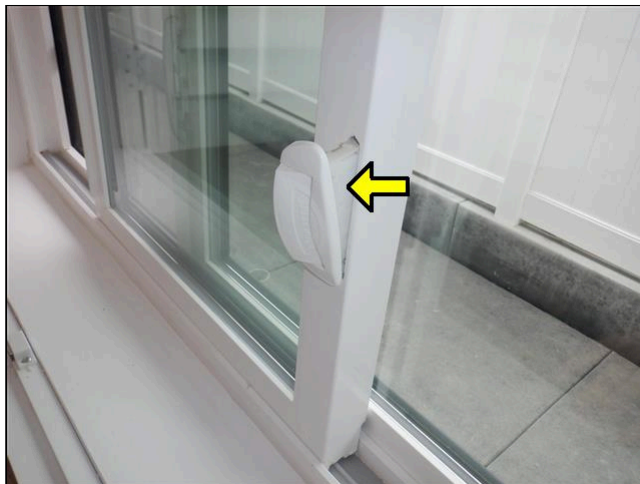
2.6 Item 3(Picture)

(2) A loose lower locking latch was observed in the 1st bedroom on the left. We recommend making repairs/replacement where needed by a licensed window contractor.

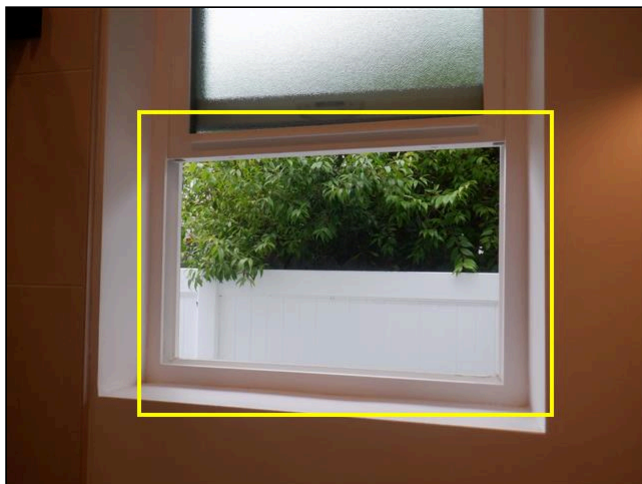
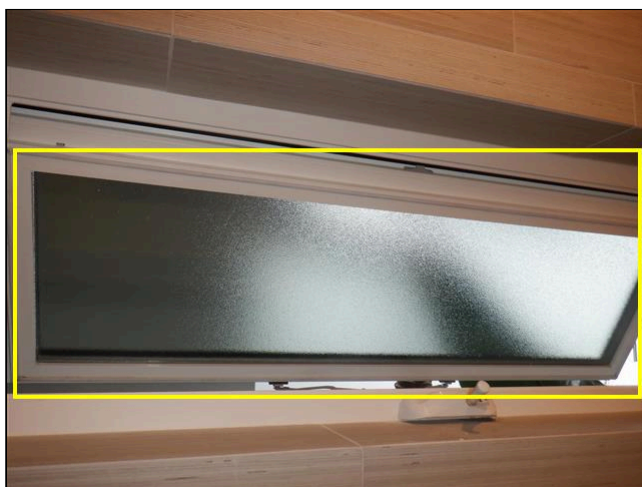
(3) There are several window screens that are missing throughout the house. We recommend repair or replace as needed by a qualified person.

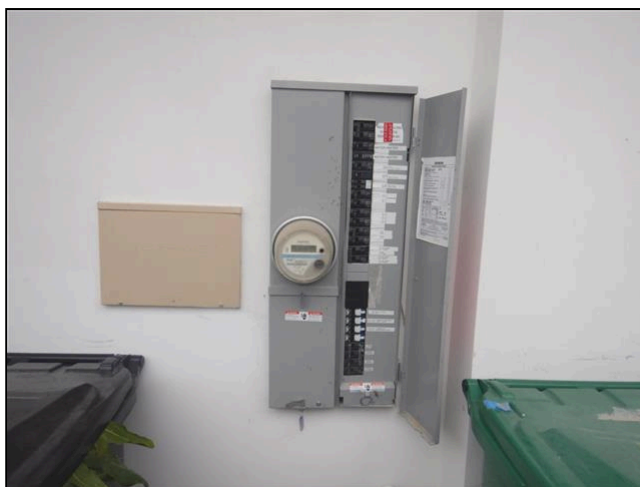
3.0 Item 1(Picture)

- (1) [Photo of the main electrical panel.](#)

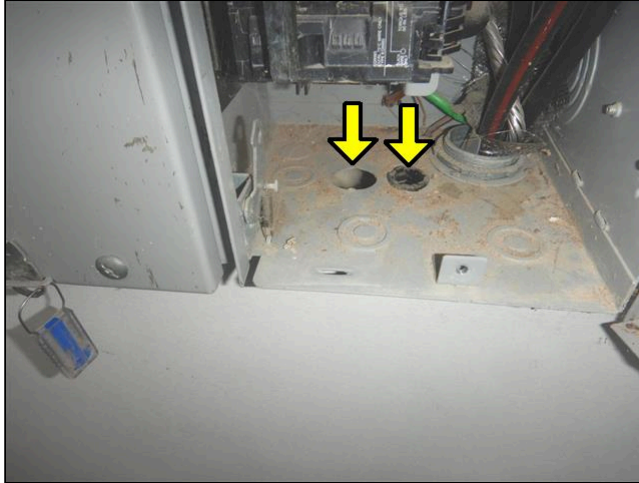
3.0 Item 2(Picture)

(2) Knockouts are noted missing from inside the main electrical panel. When a knockout is removed and left empty a cover plug is required to be installed to prevent rodent intrusion for fire safety. We recommend installing knockout plug(s) where needed by a qualified licensed electrician for safety.

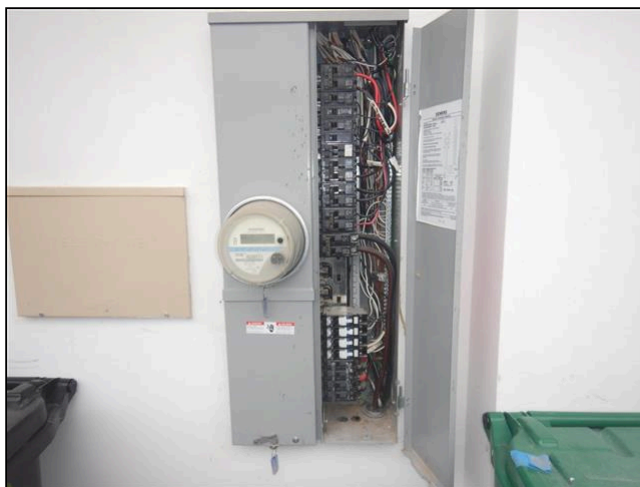
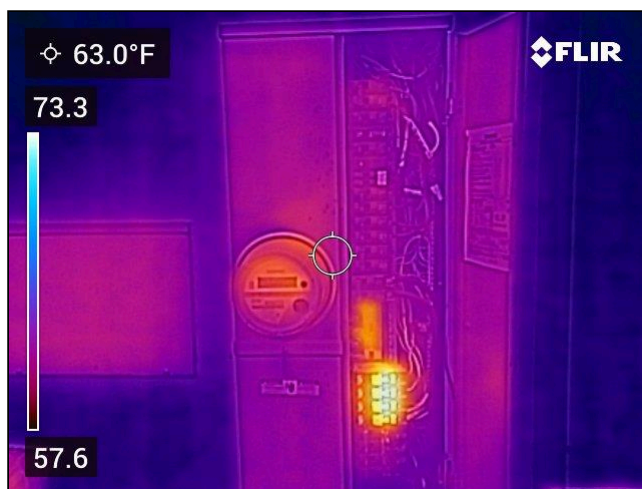
(1) [Photo inside of the main electrical panel.](#)

The dead front cover was removed at the time of the inspection and the breakers, wiring and grounding were inspected. Appears to be functioning as intended.

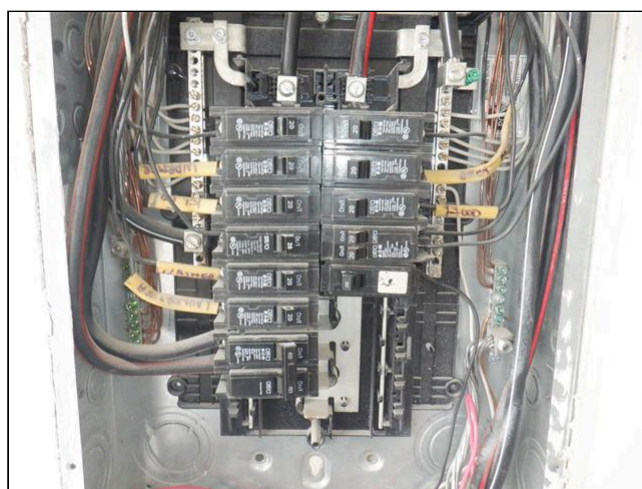
3.2 Item 3(Picture)

(2) **Photo inside of the sub electrical panel.**

The dead front cover was removed at the time of the inspection and the breakers, wiring and grounding were inspected. Appears to be functioning as intended.

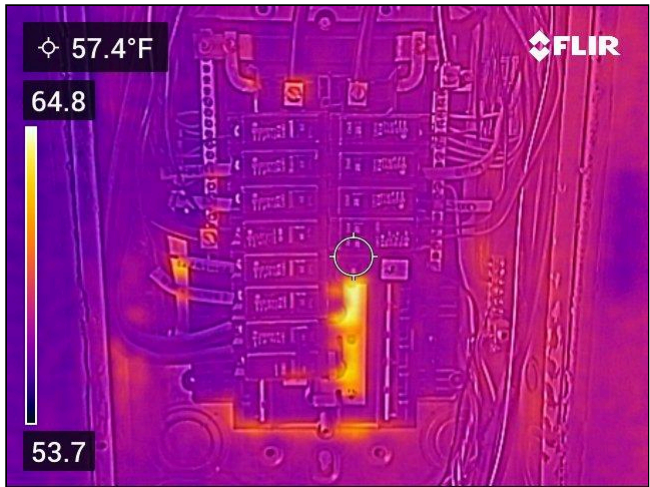
3.2 Item 4(Picture)

(3) The circuit breakers for the Main House air conditioner condensing units appear to be too small/ under fused which does not meet/ is less than the manufacturers installation requirements. We recommend further evaluation by a licensed HVAC contractor to determine if this is correct. If not we recommend necessary corrections as needed.

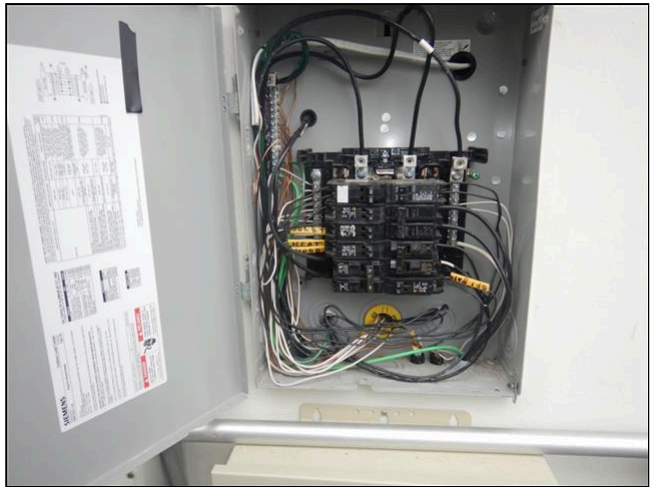
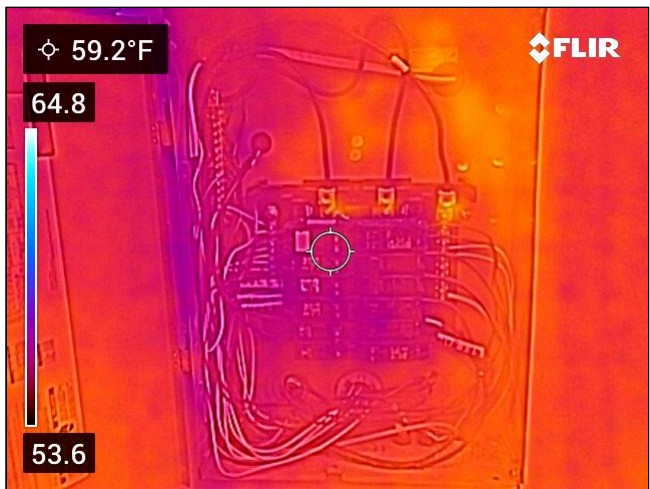
(4) **Photo inside of the pool house sub electrical panel.**

The dead front cover was removed at the time of the inspection and the breakers, wiring and grounding were inspected. Appears to be functioning as intended.

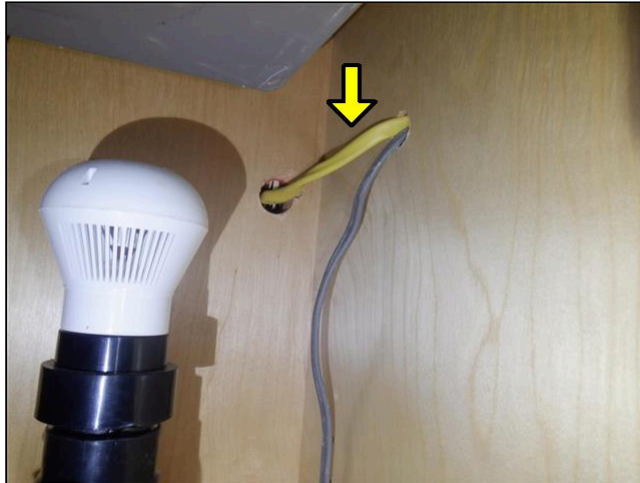
3.3 Item 1(Picture)

(1) There is exposed Romex type wires noted underneath the smaller kitchen sink cabinet. This is a safety concern if used where it could be subject to physical damage. Romex wires are normally used in attics, inside walls, or inside conduit. We recommend necessary corrections by a qualified licensed electrician for safety.

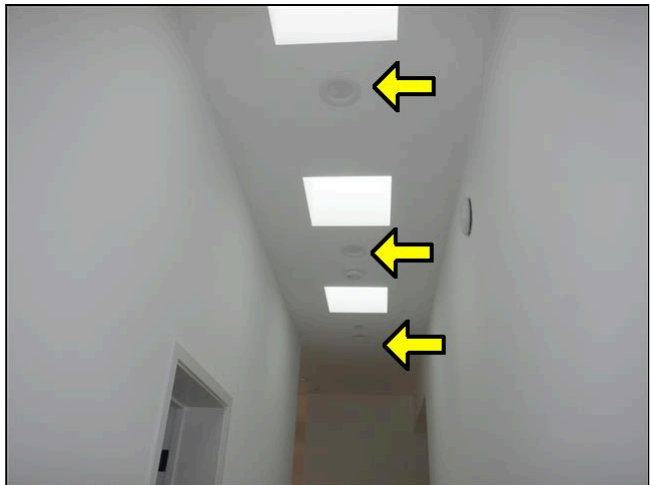
3.6 Item 2(Picture)

The right wing bedroom hallway (family room) switch did not turn the lights on at the time of the inspection. You need to go to the other side of the hallway to operate lights. We recommend further evaluation by a qualified licensed electrician and have repairs made where needed.

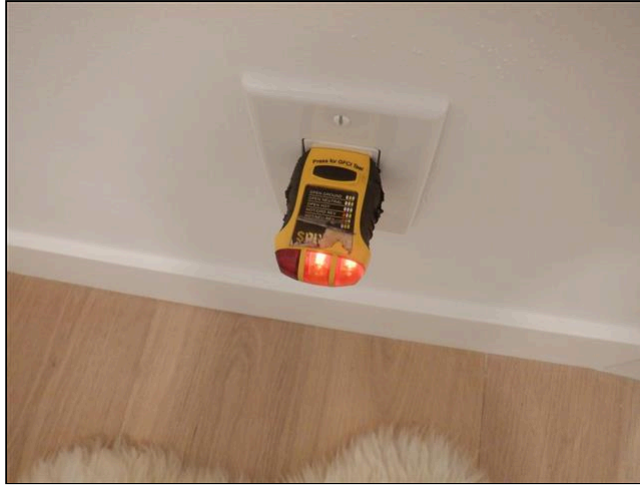
3.7 Item 1(Picture)

**Photo of a receptacle being tested.**

A representative number of receptacles throughout the property were tested for power, polarity and grounding according to our standards-of-practice. These receptacles observed to be ok at the time of the inspection unless otherwise noted.

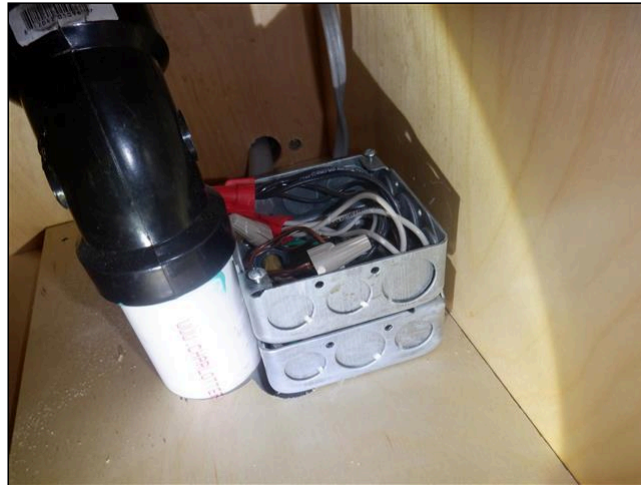
3.11 Item 1(Picture)

An open junction box is observed underneath the smaller kitchen sink cabinet. All electrical splices must be enclosed in a junction box. We recommend necessary repairs by a qualified person for safety.

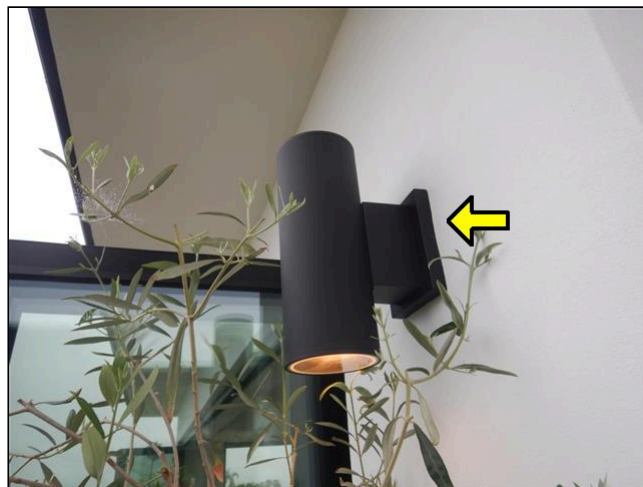
3.12 Item 4(Picture)

(2) The exterior light fixtures were not sealed where the fixture meets the wall. This condition could allow moisture intrusion in this area. We recommend sealing exterior light fixtures where they meet the wall by a qualified person.

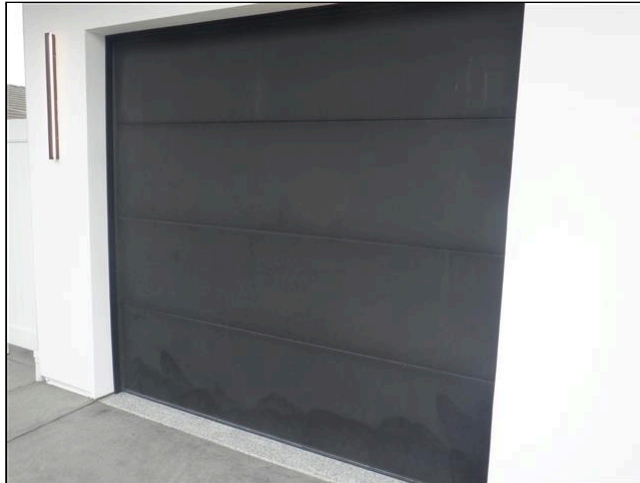
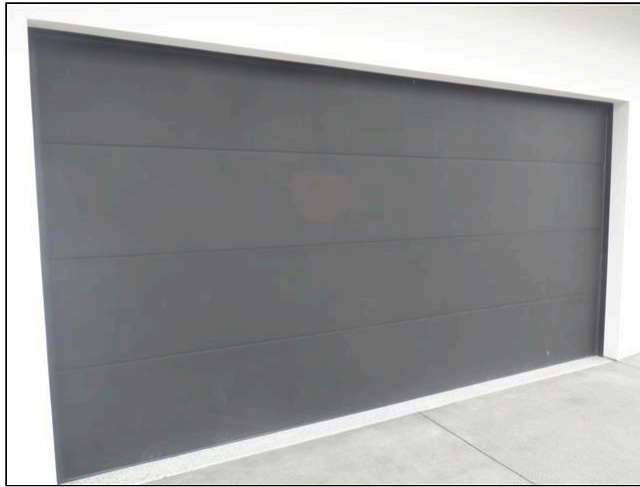
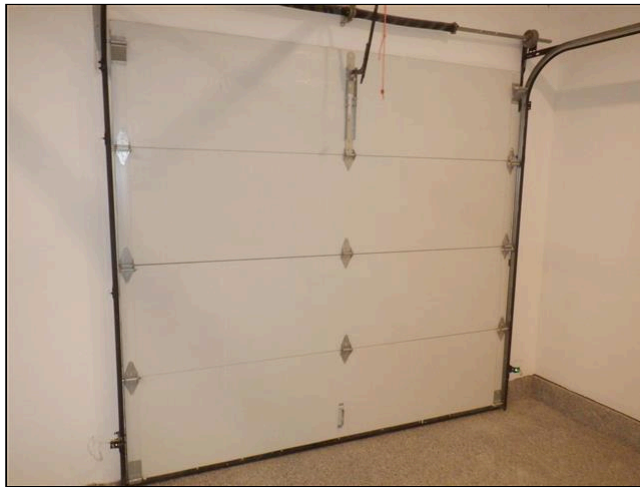
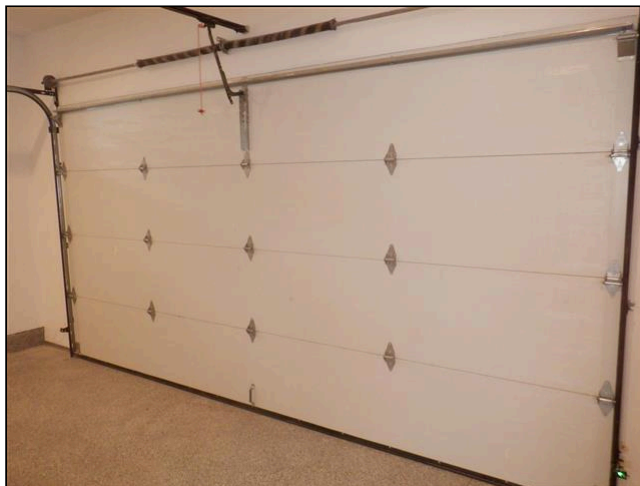
**Comments:**  
[Garage door photo\(s\).](#)

The garage vehicle door hardware including the door, track, and springs appear to be functioning as intended.

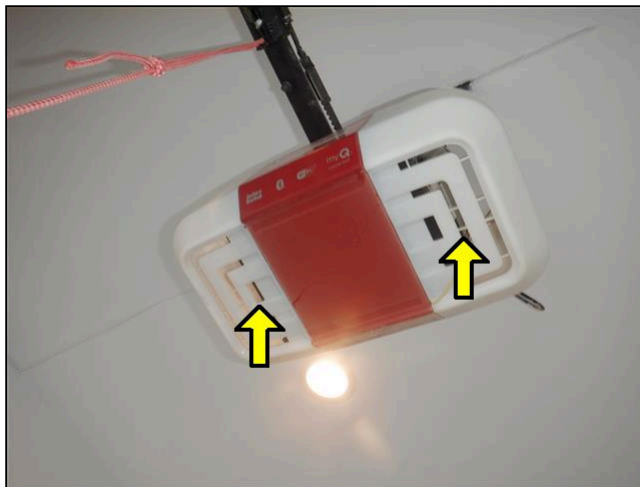
4.1 Item 2(Picture)

(1) The light bulbs are missing at the garage door opener. The lights built in the garage door opener are a safety device. We recommend installing light bulbs and testing again. If the bulbs fail to light we recommend necessary repairs or replacement by a qualified garage door contractor.

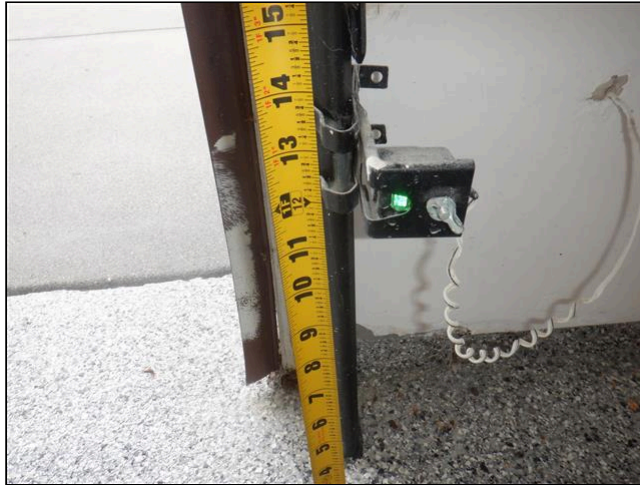
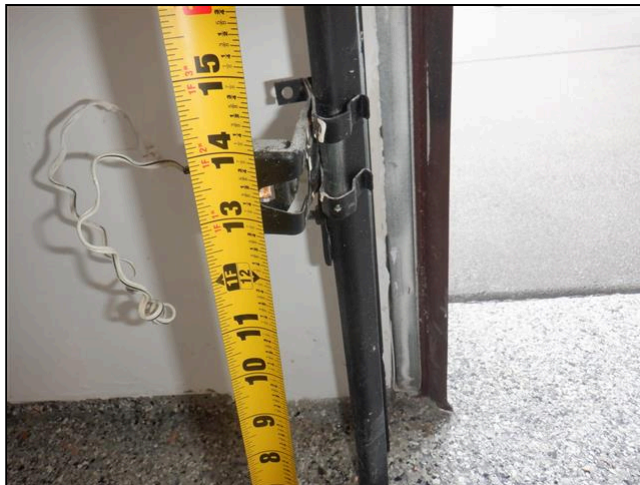
(2) The safety reverse photo-eyes are mounted at an incorrect height from the ground. Most manufacturers recommend mounting these devices at about 4"-6" from the ground for safety. We recommend necessary corrections by a qualified licensed garage door contractor.

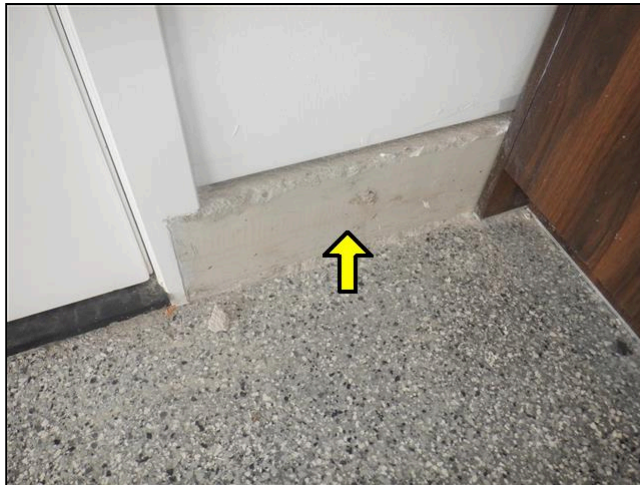
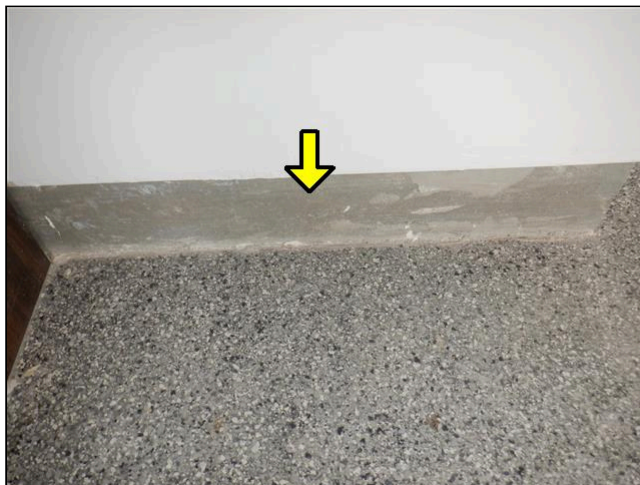
(1) Epoxy is missing at several areas of the garage stem wall. We recommend adding epoxy where needed by a licensed contractor.

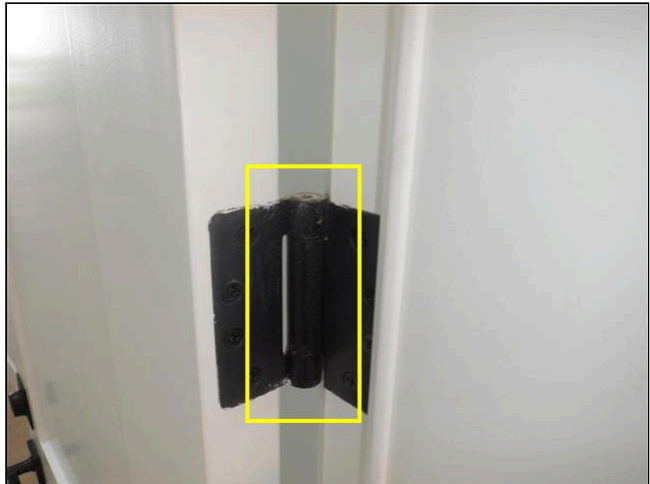
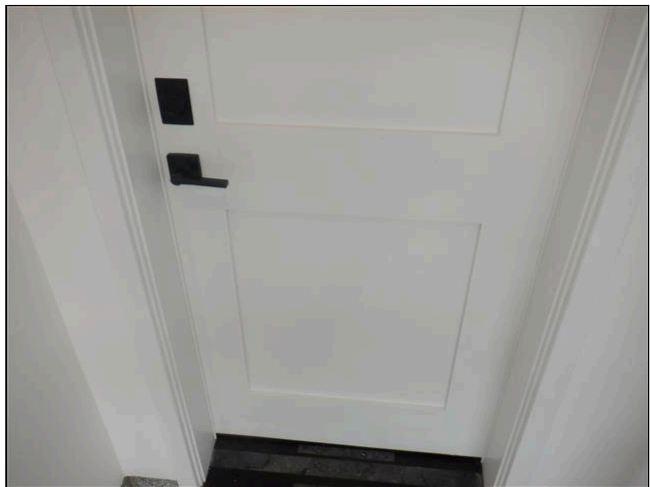
A self-closing device was present at the fire door and was operating properly when tested. The door closes and latches within 3 seconds without assistance as required.

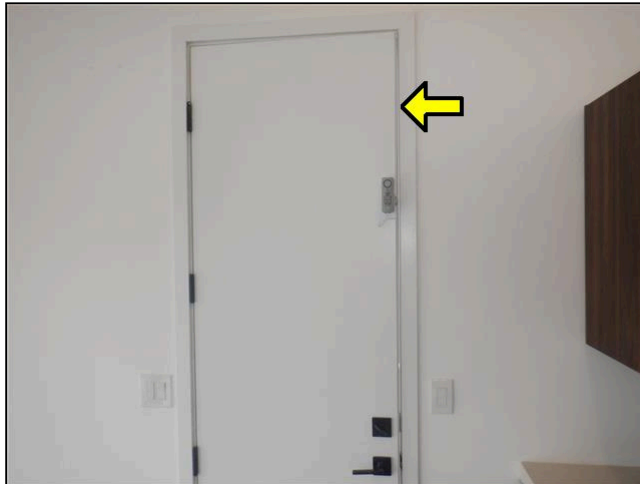
4.8 Item 1(Picture)

The garage pedestrian door rubs at the frame. We recommend making necessary adjustment by a qualified person.

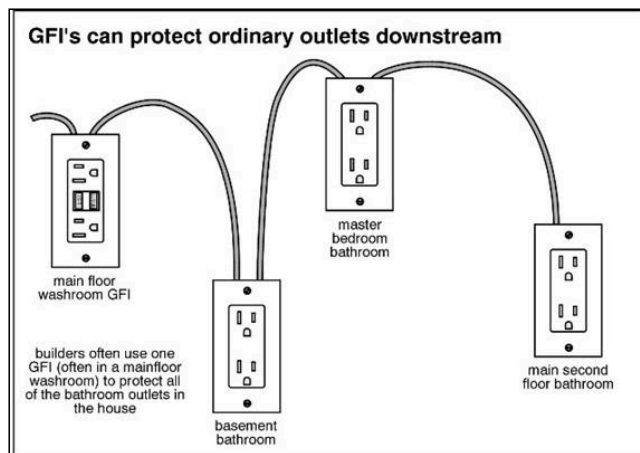
4.10 Item 1(Picture)

All accessible GFCI receptacles were tested and were functioning properly at the time of the inspection unless otherwise reported. Sometimes a tripped GFCI receptacle may be difficult to find. If you do not have power at certain receptacles please check all GFCI's and reset the tripped GFCI receptacle. If the GFCI doesn't reset than replacement of the GFCI receptacle will be required.

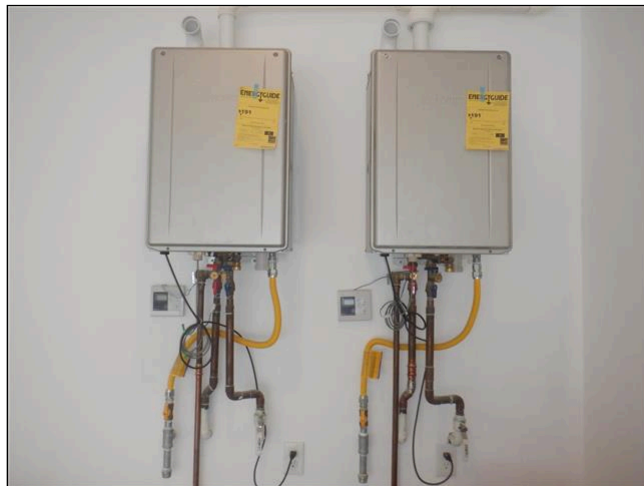
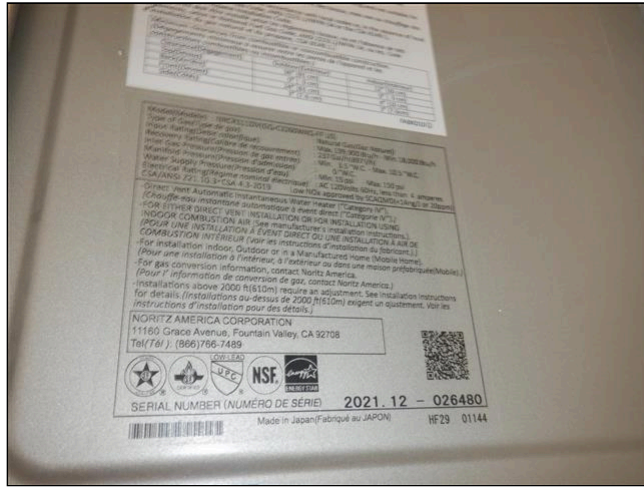
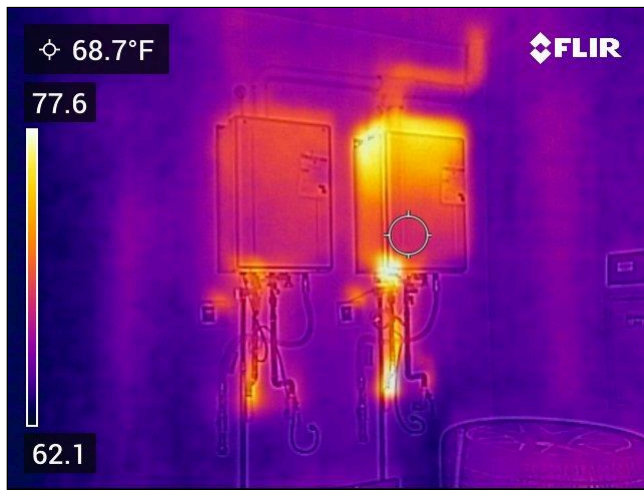
(1) [Photo of the main house water heaters.](#)

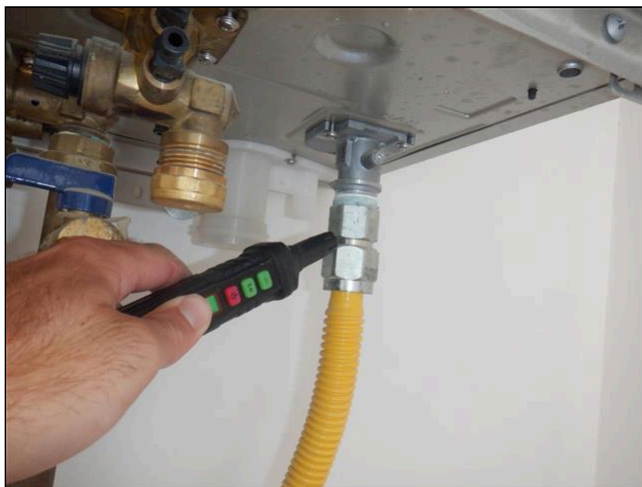
5.0.A Item 6(Picture)

(5) The water heater gas pipe fittings appear to have white teflon tape installed on them. This is non standard. White teflon tape is intended for use on water pipe fittings. We recommend necessary corrections by a qualified licensed plumber.

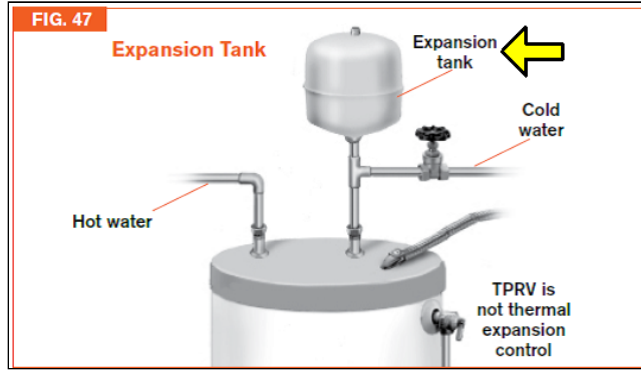
5.0.A Item 8(Picture)

(7) The water heater does not have a "Thermal Expansion Tank" installed to prevent a possible leak at the T&P or "pop-off" valve. Recent changes in code require one when a new water heater is installed. This change is not retroactive on older previously installed Gas/LP water heaters. There were no leaks or drips at the T&P valve during inspection. If your water heater does begin to drip or leak, then a thermal expansion tank may be needed. We recommend installing a thermal tank by a qualified licensed

plumber as an upgrade.

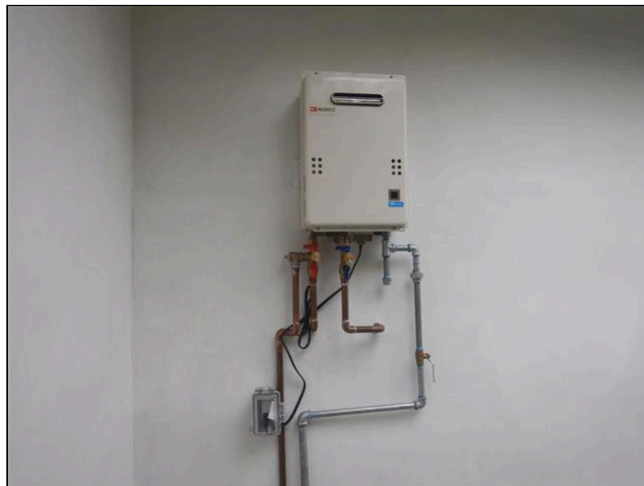
5.0.B Item 1(Picture)

- (1) [Photo of the water heater.](#)

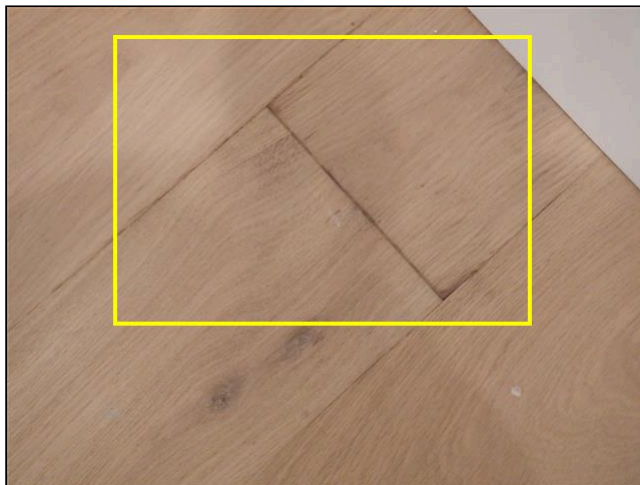
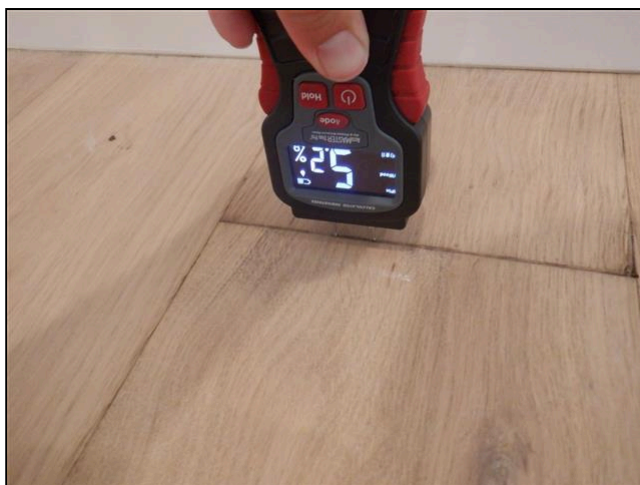
(1) Damaged flooring was observed in the left wing 2nd bedroom. This area was tested for moisture and was found to be dry at the time of the inspection. We recommend further evaluation by a qualified licensed contractor and have repairs/replacement where needed.

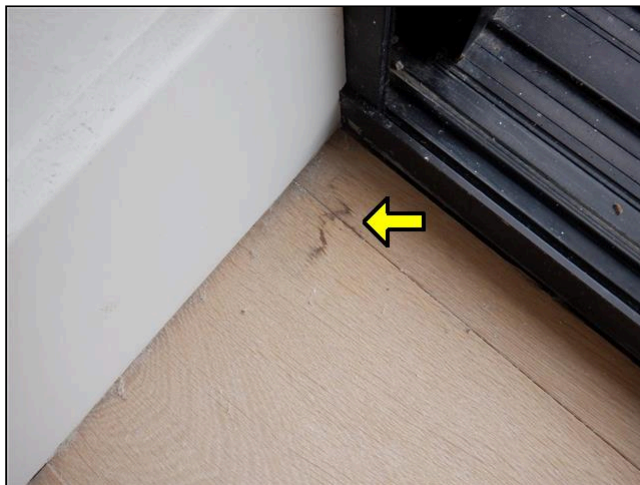
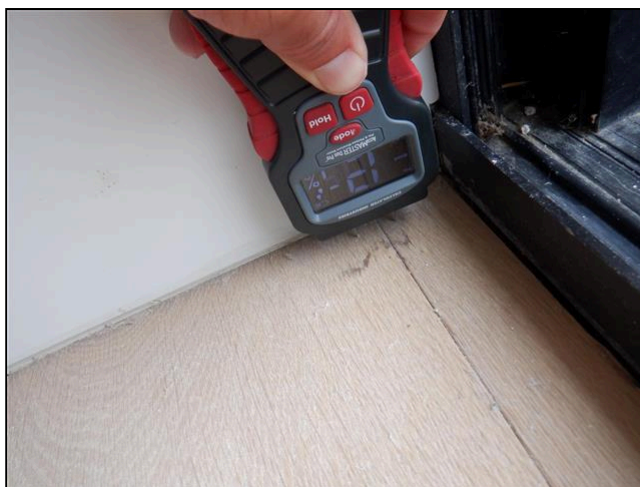
(2) Water stains and damaged flooring was observed at the master bedroom adjacent to the rear sliding door. These stains were tested for moisture and were found to be dry at the time of the inspection. We recommend further evaluation by a qualified licensed contractor and have necessary repairs/replacement made where needed.
