# Inspection Report

4132 Main Place  
San Diego CA 92037

## **The Property Inspection Pros**

<b>Date:</b> 7/11/2024	<b>Time:</b> 09:00 AM	<b>Report ID:</b>
<b>Property:</b> 4132 Main Place San Diego CA 92037	<b>Customer:</b> Rick Johns	<b>Real Estate Professional:</b>

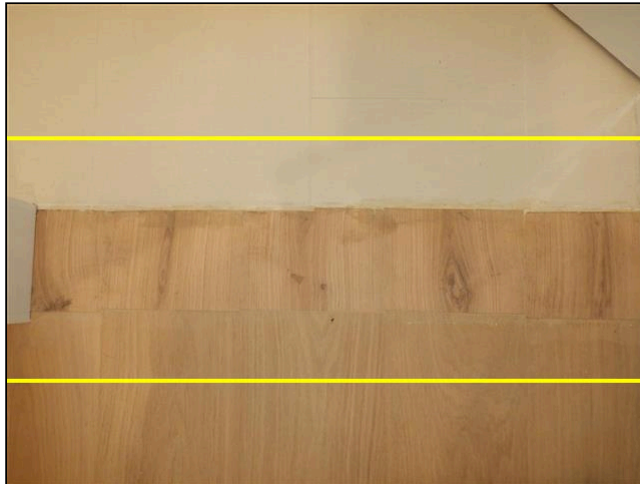
6.3 Item 5(Picture)

(4) Wood flooring in the home exhibited surface wear in several areas. We recommend repairs or replacing by a qualified licensed flooring contractor.

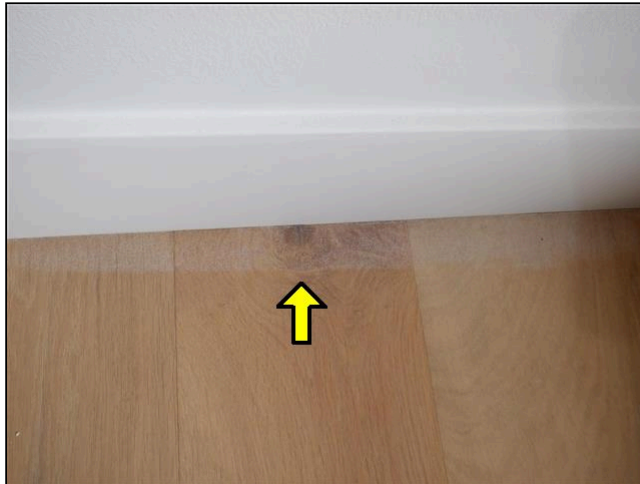
6.3 Item 7(Picture)

(5) Paint was observed to be sprayed on the flooring in several areas in the master bedroom. We recommend cleaning these areas by a qualified person.

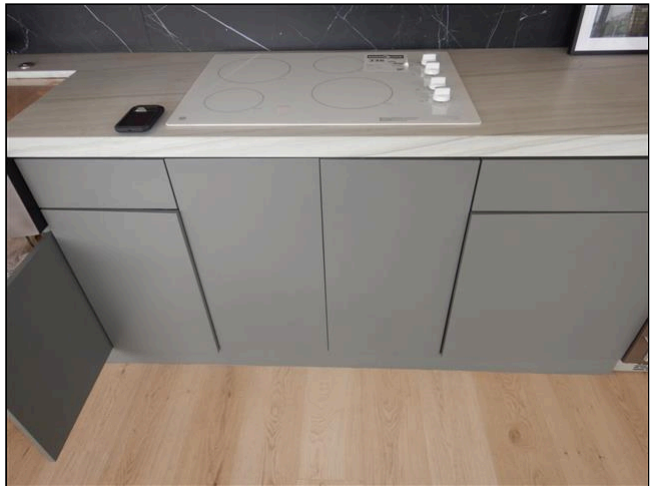
6.5 Item 3(Picture)

(4) Several pool house cabinet doors and drawers are difficult to open. We recommend necessary repairs made as needed by a qualified cabinet contractor.

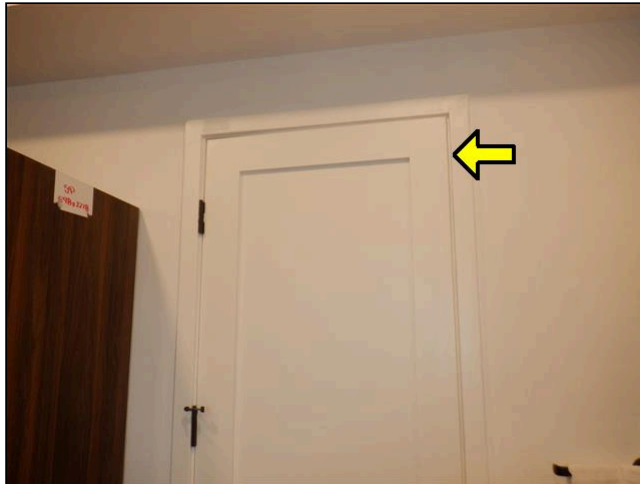
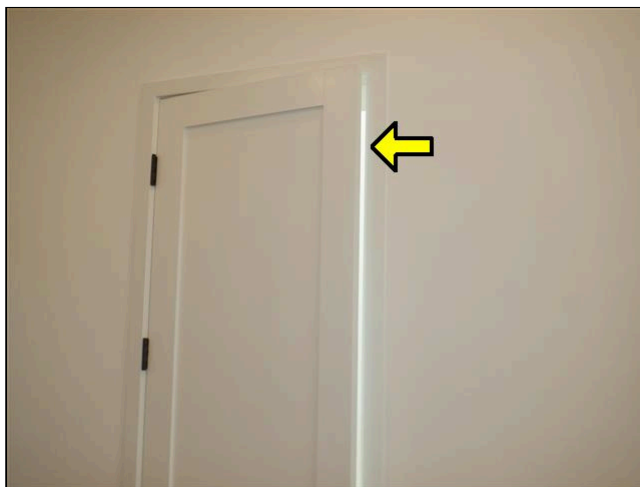
(1) Several interior doors rub at the frame. We recommend making necessary corrections where needed by a licensed contractor.

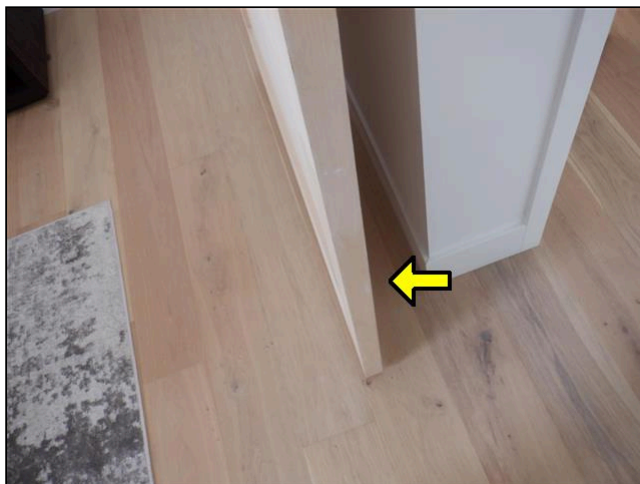
6.6 Item 3(Picture)

(2) Master bathroom sliding door floor guides are missing. This is a pinching hazard. We recommend installing where needed by a qualified person.

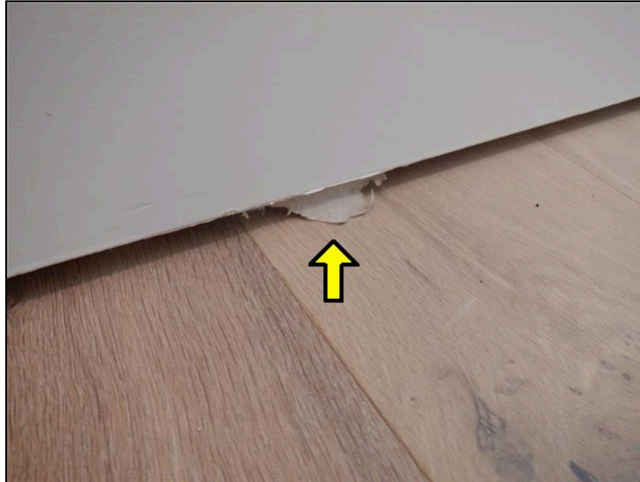
6.6 Item 5(Picture)

(4) The bottom of the larger guest bedroom door is cosmetically damaged. We recommend repairs/replacement where needed by a licensed contractor.

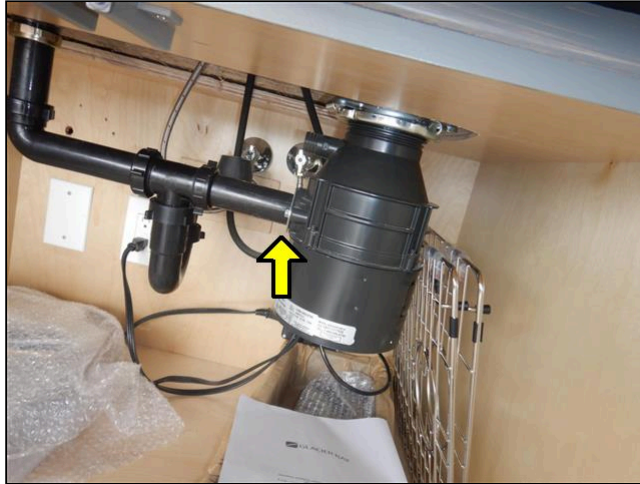
7.0 Item 3(Picture)

(3) An active leak is present at the drain pipe under the pool house kitchen sink. We recommend necessary repairs by a qualified licensed plumber.

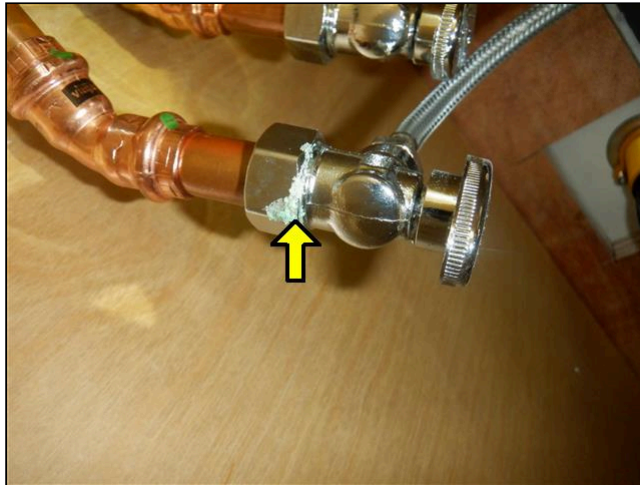
7.5 Item 1(Picture)

(1) Some of the sink angle stop valves are observed with calcium deposits on them.

Calcium deposits can corrode or deteriorate these valves and cause potential leaks. We recommend replacing all calcified angle stop valves by a qualified licensed plumber to help prevent leaks.

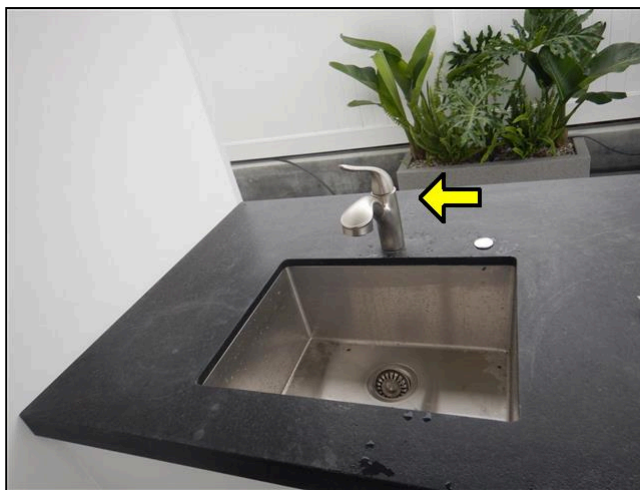
7.5 Item 2(Picture)

(2) Note: there is only cold water at the exterior BBQ island sink and not hot water. This is for your information.

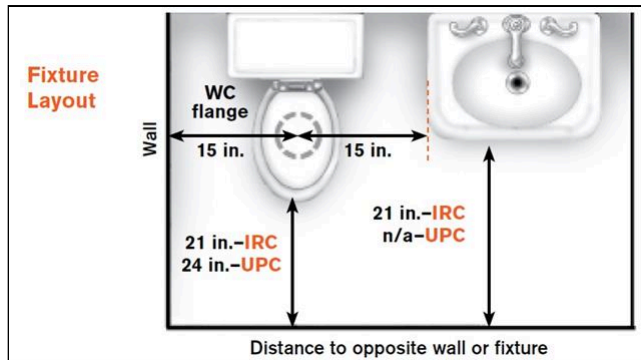
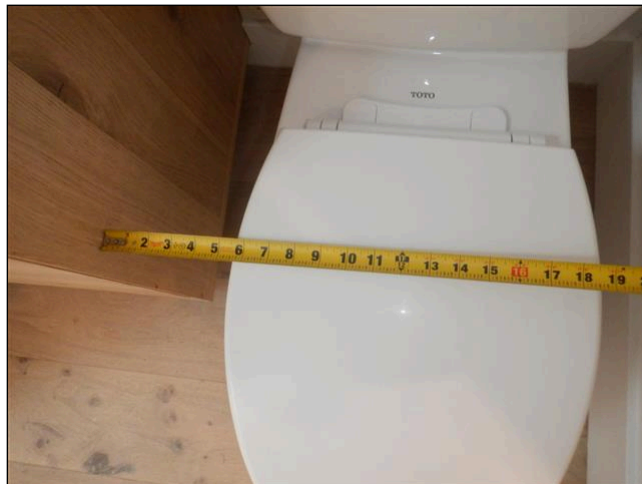
The side wall clearance to the toilet is non standard. We recommend further evaluation by a qualified licensed contractor and necessary repairs made if possible.

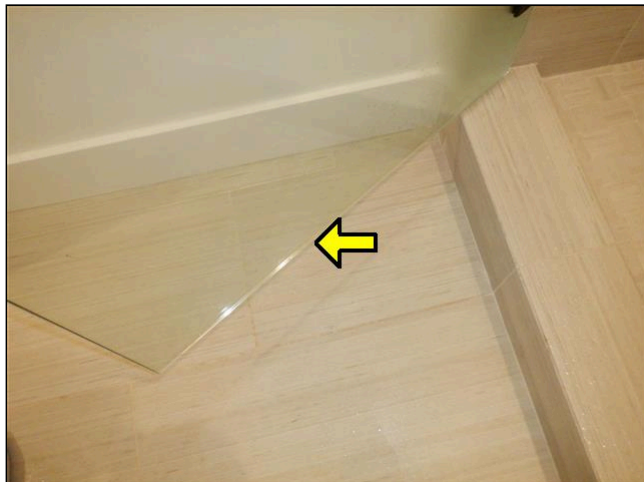
8.1.C Item 1(Picture)

to splash out of the shower and onto the bathroom floor. We recommend installing a bottom shower door seal by a qualified person.

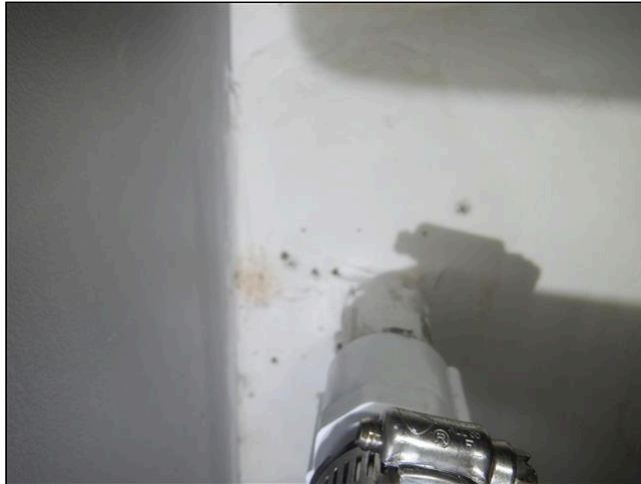
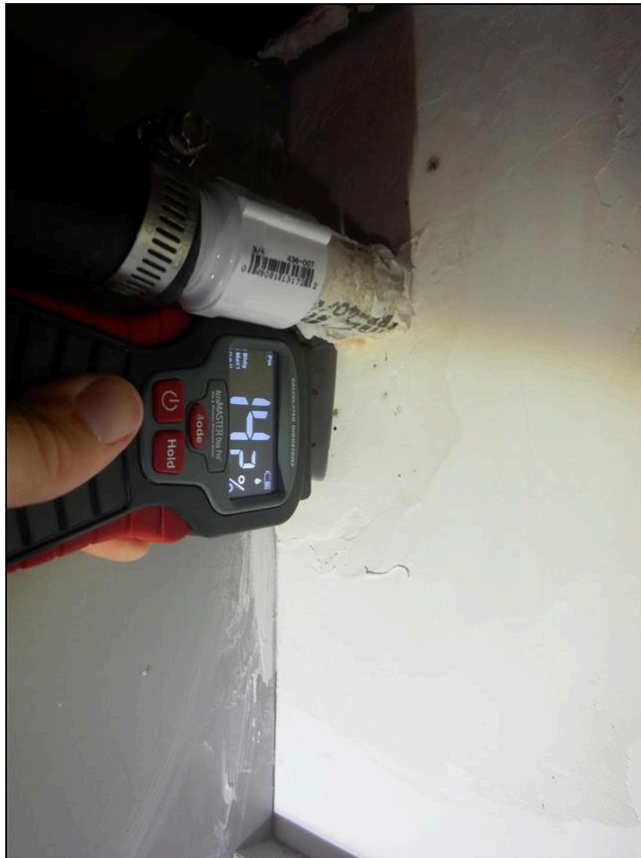
Dark stains were observed under the sink which may indicate that a leak occurred. The area was tested and was found to be dry at the time of the inspection. We recommend necessary repairs of the affected area by a qualified licensed restoration contractor. No sampling or testing of the stains were taken or included with this home inspection. If you have health issues or if you are concerned about the air quality inside this house, we recommend necessary testing be performed by a qualified licensed contractor prior to the end of your contingency period.

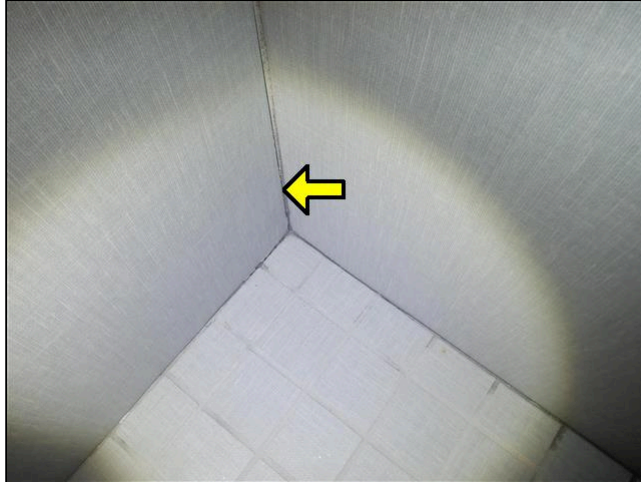
8.1.F Item 1(Picture)

The tile surround has cracked or missing grout between the tiles and needs repair or replace. There may be water damage to the wall behind the tiles which is not visible. Determining if water damage exists in the wall behind tiles is beyond the scope of our general home inspection. We recommend having the tiles repaired by a licensed tile contractor. Additional repairs may be required when tiles are removed. This area should be evaluated further by a qualified licensed tile contractor prior to the end of your contingency period.

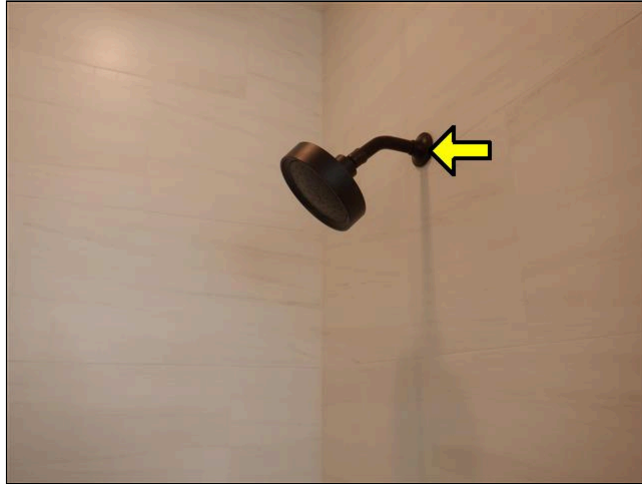
8.1.G Item 1(Picture)

enter behind the tub/shower wall and could put unwanted stress on the water supply pipes. We recommend necessary repairs by a qualified licensed plumber.

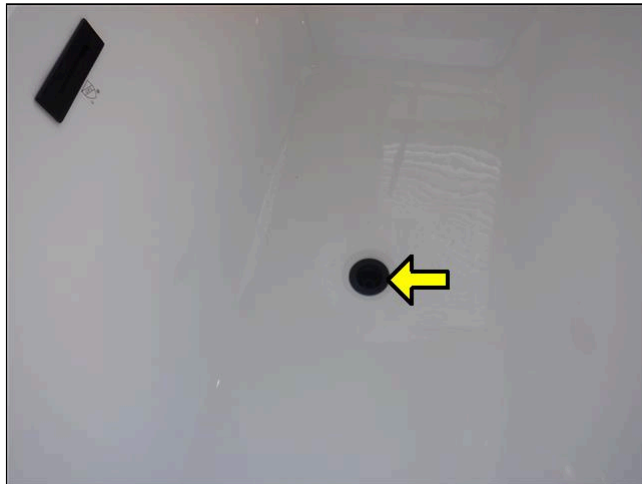
8.2.G Item 1(Picture)

(1) The tub stopper is missing. We recommend replacing by a qualified person.

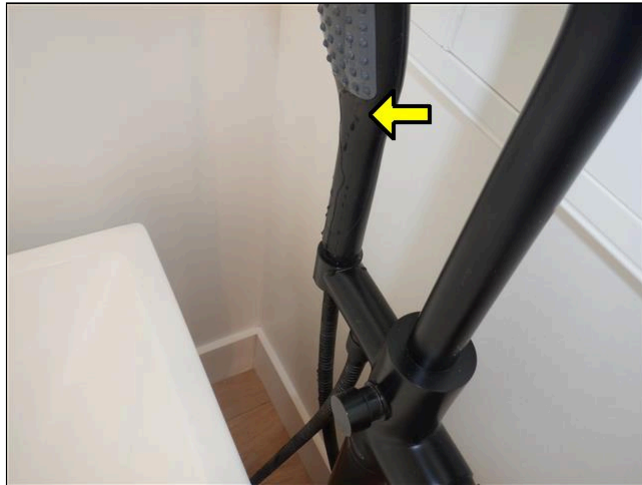
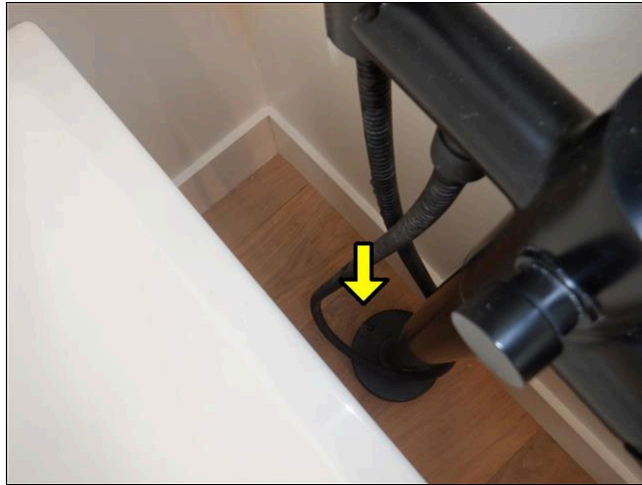
(2) The tub handheld faucet continues to drip when the diverter is activated which is dripping on the flooring. This could cause moisture damage. We recommend making necessary repairs/replacement by a licensed plumber.

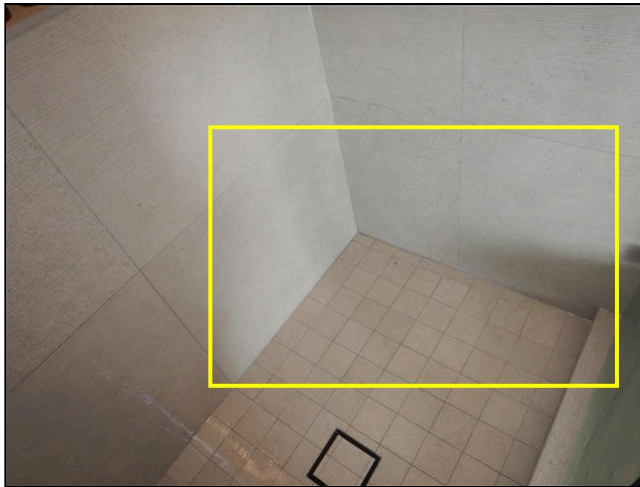
8.0.H Item 1(Picture)

We recommend caulking around the hall bathroom shower pan, curb, and adjacent walls to help prevent moisture intrusion.

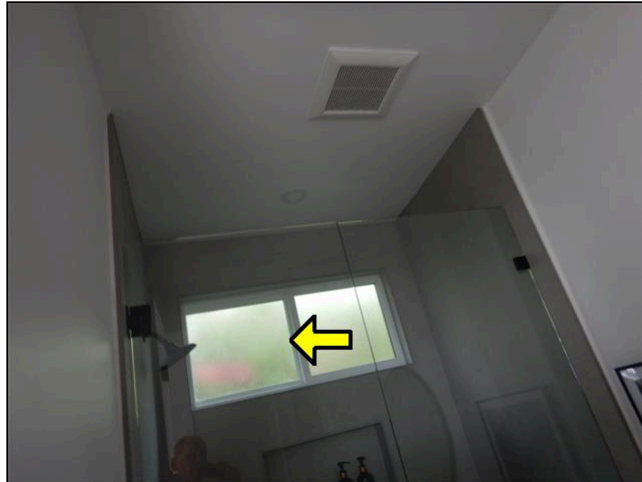
8.1.H Item 1(Picture)

The window screen is missing. We recommend replacing by a qualified person.

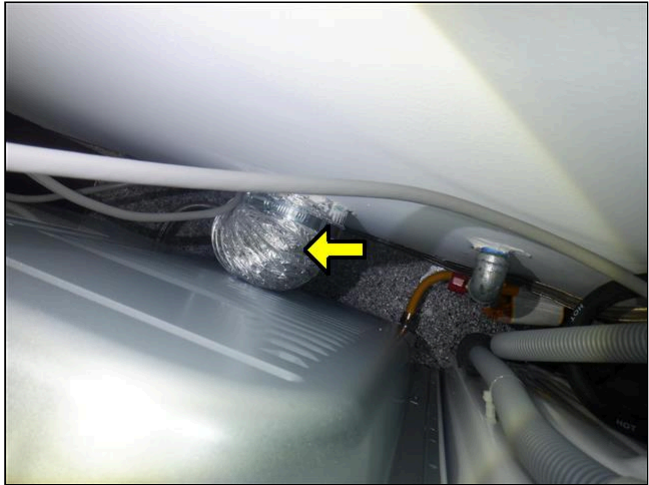
9.1 Item 1(Picture)

(1) The dryer is equipped with a foil, accordion-type duct. The U.S. Consumer Product Safety Commission considers these types of ducts to be unsafe and a fire hazard. The flexible foil type duct can more easily trap lint and is more susceptible to kinks or crushing, which can greatly reduce the airflow. We recommend replacing the duct with a rigid or corrugated semi-rigid metal duct.

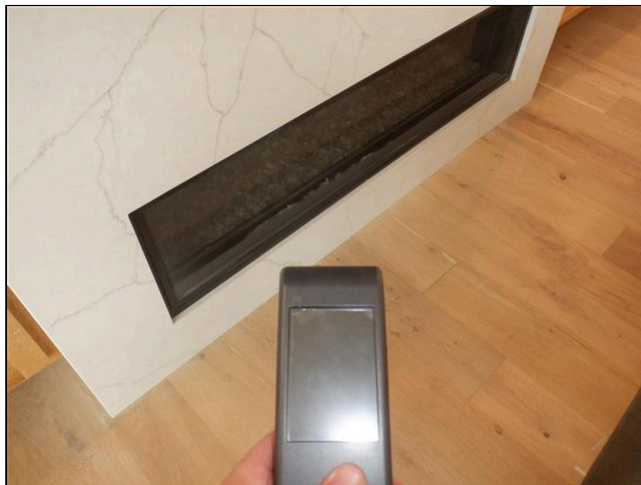
10.0.A Item 1(Picture)

The fireplace operating remote at the main house did not have power at the time of the inspection. We recommend changing the batteries and having the fireplace inspected for proper operation by a qualified person prior to the end of your contingency period.

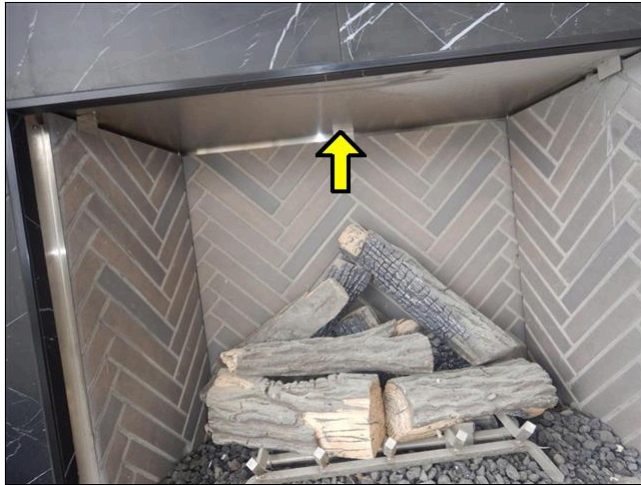
10.0.B Item 1(Picture)

There is not chimney, flue or direct vent installed at the pool house gas fireplace which is non standard and a safety hazard. We recommend having a chimney, flue or direct vent or proper fireplace and chimney installed by a licensed fireplace contractor. This fireplace is unsafe to use in its current installation and should not be used until corrections are made.

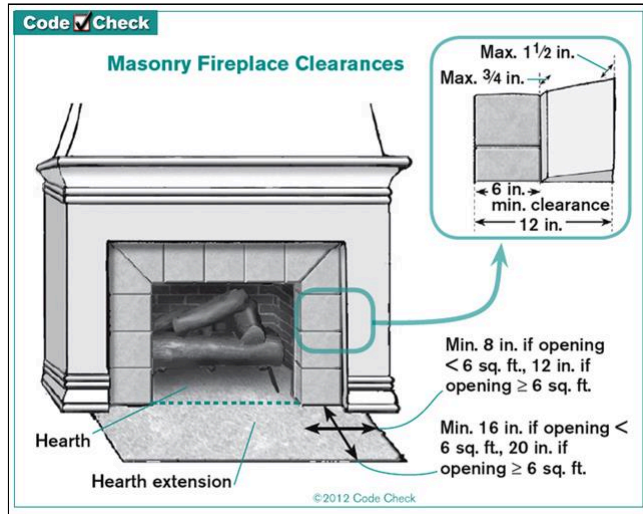
10.2.B Item 1(Picture)

The hearth at the front of the fireplace is missing/ of inadequate size/ or an improper material. This condition does not comply with current building and fire and safety requirements. We recommend installation of a properly sized hearth by a qualified licensed contractor.

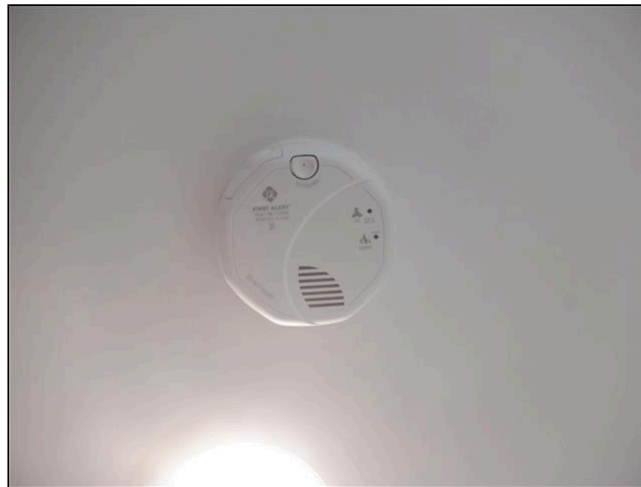
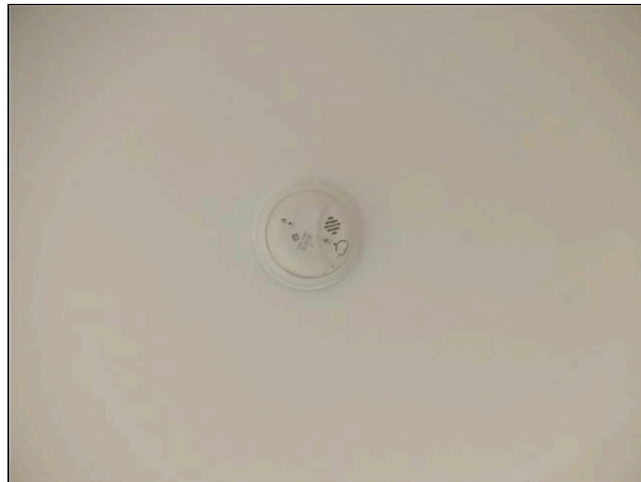
(1) [Photo of carbon monoxide detector\(s\).](#)

(2) The quantity of Carbon Monoxide detectors that are required to be installed varies with each house. Larger houses, or those with multiple levels are required to have more CO detectors. A Carbon Monoxide detector is required on each level of a multi-level

house and adjacent to each cluster of bedrooms. We recommend installing additional Carbon Monoxide detectors where needed in the main and pool house.

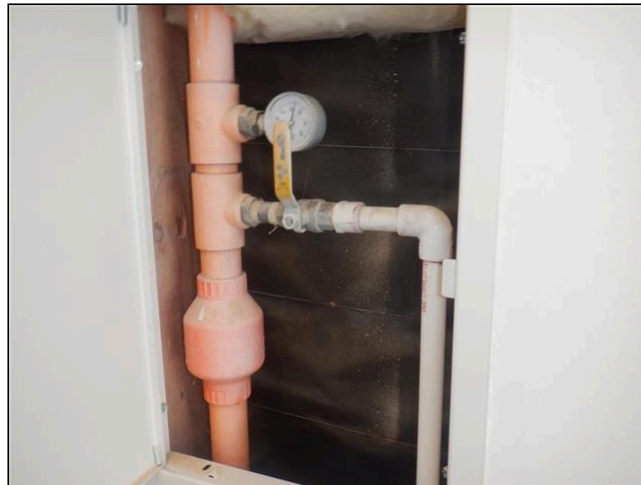
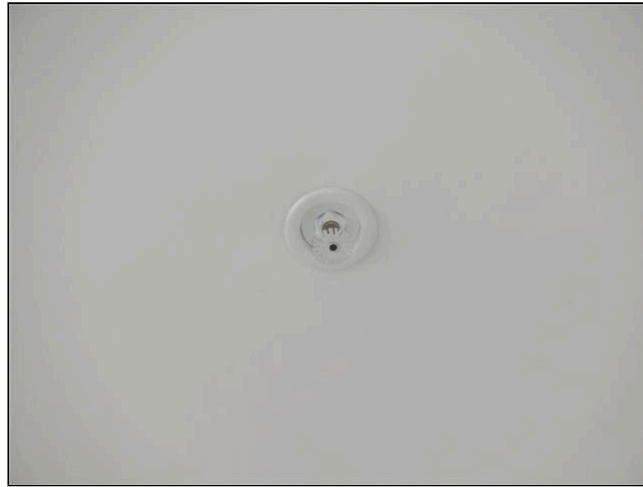
There is a fire sprinkler system installed in the house and was not inspected by this company at the time of the home inspection. Inspecting fire sprinkler systems is beyond the scope of our general home inspection. We recommend having the fire sprinkler system inspected by a qualified licensed contractor prior to the end of your contingency period.

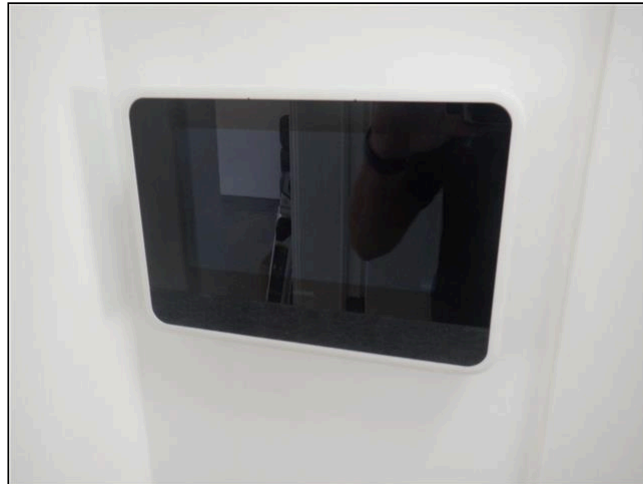
11.4 Item 1(Picture)

There is a security system installed in the house and was not inspected by this company at the time of the home inspection. Inspecting security systems is beyond the scope of a general home inspection. We recommend having the security system inspected by a qualified licensed contractor prior to the end of your contingency period.

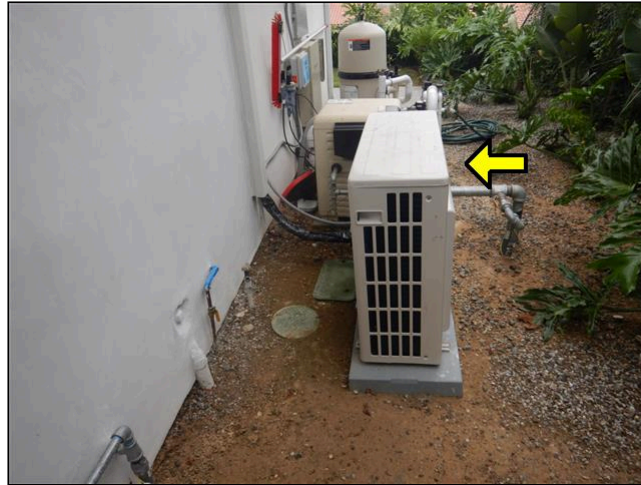
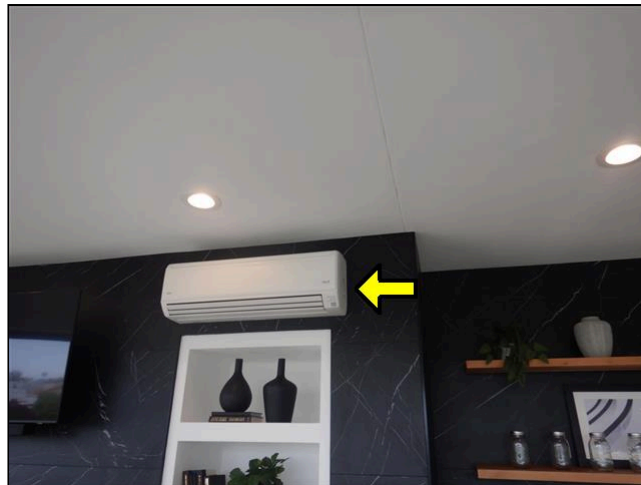
The pool house mini split did not operate in the heating mode when tested at the time of the inspection. We recommend further evaluation of the furnace and related components by a qualified licensed HVAC contractor prior to the end of your contingency and repairs or replacement made as needed.

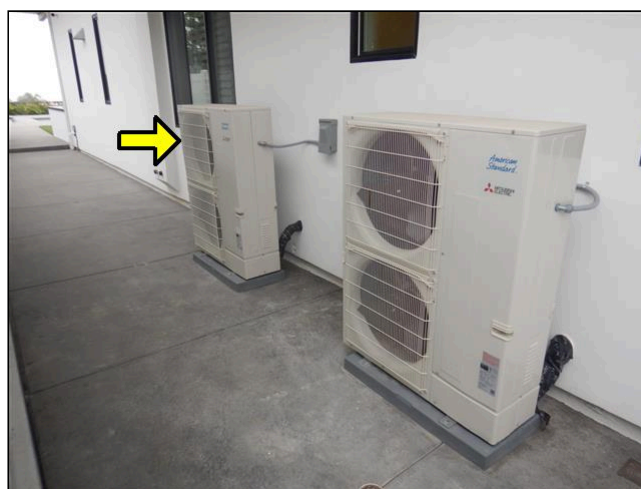
13.0 Item 1(Picture)

The Main House rear AC condenser is not level. This can put stress on the bearings and refrigerant lines. We recommend having the condenser leveled by a qualified licensed HVAC contractor.

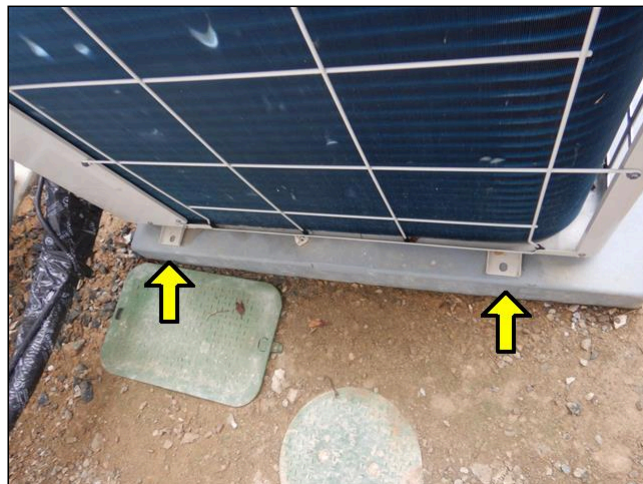
13.1 Item 1(Picture)

- (1) The pool house mini split did not operate in the cooling mode when tested at the time of the inspection. We recommend further evaluation of the furnace and related components by a qualified licensed HVAC contractor prior to the end of your contingency and repairs or replacement made as needed.
- (2) The pool house AC condenser is not properly secured to the equipment pad. Building standard require these units to be secured to the pad to prevent damage, theft, and injury. We recommend necessary corrections made by a licensed HVAC contractor.

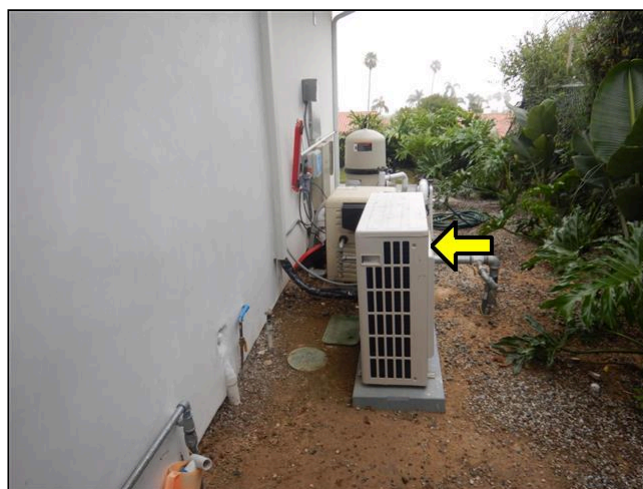
13.1 Item 2(Picture)

- (3) The pool house AC condenser is not level. This can put stress on the bearings and refrigerant lines. We recommend having the condenser leveled by a qualified licensed HVAC contractor.

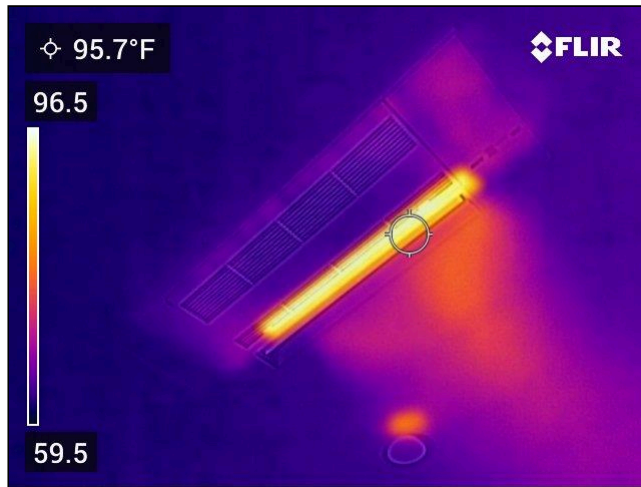
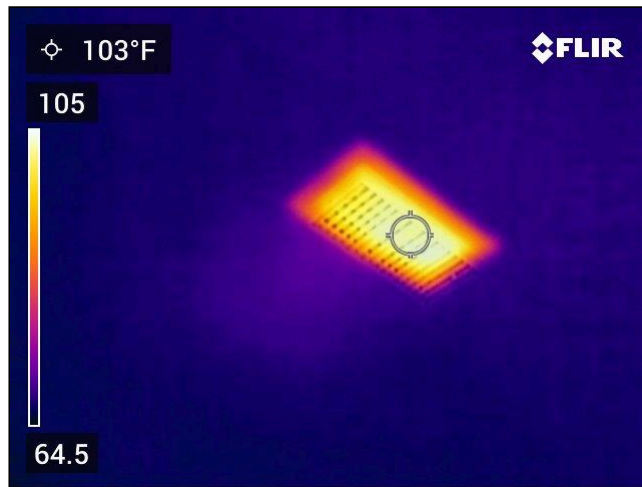
All of the Main House heat pumps were tested and were functional/ operated in the heat mode at the time of the inspection.

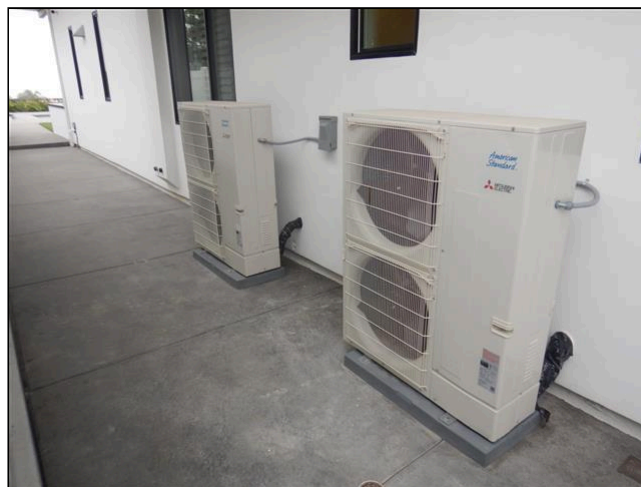
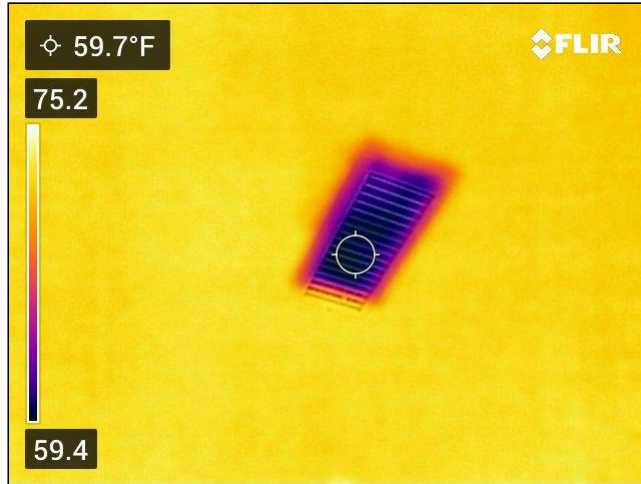
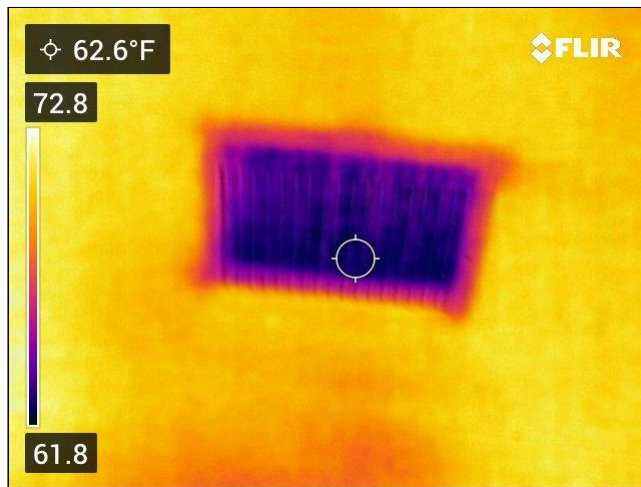
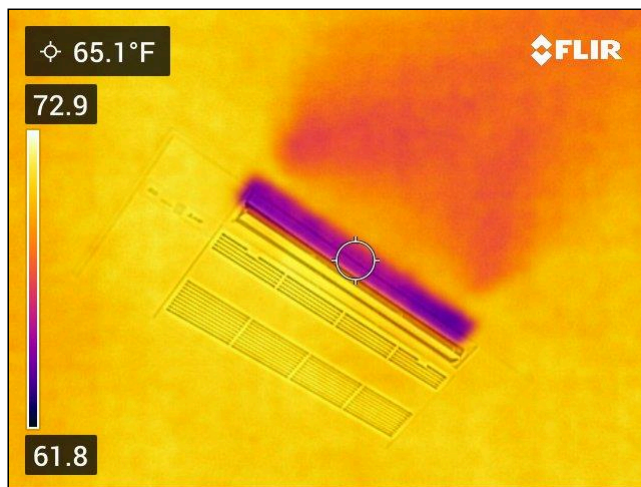
- (1) **Photo of the Main House A/C unit(s).**

(2) All of the Main House heat pumps were tested and were functional/ operated in the cooling mode at the time of the inspection.

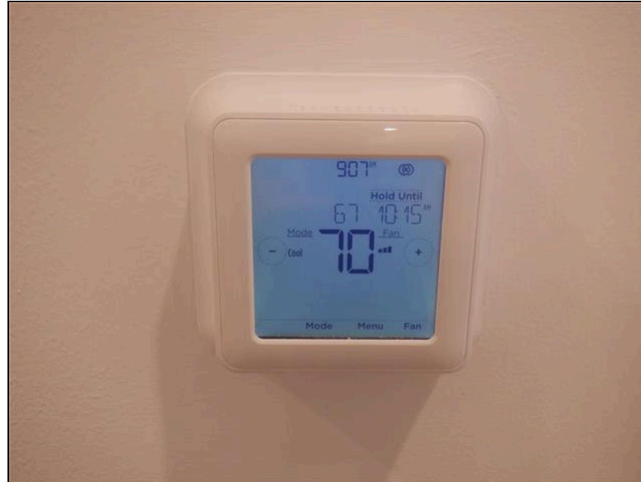
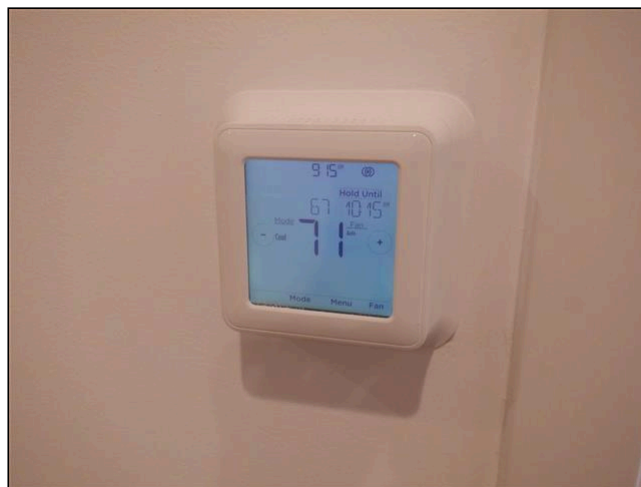
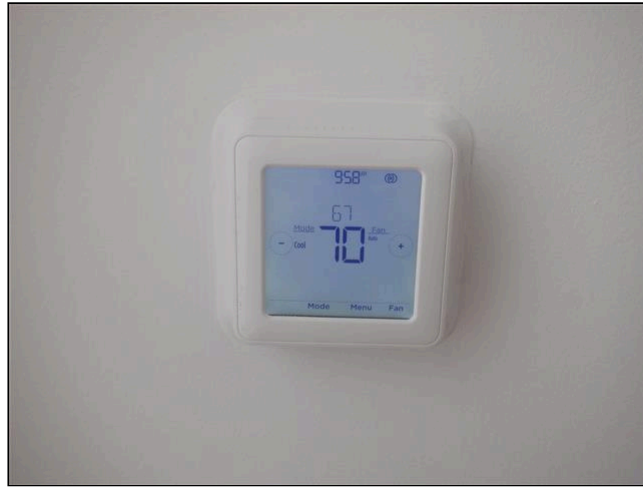
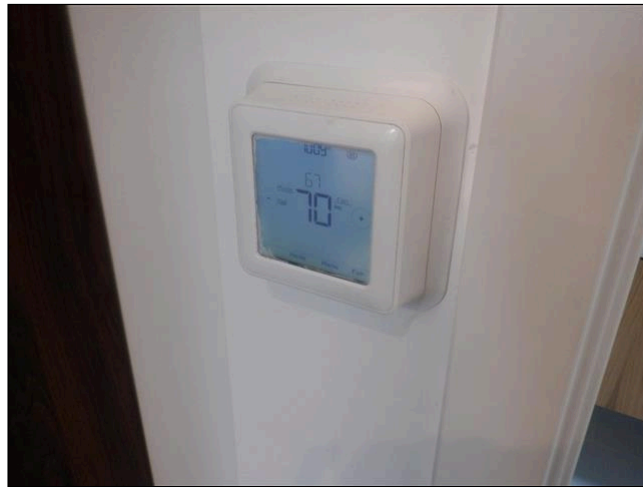
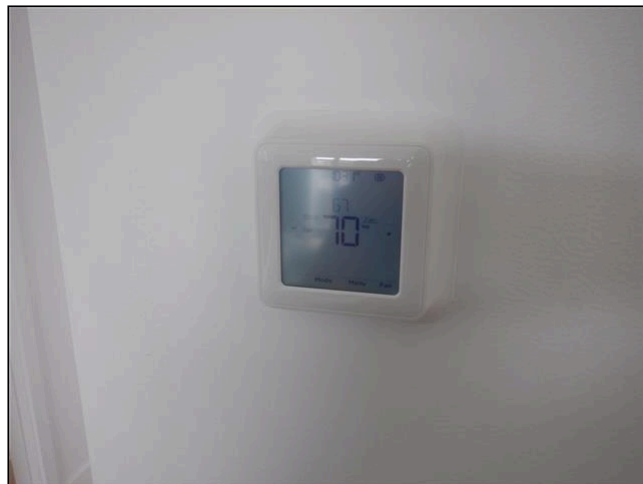
All of the thermostats were operational when used to operate the HVAC systems at the time of the inspection. Programmable thermostats are not adjusted and no testing is done to check the accuracy or programmed settings of the thermostat. If concerned we recommend verifying proper operation of the programmable settings prior to the end of your contingency period by a qualified person.

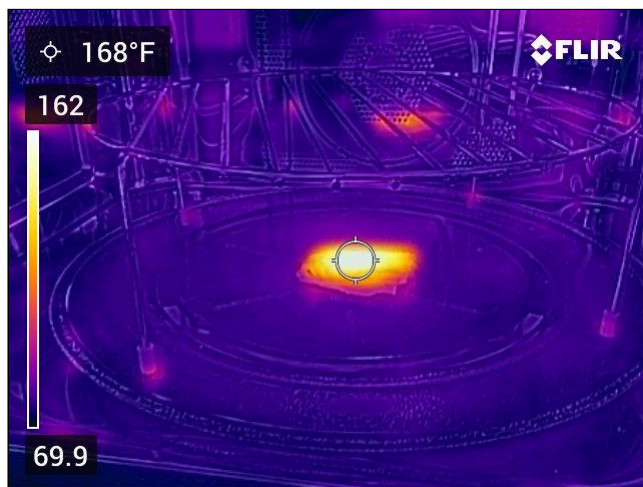
17.0 Item 1(Picture)

The built in microwave was tested with a microwave testing device and was functional at the time of the inspection. This is not an exhaustive test, and does not predict the performance of the microwave.

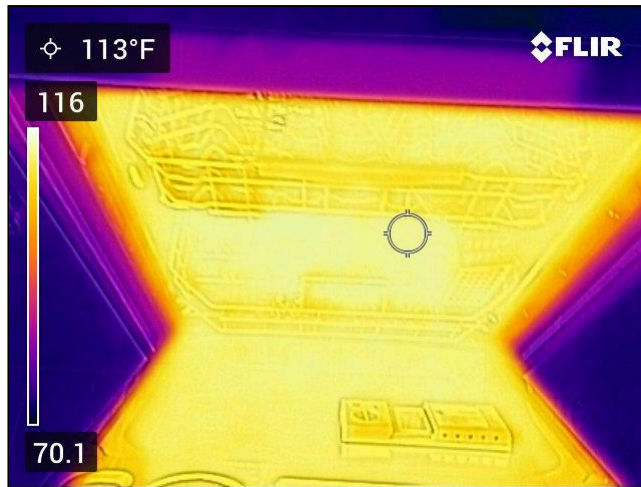
17.1 Item 1(Picture)

The dishwasher was tested and functioned properly at the time of the inspection. This is not an exhaustive test and does not verify the cleaning efficiency of the dishwasher.

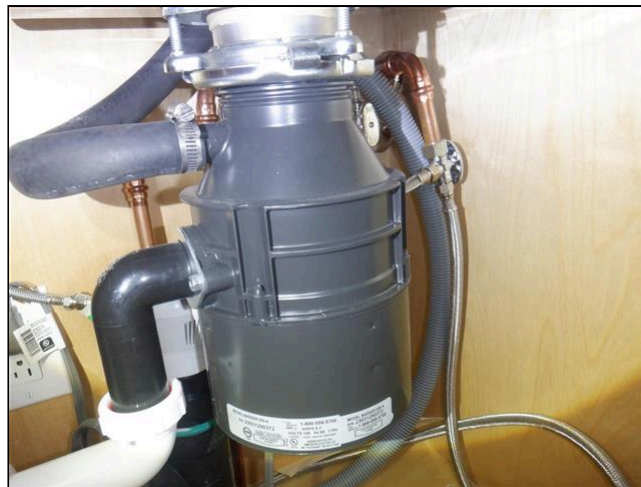
17.2 Item 1(Picture)

(1) The food waste disposer was tested and functioned properly at the time of the inspection. This is not an exhaustive test and does not verify the efficiency of the unit.

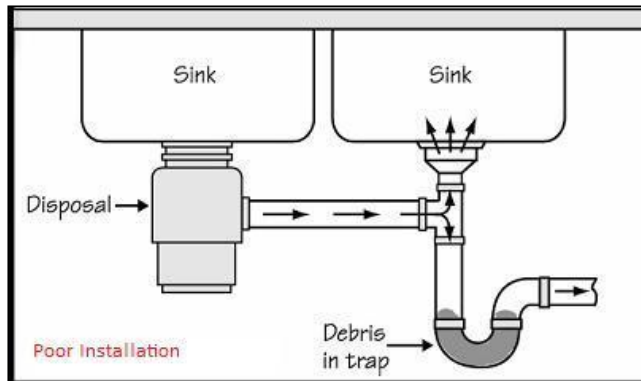
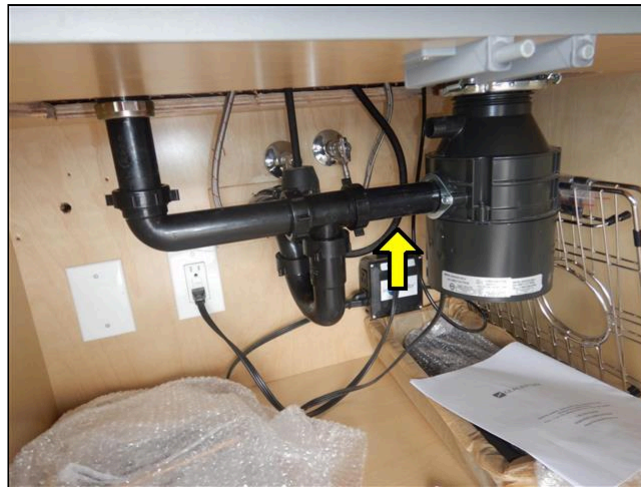
(2) The pool house food waste disposal drain is installed in a non-standard manner. The drain tube exiting the disposer is installed horizontally and intersects the drain line of the other sink basin with a "T" fitting, then down to the P-trap. This can cause waste from the disposer to rise into the opposite sink basin before draining. We recommend necessary corrections by a qualified licensed plumber.

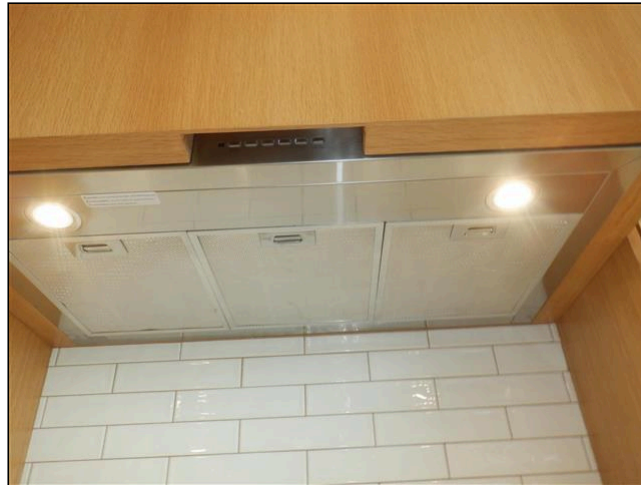
17.3 Item 1(Picture)

(1) The range exhaust vent was tested and was functional at the time of the the inspection. This is not an exhaustive test, and does not evaluate the performance or effectiveness of the unit.

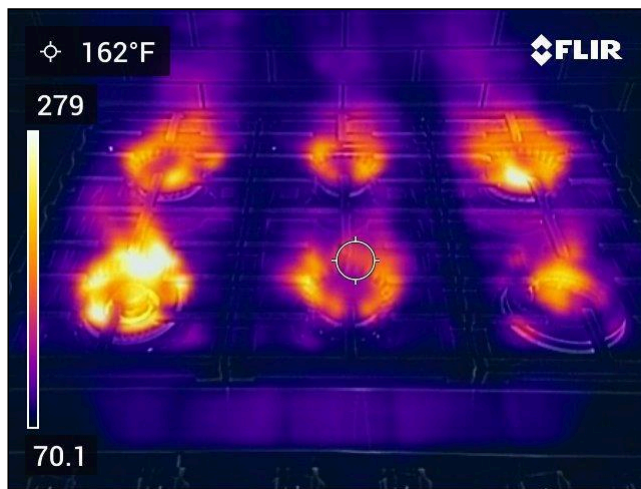
17.4 Item 1(Picture)

The cooktop was tested and was functional at the time of the inspection. This test is not exhaustive and does not confirm the performance, accuracy, or effectiveness of the cooktop.

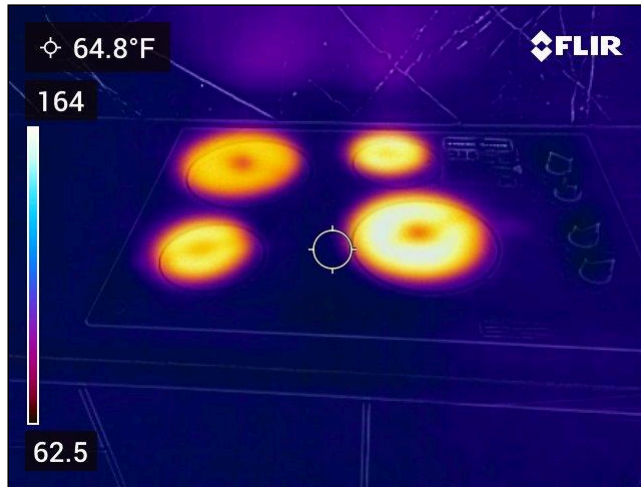
17.4 Item 2(Picture)

(2) The pool house cooktop was tested and was functional at the time of the inspection. This test is not exhaustive and does not confirm the performance, accuracy, or effectiveness of the cooktop.

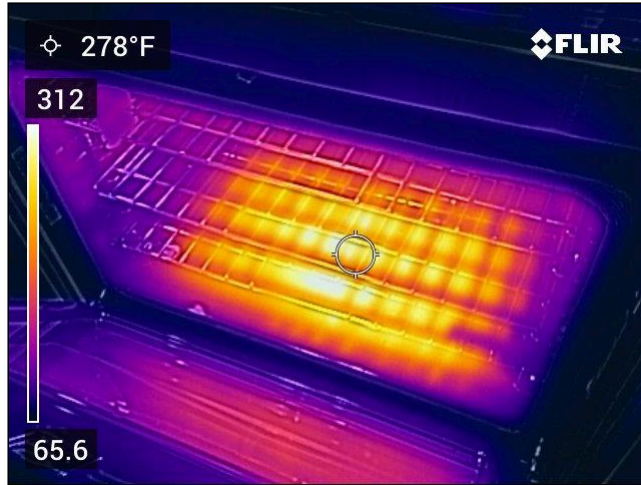
17.5 Item 1(Picture)

The wall oven was tested and was functional at the time of the inspection. This test is not exhaustive and does not confirm the performance, accuracy, or effectiveness of the wall oven.

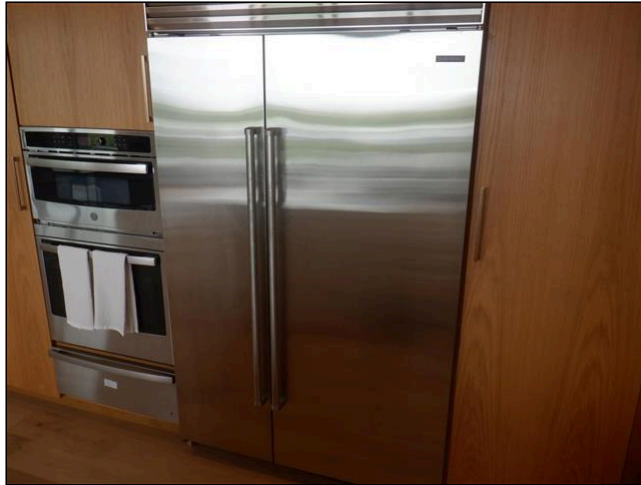
17.6 Item 1(Picture)

(1) Refrigerators built in or not are not part of our general home inspection and are not inspected or commented on. If concerned about its serviceability and functionality we recommend further evaluation by a qualified licensed appliance contractor prior to the end of your contingency period.

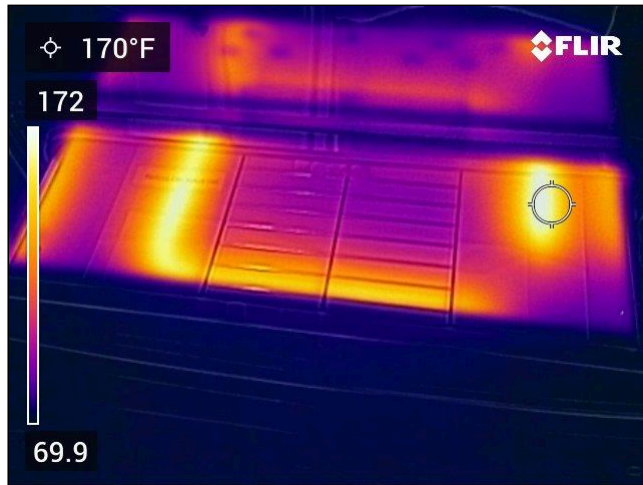
17.7 Item 1(Picture)

The warming drawer functioned when tested at the time of the inspection.

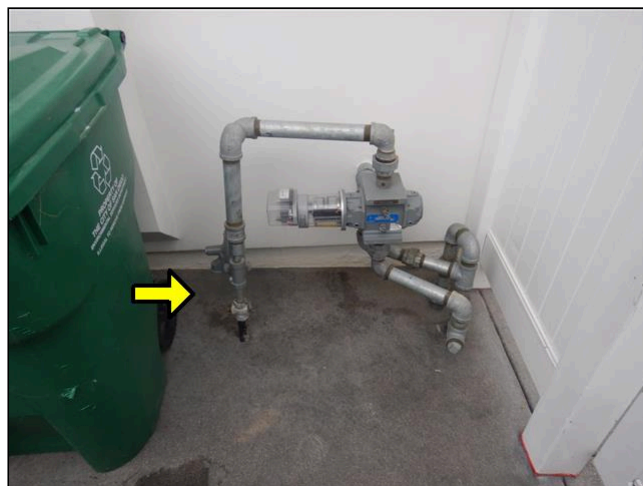
18.0 Item 1(Picture)

The main gas shut off valve is located at the gas meter at the left exterior side of the property (facing front).

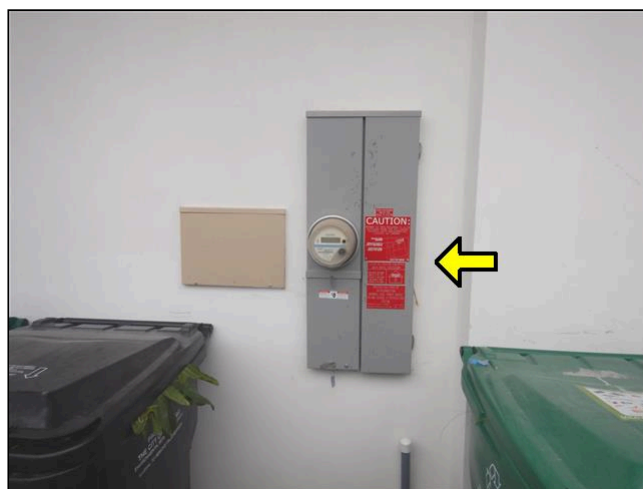
18.1 Item 1(Picture)

The Main Electrical panel is located at the left exterior side of the property (facing front).

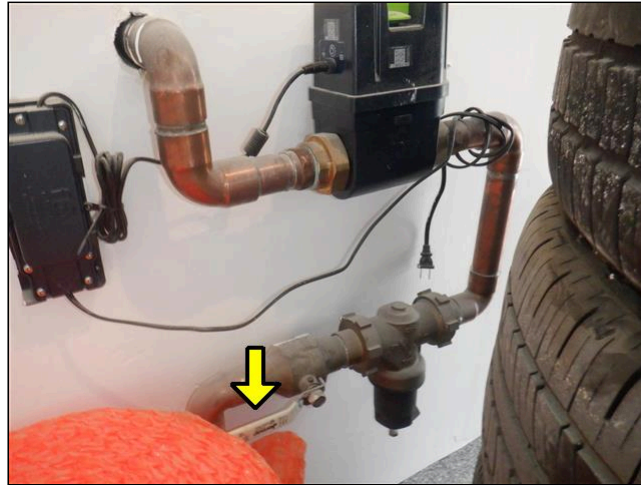
18.2 Item 1(Picture)

The main water shut off valve is located in the garage.

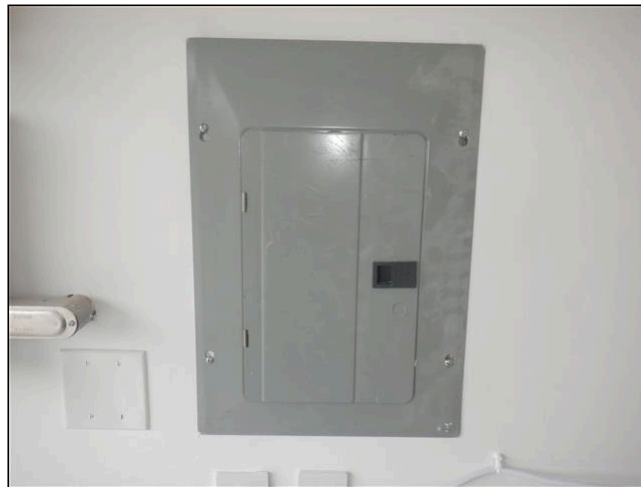
18.3 Item 1(Picture)

The sub-panel is located in the garage.

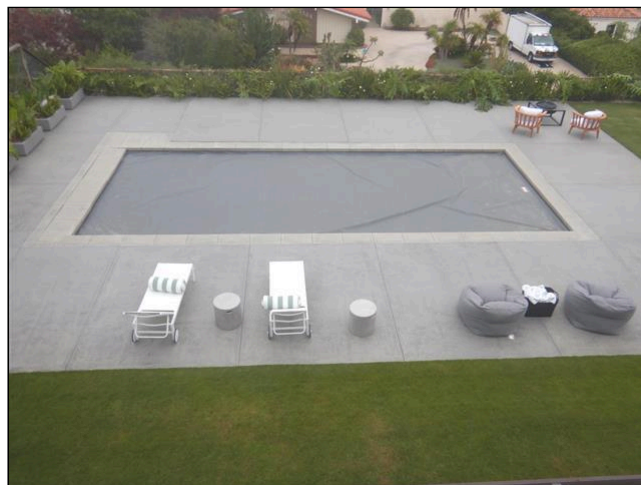
19.0 Item 1(Picture)

(1) Photo of the pool/ spa.
