# Inspection Report

4132 Main Place  
San Diego CA 92037

## **The Property Inspection Pros**

<b>Date:</b> 7/11/2024	<b>Time:</b> 09:00 AM	<b>Report ID:</b>
<b>Property:</b> 4132 Main Place San Diego CA 92037	<b>Customer:</b> Rick Johns	<b>Real Estate Professional:</b>

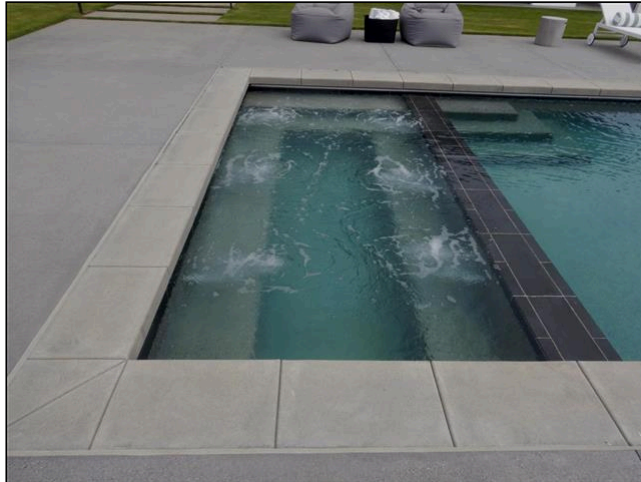
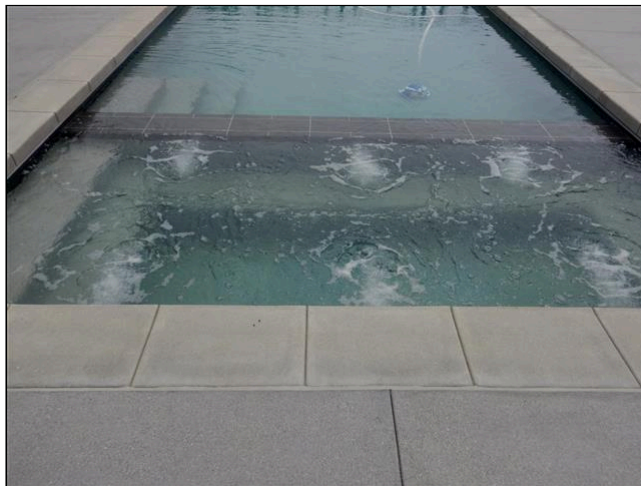
The spa jets functioned when tested.

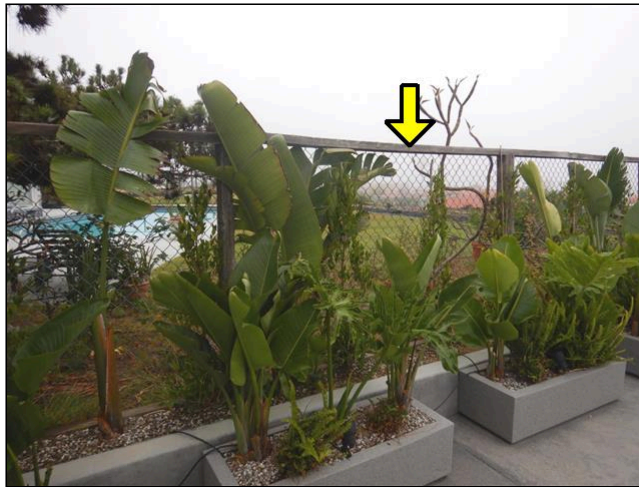
19.2 Item 1(Picture)

(1) The pool safety fencing appeared functional and may have met the standards at the time of installation. The latest safety standards call for the fencing/gates/access points to be more child-proof. These items can include the height of the fence, any openings, and the latch. We recommend upgrading the fencing by a qualified licensed fence contractor for child safety.

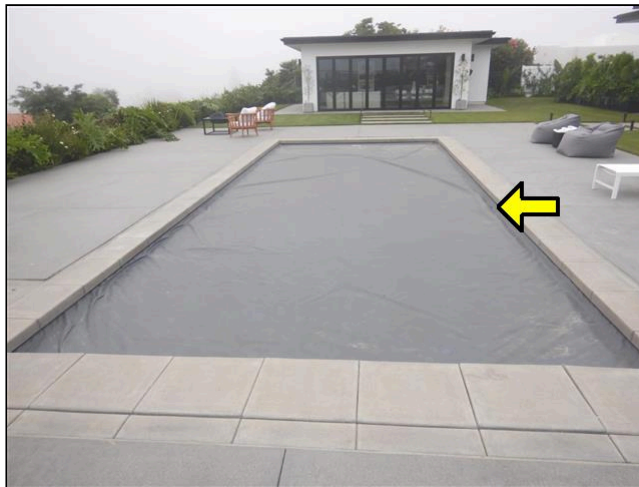
19.2 Item 2(Picture)

(2) The pool cover was operable at the time of the inspection. Our inspection is limited to the operation only. Please refer to the manufacturer's instructions and guidelines on proper use and limitations.

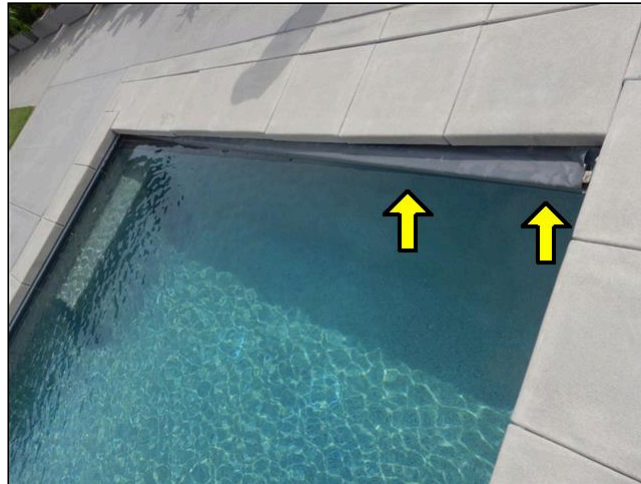
19.2 Item 3(Picture)

(3) The pool cover did not retract evenly. We recommend necessary repairs by a licensed pool contractor.

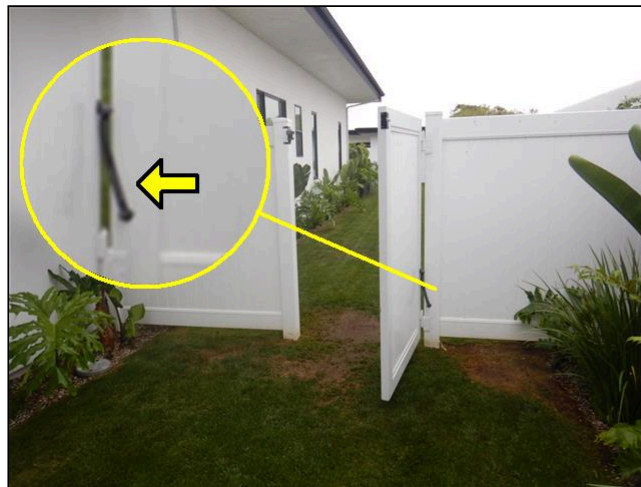
19.2 Item 4(Picture)

(5) The self-closing device at the right side pool gate does not close the gate adequately. Gates providing access to the pool area must self close and latch without assistance. This is a safety concern. We recommend necessary repairs by a qualified person.

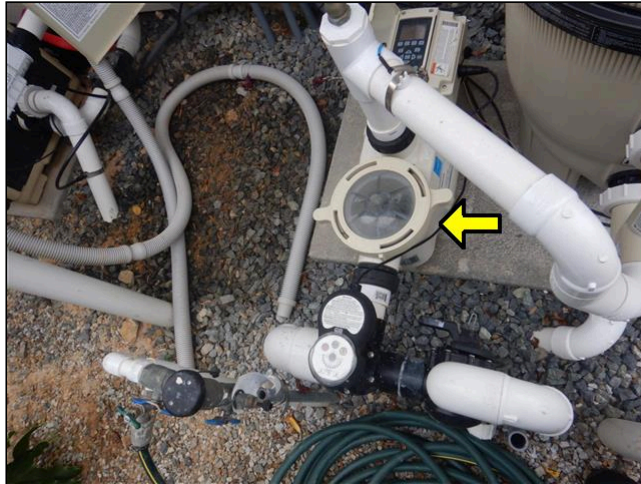
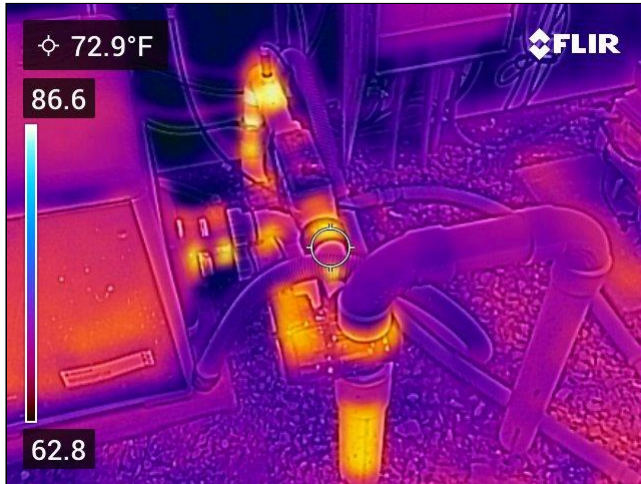
The pool/spa pump(s) were tested and were found to be operational at the time of the

inspection. Pumps are not evaluated for capacity, efficiency, flow rate or pressure.

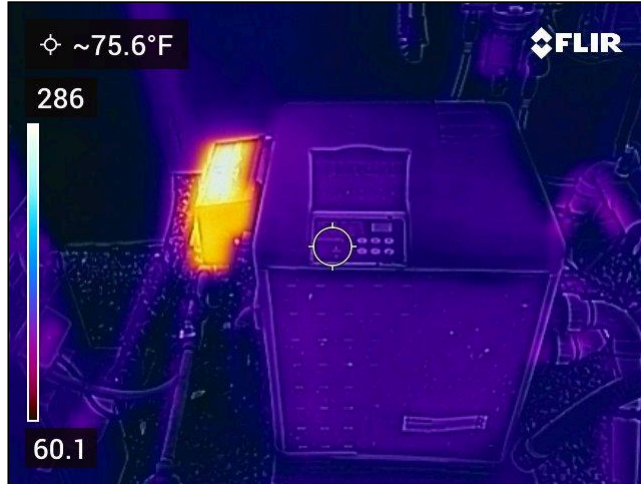
19.6 Item 1(Picture)

Infrared Thermal photo of the pool/ spa furnace being tested.

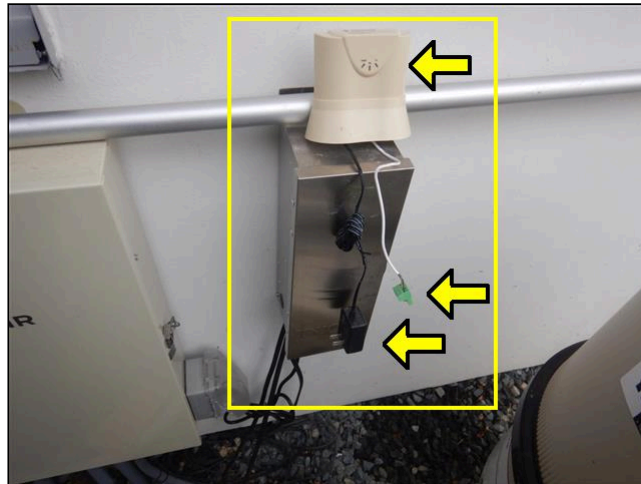
19.7 Item 1(Picture)

The Pentair screenlogic interface wireless link is not installed at the pool equipment. We recommend further evaluation and necessary corrections by a licensed pool contractor.

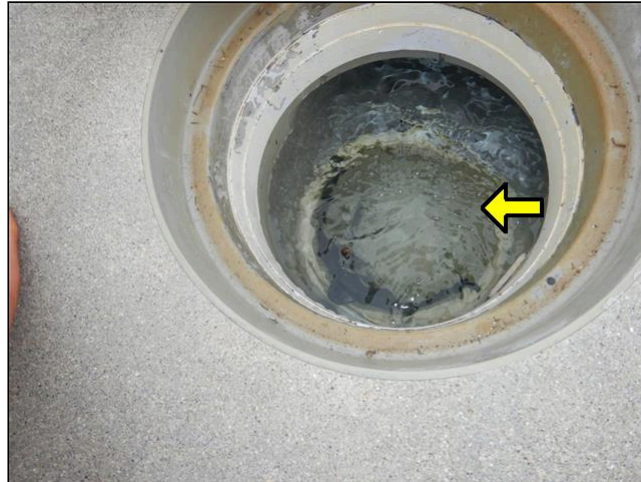
19.9 Item 1(Picture)

The skimmer basket is present.

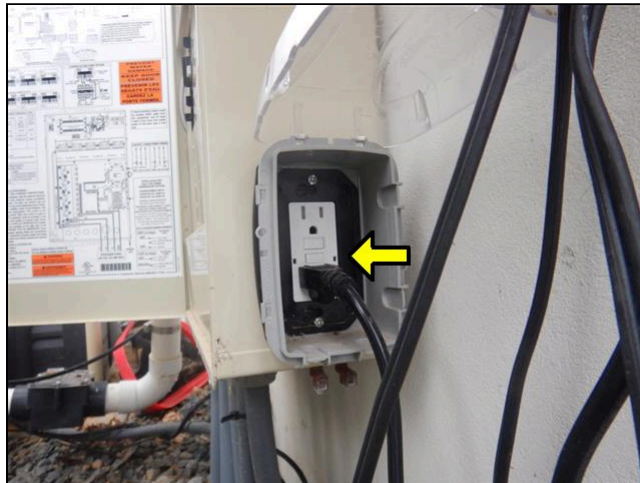
19.10 Item 1(Picture)

The GFCI outlet was tested and was found to be operable at the time of the inspection.

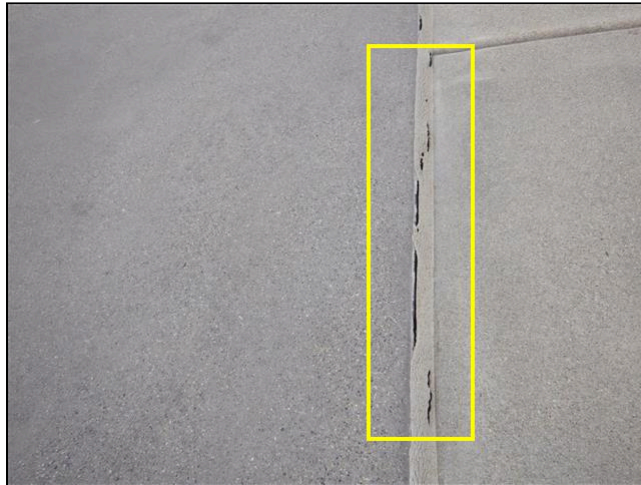
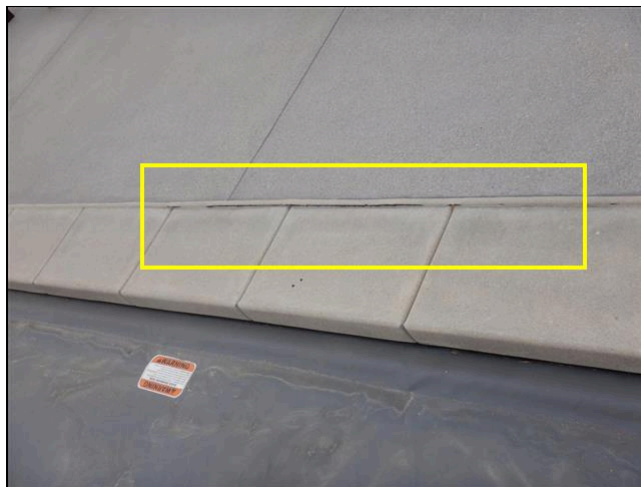
(1) The elastomeric compound (Deck-O-Seal) between the pool deck and coping is cracked/ missing in several areas. We recommend re sealing between the pool deck and coping as needed by a qualified pool contractor.

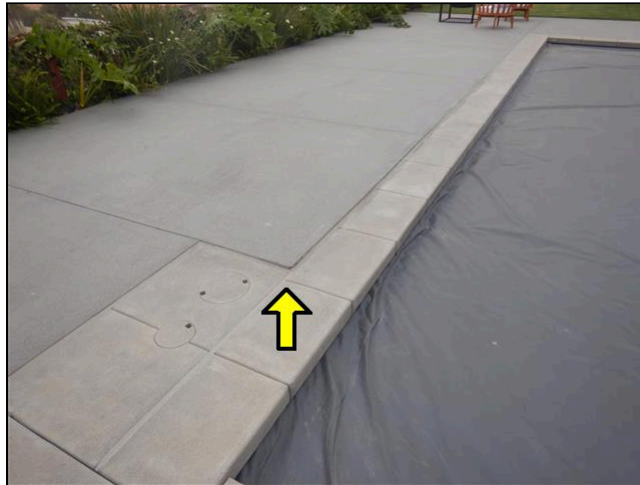
19.11 Item 3(Picture)

(2) Sections of the deck are uneven. This can pose a tripping hazard and may also indicate that soil settlement or root encroachment occurred. We recommend necessary repairs by a qualified licensed concrete contractor.

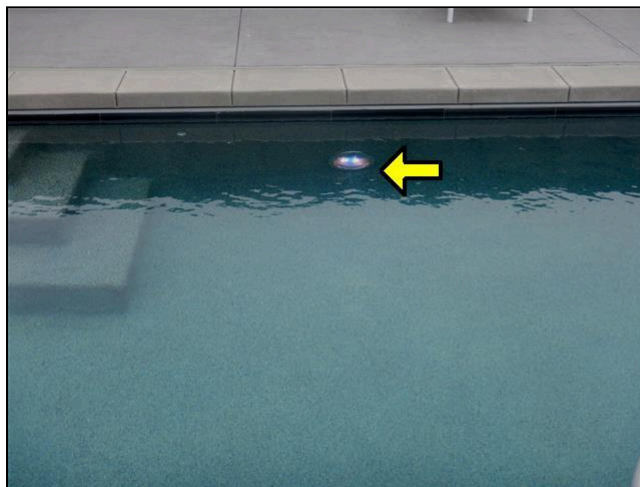
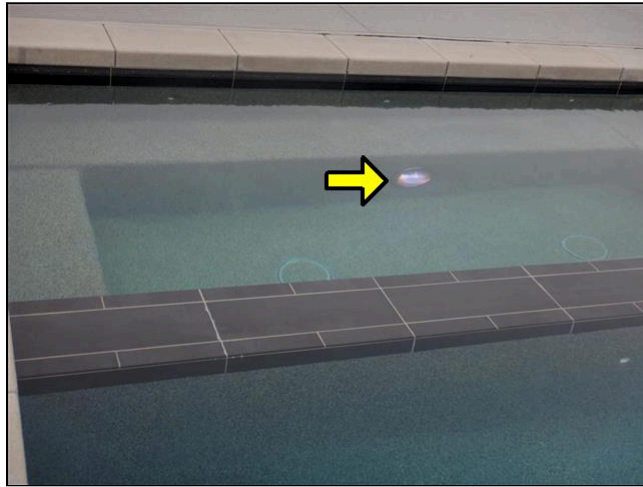
(1) The pool/ spa light(s) operated when tested.

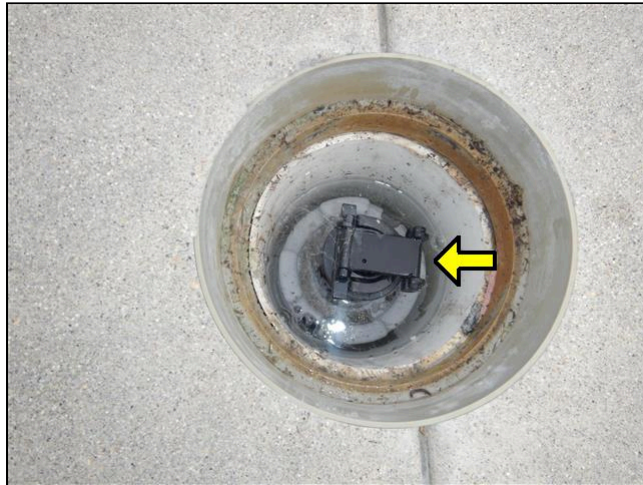
19.14 Item 1(Picture)

The pool fill device was tested and was operational at the time of the inspection.

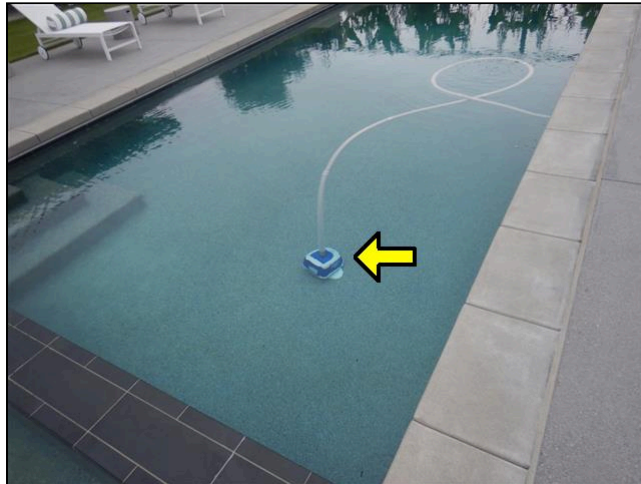
19.16 Item 1(Picture)

The pool sweep functioned at the time of the inspection. This is not an exhaustive test and does not verify the cleaning efficiency of the unit.

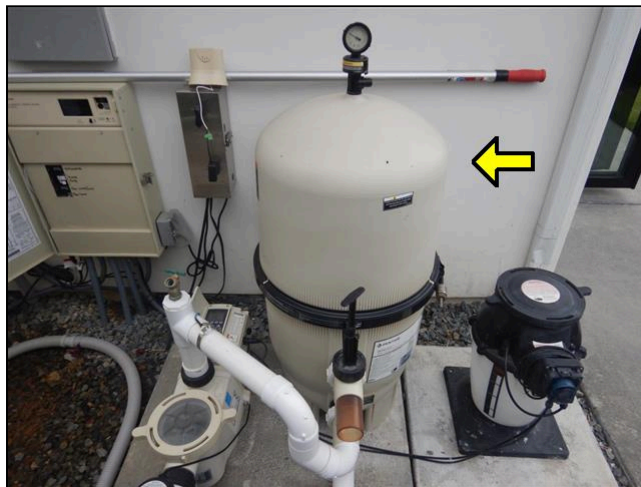
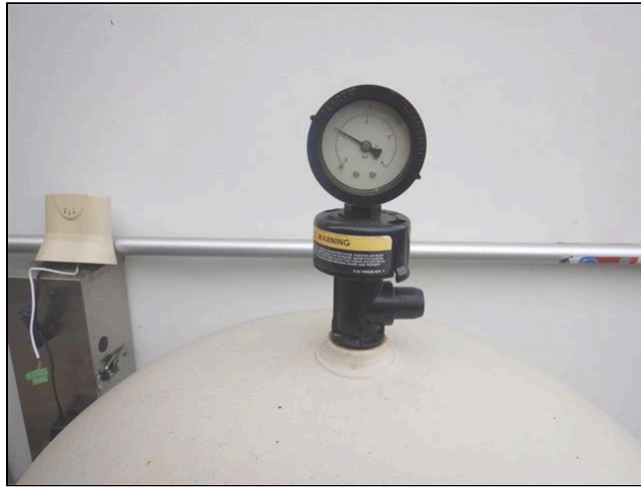
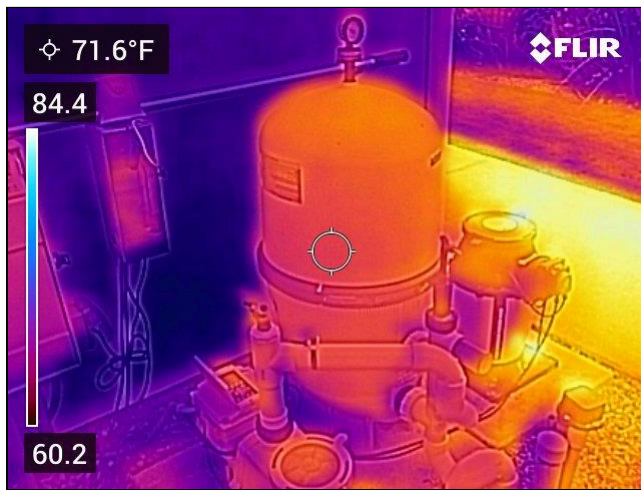
The filter appeared to be functional at the time of the inspection. This is not an exhaustive test and does not verify the cleaning efficiency of the unit.

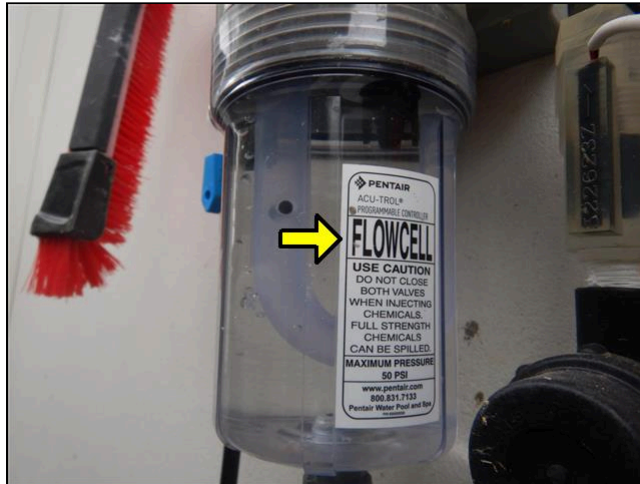
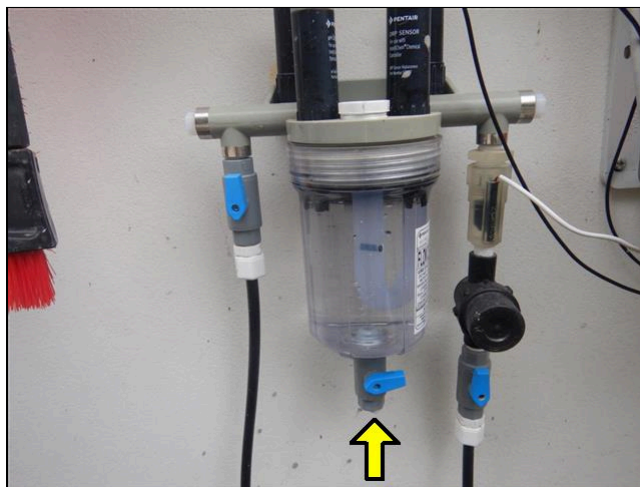
An active leak is observed at the flow cell. We recommend necessary repairs or replacement by a licensed pool contractor.

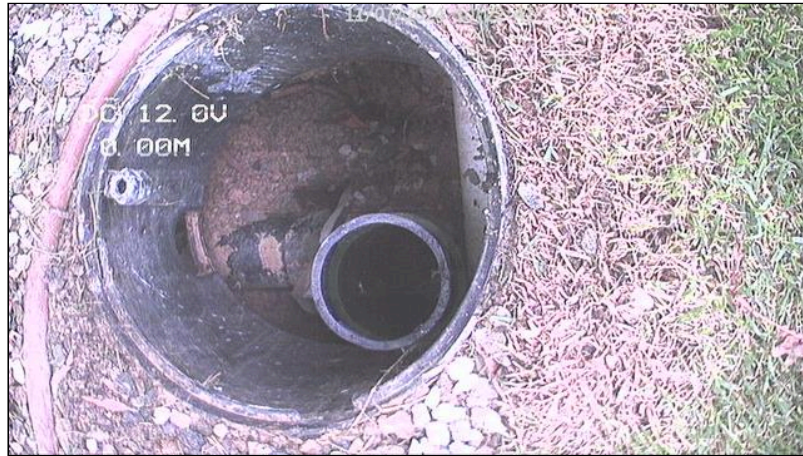
20.3 Item 1(Picture)

The main sewer line was inspected by inserting the camera at the sewer line clean out at the right side of the property.

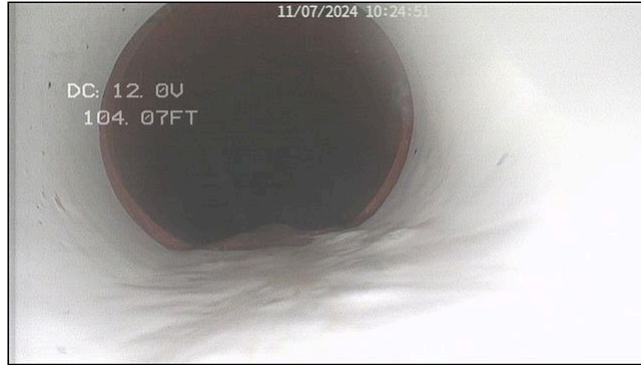
20.4 Item 1(Picture)

(1) The observable main sewer pipe inspected appears to be functioning as intended at the time of the inspection and no conditions requiring repairs were observed. We recommend necessary ongoing maintenance by a licensed plumber.

(2) The camera could not travel beyond 105 feet from the access point in the main sewer pipe due to the length of the pipe and/or multiple turns in the pipe. The remaining length of the pipe and the connection to the street sewer main line could not be evaluated.
