# Inspection Report

**Property Address:**  
123 Main Street  
San Diego CA 92129

**The Property Inspection Pros**

<b>Date:</b> 11/23/2024	<b>Time:</b> 09:00 AM	<b>Report ID:</b>
<b>Property:</b> 123 Main Street San Diego CA 92129	<b>Customer:</b> Jon Smith	<b>Real Estate Professional:</b>

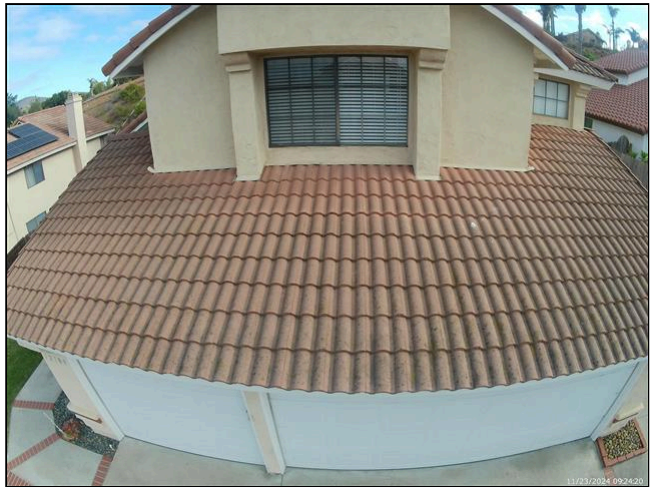
1.1 Item 1(Picture)

**Comments:**  
 (1) **Photo(s) of the roof.**

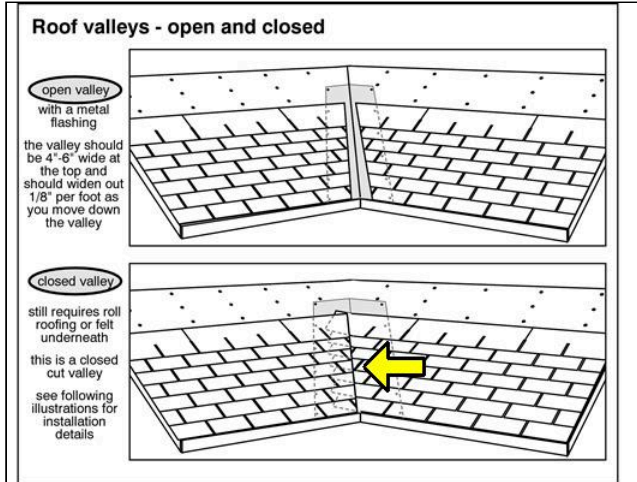
1.1 Item 5(Picture)

(5) The roof tiles were installed too close together at the valleys. This is called a closed valley. This method of having closed valleys was acceptable at the time of construction but is no longer recommended to today's standards. Debris could collect and become lodged in the valleys and create a damming effect causing leaks to occur. We recommend having the tiles cut away from the valleys to allow water to flow properly off of the roof. We recommend that a licensed roof contractor evaluate the roof to provide a quotation prior to the end of your contingency period.

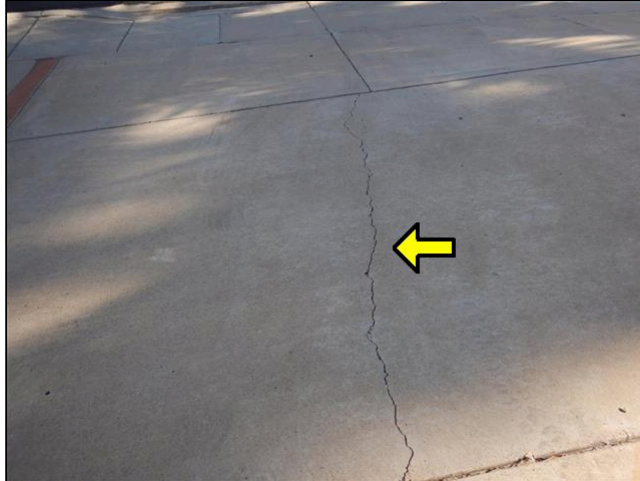
2.8 Item 1(Picture)

(1) There are several cracks in the concrete driveway. We recommend necessary repairs where needed by a licensed concrete contractor.

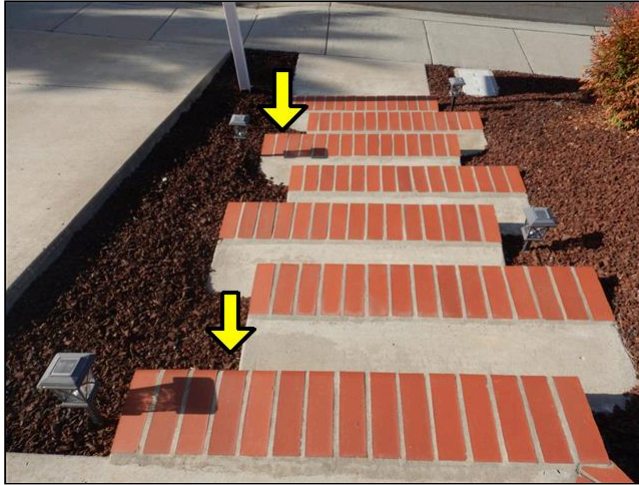
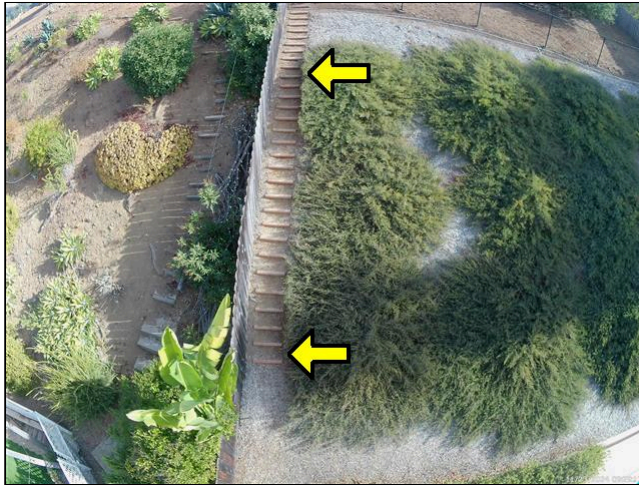
is required at least one side of the stairs when four or more steps are present. This is a safety hazard and corrections are needed. We recommend installing a handrail for safety by a qualified licensed contractor.

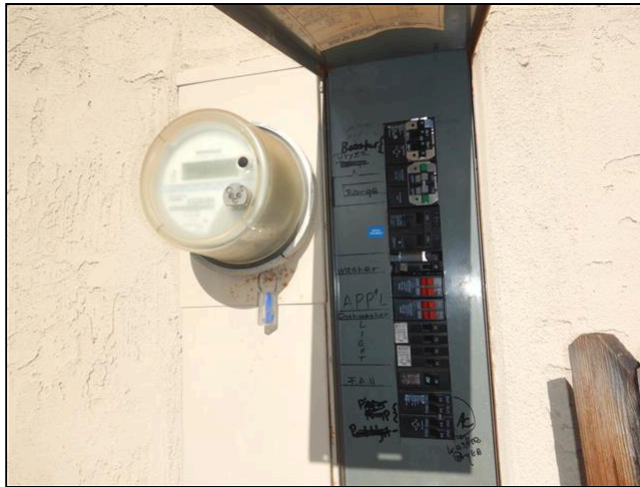
3.0 Item 1(Picture)

- (1) [Photo of the main electrical panel.](#)

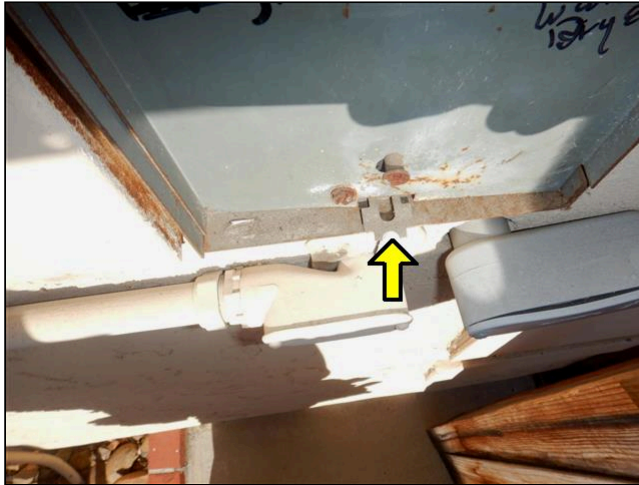
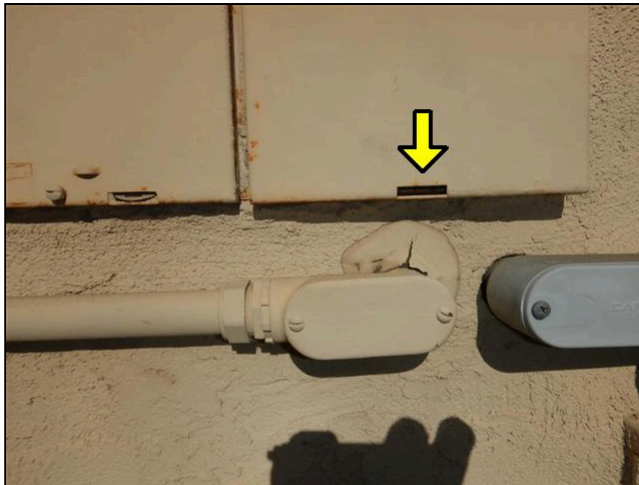
- (2) The main panel breakers are illegible or confusing. We recommend having the breakers properly labeled for safety by a qualified person.
- (3) The main panel locking tab is missing/ damaged. We recommend necessary repairs or replacement by a qualified licensed electrician.

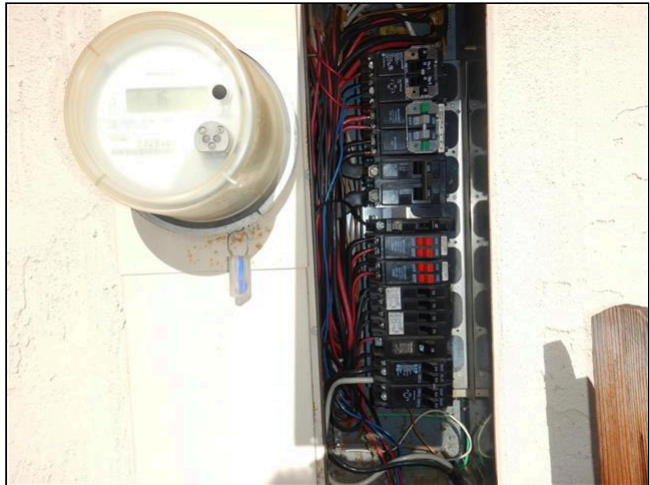
3.1 Item 1(Picture)

(1) [Photo inside of the main electrical panel.](#)

The dead front cover was removed at the time of the inspection and the breakers, wiring and grounding were inspected. Appears to be functioning as intended.

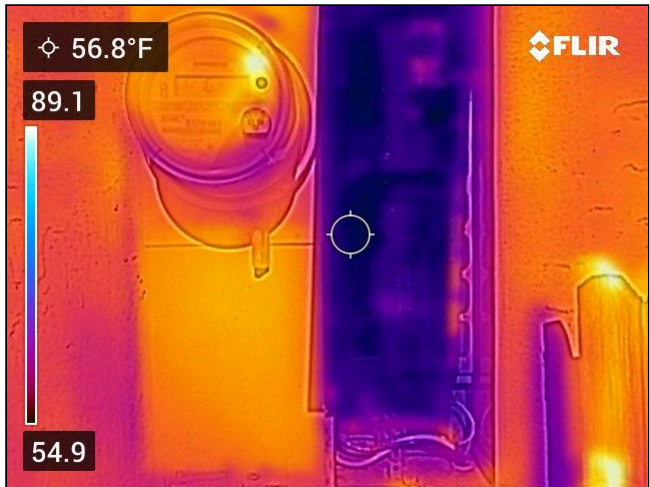
3.1 Item 2(Picture)

(2) Breakers were observed in the main panel which are from a manufacturer that is different than the panel manufacture. Most panel manufacturers require like-kind breakers to be installed from the same manufacture. Having breakers from another manufacturer could void the UL listing. We recommend further evaluation by a qualified licensed electrician and necessary corrections as needed.

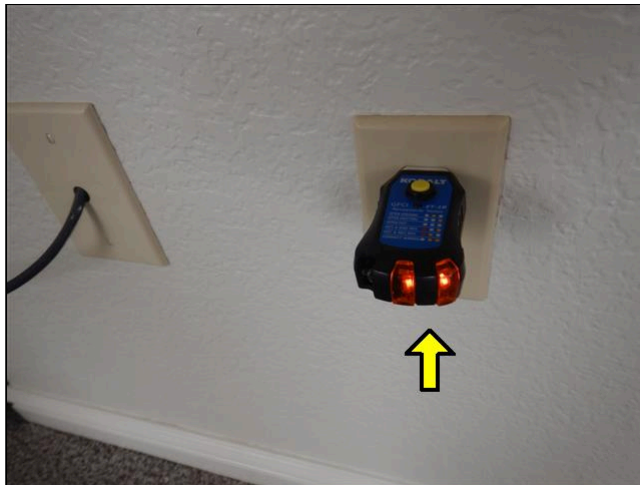
3.6 Item 1(Picture)

(1) [Photo of a receptacle being tested.](#)

A representative number of receptacles throughout the property were tested for power, polarity and grounding according to our standards-of-practice. These receptacles observed to be ok at the time of the inspection unless otherwise noted.

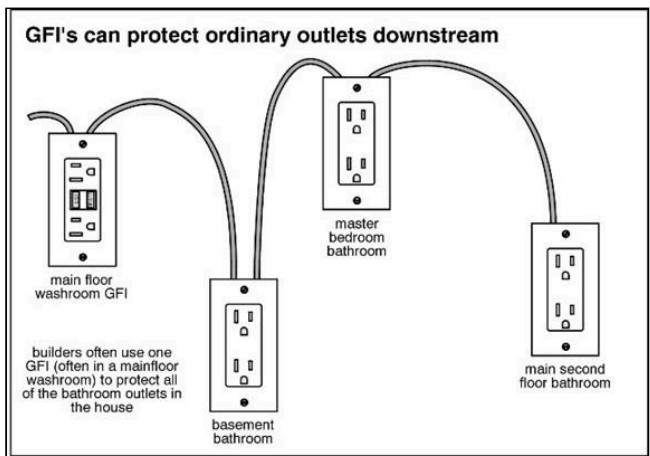
3.9 Item 1(Picture)

(1) All accessible GFCI receptacles were tested and were functioning properly at the time of the inspection unless otherwise reported. Sometimes a tripped GFCI receptacle may be difficult to find. If you do not have power at certain receptacles please check all GFCI's and reset the tripped GFCI receptacle. If the GFCI doesn't reset than replacement of the GFCI receptacle will be required.

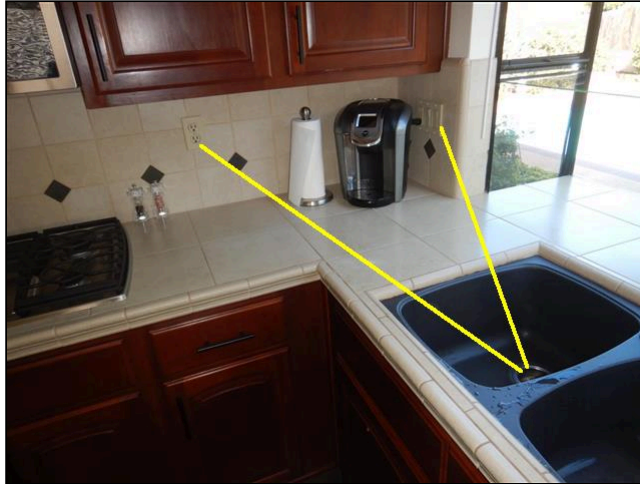
3.9 Item 2(Picture)

non-fixed appliance receptacles in the kitchen to GFCI protected receptacles by a qualified licensed electrician for safety.

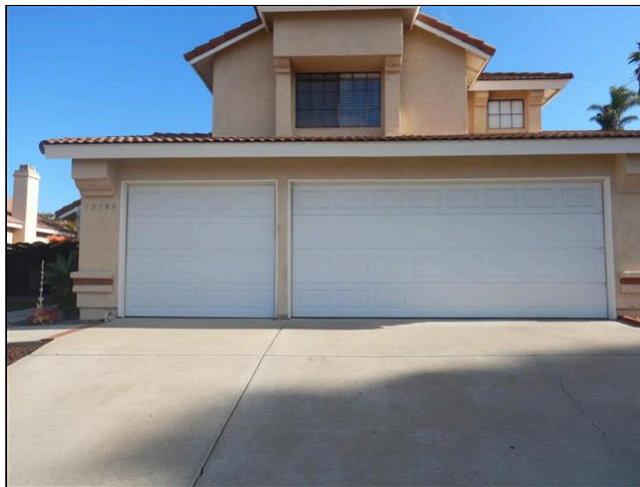
4.0 Item 1(Picture)

**Garage door(s) photo.**

The garage vehicle door hardware including the doors, tracks, and springs appear to be functioning as intended.

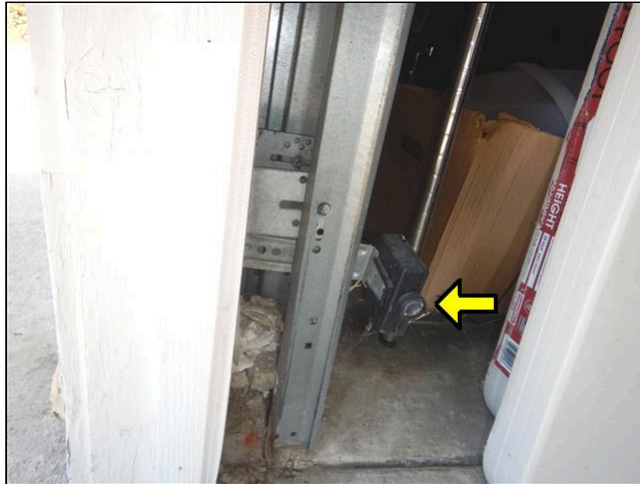
4.1 Item 3(Picture)

(7) The safety reverse photo-eyes are mounted at an incorrect height from the ground. Most manufacturers recommend mounting these devices at about 4"-6" from the ground for safety. We recommend necessary corrections by a qualified licensed garage door contractor.

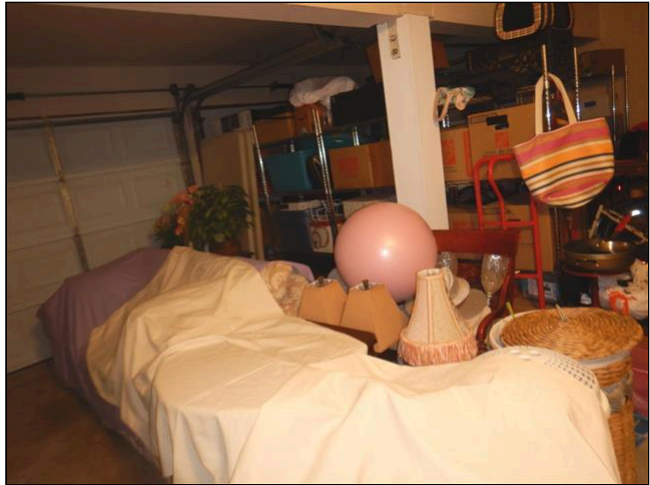
4.3 Item 1(Picture)

accessible at the time of the inspection. Several windows, doors, outlets, walls, flooring, and other areas were obstructed from view and could not be inspected. The home inspector does not move personal items, panels, furniture, equipment, plant life, soil, debris, ect. that obstructs their access or visibility. We recommend that you conduct a careful evaluation during your final walk-through or prior to the end of your contingency period to ensure that there are no hidden defects. All doors, windows, and outlets should be tested and verified for proper operation prior to the end of your contingency period by a qualified person. If any damage is observed we recommend asking the seller about it. We recommend that any damage found be repaired or replaced by a qualified licensed contractor in the appropriate trade.

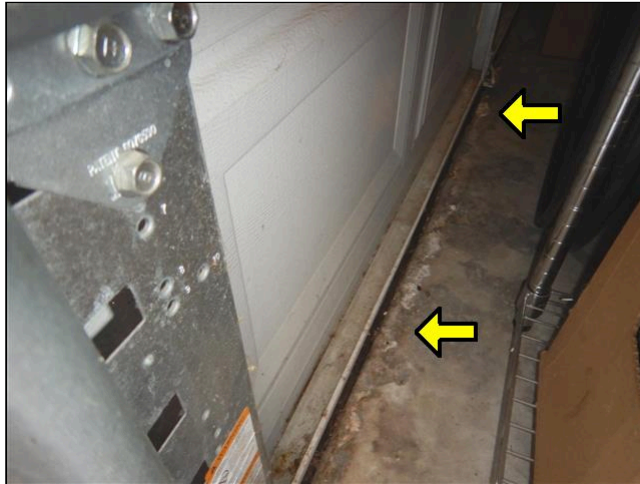
4.4 Item 1(Picture)

(2) The garage slab is deteriorated/ pitted in several areas. We recommend necessary repairs by a qualified licensed foundation contractor.

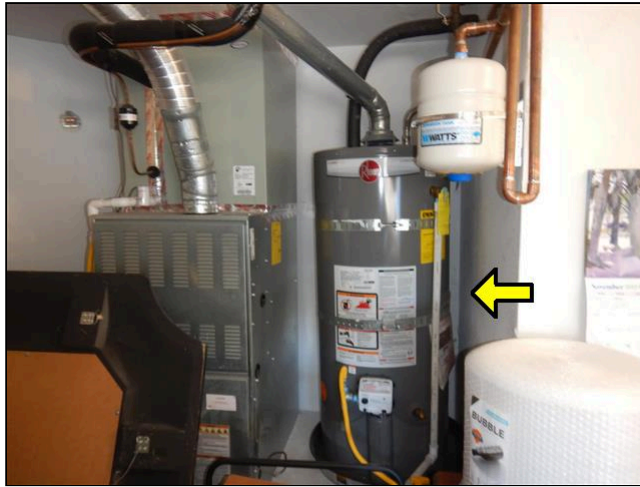
5.0 Item 1(Picture)

- (1) [Photo of the water heater.](#)

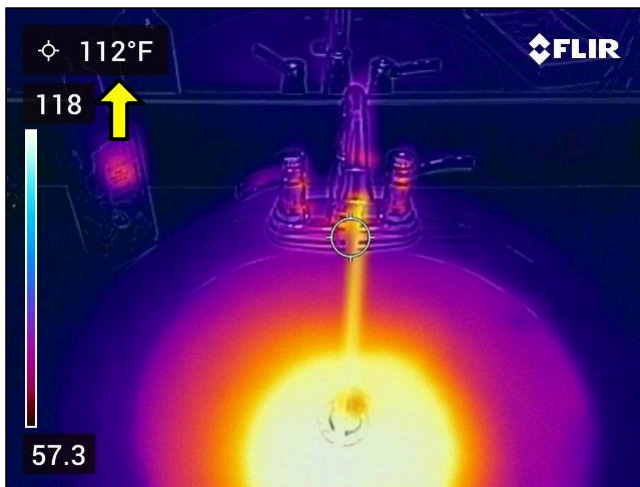
5.0 Item 2(Picture)

(3) **Thermal Photo of the water temperature.**

The temperature of the water was tested using a thermal camera during the inspection and was found to be operating within normal range.

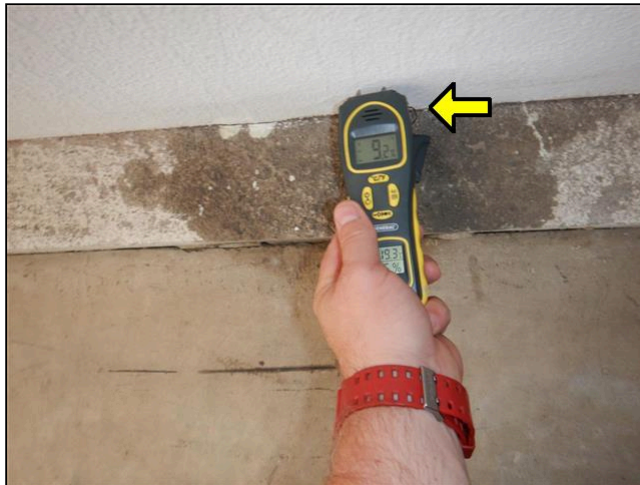
6.0 Item 1(Picture)

(1) A representative sampling for moisture was preformed at accessible interior walls using a moisture meter. (*areas prone to moisture, such as kitchens, bathrooms, below grade walls, exterior walls with doors/windows*). An elevated moisture was not detected at the time of the inspection.

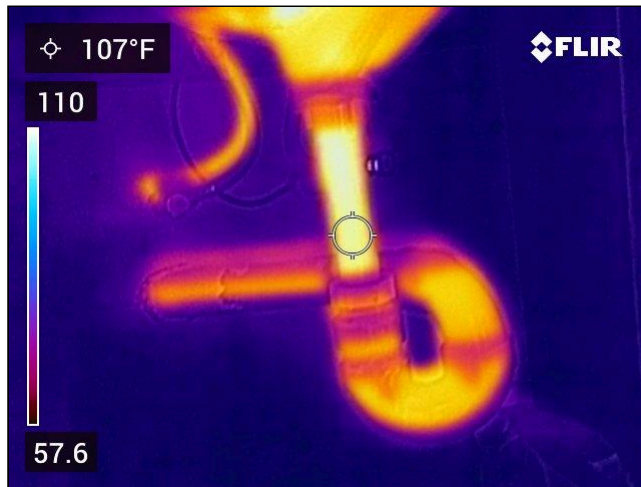
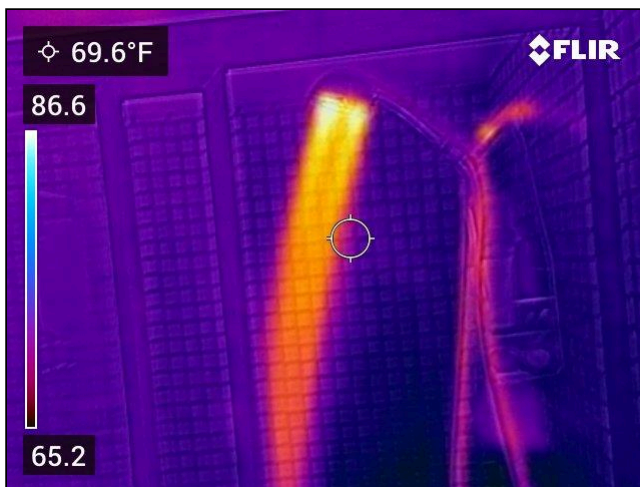
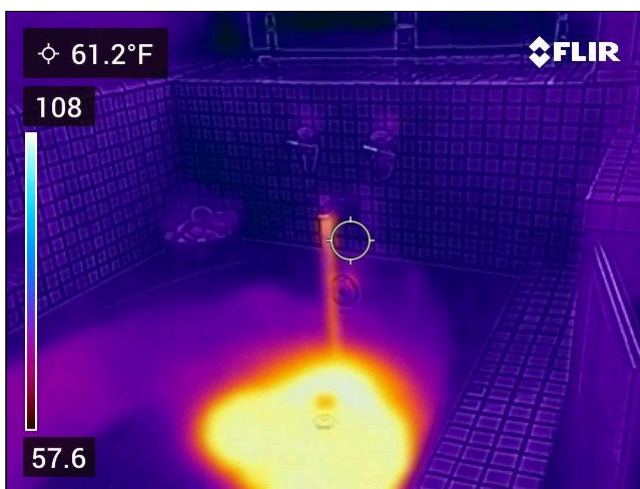
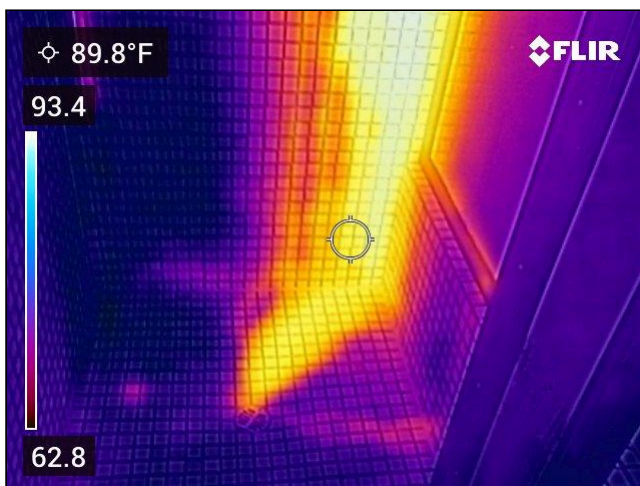
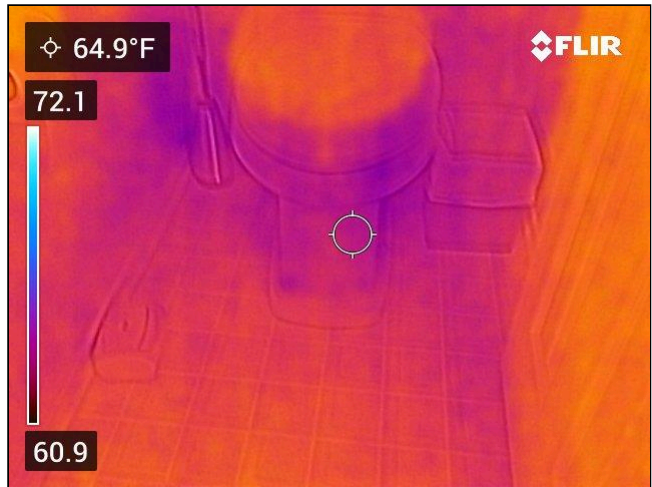
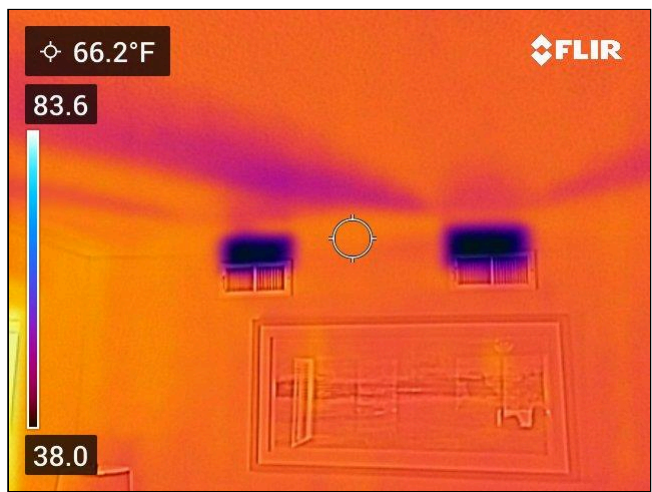
(1) [Infrared Camera Thermal Photos.](#)

(2) An infrared (thermal imaging) scan was performed throughout the property at the time of the inspection using a hand held infrared (thermal imaging) inspection camera. No anomalies were found at the time of the inspection using this camera.

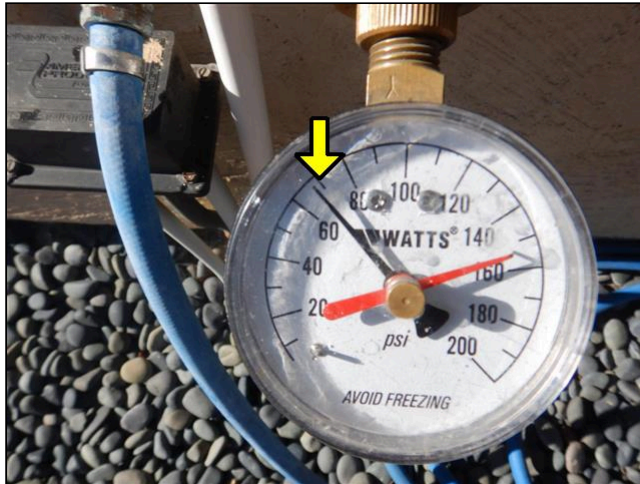
7.2 Item 1(Picture)

The water pressure was checked with a water pressure gauge and was measured and was found to be within the acceptable range at the time of the inspection.

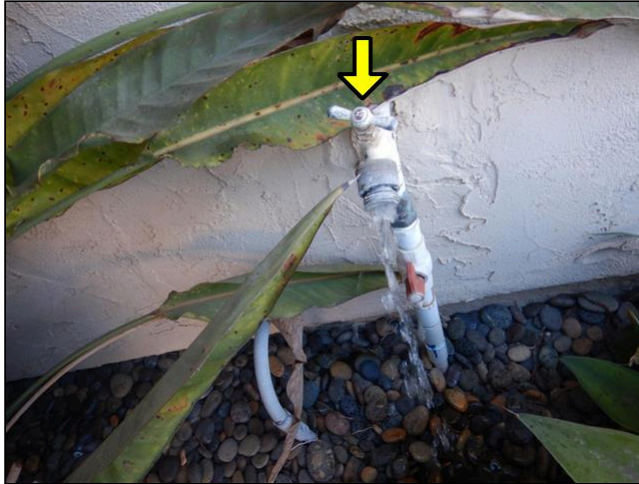
7.3 Item 2(Picture)

(2) The front hose spigot handle leaks when turned on. We recommend necessary repairs or replacement by a qualified licensed plumber.

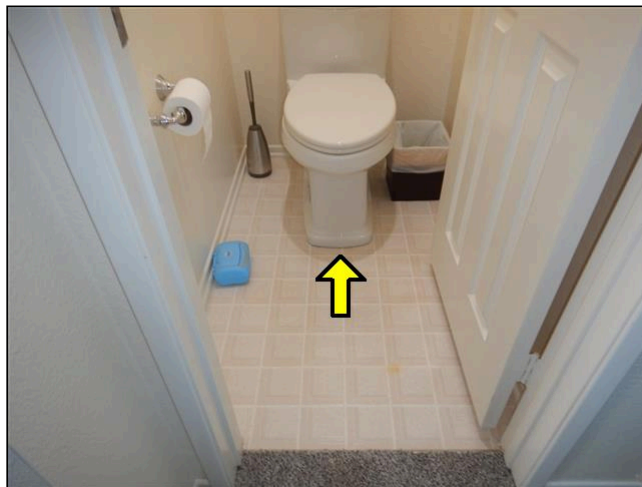
8.1.B Item 1(Picture)

The bathroom toilet is loose on the wood sub floor. This condition could cause damage to the wax ring, leaks, and damage to the wood sub floor. There could be damage to the wood sub floor which is not visible. We highly recommend further evaluation by a qualified licensed plumber or qualified licensed contractor prior to the end of your contingency period and necessary repairs made as needed.

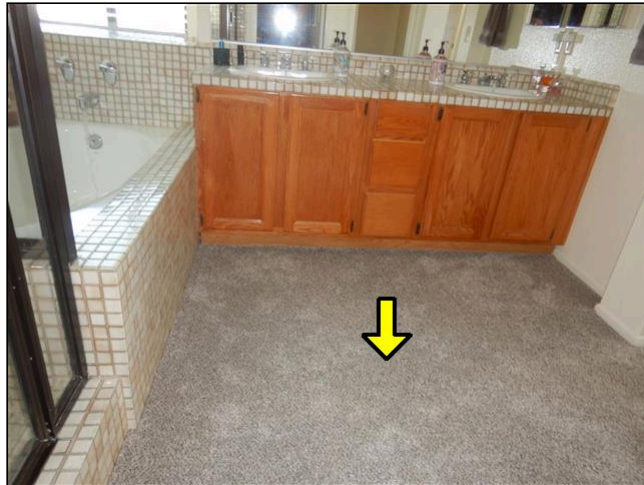
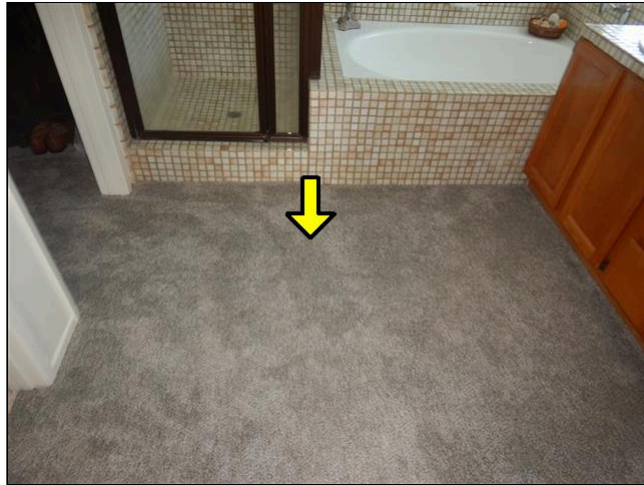
Carpets installed in bathrooms can trap moisture and urine, substances that can cause structural damage and health problems. Since this condition is conducive to mold growth, we advise removal of carpet from bathroom(s).

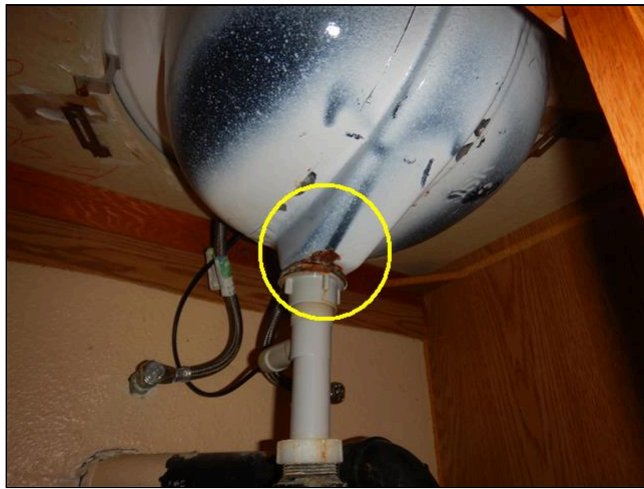
8.0.C Item 1(Picture)

The metal portions of the sink / drain are rusted or corroded. A leak was not observed at this sink drain pipe at the time of the inspection. However, we recommend replacing this drain pipe by a qualified licensed plumber to help prevent future leaks or damage.

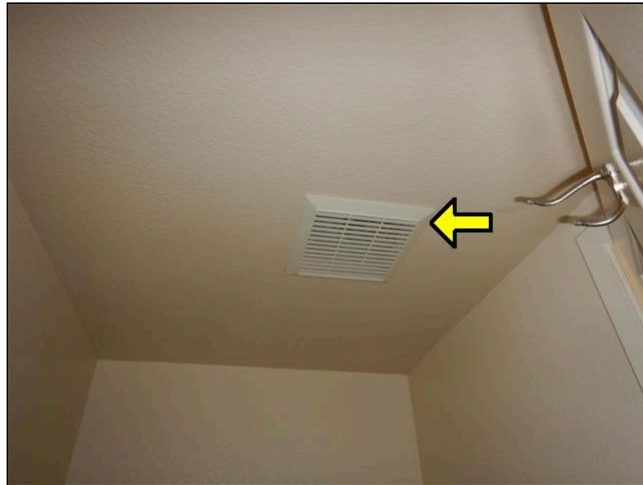
8.1.C Item 1(Picture)

The exhaust makes excessive noise during operation. This typically indicates that the unit is at or near the end of its service life. We recommend replacement by a qualified licensed contractor.

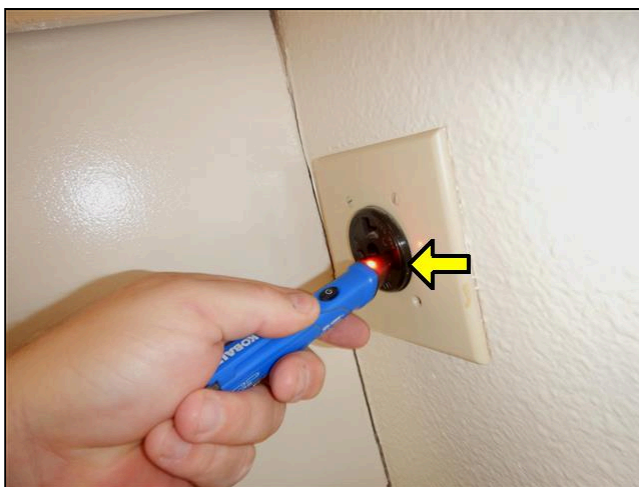
9.0 Item 1(Picture)

(1) There is a three prong 220 volt receptacle installed for the dryer. Most new electric dryers require a four prong receptacle. If you install an electric dryer, you may need to upgrade the receptacle or the dryer power cord. We recommend necessary corrections by a qualified licensed electrician.

(2) The 220V outlet in the laundry area functioned when tested at the time of the inspection.

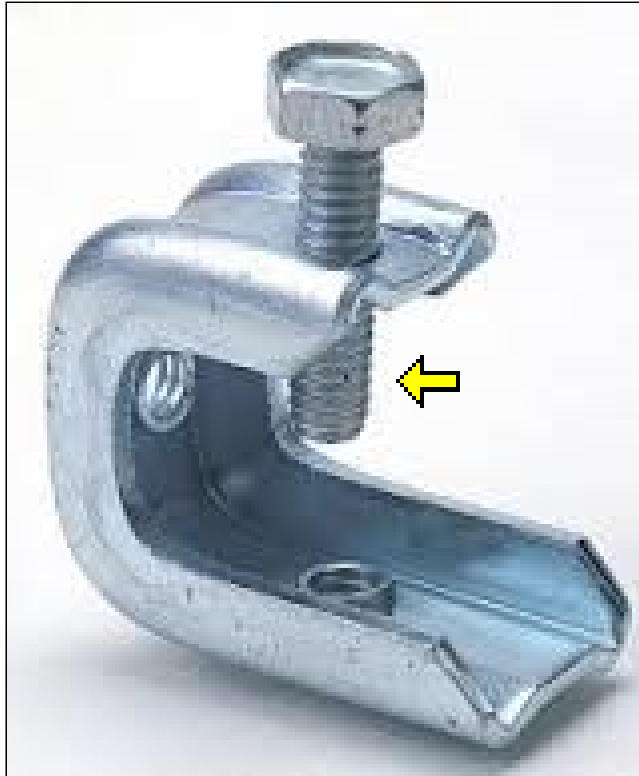
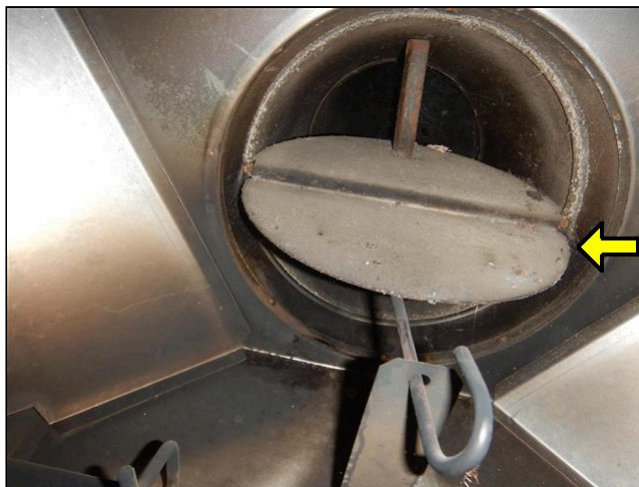
A damper clamp is not installed at the family room fireplace damper door. A damper clamp is required to be installed at a damper door when there is a gas supply to the fireplace(s). This damper clamp help prevents the damper from closing all the way as a safety precaution. If the damper is closed, Carbon Monoxide gas could enter the living space easier which is undetectable. SDG&E now requires damper clamps at all fireplaces damper doors. We recommend installation of a damper clamp by a qualified person.

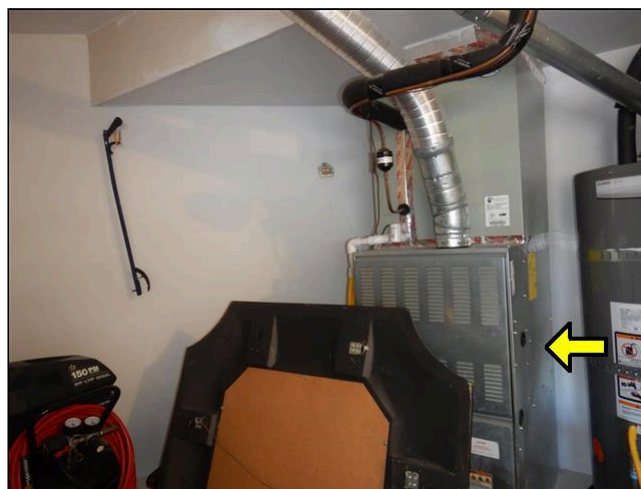
12.0 Item 1(Picture)

(1) The furnace was tested and was functional/ operated at the time of the inspection.

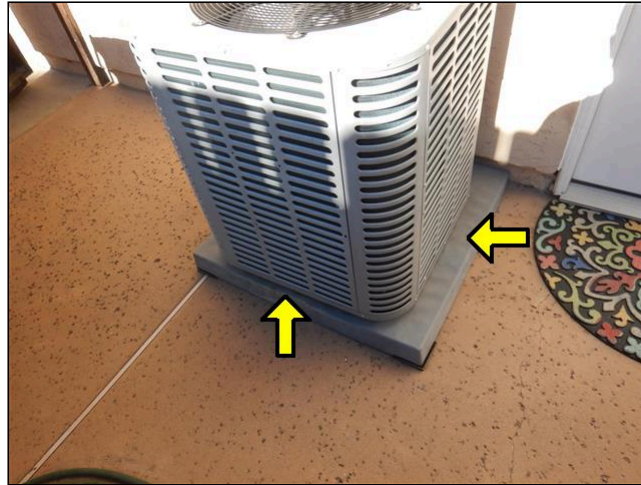
13.0 Item 4(Picture)

(3) The condensers are not strapped to pad(s). Most manufacturers installation instructions require strapping condensers to the pads. Movement of the units due to internal vibration (or earthquake) can damage the refrigerant lines and their connections. We recommend necessary repairs a licensed HVAC contractor.

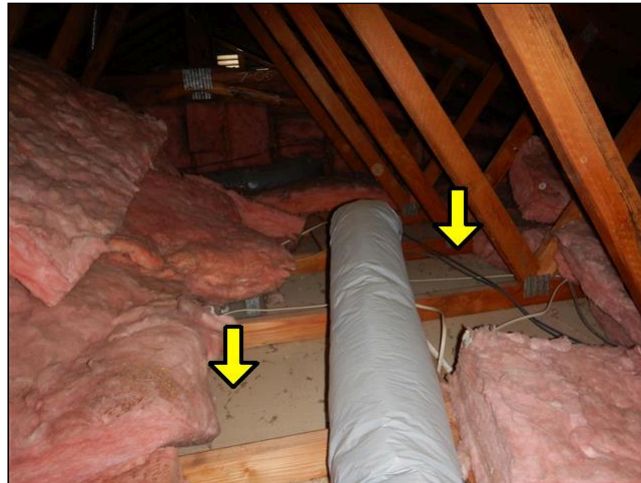
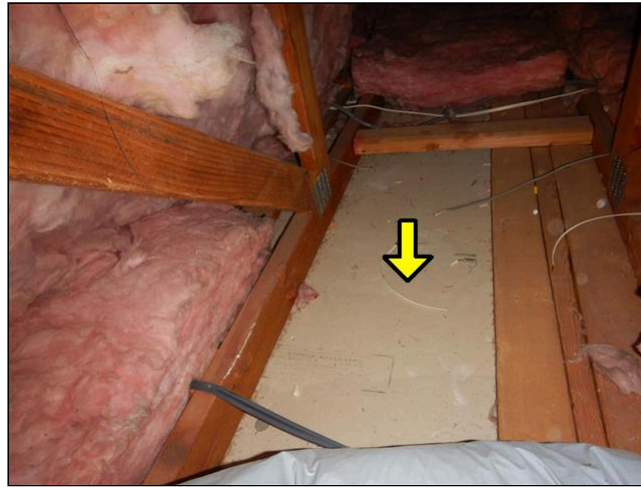
(1) Some of the batt insulation has been moved in the attic space. This insulation was not put back into position where needed. We recommend having the insulation distributed properly/ put back into place to improve the thermal efficiency of the house by a qualified person.

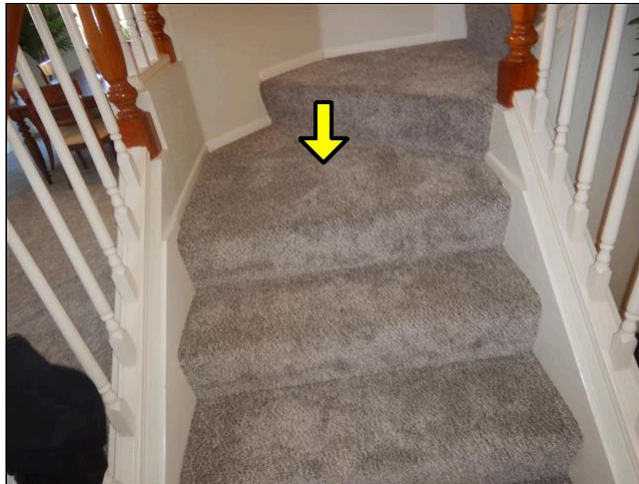
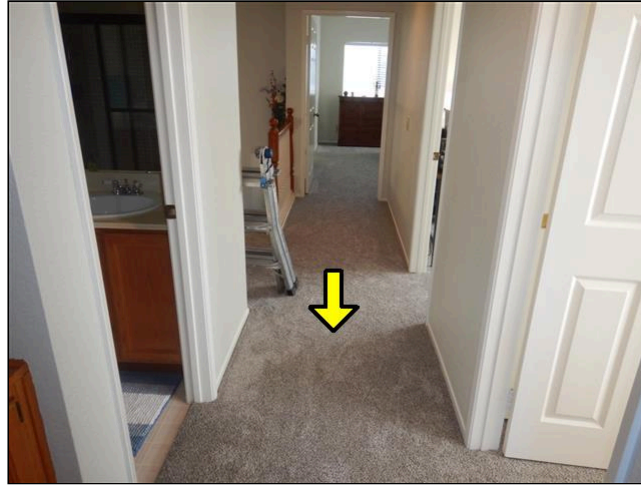
The wood sub flooring at several locations and at the interior stair steps were observed to be noisy/ squeaky when walked on. There are many causes of squeaky/creaking sub-floors such as loose nails, failed or missing adhesive, or wood rubbing together due to lack of support. We recommend necessary repairs as needed by a qualified licensed contractor.

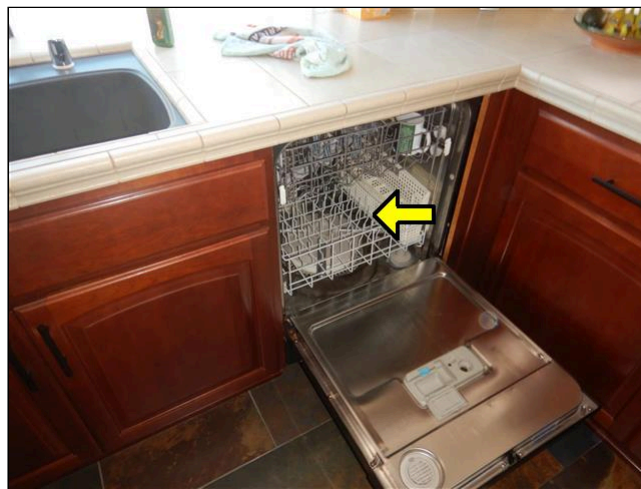
16.1 Item 2(Picture)

(2) The dishwasher racks are rusted. We recommend replacing the racks by a qualified person.

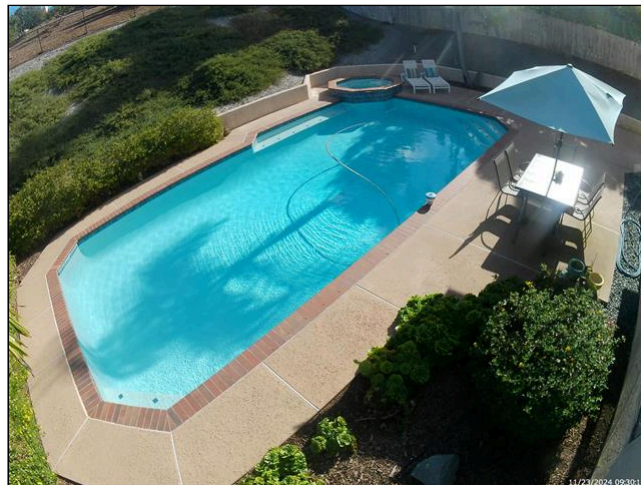
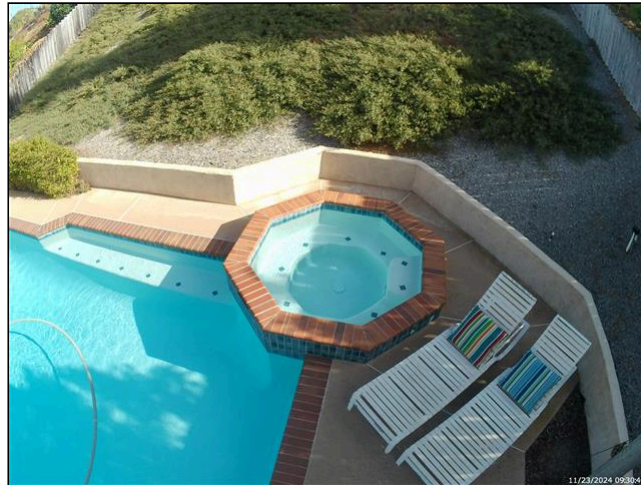
- (2) There is no visible rescue/ safety equipment placed around the pool/ spa area. This is a safety concern. We recommend placing the required rescue/ safety equipment where needed around the pool as a safety upgrade.
- (3) The pool and its related components are in overall poor condition. We recommend having a thorough evaluation performed by a qualified licensed pool contractor prior to the end of your contingency period and necessary repairs or replacement made as needed.
- (4) Our company does not inspect pools for leaks or seepage. Only components readily accessible are inspected. If concerned we recommend further evaluation by a qualified licensed pool contractor.

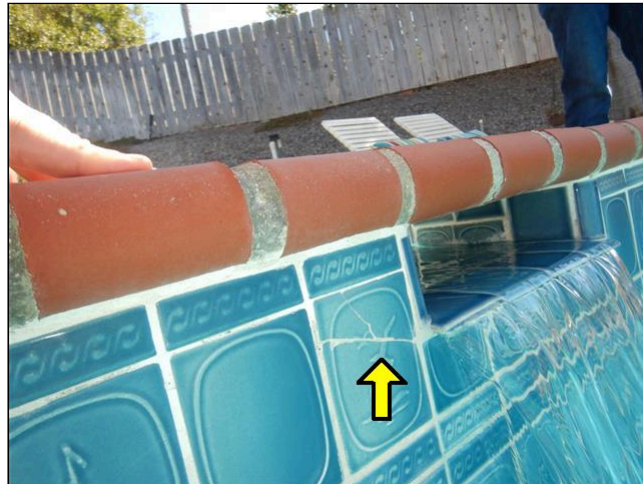
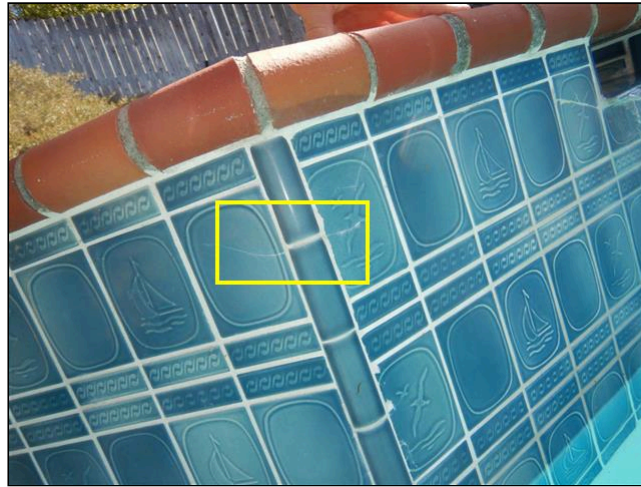
(1) The plaster surface of the pool is flaking in several locations. This can indicate that the surface is failing and may need to be replaced. We recommend further evaluation by a qualified licensed pool contractor to get an estimate of life remaining, and/or the cost of repair prior to the end of your contingency period.

(2) Several tiles are cracked at the pool walls. We recommend having the tiles repaired or replaced by a qualified licensed pool contractor.

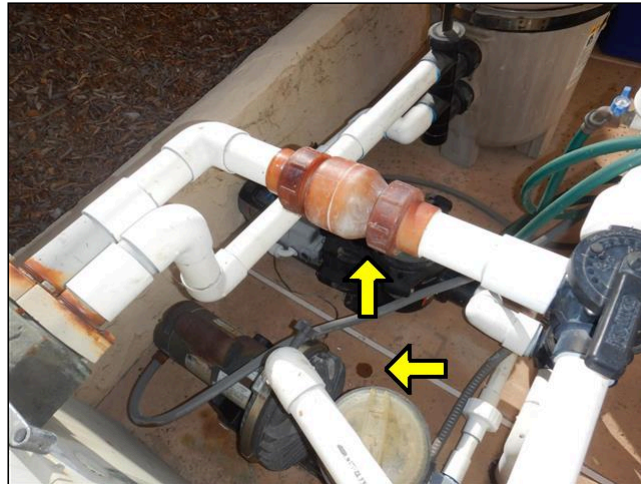
18.5 Item 1(Picture)

(1) The pool pump(s) are old/ worn. Life remaining may be limited. We recommend further evaluation by a qualified licensed pool contractor for life remaining or cost to replace prior to the end of your contingency period.

(2) An active leak was observed. We recommend necessary repair by a qualified licensed pool contractor.

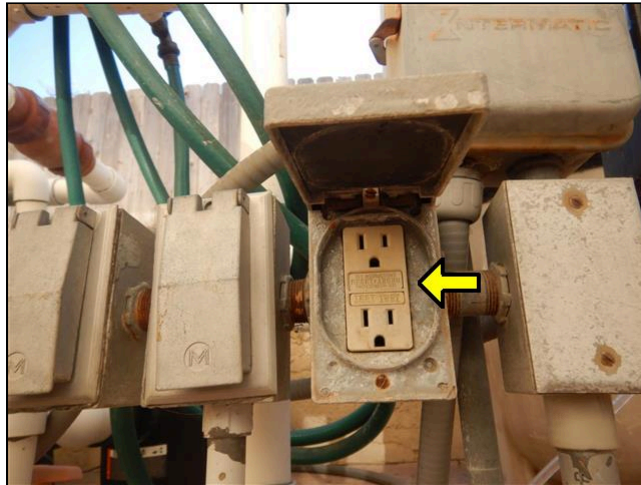
18.10 Item 1(Picture)

The GFCI outlet for the pool light(s) did not trip when tested. This is a safety concern. We recommend replacing the GFCI outlet by a qualified licensed electrician or pool contractor prior to using the pool/ as soon as possible.

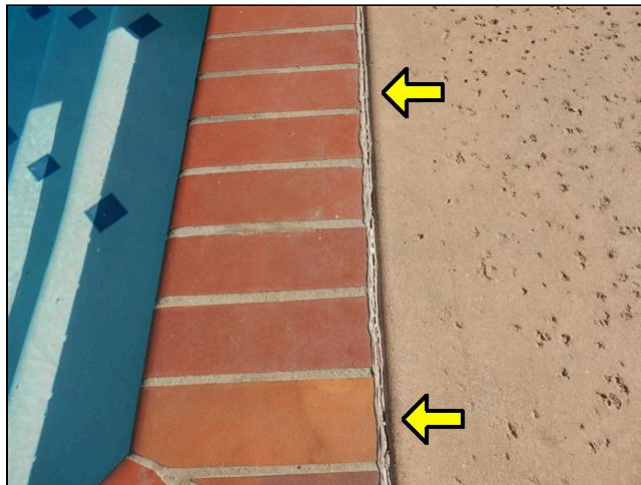
18.11 Item 1(Picture)

(1) The elastomeric compound (Deck-O-Seal) between the pool deck and coping is cracked/ missing in several areas. We recommend re sealing between the pool deck and coping as needed by a qualified pool contractor.

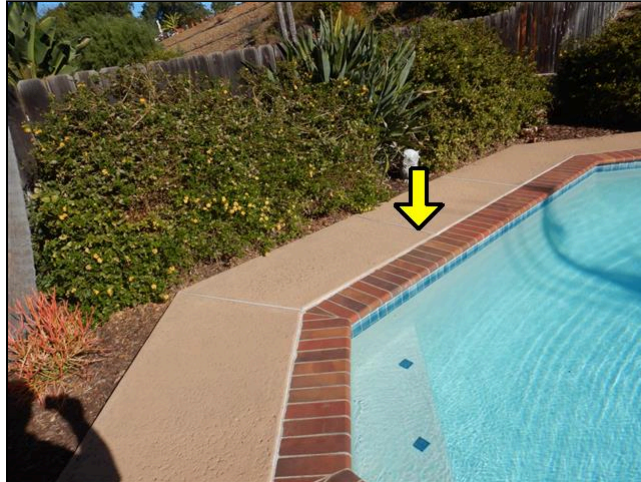
18.11 Item 2(Picture)

(2) The decking around the pool is cracked in several areas. We recommend necessary repairs by a qualified licensed concrete contractor.

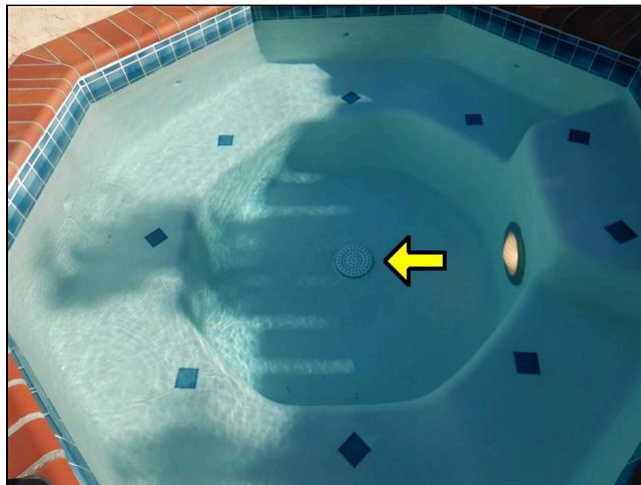
18.12 Item 1(Picture)

There is only one suction line at the bottom of the pool and spa. Dual suction lines and safety drain covers are currently required to reduce entrapment/ drowning hazards. We recommend upgrading the pool to meet the standards of the Virginia Graeme Baker Act of 2007 (This is same standard for new residential pools). We recommend further evaluation by a qualified licensed pool contractor prior to the end of your contingency period and upgraded repairs made as needed.

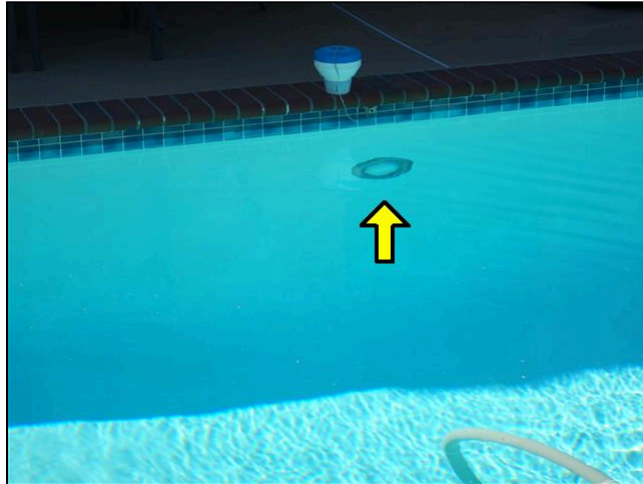
18.13 Item 1(Picture)

(1) The pool light(s) did not function when tested. We recommend further evaluation

and repair or replacement as needed by a qualified pool contractor.

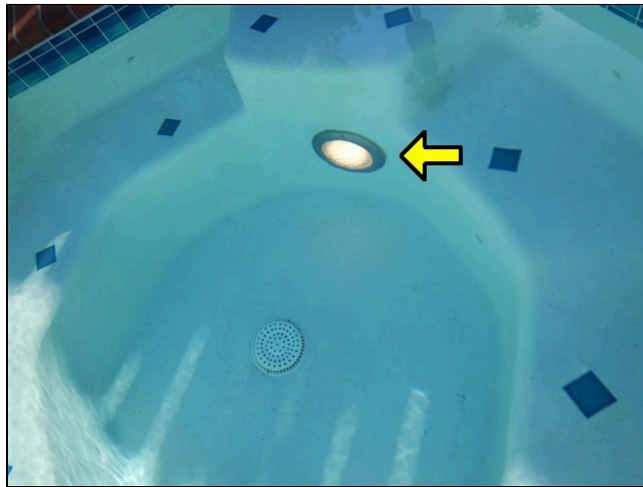
18.13 Item 2(Picture)

(2) The spa light(s) operated when tested.

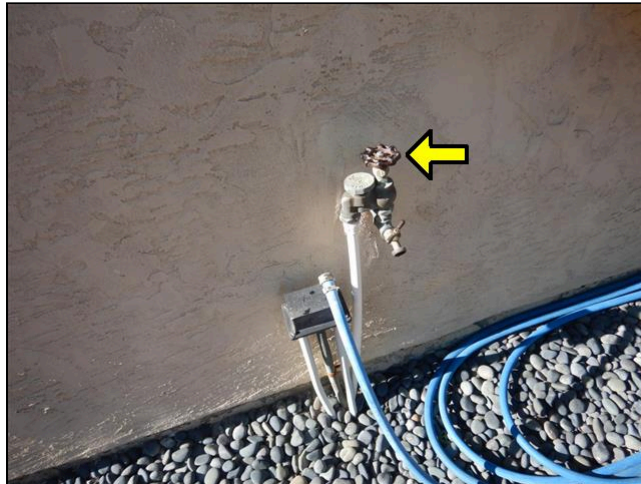
18.14 Item 1(Picture)

(1) The pool fill makes a loud noise when turned off. We recommend further evaluation by a qualified licensed pool contractor.

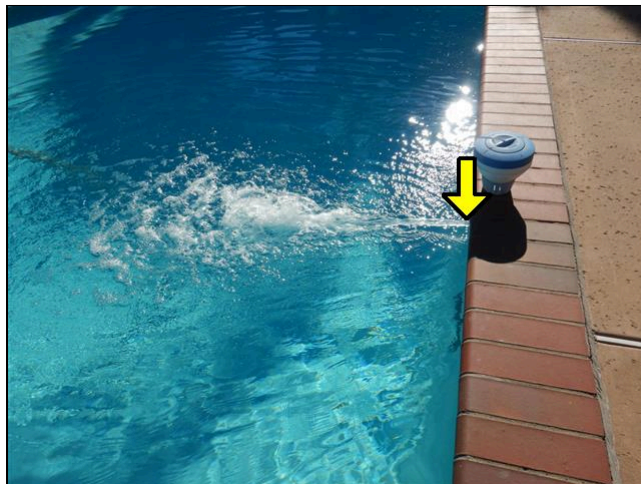
18.14 Item 2(Picture)

(2) The pool fill device was tested and was operational at the time of the inspection.

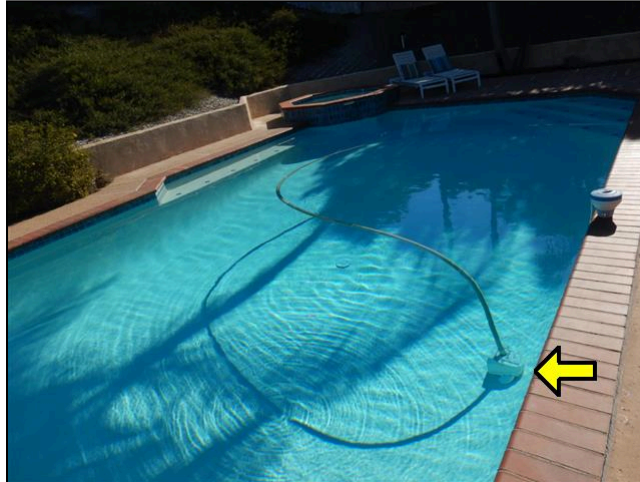
18.16 Item 1(Picture)

The pool sweep functioned at the time of the inspection. This is not an exhaustive test and does not verify the cleaning efficiency of the unit.

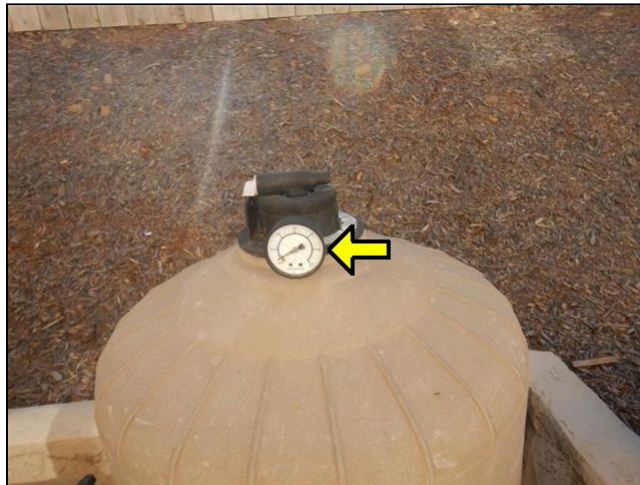
18.17 Item 1(Picture)

- (1) The filter appeared to be functional at the time of the inspection. This is not an exhaustive test and does not verify the cleaning efficiency of the unit.
- (2) The filter pressure gauge cover missing. We recommend replacing by a licensed pool contractor.

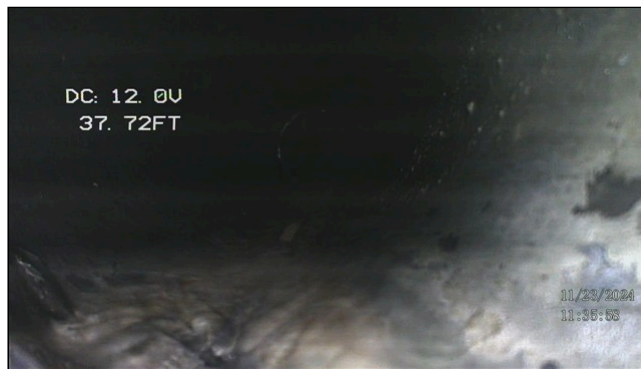
19.2 Item 1(Picture)

(1) ABS

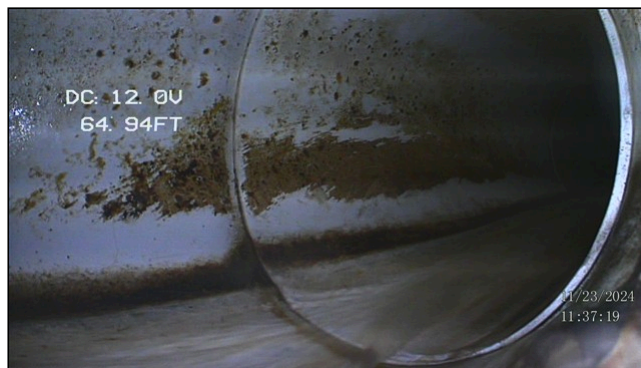
19.2 Item 2(Picture)

(2) PVC (Polyvinyl Chloride)

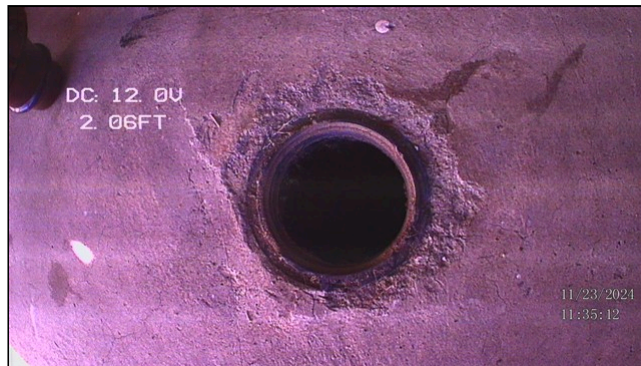
19.3 Item 1(Picture)

The main sewer line was inspected by inserting the camera at the sewer line clean out in the garage.
