Inspection Report

Property Address:
4123 Main Place
Oceanside CA 92054

The Property Inspection Pros

Date: 7/18/2024	Time: 01:00 PM	Report ID:
Property: 4123 Main Place Oceanside CA 92054	Customer: Jon Rikki	Real Estate Professional:

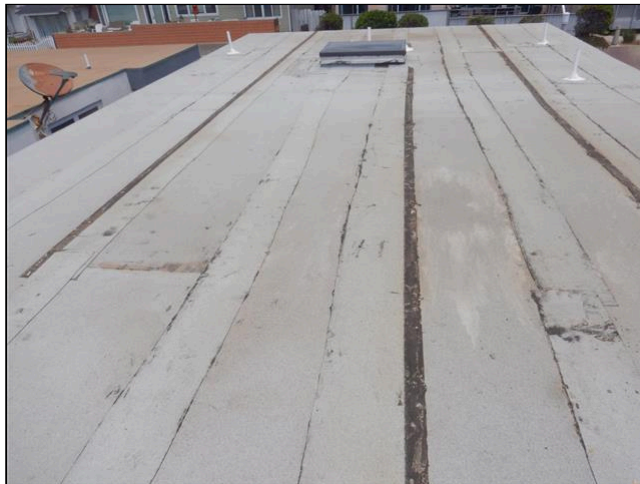
1.0 Item 1(Picture)

(1) The flat roof material shows normal wear for its age and type; appears to be in serviceable condition.

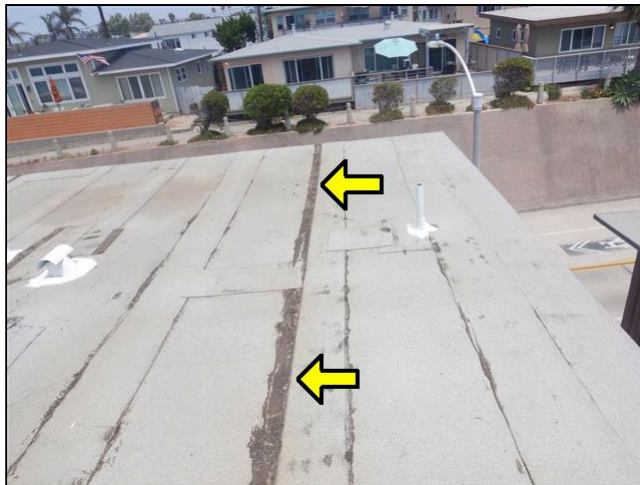
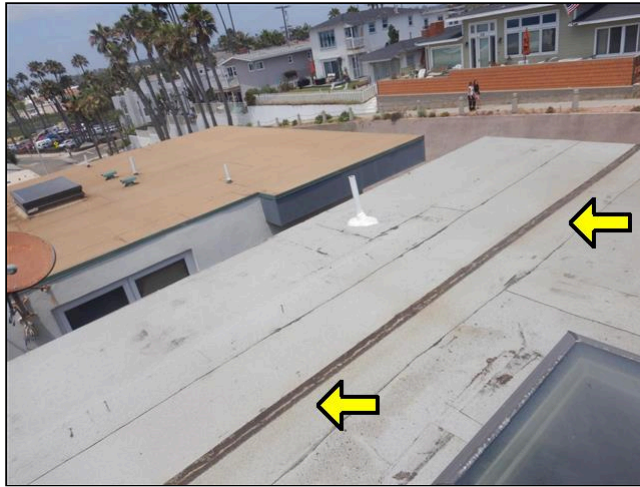
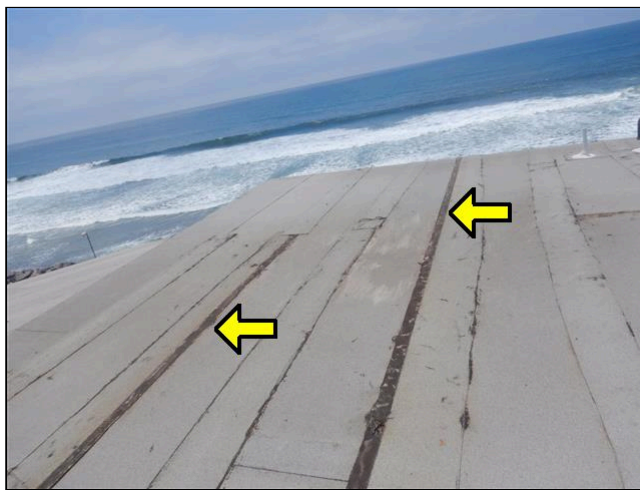
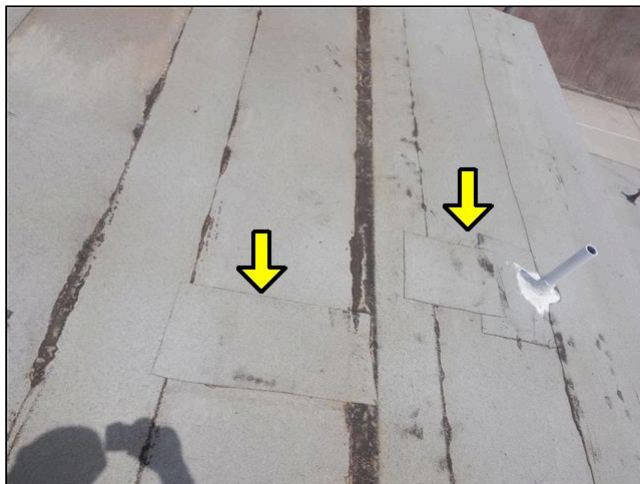
(2) The roof has had repairs made to it at several areas. We are unable to determine if these repairs are made correctly and successful. We recommend asking the seller about these repairs, and we recommend further evaluation by a qualified licensed roof contractor.

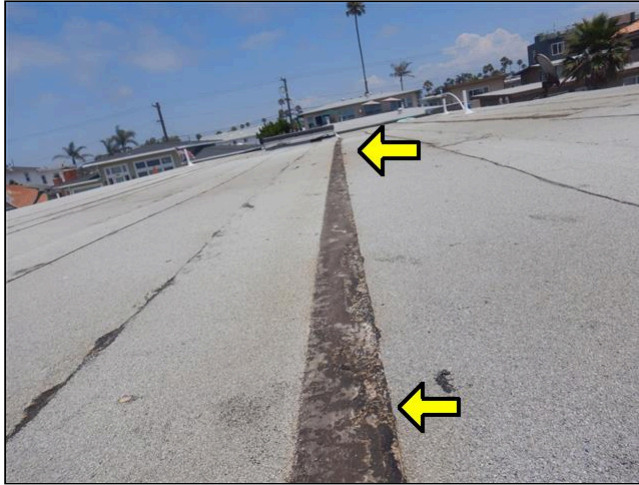
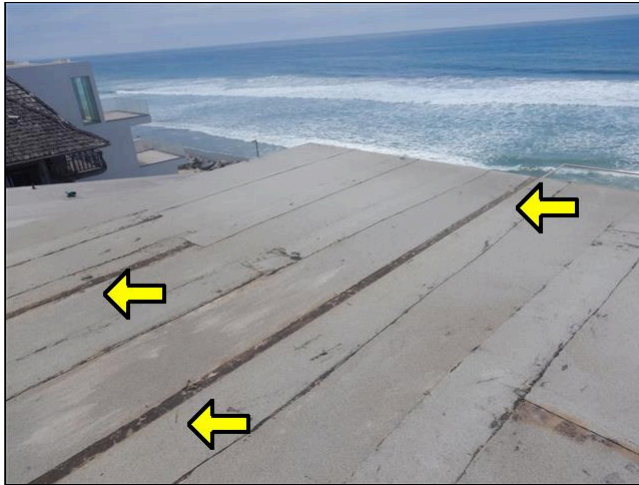
(3) Several areas of the rolled roofing material appears not to have been installed properly/ overlapped properly. We recommend further evaluation and necessary repairs by a licensed roofing contractor.

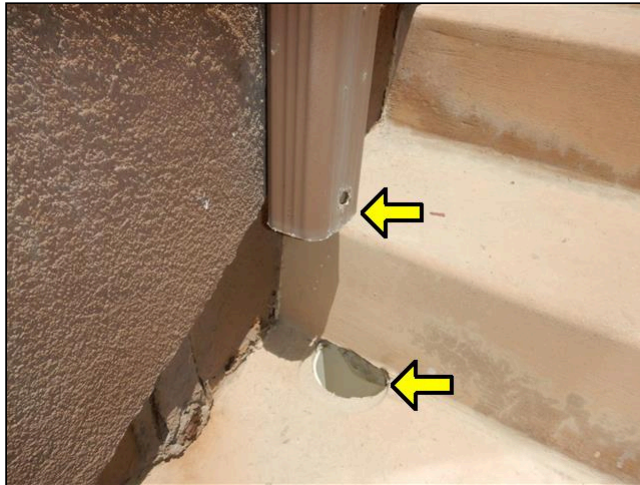
1.2 Item 1(Picture)

(1) We recommend tying the downspouts into the surface drains by a qualified licensed contractor.

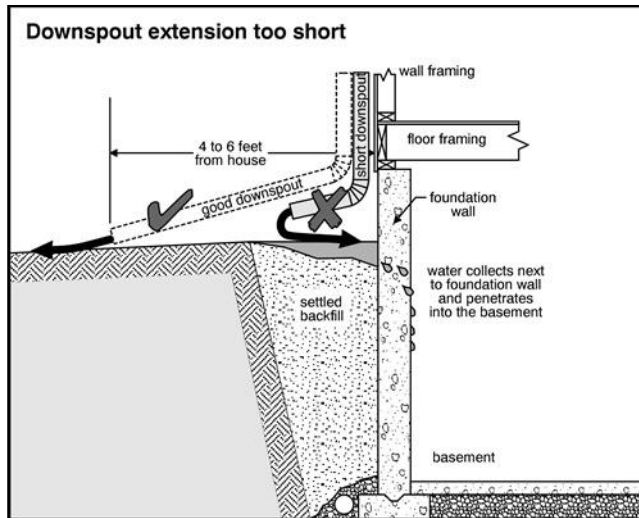
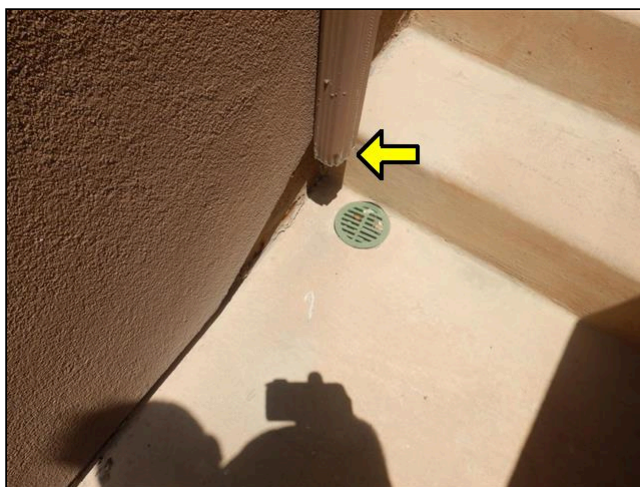
(2) Some of the downspouts need extension and/or a buried drain line to carry water away from the home at several areas. We recommend necessary corrections where needed by a qualified contractor.

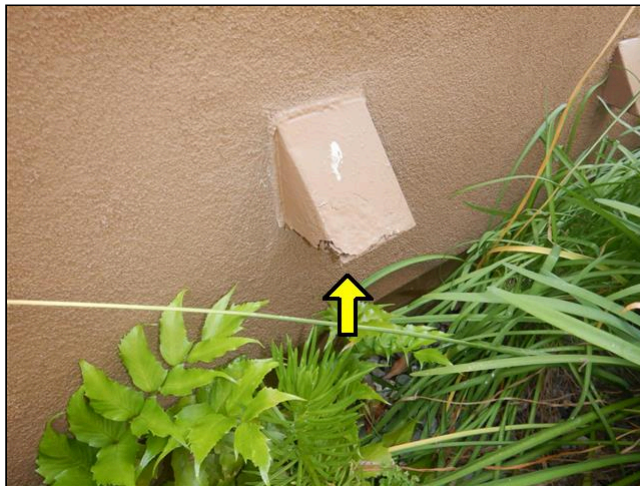
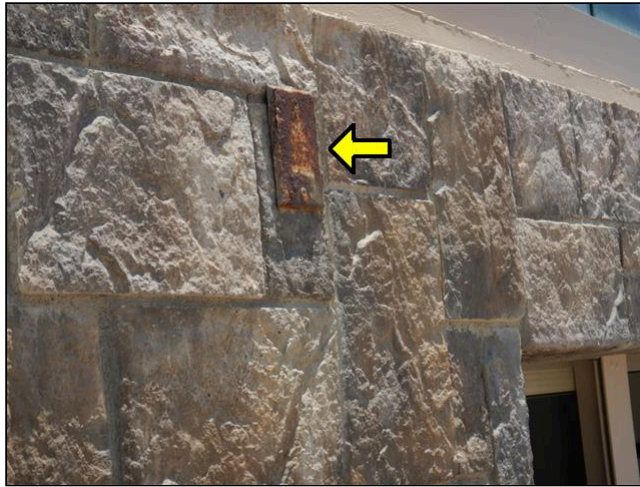
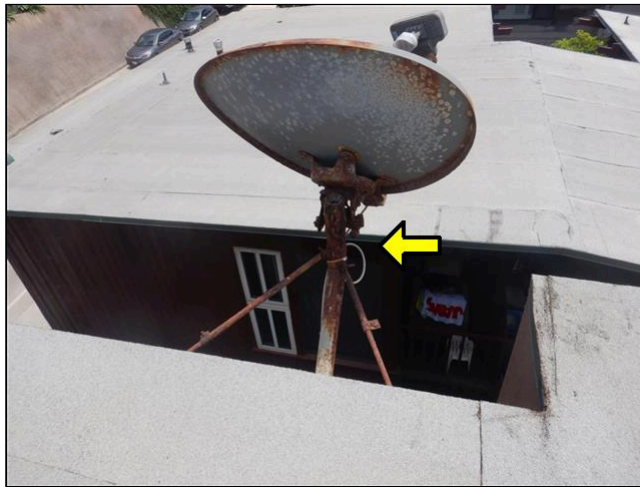
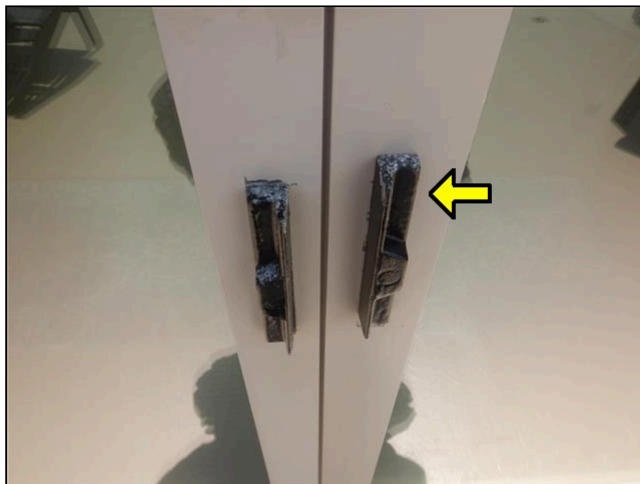
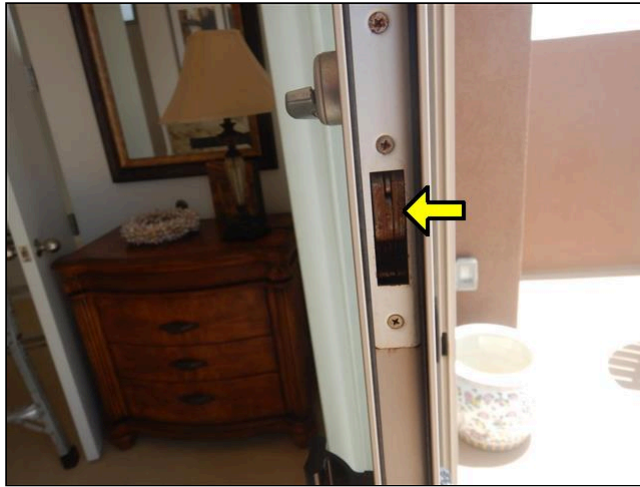
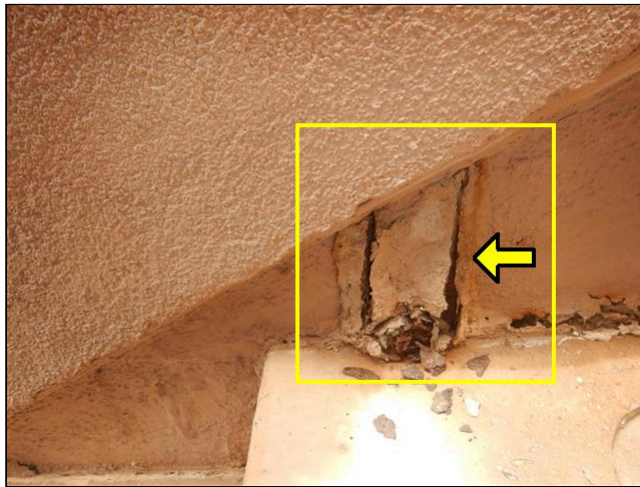
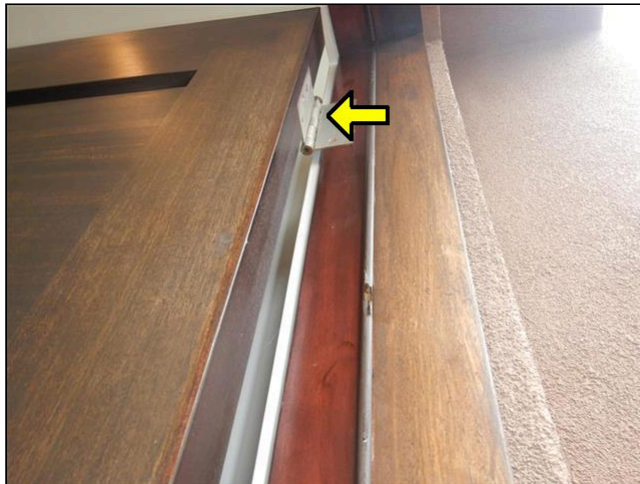
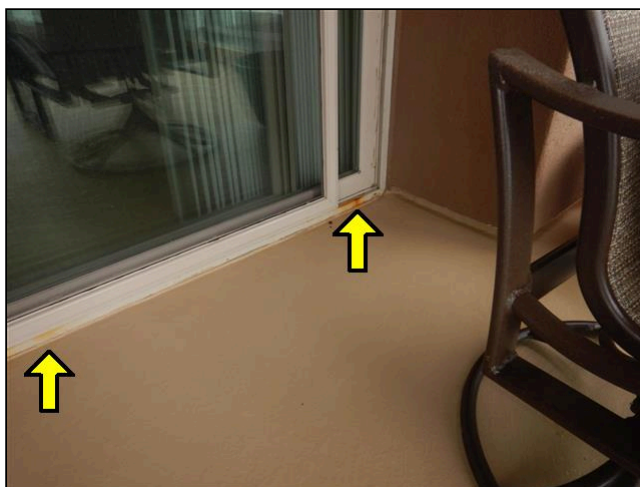
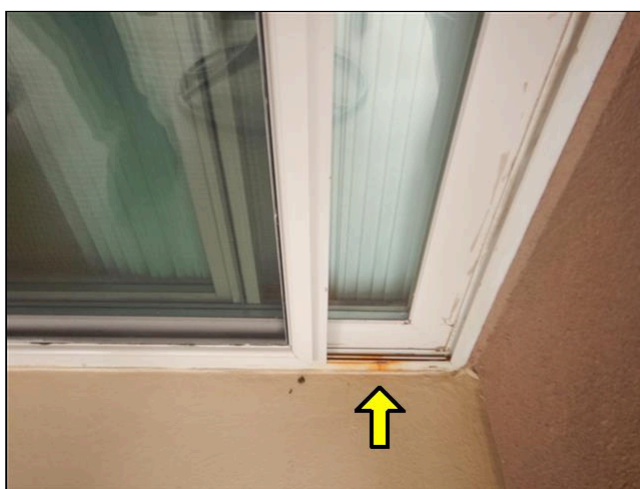
(1) This home is located close to the coast/ ocean. High-salt content in coastal environments can shorten the life spans of many types of metal components such as but not limited to fixtures, appliances, flashings, and doors/windows. Rusting/corrosion was observed at several areas, components and systems throughout the house. We recommend necessary repairs or replacement of any rusted and corroded items/ components where needed by a qualified licensed contractor in the appropriate trade.

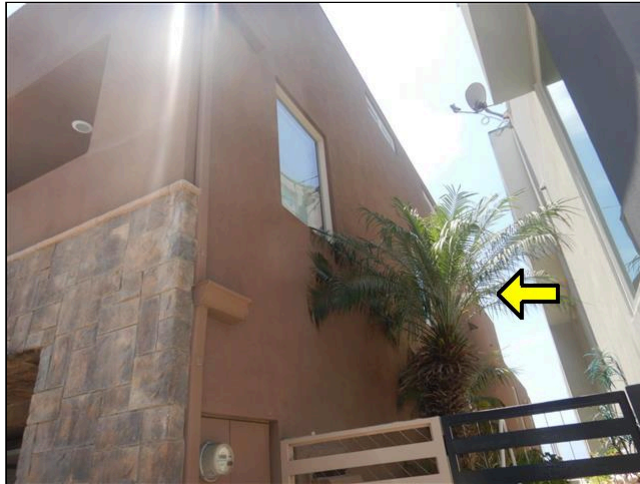
2.1 Item 1(Picture)

(1) Vegetation is in contact with the siding/ stucco at several areas. Vegetation can create moisture problems by preventing siding from drying out. Vegetation also allows rodents to easily access the roof where they can enter through small voids. We recommend removing vegetation from the siding/ stucco. We also recommend referring to the pest control report for their recommendations.

(2) Tree(s) and/or large plants are located too close to the house. Tree limbs/vegetation that are too close to the house can cause damage in several ways. Limbs or vines in contact with roof or hanging near roof should be trimmed to prevent damage to roof and/or to prevent rodent infestation. Also, as the plants grow, damage can occur to the siding, concrete flat work and to the foundation. We recommend having the foliage removed or trimmed by a qualified professional to prevent damage to the house as soon as possible.

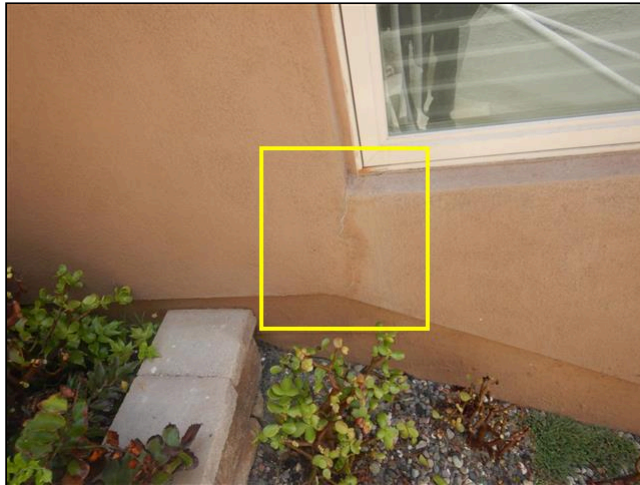
2.3 Item 1(Picture)

(1) Hairline cracking was observed at the stucco at several areas. The cracks are less than 1/8 inch in width, and generally considered common in this material. These cracks

should be caulked and painted where possible. If cracks increase in width, it may indicate that structural movement is occurring. Determining this is beyond the scope of a home inspection.

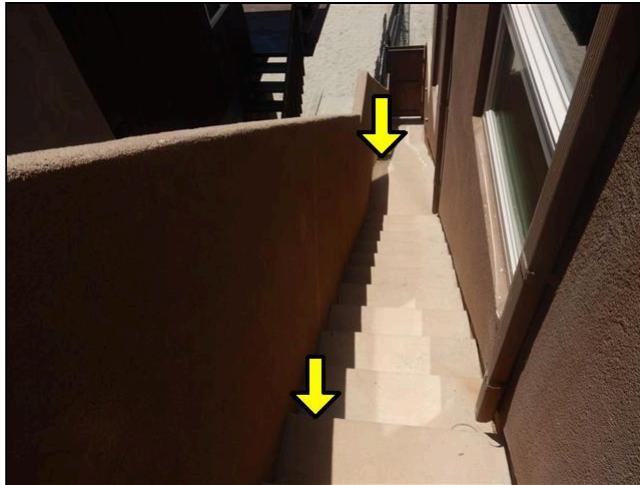
2.8 Item 1(Picture)

There is no handrail installed at the right side exterior stairs/ steps. A handrail is required at least one side of the stairs when four or more steps are present. This is a safety hazard and corrections are needed. We recommend installing a handrail for safety by a qualified licensed contractor.

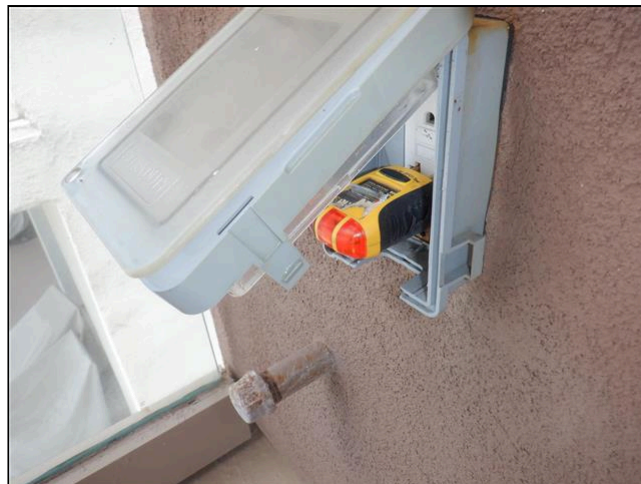
2.10 Item 1(Picture)

A receptacle at the middle balcony did not operate when tested. We recommend further evaluation and necessary repairs by a licensed electrician.

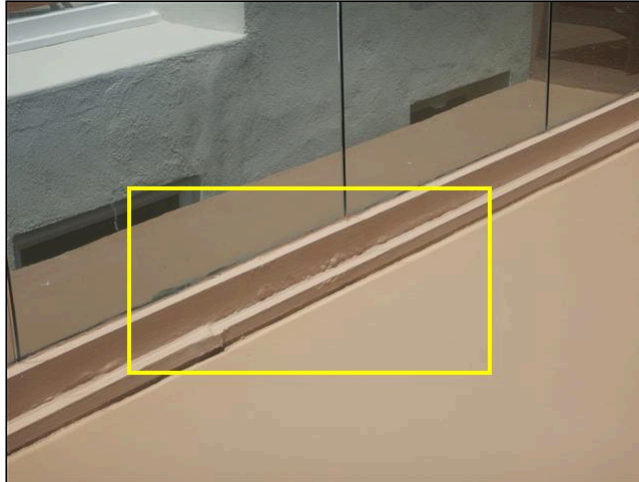
2.11 Item 5(Picture)

(3) Bubbling paint is observed at the decks and decking flashing. We recommend necessary repairs by a qualified licensed contractor.

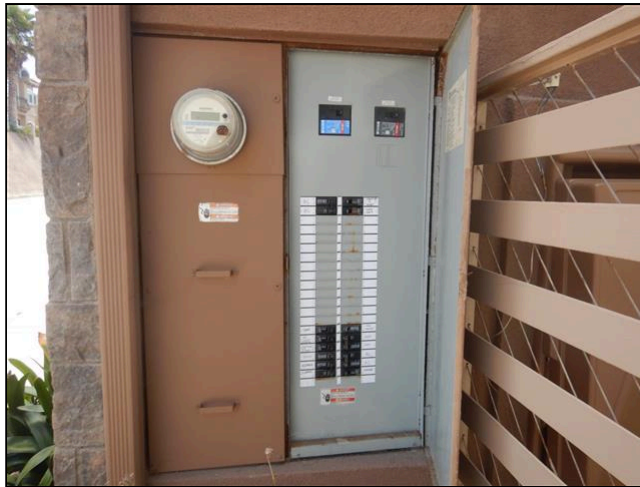
3.0 Item 1(Picture)

- (1) [Photo of the main electrical panel.](#)

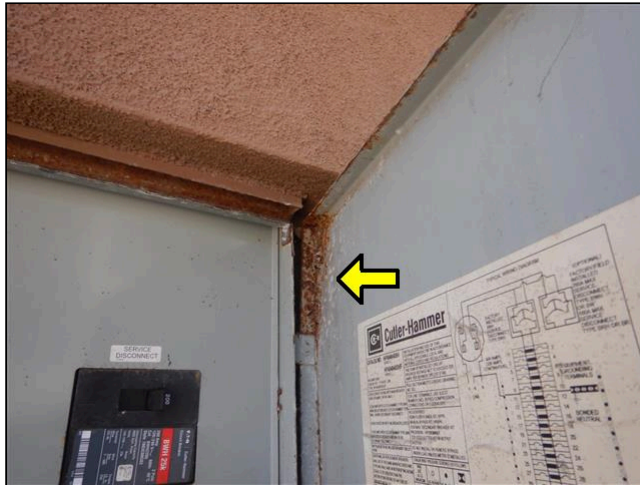
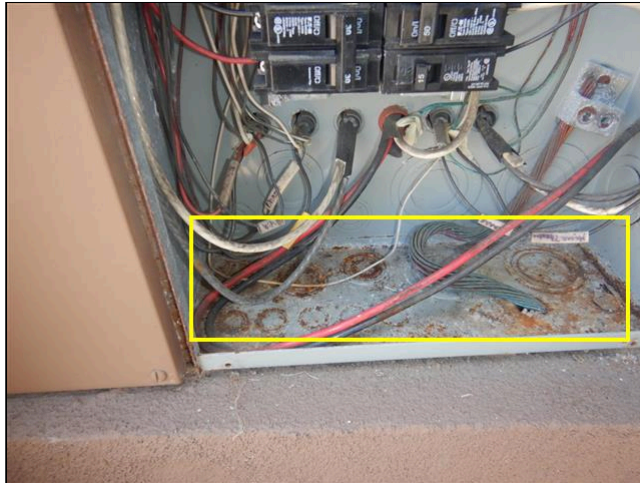
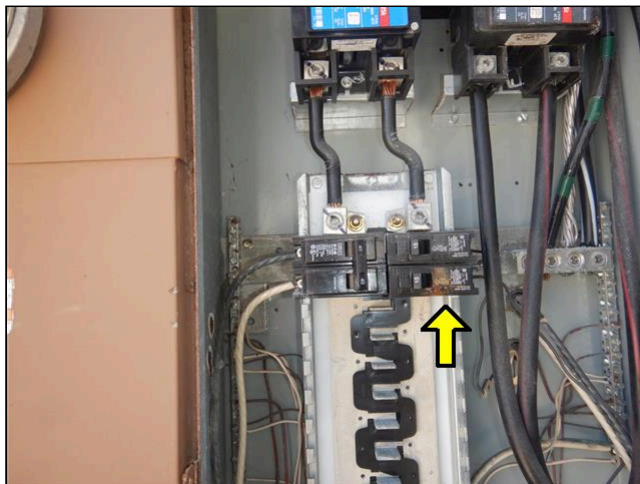
(2) Rust is observed in and around the main electric panel. This condition could cause the breakers to become unreliable or cause poor connections. We recommend further evaluation by a licensed electrician and necessary corrections as needed.

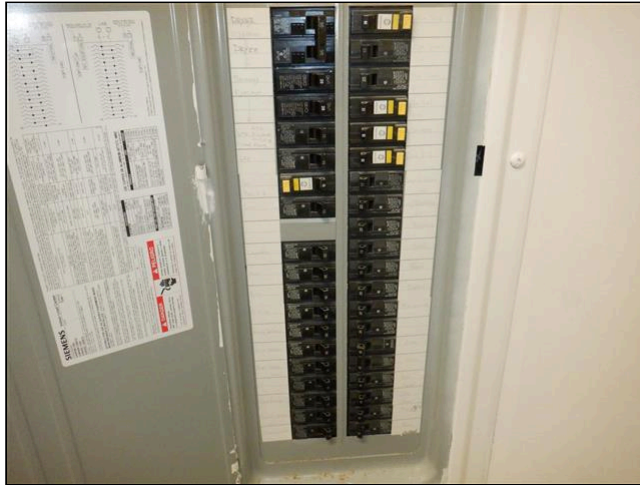
3.1 Item 1(Picture)

Photo of the sub electrical panels.

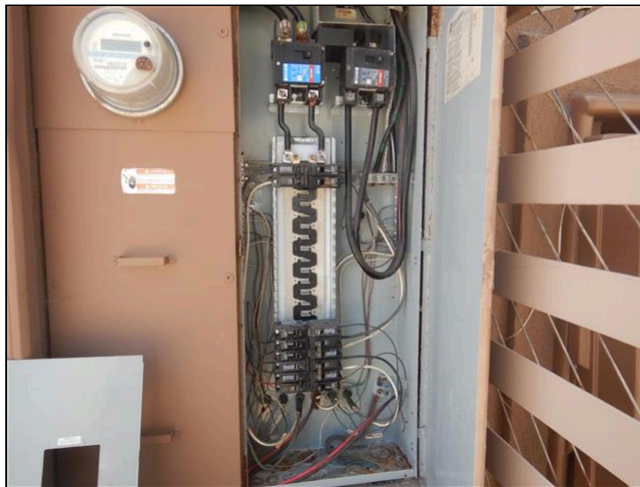
3.2 Item 1(Picture)

(1) **Photo inside of the main electrical panel.**

The dead front cover was removed at the time of the inspection and the breakers, wiring and grounding were inspected. Appears to be functioning as intended.

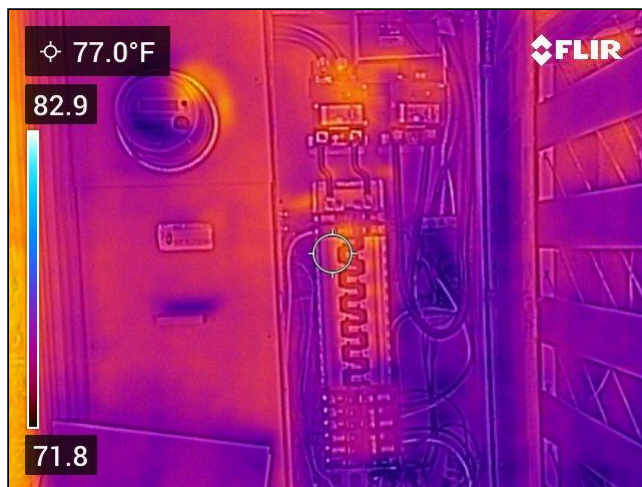
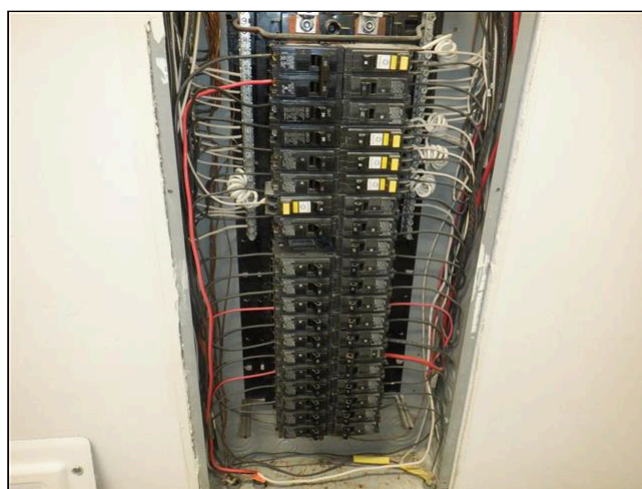
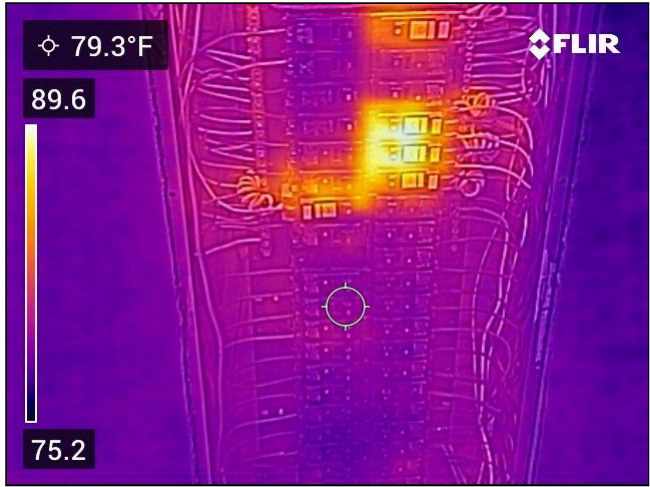
(2) **Photo inside of the sub electrical panels.**

The dead front covers were removed at the time of the inspection and the breakers, wiring and grounding were inspected. Appears to be functioning as intended.

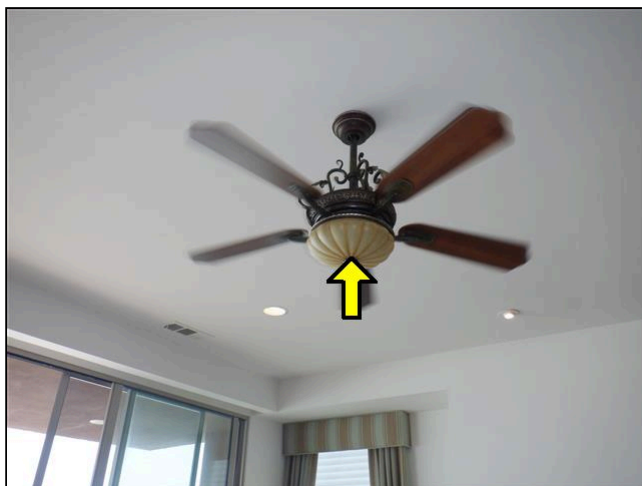
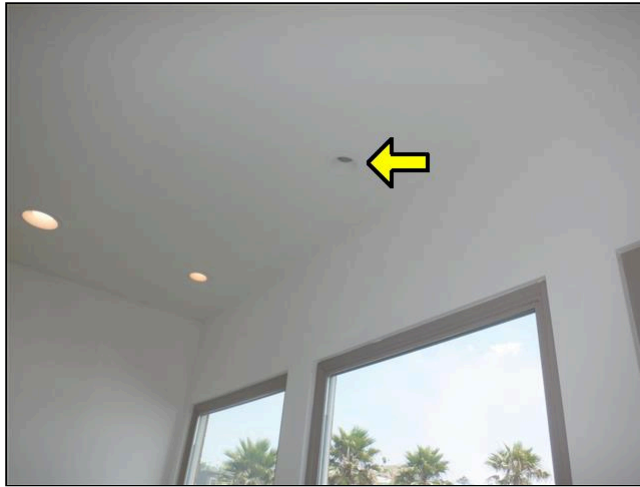
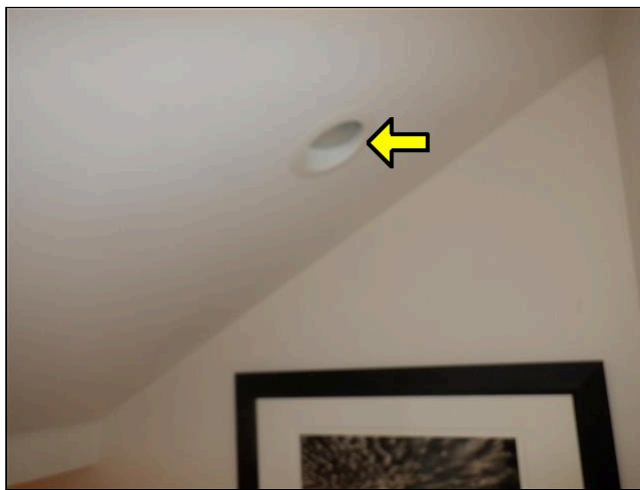
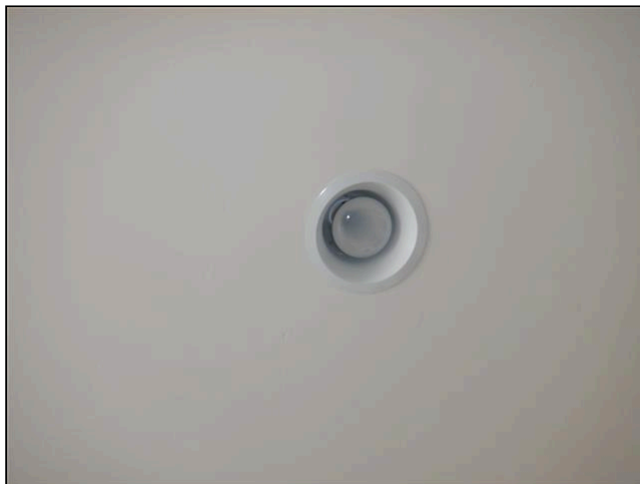
(1) Several lights throughout the house/ garage did not function when tested possibly due to bad bulbs or a miss wired fixtures. Occasionally there may something wrong with the fixtures which cannot be determined without a working bulb. We recommend asking the seller to demonstrate that theses lights are working prior to the end of the inspection contingency period, or changing the bulbs and testing again. If these lights do not function we recommend further evaluation by a qualified licensed electrician and necessary repairs or replacement as needed.

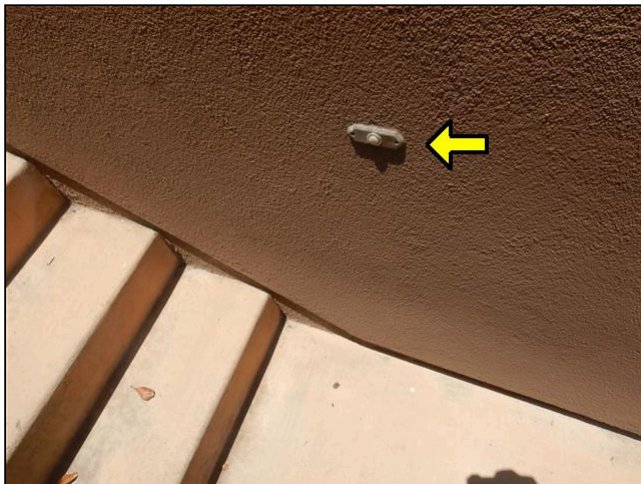
3.5 Item 6(Picture)

(2) The door bell is inoperable. We recommend necessary repair or replacement by a qualified person.

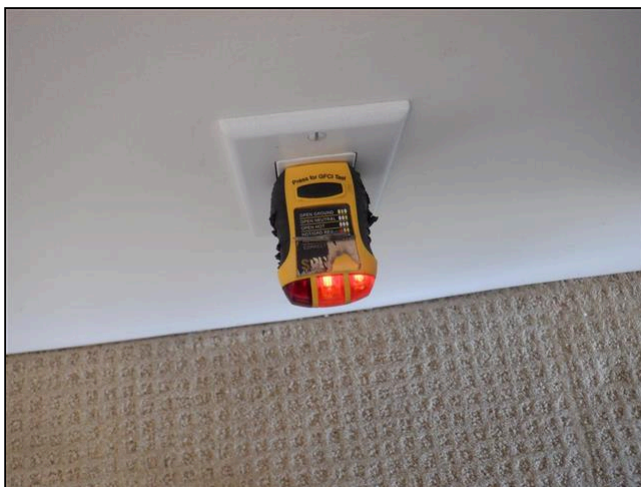
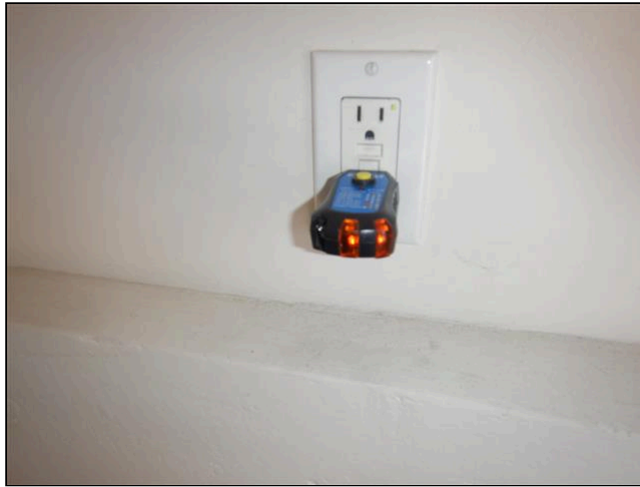
Photo of a receptacle being tested.

A representative number of receptacles throughout the property were tested for power, polarity and grounding according to our standards-of-practice. These receptacles observed to be ok at the time of the inspection unless otherwise noted.

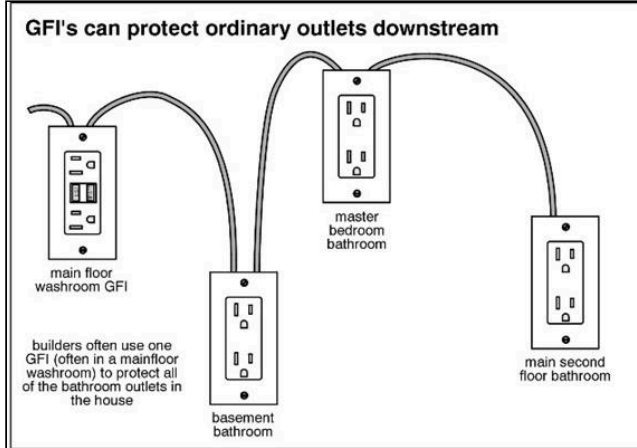
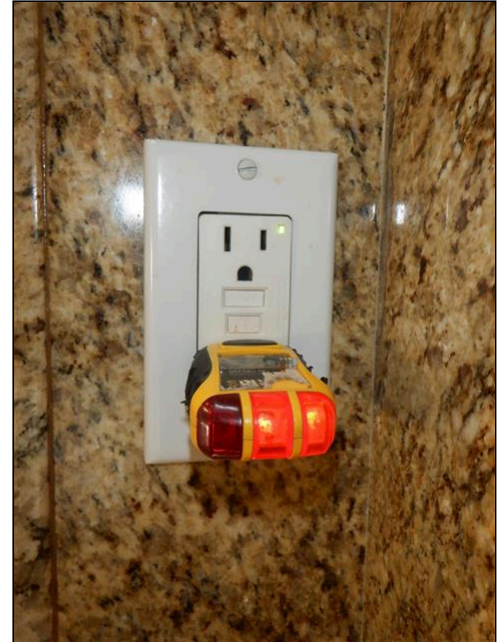
All accessible GFCI receptacles were tested and were functioning properly at the time of the inspection unless otherwise reported. Sometimes a tripped GFCI receptacle may be difficult to find. If you do not have power at certain receptacles please check all GFCI's and reset the tripped GFCI receptacle. If the GFCI doesn't reset than replacement of the GFCI receptacle will be required.

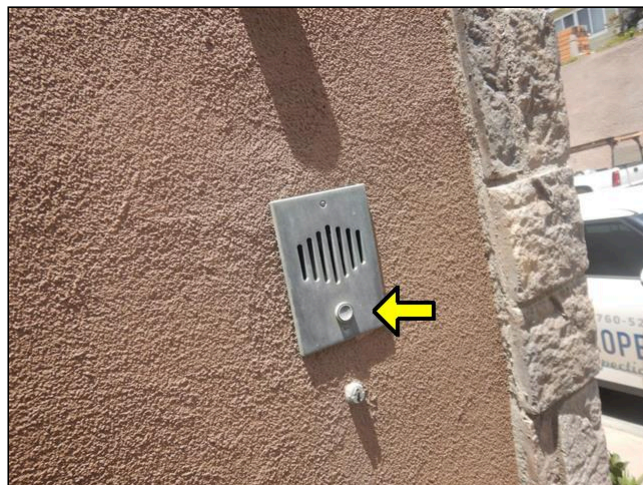
3.12 Item 1(Picture)

The intercom system is beyond the scope of the home inspection and was not inspected. We recommend verifying that the intercom system is operational prior to the end of your contingency period.

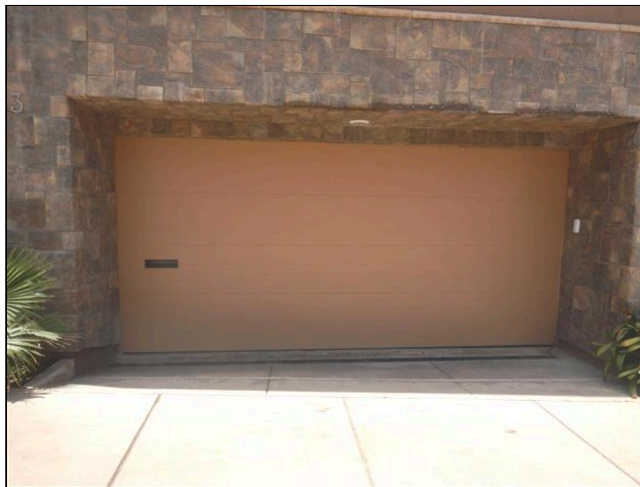
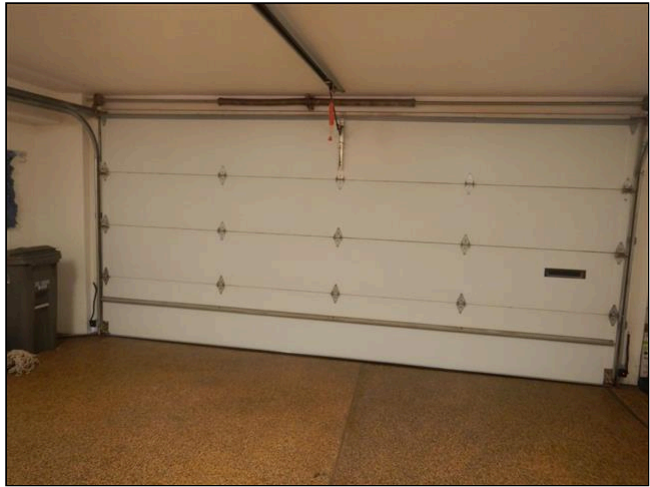
[Garage door photo\(s\).](#)

The garage vehicle door hardware including the door, track, and springs appear to be functioning as intended.

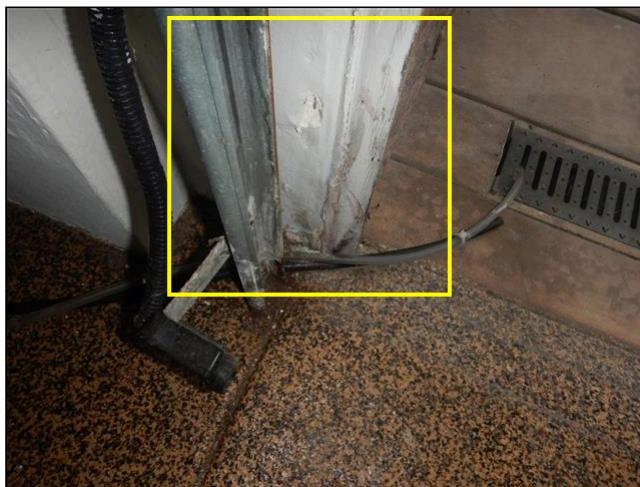
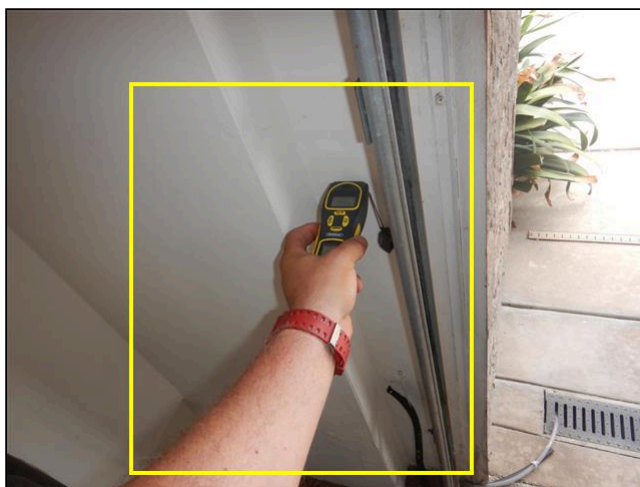
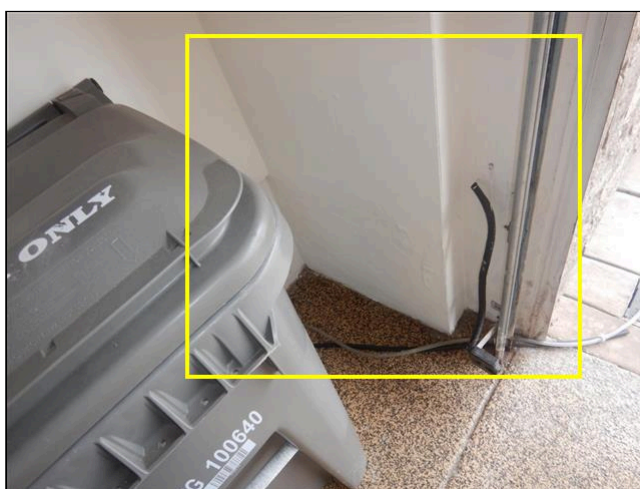
(2) Water intrusion is noted at a wall in the garage possibly due to poor installation of siding, trim, or window flashing. The exact cause of the moisture could not be determined with in the scope of this general home inspection. We recommend further evaluation by a qualified licensed contractor prior to the end of your contingency period and necessary repairs made as needed.

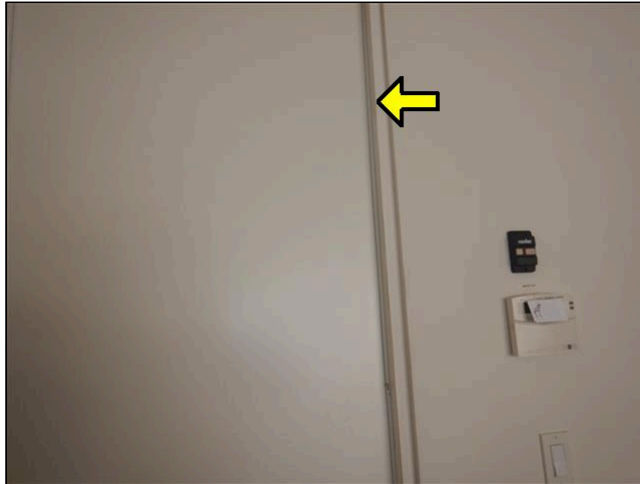
4.5 Item 1(Picture)

(2) The door from the garage to the house rubs the door frame. We recommend necessary repairs by a licensed door contractor.

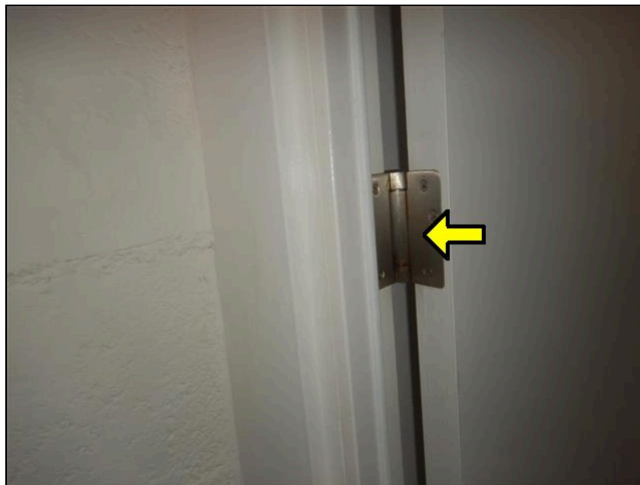
4.6 Item 1(Picture)

The self closing device at the fire door did not adequately close the door. The auto closer must close the door within 3 seconds with enough force to latch the door. We recommend adjusting or replacing the device or hardware by a qualified licensed door contractor.

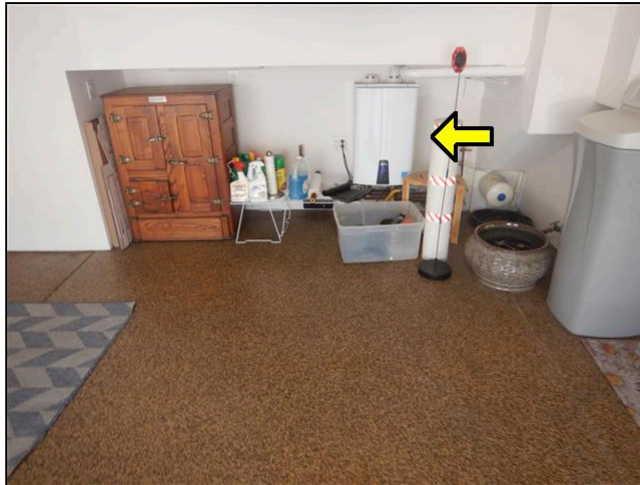
5.0 Item 1(Picture)

- (1) [Photo of the water heater.](#)

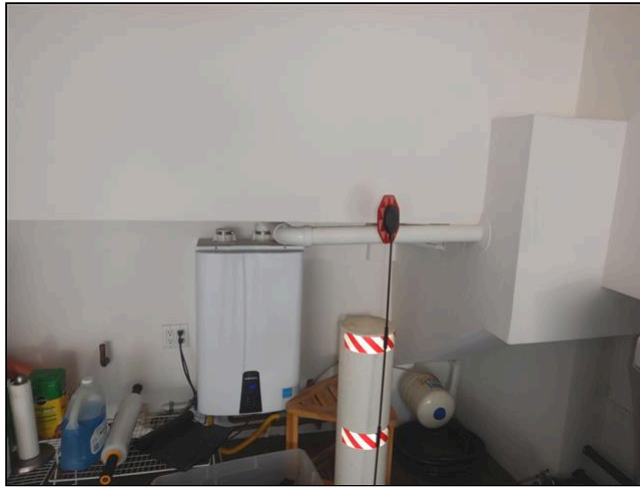
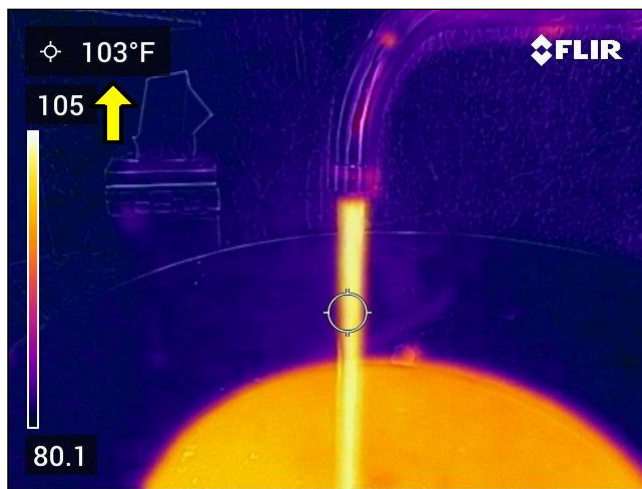
(2) **Thermal Photo of the water temperature.**

The temperature of the water was tested using a thermal camera during the inspection and was found to be operating within normal range.

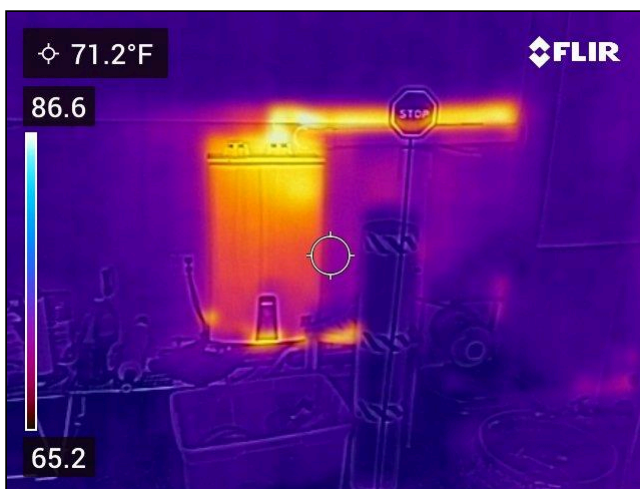
5.0 Item 4(Picture)

(3) A tankless water heater is installed in this property. Tankless water heaters do not store water in a tank like conventional tank water heater. When a hot water fixture is opened in the property, water flows into the water heater where it is heated by gas burners before flowing to the open hot water fixture. Tankless water heaters save energy by avoiding the stand-by losses associated with conventional water heaters which must constantly maintain water in a tank at a minimum temperature. Due to calcium build-up on components, tankless water heaters typically require service annually. Failure to service the water heater in a timely manner typically results in a reduced hot water flow rate and shortened life span. Due to this condition we recommend having the tankless water heaters serviced upon moving into the property and on a yearly basis or as needed by a licensed plumber.

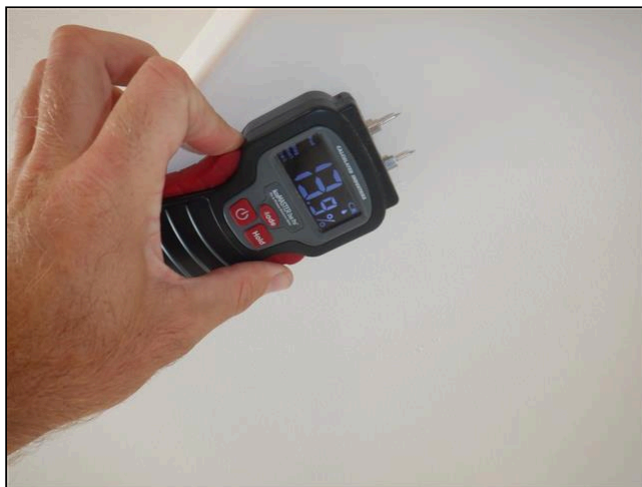
6.1 Item 2(Picture)

(2) Hairline cracking was observed at the ceiling at several locations in the house. These hairline cracks are likely due to material shrinkage or settlement of the structure. We recommend prep and paint by a qualified licensed contractor.

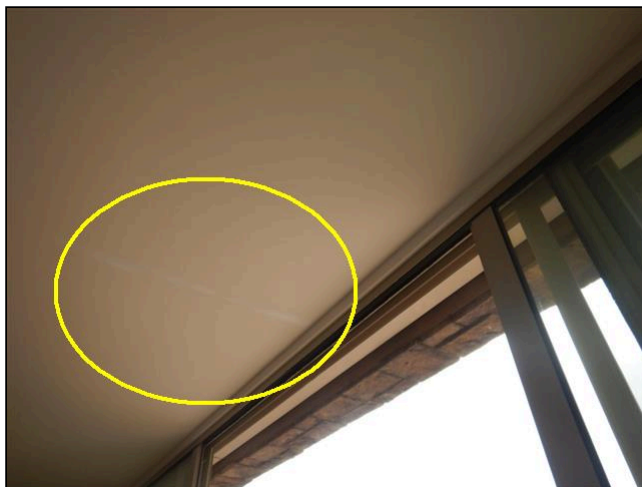
6.1 Item 5(Picture)

(4) The ceiling has typical cosmetic wear. You may wish to view this for yourself and have necessary repairs made by a qualified person.

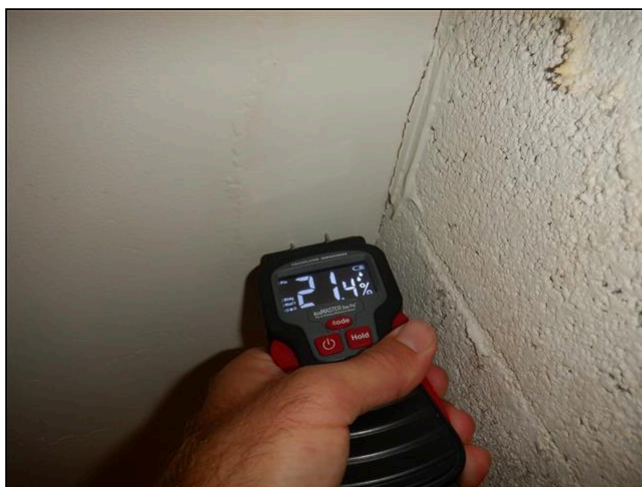
6.2 Item 6(Picture)

(4) Hairline cracking was observed at several locations. These hairline cracks are likely due to material shrinkage or settlement of the structure. We recommend prep and paint by a qualified licensed painter.

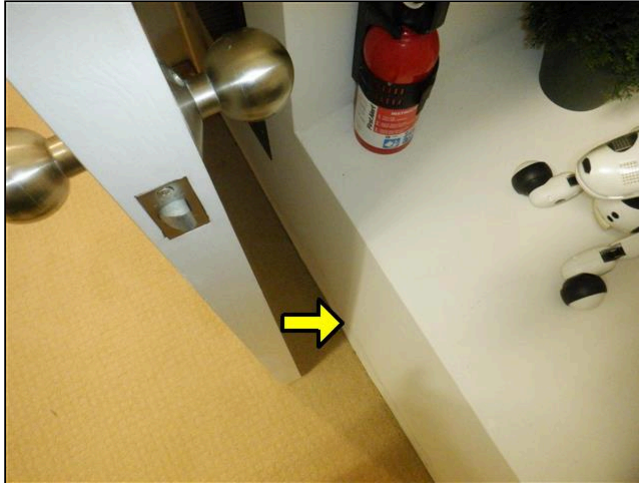
6.6 Item 1(Picture)

(1) Door stoppers are missing at several doors. Door stoppers are recommended where door handles contact walls. We recommend adding door stops and repair of any walls by a qualified person.

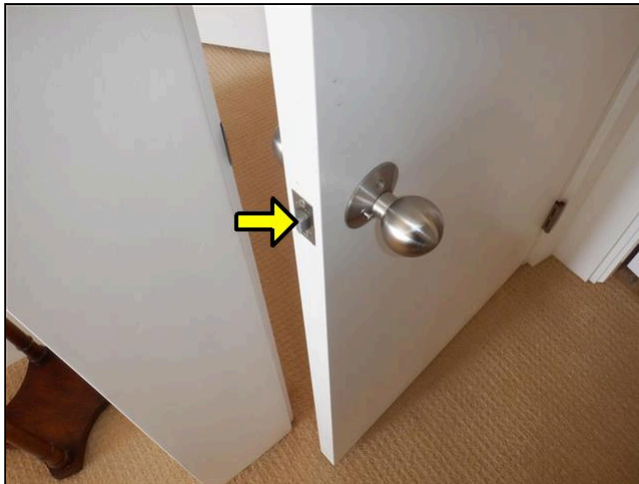
6.6 Item 2(Picture)

(2) The left side guest bedroom door hardware is misaligned; the door does not latch. We recommend adjusting the strike plate or necessary corrections made by a qualified person.

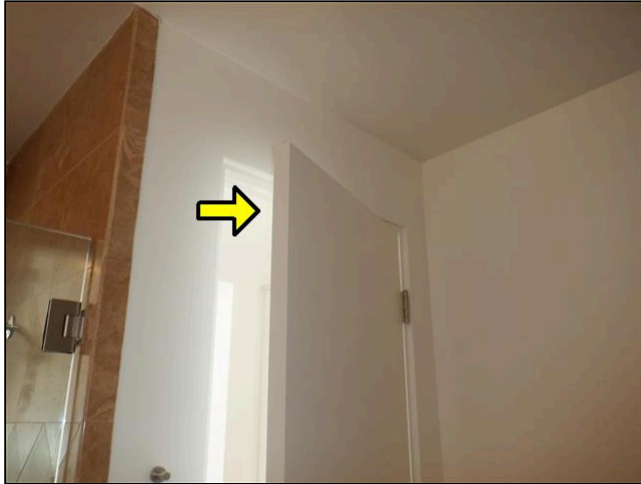
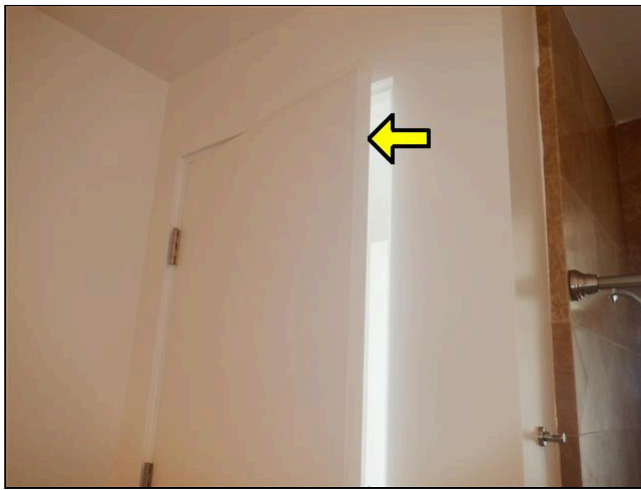
(3) Both of the guest bedroom bathroom doors rub at the frame. We recommend necessary corrections by a qualified person.

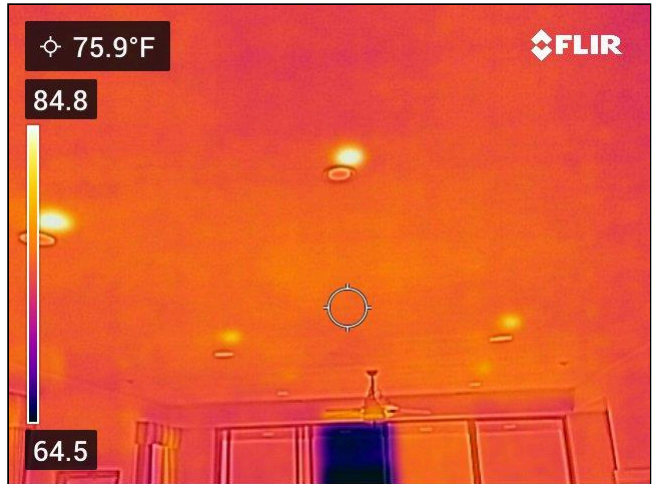
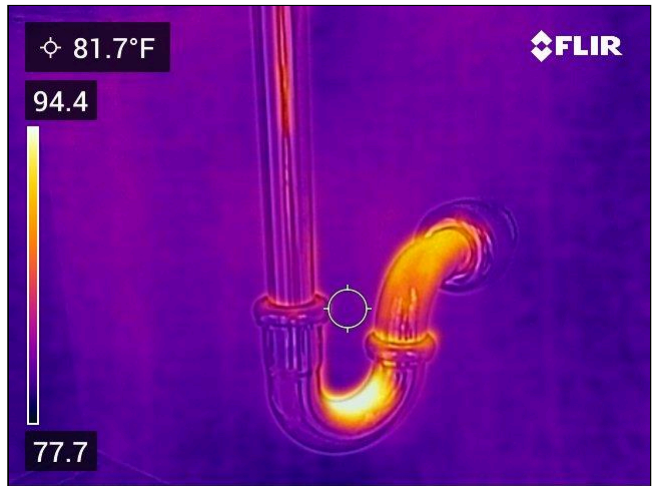
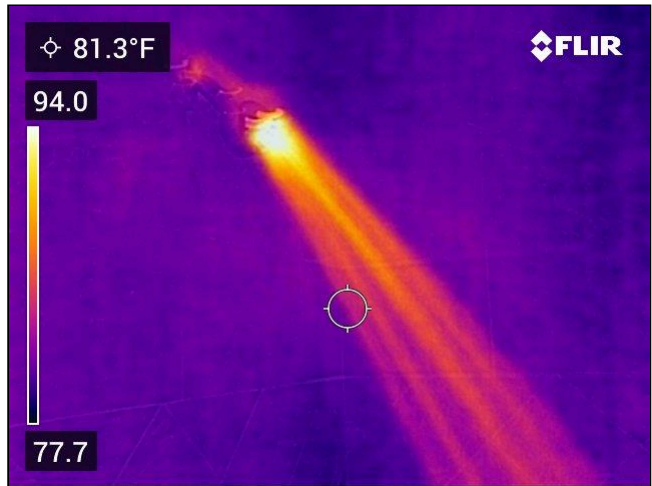
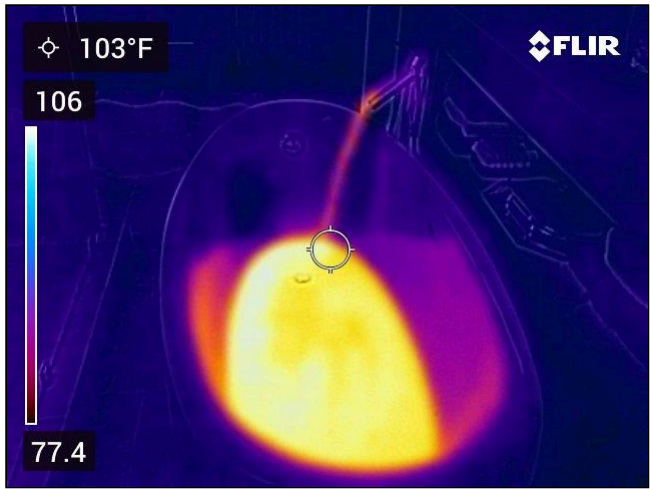
(1) Infrared Camera Thermal Photos.
