Inspection Report

Property Address:
4123 Main Place
Oceanside CA 92054

The Property Inspection Pros

Date: 7/18/2024	Time: 01:00 PM	Report ID:
Property: 4123 Main Place Oceanside CA 92054	Customer: Jon Rikki	Real Estate Professional:

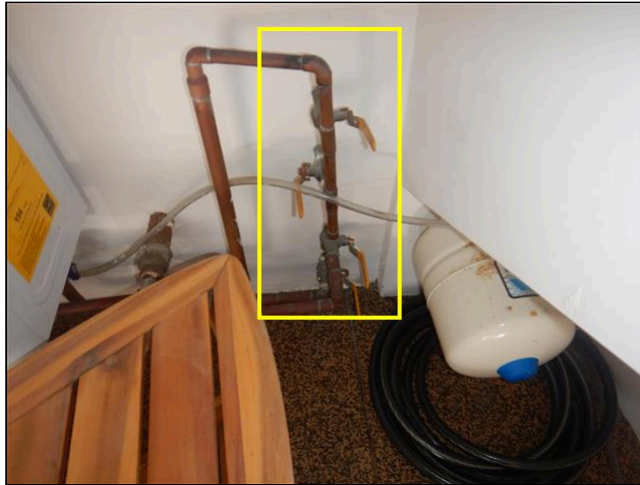
7.1 Item 1(Picture)

Several corroded pipes and water shut off valves are observed in the garage. We recommend further evaluation by a qualified licensed plumber and necessary repairs made.

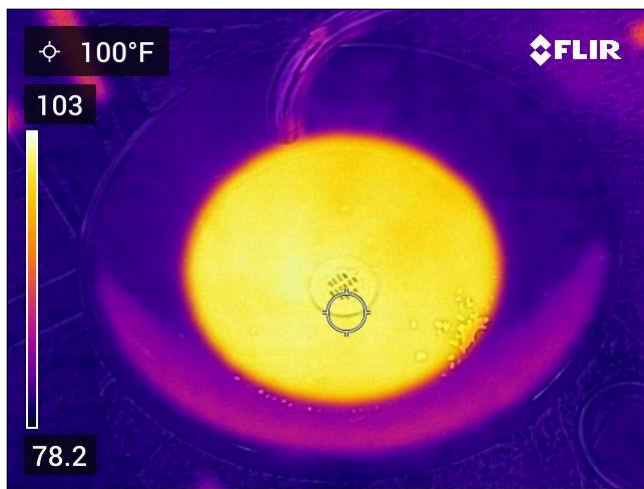
8.0.A Item 2(Picture)

(1) The sink in the bathroom was slow draining at the time of the inspection This may indicate a blockage in the drain line. We recommend further evaluation by a qualified licensed plumber and repairs as needed.

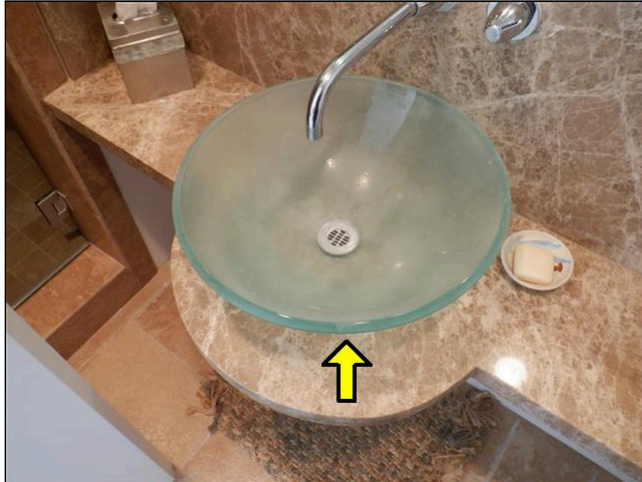
8.0.A Item 3(Picture)

(2) The sink is loose on the countertop. This is non standard. We recommend making necessary repairs where needed by a licensed plumber.

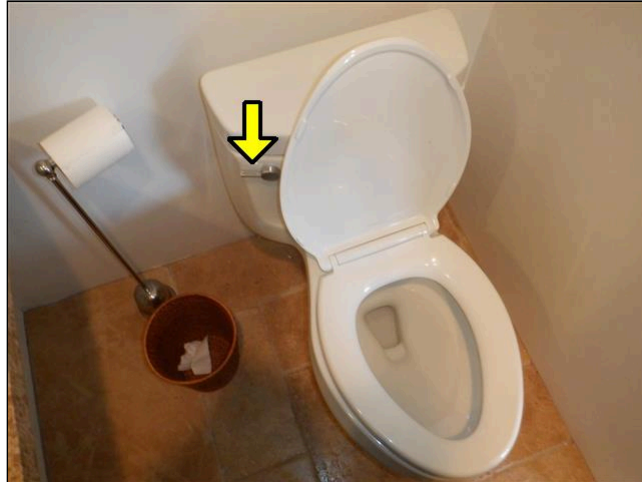
8.1.A Item 1(Picture)

The toilet did not flush when tested. We recommend further evaluation and necessary repairs by a licensed plumber.

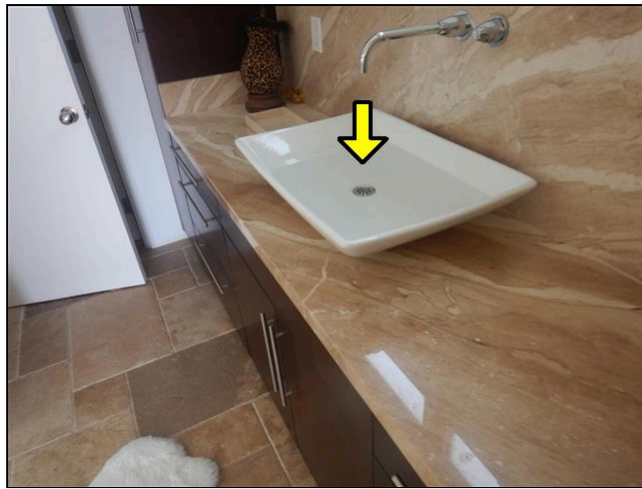
8.0.D Item 1(Picture)

The right side sink in the master bathroom was slow draining at the time of the inspection This may indicate a blockage in the drain line. We recommend further evaluation by a qualified licensed plumber and repairs as needed.

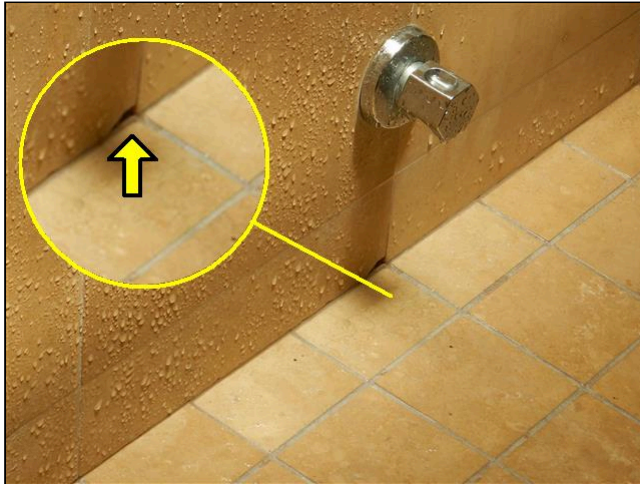
8.1.D Item 1(Picture)

(1) The tile surround has cracked or missing grout between the tiles and needs repair or replace. There may be water damage to the wall behind the tiles which is not visible. Determining if water damage exists in the wall behind tiles is beyond the scope of our general home inspection. We recommend having the tiles repaired by a licensed tile contractor. Additional repairs may be required when tiles are removed. This area should be evaluated further by a qualified licensed tile contractor prior to the end of your contingency period.

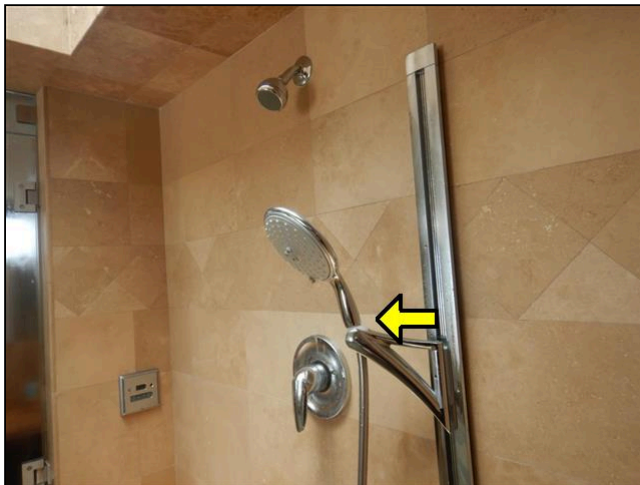
8.1.D Item 2(Picture)

(2) The shower head leaks when the water is running through it. We recommend replacement by a qualified person.

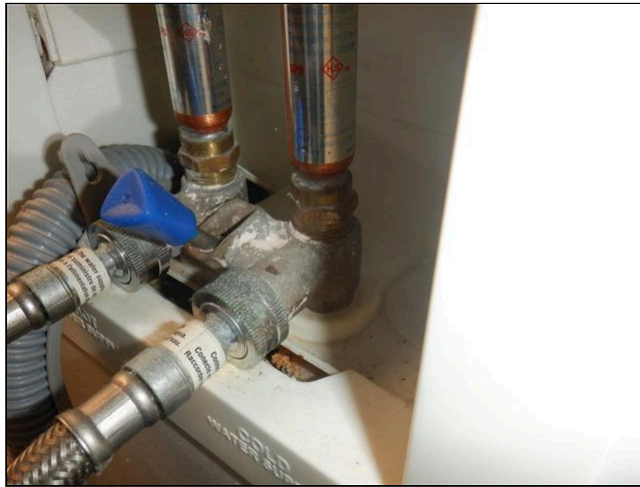
9.0 Item 1(Picture)

(1) The laundry faucet valves are corroded. We recommend replacement by a qualified licensed plumber.

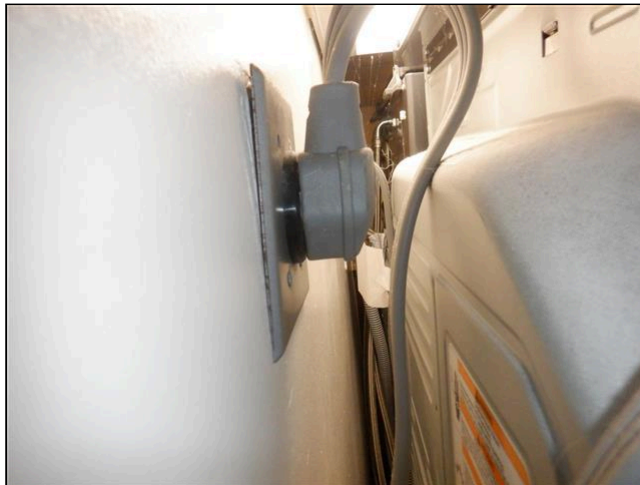
9.0 Item 2(Picture)

(2) There is a three prong 220 volt receptacle installed for the dryer. Most new electric dryers require a four prong receptacle. If you install an electric dryer, you may need to upgrade the receptacle or the dryer power cord. We recommend necessary corrections by a qualified licensed electrician.

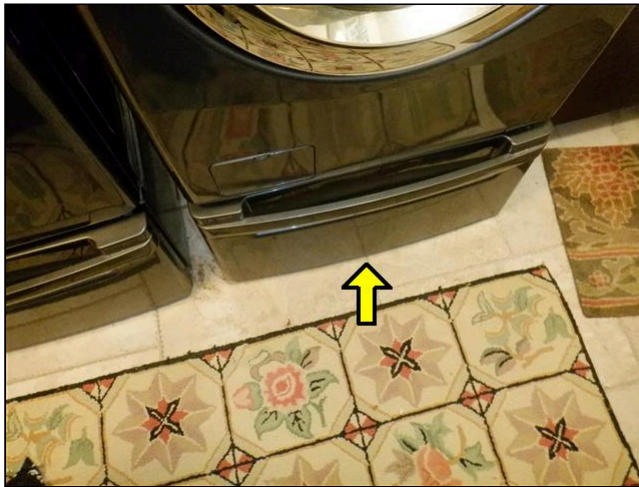
9.0 Item 3(Picture)

(3) A washer pan and drain line is not installed under the washing machine. When a washing machine is installed on a floor level above another finished floor a washer pan and drain line should be installed to help prevent damage from an overflowing washer or a leak. We recommend installing a drain pan and a drain line if possible by a qualified licensed plumber.

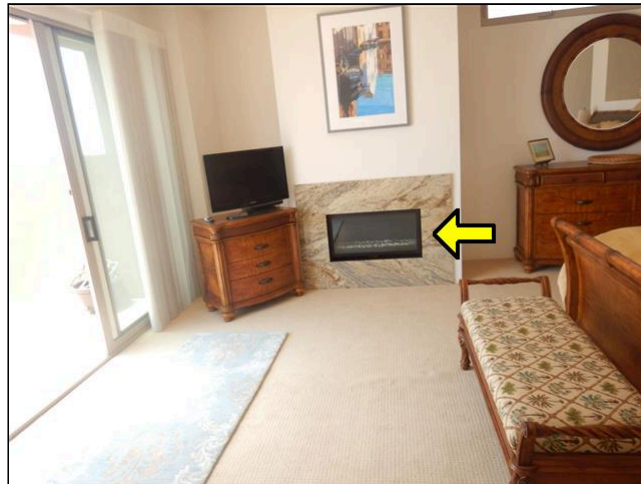
10.2 Item 1(Picture)

(1) The wall switch does not shut off the master bedroom gas fireplace. We recommend further evaluation and necessary repairs by a qualified licensed contractor.

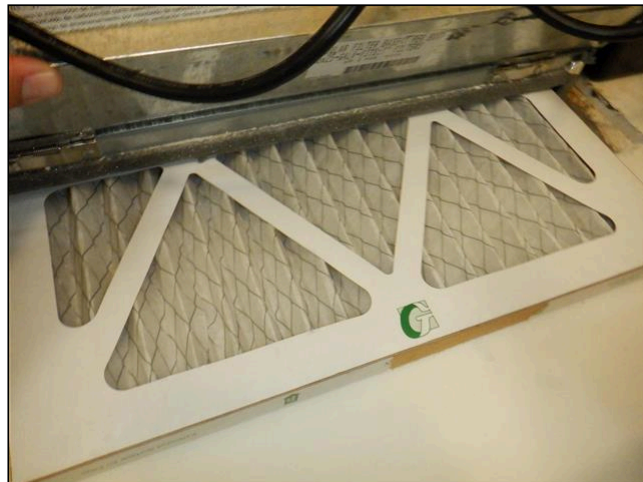
12.3 Item 1(Picture)

The air filter(s) for the HVAC system is dirty. We recommend recommend replacing by a qualified person.

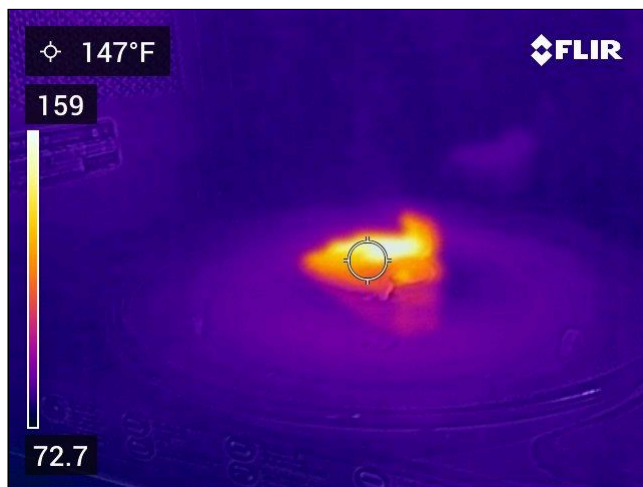
16.0 Item 1(Picture)

Photo of microwave being tested.

The built in microwave was tested with a microwave testing device and was functional at the time of the inspection. This is not an exhaustive test, and does not predict the performance of the microwave.

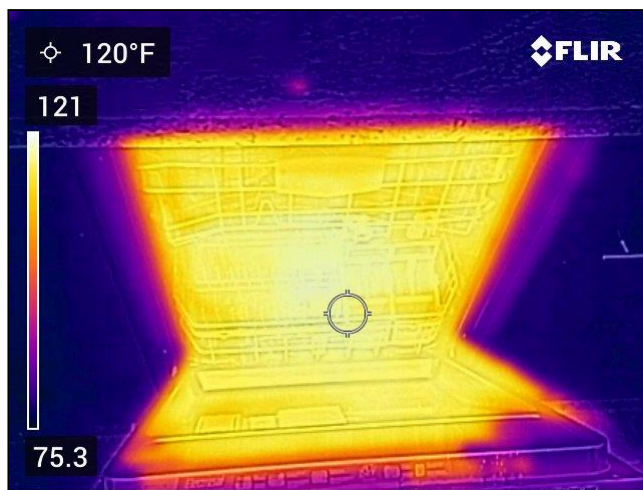
16.1 Item 1(Picture)

(1) **Infrared Thermal photo of the right side dishwasher being tested.**

The right side dishwasher was tested and functioned properly at the time of the inspection. This is not an exhaustive test and does not verify the cleaning efficiency of the dishwasher.

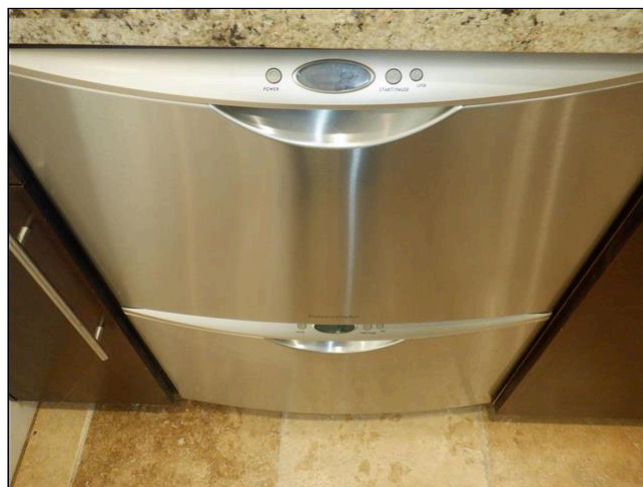
16.1 Item 2(Picture)

(2) The left side double dishwashers showed an error code when turned on. We recommend further evaluation by a licensed appliance contractor and have repairs/ replacement made where needed.

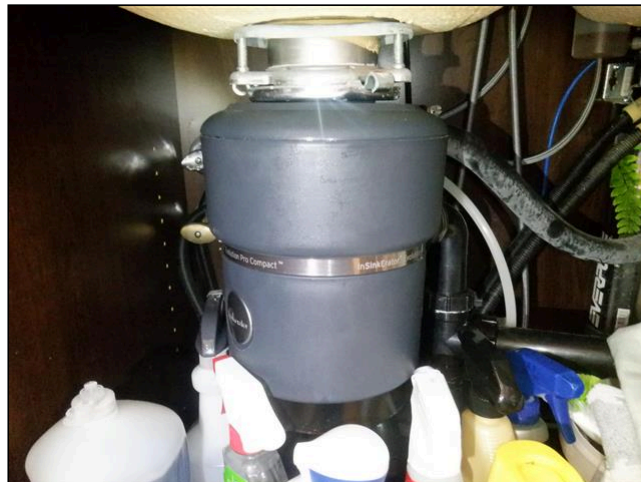
16.2 Item 1(Picture)

The food waste disposer was tested and functioned properly at the time of the inspection. This is not an exhaustive test and does not verify the efficiency of the unit.

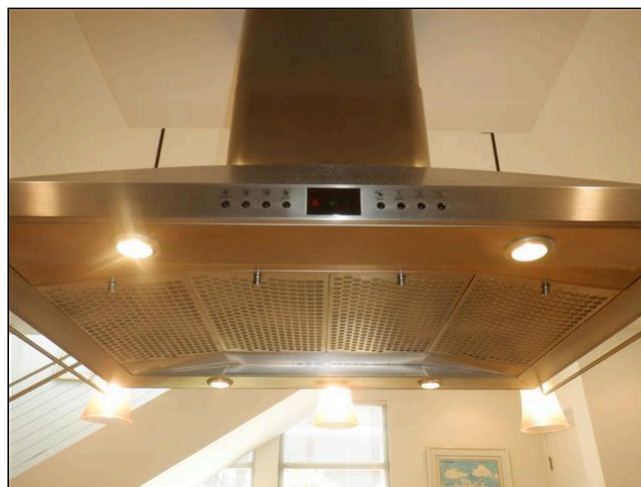
16.3 Item 1(Picture)

The range exhaust vent was tested and was functional at the time of the the inspection. This is not an exhaustive test, and does not evaluate the performance or effectiveness of the unit.

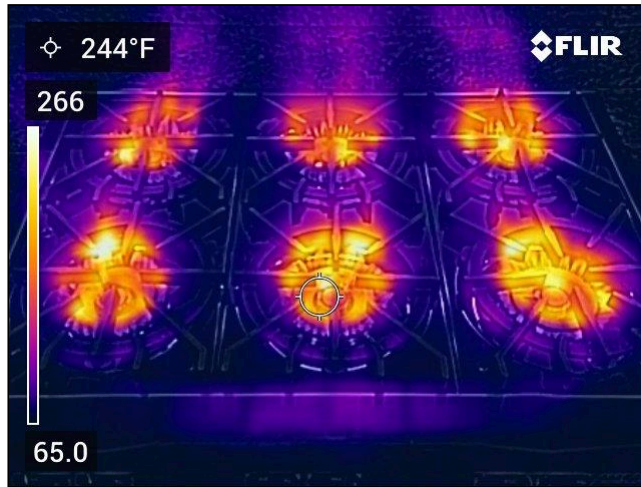
16.4 Item 1(Picture)

Infrared Thermal photo of the cooktop being tested.

The cooktop was tested and was functional at the time of the inspection. This test is not exhaustive and does not confirm the performance, accuracy, or effectiveness of the cooktop.

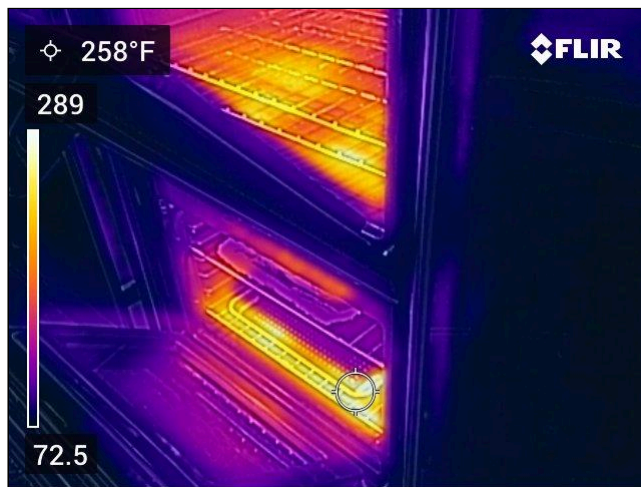
16.5 Item 1(Picture)

Infrared Thermal photo of the wall oven(s) being tested.

Both of the wall ovens were tested and were both functional at the time of the inspection. This test is not exhaustive and does not confirm the performance, accuracy, or effectiveness of the wall ovens.

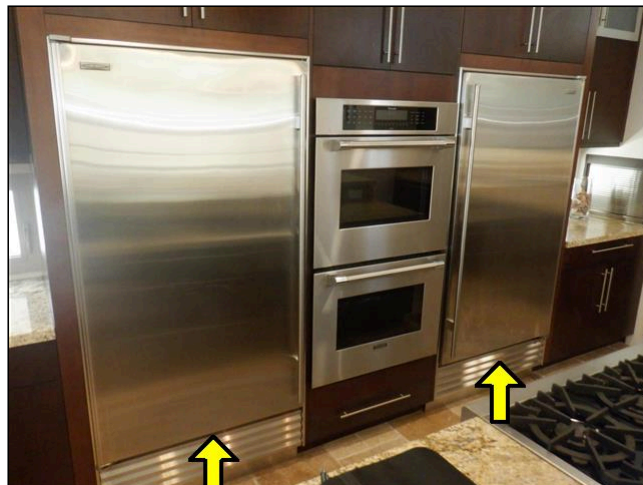
16.6 Item 1(Picture)

(1) Refrigerators built in or not are not part of our general home inspection and are not inspected or commented on. If concerned about its serviceability and functionality we recommend further evaluation by a qualified licensed appliance contractor prior to the end of your contingency period.

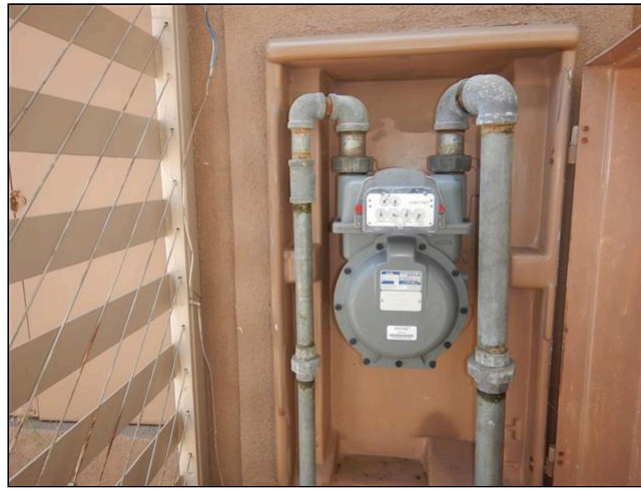
17.0 Item 1(Picture)

The main gas shut off valve is located at the gas meter at the right exterior side of the property (facing front).

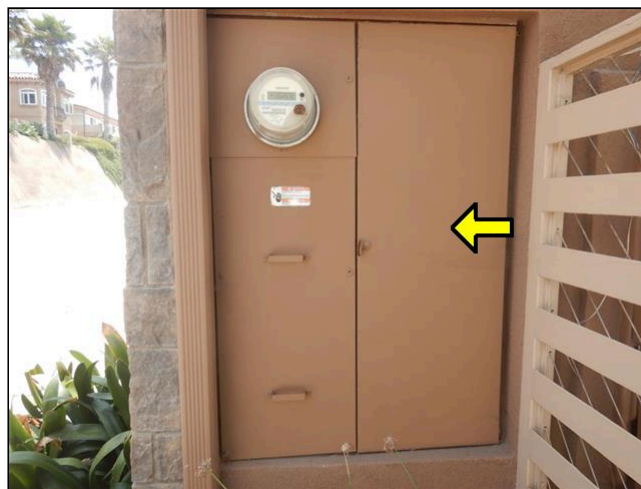
17.1 Item 1(Picture)

The Main Electrical panel is located at the right exterior side of the property (facing front).

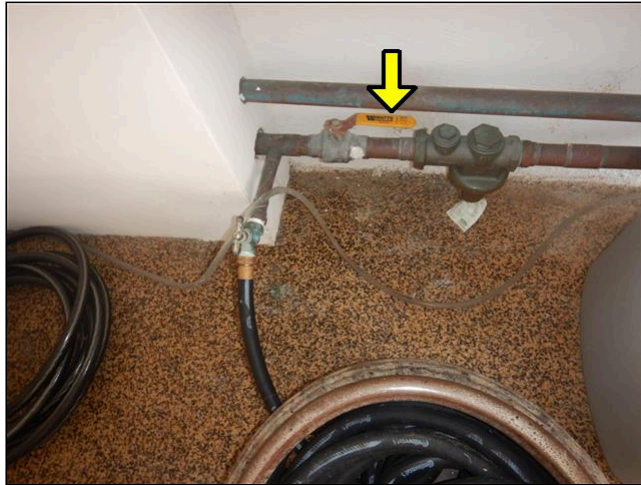
17.2 Item 1(Picture)

The main water shut off valve is located in the garage.

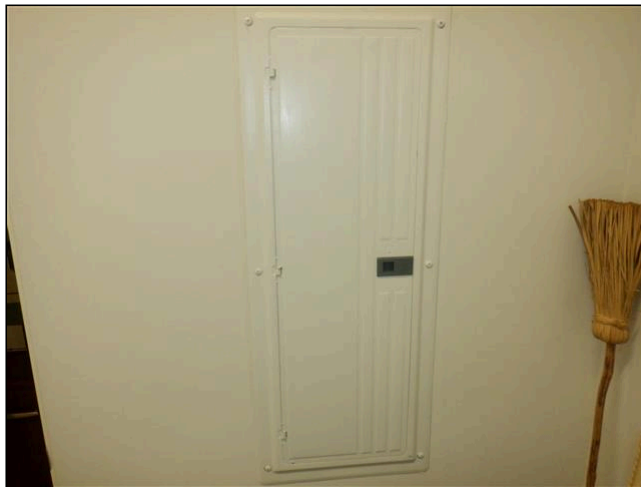
17.3 Item 1(Picture)

A sub panel is located in the downstairs "office."
