# Inspection Report

**Property Address:**  
4312 Main Place  
Coronado CA 92118

**The Property Inspection Pros**

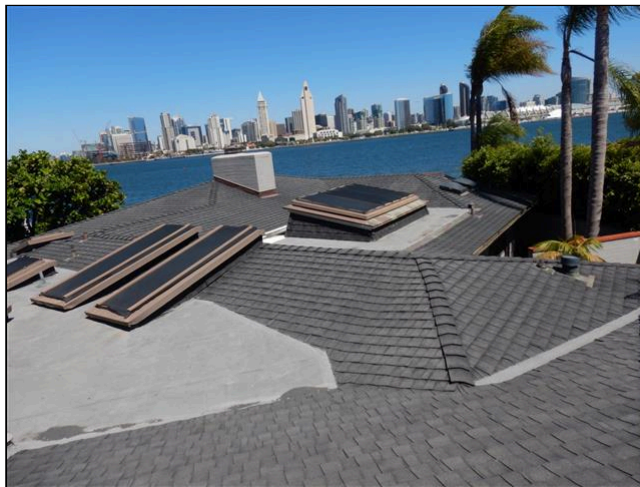
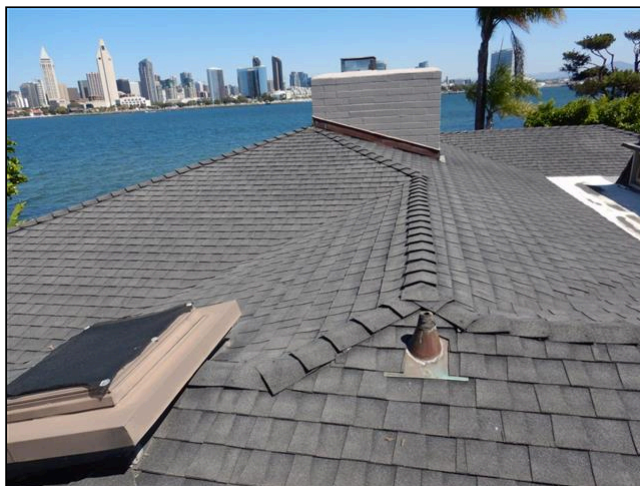
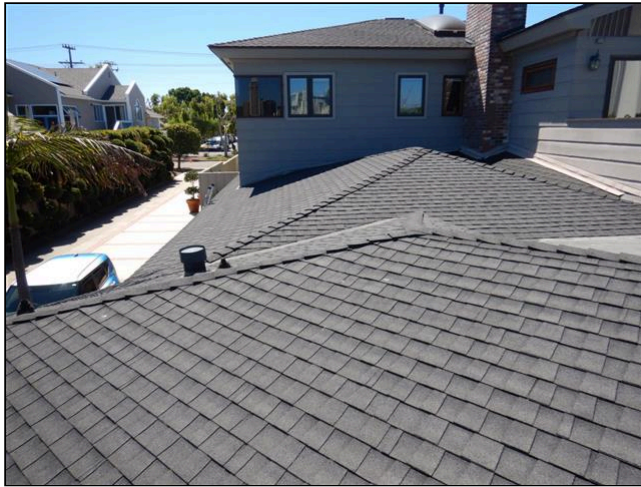
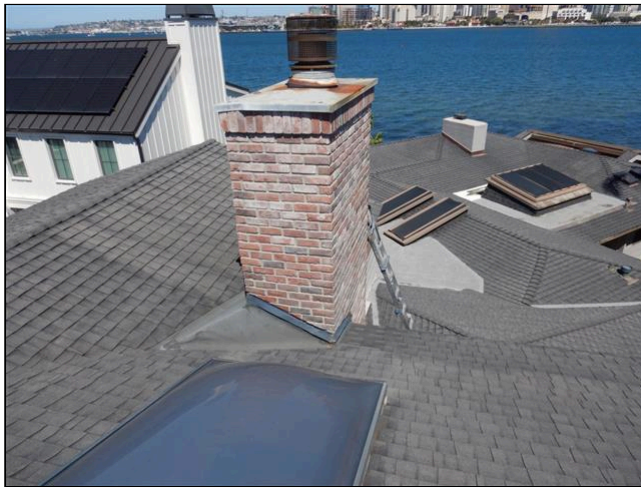
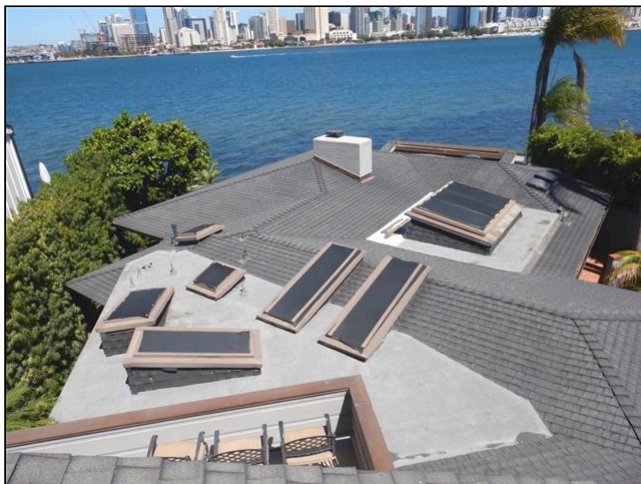
(1) [Photo\(s\) of the roof.](#)

(2) The roof material shows normal wear for its age and type; appears to be in serviceable condition.

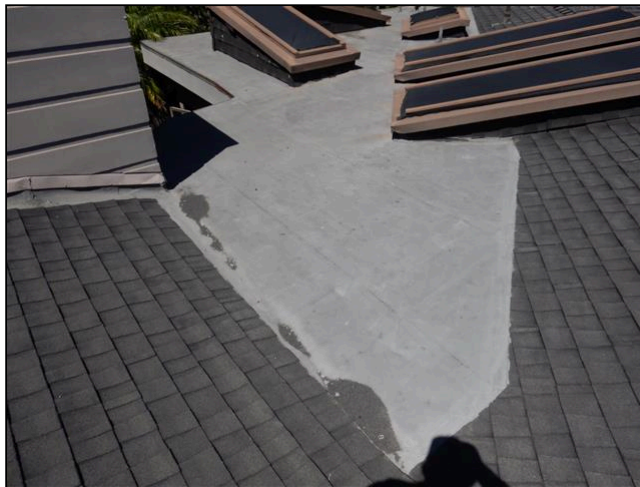
1.1 Item 1(Picture)

The flat roof material shows normal wear for its age and type; appears to be in serviceable condition.

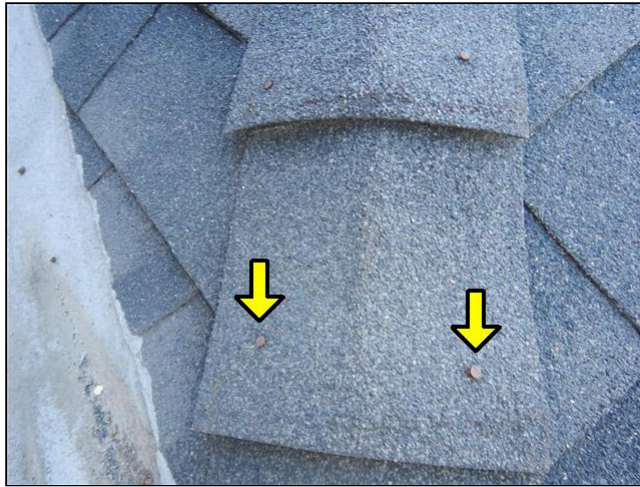
1.2 Item 3(Picture)

(1) Sealant around some of the roof flashings/ penetrations is cracked. We recommend having sealant applied where needed to help prevent roof leaks by a licensed roofer.

(2) There are several exposed nails at the metal flashings and ridge caps. We recommend properly sealing these surfaces by a qualified person to help prevent roof leaks.

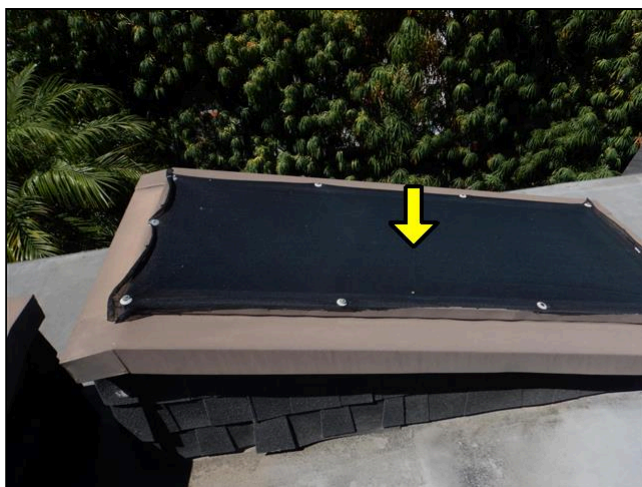
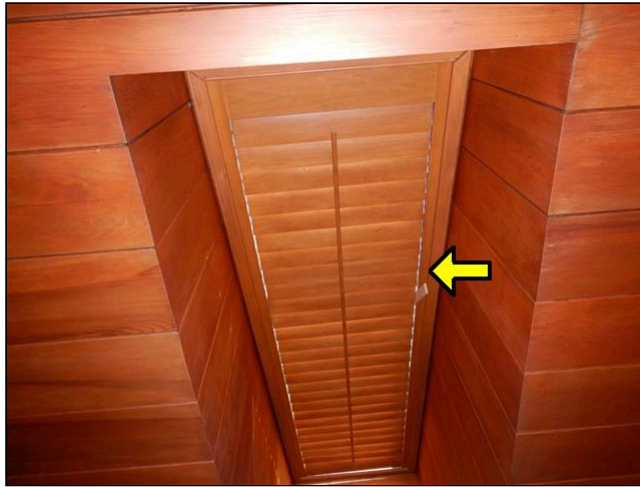
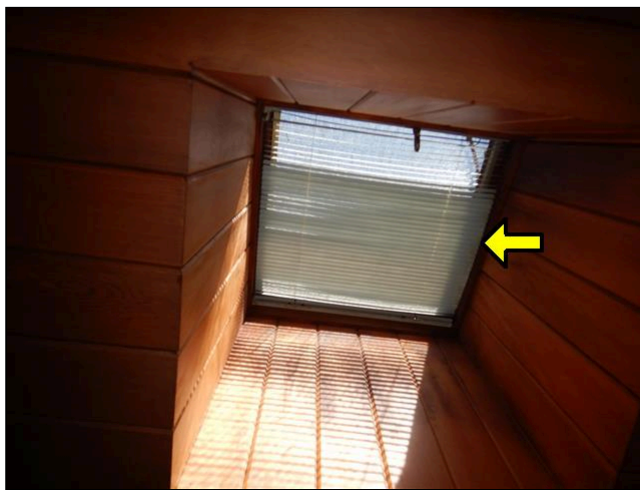
(1) The majority of the skylights had a shade cover material installed over them. Due to this condition we could not observe these skylights. We recommend having the shade material removed and these skylights inspected by a licensed roofing contractor prior to the end of your contingency period.

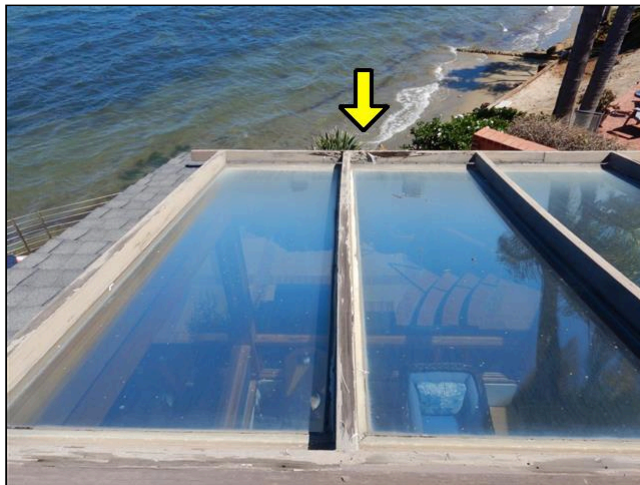
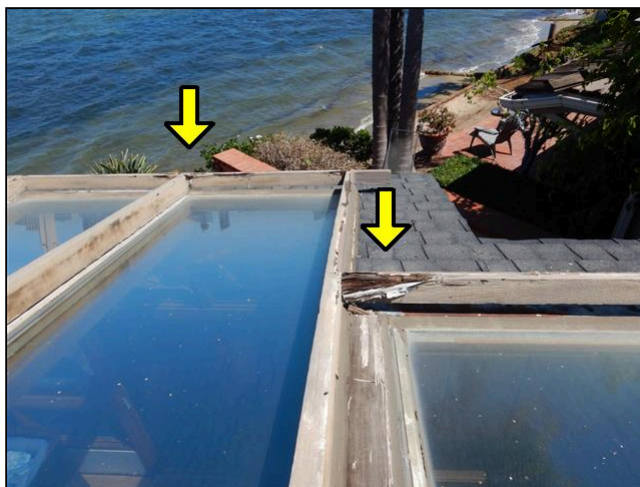
(3) Damaged wood is observed at the sun room skylights at several areas. We recommend replacing the damaged wood where needed by a qualified licensed contractor.

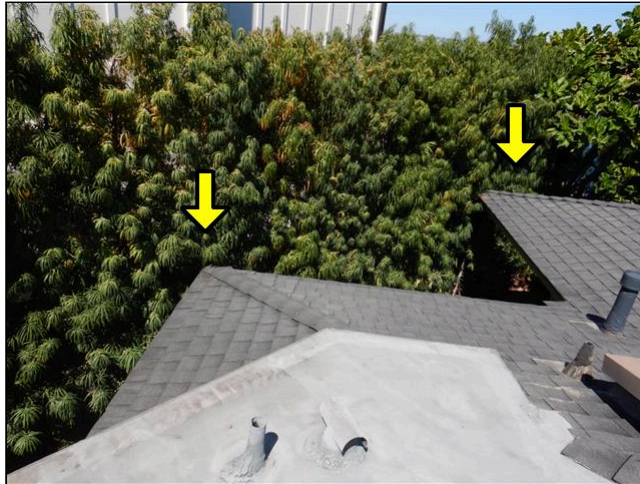
2.1 Item 1(Picture)

Tree(s) and/or large plants are located too close to the house. Tree limbs/vegetation that are too close to the house can cause damage in several ways. Limbs or vines in contact with roof or hanging near roof should be trimmed to prevent damage to roof and/or to prevent rodent infestation. Also, as the plants grow, damage can occur to the siding, concrete flat work and to the foundation. We recommend having the foliage removed or trimmed by a qualified professional to prevent damage to the house as soon as possible.

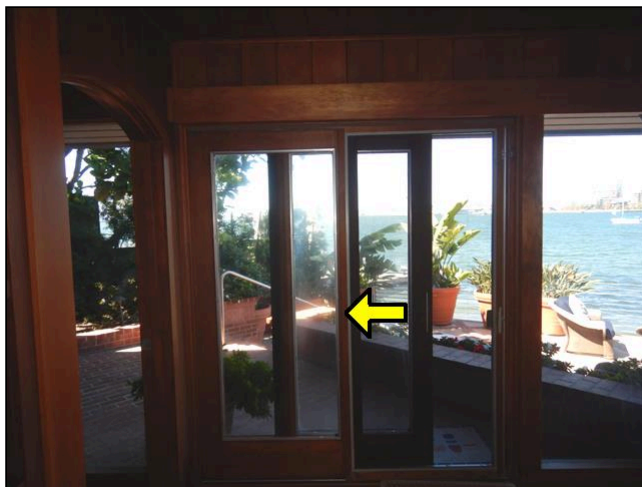
2.5 Item 3(Picture)

(3) The glass doors throughout the house were dirty at the time of the inspection. This condition limits the inspectors ability to observed fogged glass (failed seals in double pane glass) or cracked glass. We recommend that all the glass doors be professionally cleaned and then inspected by this company or by a qualified licensed window contractor prior to the end of your contingency period.

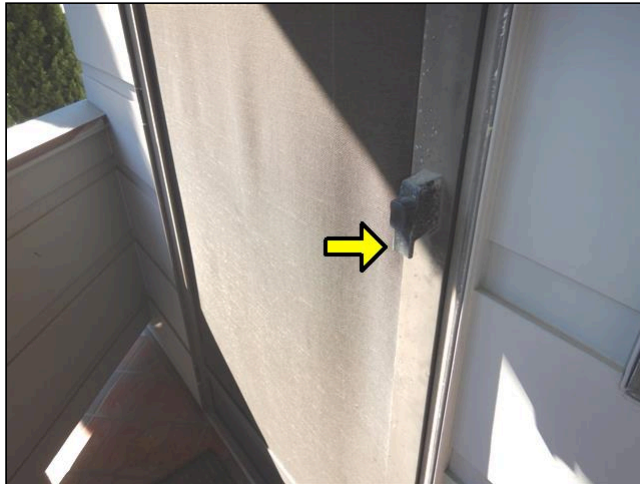
2.5 Item 5(Picture)

(5) The guest house kitchen screen door has a damaged handle. We recommend replacement by a qualified person.

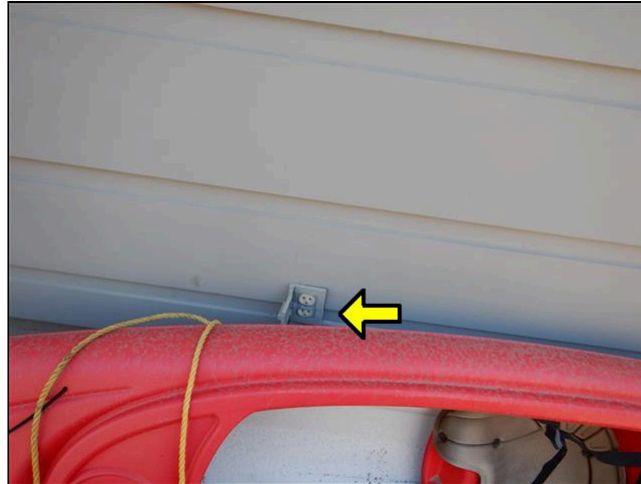
2.11 Item 1(Picture)

There are no GFCI protected receptacles at the exterior of the house(s). We recommend upgrading the exterior receptacles to GFCI protected receptacles by a qualified licensed electrician for safety.

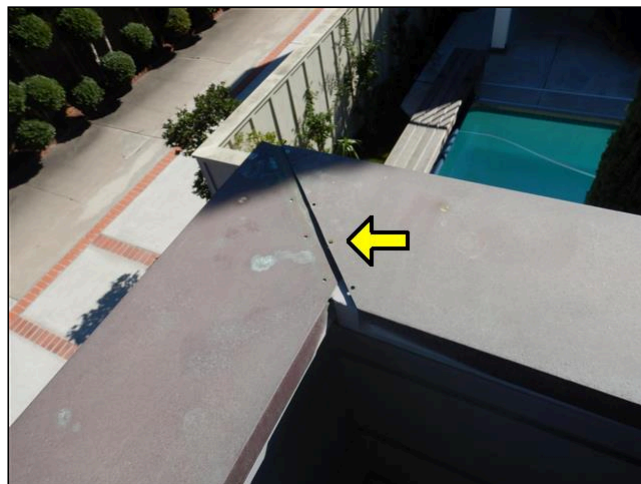
2.13 Item 1(Picture)

The top metal cap is loose at the upper left side deck area. We recommend necessary repairs by a qualified licensed contractor.

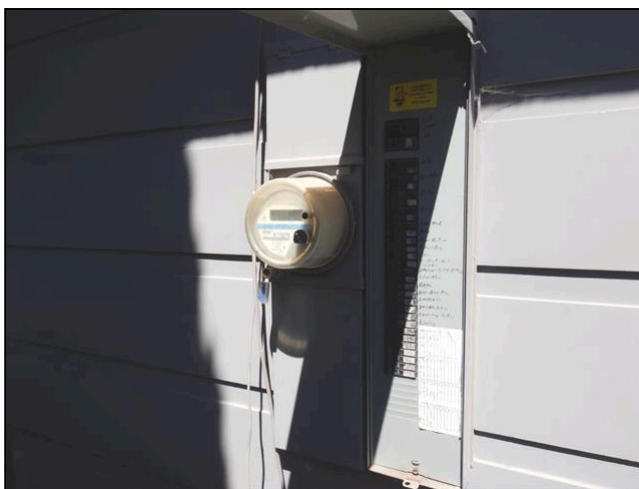
3.0 Item 1(Picture)

[Photo of the main electrical panel.](#)

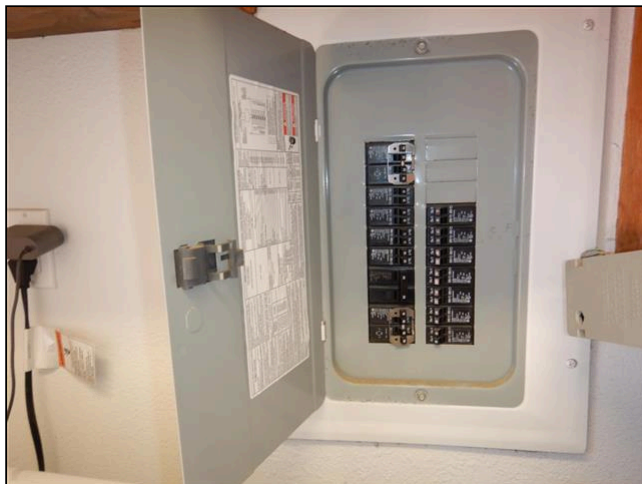
3.1 Item 1(Picture)

(1) **Photo of the sub electrical panel in the main house laundry room.**

(2) The sub panel breakers are not labeled at the sub panel in the main house laundry room. We recommend having the breakers properly labeled for safety by a qualified person.

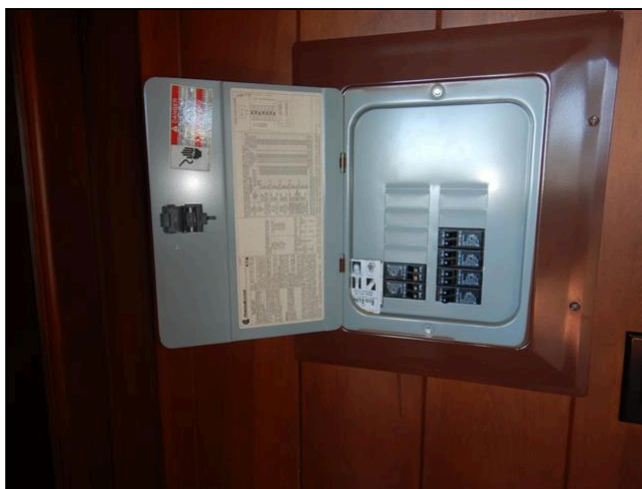
3.1 Item 2(Picture)

(3) **Photo of the sub electrical panel located in the main house bedroom.**

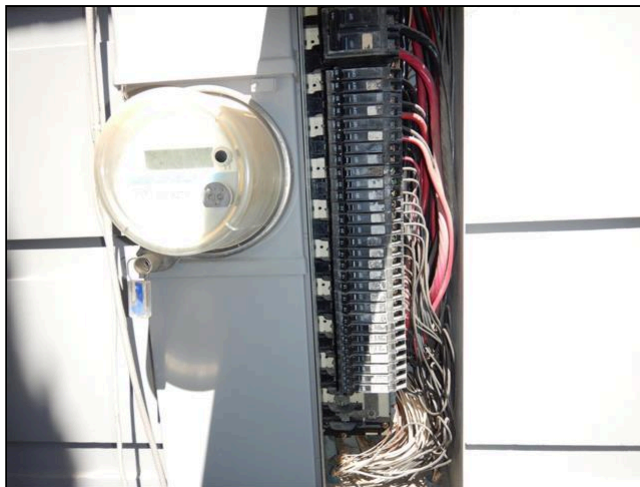
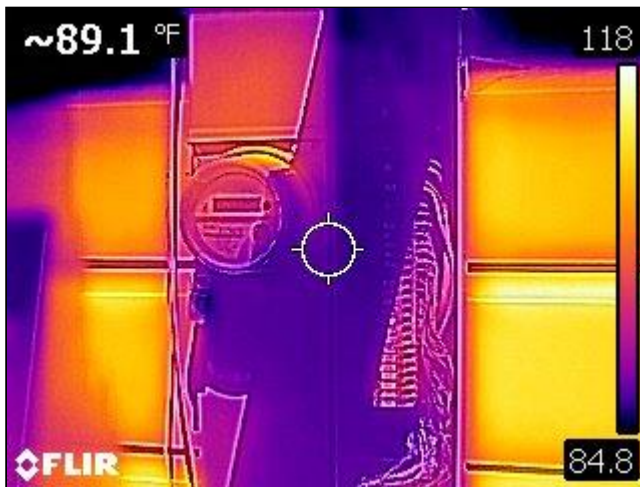
(1) **Photo inside of the main electrical panel.**

The dead front cover was removed at the time of the inspection and the breakers, wiring and grounding were inspected. Appears to be functioning as intended.

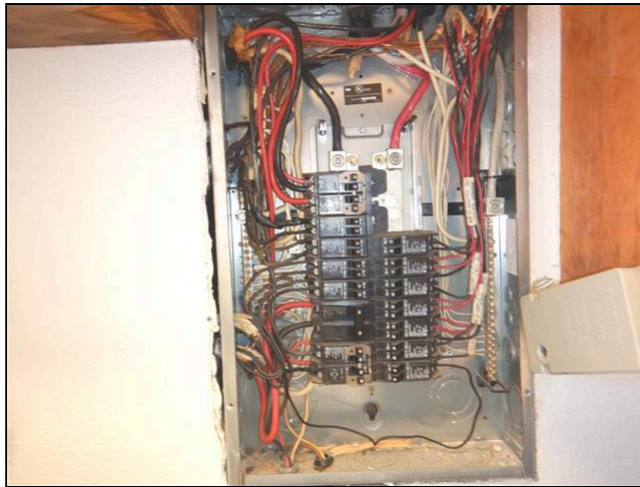
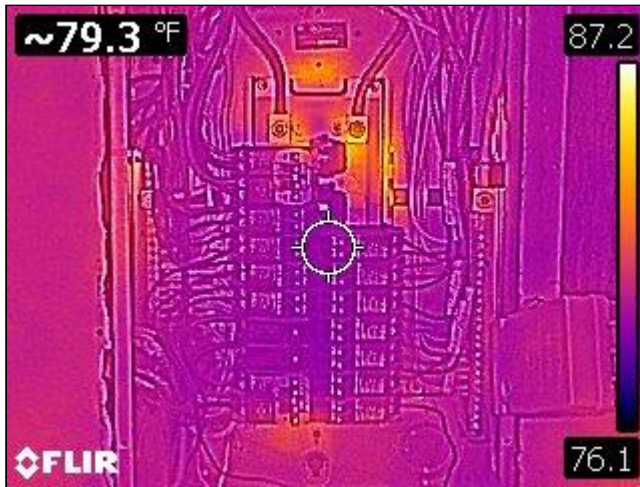
(2) **Photo inside of the main house laundry room sub electrical panel.**

The dead front cover was removed at the time of the inspection and the breakers, wiring and grounding were inspected. Appears to be functioning as intended.

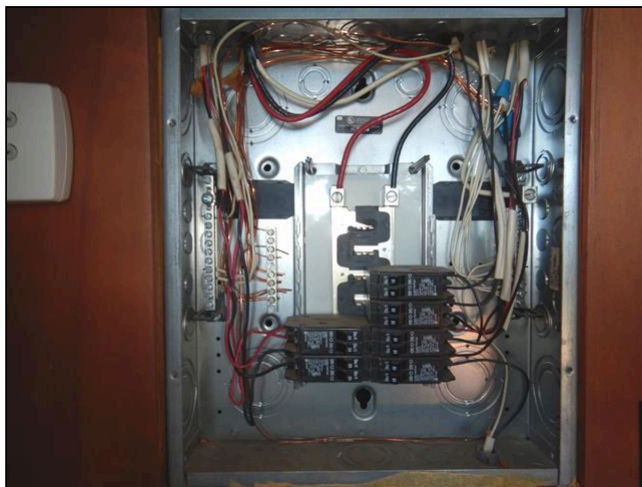
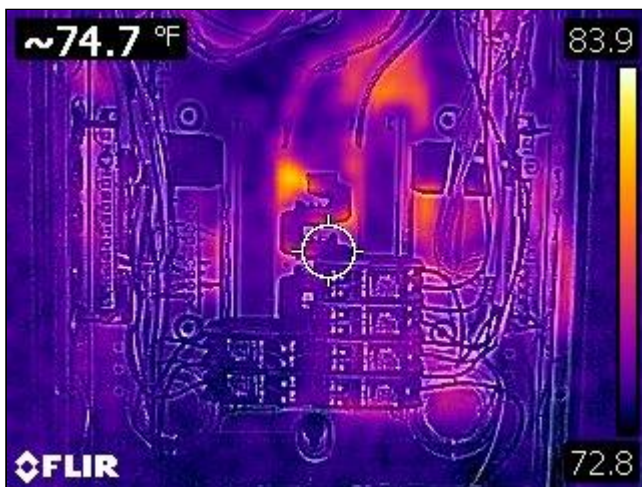
(3) **Photo inside of the sub electrical panel located in the main house bedroom.**

The dead front cover was removed at the time of the inspection and the breakers, wiring and grounding were inspected. Appears to be functioning as intended.

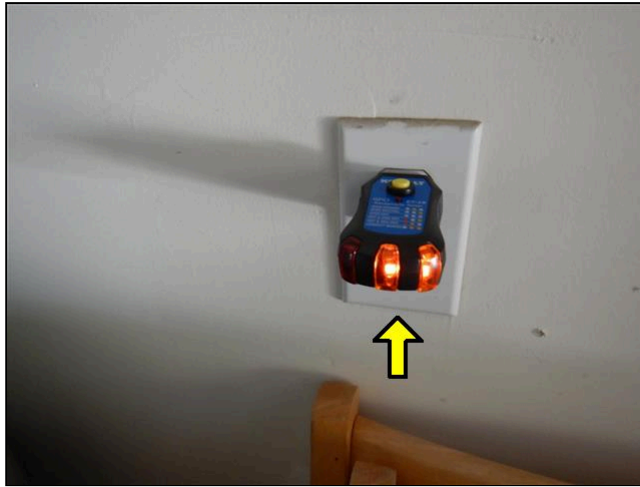
3.7 Item 1(Picture)

**Photo of a receptacle being tested.**

A representative number of receptacles throughout the property were tested for power, polarity and grounding according to our standards-of-practice. These receptacles observed to be ok at the time of the inspection unless otherwise noted.

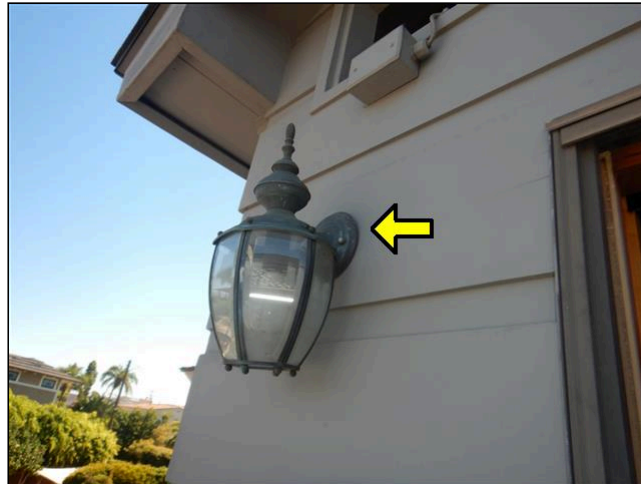
3.13 Item 1(Picture)

condition could allow moisture intrusion in this area. We recommend sealing exterior light fixtures where they meet the wall by a qualified person.

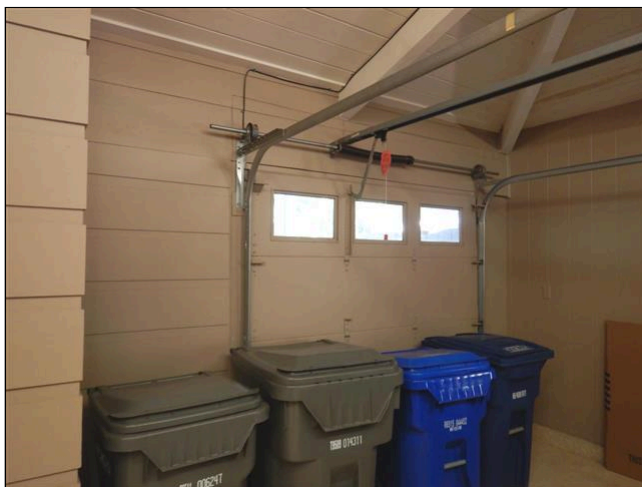
4.0.A Item 1(Picture)

The garage vehicle door hardware including the doors, tracks, and springs appear to be functioning as intended.

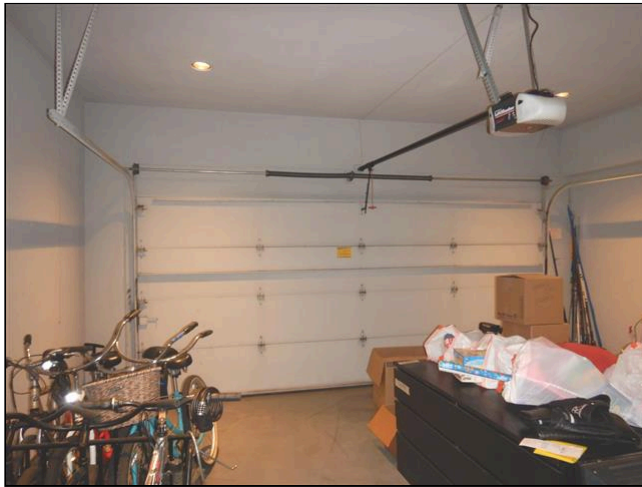
4.0.B Item 1(Picture)

The garage vehicle door hardware including the door, track, and springs appear to be functioning as intended.

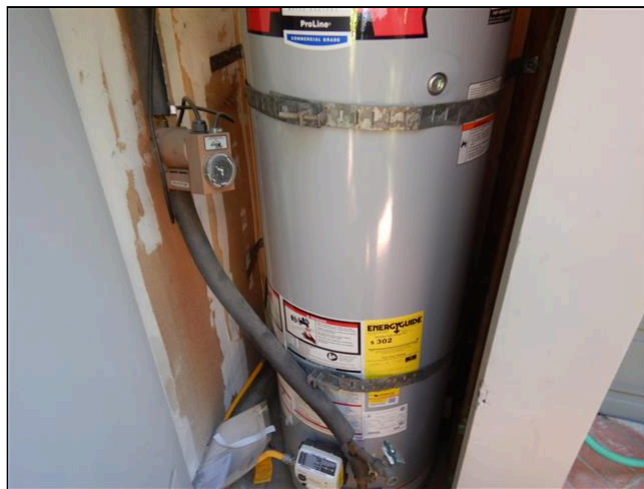
5.0.A Item 1(Picture)

- (1) [Photo of the water heater.](#)

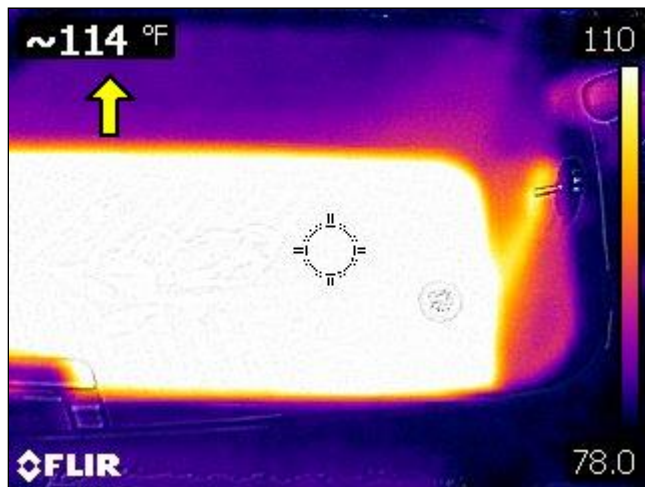
5.0.A Item 2(Picture)

(2) The water heater was inspected and was found to be operational at the time of the inspection. We did not evaluate the efficiency or recover rate of the water heater which is beyond the scope of a general home inspection. If concerned we recommend you consult a licensed plumber. We recommend flushing the water heater routinely as regular maintenance.

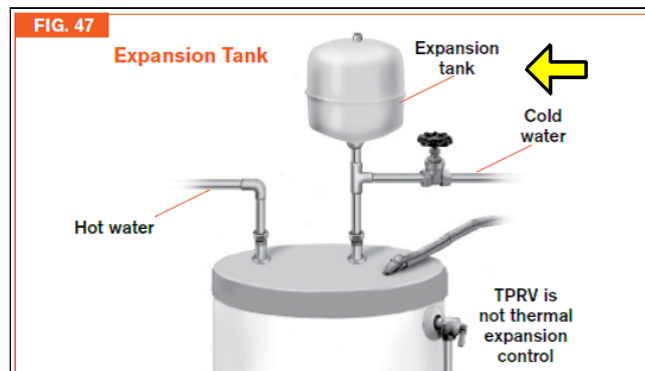
5.0.A Item 4(Picture)

(5) The water heater does not have a "Thermal Expansion Tank" installed to prevent a possible leak at the T&P or "pop-off" valve. Recent changes in code require one when a new water heater is installed. This change is not retroactive on older previously installed Gas/LP water heaters. There were no leaks or drips at the T&P valve during inspection. If your water heater does begin to drip or leak, then a thermal expansion tank may be needed. We recommend installing a thermal tank by a qualified licensed plumber as an upgrade.

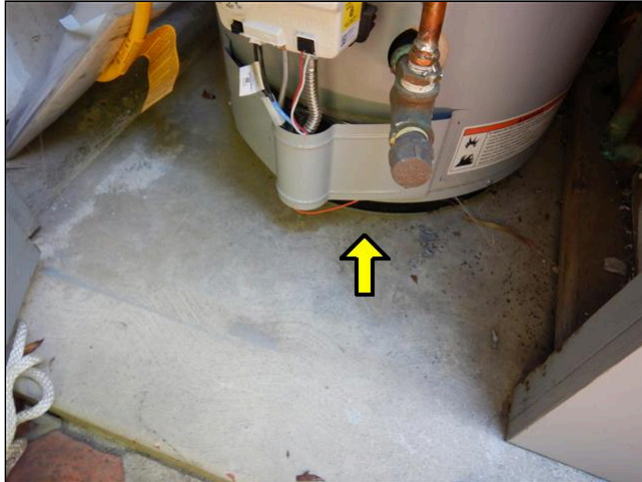
5.0.A Item 5(Picture)

(6) A leak pan is not installed under the water heater. We recommend installing a leak pan under the water heater by a qualified licensed plumber.

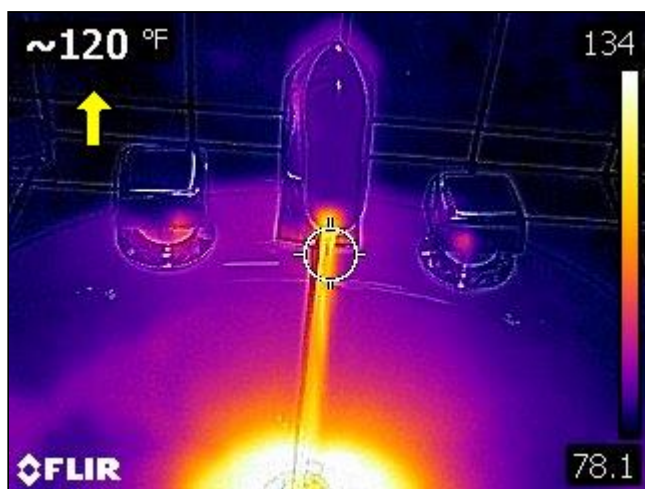
5.0.B Item 1(Picture)

- (1) The water heater was inspected and was found to be operational at the time of the inspection. We did not evaluate the efficiency or recover rate of the water heater which is beyond the scope of a general home inspection. If concerned we recommend you consult a licensed plumber. We recommend flushing the water heater routinely as regular maintenance.
- (2) **Thermal Photo of the water temperature.**

The temperature of the water was tested using a thermal camera during the inspection and was found to be operating within normal range.

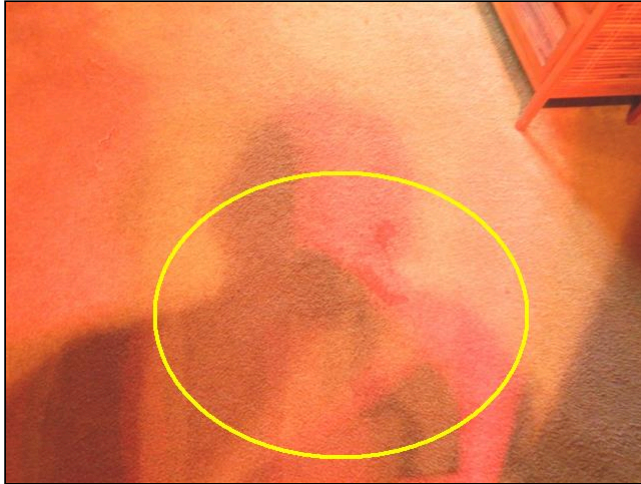
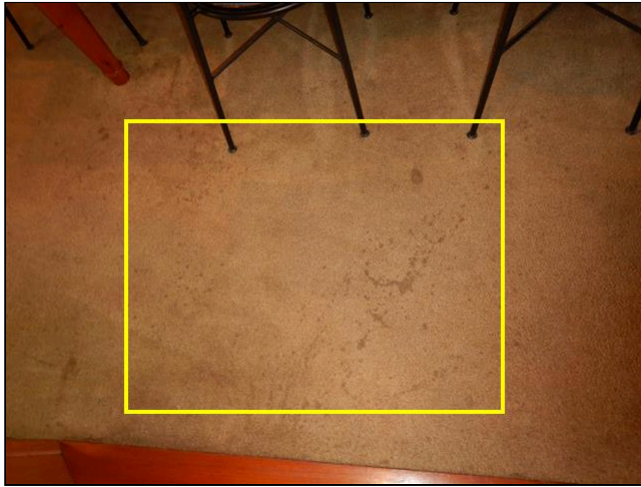
Carpets throughout both houses are dirty and stained. We recommend having them professional cleaned or replaced by a qualified licensed flooring contractor.

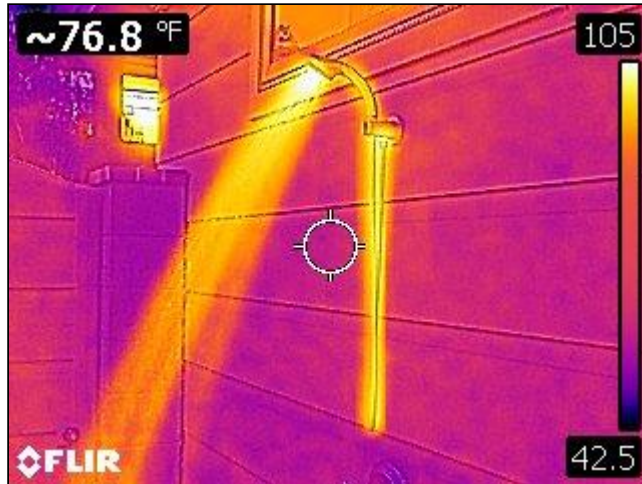
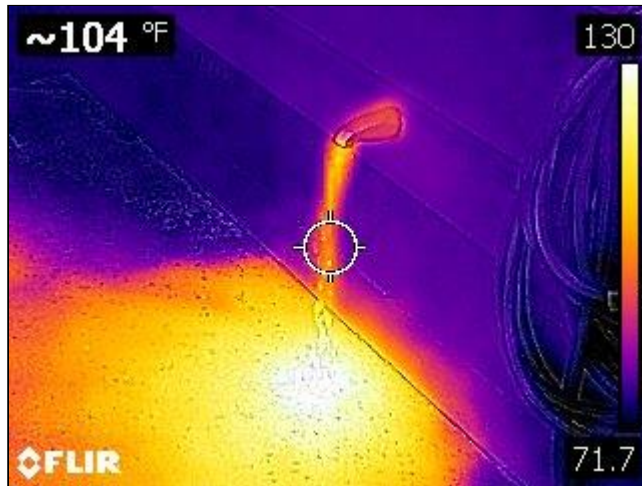
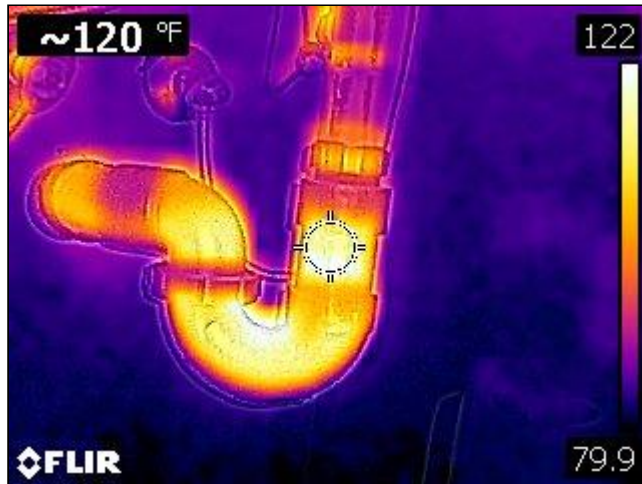
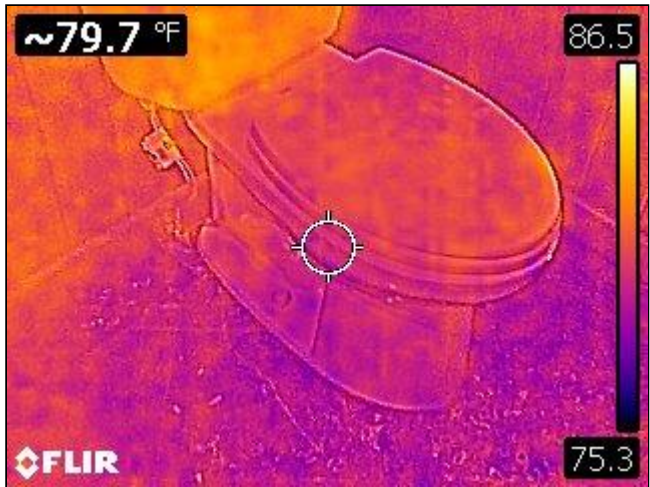
(1) Infrared Camera Thermal Photos.

(2) An infrared (thermal imaging) scan was performed throughout the property at the time of the inspection using a hand held infrared (thermal imaging) inspection camera. No anomalies were found at the time of the inspection using this camera.

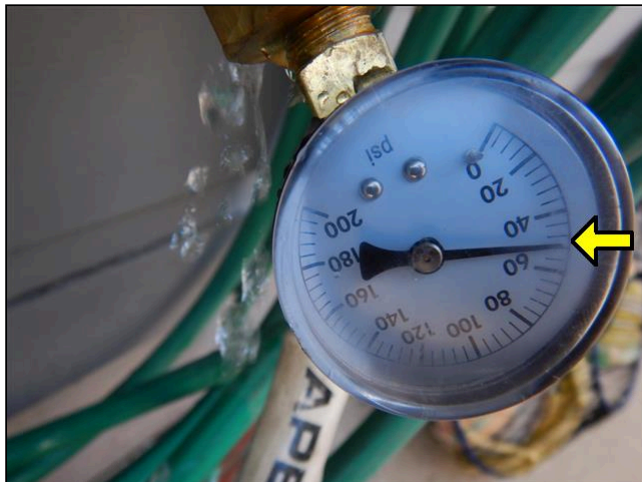
7.2 Item 1(Picture)

The water pressure was checked with a water pressure gauge and was measured and was found to be within the acceptable range at the time of the inspection.

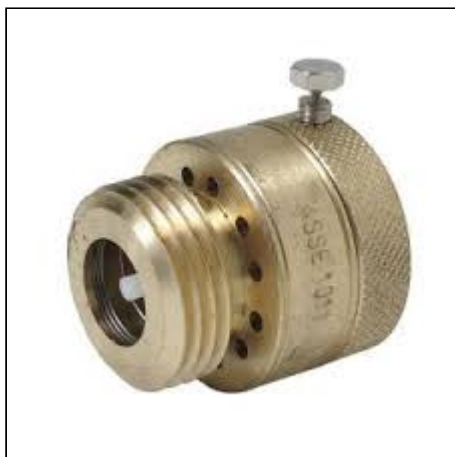
7.3 Item 1(Picture)

(1) Some of the exterior hose spigots do not have anti-siphon or anti-backflow devices installed on them. These anti-siphon or anti-backflow devices help prevent contaminated water from flowing back into the the house water supply system. We recommend installing anti-siphon or anti-backflow devices where needed by a qualified person.

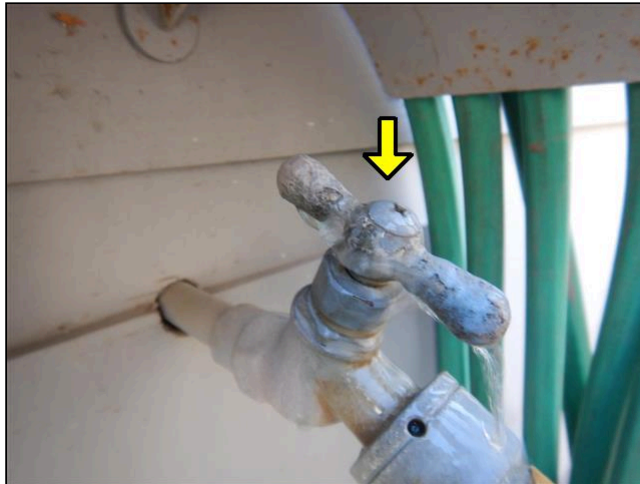
7.3 Item 2(Picture)

(2) Several exterior hose spigot handles leak when turned on. We recommend necessary repairs or replacement by a qualified licensed plumber.

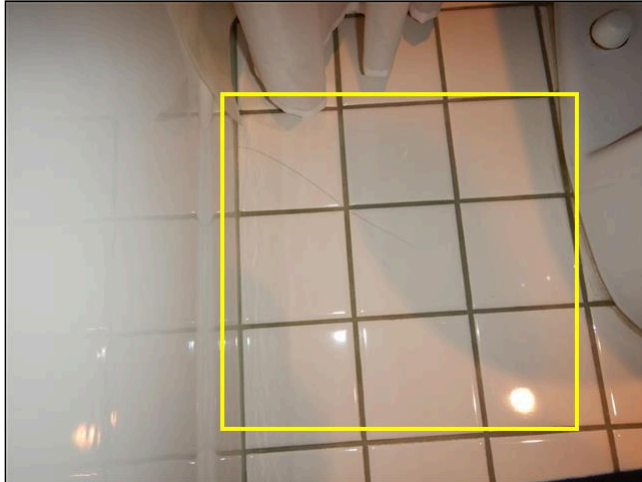
8.1.A Item 1(Picture)

Several cracked floor tiles are observed. We recommend necessary repairs or replacement by a qualified licensed flooring contractor.

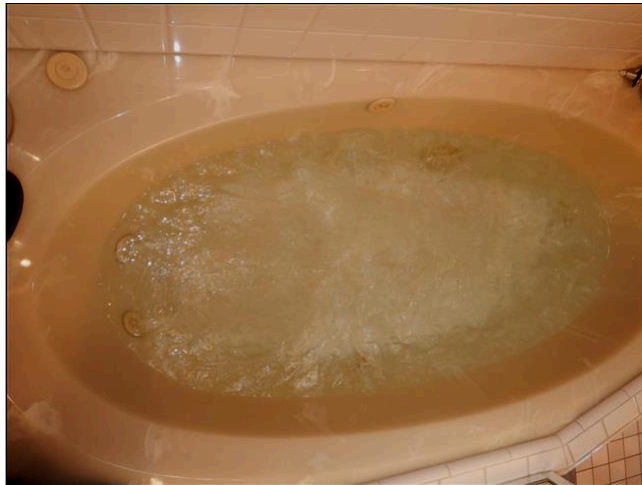
8.0.C Item 1(Picture)

(1) The jetted tub was filled and operated at the time of the inspection.

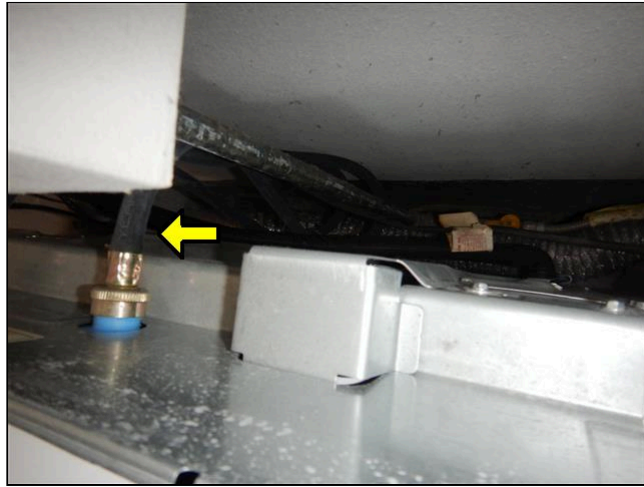
9.0.B Item 1(Picture)

**MAINTENANCE RECOMMENDATION:** Washer hoses are a common source of flooding in a home. Prior to connecting the washing machine we recommend installing new braided steel washer hoses to help reduce leaks caused by failed hoses. If any hoses are left in the house they should be replaced. The washing machine and dryer are not part of our general home inspection.

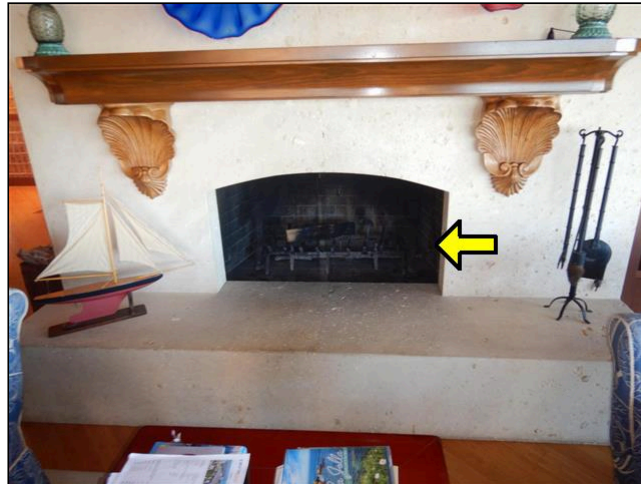
10.1 Item 1(Picture)

There are no glass doors installed at the main house fireplace. We recommend having glass doors installed by a qualified licensed chimney contractor as a safety upgrade.

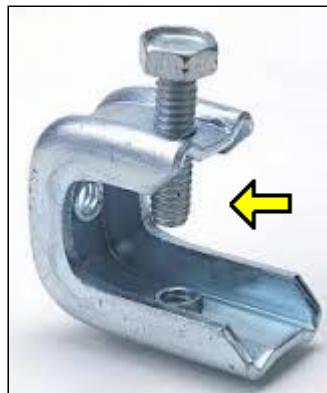
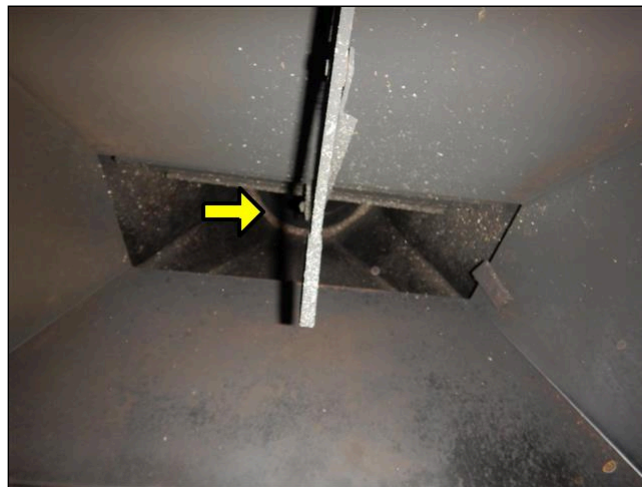
(1) Damper clamps are not installed at the fireplace damper doors. A damper clamp is required to be installed at a damper door when there is a gas supply to the fireplace(s). This damper clamp help prevents the damper from closing all the way as a safety precaution. If the damper is closed, Carbon Monoxide gas could enter the living space easier which is undetectable. SDG&E now requires damper clamps at all fireplaces damper doors. We recommend installation of a damper clamp at each fireplace damper door by a qualified person.

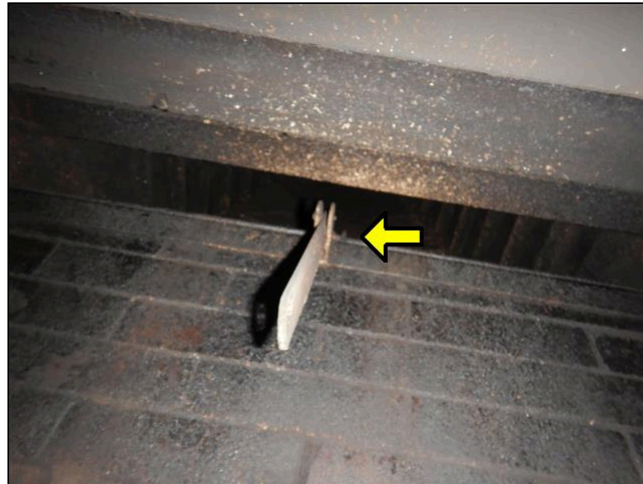
10.2 Item 3(Picture)

(2) The main house fireplace damper door is inoperable/ did not operate when tested. We recommend necessary repairs by a licensed chimney contractor.

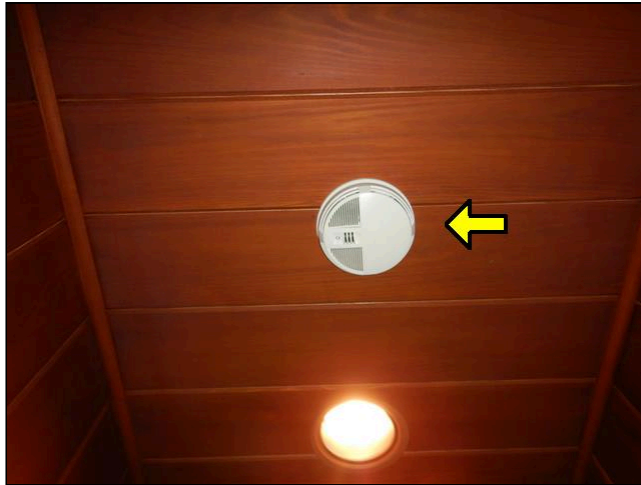
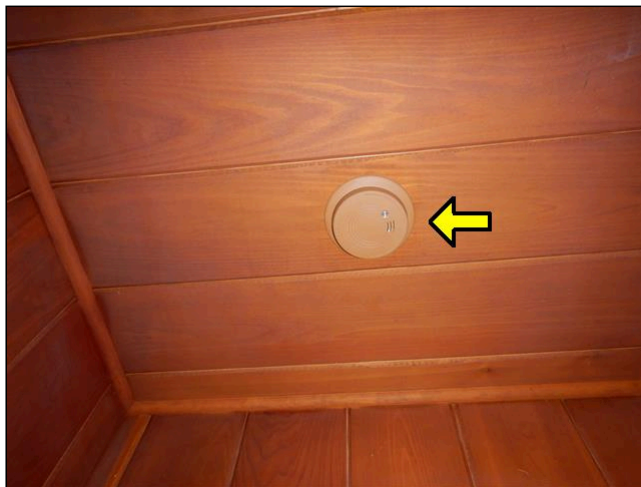
(1) The smoke detectors in the property (each house) are older. Studies show that detectors that are more than 10 years old have a high rate of failure. Many old detectors do not have battery back-up, and will not work if the electricity is off. We recommend that all old detectors be replaced prior to occupancy of the house for safety.

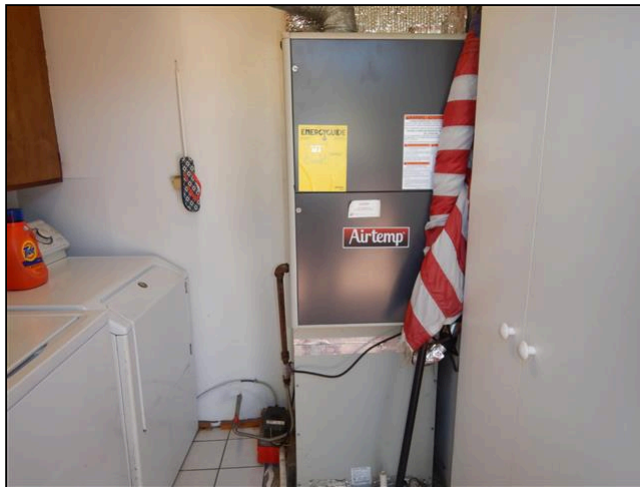
12.0.A Item 1(Picture)

(1) The furnace was tested and was functional/ operated at the time of the inspection.

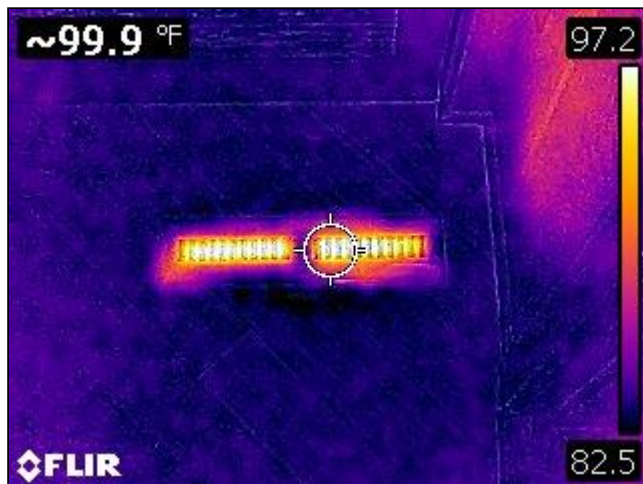
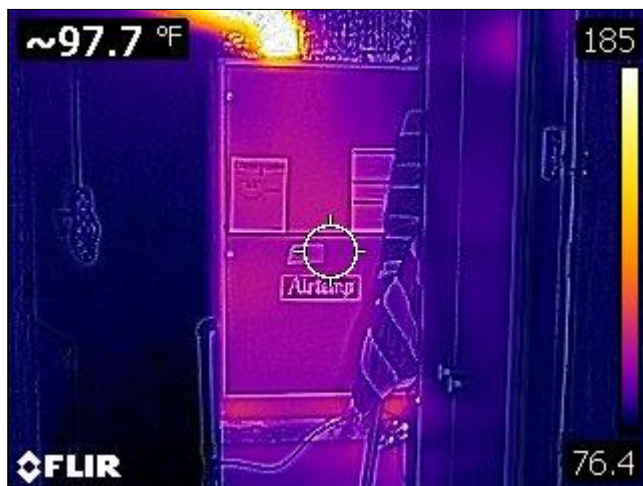
(2) Infrared Thermal photo of the furnace(s) being tested.

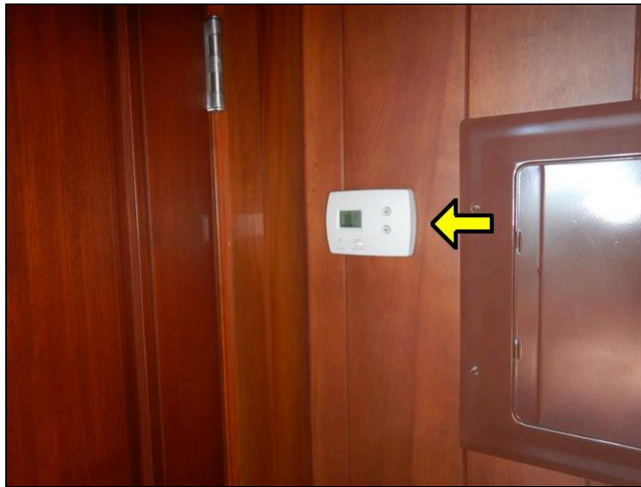
12.1.A Item 1(Picture)

The thermostat was operational when used to operate the HVAC system at the time of the inspection. Programmable thermostats are not adjusted and no testing is done to check the accuracy or programmed settings of the thermostat. If concerned we recommend verifying proper operation of the programmable settings prior to the end of your contingency period by a qualified person.

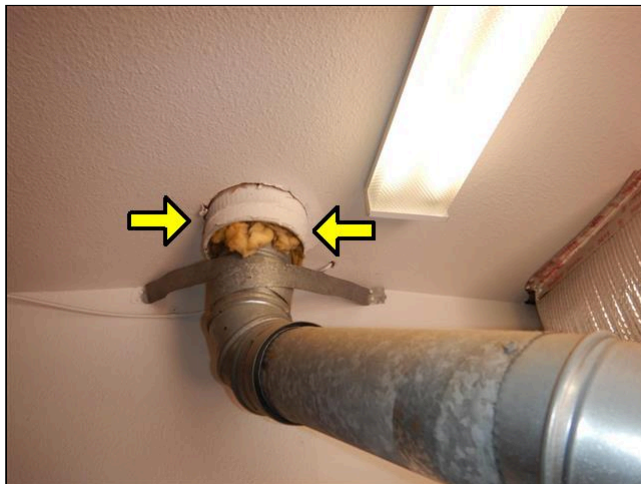
12.2.A Item 1(Picture)

A section of the furnace flue may contain asbestos. It is beyond the scope of a home inspection to test for the presence or absence of asbestos. If the flue contains asbestos, there may be additional costs to remove the flue if you upgrade the Transite flue to metal. Inspecting the Transite flue should be part of an annual furnace servicing until it is replaced. We recommend replacement of the Transite flue upon replacement of the furnace, replacement of the roof, or if you are concerned about asbestos by a qualified licensed HVAC contractor.

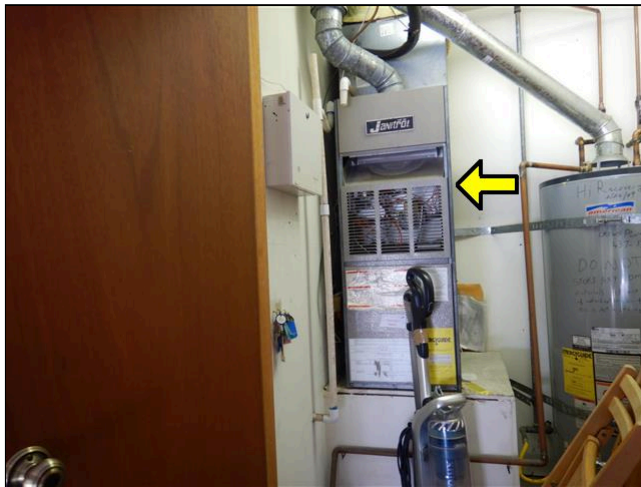
12.0.B Item 1(Picture)

(1) The furnace was tested and was functional/ operated at the time of the inspection.

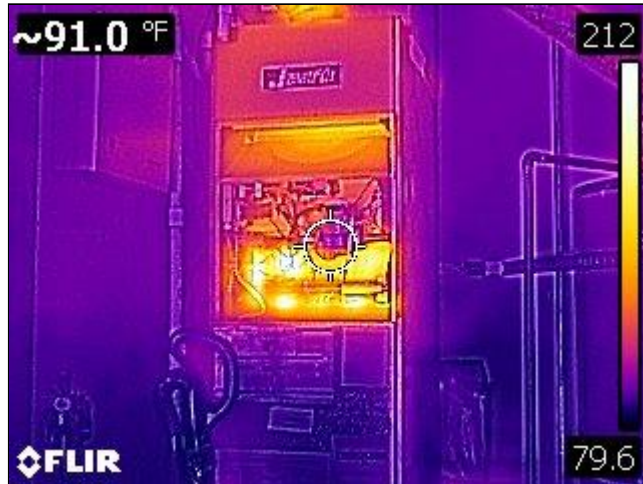
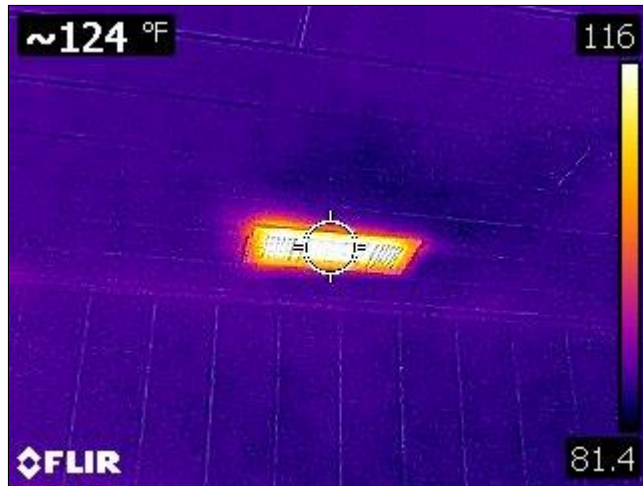
(2) Infrared Thermal photo of the furnace(s) being tested.

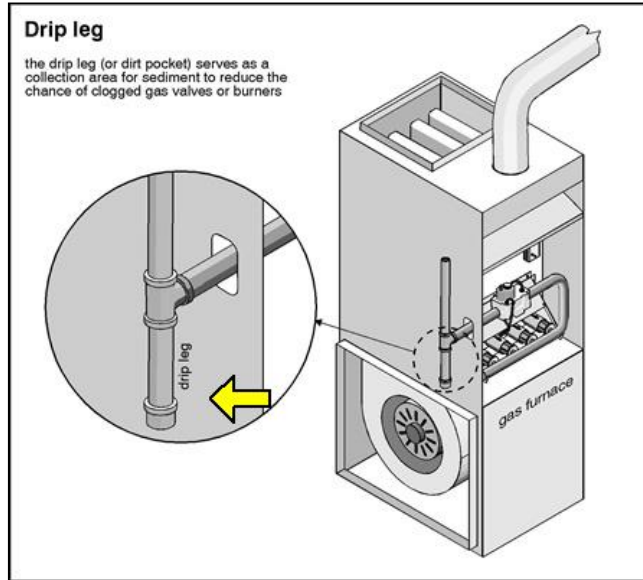
12.0.B Item 4(Picture)

(3) The gas supply pipe at the furnace did not contained a drip leg/ sediment trap. This may have been standard at the time of installation but now is highly recommended. The purpose of a drip leg is to help prevent sediment/ debris from entering and clogging the furnace gas valve which could cause the furnace to shut down. We recommend having a drip leg installed by a qualified licensed HVAC contractor.

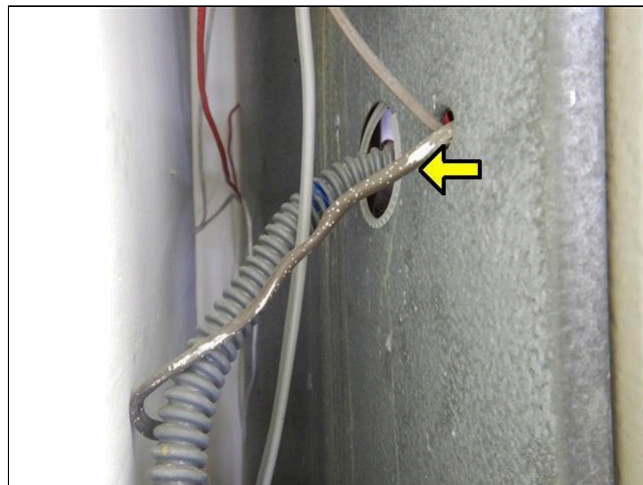
12.0.B Item 5(Picture)

(4) The flexible gas supply pipe passes through the furnace housing. Vibration from the furnace can wear through flexible gas pipe which could cause a gas leak. SDG&E is "Red Tagging" this condition as they considered it to be unsafe. Due to this condition we recommend a rigid cast pipe be installed from the gas regulator through furnace housing, to the exterior of furnace housing by a qualified licensed HVAC contractor.

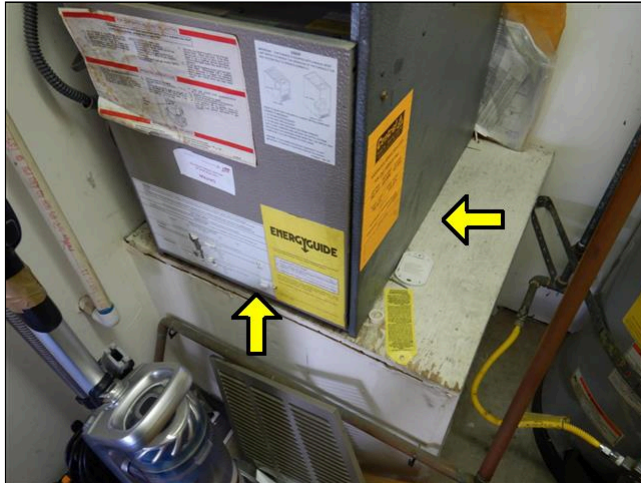
12.0.B Item 6(Picture)

(5) The furnace is not sealed around the base of the unit. Current standards and SDG&E require that the base of the unit is sealed to prevent exhaust from mixing with the house air. We recommend having the base of the furnace be sealed by a qualified person.
