# Inspection Report

**Property Address:**  
4312 Main Place  
Coronado CA 92118

**The Property Inspection Pros**

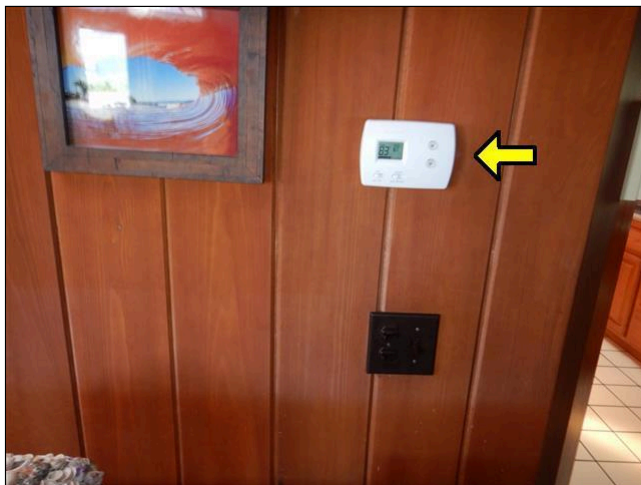
12.1.B Item 1(Picture)

The thermostat was operational when used to operate the HVAC system at the time of the inspection. Programmable thermostats are not adjusted and no testing is done to check the accuracy or programmed settings of the thermostat. If concerned we recommend verifying proper operation of the programmable settings prior to the end of your contingency period by a qualified person.

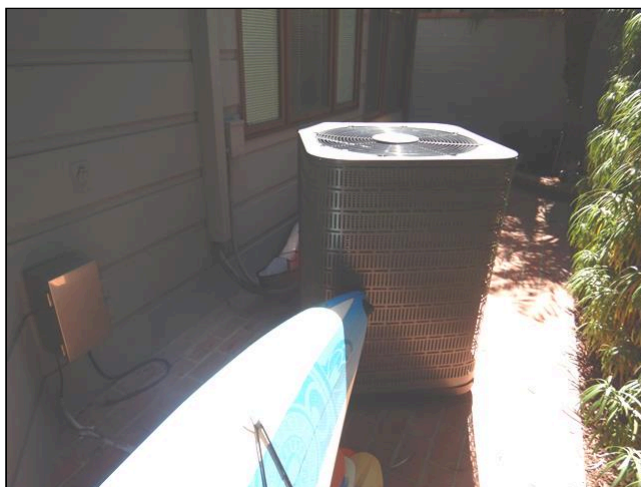
13.0.A Item 1(Picture)

- (1) [Photo of the A/C unit\(s\).](#)

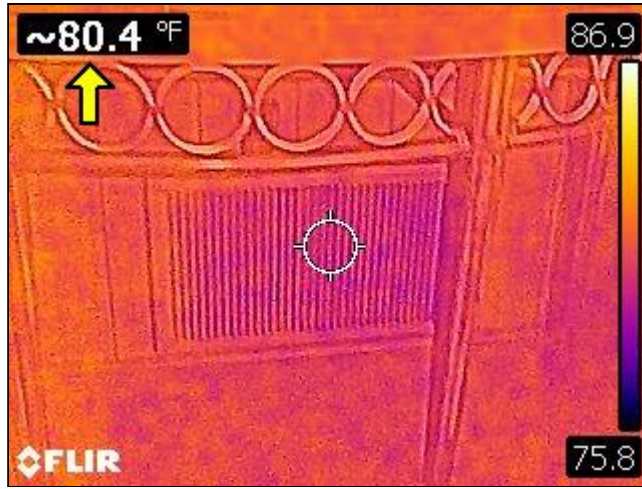
13.0.A Item 2(Picture)

The air returning to the system (return) was measured at **80 degrees**.

This indicates that the range in temperature drop is normal. This is not an exhaustive test and cannot predict the performance of the AC systems on extremely hot or humid days.

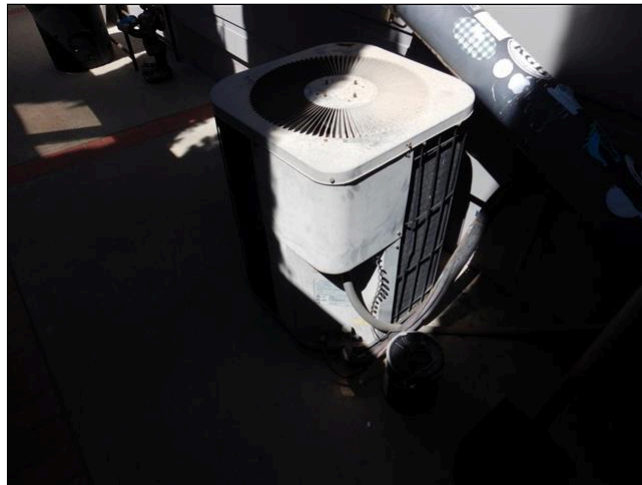
13.0.B Item 1(Picture)

- (1) **Photo of the A/C unit(s).**

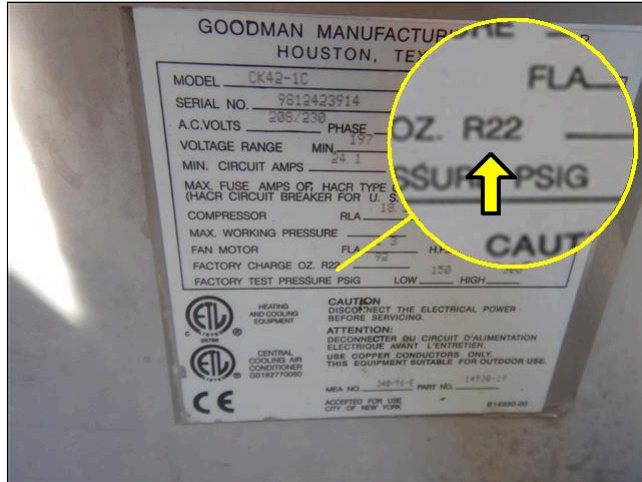
13.0.B Item 2(Picture)

(2) The air conditioning system in this property is an older system which may have R 22 freon. Effective January 1, 2020 the Department of Energy mandates that all manufactured air conditioner condensing units use R 410-A freon. The older R 22 freon will no longer be allowed. We recommend further evaluation by a licensed HVAC contractor prior to the end of your contingency period to check the freon level and for upgrade or replacement options. If the repair requires adding R22 refrigerant to the system, the only options will be reclaimed and previously-produced R22 refrigerant. Once there is no more R22 refrigerant available the compressor must be replaced. We also recommend budgeting for replacement and obtaining and keeping a Home Warranty that covers this HVAC system.

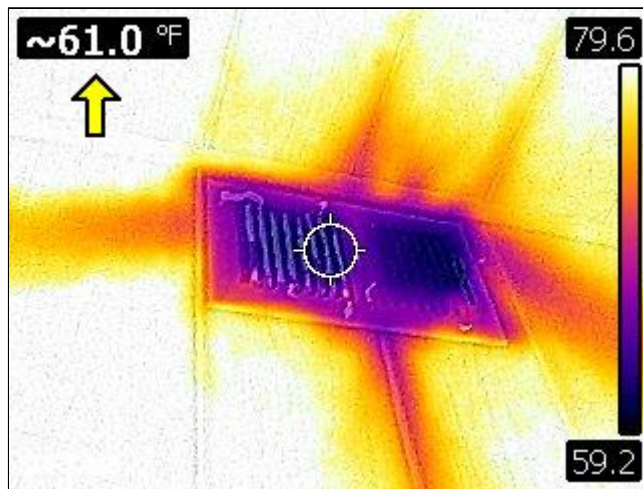
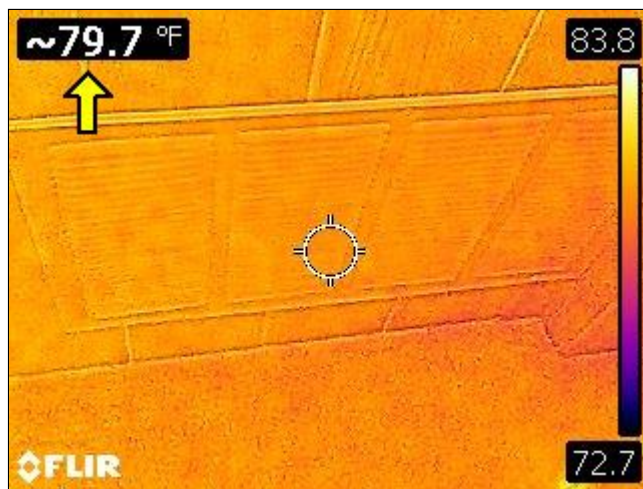
13.0.B Item 3(Picture)

(3) The AC system is 15 or more years old and may be near the end of its useful life. The average life of an AC system is approximately 10-15 years. We recommend further evaluation and servicing by a qualified licensed HVAC contractor to determine life remaining and potential cost to replace so that you can budget accordingly. We also recommend that you keep a good home warranty in place, which covers the AC system.

The air returning to the system (return) was measured at **79 degrees**.

This indicates that the range in temperature drop is normal. This is not an exhaustive test and cannot predict the performance of the AC systems on extremely hot or humid days.

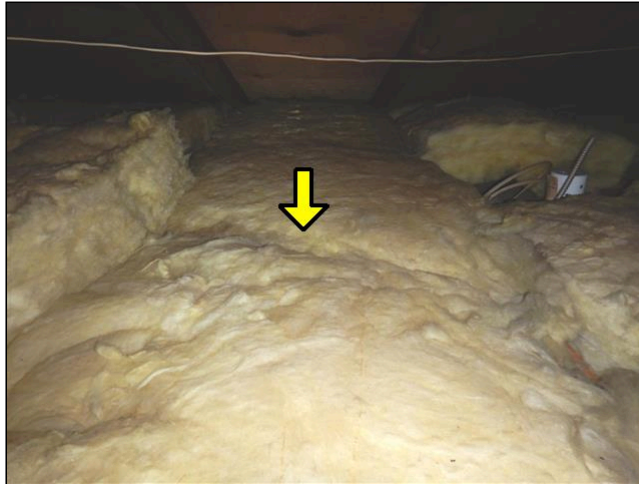
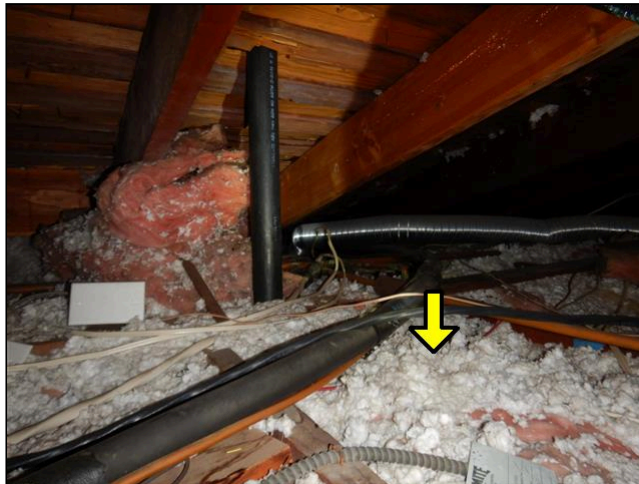
14.0 Item 1(Picture)

- (1) **Photo of the insulation.**

- (2) The insulation in the attic appears to be functioning as intended.
- (3) The attic space access hatch covers in each house were not insulated. We

recommend insulating the attic access hatch cover to reduce unwanted heat loss/gain by a qualified person.

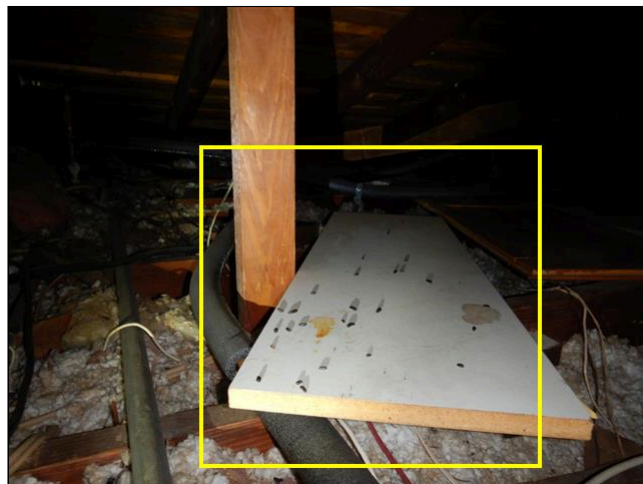
15.1 Item 1(Picture)

- (1) Material which may be rodent droppings was observed throughout the attic space. If present, pests may chew, damage or contaminate components such as insulation and heating/AC ducts. Rodents have been found throughout San Diego County which have Hantavirus, which is a health hazard, according to [San Diego County Vector Control](#).

We recommend further evaluation by a professional licensed Level II pest exterminator

for a complete review and removal of any pests, waste material or contaminated components prior to the end of your contingency period.

We also recommend further evaluation by a qualified licensed contractor and having any openings, gaps, or voids be sealed where pests could be entering the property.

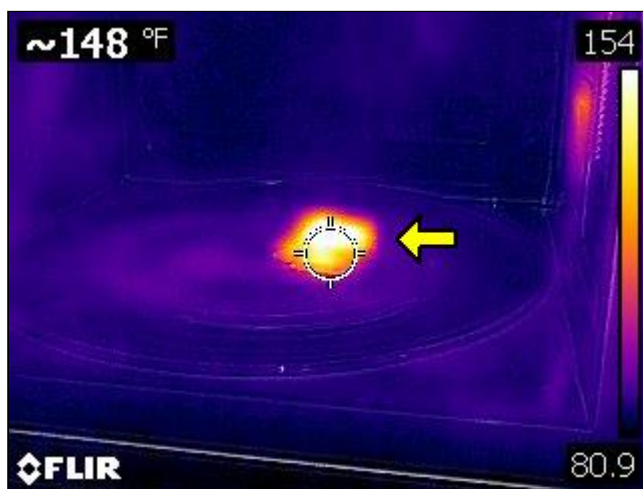
16.0.A Item 1(Picture)

**Photo of microwave being tested.**

The built in microwave was tested with a microwave testing device and was functional at the time of the inspection. This is not an exhaustive test, and does not predict the performance of the microwave.

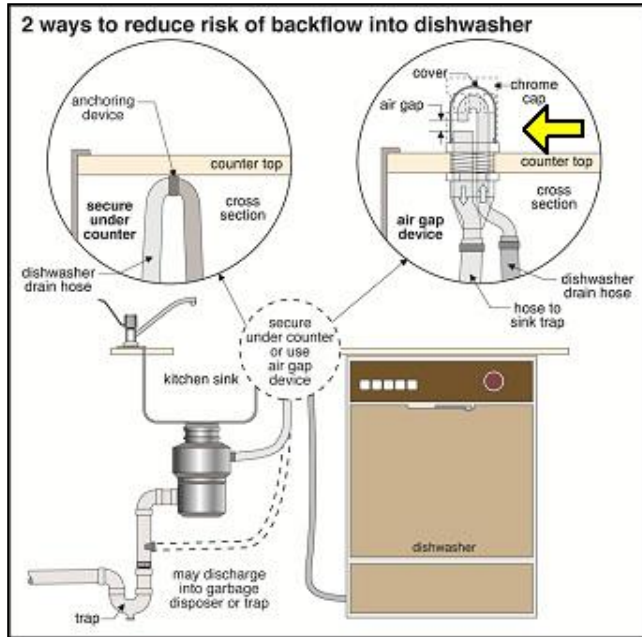
16.1.A Item 1(Picture)

The dishwasher was tested and functioned properly at the time of the inspection. This is not an exhaustive test and does not verify the cleaning efficiency of the dishwasher.

(2) An air gap device or high-loop is not present at the dishwasher drain line as required. We recommend having an air gap device or a high-loop installed at the dishwasher drain line by a qualified licensed plumber.

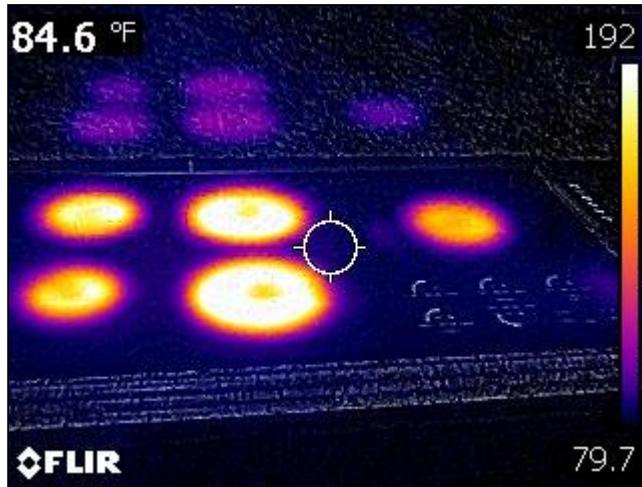
16.4.A Item 1(Picture)

**Infrared Thermal photo of the cooktop being tested.**

The cooktop was tested and was functional at the time of the inspection. This test is not exhaustive and does not confirm the performance, accuracy, or effectiveness of the cooktop.

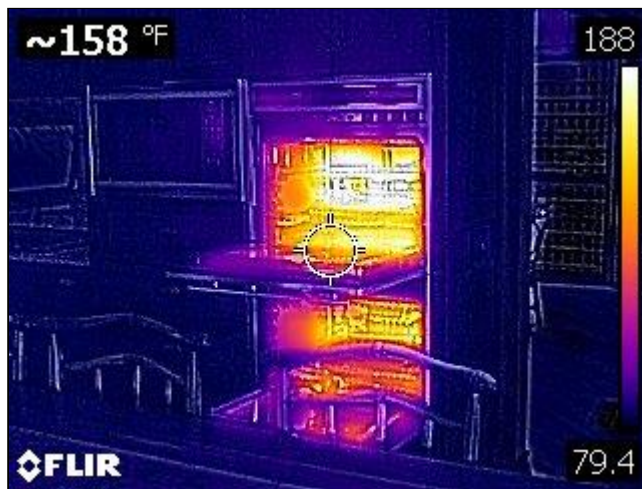
16.5.A Item 1(Picture)

**Infrared Thermal photo of the wall oven(s) being tested.**

The wall oven was tested and was functional at the time of the inspection. This test is not exhaustive and does not confirm the performance, accuracy, or effectiveness of the wall oven.

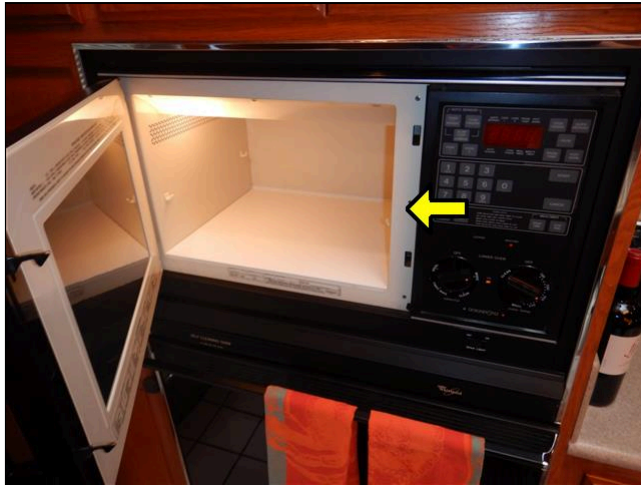
16.0.B Item 1(Picture)

The built in microwave did not work when tested. We recommend replacement.

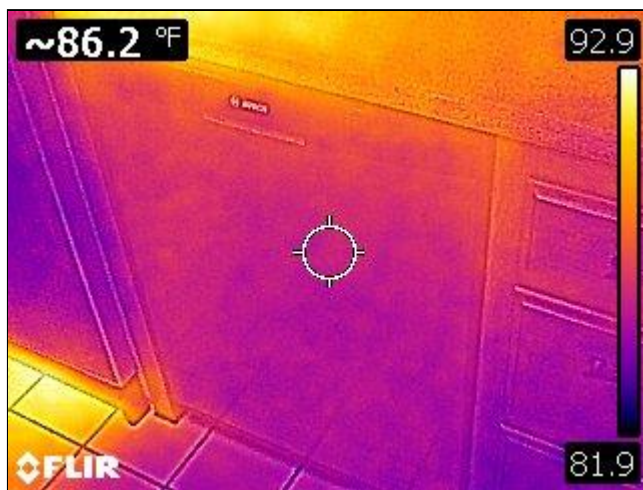
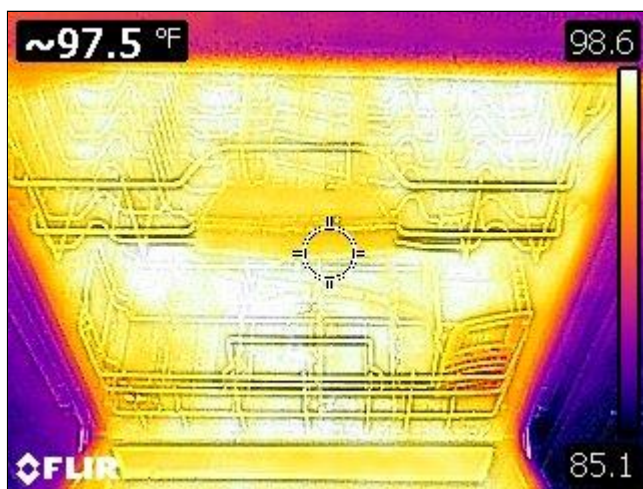
16.1.B Item 1(Picture)

**Infrared Thermal photo of the dishwasher being tested.**

The dishwasher was tested and functioned properly at the time of the inspection. This is not an exhaustive test and does not verify the cleaning efficiency of the dishwasher.

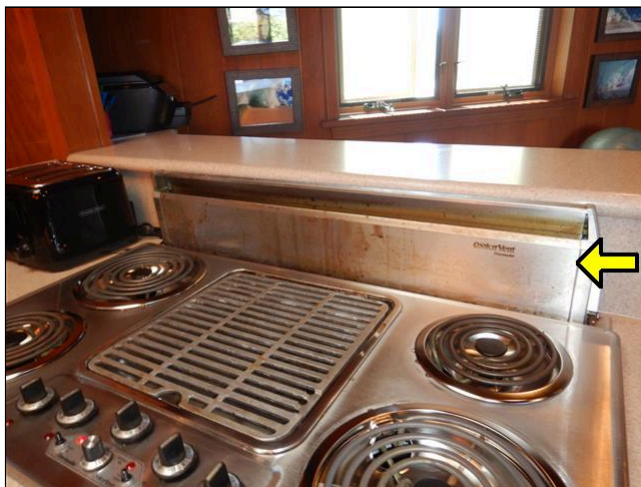
16.3.B Item 1(Picture)

The range exhaust vent was tested and was functional at the time of the the inspection. This is not an exhaustive test, and does not evaluate the performance or effectiveness of the unit.

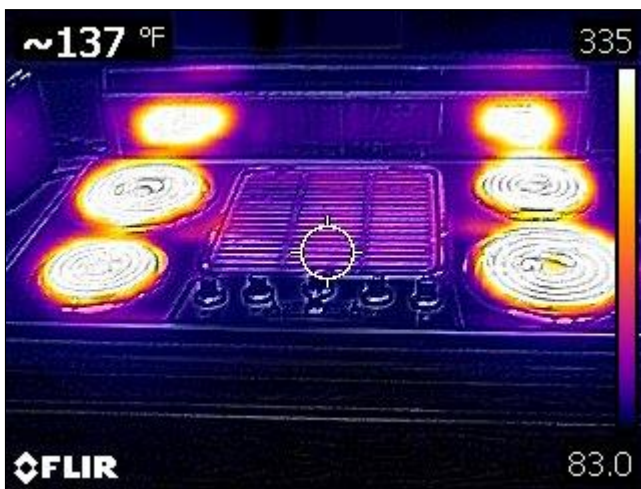
16.4.B Item 1(Picture)

Infrared Thermal photo of the cooktop being tested.

The cooktop was tested and was functional at the time of the inspection. This test is not exhaustive and does not confirm the performance, accuracy, or effectiveness of the cooktop.

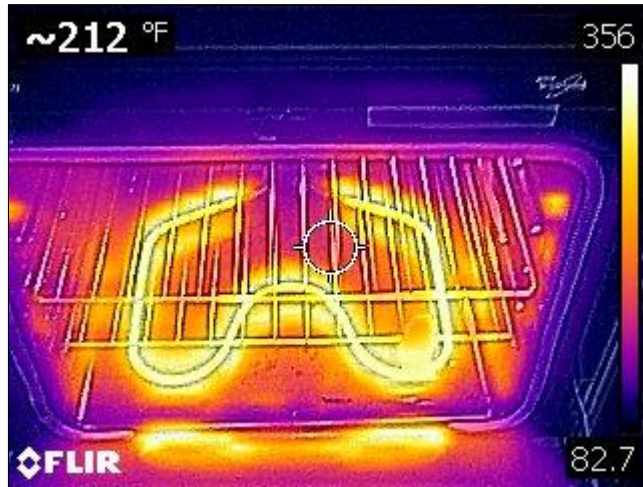
16.5.B Item 1(Picture)

**IN NI NP RR IO Items****Infrared Thermal photo of the wall oven(s) being tested.**

The wall oven was tested and was functional at the time of the inspection. This test is not exhaustive and does not confirm the performance, accuracy, or effectiveness of the wall oven.

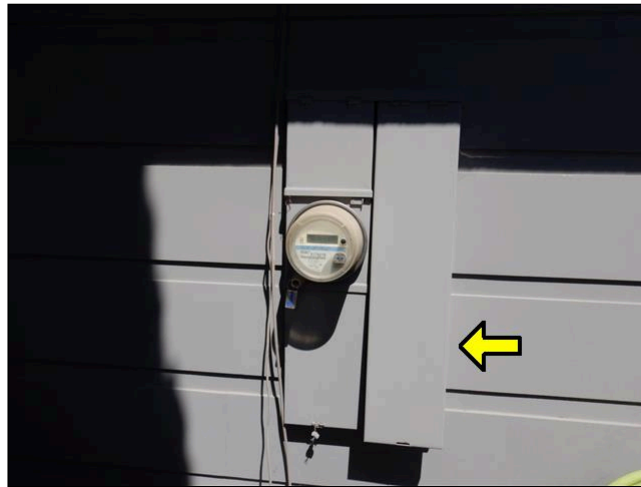
17.1 Item 1(Picture)

The Main Electrical panel is located at the left exterior side of the property (facing front).

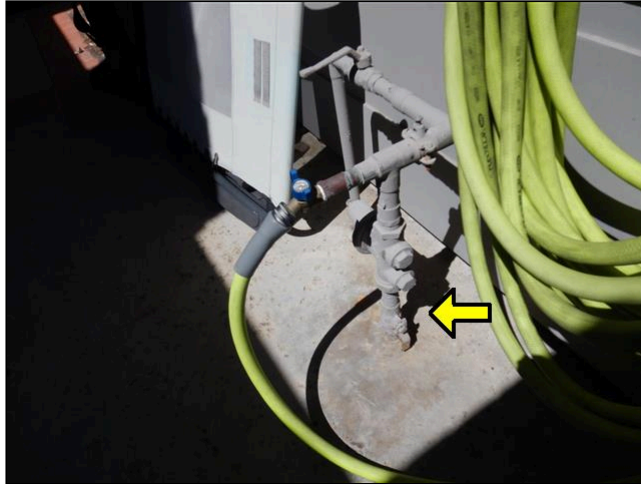
17.2 Item 1(Picture)

The main water shut-off valve is located at the left exterior side of the property (facing front).

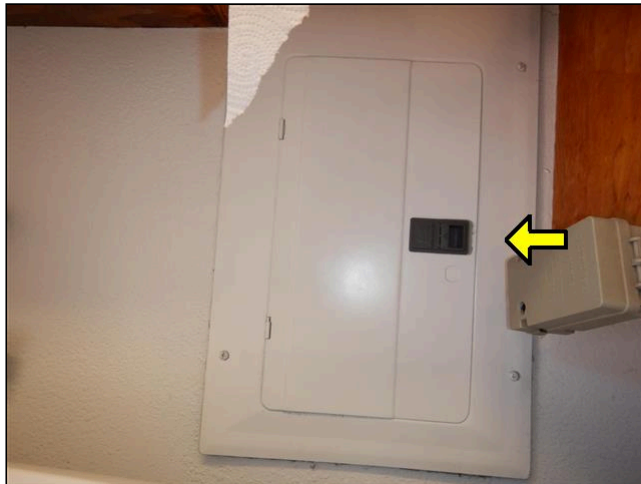
17.3 Item 1(Picture)

(1) The sub-panel is located in the main house laundry room.

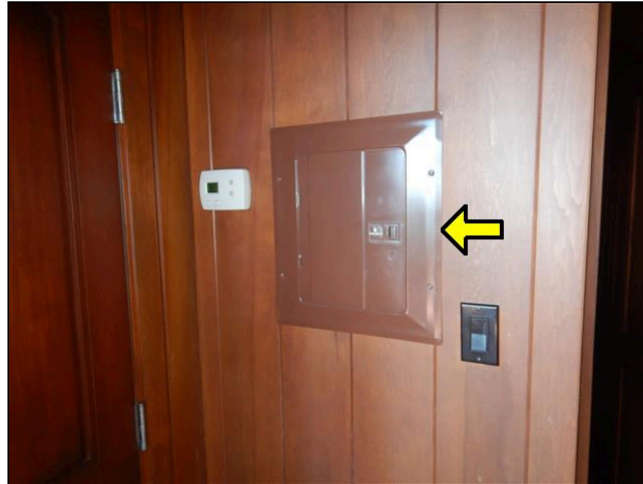
17.3 Item 2(Picture)

(2) A sub panel is located in a main house bedroom.
