Inspection Report

Property Address:
4312 Smith Drive
Small Building, 4 Units
El Cajon CA 92019

The Property Inspection Pros

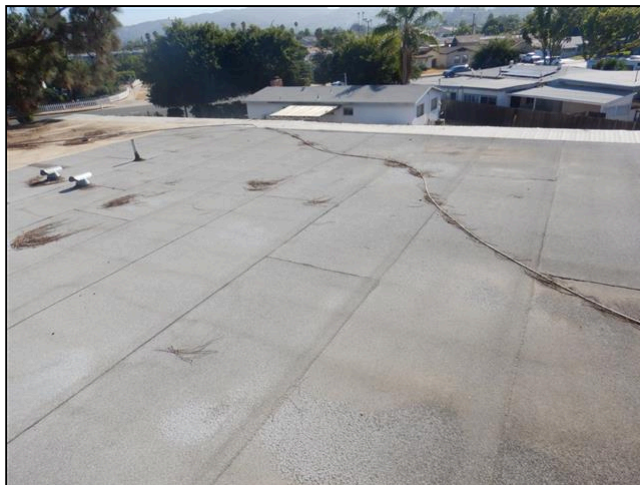
1.1 Item 1(Picture)

(1) Pictures of the roof.

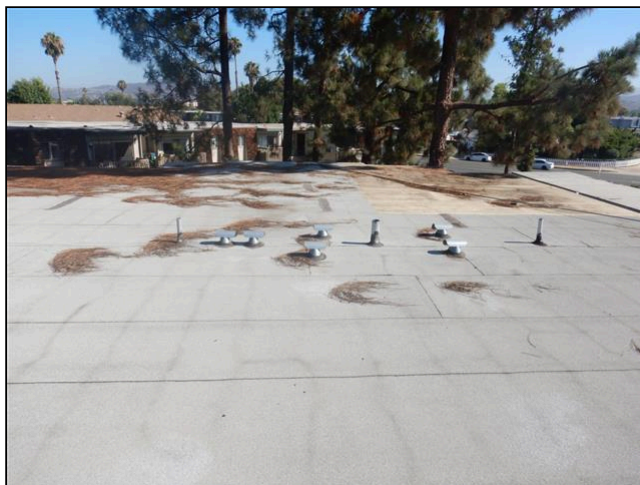
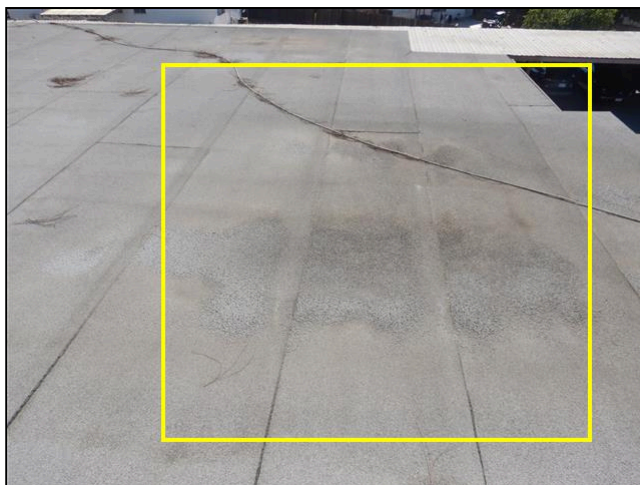
1.1 Item 2(Picture)

(2) The flat roof shows several areas of ponding (standing water) noted by dirt on the flat roof covering. This can lead to premature failure of the flat roof in these areas. We recommend further evaluation by a licensed roof contractor prior to the end of your contingency period and necessary repairs made.

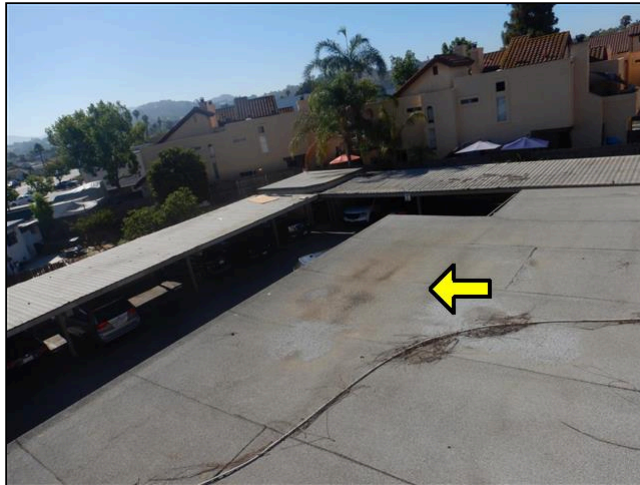
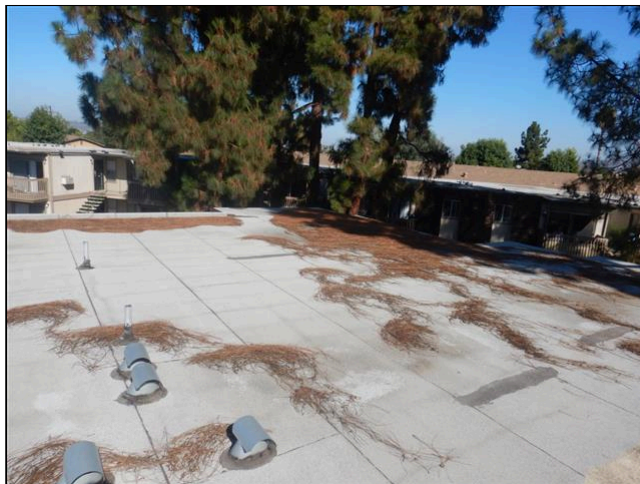
1.1 Item 4(Picture)

(3) Excessive leaves and debris are noted on the roof. Leaves and debris can hold unwanted moisture on the roof. We recommend having the leaves and debris removed by a qualified person.

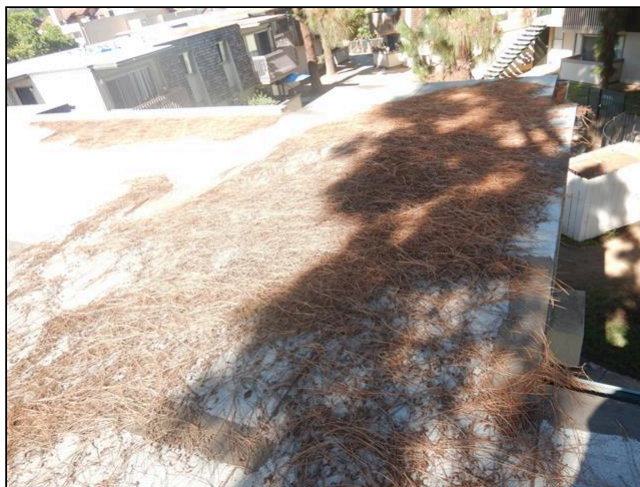
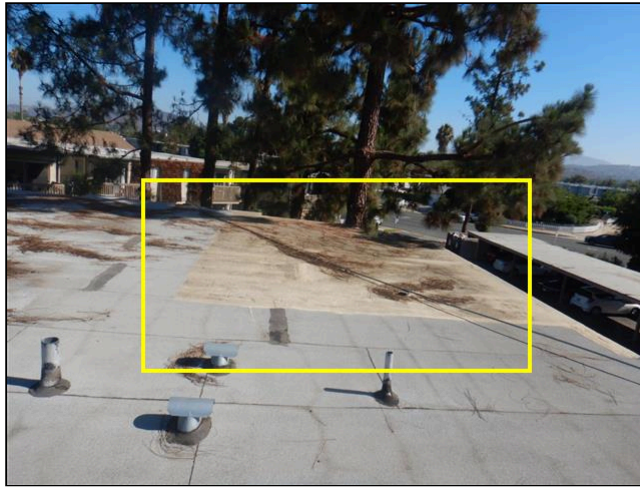
1.1 Item 6(Picture)

(4) The roof has had repairs made to it at several areas. We are unable to determine if these repairs are made correctly and successful. We recommend asking the seller about these repairs, and if concerned we recommend further evaluation by a qualified licensed roof contractor.

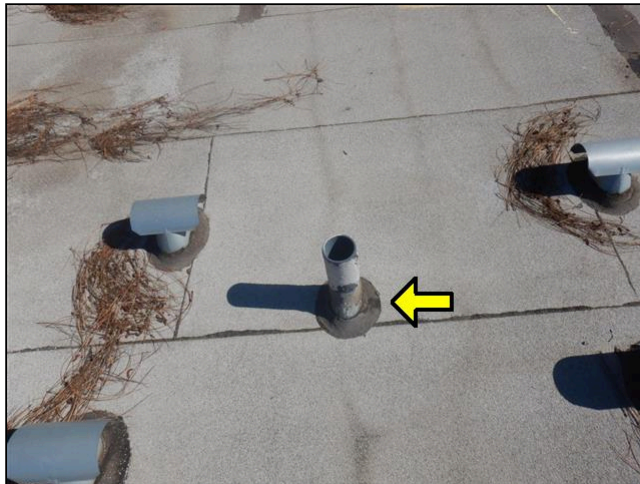
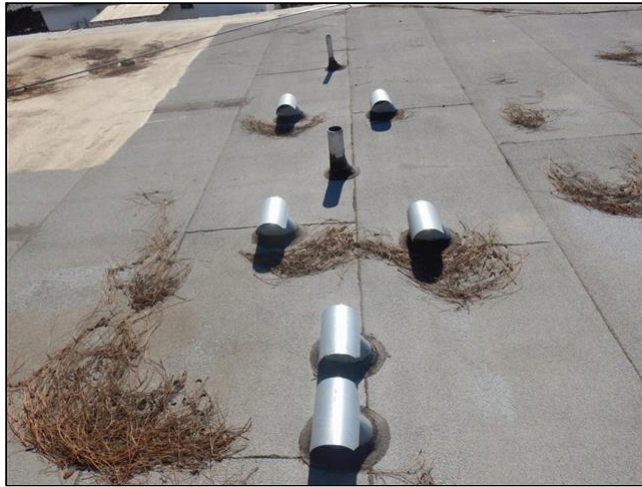
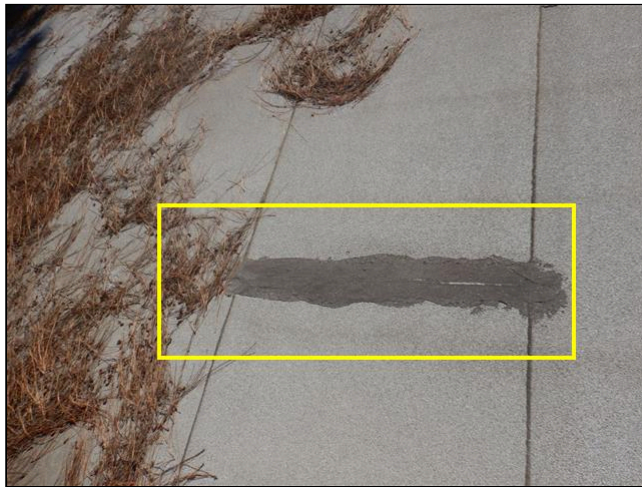
1.2 Item 1(Picture)

Sealant around some of the roof flashings/ penetrations and seams is cracked. We recommend having sealant applied where needed to help prevent roof leaks by a licensed roofer.

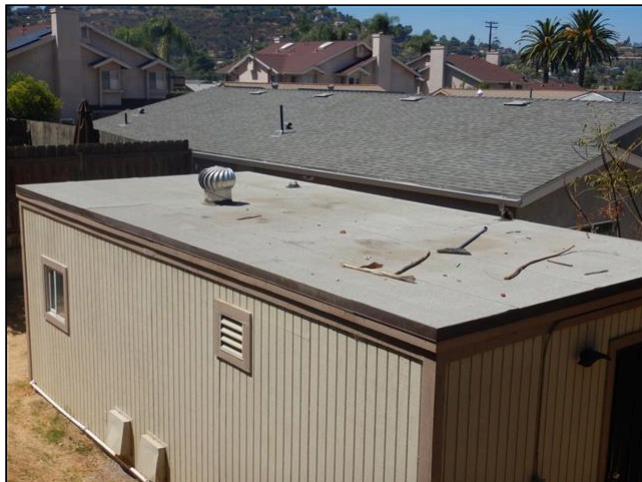
1.5 Item 1(Picture)

The laundry building flat roof material shows normal wear for its age and type; appears to be in serviceable condition.

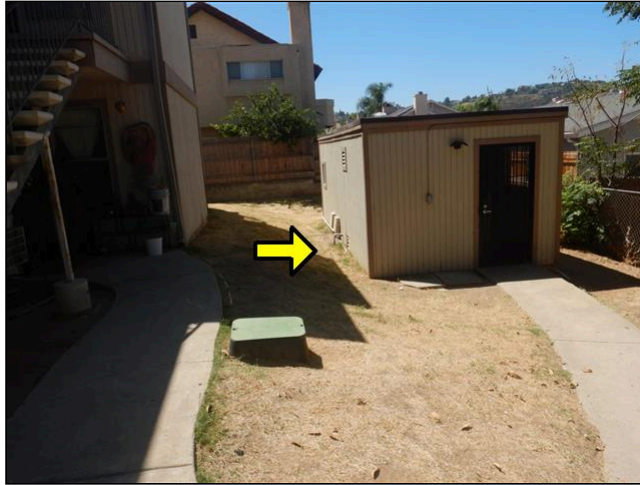
2.2 Item 4(Picture)

(2) There is a negative slope towards the laundry building and could cause or contribute to water intrusion or deterioration. This area does not appear to drain water away from this building and needs landscaping and drainage corrections. It is important to prevent or minimize standing water near the building to avoid damage to the foundation. This can be accomplished by properly sloping the ground away from the building and/or adding yard drains to carry water away from the low lying areas. Rain gutters can also be an effective method of diverting water away from the low-lying area. Rain gutters should direct water away from this area. We recommend further evaluation and necessary corrections by a qualified landscape contractor.

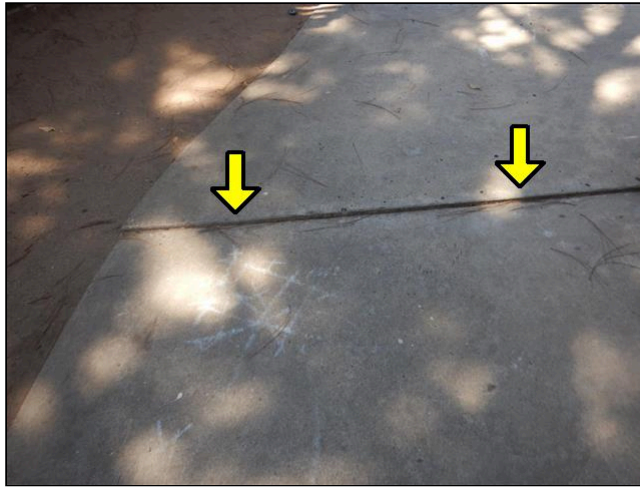
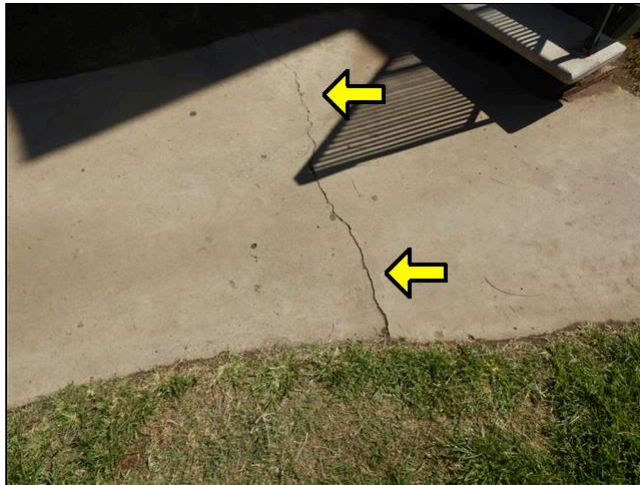
2.8 Item 3(Picture)

(3) There are numerous cracks in the concrete walkways around the property. We recommend necessary repairs or replacement where needed by a licensed concrete contractor.

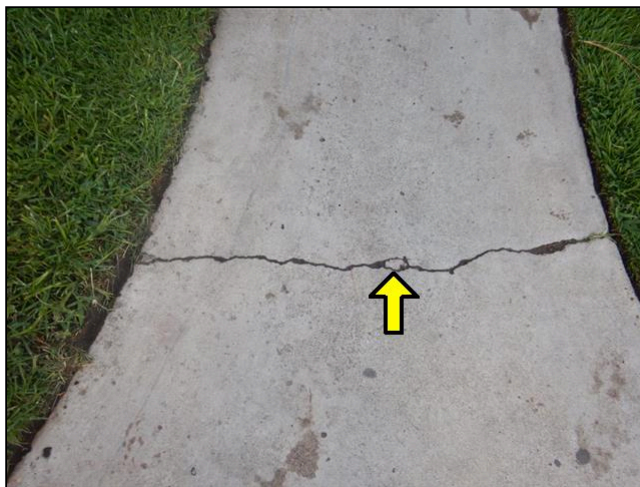
2.8 Item 5(Picture)

(4) The walkway slope in several areas is such that water does not run off and is ponding. All walkways should slope to allow water to run away/ off. We recommend further evaluation by a qualified contractor to obtain quotations for repairs or corrections where needed prior to the end of your contingency period.

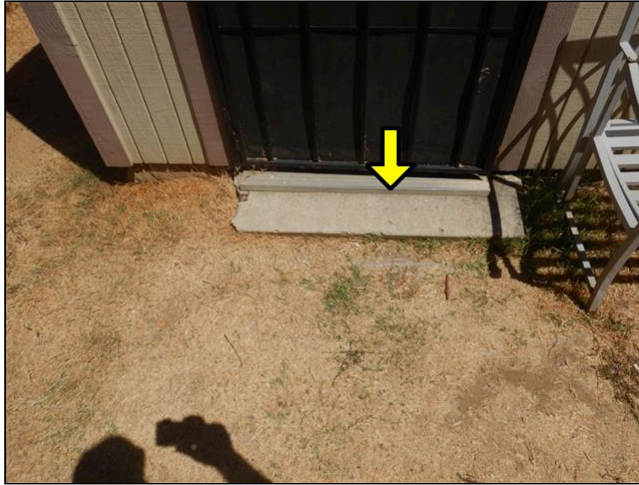
2.8 Item 7(Picture)

(5) The landing outside the rear door of the laundry building is non standard and a safety hazard. We recommend having a proper landing installed outside this door by a licensed contractor.

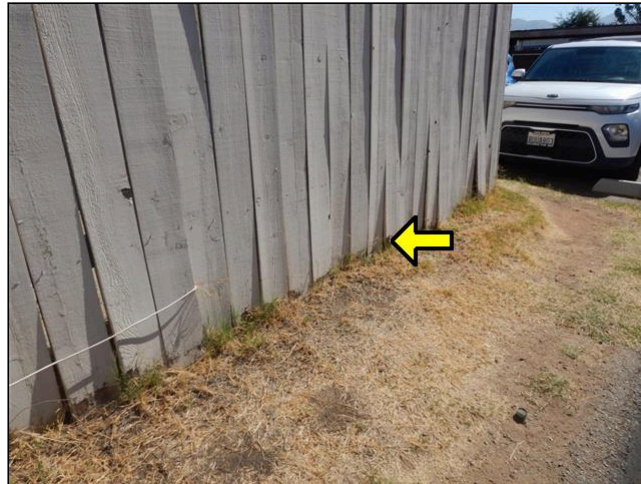
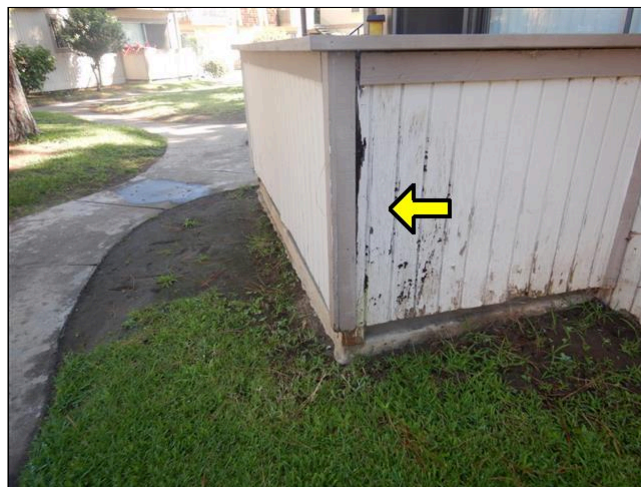
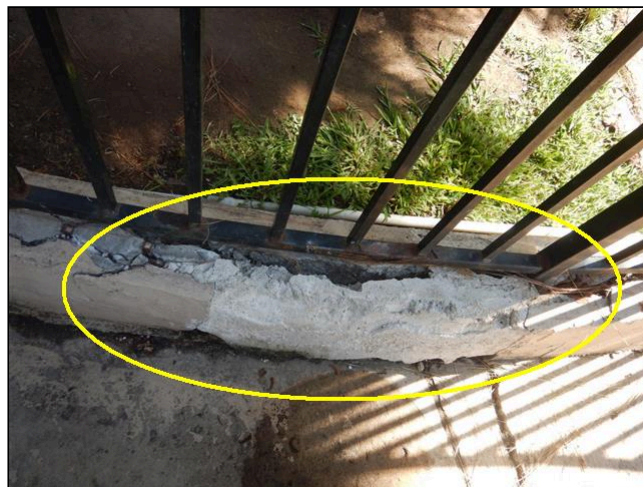
2.10 Item 1(Picture)

(1) The wood fence is damaged in several areas. We recommend necessary repairs or replacing as needed by a licensed fence contractor.

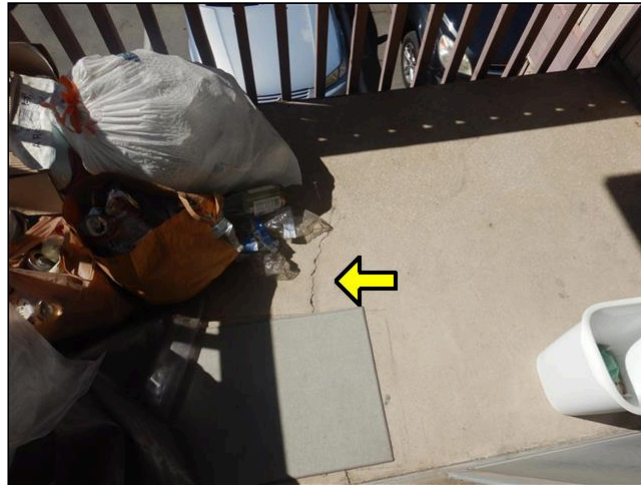
2.13 Item 3(Picture)

- (4) Incorrect installation of guard rail post(s) is observed at the deck. The post(s) should be spaced no more than 6 feet apart. Incorrect installation is a safety hazard. Depending on date of construction, this indicates the deck may have been built without a permit. We recommend further evaluation of the all decks by a licensed deck contractor or qualified engineer prior to the close of your contingency period
- (5) Due to all the deck issues we recommend having all the decks and all related components inspected by a licensed deck contractor prior to the end of your contingency period and necessary repairs or replacement made as needed.
- (6) The deck guard rail is to loose at Unit 2 which is a safety hazard. We recommend necessary repairs or replacement by a licensed deck contractor.

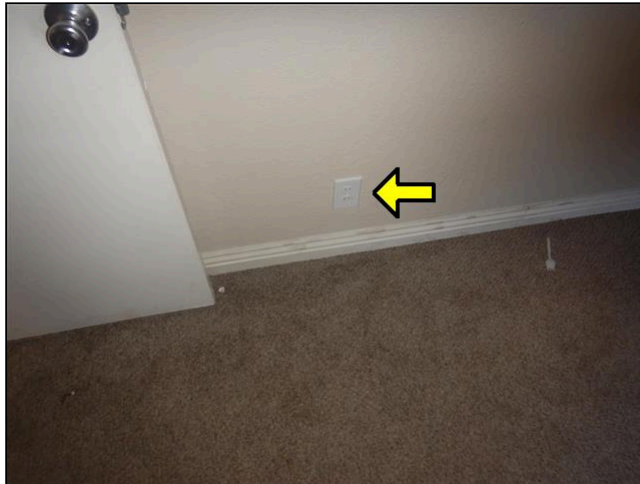
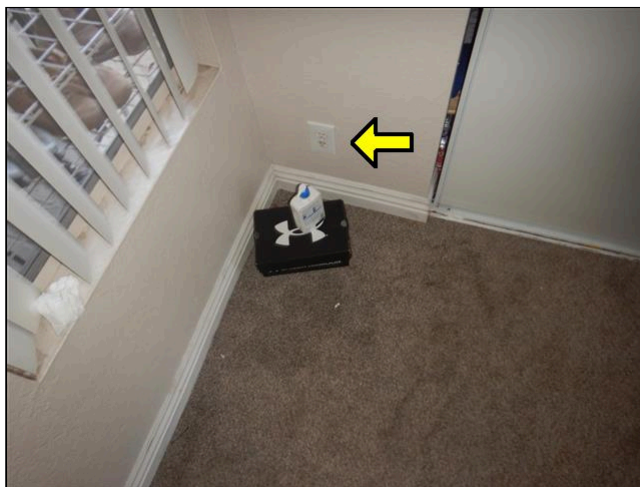
3.7 Item 1(Picture)

Several interior outlets in Unit 1 were found to be wired with no ground connection. We recommend necessary corrections by a qualified licensed electrician.

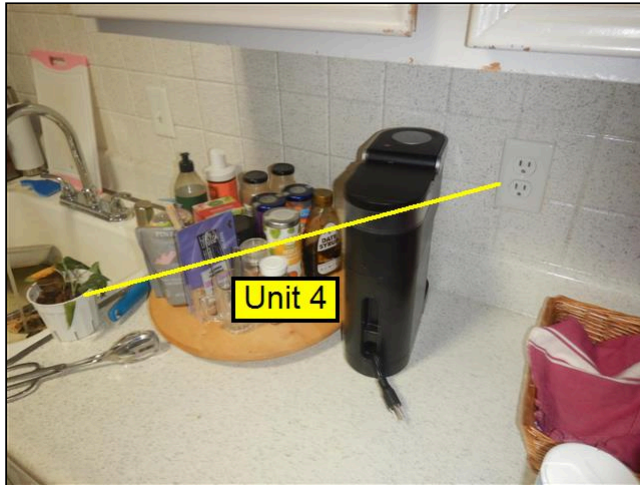
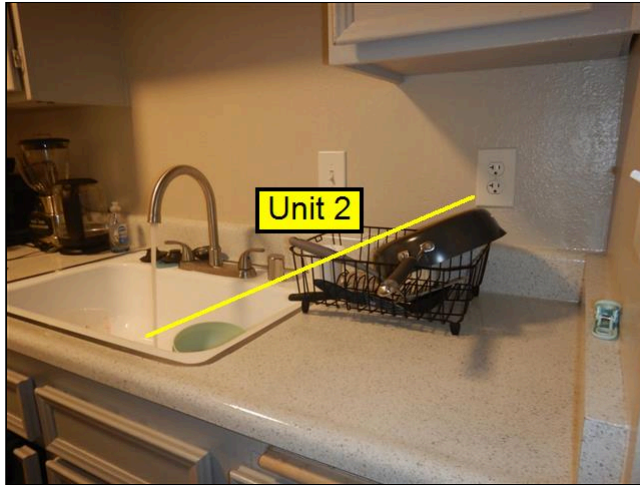
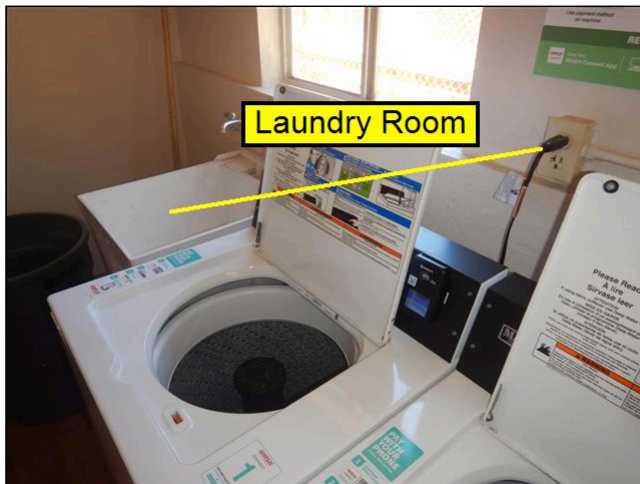
3.9 Item 1(Picture)

(1) We recommend upgrading all receptacles within 6 feet of any plumbing fixtures, outside/ exterior, in all Units where needed, and any non fixed appliance receptacles in the kitchens to GFCI protected receptacles by a qualified licensed electrician for safety.

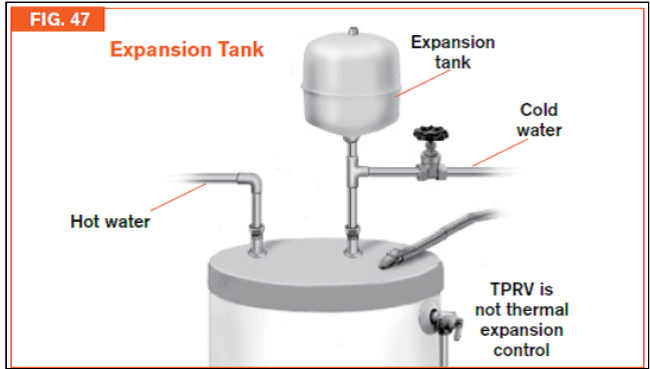
5.0 Item 2(Picture)

(5) The water heater in the laundry building does not have a "Thermal Expansion Tank" installed to prevent a possible leak at the T&P or "pop-off" valve. Recent changes in code require one when a new water heater is installed. This change is not retroactive on older previously installed Gas/LP water heaters. There were no leaks or drips at the T&P valve during inspection. If your water heater does begin to drip or leak, then a thermal expansion tank may be needed. We recommend installing a thermal tank by a qualified licensed plumber as an upgrade.

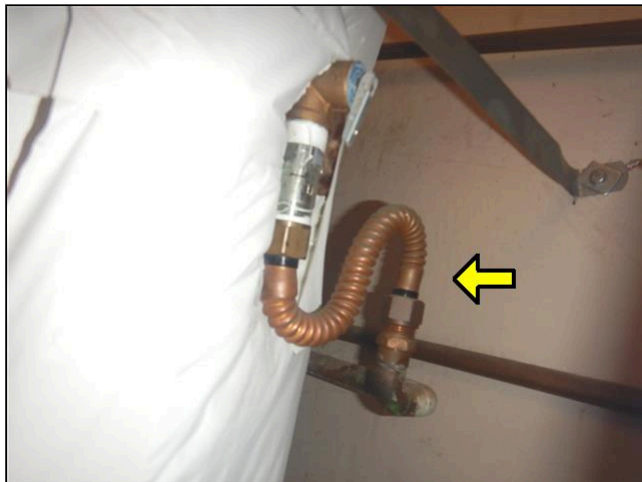
5.3 Item 1(Picture)

the manufacturer's installation requirements. We recommend necessary corrections by a qualified licensed plumber.

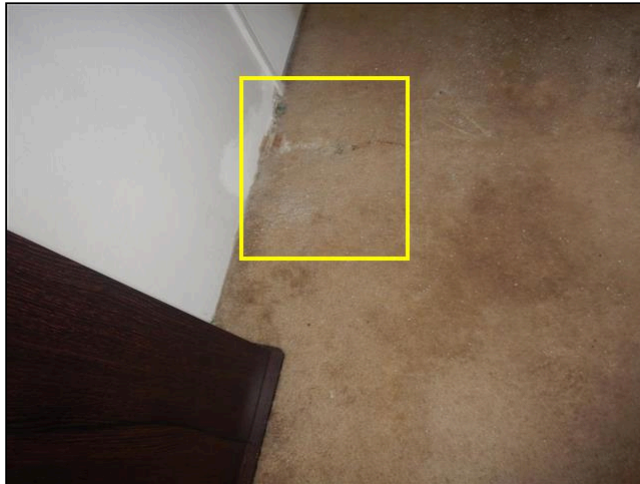
6.3 Item 2(Picture)

(2) There is damaged carpet in Unit 4 in several areas. We recommend replacing where needed by a qualified licensed flooring contractor.

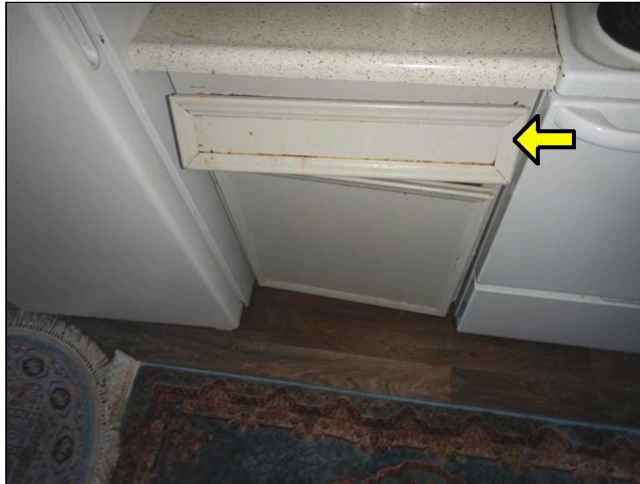
6.4 Item 2(Picture)

(4) Damage, missing or loose drawer guides are noted at the kitchen cabinet drawers in Unit 1. We recommend necessary corrections by a qualified person.

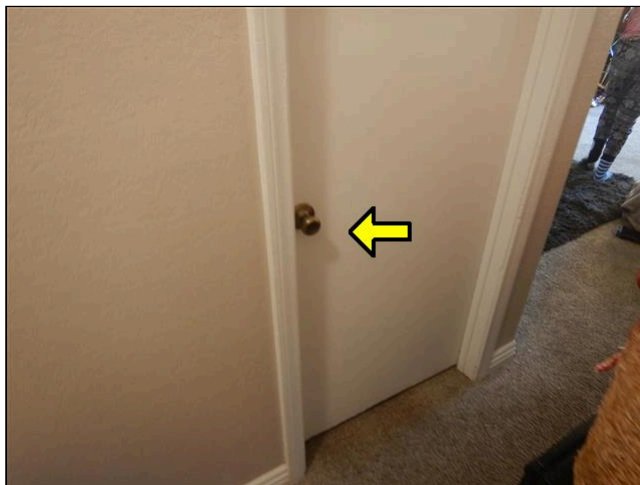
6.5 Item 1(Picture)

(1) There were tenants in bedroom 2 in the 3rd unit at the time of the inspection. Due to this condition this bedroom and related components could not be inspected. We recommend having this bedroom and related components be inspected by a qualified person or this company prior to the end of your contingency period.

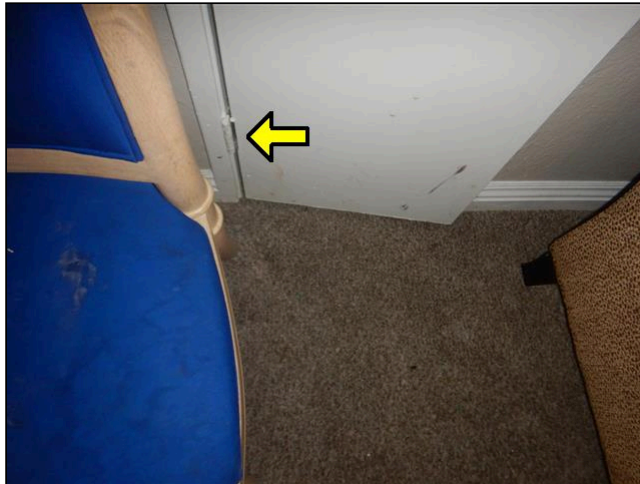
6.5 Item 2(Picture)

(2) The hall closet door lower hinge is damaged in Unit 3. We recommend replacement by a qualified contractor.

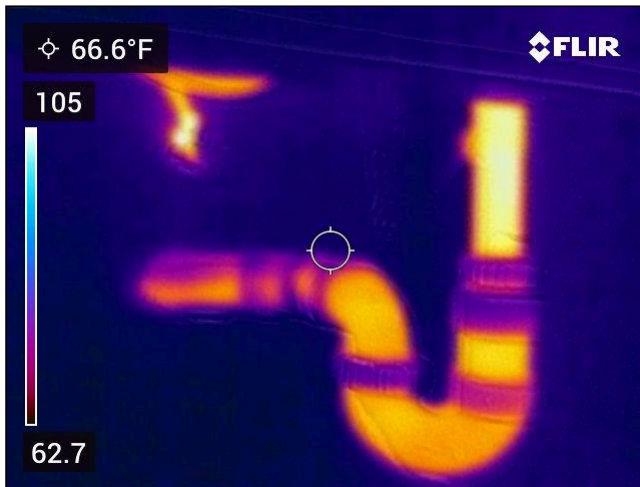
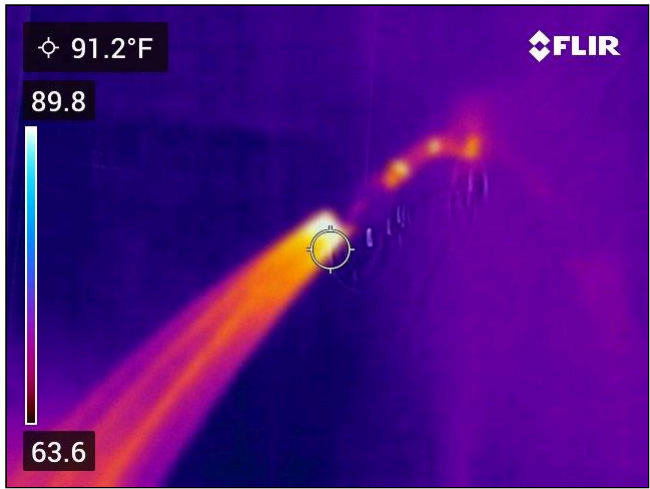
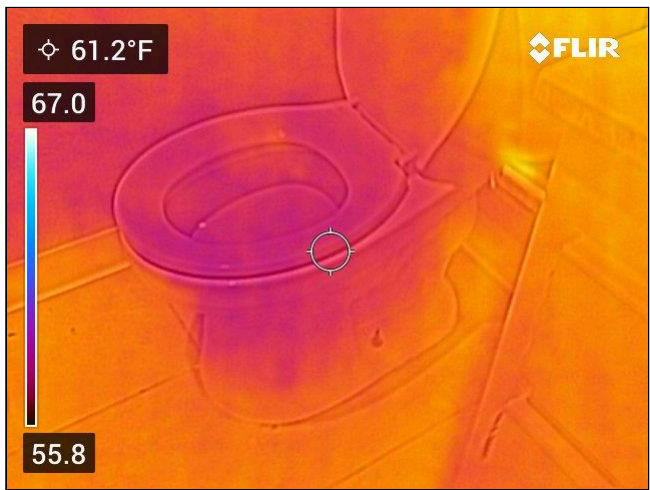
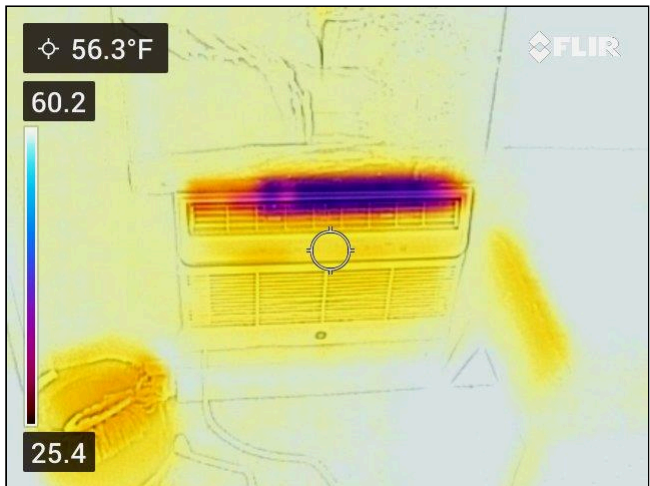
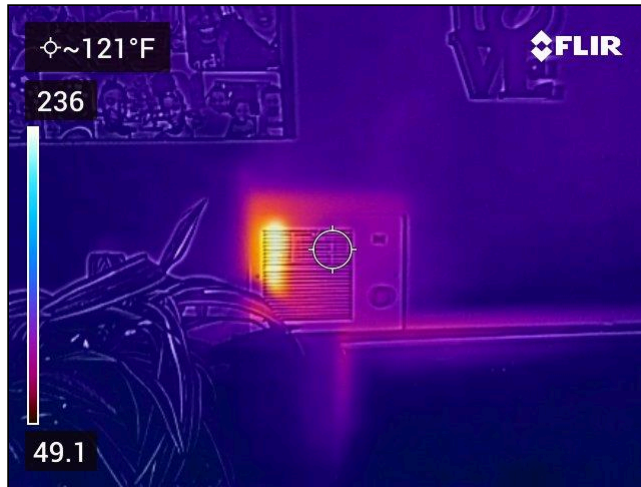
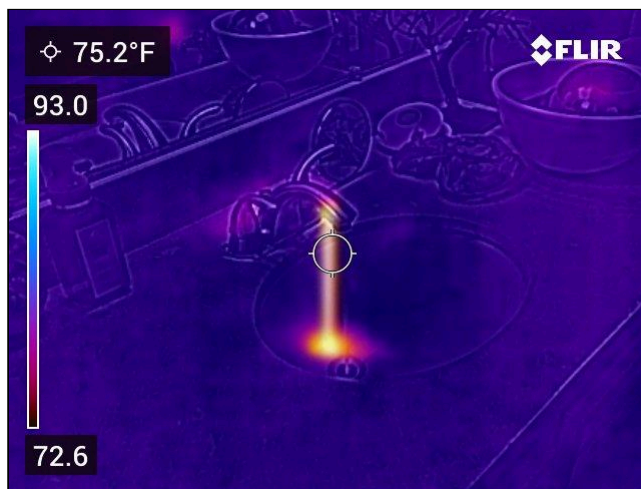
(1) **Infrared Camera Thermal Photos.**

(2) An infrared (thermal imaging) scan was performed throughout the property at the time of the inspection using a hand held infrared (thermal imaging) inspection camera. No anomalies were found at the time of the inspection using this camera.

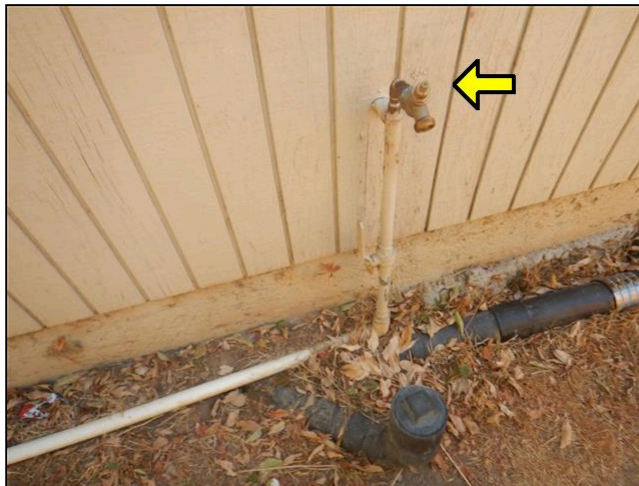
7.3 Item 2(Picture)

(2) Several hose spigot handles are missing. We recommend necessary repairs or replacement by a qualified licensed plumber.

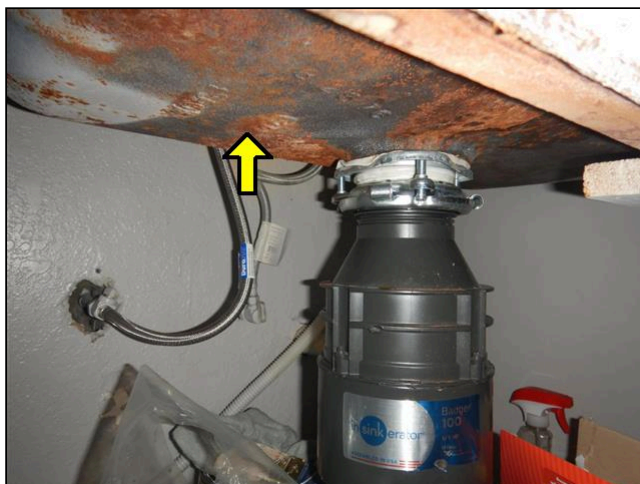
7.5 Item 1(Picture)

(1) The kitchen sink is in unit 1 and Unit 2 is old/ worn. We recommend replacement by

a qualified person.

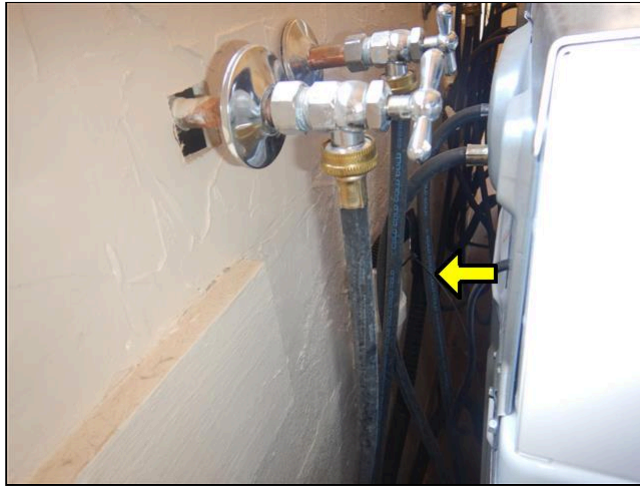
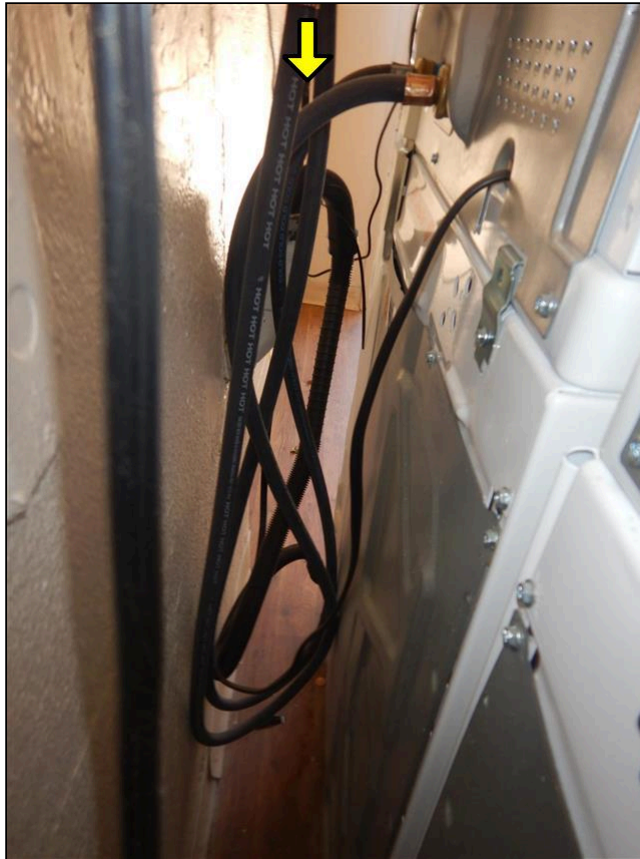
MAINTENANCE RECOMMENDATION: Washer hoses are a common source of flooding in a home. Prior to connecting the washing machine we recommend installing new braided steel washer hoses to help reduce leaks caused by failed hoses. If any hoses are left in the house they should be replaced. The washing machine and dryer are not part of our general home inspection.

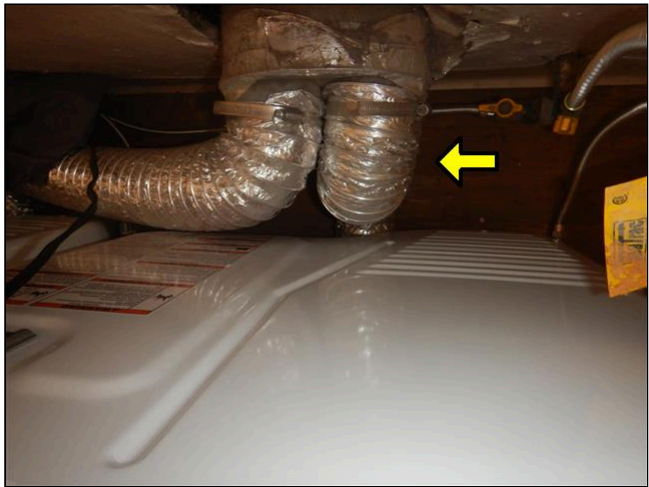
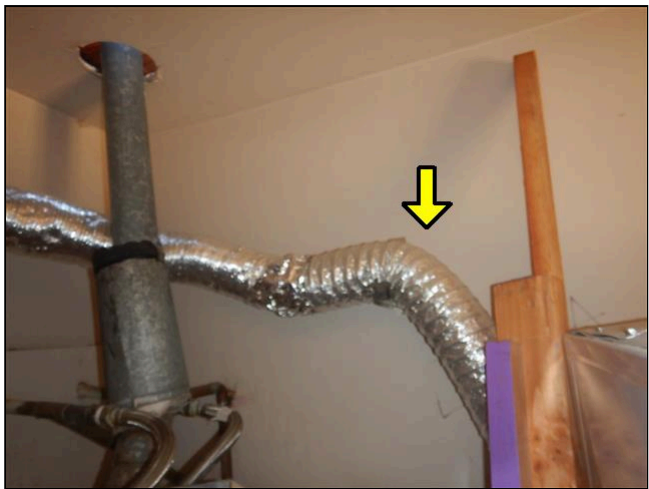
(1) The dryer is equipped with a foil, accordion-type duct. The U.S. Consumer Product Safety Commission considers these types of ducts to be unsafe and a fire hazard. The flexible foil type duct can more easily trap lint and is more susceptible to kinks or crushing, which can greatly reduce the airflow. We recommend replacing the duct with a rigid or corrugated semi-rigid metal duct.

(2) We recommend having all dryer vents cleaned by a qualified person.

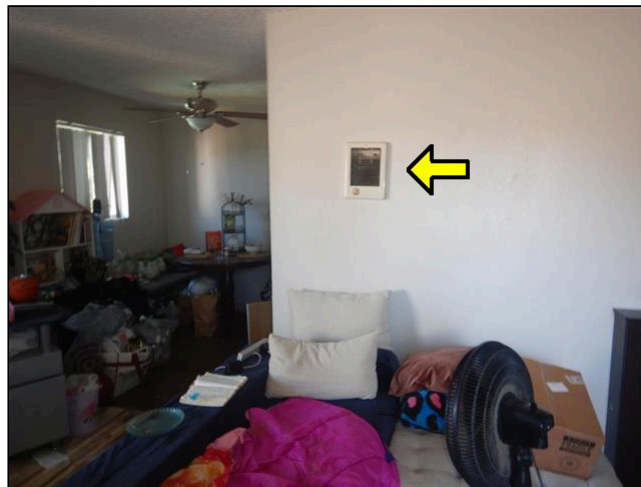
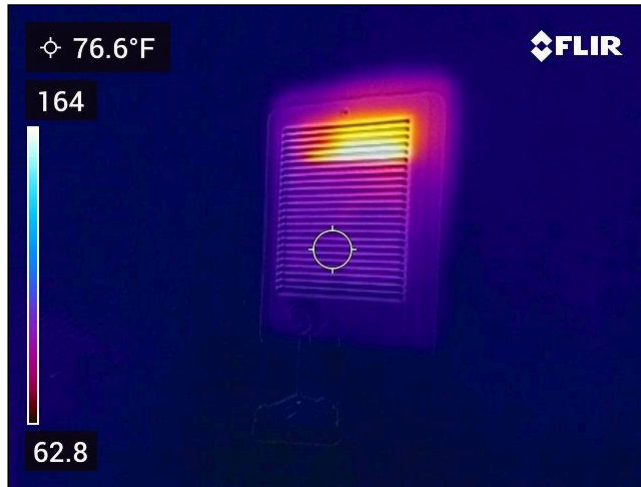
The accessible wall heaters in the Units(s) were tested and were functional/ operated at the time of the inspection.

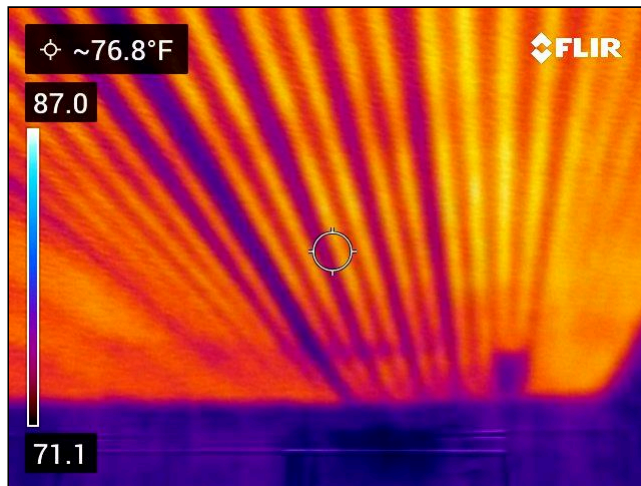
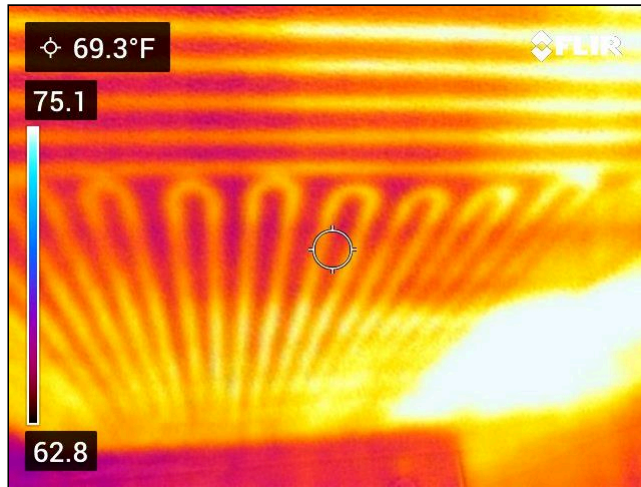
The accessible radiant ceiling heat in the Units(s) were tested and were functional/ operated at the time of the inspection.

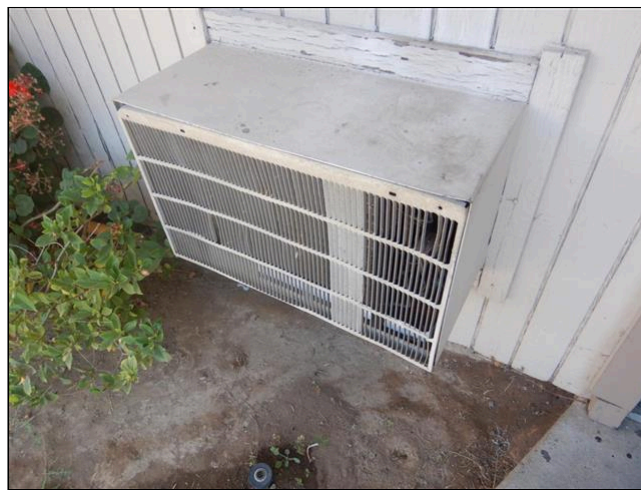
12.0 Item 1(Picture)

(1) Several wall AC units are older units. We recommend budgeting for replacement.

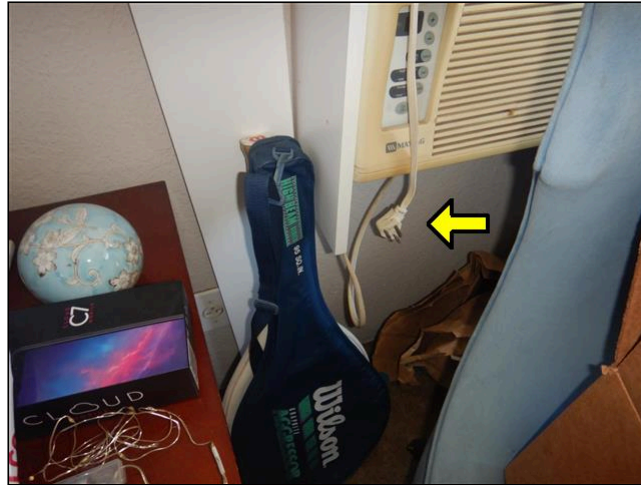
12.0 Item 2(Picture)

(2) The wall AC unit in Unit 4 was unplugged and was not inspected at the time of the inspection. We do not restore power to systems that have been unplugged/ shut down. We recommend further evaluation by a licensed HVAC contractor prior to the end of your contingency period.

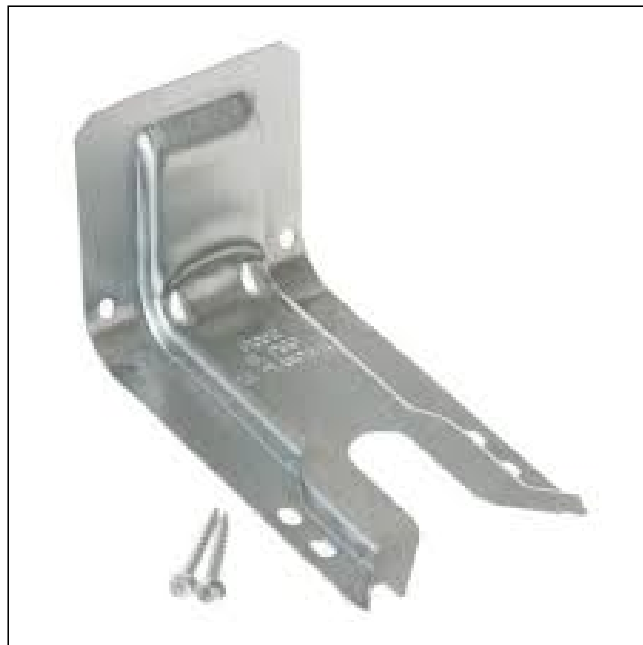
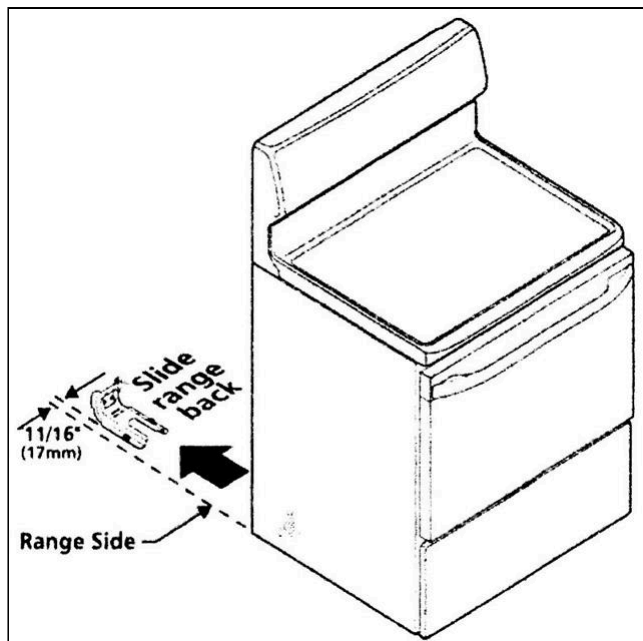
An anti tip bracket was not installed at the range in Unit 1 and Unit 2. This bracket prevents the range from tipping forward which could cause the range to fall over. We recommend installation of an anti tip bracket by a qualified person for safety and to help prevent injury.

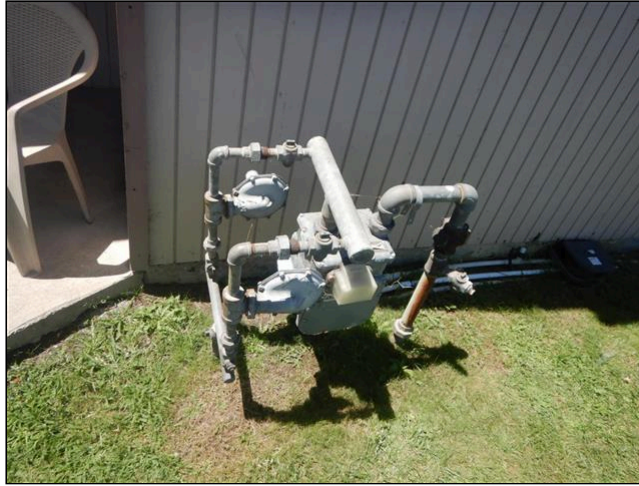
16.0 Item 1(Picture)

The main gas shut off valve is located at the gas meter at the front exterior side of the property (facing front).

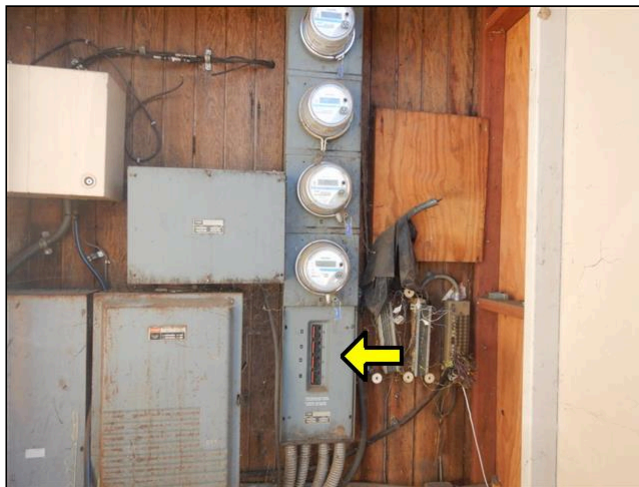
16.1 Item 1(Picture)

The Main Electrical panel is located at the right exterior side of the property (facing front).

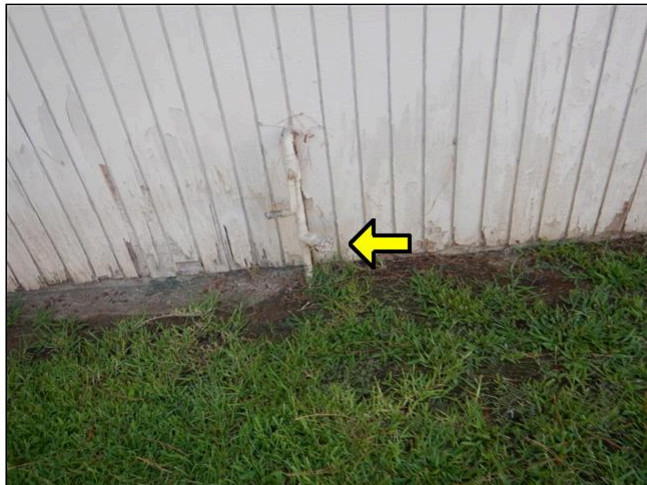
16.2 Item 1(Picture)

(1) The main water shut-off valve is located at the front exterior side of the property (facing front).

(2) This house has a "gate" valve type main water shut off. The valve appears to be original and aged. Gate valves that are aged are more prone to leaking or breakage. Often times the valve has not been turned for an extended period of time causing the valve to fail. This or any other valve was not tested during the inspection in accordance with our Standards of Practice. We recommend installing a new "ball" valve type shut off by a licensed plumber.

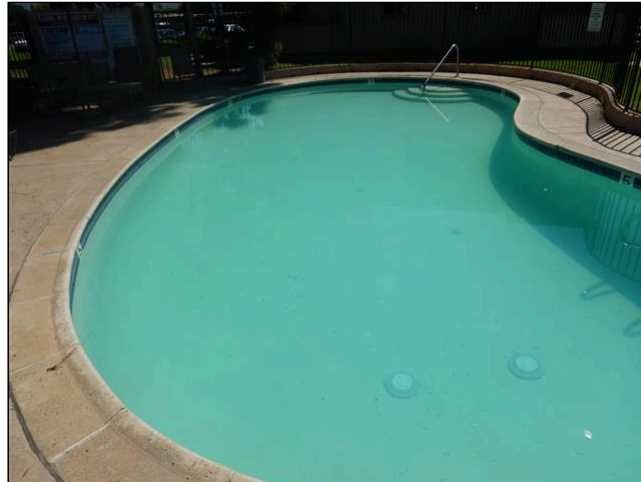
17.0 Item 1(Picture)

(1) Photo of the pool.

- (2) The water in the pool was dirty. Testing the water for proper chemical balance or contaminates is beyond the scope of our general home inspection. We recommend having the pool cleaned, and water tested by a qualified licensed pool contractor.

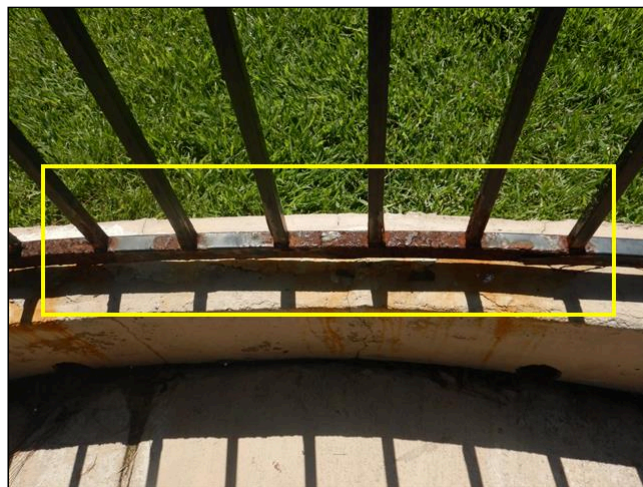
17.1 Item 1(Picture)

(1) The wrought iron fence around the pool is rusted and/ or damaged and is loose/ leaning at several areas. We recommend necessary repairs or replacement where needed by a fence contractor and adjusting the sprinklers away from the wrought iron fencing to prevent further/ future damage.

(2) The fence around the pool is loose, leaning and deteriorated in several areas. We recommend necessary repairs or replacing as needed by a licensed fence contractor.

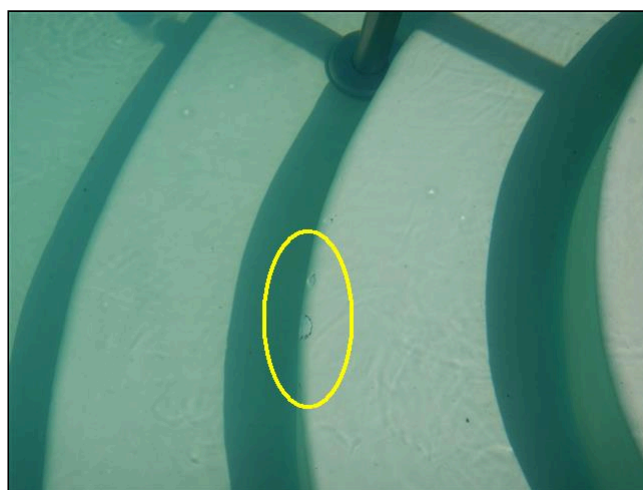
17.2 Item 1(Picture)

(1) Plaster on the walls is deteriorated in some areas. We recommend further evaluation by a qualified licensed pool contractor to get an estimate of life remaining, and/or the cost of repair prior to the end of your contingency period.

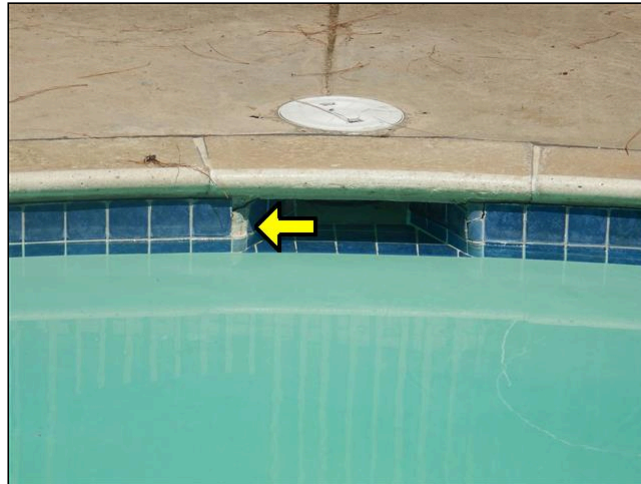
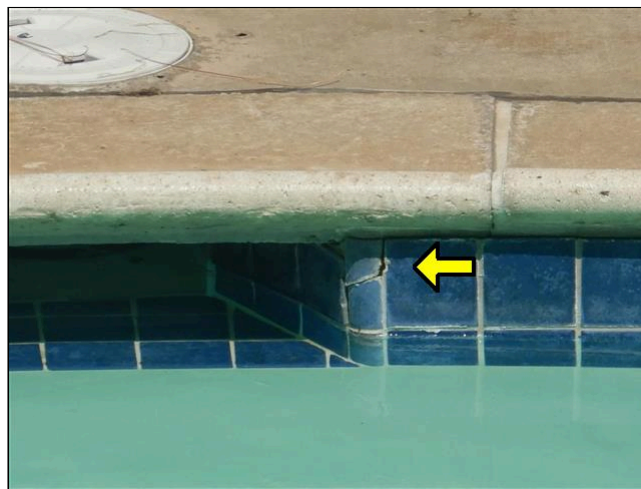
(2) Several tiles are missing or cracked at the pool walls. We recommend having the tiles repaired or replaced by a qualified licensed pool contractor.

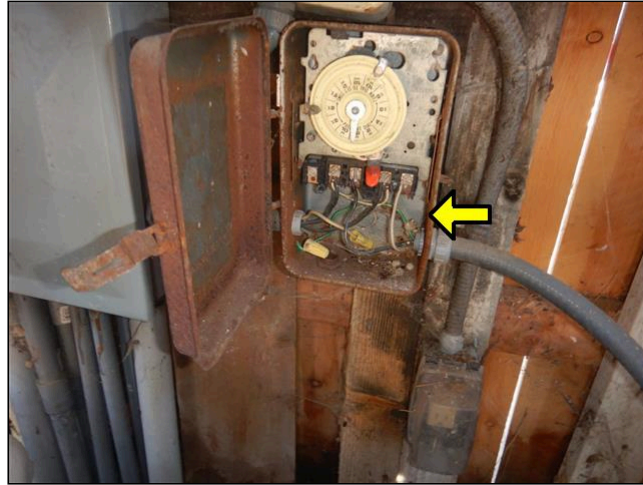
17.6 Item 1(Picture)

- (1) The bonding wire is missing at the pool equipment. This is a safety hazard. A bonding wire should connect all metal components of the pool for safety. We recommend installing a bonding wire by a licensed electrician for safety.
- (2) Exposed wires were observed at the pool equipment. This is a shock hazard. We recommend necessary repairs by a qualified licensed pool contractor or electrician.
- (3) The plastic insulator is missing from the timer box. A plastic insulator is required in the timer box to prevent shocks. We recommend installing a plastic insulator by a qualified person.

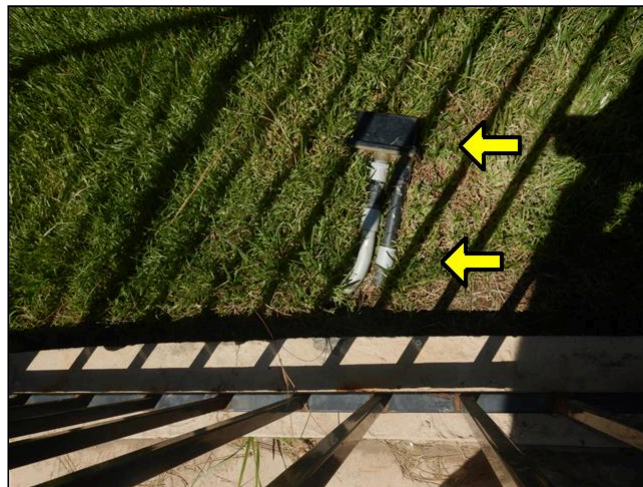
17.6 Item 2(Picture)

- (4) An electrical junction box is damaged outside the pool fence We recommend necessary repairs or replacement by a qualified person.

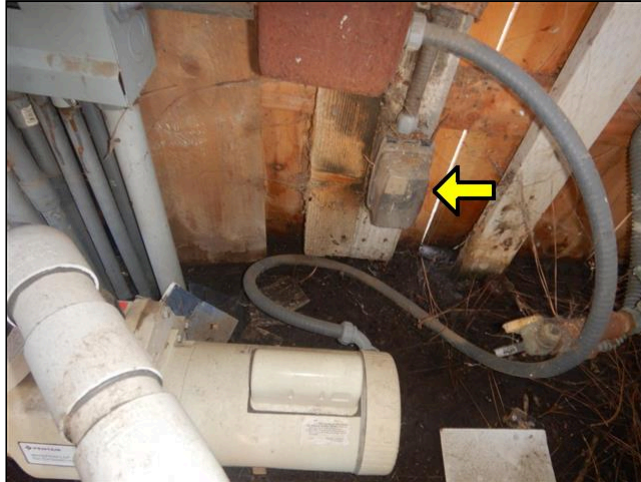
17.9 Item 1(Picture)

The GFCI outlet for the pool light(s) did not trip when tested. This is a safety concern. We recommend replacing the GFCI outlet by a qualified licensed electrician or pool contractor prior to using the pool/ as soon as possible.
