Inspection Report

Property Address:
4312 Smith Drive
Small Building, 4 Units
El Cajon CA 92019

The Property Inspection Pros

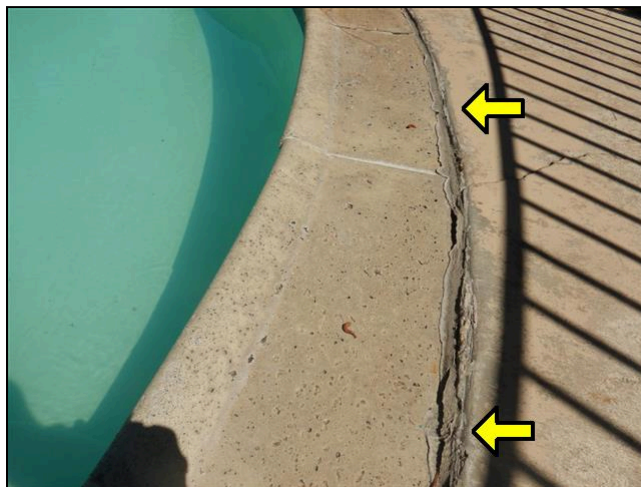
17.10 Item 1(Picture)

(1) The elastomeric compound (Deck-O-Seal) between the pool deck and coping is cracked/ missing in several areas. We recommend re sealing between the pool deck and coping as needed by a qualified pool contractor.

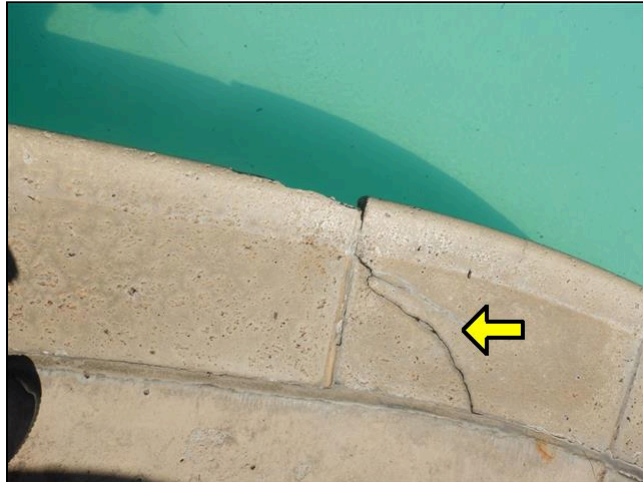
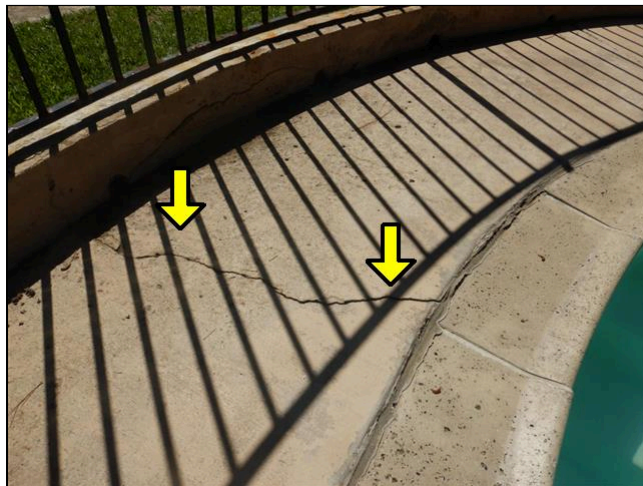
(2) The decking and the coping around the pool is cracked in several areas. We

recommend necessary repairs by a qualified licensed concrete contractor.

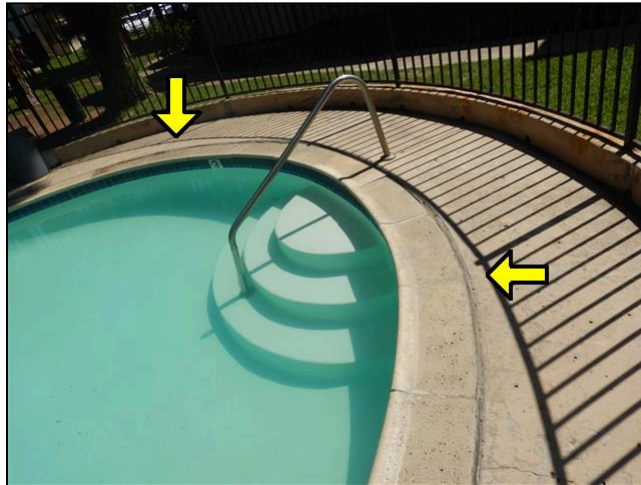
17.10 Item 4(Picture)

(3) Sections of the deck are uneven. This can pose a tripping hazard and may also indicate that soil settlement or root encroachment occurred. We recommend necessary repairs by a qualified licensed concrete contractor.

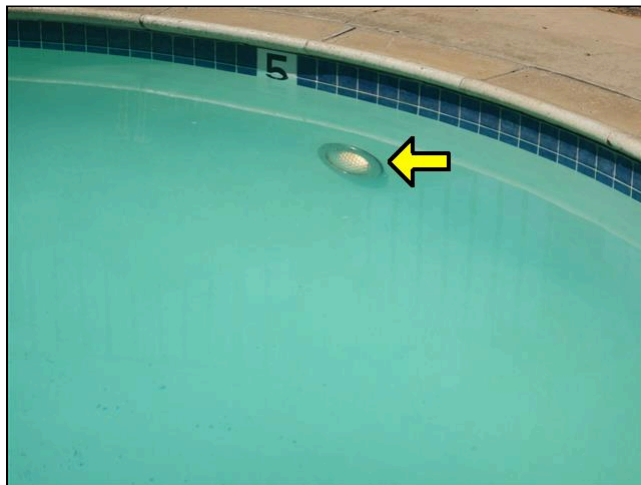
17.12 Item 1(Picture)

- (1) Pool and spa light(s) are not taken out and we did not observe the condition of the wiring to the pool and spa light(s). This is out of the scope of a general home inspection. If concerned about the wiring to these lights we recommend further evaluation by a licensed pool contractor prior to the end of your contingency period.
- (2) The pool light(s) operated when tested.

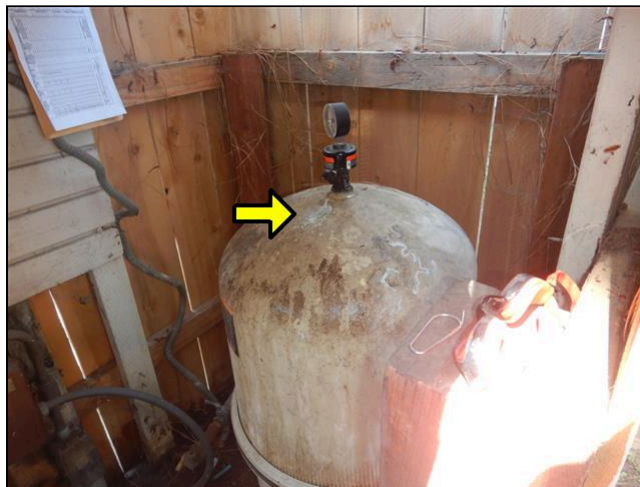
17.16 Item 1(Picture)

An active leak was observed at the filter at the time of the inspection. We recommend necessary repairs by a qualified licensed pool contractor.
