Inspection Report

Property Address:
3212 Main Pl
Rancho Santa Fe CA 92067

The Property Inspection Pros

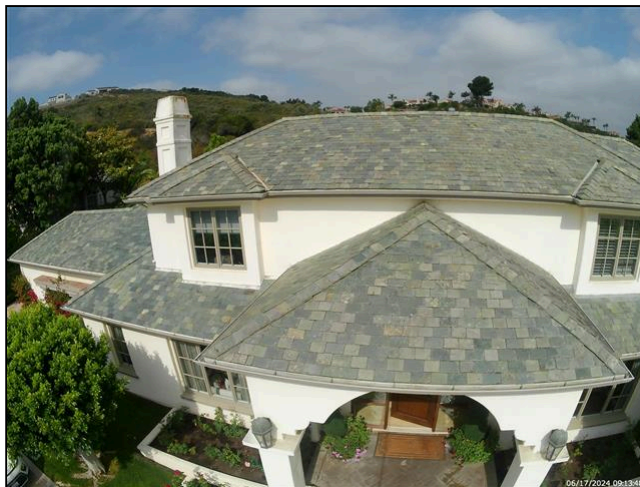
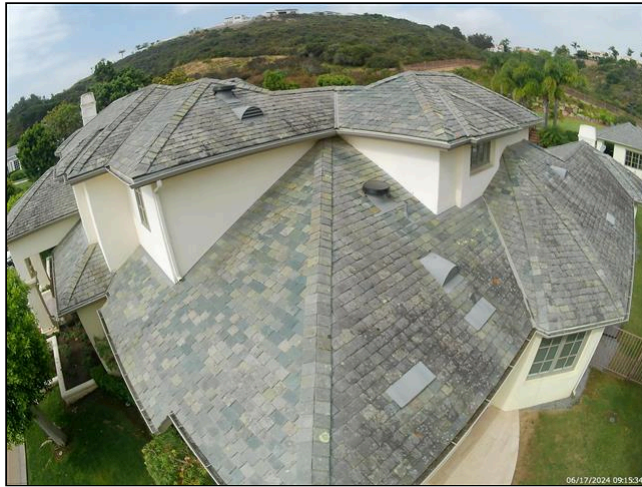
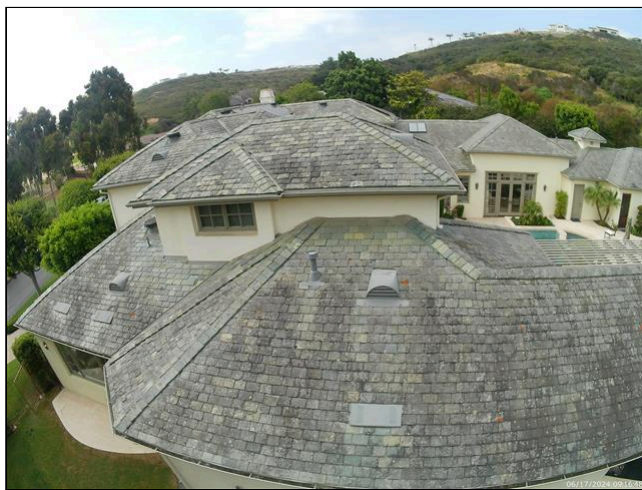
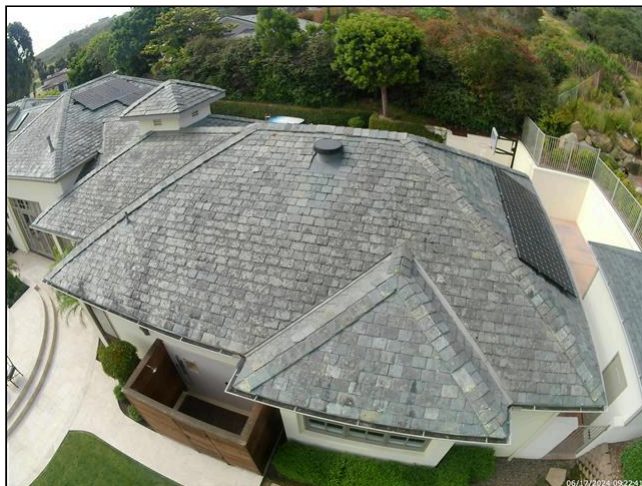
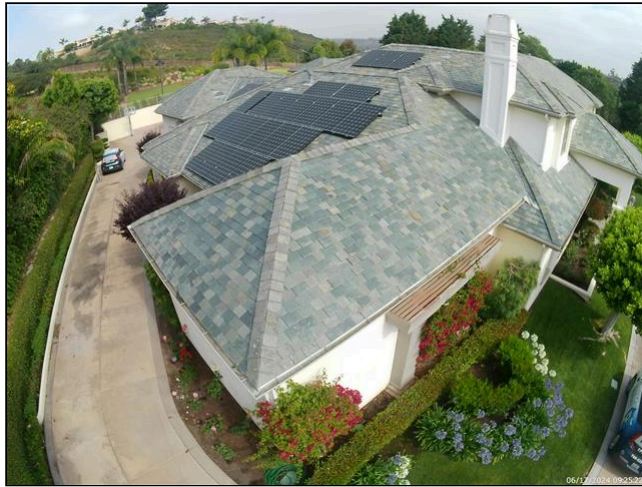
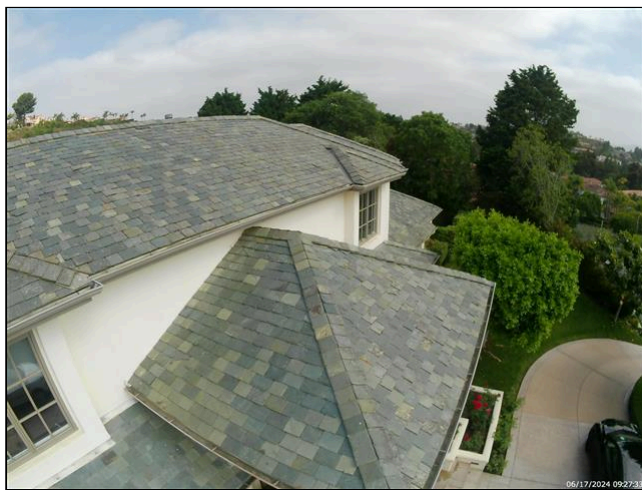
(1) **Photo(s) of the roof.**

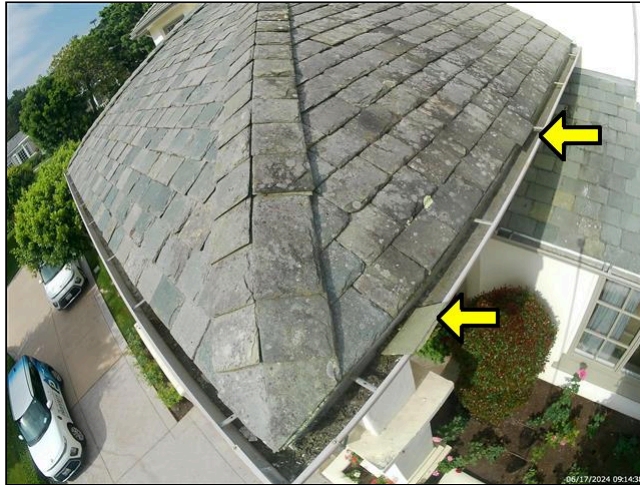
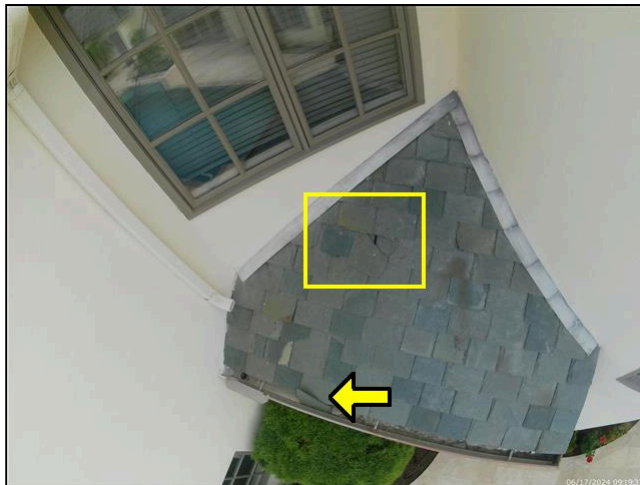
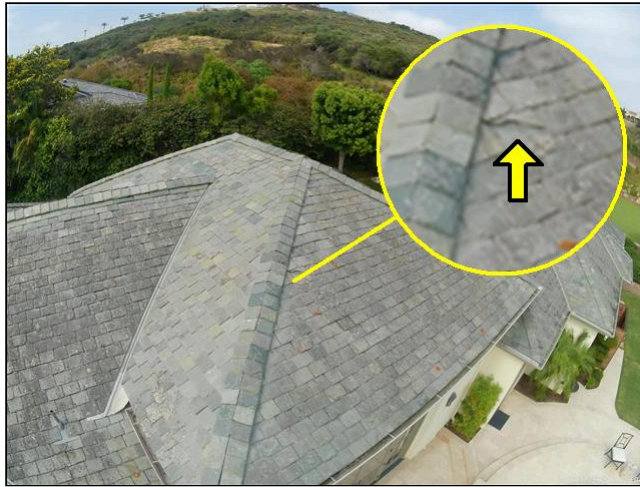
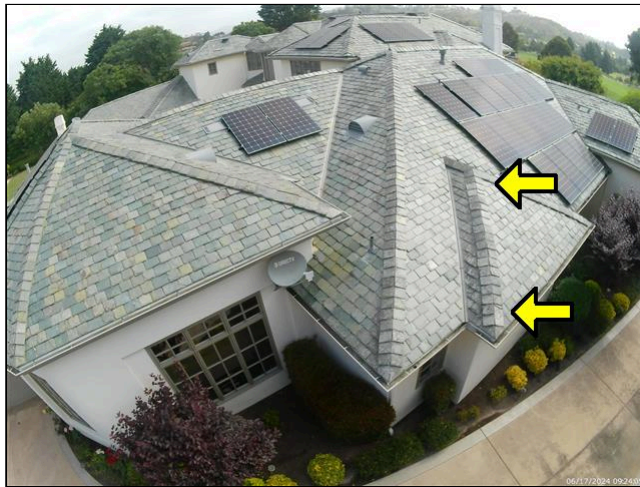
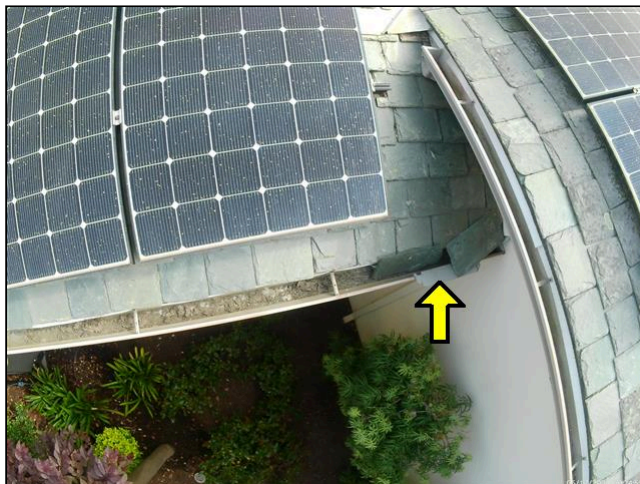
(2) There are several missing, damaged, cracked and slipped roof tiles noted at several areas throughout the roof. We recommend further evaluation of the entire roof prior to the end of your contingency period by a licensed roof contractor and necessary repairs or replacement made.

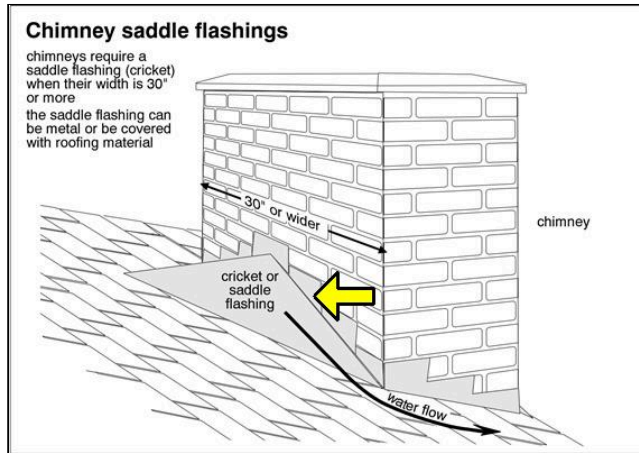
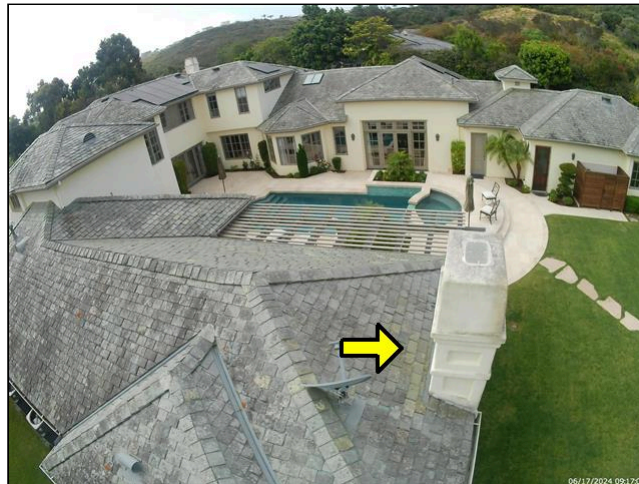
No saddle or cricket flashing was installed at the chimney. This is required when chimneys are 30 inches wide or more. We recommend further evaluation and necessary corrections by a licensed roof contractor.

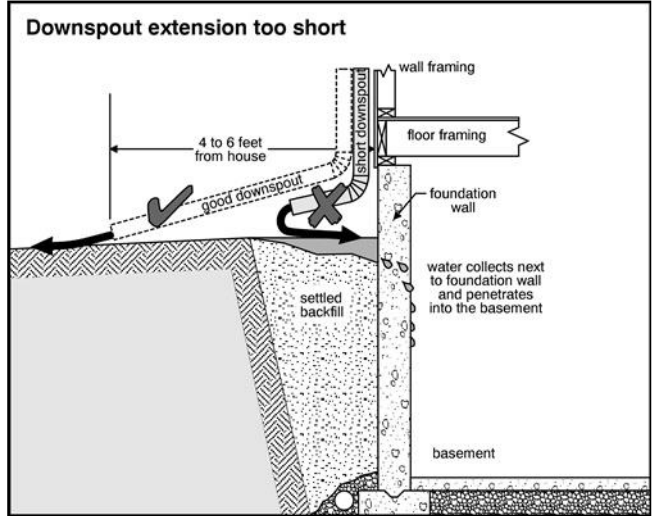
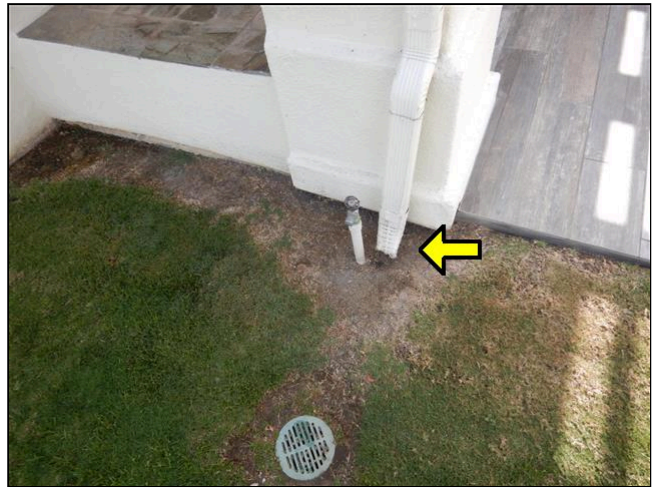
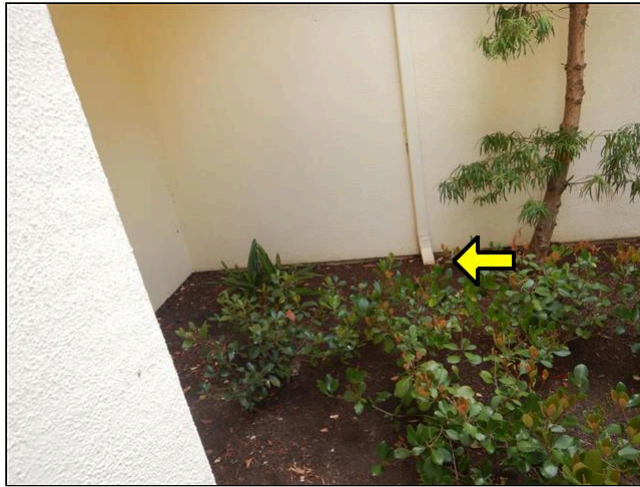
- (1) Gutters appear intact but due to the lack of recent or current rain I am unable to determine if the gutters leak at seams or drain properly.
- (2) Gutters require cleaning. We recommend having the gutters cleaned by a qualified contractor.
- (3) Some of the downspouts need extension and/or a buried drain line to carry water away from the home at several areas. We recommend necessary corrections where needed by a qualified contractor.

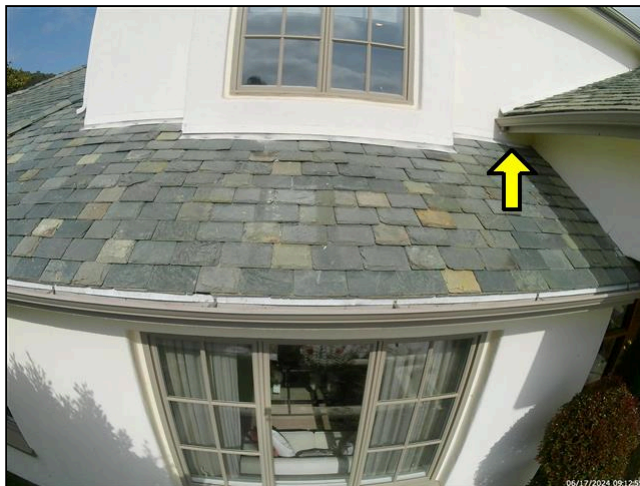
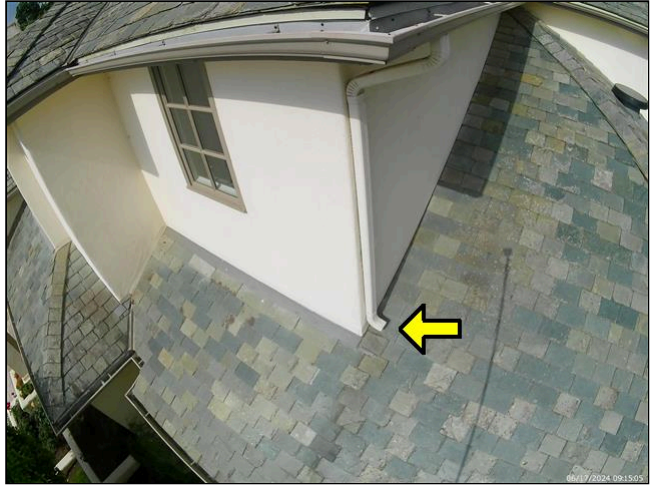
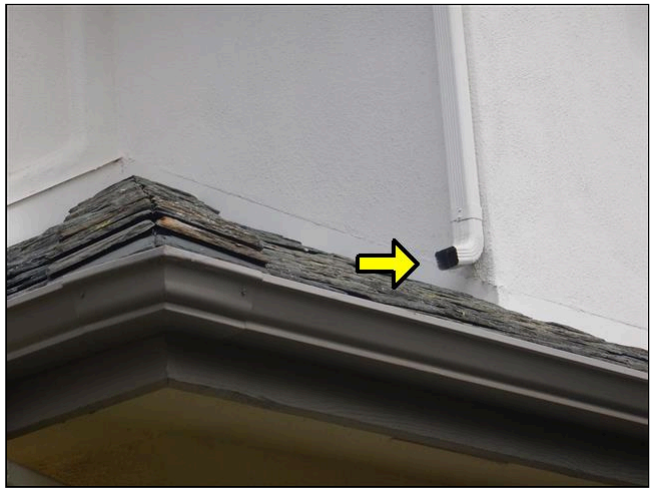
(4) There are upper level roof downspouts that discharge water onto the lower roof. This causes excessive water to flow in a concentrated portion of the roof causing wear, and staining. During heavy rain water can also be forced under the roofing material causing leaks. We recommend rerouting the downspouts to direct water away from the lower roof to an approved location such as a lower gutter, or a downspout all the way to the ground by a qualified contractor.

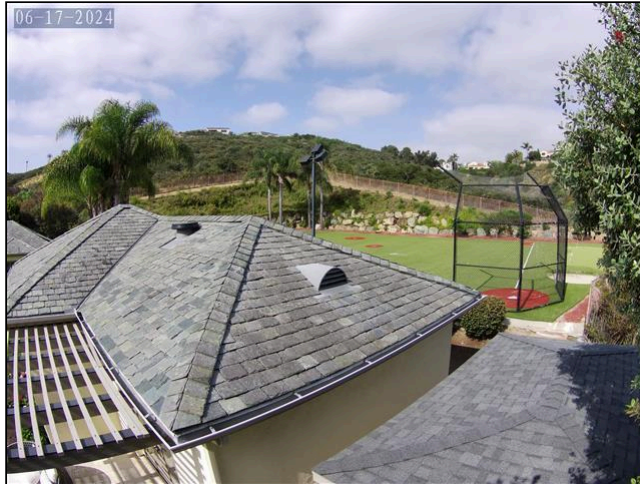
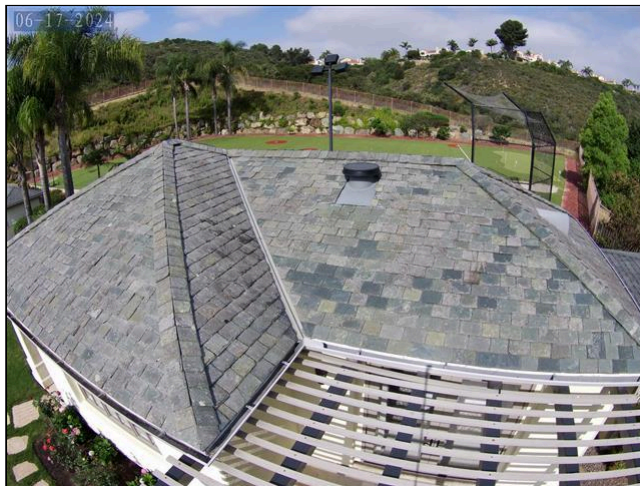
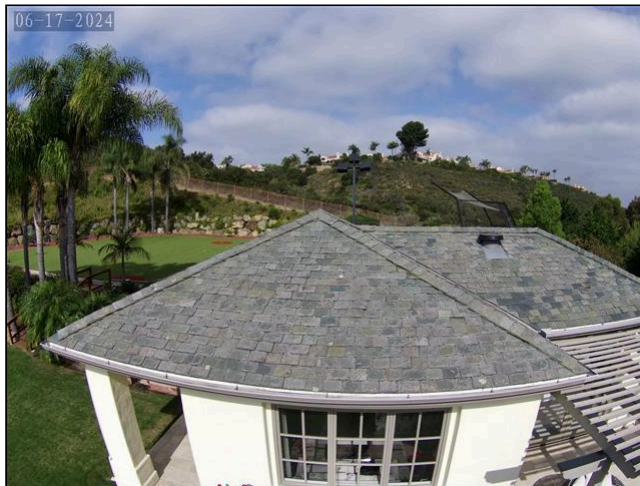
(1) Pictures of the roof.

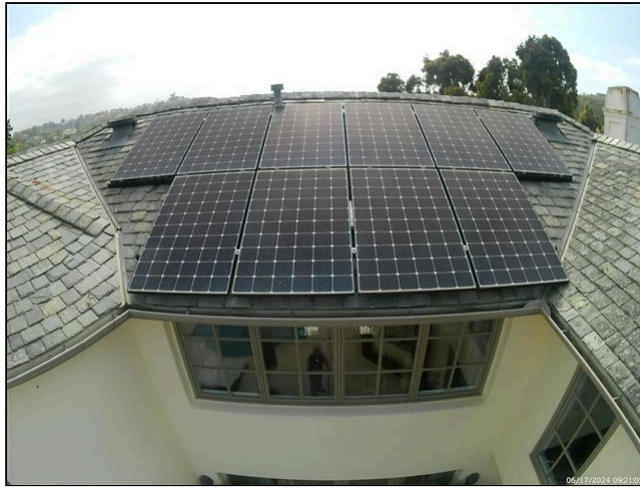
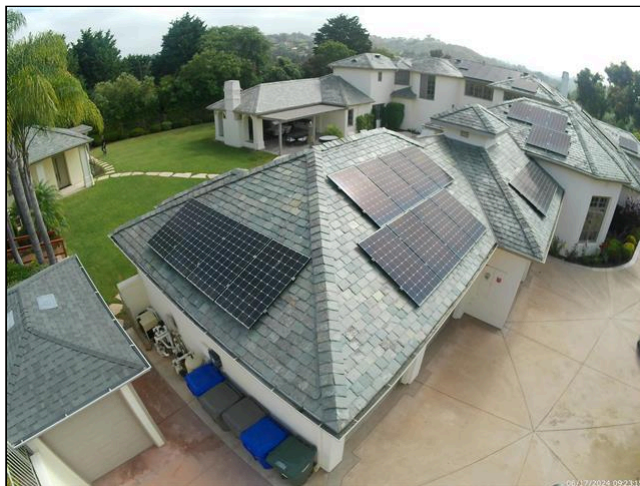
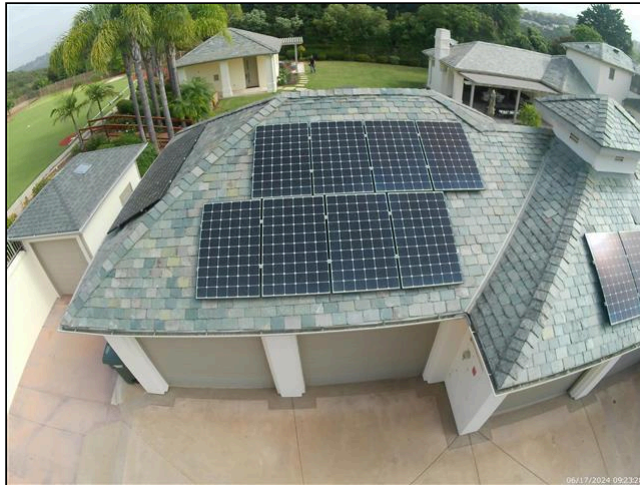
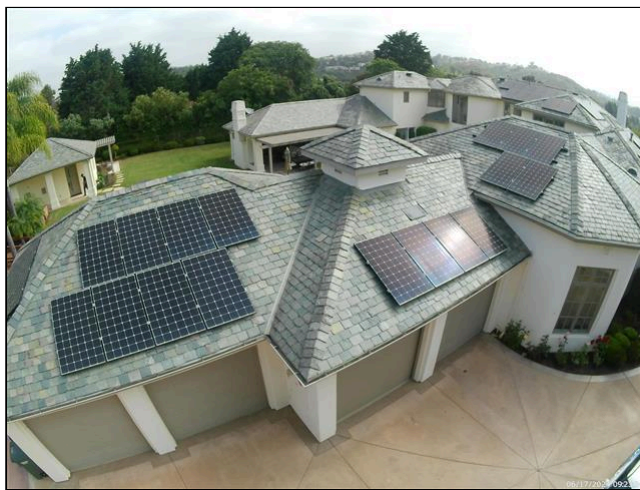
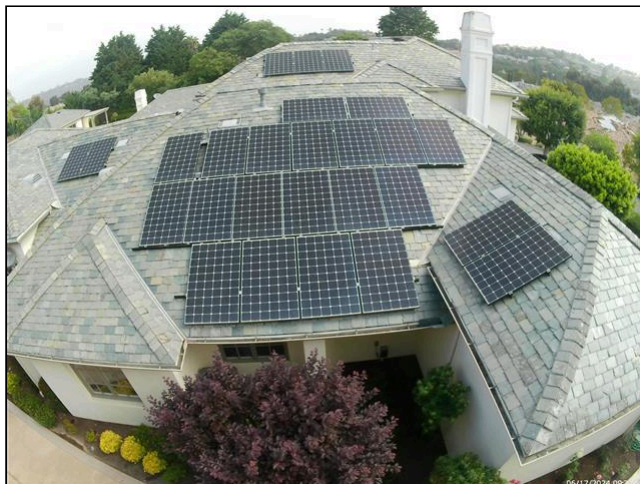
The electric solar system and its related components are beyond the scope of the home inspection and was not inspected. We recommend verifying that the electric solar system is operational prior to the end of your contingency period.

We also recommend having all the solar panels cleaned by a qualified person.

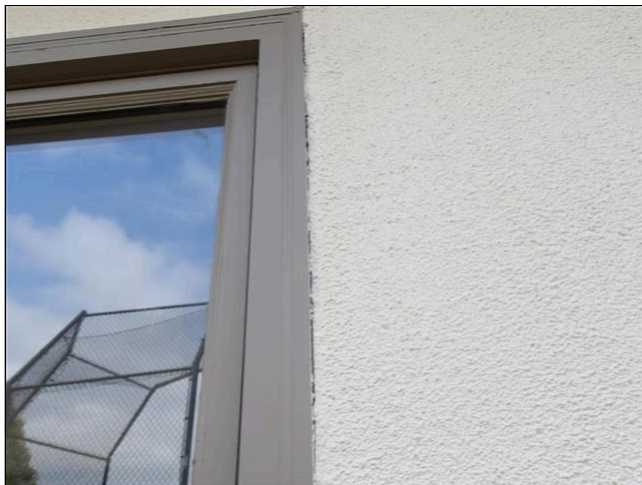
2.6.A Item 1(Picture)

(1) Gaps observed between the frame and the stucco on the exterior of several windows. We recommend further evaluation and any repairs made by a qualified licensed window contractor.

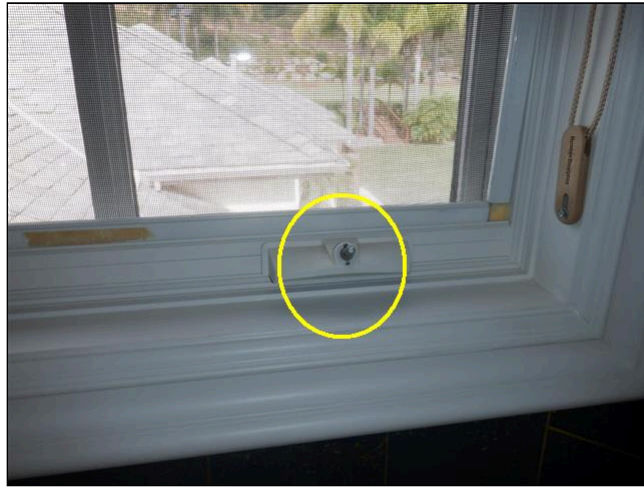
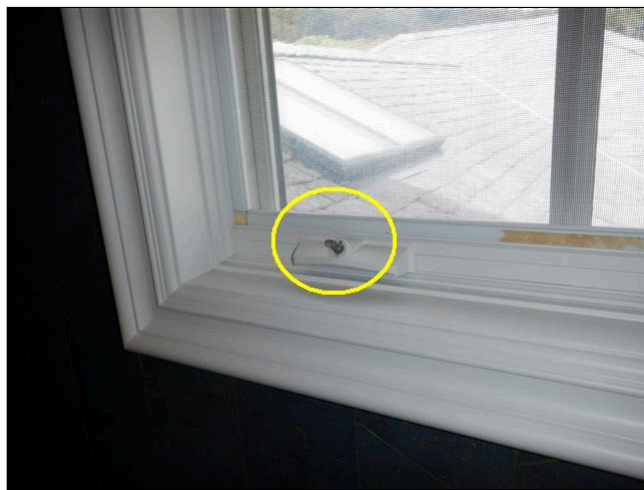
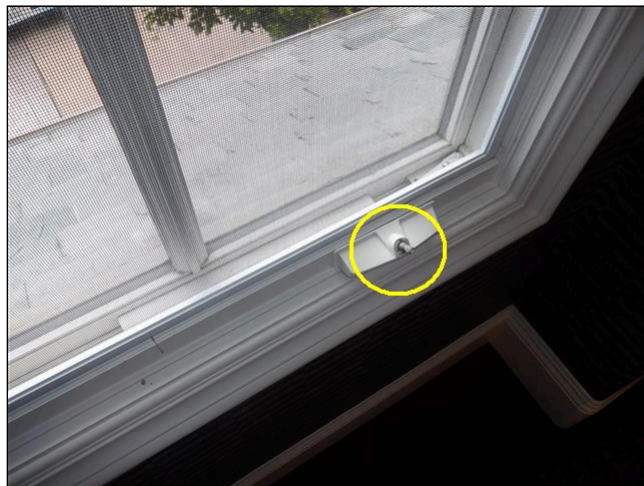
(5) Casement window(s) had missing crank handles at several windows throughout the house. These windows could not be tested for proper operation. We recommend replacing the handles and testing these windows for proper operation prior to the end of your contingency period.

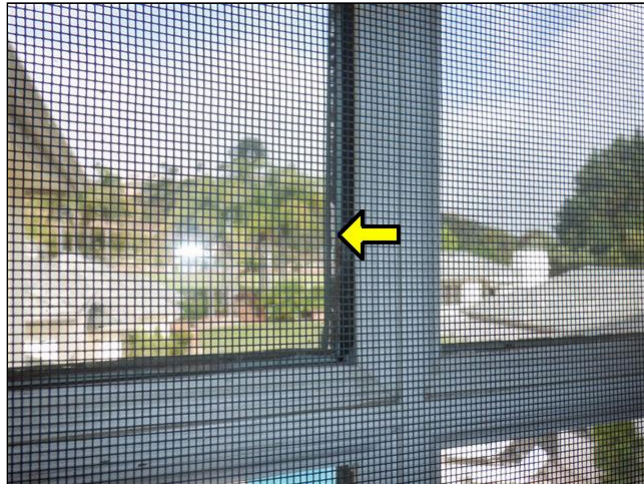
2.6.A Item 9(Picture)

(6) Damaged seals were observed between the panes of glass at several window(s). This can be caused by exposure to the sun (excessive heat) or a manufacturing flaw. Replacement of the insulated unit is needed to restore visibility. We recommend having

all of the windows reviewed by a qualified licensed window contractor to determine how many windows require repair/replacement.

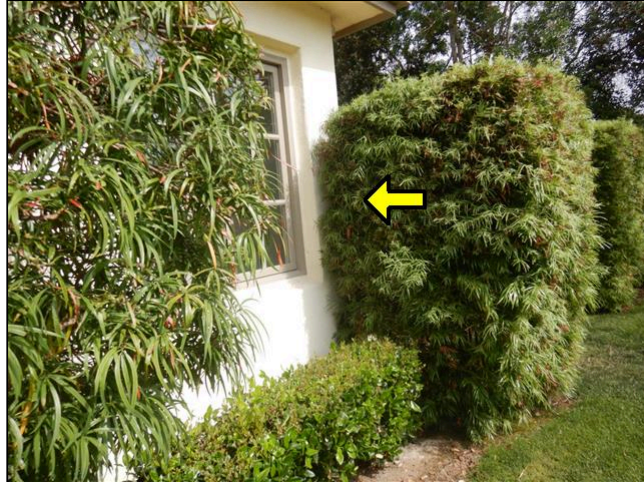
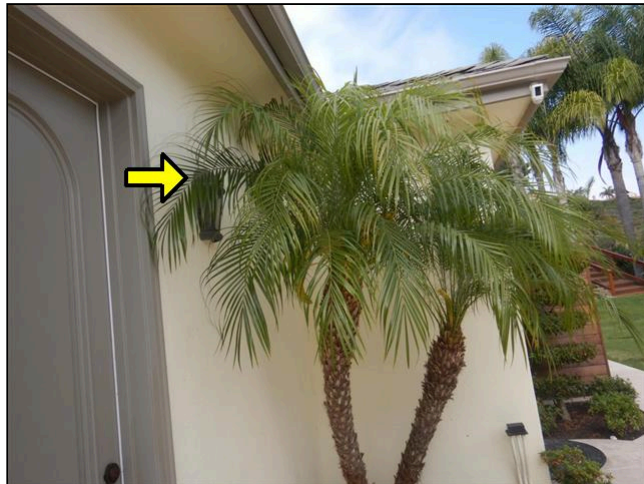
(1) Tree(s) and/or large plants are located too close to the house. Tree limbs/vegetation that are too close to the house can cause damage in several ways. Limbs or vines in contact with roof or hanging near roof should be trimmed to prevent damage to roof and/or to prevent rodent infestation. Also, as the plants grow, damage can occur to the siding, concrete flat work and to the foundation. We recommend having the foliage removed or trimmed by a qualified professional to prevent damage to the house as soon as possible.

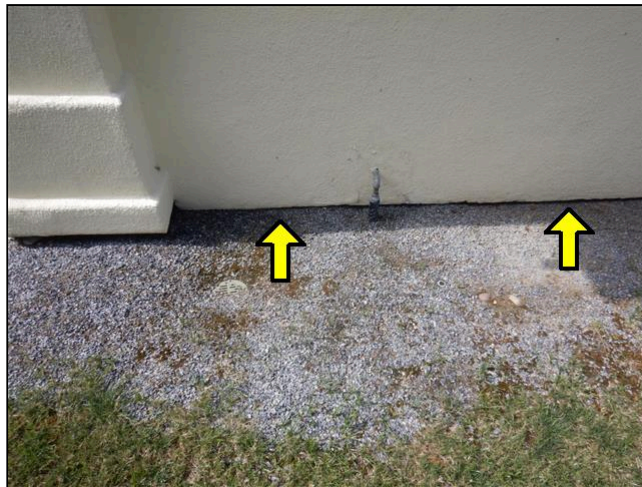
2.2.B Item 2(Picture)

to "breathe" and water to "weep" from the stucco. Having the soil above the weep screed can lead to stucco damage due to limited air flow. We recommend a ground clearance of four inches where possible allow for proper drainage and for ventilation of the stucco walls. Dirt in contact with the stucco can promote deterioration, including rot, pest infestation, and water intrusion during rain. We recommend further evaluation and necessary corrections by a qualified licensed contractor.

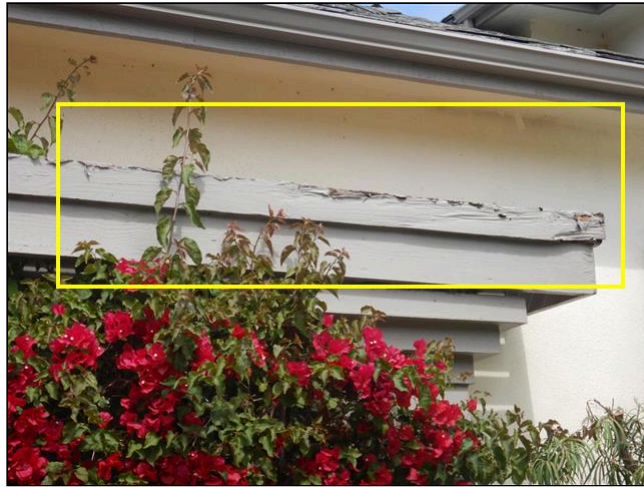
2.3.B Item 2(Picture)

(1) Some damaged wood is observed at several areas. We recommend referring to the pest inspection report for a detailed evaluation of the wood. We also recommend necessary repairs or replacing the wood siding as needed by a qualified licensed contractor.

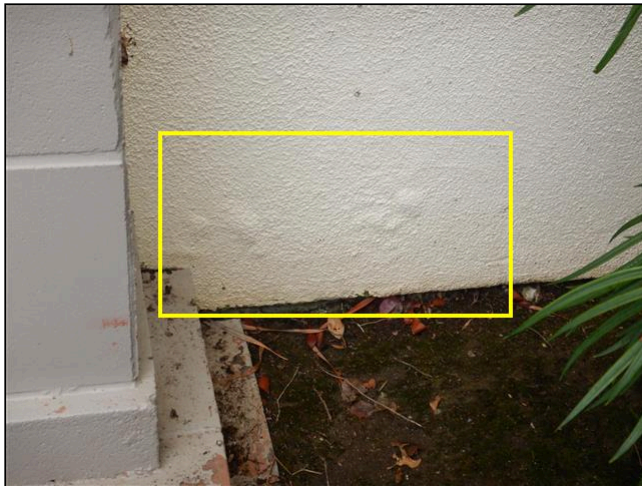
2.3.B Item 5(Picture)

(5) Routine Maintenance Tip: Seal all gaps, cracks and openings in the stucco. This includes cracks around windows and doors, gaps between flashing and stucco and small holes in the siding. This is a normal maintenance item and should be done on an annual basis. Small cracks and gaps can cause big problems over time due to water infiltration and pest infestation.

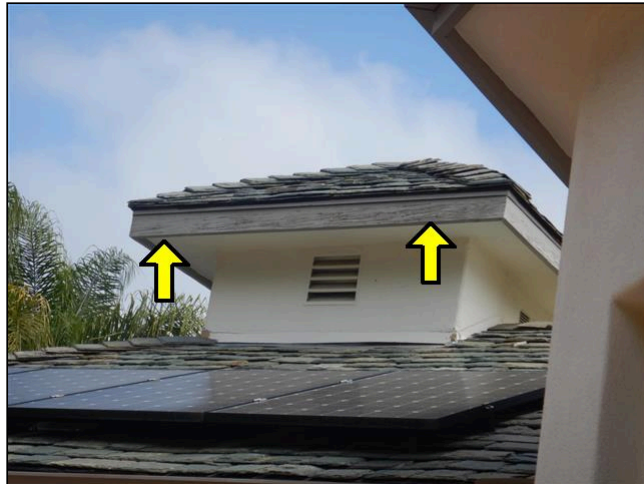
2.4.B Item 1(Picture)

Paint is failing at the eaves at several areas and needs prep and paint. We recommend prep and paint where needed by a licensed paint contractor.

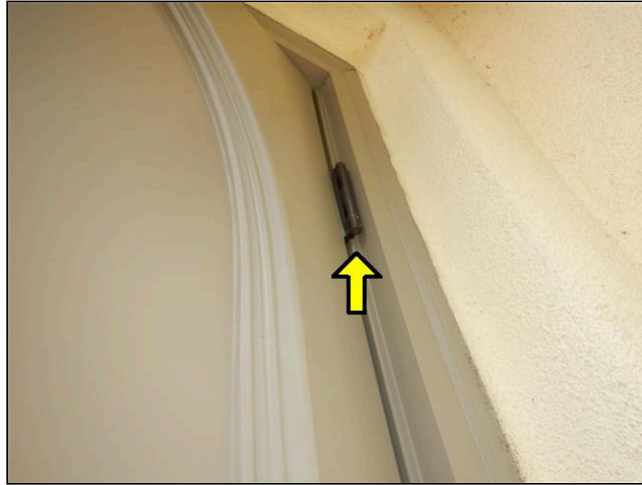
2.5.B Item 2(Picture)

(2) One of the rear patio exterior door handles is loose/damaged. We recommend repairs/replacement where needed by a qualified licensed contractor.

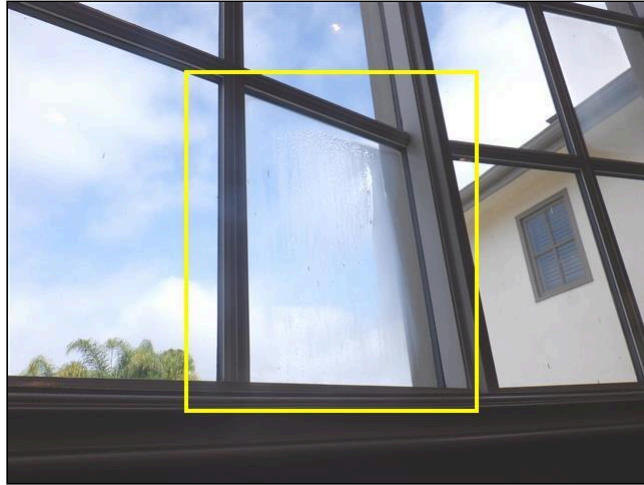
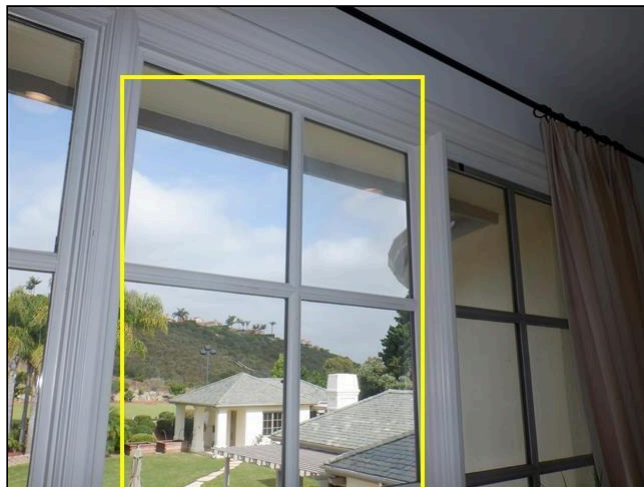
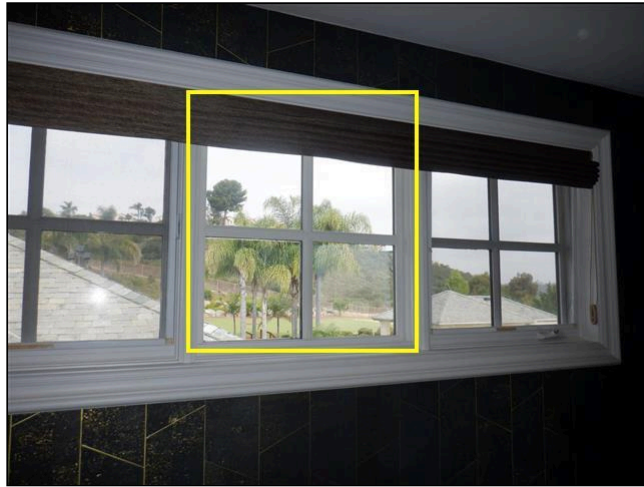
(1) Condensation was observed between the panes of glass at several windows throughout the house. This occurs when the seal has failed between the panes of glass, and ambient air has entered the assembly. Replacement of the glass is required. Since some failed windows may not be easily found due to changing ambient conditions (heat, humidity, etc). We recommend having all of the windows reviewed by a licensed window contractor to determine how many windows require repair/ replacement. We recommend repairing or replacing all windows that have failed window seals by a licensed window contractor.

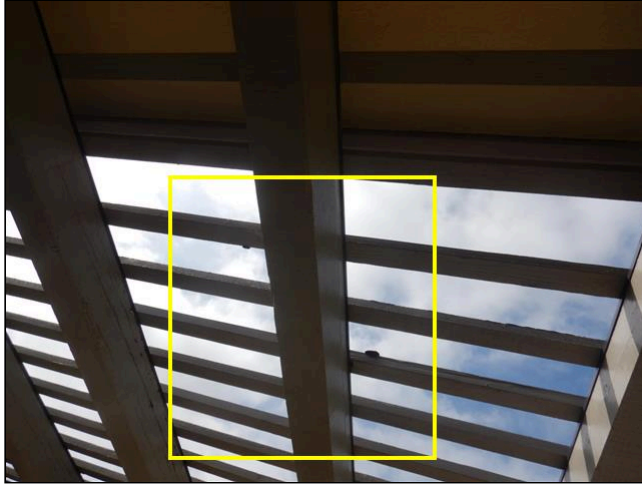
2.8.B Item 1(Picture)

(1) Some damaged wood is observed at the patio cover at several areas. We recommend referring to the pest inspection report for a detailed evaluation of the wood. We also recommend necessary repairs or replacing the damaged wood as needed by a qualified licensed contractor.

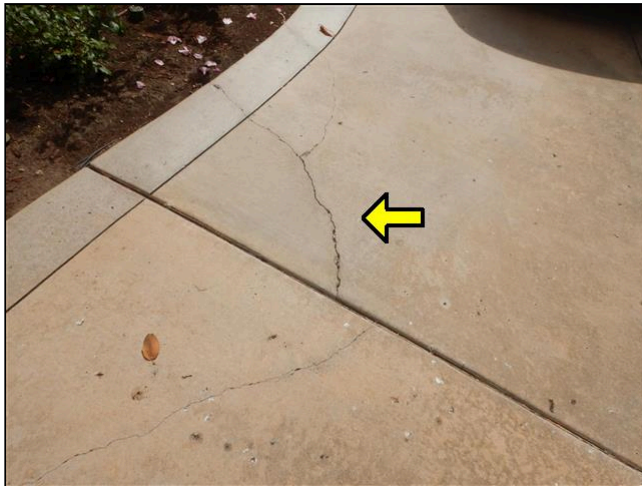
2.8.B Item 2(Picture)

(2) There are several cracks in the concrete driveway. We recommend necessary repairs by a licensed concrete contractor.

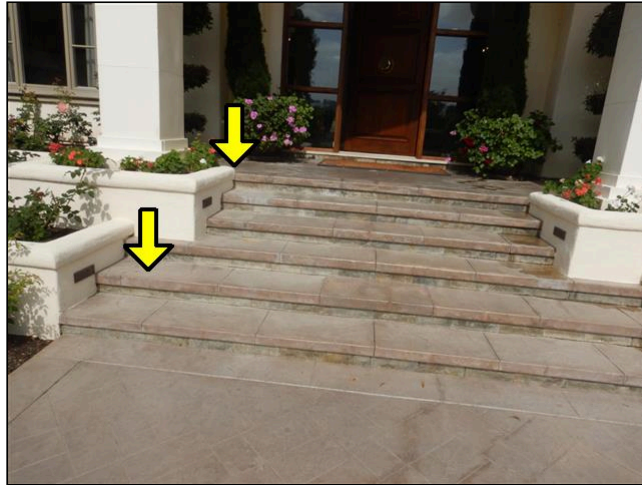
2.9.B Item 1(Picture)

There is no handrail installed at the front yard exterior stairs/ steps. A handrail is required at least one side of the stairs when four or more steps are present. This is a safety hazard and corrections are needed. We recommend installing a handrail for safety by a qualified licensed contractor.

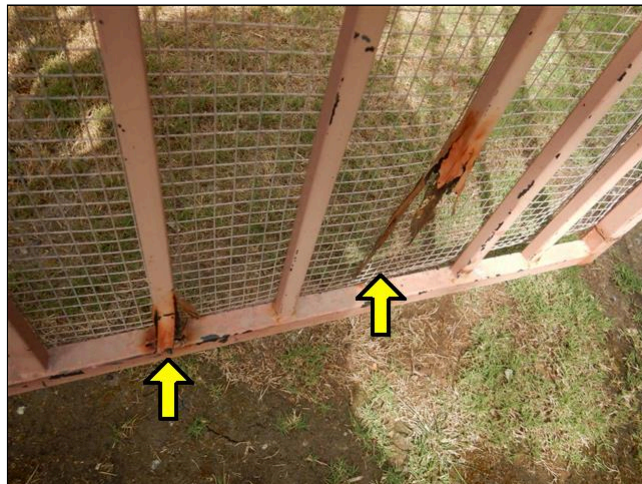
2.10.B Item 1(Picture)

(1) The wrought iron fence is rusted and/ or damaged at several areas. This is commonly caused by sprinkler over-spray. We recommend repair or replacement by a fence contractor and adjusting the sprinklers away from the wrought iron fencing to prevent further/ future damage.

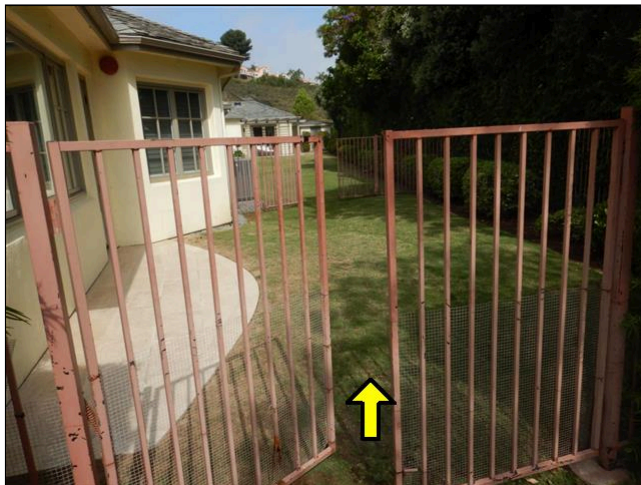
2.10.B Item 3(Picture)

(4) The gates at the pool fence swings inward. This is incorrect and repairs are needed for safety. Pool gates must swing away from the pool area. We recommend necessary corrections by a qualified person for safety.

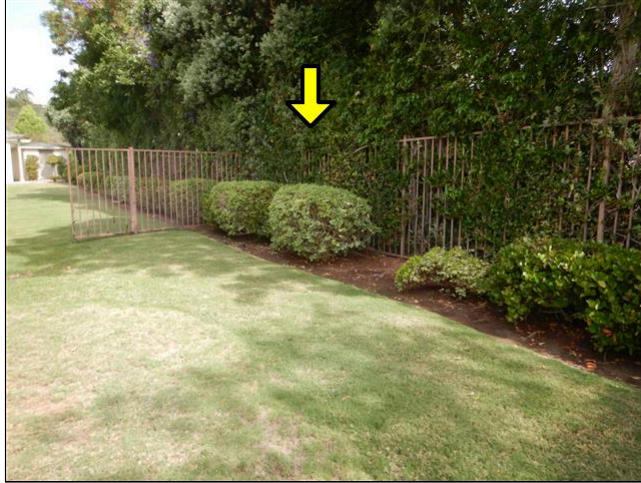
2.10.B Item 4(Picture)

(7) Vegetation is growing on the fence in several areas. Vegetation can hold moisture to the fence and cause excessive weight and damage. We recommend trimming back and removing the vegetation by a qualified licensed landscaper.

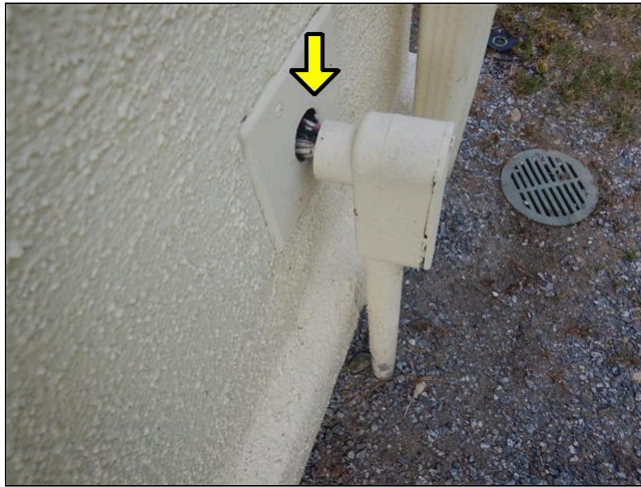
2.11.B Item 1(Picture)

A gap is observed at the right side conduit. We recommend necessary repair or replacement by a qualified person.

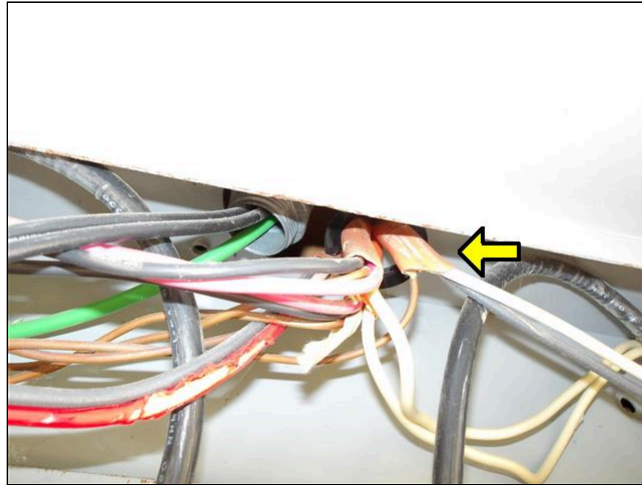
3.0.A Item 4(Picture)

(2) A knockout is noted missing from inside the sub electrical panel. When a knockout is removed and left empty a cover plug is required to be installed to prevent rodent intrusion for fire safety. We recommend installing knockout plug(s) where needed by a qualified licensed electrician for safety.

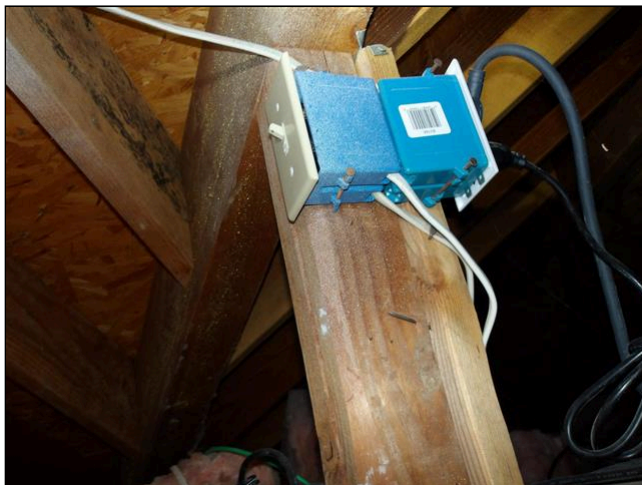
3.2.A Item 2(Picture)

(2) Unprotected Romex was present in the detached house attic adjacent to the attic scuttle. Romex located within 6 feet of the attic scuttle must be protected from damage. We recommend adding protection to the Romex in attic by the access a qualified licensed electrician.

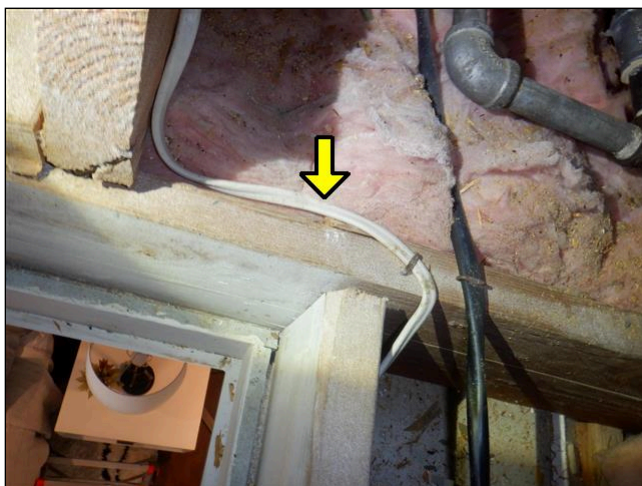
3.2.A Item 3(Picture)

(5) Unprotected Romex was present in the attic adjacent to the attic scuttle. Romex located within 6 feet of the attic scuttle must be protected from damage. We recommend adding protection to the Romex in attic by the access a qualified licensed electrician.

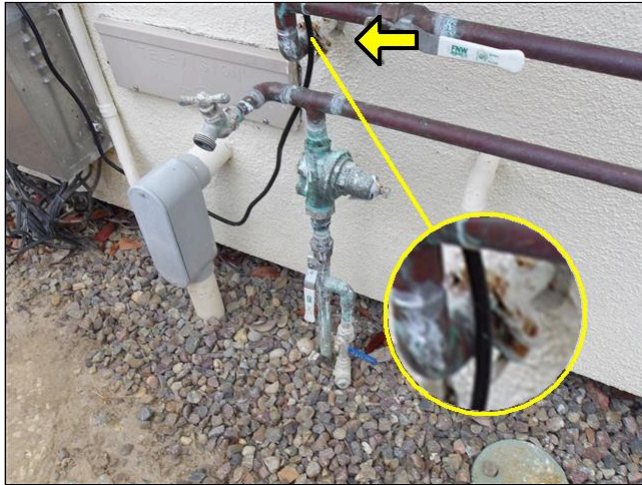
3.3.A Item 1(Picture)

The electrical system appears to be grounded through the plumbing system only which was standard at the time of construction. Newer homes have a separate ground rod which improves grounding. We recommend having a ground rod and wire installed by a qualified licensed electrician to improve grounding and safety.

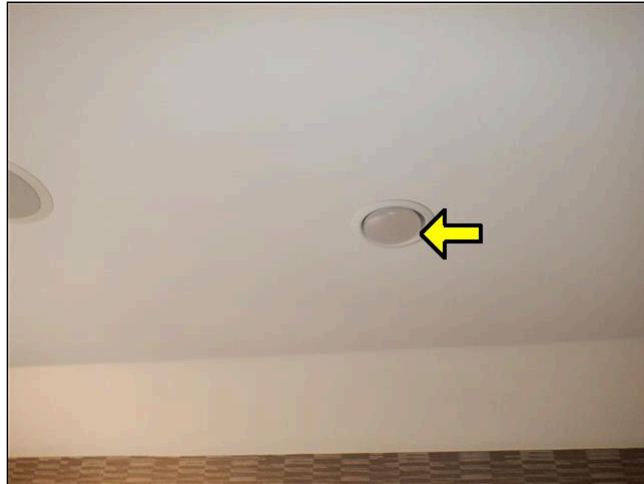
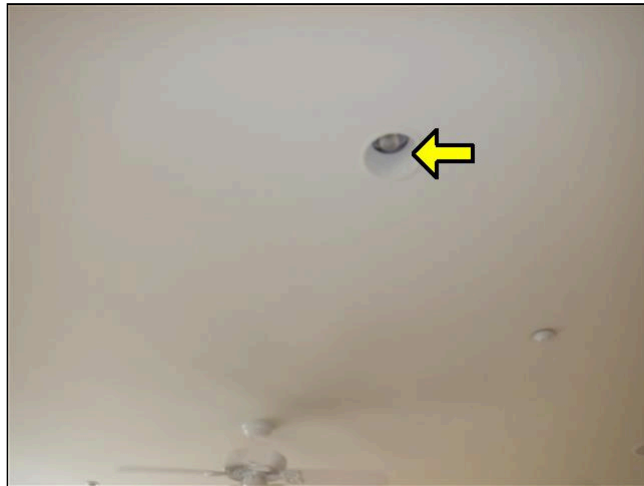
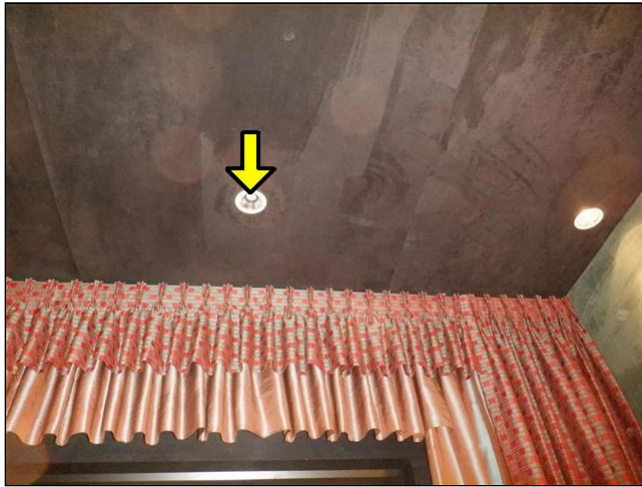
(1) Several lights throughout the house did not function when tested possibly due to bad bulbs or a miss wired fixtures. Occasionally there may something wrong with the fixtures which cannot be determined without a working bulb. We recommend asking the seller to demonstrate that theses lights are working prior to the end of the inspection contingency period, or changing the bulbs and testing again. If these lights do not function we recommend further evaluation by a qualified licensed electrician and necessary repairs or replacement as needed.

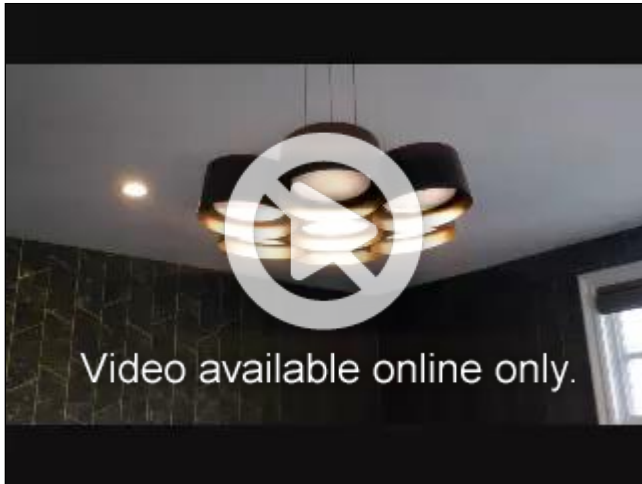
3.4.A Item 4(Video)

(2) The upstairs right side media room over head light was flickering when operated at the time of the inspection. This is non standard. We recommend further evaluation by a licensed electrician and have necessary repairs/replacement made where needed.

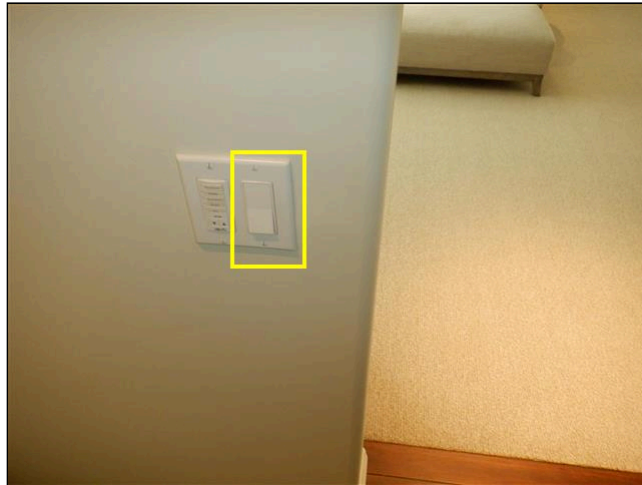
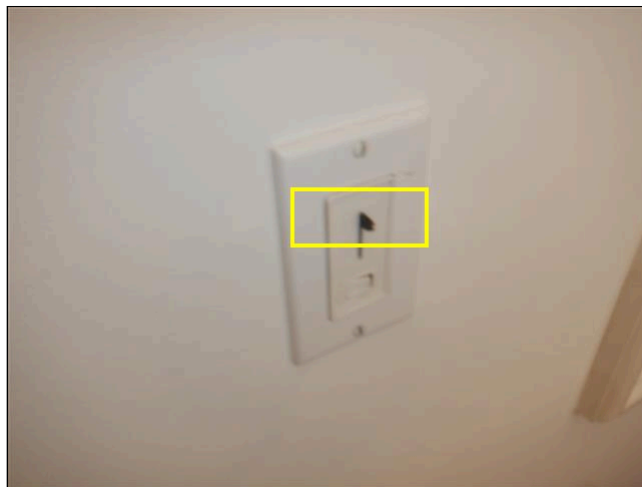
(1) I was unable to determine the function of the switch in the master bedroom. We recommend further evaluation by a qualified licensed electrician and repairs made as needed.

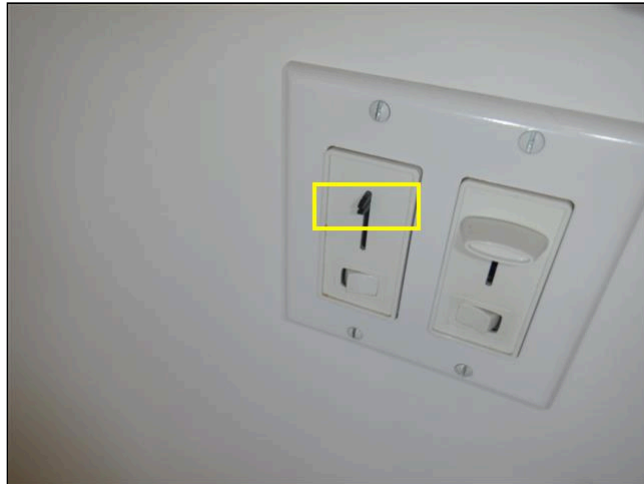
3.5.A Item 3(Picture)

(2) Several light switch dimmer covers are missing at several switches. We recommend replacement by a where needed qualified person.

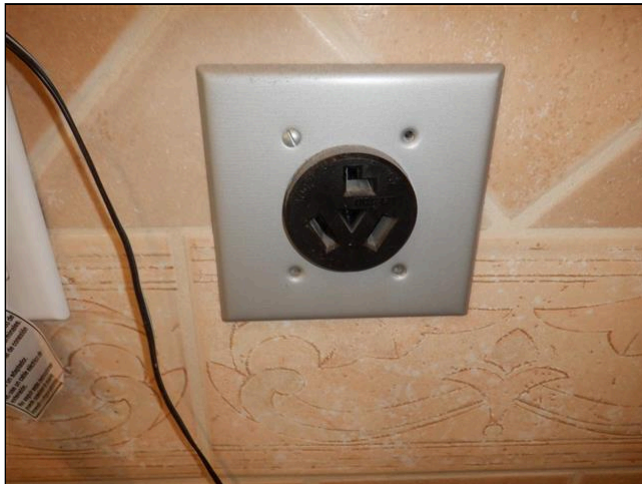
3.8.A Item 2(Picture)

(2) There is a three prong 220 volt receptacle installed for the dryer. Most new electric dryers require a four prong receptacle. If you install an electric dryer, you may need to upgrade the receptacle or the dryer power cord. We recommend necessary corrections by a qualified licensed electrician.

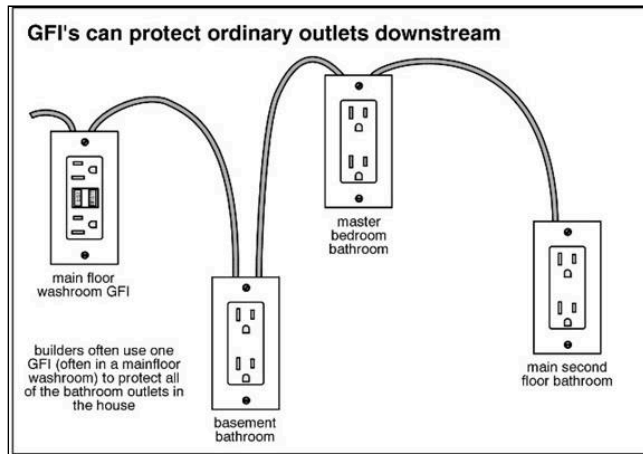
3.9.A Item 1(Picture)

(2) The GFCI receptacles located at the exterior of the detached house are not operating properly, or has failed as it did not trip when tested. The outlet may be defective or mis-wired. We recommend replacement by a qualified licensed electrician.

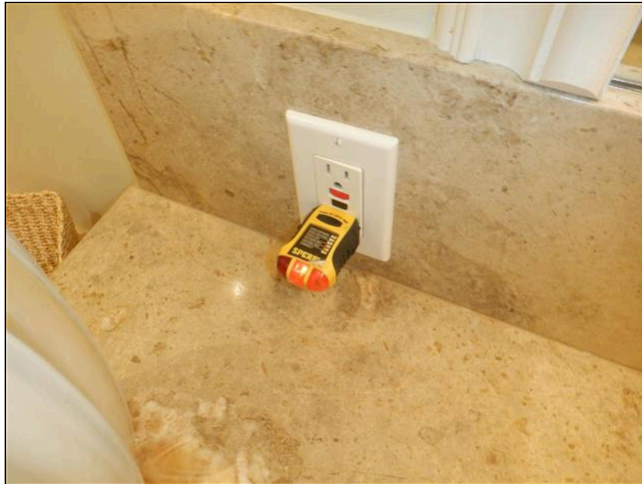
3.9.A Item 3(Picture)

(5) The GFCI outlet in master bathroom is a non-grounded outlet which is legal, but not as safe as a grounded GFCI. Non-grounded GFCI protected receptacles require a label stating "No Equipment Ground". We recommend labeling for safety or having this outlet grounded by a qualified licensed electrician.

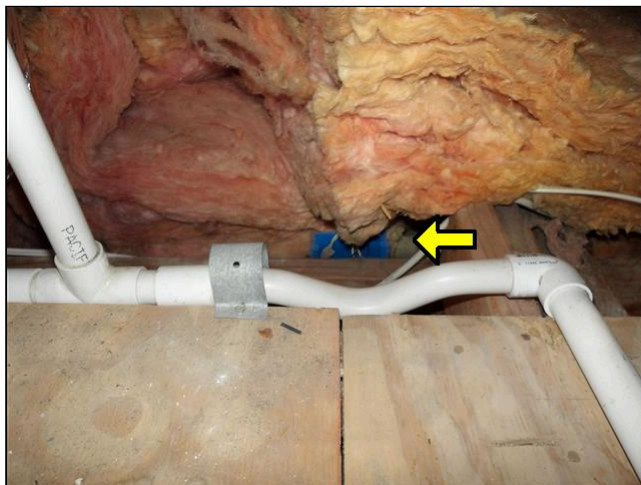
3.10.A Item 1(Picture)

Several open junction boxes were observed in the attic. All electrical splices must be enclosed in a junction box. We recommend necessary repairs by a qualified person for safety.
