Inspection Report

Property Address:
3212 Main Pl
Rancho Santa Fe CA 92067

The Property Inspection Pros

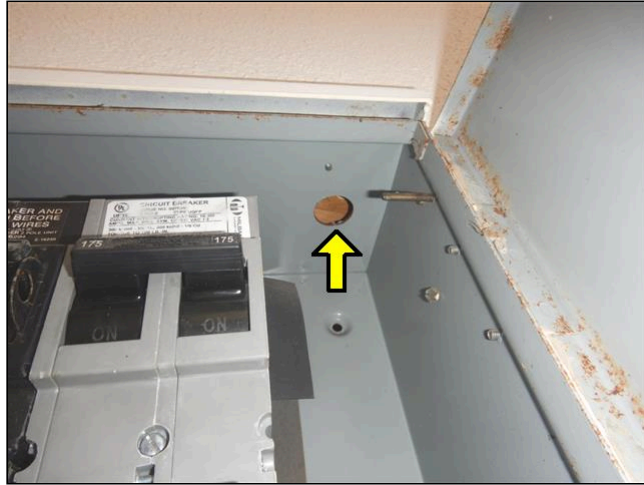
3.0.B Item 2(Picture)

- (2) The main panel breakers are illegible or confusing. We recommend having the breakers properly labeled for safety by a qualified person.
- (3) A knockout is noted missing from inside the main electrical panel. When a knockout is removed and left empty a cover plug is required to be installed to prevent rodent intrusion for fire safety. We recommend installing knockout plug(s) where needed by a qualified licensed electrician for safety.

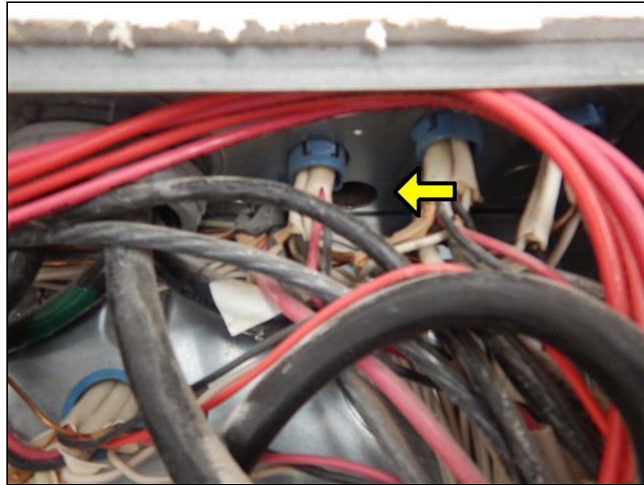
3.1.B Item 2(Picture)

(2) A knockout is noted missing from inside the sub electrical panel. When a knockout is removed and left empty a cover plug is required to be installed to prevent rodent intrusion for fire safety. We recommend installing knockout plug(s) where needed by a qualified licensed electrician for safety.

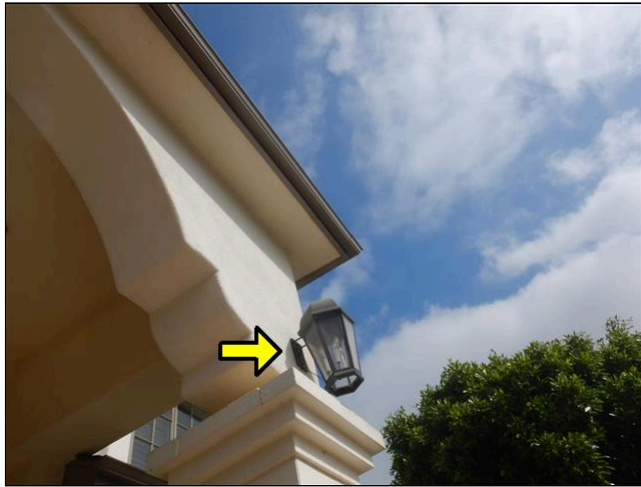
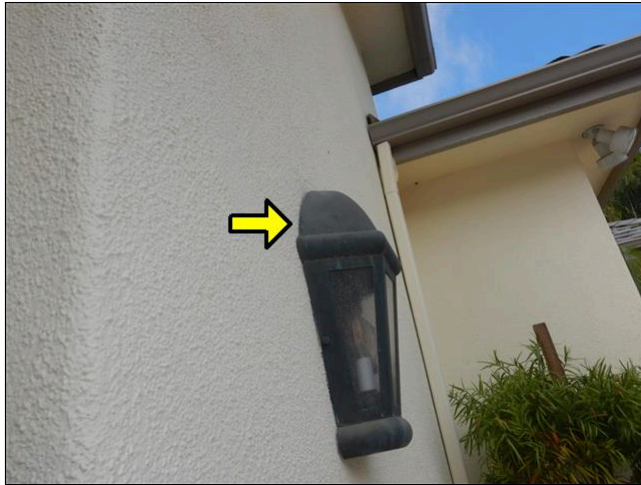
(1) The exterior light fixtures were not sealed where the fixture meets the wall. This condition could allow moisture intrusion in this area. We recommend sealing exterior light fixtures where they meet the wall by a qualified person.

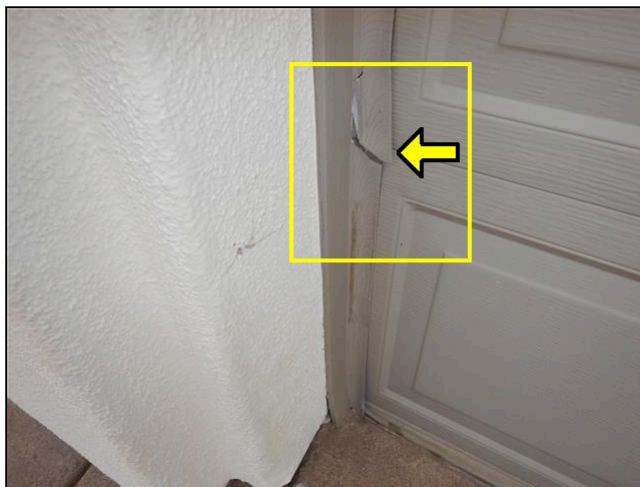
4.0 Item 1(Picture)

- (1) The garage vehicle door hardware including the doors, tracks, and springs appear to be functioning as intended.
- (2) The side weather seal is damaged at one the garage vehicle door. We recommend replacing the weather seal by a qualified licensed garage door contractor.

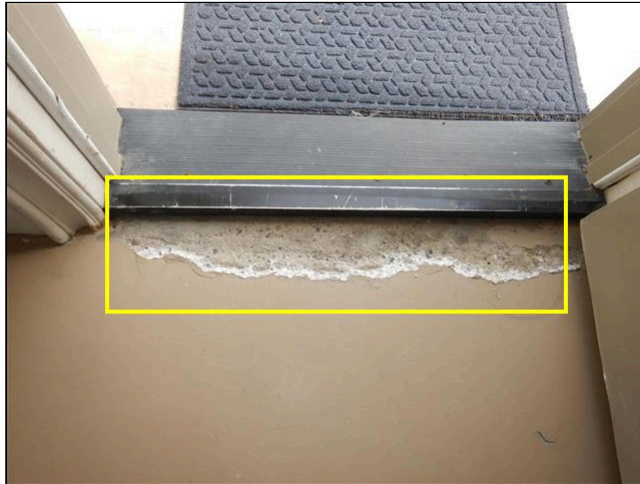
4.4 Item 2(Picture)

(3) The garage slab is deteriorated/ pitted in several areas. We recommend necessary repairs by a qualified licensed foundation contractor.

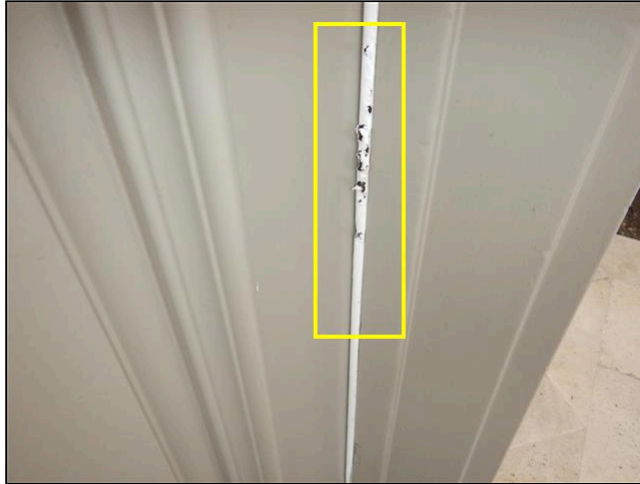
4.7 Item 1(Picture)

Weather-stripping is damaged at the garage pedestrain door. We recommend installing weather-stripping by a qualified person.

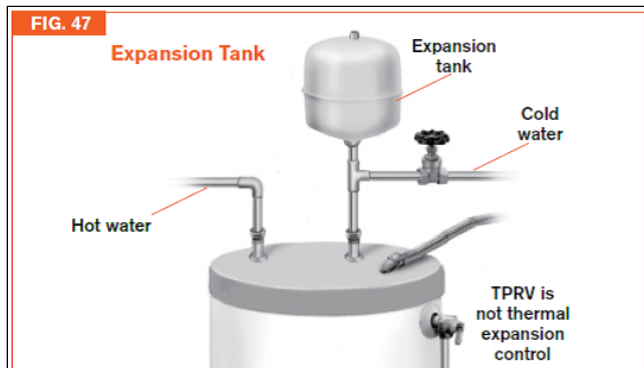
5.0.A Item 2(Picture)

(3) The water heater does not have a "Thermal Expansion Tank" installed to prevent a possible leak at the T&P or "pop-off" valve. Recent changes in code require one when a new water heater is installed. This change is not retroactive on older previously installed Gas/LP water heaters. There were no leaks or drips at the T&P valve during inspection. If your water heater does begin to drip or leak, then a thermal expansion tank may be needed. We recommend installing a thermal tank by a qualified licensed plumber as an upgrade.

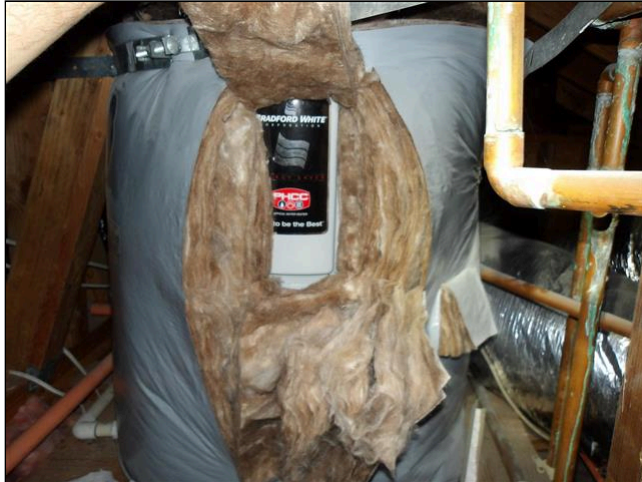
5.0.A Item 4(Picture)

recommend removal to help prevent moisture from being trapped between the blanket and tank which could lead to premature corrosion.

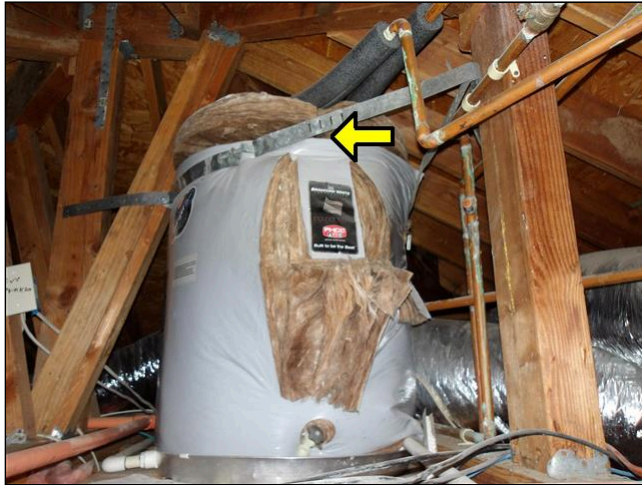
5.1.A Item 1(Picture)

- (1) The water heater is adequately strapped as required.
- (2) The water heater is improperly strapped as required. Seismic strapping is required to be installed at the top 1/3 of the water heater and 4 inches above the water heater controls. We recommend installing seismic straps by a qualified person.

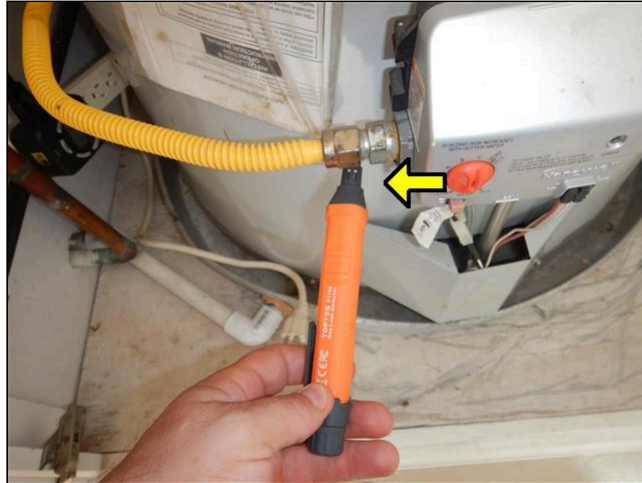
5.0.B Item 2(Picture)

(3) A gas leak test was conducted at accessible gas fittings at the water heater using a gas leak detector. A gas leak was detected at the water heater gas pipe at the time of the inspection. We recommend necessary repairs by a licensed plumber.

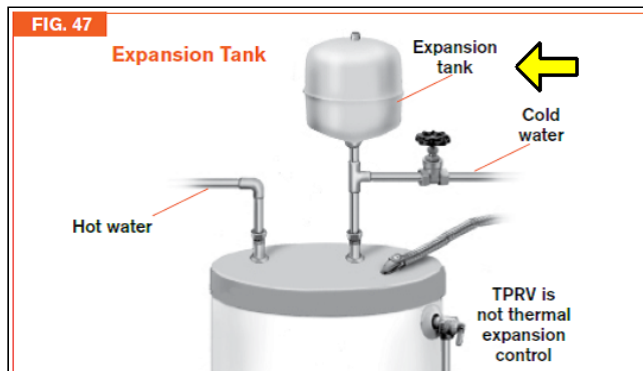
5.0.B Item 4(Picture)

(6) The water heater does not have a "Thermal Expansion Tank" installed to prevent a possible leak at the T&P or "pop-off" valve. Recent changes in code require one when a new water heater is installed. This change is not retroactive on older previously installed Gas/LP water heaters. There were no leaks or drips at the T&P valve during inspection. If your water heater does begin to drip or leak, then a thermal expansion tank may be needed. We recommend installing a thermal tank by a qualified licensed plumber as an upgrade.

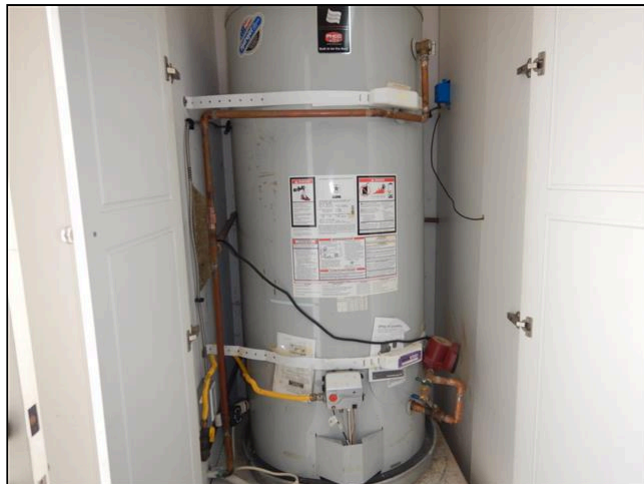
5.1.B Item 1(Picture)

The water heater is improperly strapped as required. Seismic strapping is required to be installed at the top 1/3 of the water heater and 4 inches above the water heater controls. We recommend installing seismic straps by a qualified person.

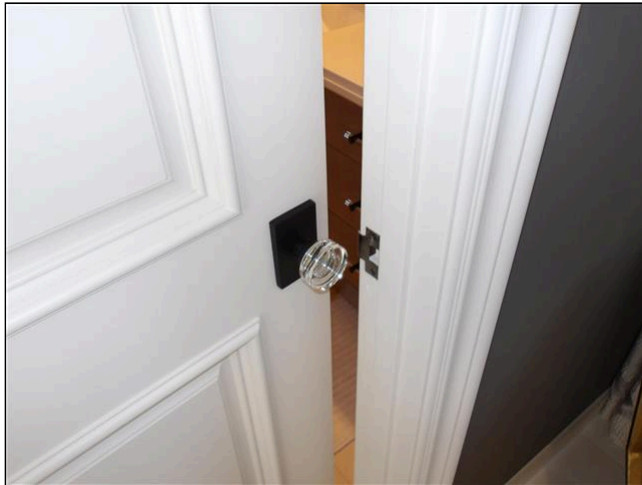
6.5.A Item 1(Picture)

(1) The bathroom door hardware is misaligned; the door does not latch. We recommend adjusting the strike plate or necessary corrections made by a qualified person.

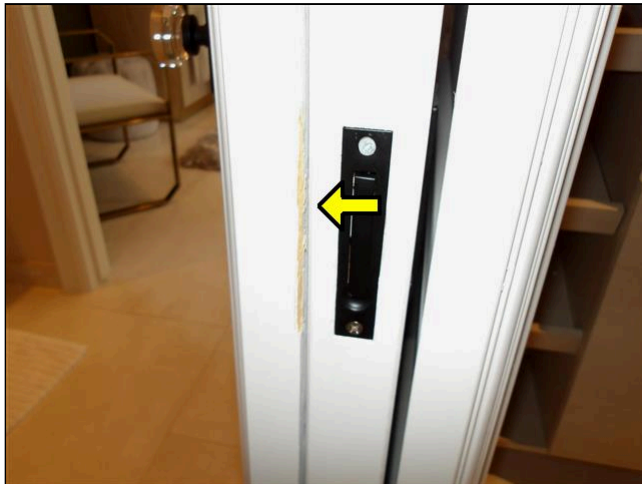
6.5.A Item 2(Picture)

(2) Sliding closet door hardware makes contact with the frame and there is damage to the frame. We recommend further evaluation and any necessary repairs/replacement made by a qualified licensed door contractor.

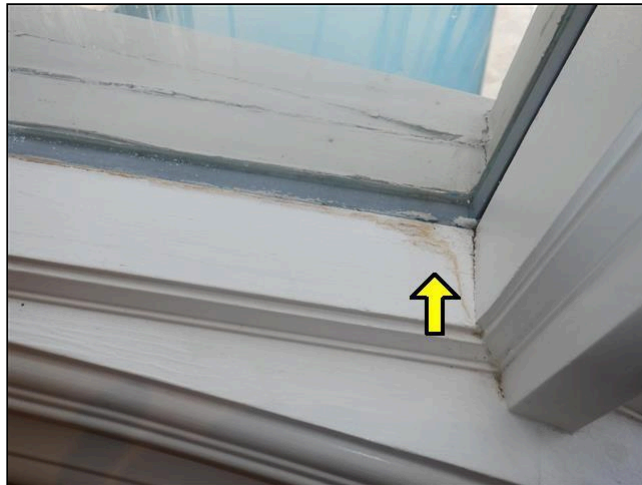
6.2.B Item 2(Picture)

- (3) Water staining was observed at window sill/jamb in the staircase. This can be caused by humidity due to difference in air temperatures between interior and exterior. In some cases this indicates a drafty window. We recommend having these areas cleaned/ painted as needed by a qualified person.

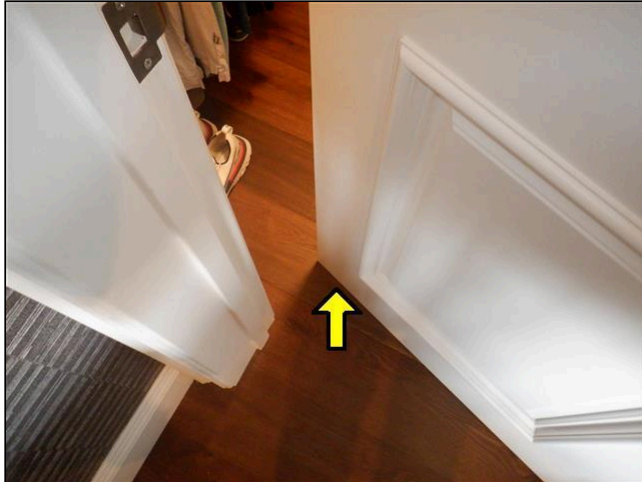
6.6.B Item 4(Picture)

(4) Damaged/missing door trim was observed at a door in the right side hall closet. We recommend repairs/replacement where needed by a qualified licensed contractor.

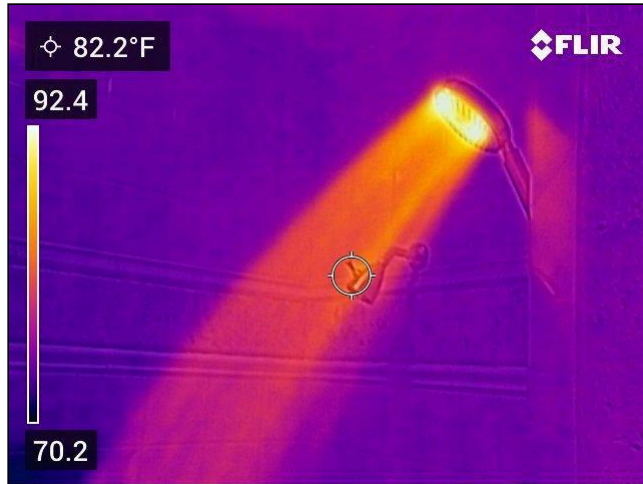
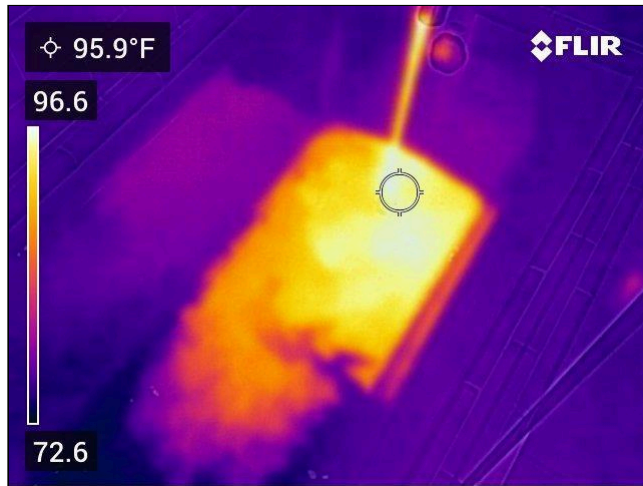
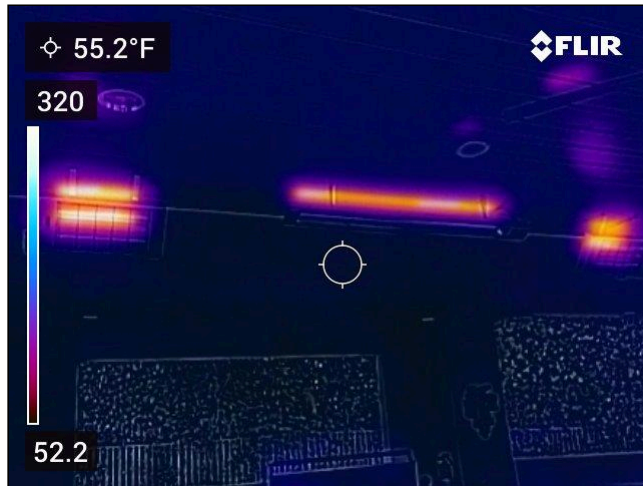
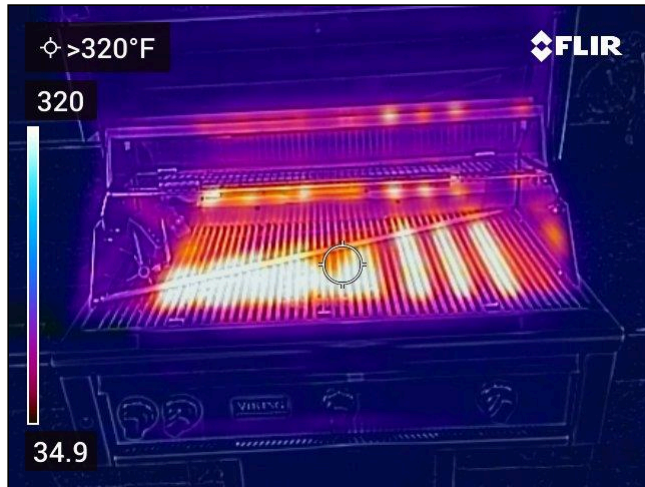
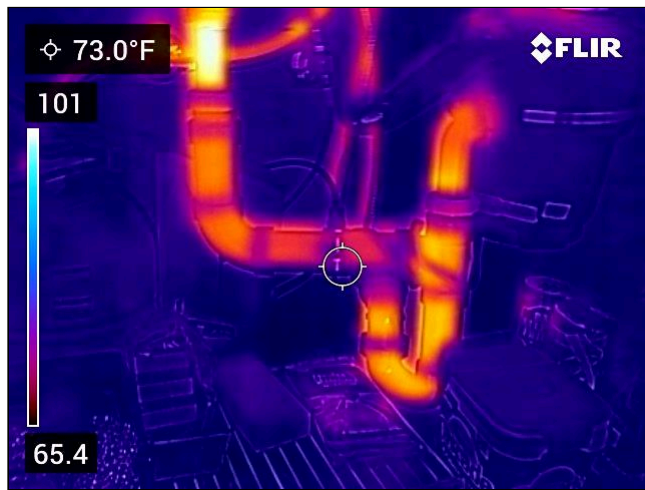
(1) Infrared Camera Thermal Photos.

(2) An infrared (thermal imaging) scan was performed throughout the property at the time of the inspection using a hand held infrared (thermal imaging) inspection camera. No anomalies were found at the time of the inspection using this camera.

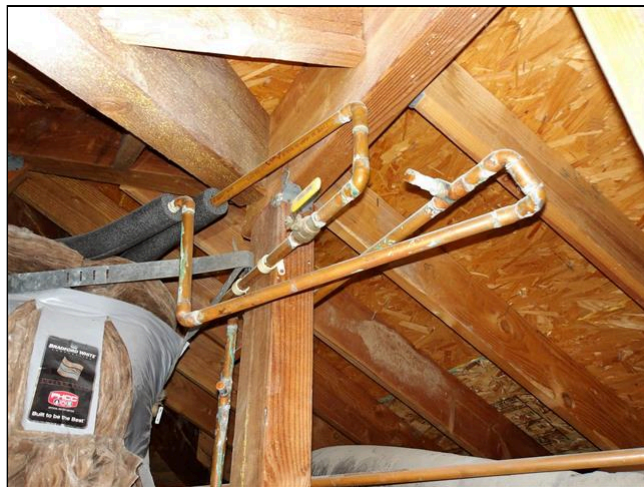
7.1.A Item 2(Picture)

(2) Picture of the copper piping in the attic space. Appears to be functioning as intended.

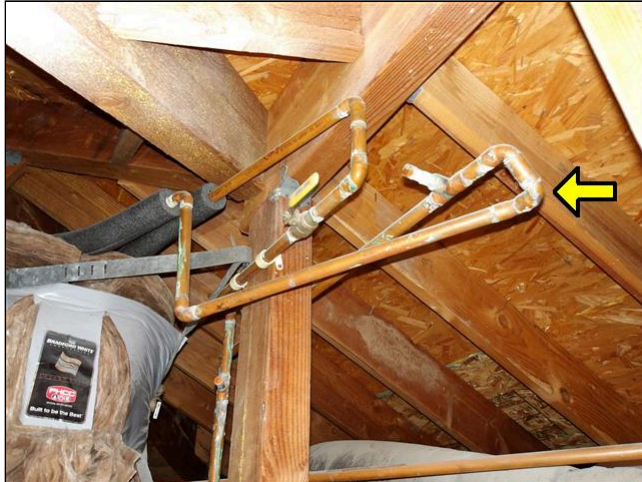
7.1.A Item 3(Picture)

(3) A corroded pipe is observed in the attic. We recommend further evaluation by a qualified licensed plumber and necessary repairs made.

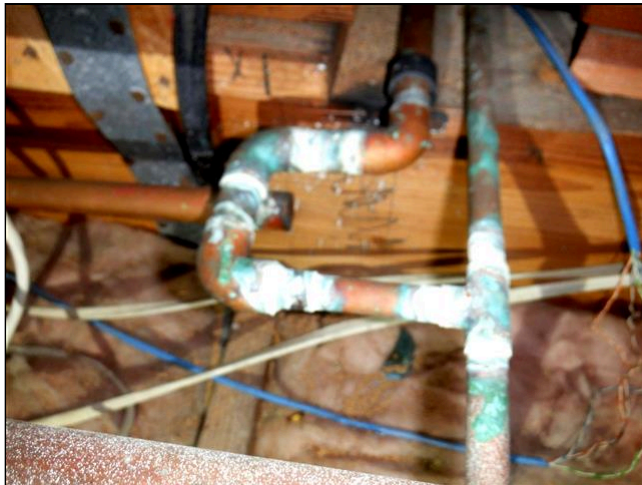
7.1.A Item 4(Picture)

(4) A corroded pipe is observed in the attic. We recommend further evaluation by a qualified licensed plumber and necessary repairs made.

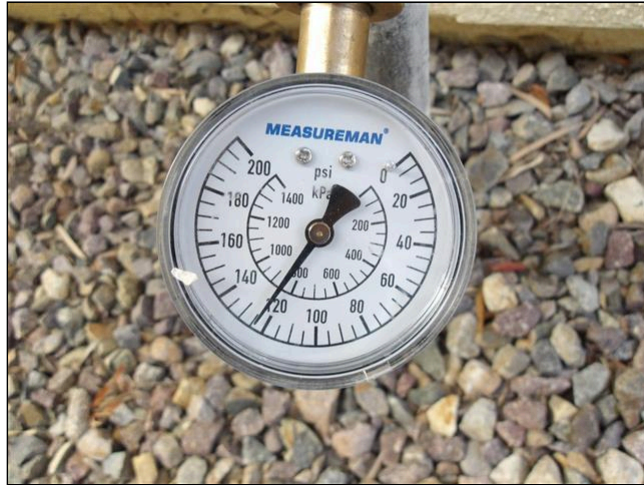
7.2.A Item 1(Picture)

The water pressure was checked with a water pressure gauge and was measured to be higher than 80 PSI at the time of the inspection. This is to high and corrections are needed. We recommend further evaluation by a qualified licensed plumber for necessary repairs or corrections.

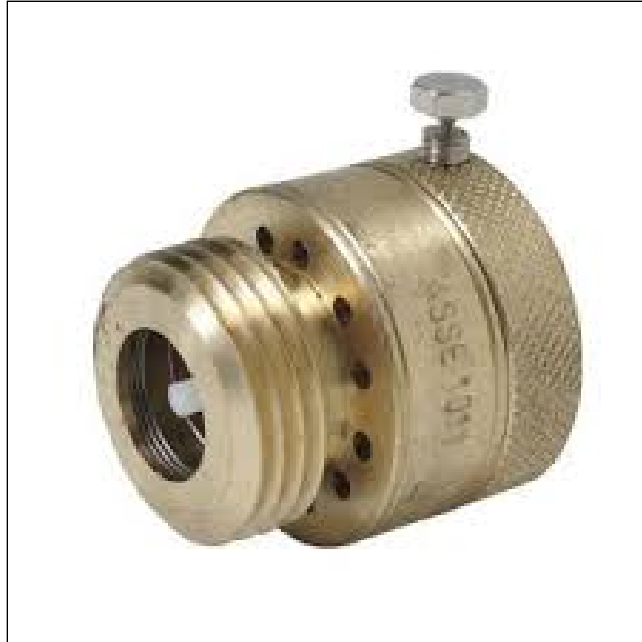
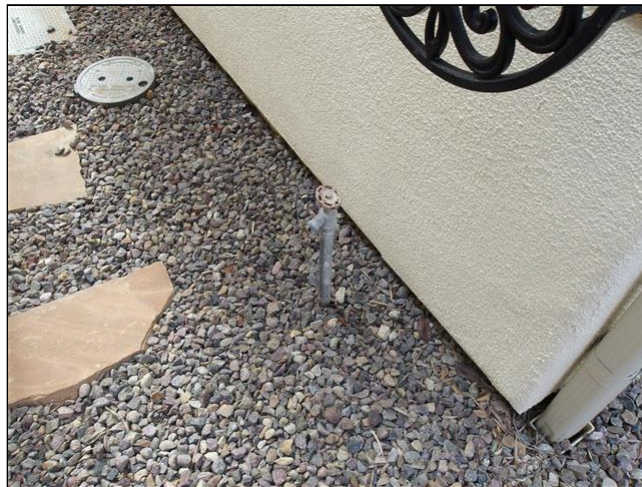
- (1) The accessible hose spigots were tested and were found to be operational at the time of the inspection. Note: Some hose spigots may leak or drip when a watering hose is connected due to back pressure.
- (2) The exterior hose spigots do not have anti-siphon or anti-backflow devices installed on them. These anti-siphon or anti-backflow devices help prevent contaminated water from flowing back into the the house water supply system. We recommend installing anti-siphon or anti-backflow devices at the every exterior hose spigots by a qualified person.

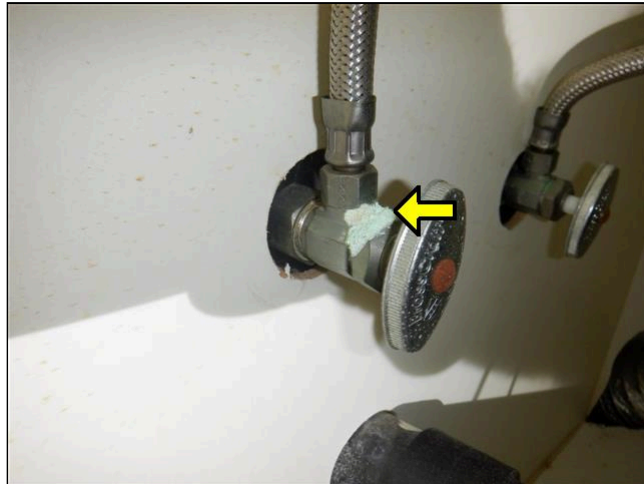
7.5.A Item 1(Picture)

Some of the sink angle stop valves are observed with calcium deposits on them. Calcium deposits can corrode or deteriorate these valves and cause potential leaks. We recommend replacing all calcified angle stop valves by a qualified licensed plumber to help prevent leaks.

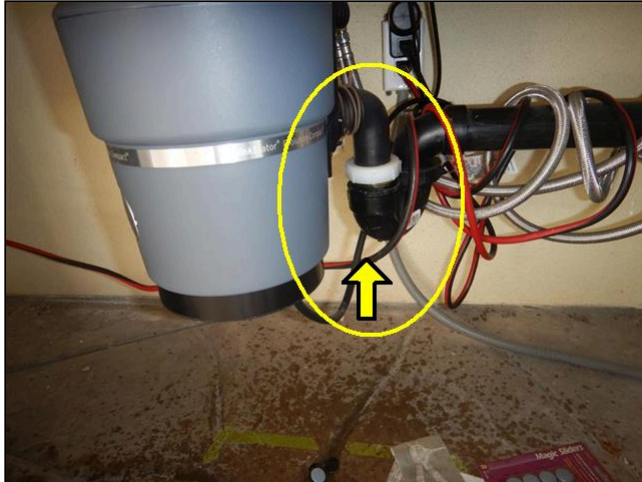
7.0.B Item 1(Picture)

(1) An active leak is present at the drain pipe under the outdoor BBQ sink. We recommend necessary repairs by a qualified licensed plumber.

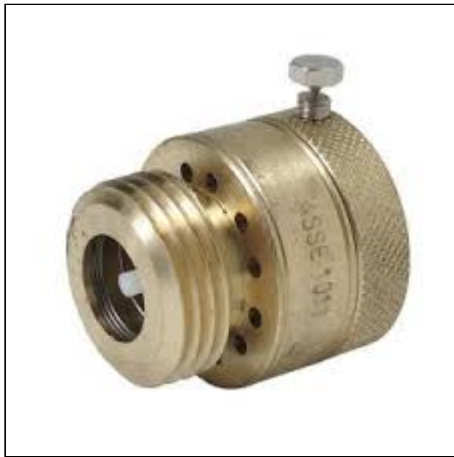
7.3.B Item 1(Picture)

(2) The exterior hose spigots do not have anti-siphon or anti-backflow devices installed on them. These anti-siphon or anti-backflow devices help prevent contaminated water from flowing back into the the house water supply system. We recommend installing anti-siphon or anti-backflow devices at the every exterior hose spigots by a qualified person.

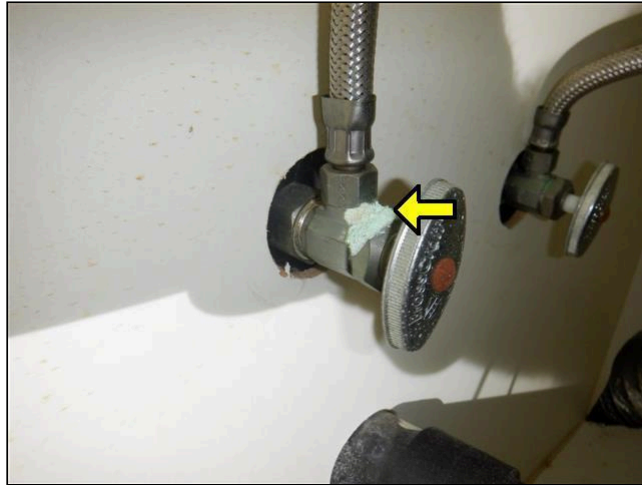
7.5.B Item 1(Picture)

Some of the sink angle stop valves are observed with calcium deposits on them. Calcium deposits can corrode or deteriorate these valves and cause potential leaks. We recommend replacing all calcified angle stop valves by a qualified licensed plumber to help prevent leaks.

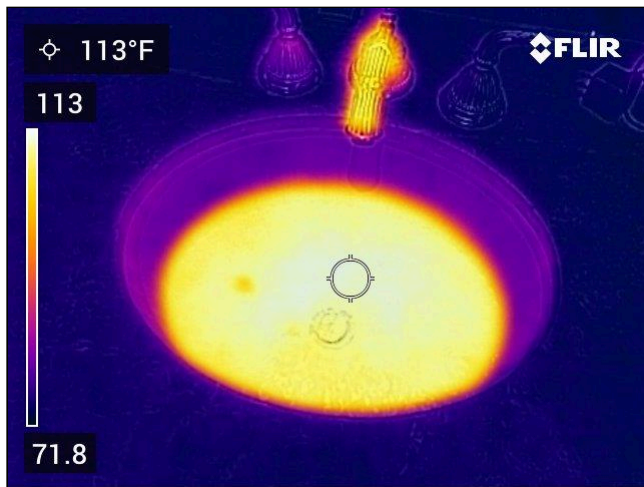
8.0.B Item 2(Picture)

(1) The left side sink in the bathroom was slow draining at the time of the inspection This may indicate a blockage in the drain line. We recommend further evaluation by a qualified licensed plumber and repairs as needed.

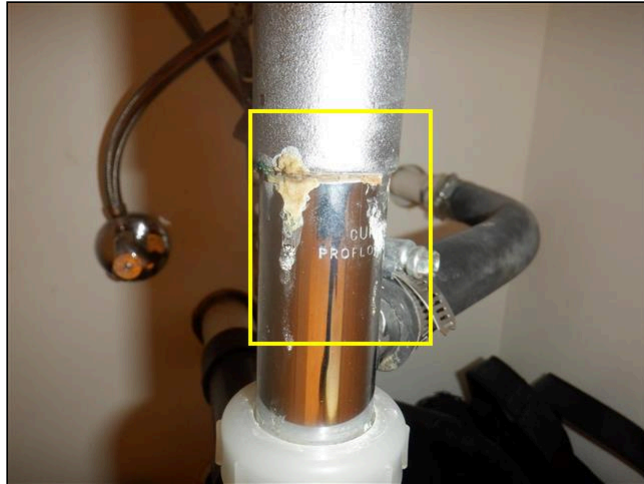
8.0.B Item 3(Picture)

(2) The metal portions of the sink drain are rusted or corroded. A leak was not observed at this sink drain pipe at the time of the inspection. However, we recommend replacing this drain pipe by a qualified licensed plumber to help prevent future leaks or

damage.

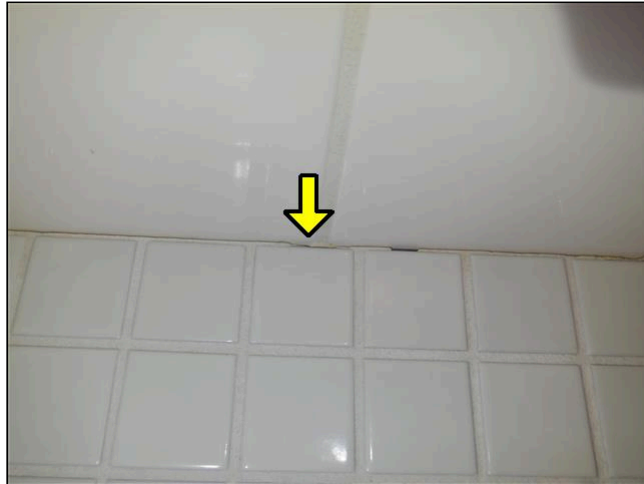
8.1.B Item 2(Picture)

(2) The tile surround has cracked or missing grout between the tiles and needs repair or replace. There may be water damage to the wall behind the tiles which is not visible. Determining if water damage exists in the wall behind tiles is beyond the scope of our general home inspection. We recommend having the tiles repaired by a licensed tile contractor. Additional repairs may be required when tiles are removed. This area should be evaluated further by a qualified licensed tile contractor prior to the end of your contingency period.

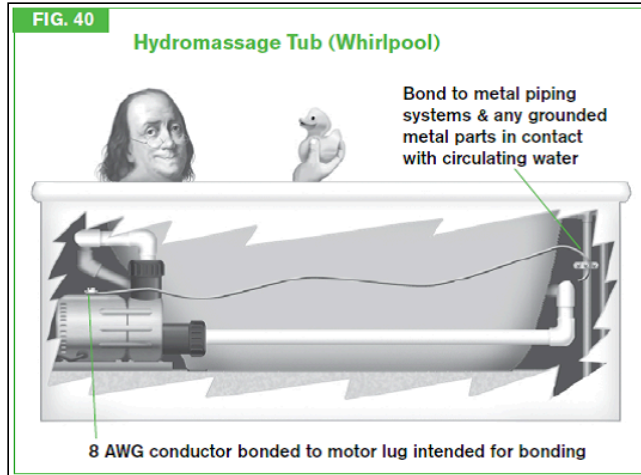
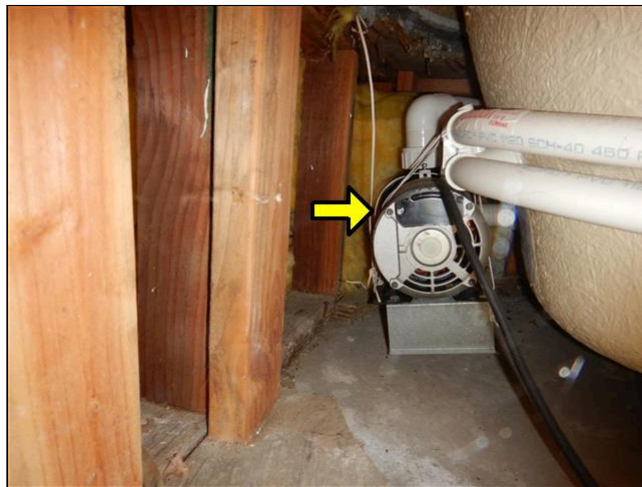
(1) The bonding wire is missing at the jetted tub equipment. This is a safety hazard. A

bonding wire should connect all metal components of the for safety. We recommend installing a bonding wire by a qualified licensed electrician for safety.

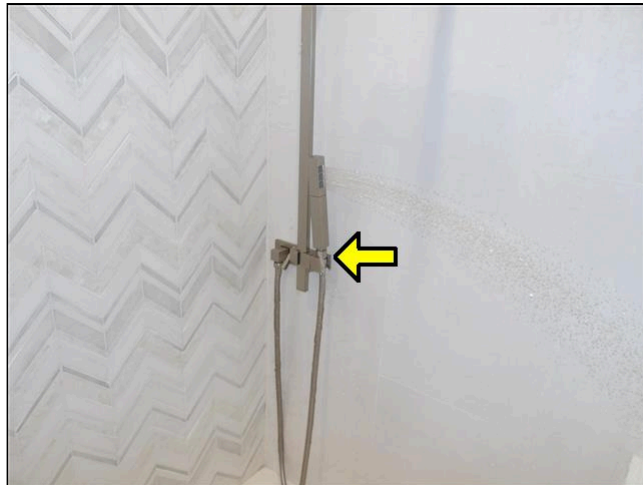
8.0.C Item 1(Picture)

(1) The handheld shower faucet leaks when operated. We recommend necessary repairs or replacement by a qualified licensed plumber.

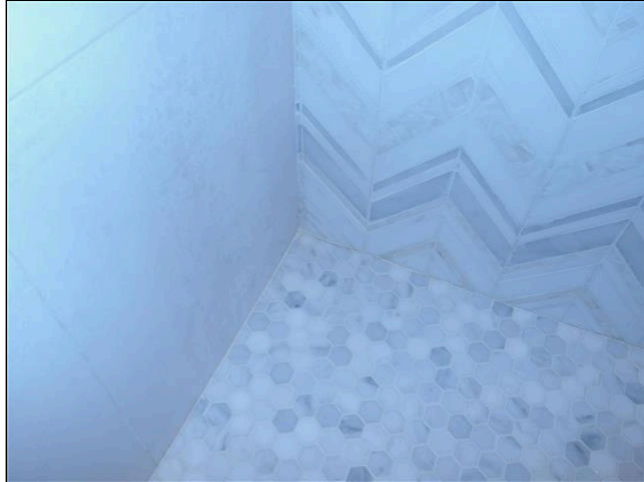
8.0.C Item 2(Picture)

(2) The tile surround has cracked or missing grout between the tiles and needs repair or replace. There may be water damage to the wall behind the tiles which is not visible. Determining if water damage exists in the wall behind tiles is beyond the scope of our general home inspection. We recommend having the tiles repaired by a licensed tile contractor. Additional repairs may be required when tiles are removed. This area should be evaluated further by a qualified licensed tile contractor prior to the end of your contingency period.

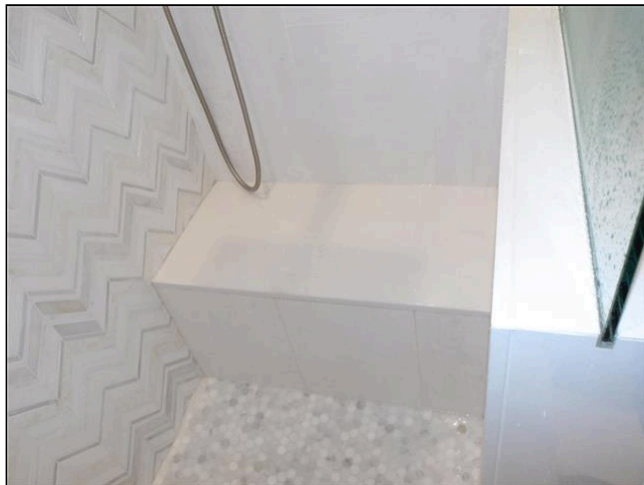
8.0.C Item 3(Picture)

(3) We recommend caulking around the hall bathroom shower pan, curb, and adjacent walls to help prevent moisture intrusion.

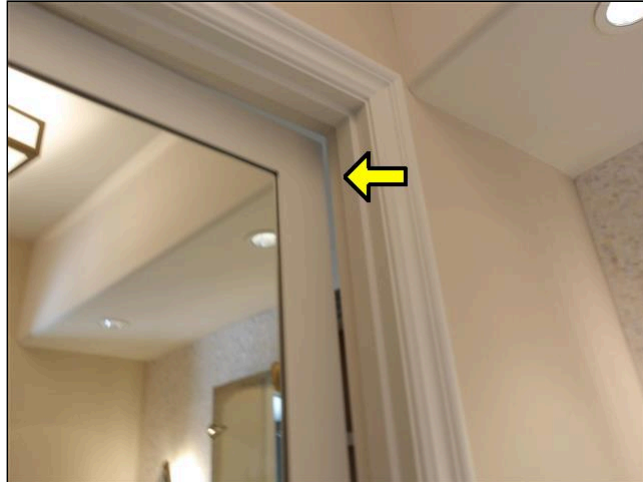
8.1.C Item 1(Picture)

The door rubs at the frame. We recommend necessary corrections by a qualified person.

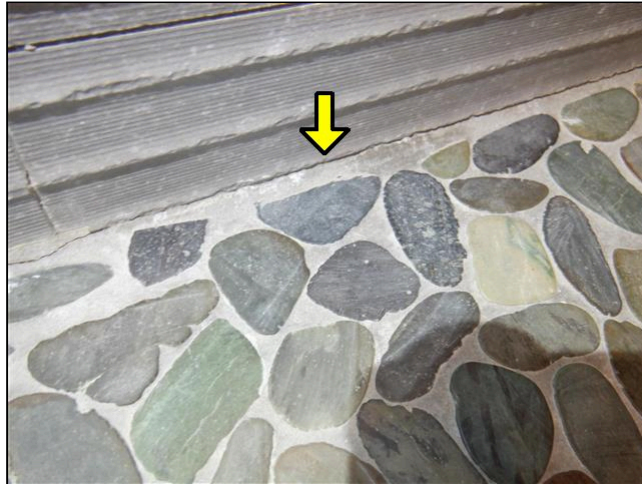
8.1.D Item 1(Picture)

(1) The tile surround has cracked or missing grout between the tiles and needs repair or replace. There may be water damage to the wall behind the tiles which is not visible. Determining if water damage exists in the wall behind tiles is beyond the scope of our general home inspection. We recommend having the tiles repaired by a licensed tile contractor. Additional repairs may be required when tiles are removed. This area should be evaluated further by a qualified licensed tile contractor prior to the end of your contingency period.

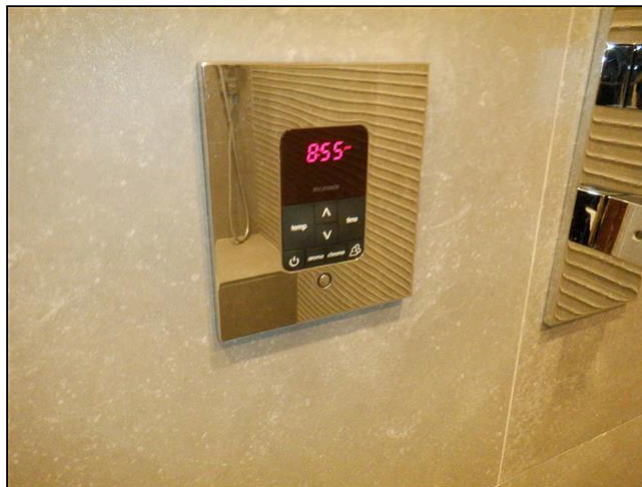
8.1.D Item 2(Picture)

(2) There is a steam shower installed. Steam showers are out of the scope of our general home inspection. We recommend further evaluation by a qualified person if concerned.

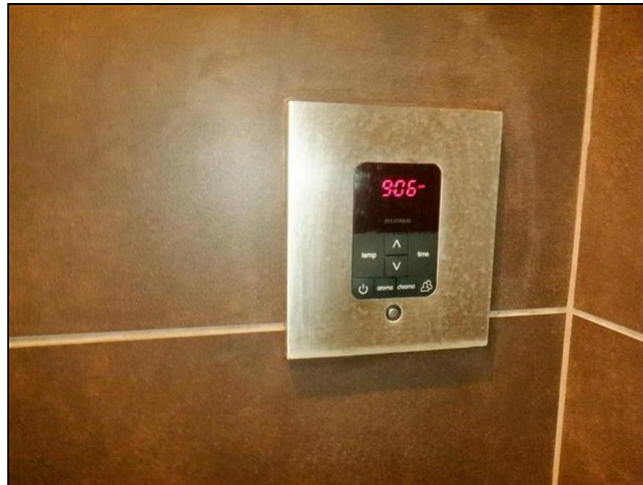
8.0.F Item 1(Picture)

There is a steam shower installed. Steam showers are out of the scope of our general home inspection. We recommend further evaluation by a qualified person if concerned.

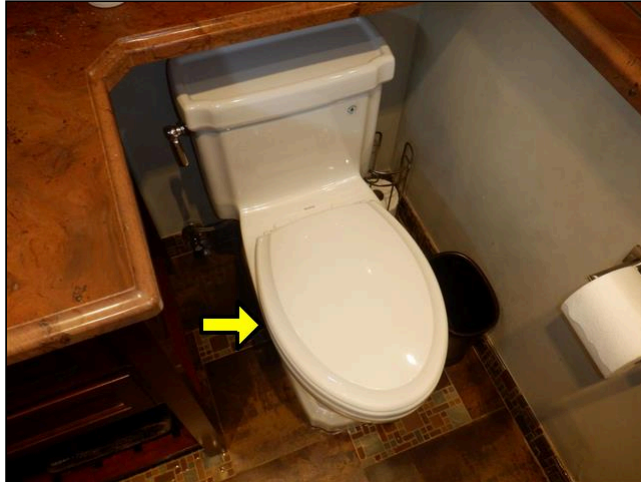
8.1.F Item 1(Picture)

The toilet is loose on the floor. This condition could damage the wax ring under the toilet. We recommend necessary repairs by a licensed plumber.

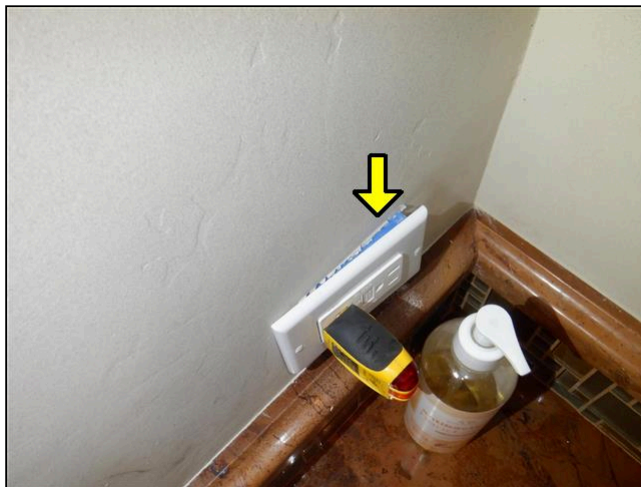
8.2.F Item 1(Picture)

A receptacle was found to be loose in the wall. We recommend necessary repair by a licensed electrician.

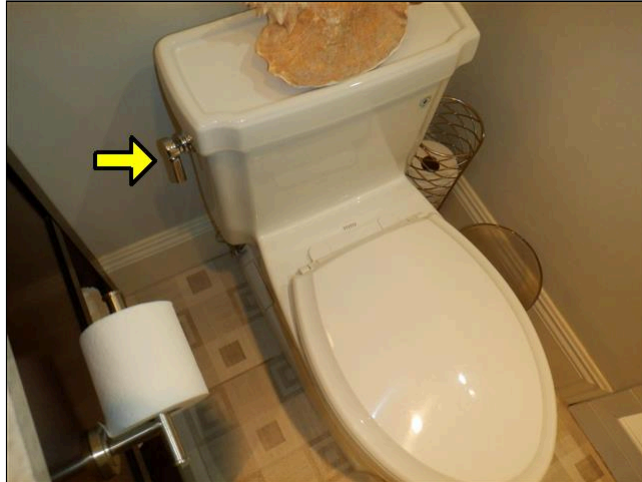
8.1.G Item 1(Picture)

The toilet did not flush when tested. We recommend further evaluation and necessary repairs by a licensed plumber.

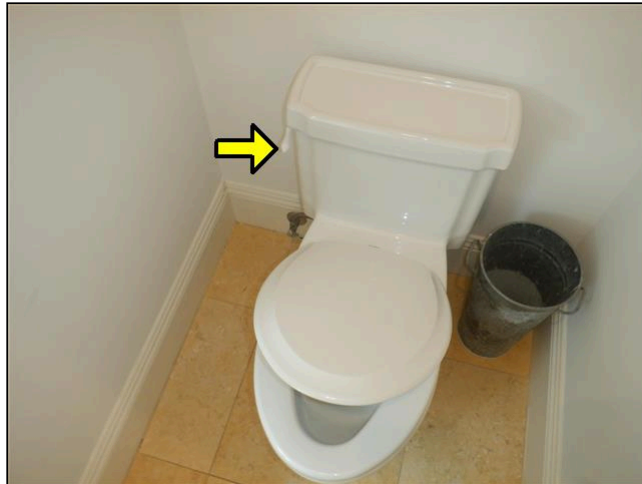
8.1.H Item 1(Picture)

The toilet did not flush when tested. We recommend further evaluation and necessary repairs by a licensed plumber.

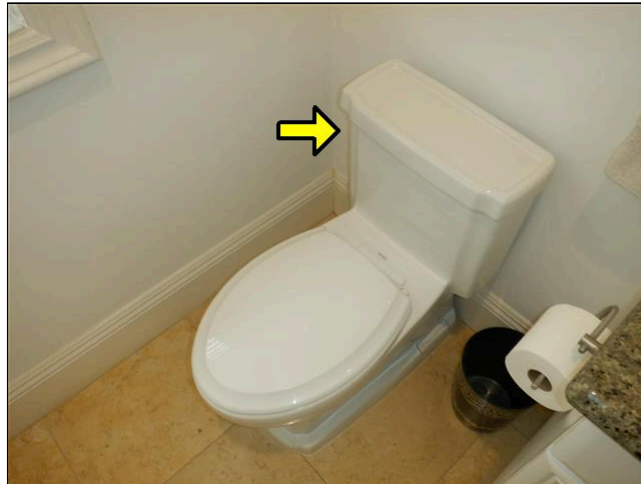
8.1.I Item 1(Picture)

The toilet was "running" at the time of the inspection. We recommend necessary repairs by a licensed plumber.

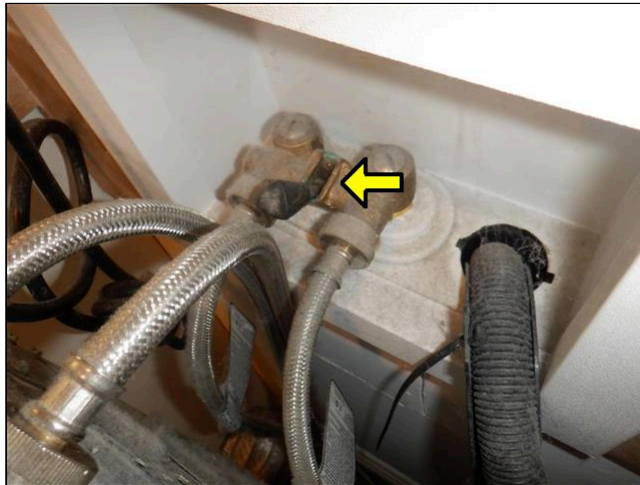
9.0 Item 1(Picture)

(1) The laundry faucet valves are leaking. We recommend necessary repairs or replacement by a qualified licensed plumber.

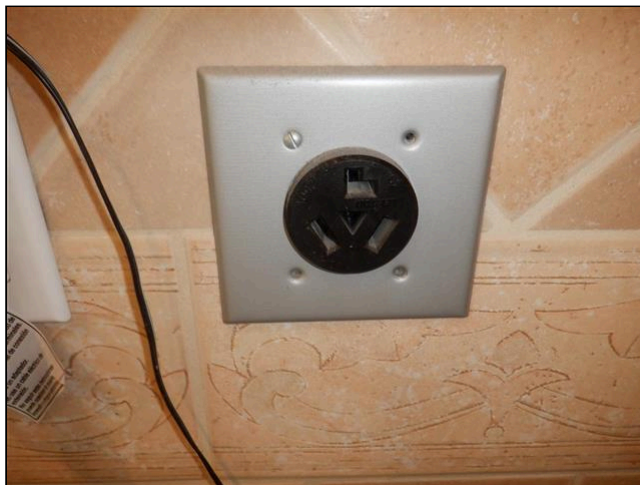
9.0 Item 2(Picture)

(2) There is a three prong 220 volt receptacle installed for the dryer. Most new electric dryers require a four prong receptacle. If you install an electric dryer, you may need to upgrade the receptacle or the dryer power cord. We recommend necessary corrections by a qualified licensed electrician.

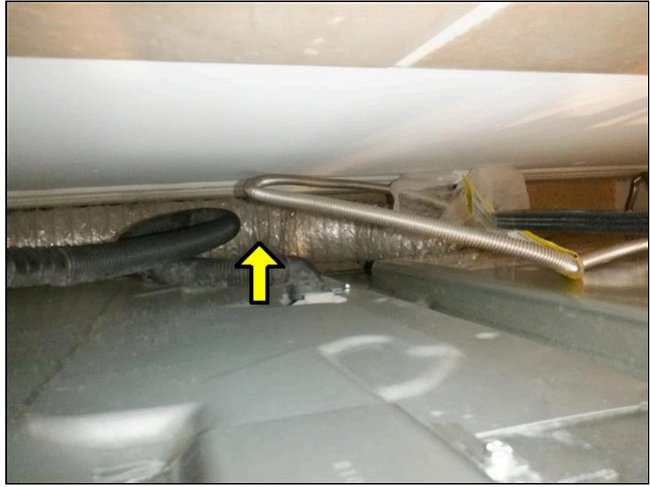
9.1 Item 1(Picture)

(1) We recommend having the dryer vent cleaned by a qualified person.
 (2) The dryer is equipped with a foil, accordion-type duct. The U.S. Consumer Product Safety Commission considers these types of ducts to be unsafe and a fire hazard. The flexible foil type duct can more easily trap lint and is more susceptible to kinks or crushing, which can greatly reduce the airflow. We recommend replacing the duct with a rigid or corrugated semi-rigid metal duct.

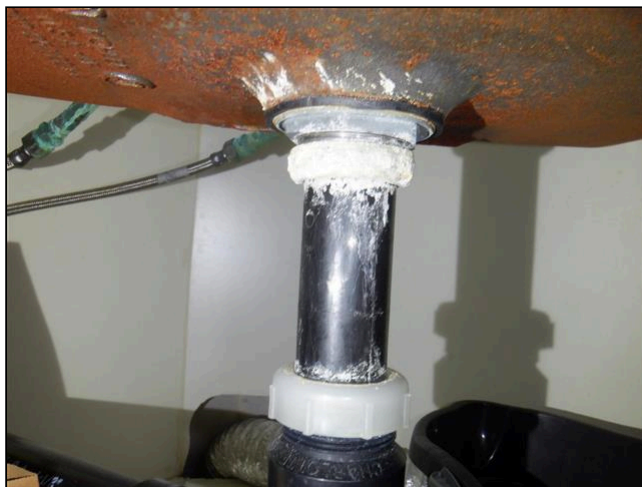
9.4 Item 1(Picture)

The metal portions of the sink drain are rusted or corroded. A leak was not observed at this sink drain pipe at the time of the inspection. However, we recommend replacing this drain pipe by a qualified licensed plumber to help prevent future leaks or damage.

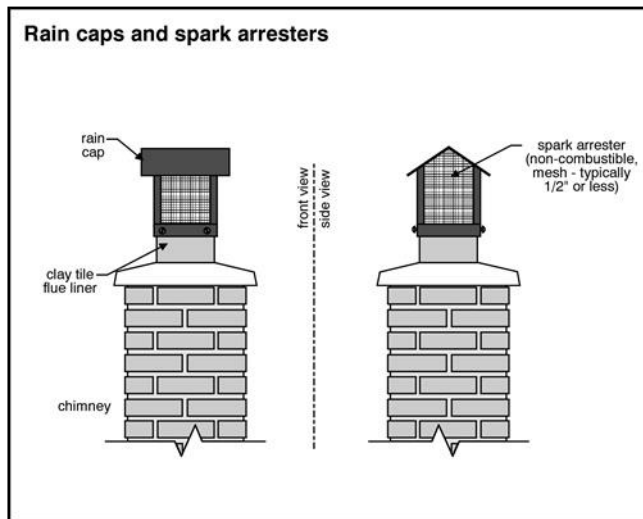
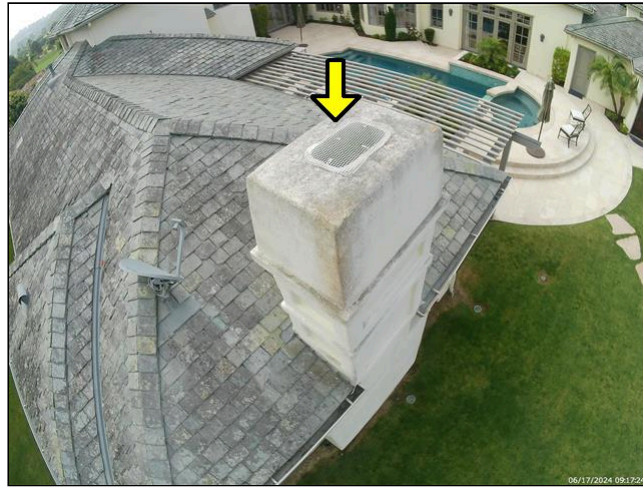
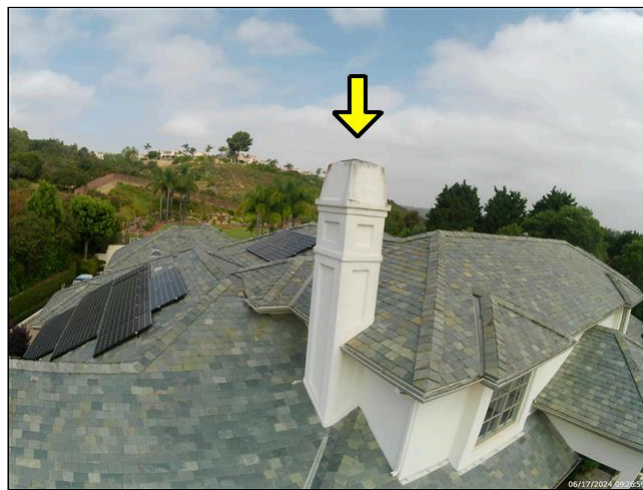
- (1) We recommend having all of the fireplaces and chimneys cleaned and inspected by a licensed chimney sweep for safety prior to using.
- (2) The chimney liner was not inspected by our company. We recommend a qualified chimney contractor inspect for safety if concerned.
- (3) A rain cap is not present/ installed at the chimneys. This may have been acceptable at the time of construction. The rain cap prevents water from entering the chimney flue to help prevent deterioration. We recommend having a spark arrester/ rain cap installed by a qualified person.

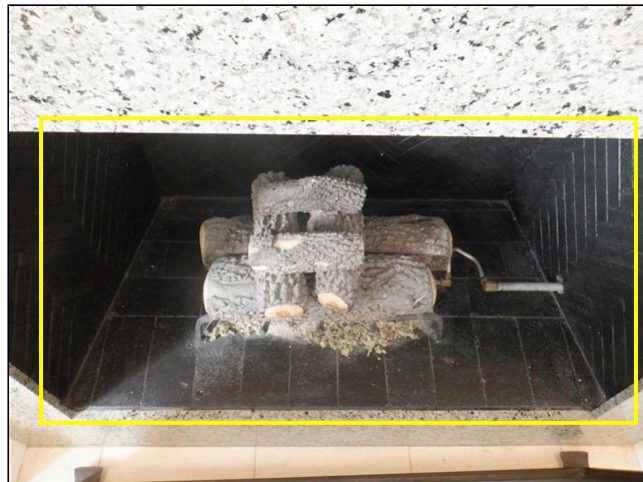
10.1 Item 1(Picture)

(1) There are no glass doors installed at the fireplace. We recommend having glass doors installed by a qualified licensed chimney contractor as a safety upgrade.

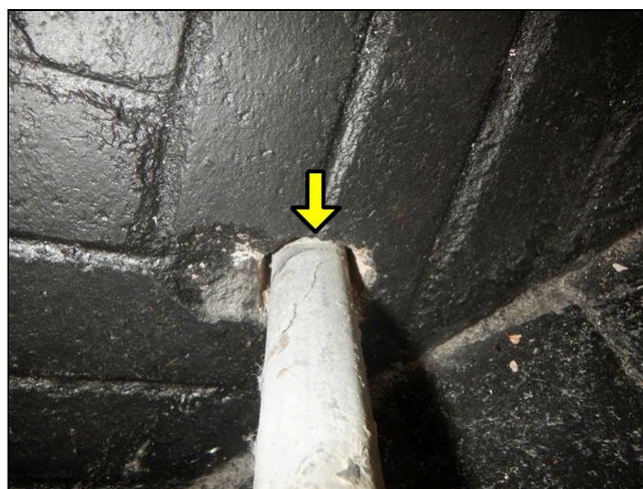
10.1 Item 2(Picture)

(2) A gap was observed at the gas stub inside the family room fireplace. This gap should be sealed with an approved sealant to help prevent chimney fires. We recommend corrections made by a licensed chimney contractor.

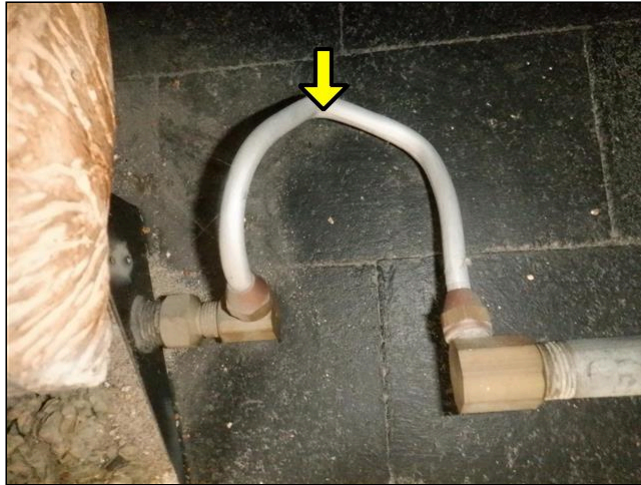
10.1 Item 3(Picture)

(3) There is an Aluminum Semi-Rigid gas connector installed at the fireplace gas logs. Aluminum gas connectors are no longer used and considered a fire hazard by SDG&E. We recommend replacing and installing an approved gas flex line by a qualified licensed plumber.

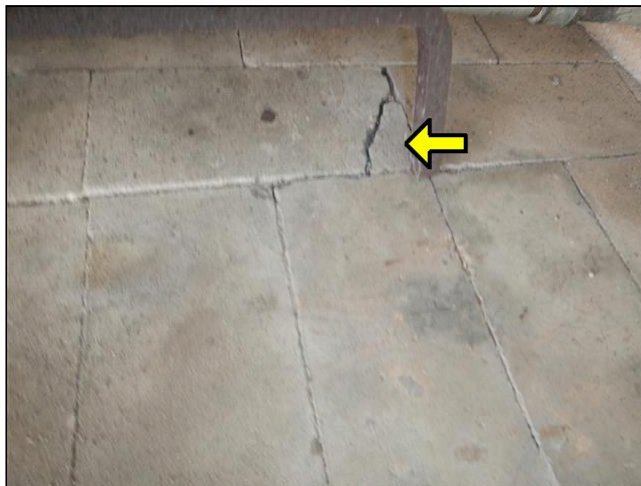
10.1 Item 4(Picture)

(4) Cracking is observed in the outside fireplace. We recommend necessary repairs by a qualified licensed chimney contractor.

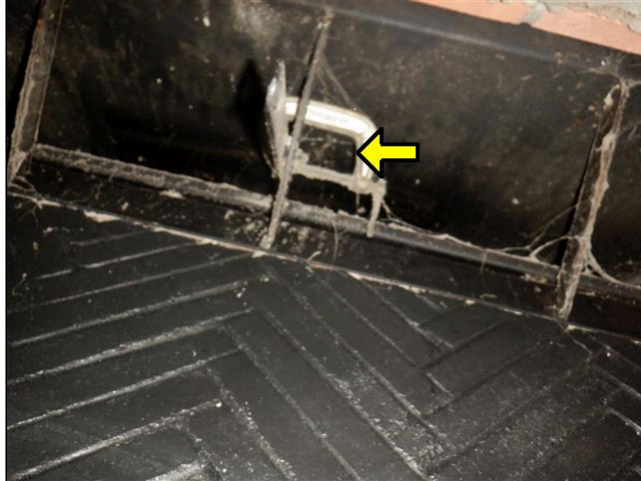
10.2 Item 1(Picture)

(1) There is a damper clamp installed at the family room fireplace for safety.
