Inspection Report

Property Address:
3212 Main Pl
Rancho Santa Fe CA 92067

The Property Inspection Pros

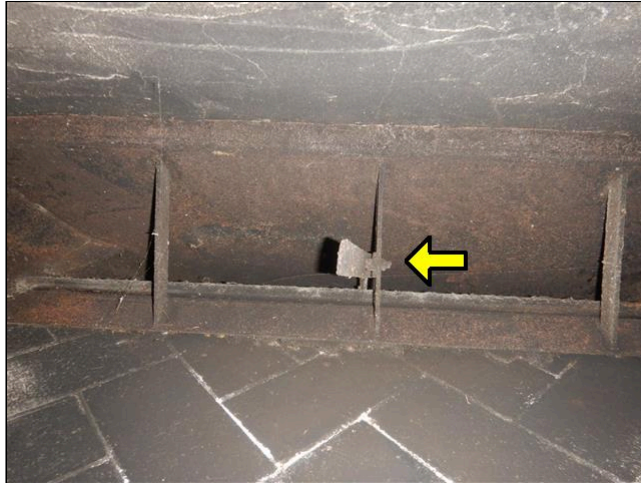
10.2 Item 2(Picture)

(2) The damper is inoperable or difficult to open at the outdoor fireplace. We recommend necessary repairs by a licensed chimney contractor.

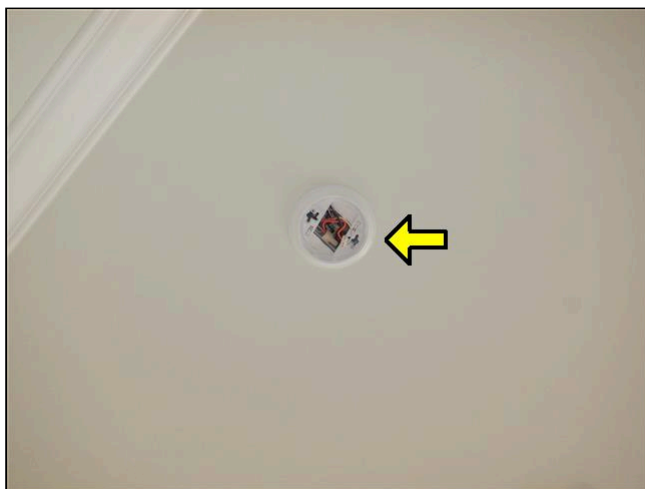
11.0.A Item 2(Picture)

(2) A smoke detector is missing in master bedroom. This is a safety hazard. We recommend installing a smoke detectors in order to comply with current fire and safety standards and regulations by a qualified person.

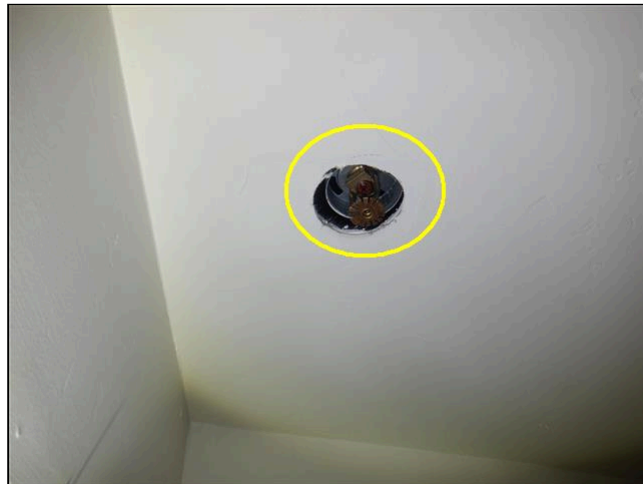
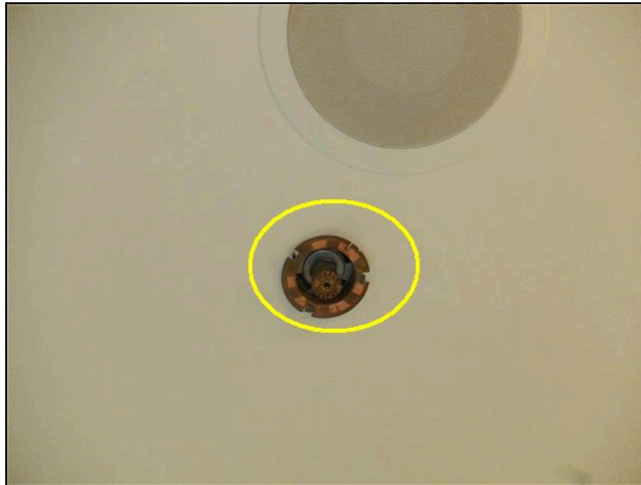
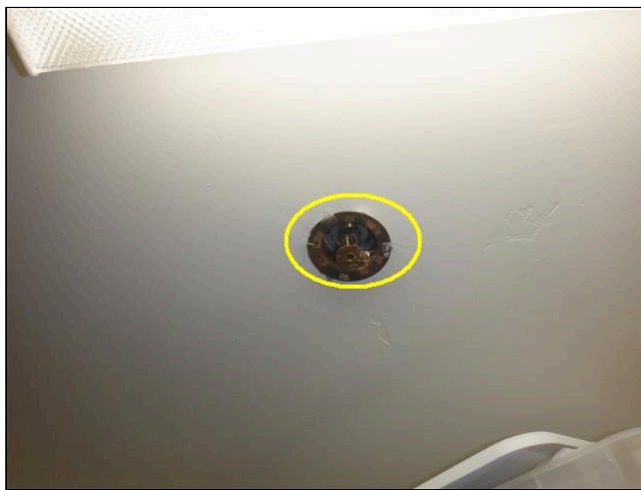
(2) Several fire sprinkler caps are missing at several sprinkler heads throughout the house. We recommend replacement where needed by a qualified person.

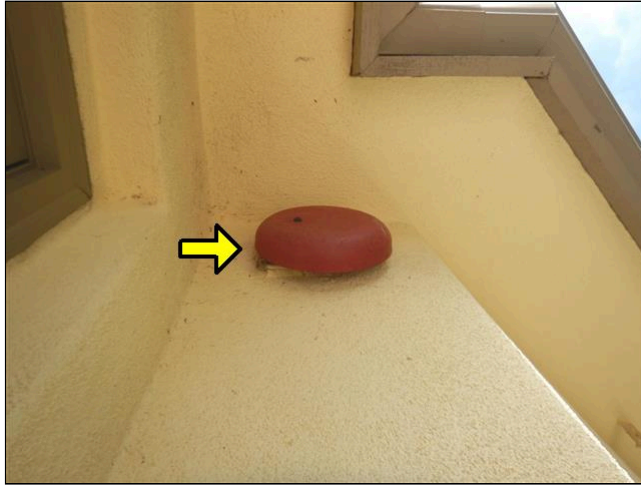
11.3.B Item 1(Picture)

(2) There is a bird nest inside the exterior fire alarm bell. This condition may interfere with the proper operation of the fire alarm bell. This is a safety hazard and corrections are needed. We recommend removing the bird nest from the fire alarm bell prior to occupying the house for safety.

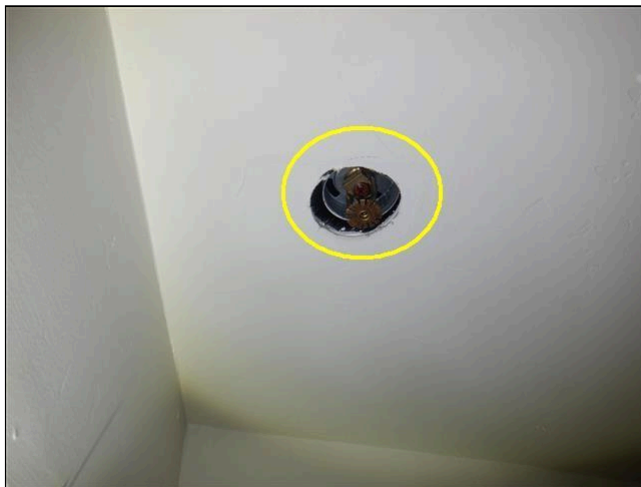
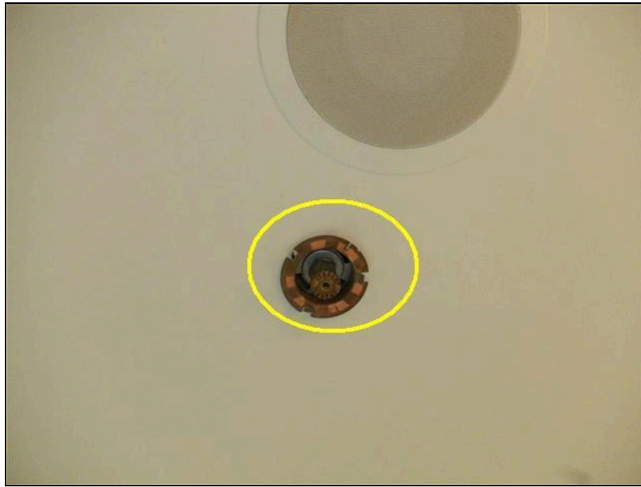
(3) Several fire sprinkler caps are missing at several sprinkler heads throughout the house. We recommend replacement where needed by a qualified person.

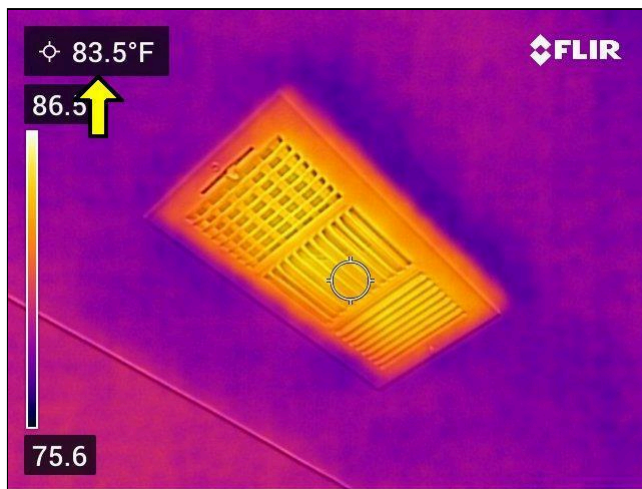
12.0.B Item 3(Picture)

(2) The furnace was tested and was functional/ operated at the time of the inspection.
(3) The upstairs furnace was tested and turned on, however it appeared to have an inadequate temperature at the time of the inspection. We recommend further evaluation by a qualified licensed HVAC contractor and have repairs/replacement made if needed prior to the end of your contingency period.

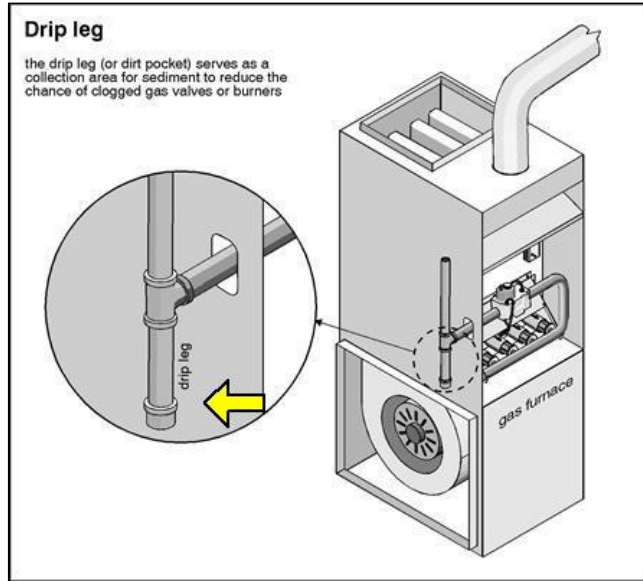
12.0.B Item 6(Picture)

(8) The gas supply pipe at the furnaces did not contained a drip leg/ sediment trap. This may have been standard at the time of installation but now is highly recommended. The purpose of a drip leg is to help prevent sediment/ debris from entering and clogging the furnace gas valve which could cause the furnace to shut down. We recommend having a drip leg installed at both furnaces by a qualified licensed HVAC contractor.

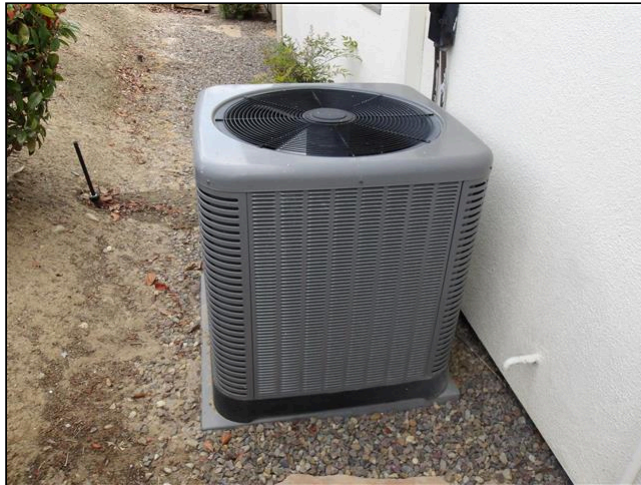
13.0.A Item 2(Picture)

(2) The AC condenser is making excessive noise when operating. We recommend further evaluation by a qualified licensed HVAC contractor to obtain an estimate of life remaining, or cost to repair/replace.

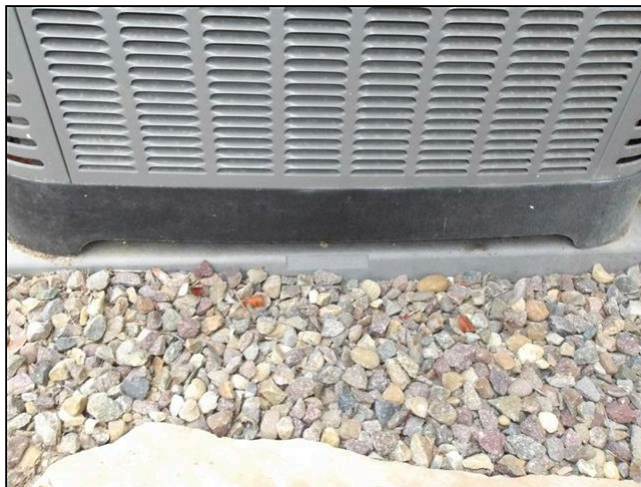
13.0.A Item 3(Picture)

(3) The AC unit(s) are not strapped to pad(s). Most manufacturers installation instructions require strapping condensers to the pads. Movement of the units due to internal vibration (or earthquake) can damage the refrigerant lines and their connections. We advise repair with qualified person.

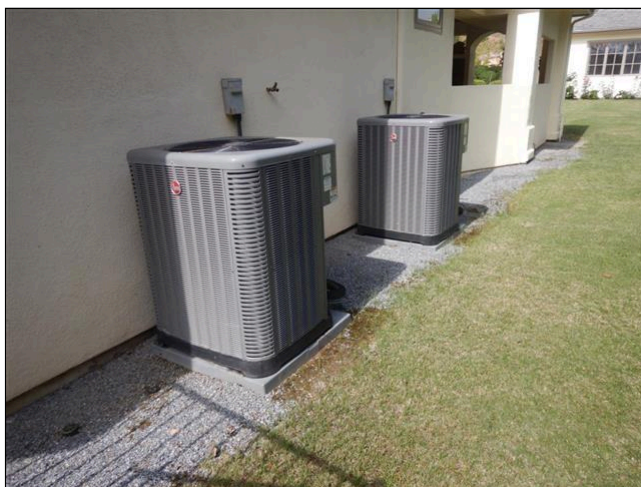
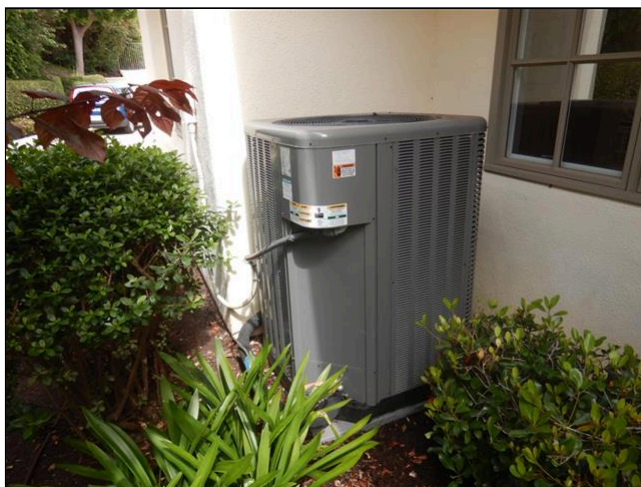
(1) **Photo of the A/C unit(s).**

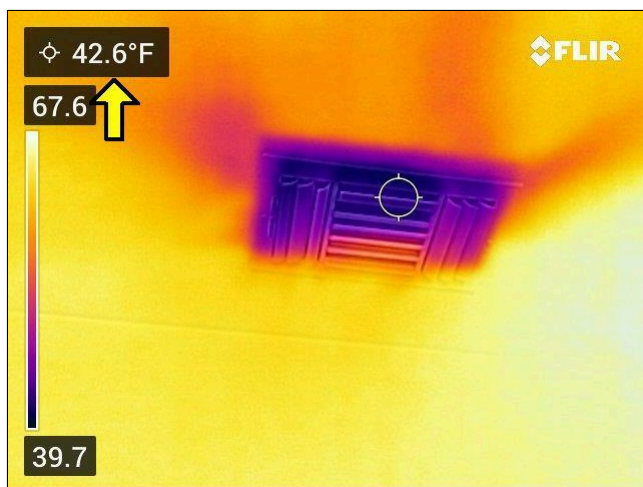
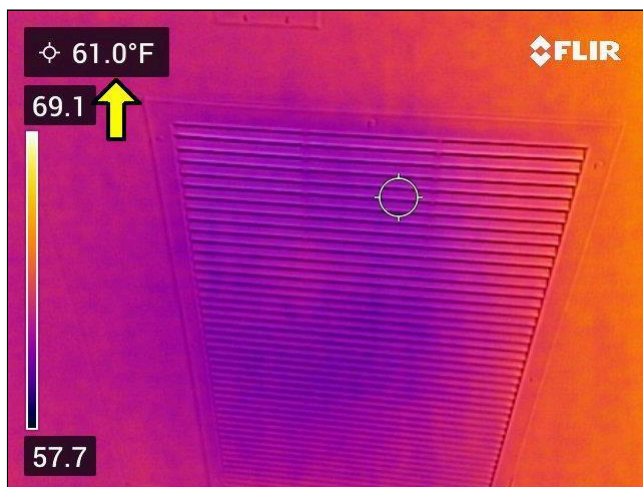
The air returning to the system (return) upstairs was measured at **61 degrees**.

This indicates that the range in temperature drop is normal at both AC systems. This is not an exhaustive test and cannot predict the performance of the AC systems on extremely hot or humid days.

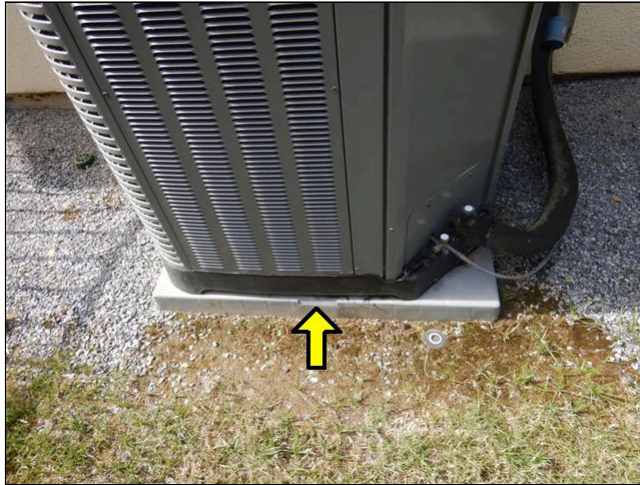
13.0.B Item 7(Picture)

(4) The AC unit(s) are not strapped to pad(s). Most manufacturers installation instructions require strapping condensers to the pads. Movement of the units due to internal vibration (or earthquake) can damage the refrigerant lines and their connections. We advise repair with qualified person.

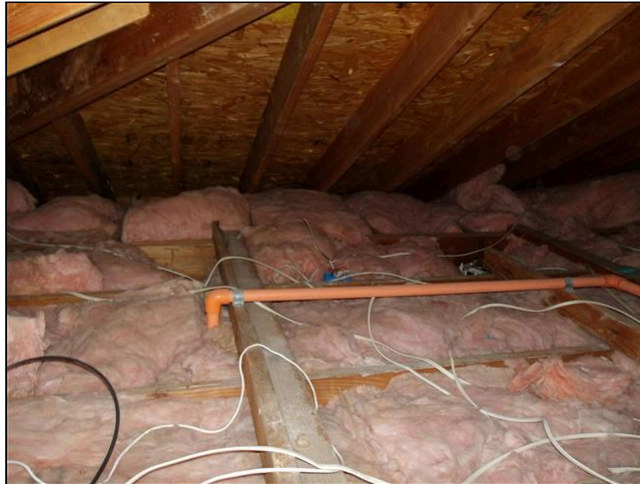
14.0.A Item 1(Picture)

- (1) [Photo of the insulation.](#)

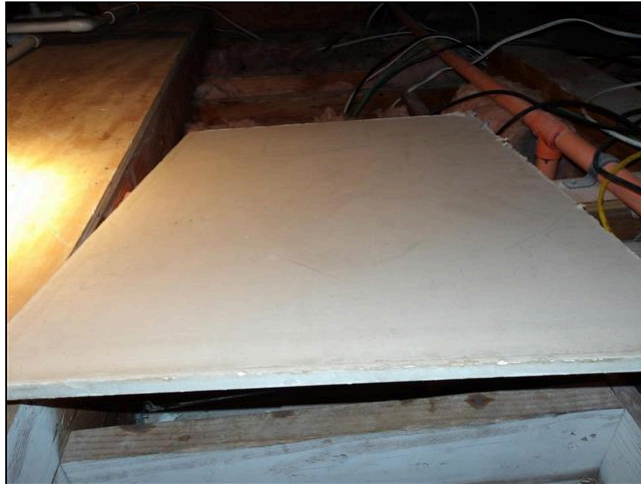
14.0.A Item 2(Picture)

- (2) The insulation in the attic appears to be functioning as intended.
- (3) The attic space access hatch cover is not insulated. We recommend insulating the attic access hatch cover to reduce unwanted heat loss/gain by a qualified person.

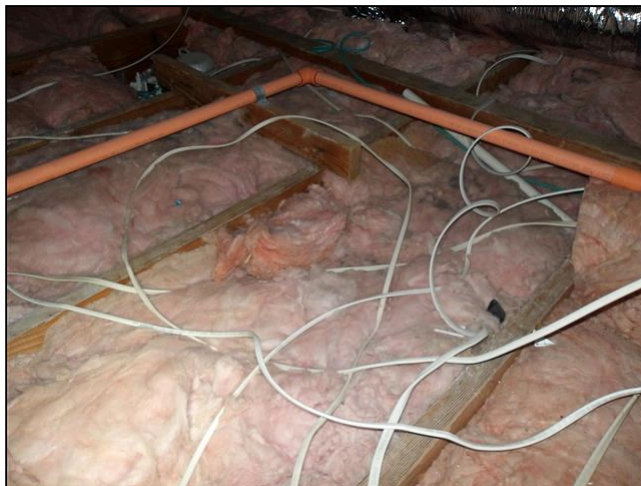
14.0.A Item 3(Picture)

- (4) Insulation was noted to be in contact with several recessed lights in the attic area. This is a safety/ fire hazard. We recommend removal/ necessary corrections by a qualified person.

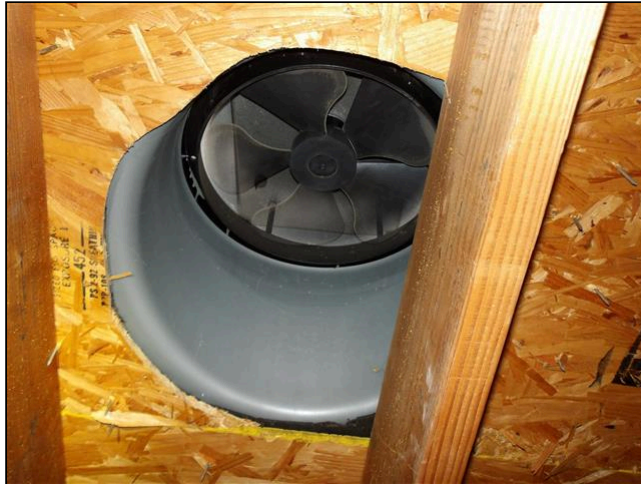
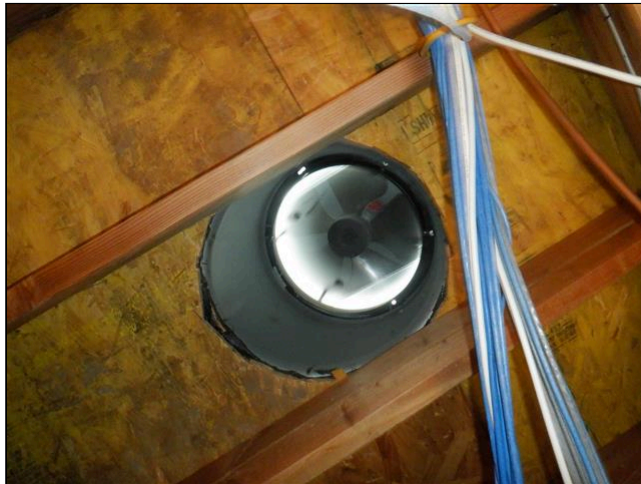
The attic vent fan did operate when tested at the time of the inspection.

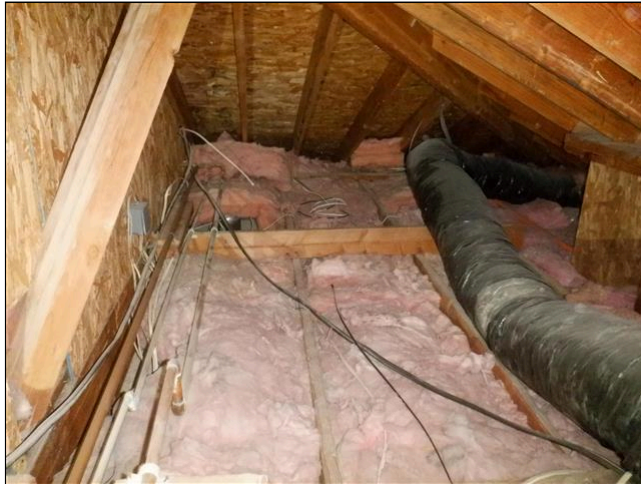
14.0.B Item 1(Picture)

- (1) [Photo of the insulation.](#)

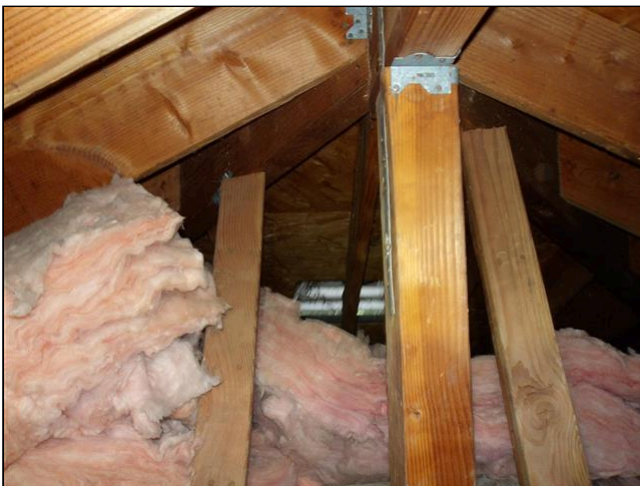
15.0.A Item 1(Picture)

- (1) [Photo of the attic space/ garage slab.](#)

- (2) At the time of the inspection, the Inspector observed no visual defects in the condition of the homes structure. A general home inspection does not include the evaluation of any structural components that are hidden behind floors, walls, or ceiling coverings. Such as anchor bolts, shear walls and seismic hardware, but is visual and non-invasive only.

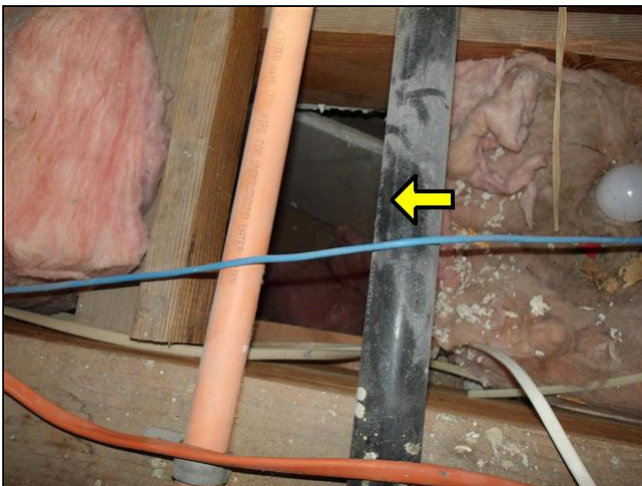
15.1.A Item 1(Picture)

(1) A hole was observed in the attic ceiling to the drop ceiling above the bathroom. We recommend further evaluation and any necessary repairs made by a qualified licensed contractor.

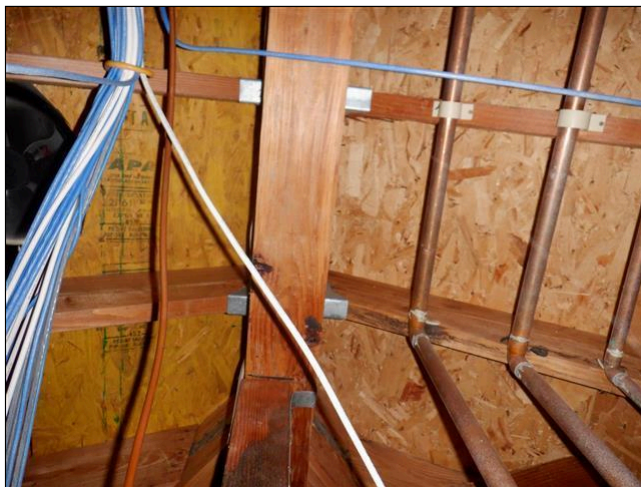
15.0.B Item 1(Picture)

(1) At the time of the inspection, the Inspector observed no visual defects in the condition of the homes structure. A general home inspection does not include the evaluation of any structural components that are hidden behind floors, walls, or ceiling coverings. Such as anchor bolts, shear walls and seismic hardware, but is visual and non-invasive only.

(2) [Photo of the attic space.](#)

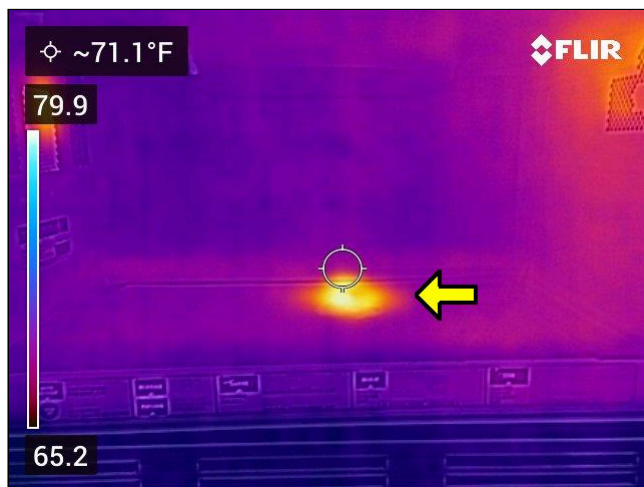
16.0 Item 1(Picture)

Photo of microwave being tested.

The built in microwave was tested with a microwave testing device and was functional at the time of the inspection. This is not an exhaustive test, and does not predict the performance of the microwave.

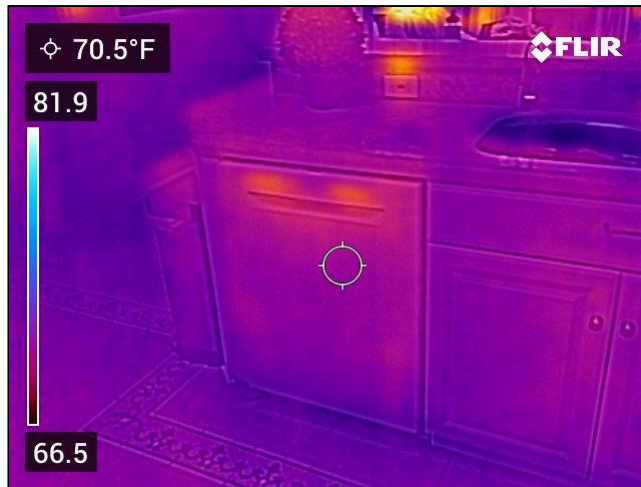
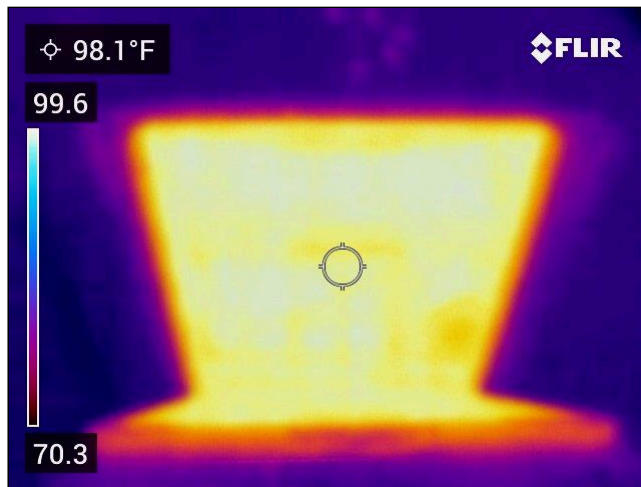
Infrared Thermal photo of the dishwasher being tested.

The dishwasher was tested and functioned properly at the time of the inspection. This is not an exhaustive test and does not verify the cleaning efficiency of the dishwasher.

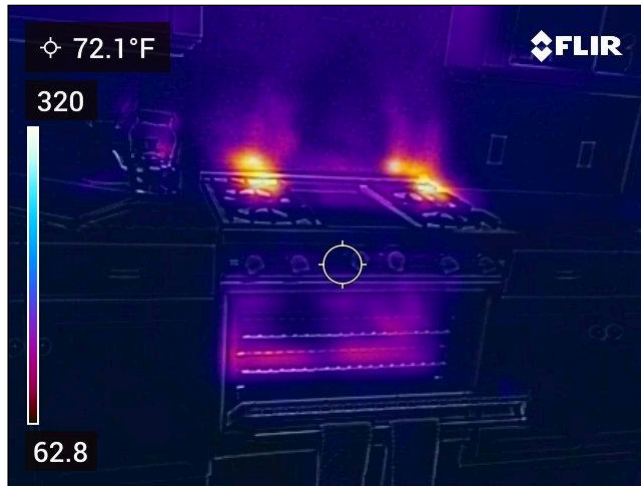
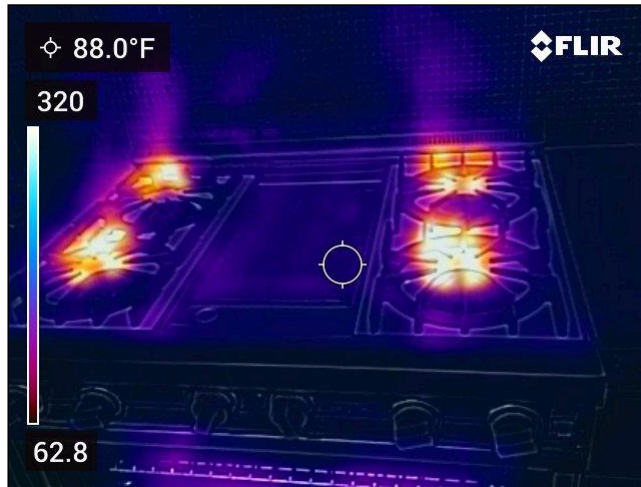
Infrared Thermal photo of the oven being tested.

The oven was tested and was functional at the time of the inspection. This test is not exhaustive and does not confirm the performance, accuracy, or effectiveness of the oven.

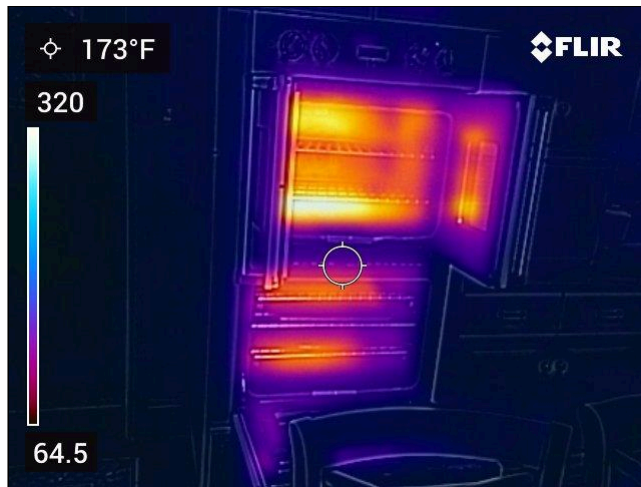
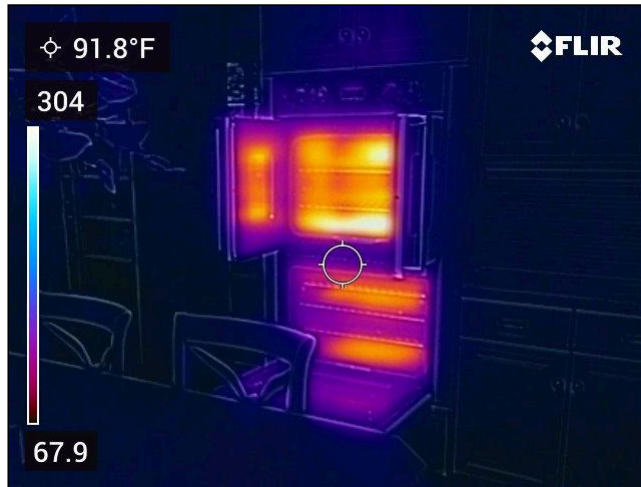
Infrared Thermal photo of the wall oven(s) being tested.

Both of the wall ovens were tested and were both functional at the time of the inspection. This test is not exhaustive and does not confirm the performance, accuracy, or effectiveness of the wall ovens.

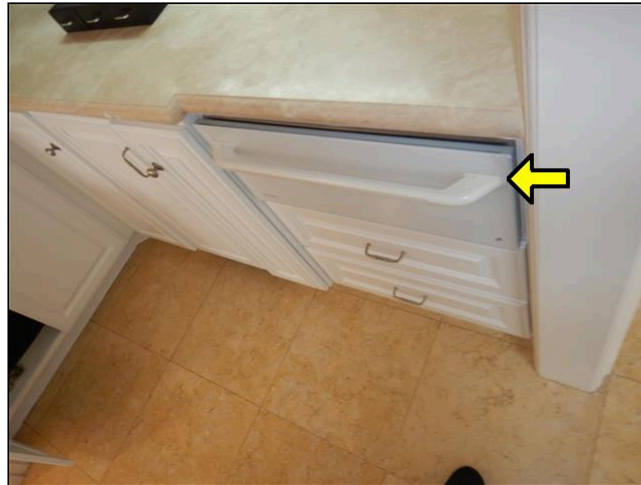
16.7 Item 1(Picture)

The warming drawer did not function when tested at the time of the inspection. We recommend further evaluation and necessary repairs or replacing by a qualified licensed appliance contractor.

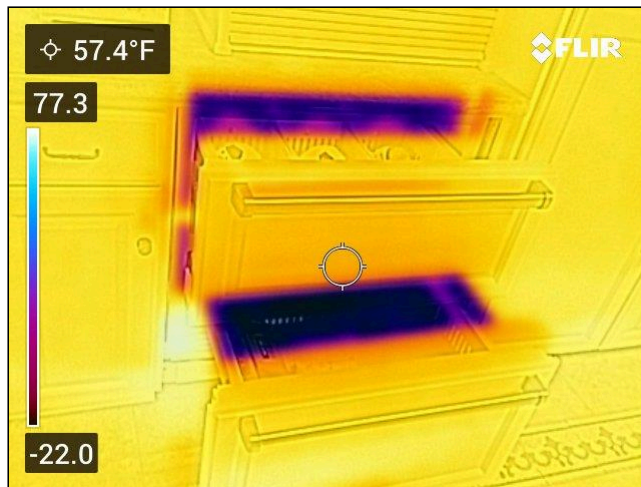
16.8 Item 1(Picture)

Both of the cooling drawers were tested and were both functional at the time of the inspection. This test is not exhaustive and does not confirm the performance, accuracy, or effectiveness of the cooling drawers.

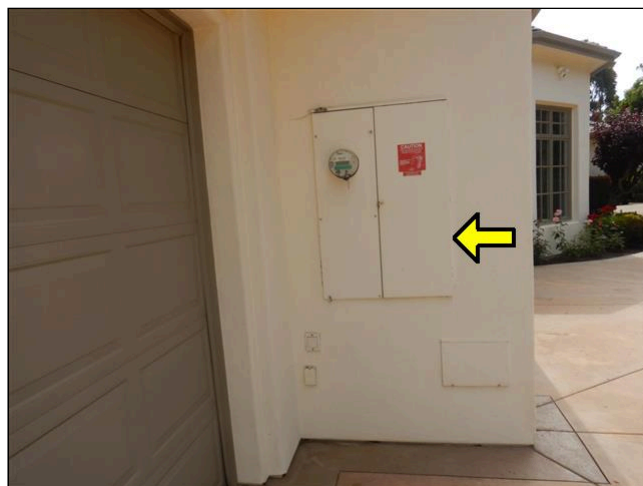
17.1 Item 1(Picture)

The Main Electrical panel is located at the left exterior side of the property (facing front).

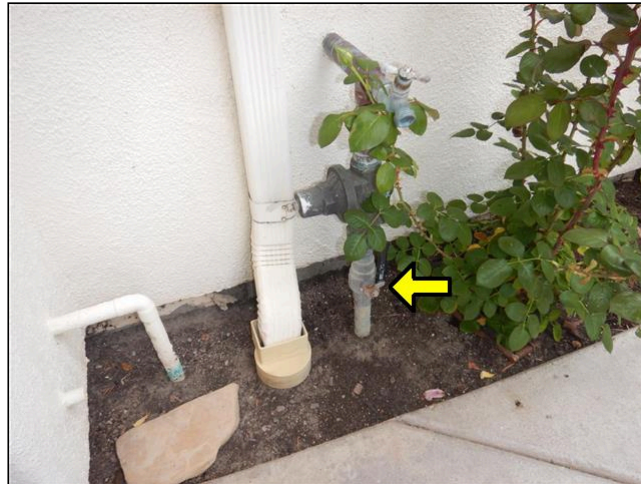
17.2 Item 1(Picture)

The main water shut-off valve is located at the left exterior side of the property (facing front).

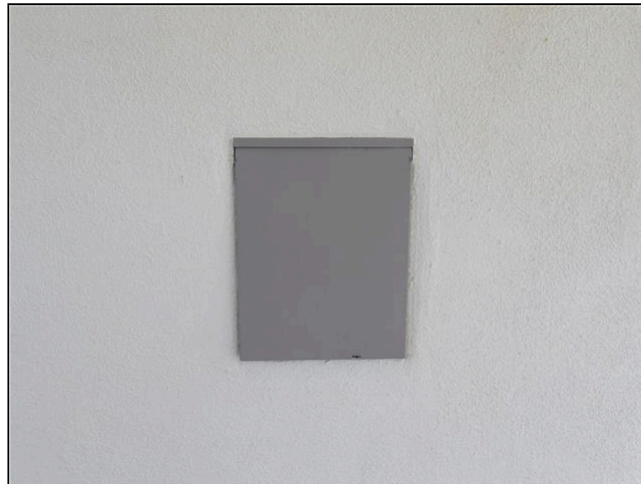
17.3 Item 1(Picture)

(1) A sub panel is located on the front exterior of the guest house.

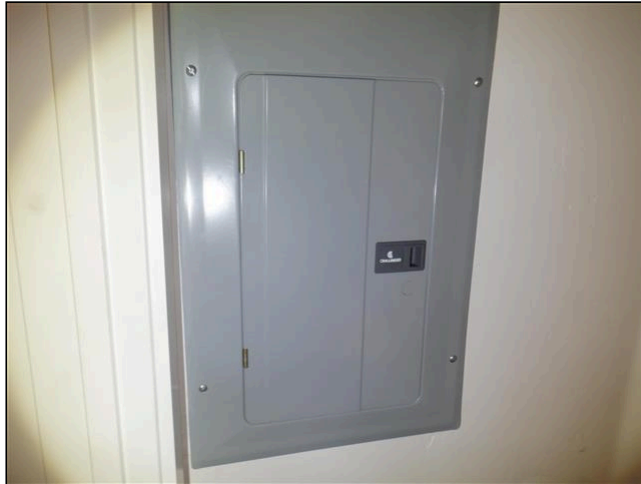
17.3 Item 2(Picture)

(2) A sub panel is located in the right side hall closet.

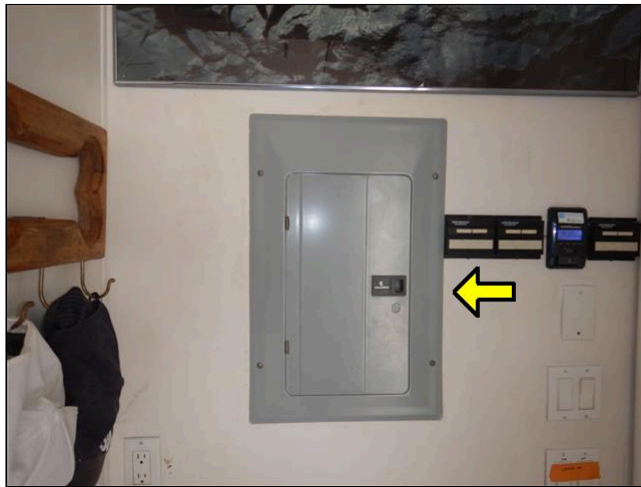
17.3 Item 3(Picture)

(3) A sub-panel is located in the garage.

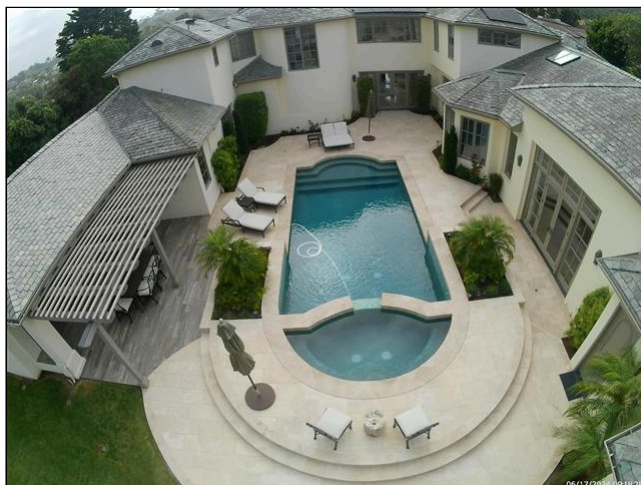
18.0 Item 1(Picture)

(1) Photo of the pool/ spa.

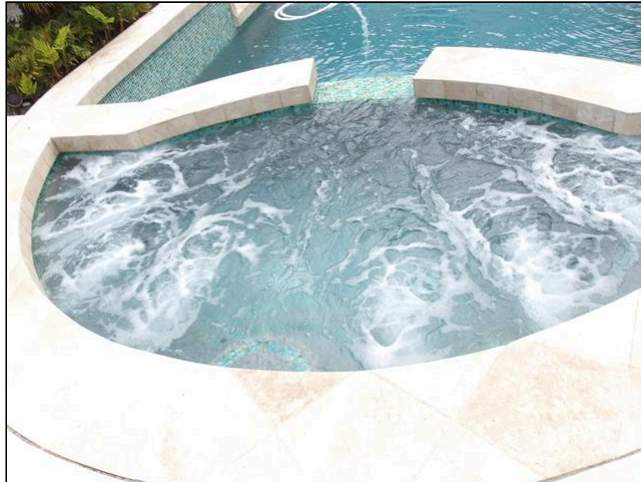
18.1 Item 1(Picture)

(1) The spa jets functioned when tested.

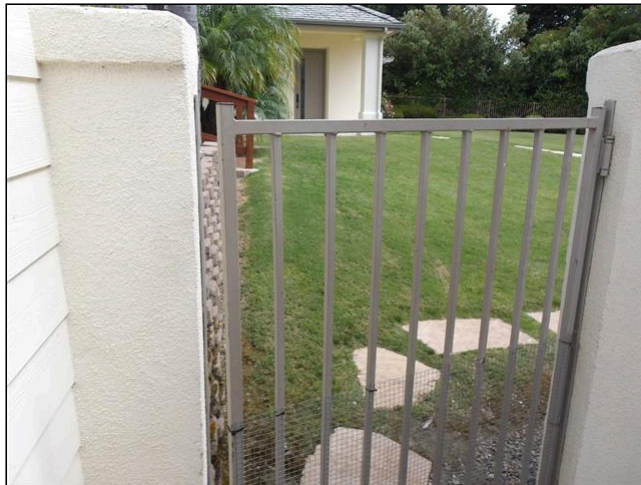
18.2 Item 1(Picture)

(1) There is no self-closing device at the left side pool gate. Gates providing access to the pool area must self close and latch without assistance. This is a safety concern. We recommend having a self-closing device installed by a qualified person.

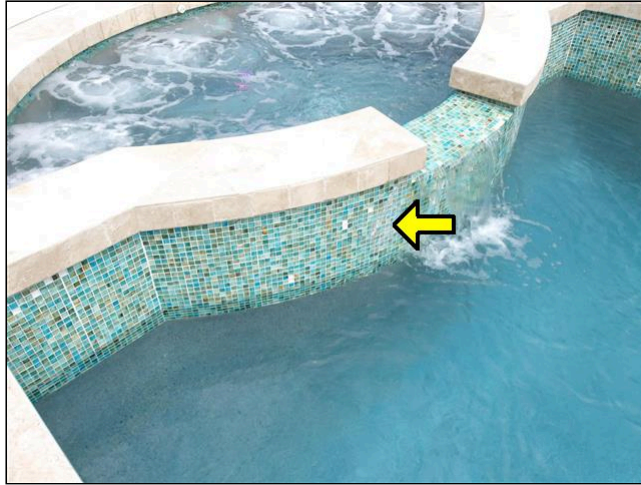
18.3 Item 1(Picture)

(1) Calcium nodules are observed at the pool surface. This can be caused by poor chemical maintenance or unbalanced Ph levels. We recommend further evaluation by a qualified licensed pool contractor prior to the end of your contingency period.

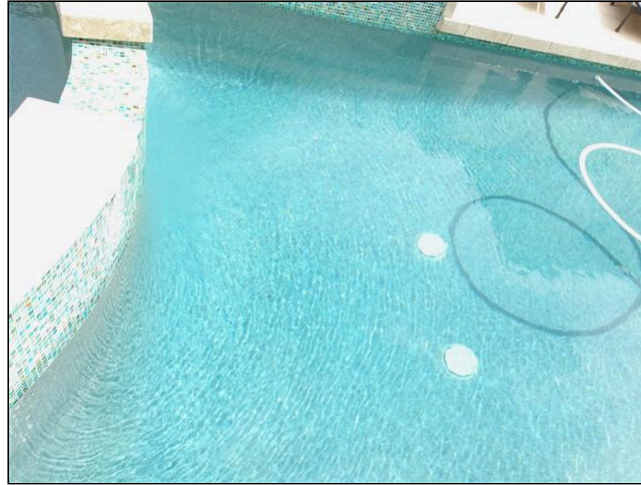
18.4 Item 1(Picture)

There are no steps or ladders to exit the pool. This poses a potential drowning hazard. We recommend installing steps or a ladder by a qualified licensed pool contractor for safety.

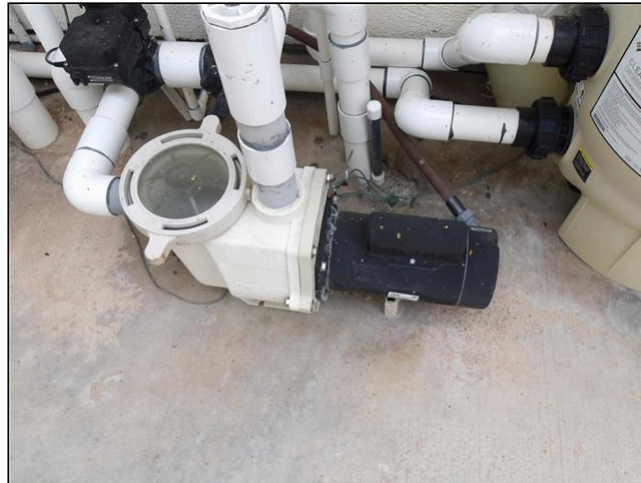
18.5 Item 1(Picture)

(1) The pool/spa pump(s) were tested and were found to be operational at the time of the inspection. Pumps are not evaluated for capacity, efficiency, flow rate or pressure.

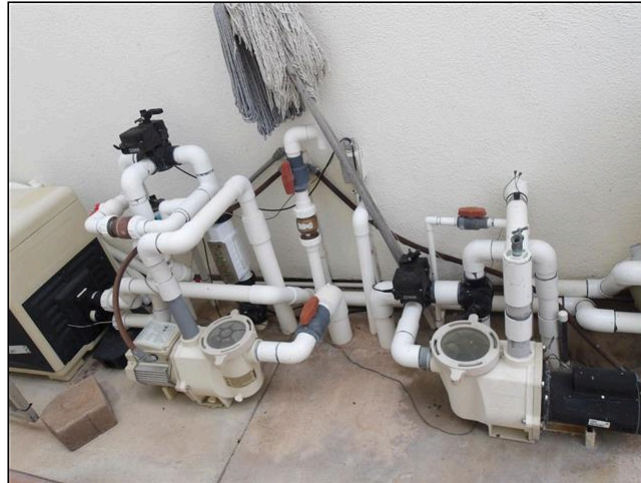
18.5 Item 2(Picture)

(2) **Note:** White plastic PVC pipes were exposed to direct sunlight at pool equipment. This type material is deteriorated by the ultra-violet (UV) radiation in sunlight, and this condition will result in premature failure of pipes compared to similar pipes protected from UV.

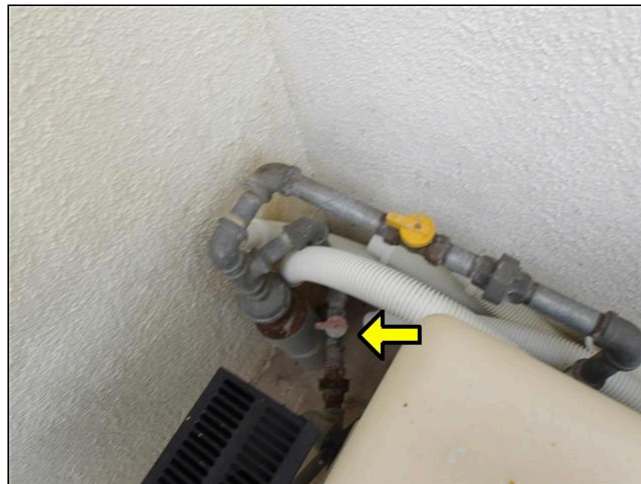
18.6 Item 1(Picture)

(1) The pool furnace was off at the time of the inspection. The gas supply has been turned off. Home inspectors do not light pilots. We recommend further evaluation and verifying that the system operates by a qualified licensed pool contractor prior to the end of your contingency period.

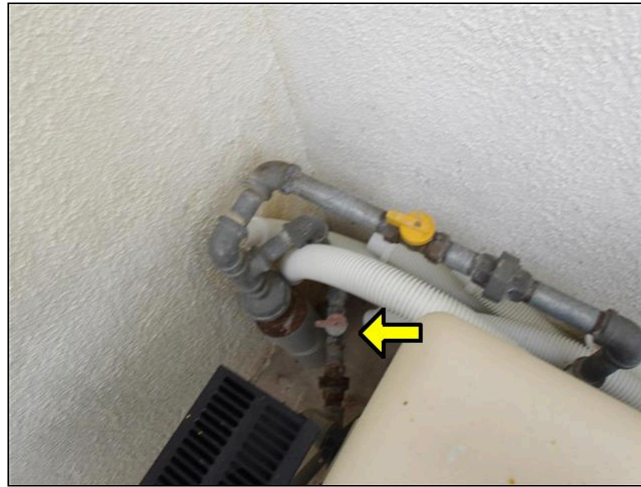
18.6 Item 2(Picture)

(2) The gas supply pipe at the pool/ spa heater did not contained a drip leg/ sediment trap. This may have been standard at the time of installation but now is highly recommended. The purpose of a drip leg is to prevent sediment/ debris from entering and clogging the heater gas valve which could cause the heater to shut down. We recommend having a drip leg installed by a qualified licensed plumber or licensed pool contractor.

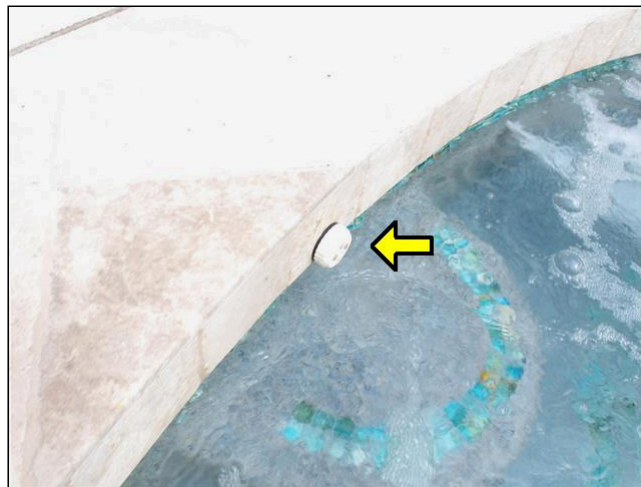
18.7 Item 1(Picture)

(1) The control button(s) located at the spa did not function when tested. We recommend further evaluation by a qualified licensed pool contractor prior to the end of your contingency period and necessary repair or replacement as needed.

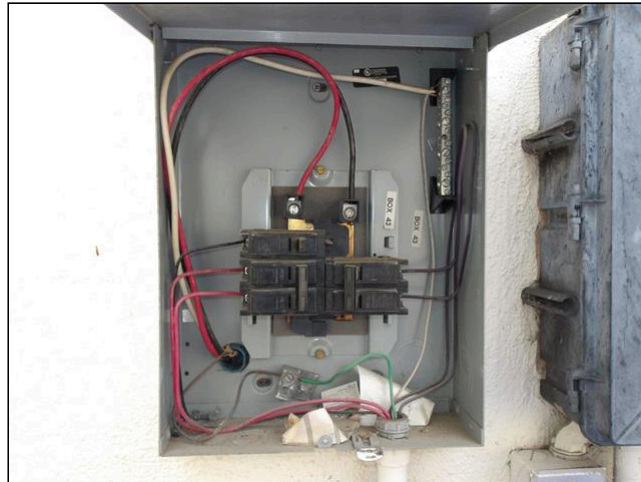
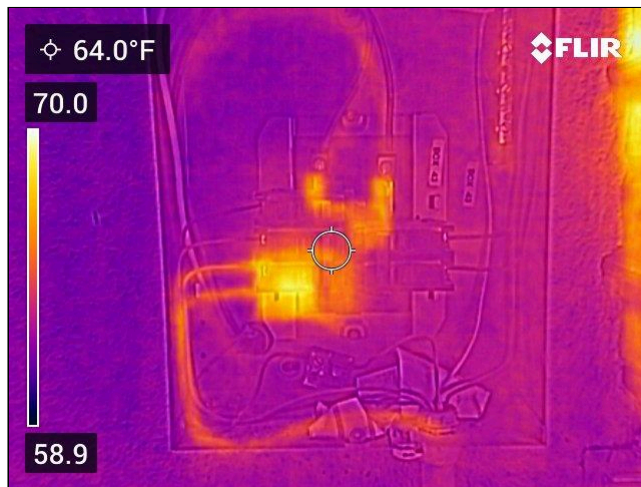
18.7 Item 2(Picture)

(2) Picture inside the pool sub-panel. The dead front cover was removed and breakers, wiring and grounding were inspected. Appears to be functioning as intended.

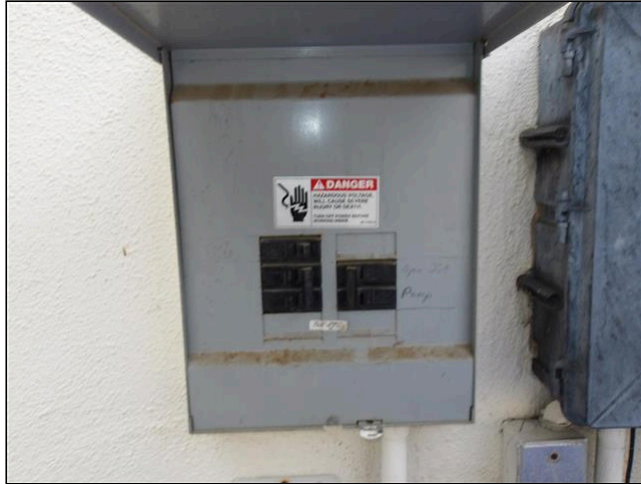
18.7 Item 4(Picture)

(3) The pool equipment electric panel breaker labels are illegible. We recommend having the breakers properly labeled for safety by a qualified person.

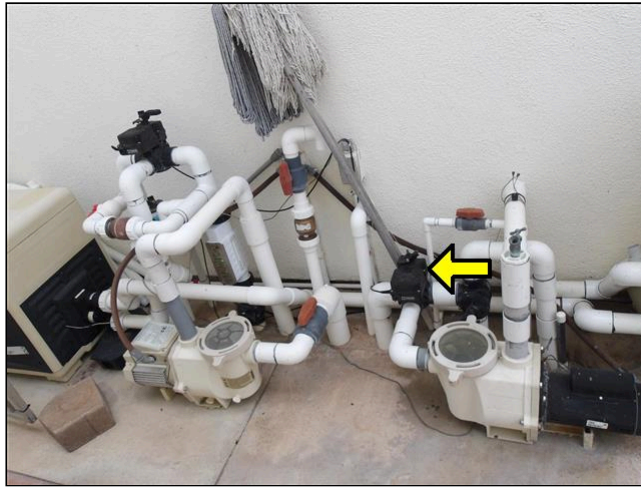
18.8 Item 1(Picture)

A valve handle is damaged. We recommend replacement by a qualified licensed pool contractor.

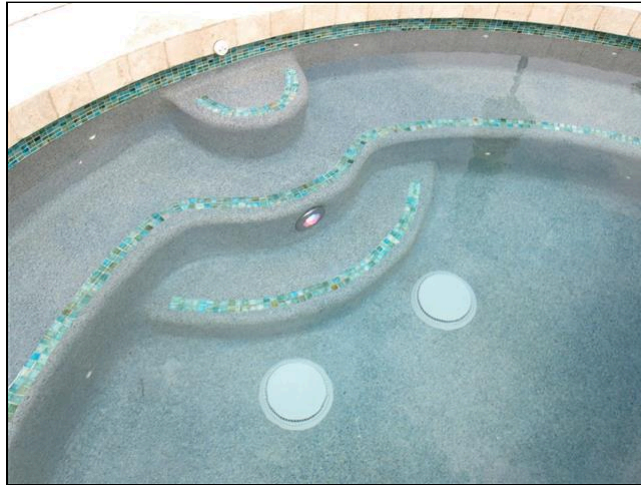
18.13 Item 1(Picture)

(1) The spa light(s) operated when tested.

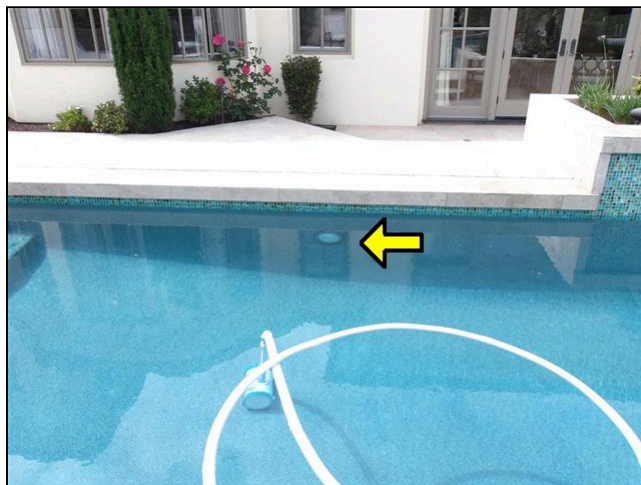
18.13 Item 2(Picture)

(2) The pool light(s) did not function when tested. We recommend further evaluation and repair or replacement as needed by a qualified pool contractor.

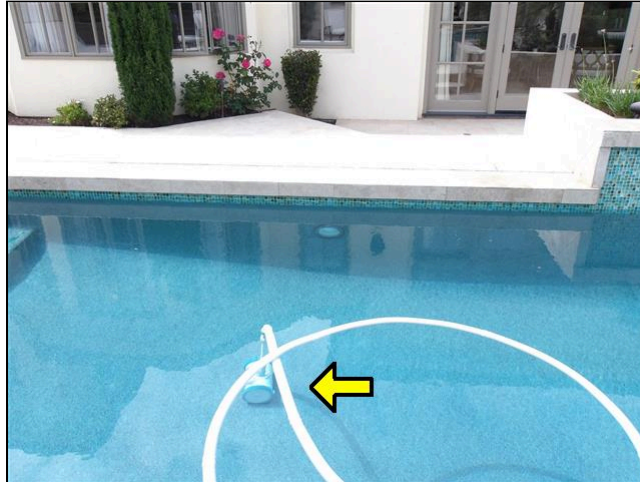
18.16 Item 1(Picture)

The pool sweep functioned at the time of the inspection. This is not an exhaustive test and does not verify the cleaning efficiency of the unit.

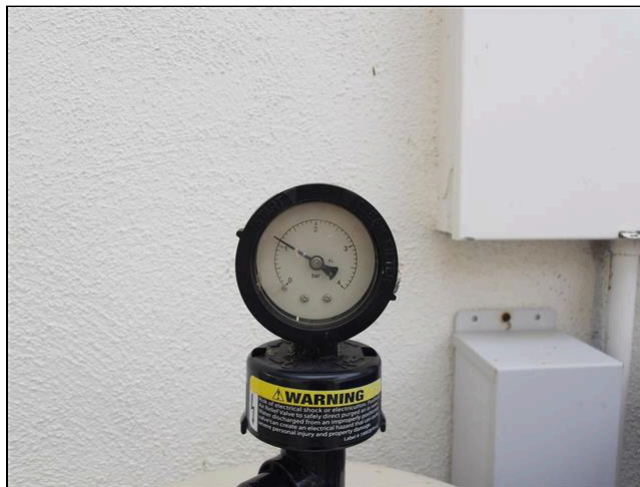
18.17 Item 1(Picture)

The filter appeared to be functional at the time of the inspection. This is not an exhaustive test and does not verify the cleaning efficiency of the unit.

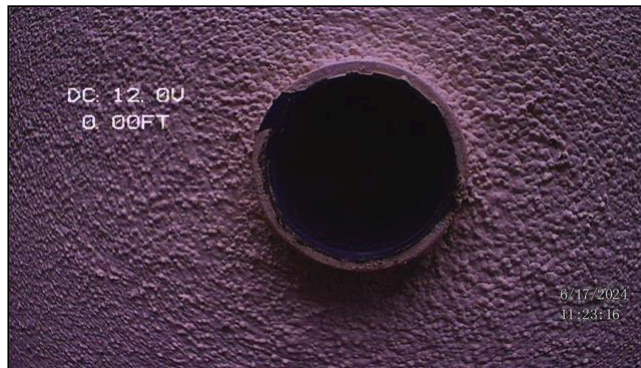
19.3 Item 1(Picture)

The main sewer line was inspected by inserting the camera at the sewer line clean out at the right side of the property master bathroom.

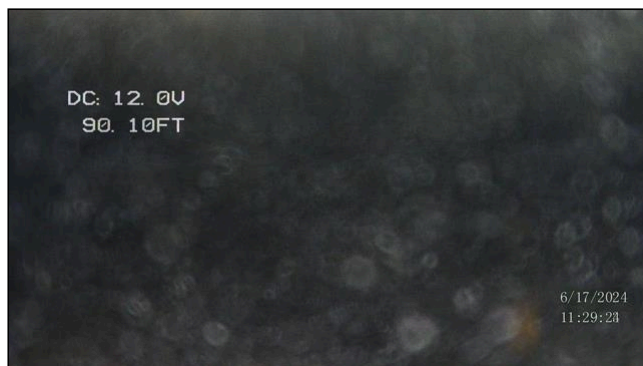
19.4 Item 1(Picture)

(1) The main sewer pipe was holding water at approximately 90 feet from the access point. We recommend further evaluation prior to the end of your contingency period by a licensed plumber and necessary repairs or replacement made as needed.

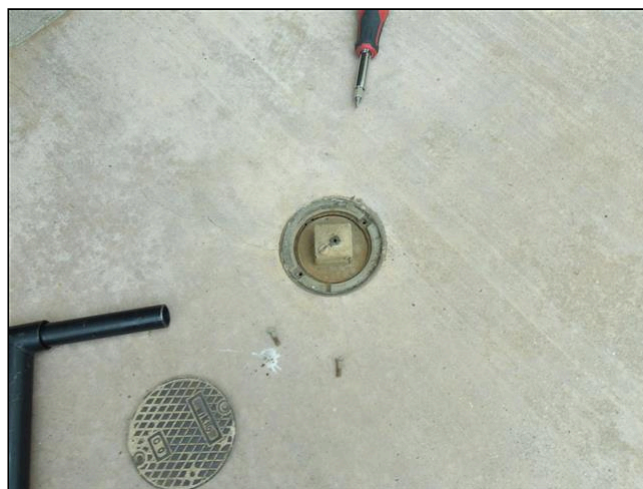
19.4 Item 2(Picture)

(2) The clean out drain plug (cap) of the main sewer pipe in front of the garage could not be made to come off. Due to this condition the main sewer pipe could not be inspected through this cleanout and was inspected through the master bathroom cleanout. We recommend contacting a licensed plumber and having this clean out cap removed and the main sewer pipe inspected prior to the end of your contingency period by this company.
